**Re. SSD-65490715 Central Park Bradfield City Centre - Post Approval Document Submission  
Condition C11 – Dilapidation Report**

# Dilapidation Inspection Report

Council Assets – 215 Badgerys Creek Rd, Bradfield NSW 2556

W03125.CA.DLP

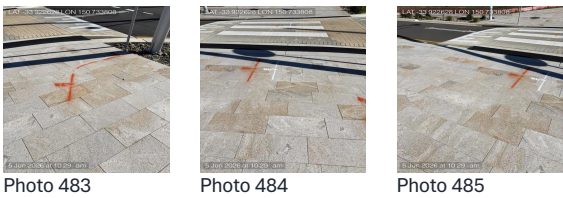
LocationNorth end

Defect descriptionSpray paint to pavers

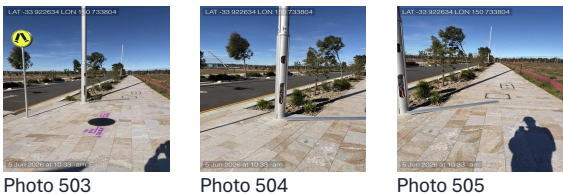
Service cover removed from light pole

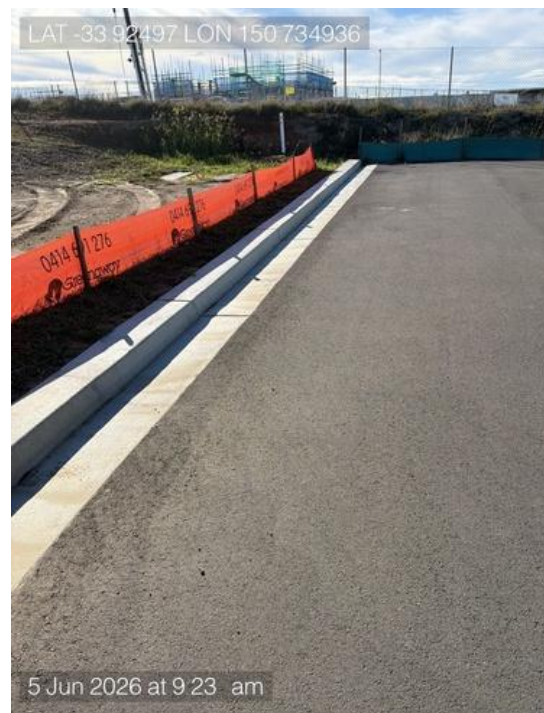
Photo 36

Approximately 7 metres west from start north kerb

Fine crack

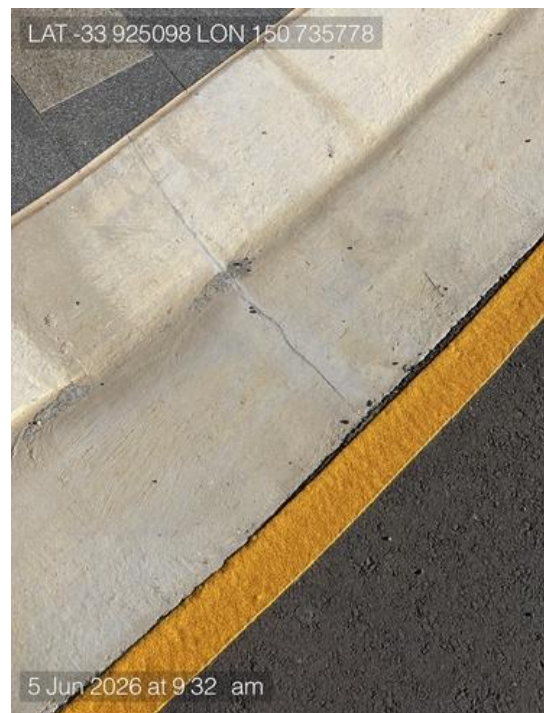
Photo 120

| <b>Location</b> | Southwest corner of south intersection |
| <b>Defect description</b> | Cracking to layback |
