HUNTER INDOOR SPORTS CENTRE (HISC)

ARBORICULTURAL IMPACT ASSESSMENT

MAY 2024

Arboricultural Impact Assessment

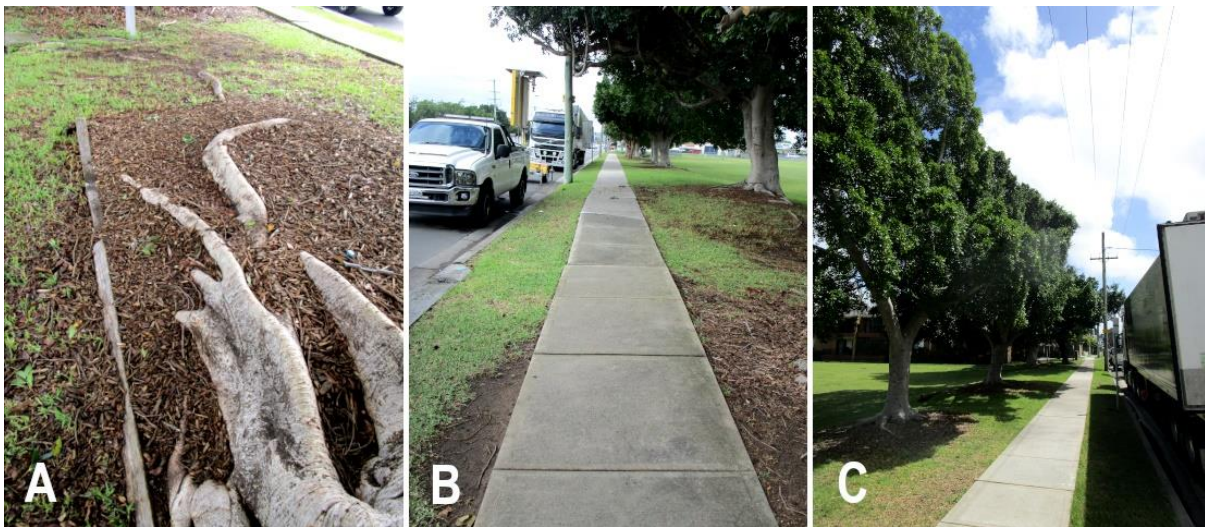
FIGURE 5: TREES 1-12 – COMMON PROBLEMS

Trees 1-12 are located along the eastern boundary and running parallel to Turton Road. They are comprised mainly of *Ficus microcarpa* var. *hillii* (Hills Weeping Fig) growing within a formed garden bed that has come into disrepair. The timber edging used to form the garden bed on the western side has acted as a root deflector for the surface roots resulting in the early surface roots running north and south (Figure 5A). Deeper roots have spread beyond the timber edge and can be seen growing away from the trunk of the tree in a typical radial configuration. It is unlikely that the current root pattern, although not desirable, will result in pronounced instability for the figs as they develop in size. Most of the figs have included bark at branch junctions that on occasions can lead to failure end weights become excessive. This is a typical characteristic of these figs if not specifically bred to avoid this tendency. In some instances, the roots of the trees have led the lifting of the nearby footpath resulting in some sections having to be repaired (Figure 5B). Most trees in this grouping have had to have their canopies trimmed to provide clearances to the powerlines occurring alongside Turton Road (Figure 5C) resulting in asymmetric canopies. All trees in this group (Trees 1-12) except for Trees 4 and 6, are good specimens.

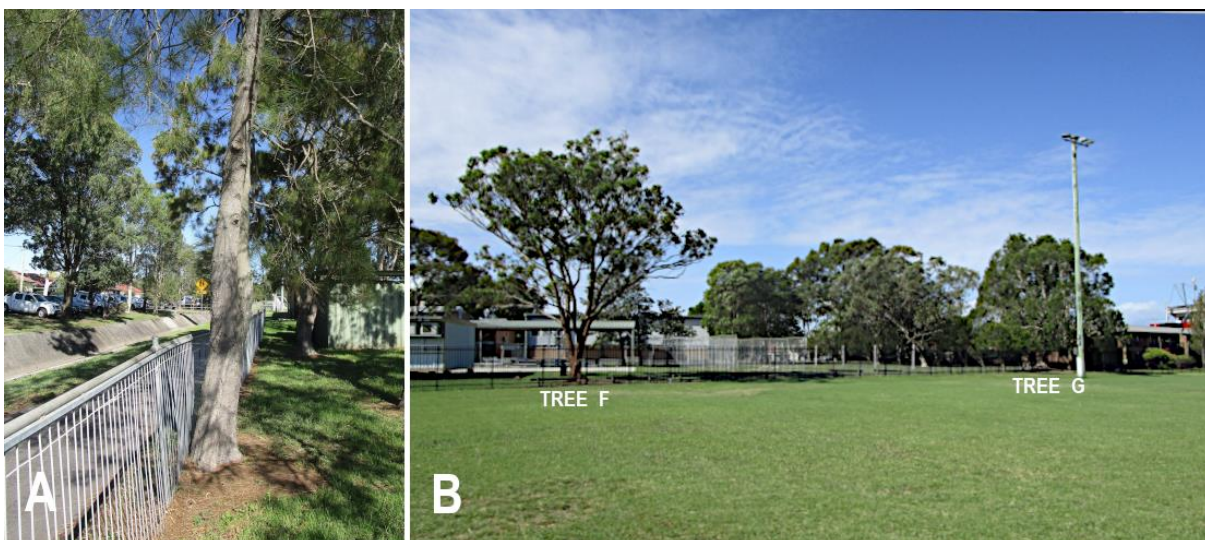
FIGURE 6: TREES 13, F & G

Trees 13-19 occur along the southern boundary as a group of 6 and a single tree. Tree species are either *Casuarina glauca* (Swamp She-oak) or *Melaleuca quiquenervia* (Swamp Paperbark). All trees with the exception of Tree 16 are in good condition. Tree 16 is in decline and consideration should be given to its removal and replacement although not critical at this stage. Trees 13 and 19 are located close to the fenceline and are causing damage to the fence (Figure 6A). Consideration should be given to removing the affected fencing panels to prevent possible damage to the trees and allow future growth to be unimpeded.

Trees A – F are without significant problems that would justify their removal. All are suitable for retention.

Trees 7, 16, F and G have been assessed as being "Threatened". Although the encroachments for these trees exceeds the requirements of AS 4970, it is considered that the type of encroachment and with proper management of the areas associated with the trees including implementing the the Tree Protection Plan (Appendix D), it will be possible for these trees to be retained.

It is considered reasonable to take the effort in retaining Trees 16, F and G with the understanding that should they fail, then compensatory planting will need to be undertaken.

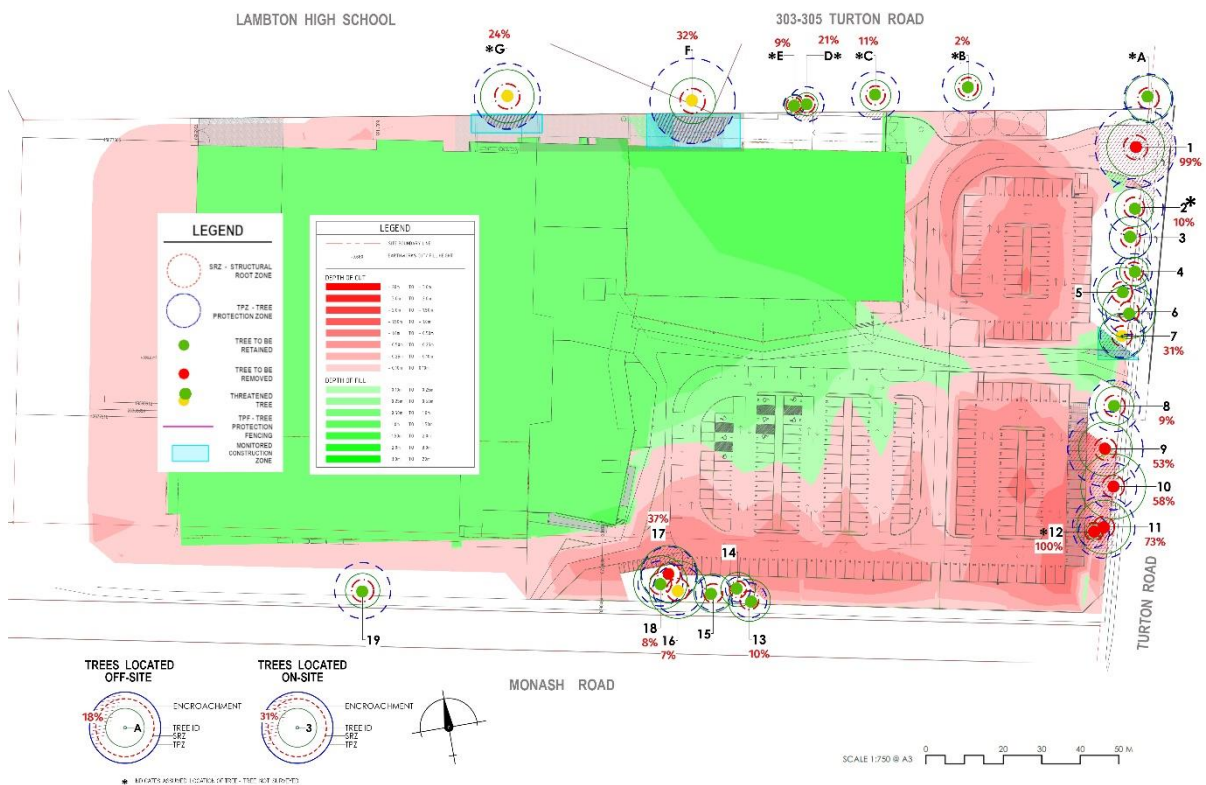
FIGURE 8: TREE IMPACT ASSESSMENT DIAGRAM.
[SOURCE: E.E ARCHITECTURE]

Figure 8 (and Appendix C2) shows that Trees 1, 9, 10, 11, 12 & 17 will need to be removed based on the proposed design.

On-site, Trees 2, 3, 4, 5, 6, 8, 13, 14, 15, 18 and 19 will not be impacted by the the proposed works as the TPZs of these trees will be subjected to minor encroachments only, if at all. Off-site Trees A, B, C, D, and E will also be retained as encroachments are within acceptable limits of encroachment having regard to their locations, type of tree and condition. It should be noted that Tree D has an encroachment of 21% which is the upper tolerance for this species having average health. Nevertheless routine monitoring will be required.

The encroachment for Tree 7 is a combination of 11% reduced root plate within the TPZ and a 20% change of levels with the addition of fill. It is proposed that during the detailed design, that the amount of fill covering the root plate will be locally reduced to an extent that will not impact significantly on the tree. Levels within the TPZ of Tree F are not being modified greatly as a suspended ramp is proposed for the ramped section of road including approaches. The amount of cover is shown as a 32% encroachment, although the impact will be considerably less. At the detailed design stage, an allowance will need to be made that permits water to enter under the slab to prevent the soil from drying out in this area. Tree G has a 34% encroachment due to a reduction of levels and the installation of a decomposed granite track. Levels within the TPZ of Tree G are being reduced by no greater than 100mm which is not significant for a Swamp Mahogany

Tree 16 has also been noted as being "Threatened". This tree is in decline and even if left undisturbed, it is likely to fail. By removing the existing containers and making changes nearby, it is likely that its decline will be hastened although not directly affected by the construction works. It would be possible to minimise the decline by removing grass from around the base of the tree and covering the exposed area with an organic mulch.

- that Trees 1, 9, 10, 11, 12 & 17 be removed;
- that Trees 2, 3, 4, 5, 6, 8, 13, 14, 15, 18, 19, A, B, C, D, and E be retained; and,
- that Trees 7, 16, F and G be retained by following the requirements of the Tree Protection Plan (refe Appendix D) subject to careful detailing during the detailed design and documentation phases and further investigations occurring at the commencement of construction to ensure major roots are not damaged and/or further action taken.

Further, to compensate for the loss of Trees 1, 9, 10, 11, 12 and 17, it is recommended that 28 standard trees [45litre] be planted on the site. Compensatory planting has been calculated using Section 4.3 of the *Newcastle Urban Forest Technical Manual* using a rate of one standard tree/20m² of projected crown cover (i.e. 550m² of combined projected cover for the 6 trees to be removed). This can be addressed as a condition within the Notice of Determination as can the requirement that the Tree Protection Plan described in Appendix D be implemented.

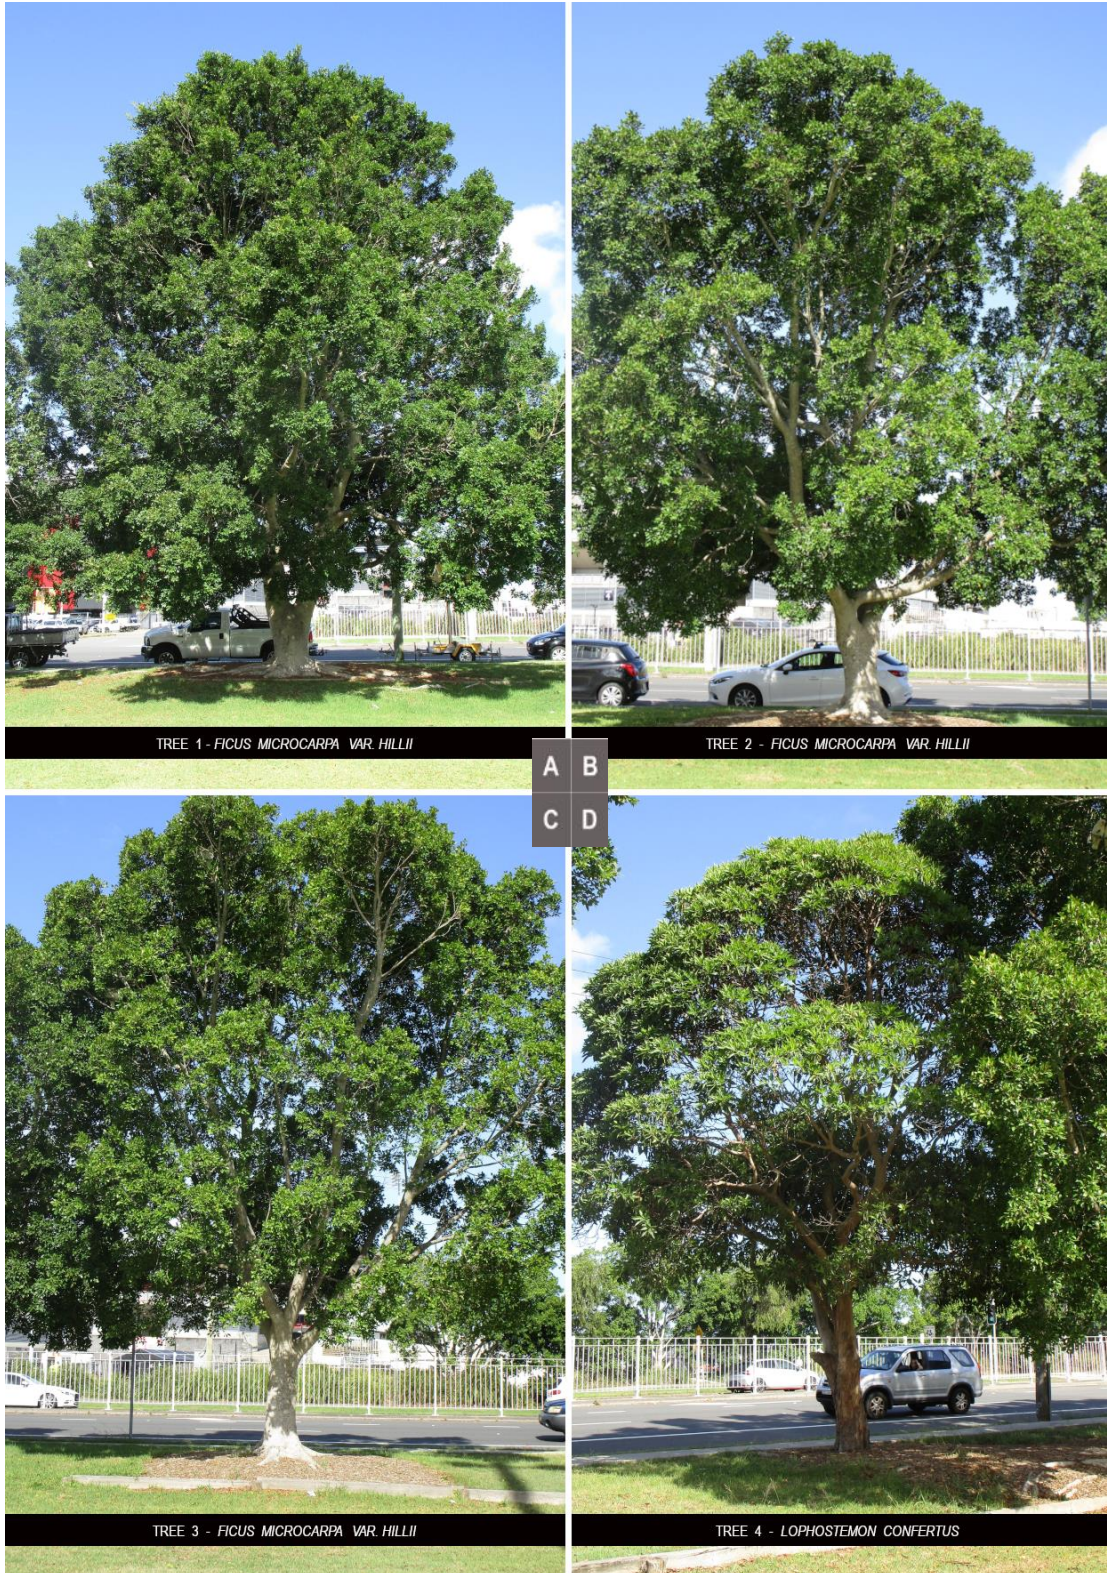
FIGURE A1: Trees 1-4

3	<i>Ficus microcarpa var. hillii</i>	Hills Weeping Fig	M	11	460	5.52	540	2.55	+40	AV	AV	A1	A1C	3. [CoN TREE ID 67123] LARGE SURFACE ROOTS MANY RUNNING PARALLEL TO ROAD DUE TO THE PRESENCE OF TIMBER EDGING TO THE WEST AND FOOTPATH TO THE EAST. TREE ROOTS NOW RUNNING BEYOND EDGING AND INTO NEARBY TURF. PRUNING TO ROADSIDE CANOPY RESULTING IN AN ASYMMETRIC CANOPY. TO BE RETAINED
4	<i>Lophostemon confertus</i>	Brush Box	M	7.5	390 ¹	4.68	480	2.43	15-40	P	AV	A1	A1D	4. [CoN TREE ID 67122] [DBH: 300/250] TREE PLANTED CLOSER TO POWERLINES. PRUNING TO ROADSIDE CANOPY RESULTING IN AN ASYMMETRIC CANOPY. EPICORMIC GROWTH PRESENT AT PRUNING SITES. SNAPPED FIRST ORDER BRANCH WITH BRANCH TEAR (OLD). TO BE RETAINED
5	<i>Ficus microcarpa var. hillii</i>	Hills Weeping Fig	M	13	630	7.56	630	2.73	+40	AV	AV	A1	A2A	5. [CoN TREE ID 67121] TREE WITH SLIGHT LEAN TO THE WEST. TREE DISLODGING EDGING. LARGE SURFACE ROOTS MANY RUNNING PARALLEL TO ROAD DUE TO THE PRESENCE OF TIMBER EDGING TO THE WEST AND FOOTPATH TO THE EAST. TREE ROOTS NOW RUNNING BEYOND EDGING AND INTO NEARBY TURF. MINOR ENCROACHMENT. TO BE RETAINED

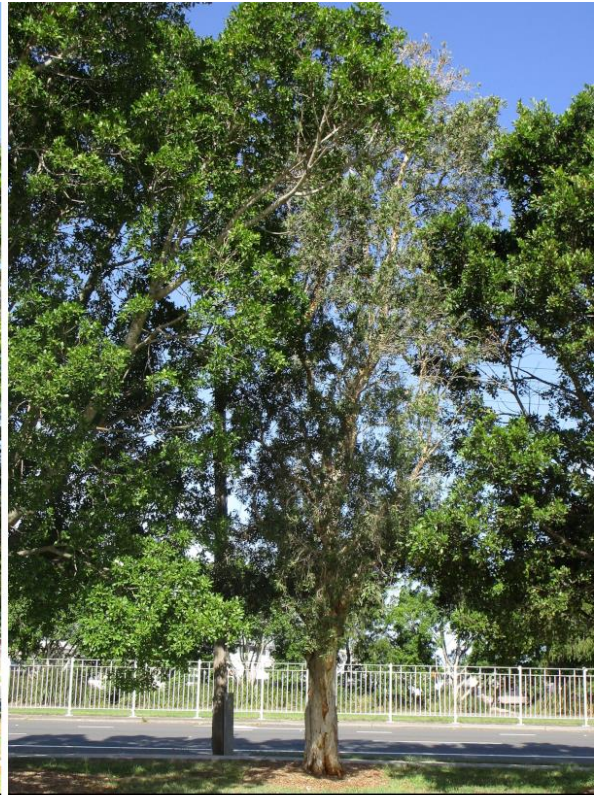
TREE 6 - *MELALEUCA QUINQUENERVIA*

6	<i>Melaleuca quinquenervia</i>	Swamp Paperbark	M	14	500 ¹	6.00	600	2.67	15-40	P	AV	A1	A2B	6. [CoN TREE ID 67120] [DBH: 240/440] EXTENSIVE PRUNING INCLUDING THE REMOVAL OF A ROADSIDE CO-DOMINANT TRUNK. PAST BORER ACTIVITY NOTED. PRUNING TO ROADSIDE CANOPY RESULTING IN AN ASYMMETRIC CANOPY. MODERATE CANOPY DENSITY. TO BE RETAINED
7	<i>Ficus microcarpa var. hillii</i>	Hills Weeping Fig	M	12	470	5.64	570	2.61	+40	AV	AV	A1	A2C	7. [CoN TREE ID 67119] TREE WITH UPRIGHT FORM PARTIALLY DUE TO REDUCTION OF CANOPY. ROOT GROWTH MODIFIED BY TIMBER EDGING BUT NOT AS MARKEDLY AS OTHER LOCATIONS. THE TREE WILL NEED TO BE MONITORED DURING CONSTRUCTION AND AN EFFORT TO REDUCE FILL LEVELS WITHIN THE TPZ.
8	<i>Ficus microcarpa var. hillii</i>	Hills Weeping Fig	M	10	560	6.72	650	2.76	+40	F	AV	A1	A2D	8. [CoN TREE ID 67118] TREE CONTAINS ONE NEST. GOOD, SPREADING CANOPY WITH SOMEWHAT CROWDED FORM. MINOR ENCROACHMENT. TO BE RETAINED

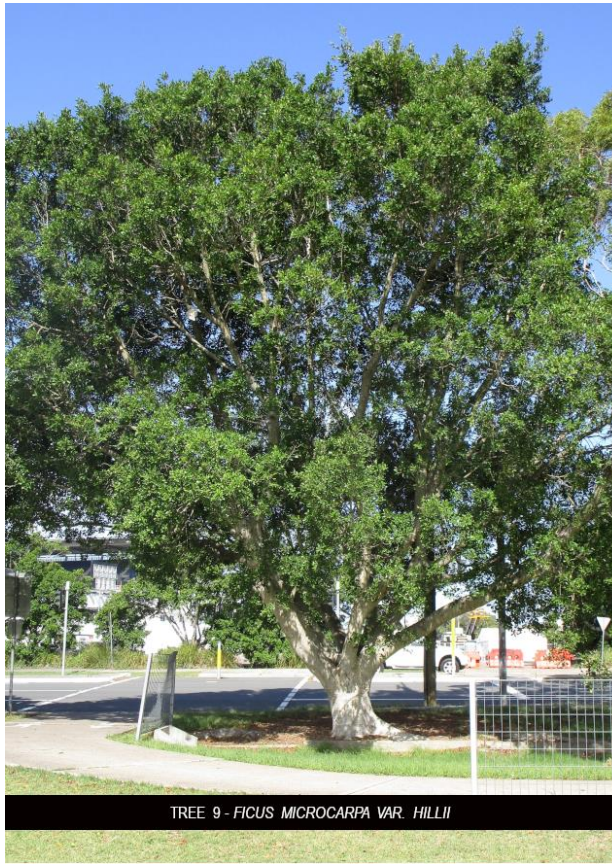
FIGURE A3: Trees 9-12

9	<i>Ficus microcarpa var. hillii</i>	Hills Weeping Fig	M	14	820	9.84	720	2.88	+40	AV	AV	A1	A3A	9. [CoN TREE ID 67117] TREE CONTAINS ONE NEST AND BRUSH-TAILED POSSUM. LARGE SURFACE ROOTS MANY RUNNING PARALLEL TO ROAD DUE TO THE PRESENCE OF TIMBER EDGING TO THE WEST AND FOOTPATH TO THE EAST. TREE ROOTS NOW RUNNING BEYOND EDGING AND INTO NEARBY TURF. PREVIOUS FOOTPATH DAMAGE AND REPAIRS NOTED. THIS TREE WILL NEED TO BE REMOVED.
10	<i>Corymbia citriodora</i>	Lemon-scented Gum	M	17	510	6.12	720	2.88	+40	AV	AV	A1	A3B	10. [CoN TREE ID 67116] PAST PRUNING OF LOWER CANOPY WITH UPPER BRANCHES CLEAR OF WIRES. PRUNING TO ROADSIDE CANOPY RESULTING IN AN ASYMMETRIC CANOPY. MINOR ENCROACHMENT. TO BE RETAINED
11	<i>Ficus microcarpa var. hillii</i>	Hills Weeping Fig	M	14	680	8.16	650	2.76	+40	AV	AV	A1	A3C	11. [CoN TREE ID 67115] SEWER MANHOLE NOTED NEARBY INDICATING PRESENCE OF SEWER. MECHANICAL DAMAGE TO SURFACE ROOTS. PRUNING TO ROADSIDE CANOPY RESULTING IN AN ASYMMETRIC CANOPY. THIS TREE WILL NEED TO BE REMOVED.

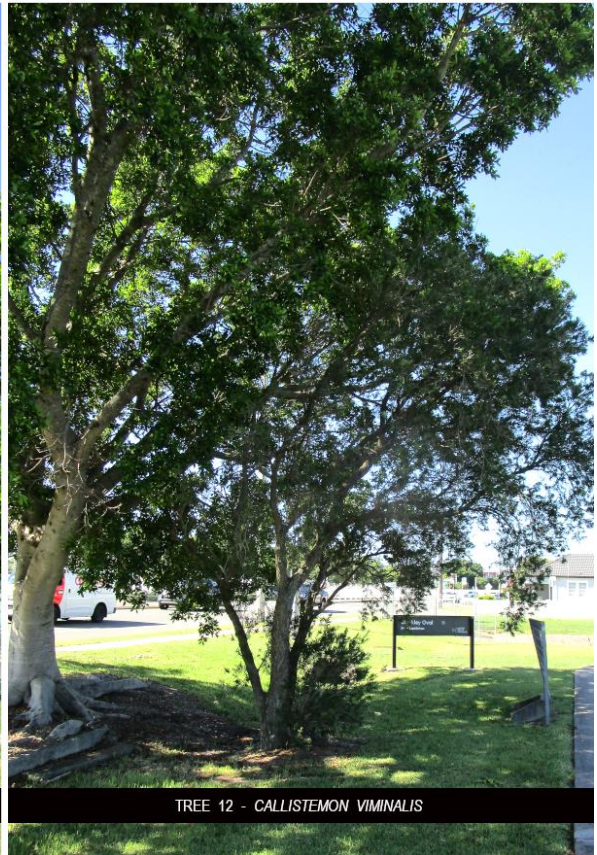
12	<i>Callistemon viminalis</i>	Weeping Bottlebrush	M	4	340	4.08	460	2.39	15-40	F	AV	A1	A3D	12. [CoN TREE ID 67114] [DBH: 160/300] TREE OCCURRING CLOSE TO TREE 11 RESULTING IN SUPPRESSED GROWTH AND ASYMMETRIC CANOPY. BASE OF TREE BEING ENCIRCLED BY ROOTS FROM TREE 11. PREVIOUS PRUNING OF LOWER BRANCHES. THIS TREE WILL NEED TO BE REMOVED.
13	<i>Casuarina cunninghamiana</i>	River She-oak	M	11	380	4.56	480	2.43	+40	F	F	A1	A4A	13. [CoN TREE ID 67109] TREE LOCATED ON FENCELINE RESULTING IN DISTORTION OF FENCE. LOWER BRANCHES REMOVED ESPECIALLY THOSE THAT WOULD HAVE IMPACTED ON SHARE PATH USERS. CO-DOMINANT TRUNK OCCURRING @ 1.7M AGL SLIGHT LEAN IN THE TRUNK FROM THE MIDDLE AND UPPER CANOPY. THIS TREE WILL NEED TO BE REMOVED.
14	<i>Casuarina cunninghamiana</i>	River She-oak	M	9	270	3.24	370	2.18	15-40	F	F	A1	A4B	14. [CoN TREE ID 67108] TREE WITH STORM DAMAGE AND LOST LIMBS RESULTING IN ELONGATED BRANCH STUBS. TRUNK WITH SLIGHT LEAN TO THE NORTH SELF-CORRECTING MID-HEIGHT. TO BE RETAINED.
