# HUNTER INDOOR SPORTS CENTRE (HISC)

ARBORICULTURAL IMPACT ASSESSMENT

JUNE 2025

# Arboricultural Impact Assessment

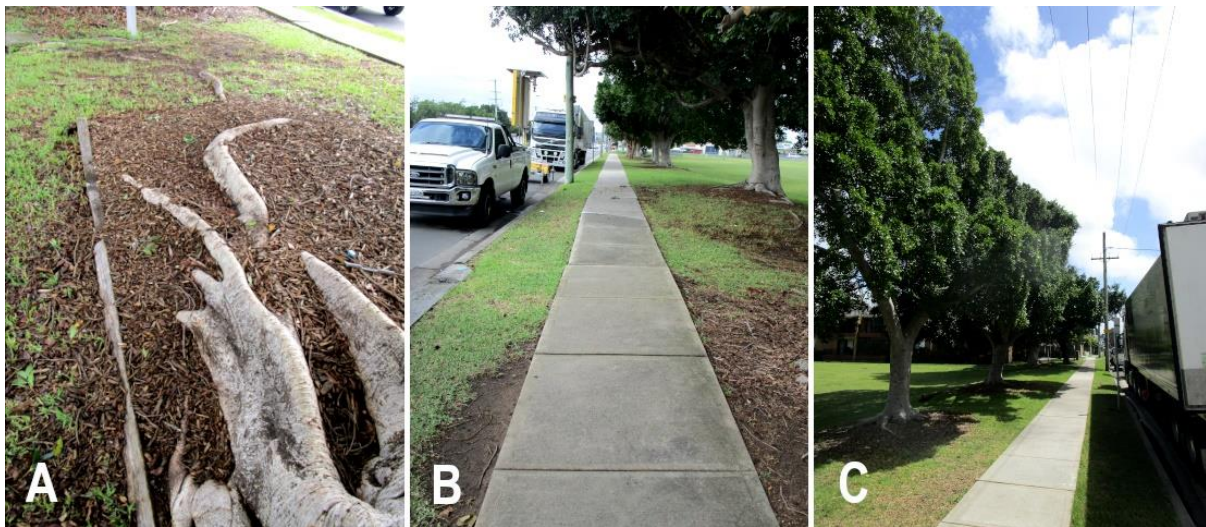
Trees 1-12 are located along the eastern boundary and running parallel to Turton Road. They are comprised mainly of *Ficus microcarpa* var. *hillii* (Hills Weeping Fig) growing within a formed garden beds that have come into disrepair. The timber edging used to form the garden bed on the western side has acted as a root deflector for the surface roots resulting in the early surface roots running north and south (Figure 5A). Deeper roots have spread beyond the timber edge and can be seen growing away from the trunk of the tree in a typical radial configuration. It is unlikely that the current root pattern, although not desirable, will result in pronounced instability for the figs as they develop in size. Most of the figs have included bark at branch junctions that on occasions can lead to failure as end weights become excessive. This is a typical characteristic of these figs if not specifically bred to avoid this tendency. In some instances, the roots of the trees have led the lifting of the nearby footpath resulting in some sections having to be repaired (Figure 5B). Most trees in this grouping have had to have their canopies trimmed to provide clearances to the powerlines occurring alongside Turton Road (Figure 5C) resulting in asymmetric canopies. All trees in this group (Trees 1-12) except for Trees 4 and 6, are good specimens.

FIGURE 5: TREES 1-12 – COMMON PROBLEMS

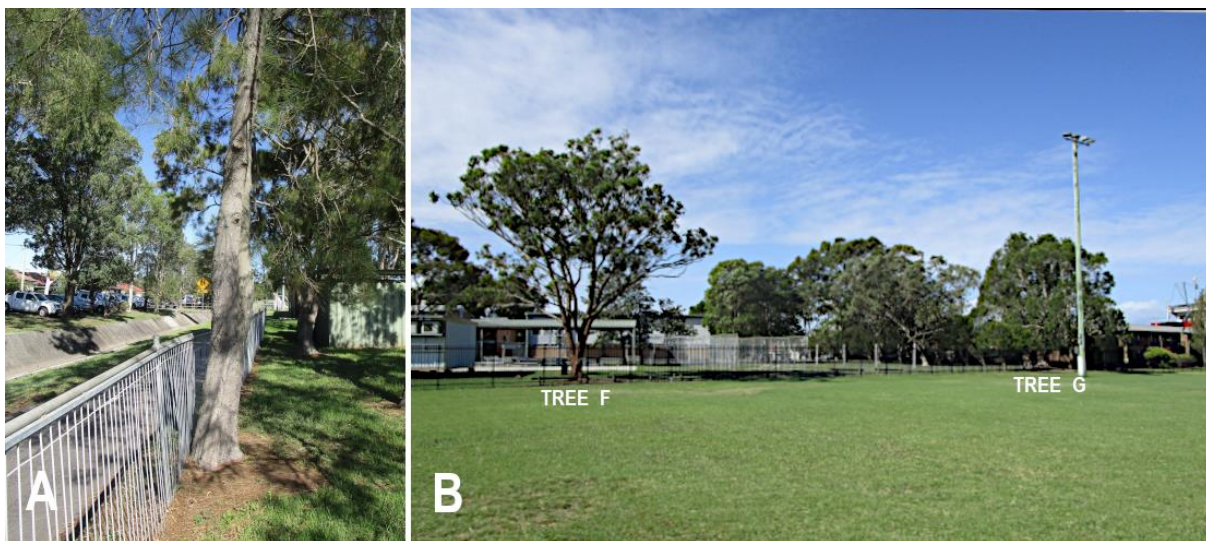
FIGURE 6: TREES 13, F & G

Trees A – F are without significant problems that would justify their removal due to likely risks. All are suitable for retention.

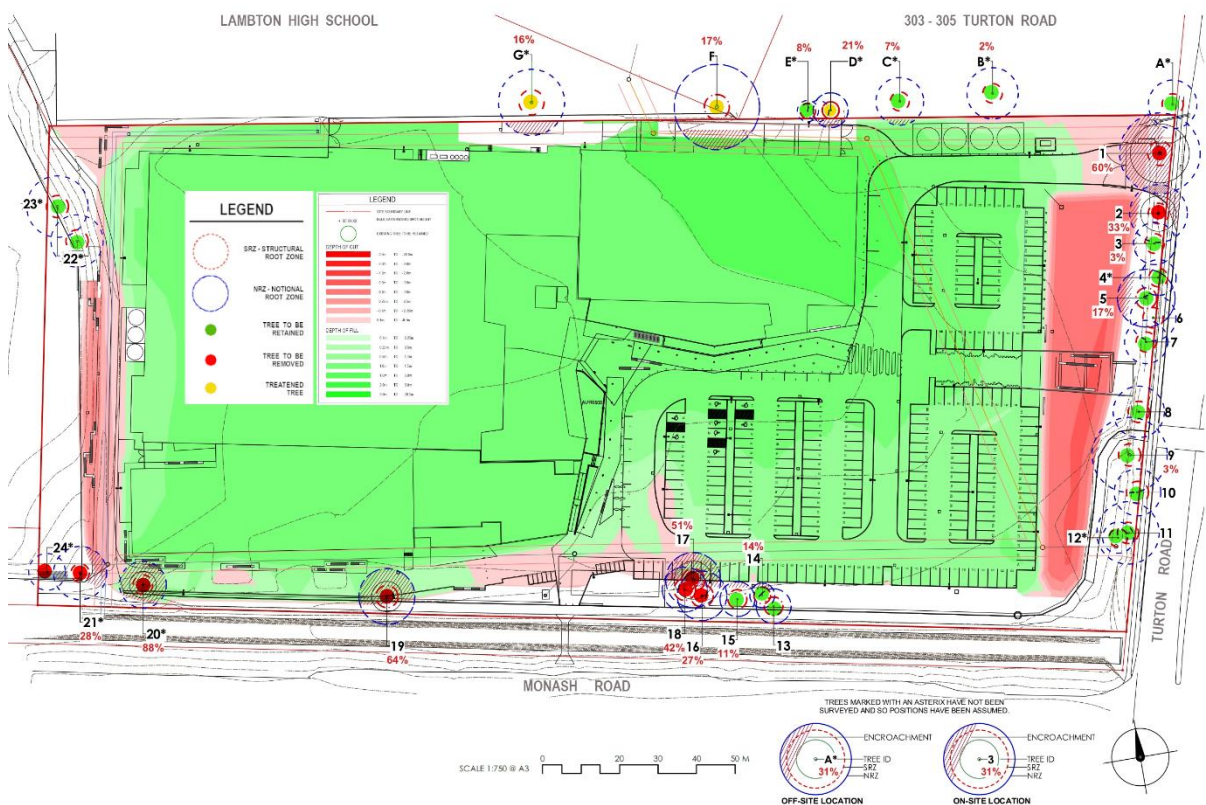
Figure 8 (and Appendix C2) shows that Trees 1, 2, 16-21 and 24 will need to be removed based on the proposed design. Changes to the design has protected all but two trees growing within the verge of Turton Road. Trees 1 and 2 will be required to be removed to allow access into the site. Trees 21 and 24 will be significantly impacted by the construction of a rain garden needed as part of the site's stormwater strategy

Trees 3 – 15, 22 and 23 will not be impacted by the the proposed 3 works as the NRZs of these trees will be subjected to minor encroachments only, if at all. The exception is Tree 17 that has an encroachment of 17% . This is regarded as moderate and acceptable for a tree of this species with average vigour. A pedestrian walkway runs between Trees 7 and 8. Based on the details available, there will be on a slight encroachment to thes two trees but monitoring during the detailed design phase and construction will be required.

Off-site Trees A, B, C, D, and E will also be retained as encroachments are within acceptable limits having regard to their locations, type of tree and condition. It should be noted that Tree D has an encroachment of 21% which is the upper tolerance for this species having average vigour. Soil levels around this tree are not being changed and so consideration has included the impact of the roadworks. Nevertheless routine monitoring will be required and so it has been designated as "Threatened" requiring monitoring by the Project Arborist during construction.

Trees F and G have been also assessed as being "Threatened". Although the encroachments for these trees are with acceptable limits for a moderate NRZ encroachment according to AS 4970-2025, soil levels around these trees are not being changed and so consideration has included the impact of the roadworks including the provision of an elevated deck over the NRZ of Tree G. Tree G will also be impacted by the relocation of the sewer. It is considered that the type of encroachment and with proper management of the areas associated with the trees including implementing the the Preliminary Tree Protection Plan (Appendix D), it will be possible for these trees to be retained.

Tree 16 has also been noted as being "Removed". This tree is in severe decline and even if left undisturbed, it is likely to fail. By removing the existing containers and making changes nearby, it is likely that its decline will be hastened although not directly affected by the construction works. Changes to the design of the proposal, even if practical, would not prevent this tree from failing.

**FIGURE 8: TREE IMPACT ASSESSMENT DIAGRAM.**  
[SOURCE: EJE ARCHITECTURE]

- that Trees 1, 2 occurring off-site, be removed, subject to negotiations with the City of Newcastle;
- that Trees 16-21 and 24, occurring on-site, be removed;
- that Trees 3-15, 22, 23, A-C and E be retained; and,
- that Trees D, F and G be retained by following the requirements of the Preliminary Tree Protection Manual (refer Appendix D) subject to careful detailing during the detailed design and documentation phases and further investigations occurring at the commencement of construction to ensure major roots are not damaged and/or further action taken.

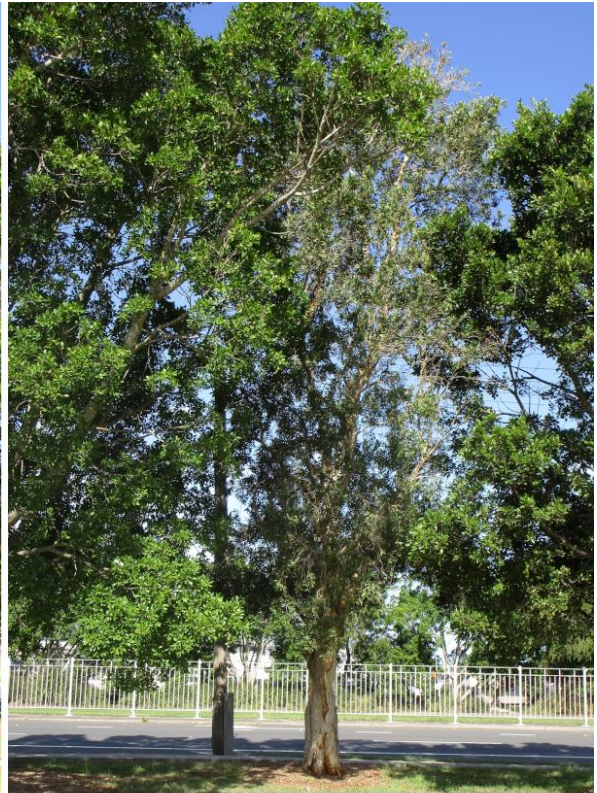
TREE 6 - *MELALEUCA QUINQUENERVIA*

6	<i>Melaleuca quinquenervia</i>	Swamp Paperbark	M	14	500 <sup>1</sup>	6.00	600	2.67	15-40	P	AV	A1	A2B	6. [CoN TREE ID 67120] [DBH: 240/440] EXTENSIVE PRUNING INCLUDING THE REMOVAL OF A ROADSIDE CO-DOMINANT TRUNK. PAST BORER ACTIVITY NOTED. PRUNING TO ROADSIDE CANOPY RESULTING IN AN ASYMMETRIC CANOPY. MODERATE CANOPY DENSITY. <b>TO BE RETAINED</b>
7	<i>Ficus microcarpa var. hillii</i>	Hills Weeping Fig	M	12	470	5.64	570	2.61	+40	AV	AV	A1	A2C	7. [CoN TREE ID 67119] TREE WITH UPRIGHT FORM PARTIALLY DUE TO REDUCTION OF CANOPY. ROOT GROWTH MODIFIED BY TIMBER EDGING BUT NOT AS MARKEDLY AS OTHER LOCATIONS. SOOTY MOULD PRESENT TO THE FOLIAGE OF THE LOWER CANOPY. <b>TO BE RETAINED</b>
8	<i>Ficus microcarpa var. hillii</i>	Hills Weeping Fig	M	10	560	6.72	650	2.76	+40	F	AV	A1	A2D	8. [CoN TREE ID 67118] TREE CONTAINS ONE NEST. GOOD, SPREADING CANOPY WITH SOMEWHAT CROWDED FORM. <b>TO BE RETAINED</b>
9	<i>Ficus microcarpa var. hillii</i>	Hills Weeping Fig	M	14	820	9.84	720	2.88	+40	AV	AV	A1	A3A	9. [CoN TREE ID 67117] TREE CONTAINS ONE NEST AND BRUSH-TAILED POSSUM. LARGE SURFACE ROOTS MANY RUNNING PARALLEL TO ROAD DUE TO THE PRESENCE OF TIMBER EDGING TO THE WEST AND FOOTPATH TO THE EAST. TREE ROOTS NOW RUNNING BEYOND EDGING AND INTO NEARBY TURF. PREVIOUS FOOTPATH DAMAGE AND REPAIRS NOTED. <b>MINOR ENCROACHMENT. TO BE RETAINED</b>

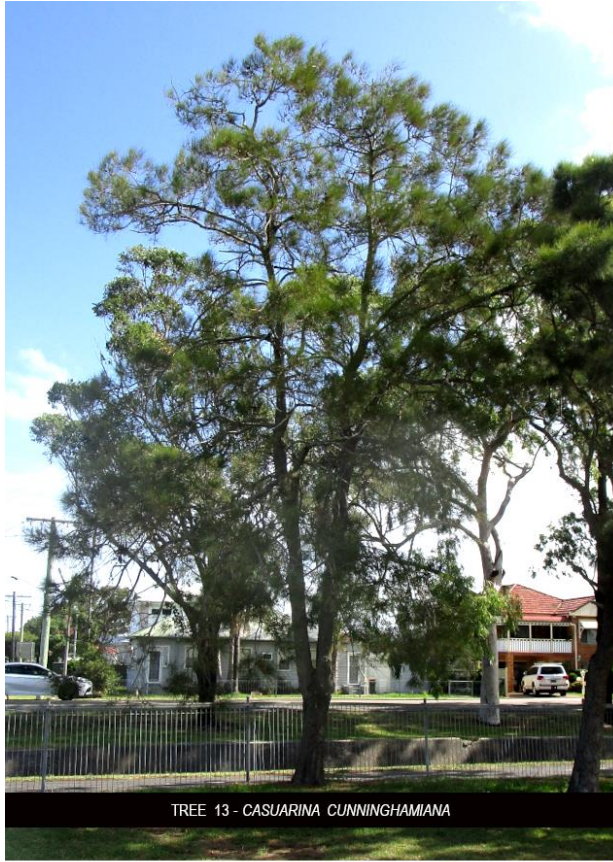
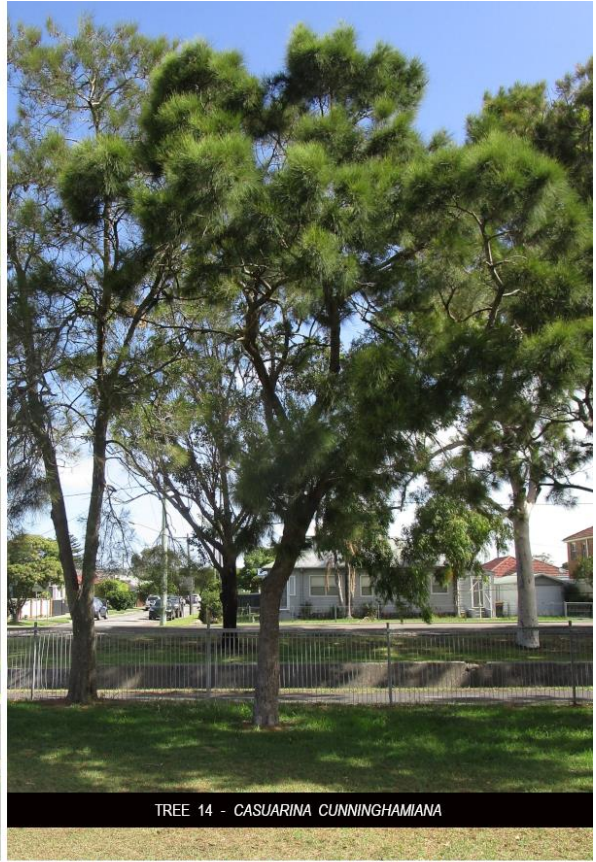
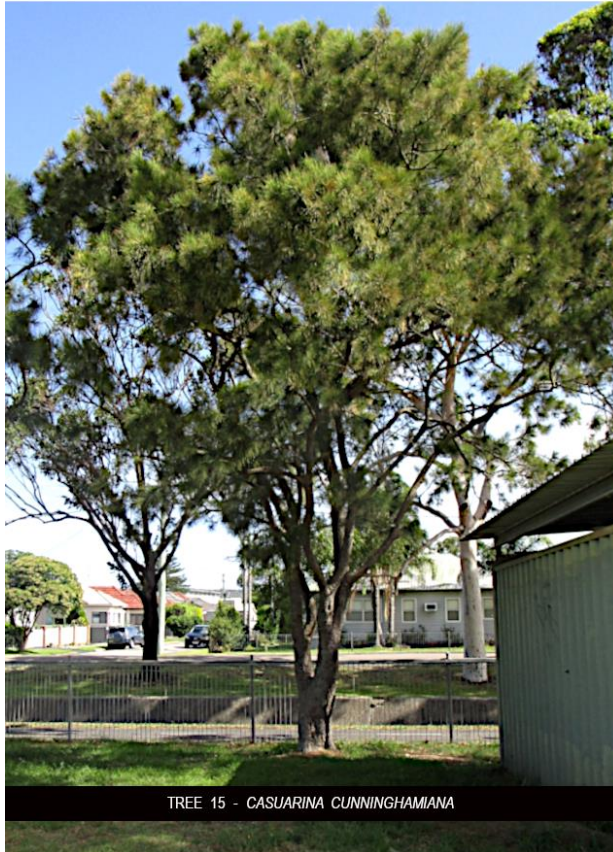
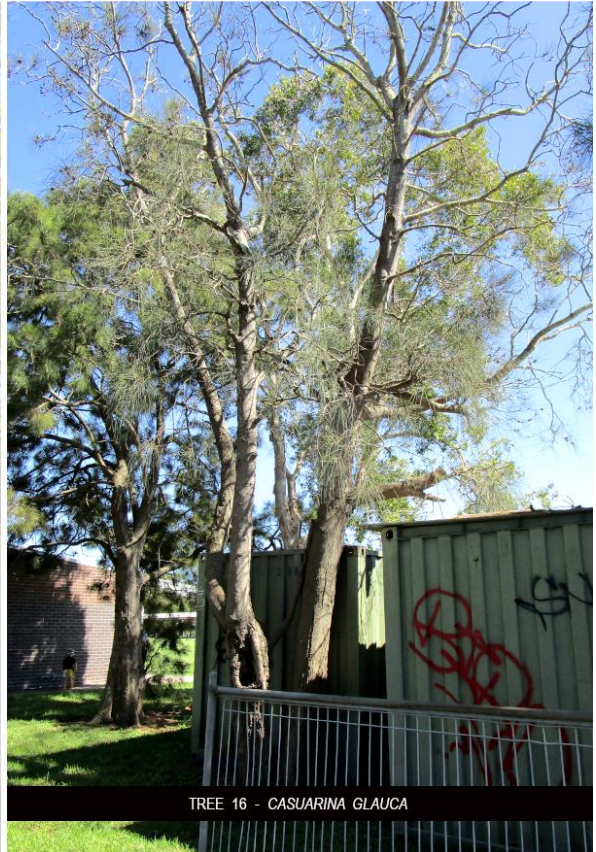
FIGURE A4: Trees 13-16 (INSPECTED 2024/02)

13	<i>Casuarina cunninghamiana</i>	River She-oak	M	11	380	4.56	480	2.43	+40	F	F	A1	A4A	13. [CoN TREE ID 67109] TREE LOCATED ON FENCELINE RESULTING IN DISTORTION OF FENCE. LOWER BRANCHES REMOVED ESPECIALLY THOSE THAT WOULD HAVE IMPACTED ON SHARE PATH USERS. CO-DOMINANT TRUNK OCCURRING @ 1.7M AGL SLIGHT LEAN IN THE TRUNK FOM THE MIDDLE AND UPPER CANOPY. <b>TO BE RETAINED</b>
14	<i>Casuarina cunninghamiana</i>	River She-oak	M	9	270	3.24	370	2.18	15-40	F	F	A1	A4B	14. [CoN TREE ID 67108] TREE WITH STORM DAMAGE AND LOST LIMBS RESULTING IN ELONGATED BRANCH STUBS. TRUNK WITH SLIGHT LEAN TO THE NORTH SELF-CORRECTING MID-HEIGHT. <b>MODERATE ENCROACHMENT. TO BE RETAINED</b>
15	<i>Casuarina cunninghamiana</i>	River She-oak	M	10	380	4.56	500	2.47	+40	AV	AV	A1	A4C	15. [CoN TREE ID 67107] [DBH: 250/290] STAR PICKET EMBEDDED INTO THE BASE OF THE TREE. OLD CAVITIES EXIST AT OLD PRUNING SITES. CO-DOMINANT TRUNG @ 750MM AGL. <b>MODERATE ENCROACHMENT. TO BE RETAINED</b>

16	<i>Casuarina glauca</i>	Swamp She-oak	OM	15	540	6.48	770	2.97	<5	F	P	Z4	A4D	16. [CoN TREE ID 67106] [DBH: 370/400] OVER-MATURE TREE. SPARSE CANOPY (<5%). DEADWOOD IN CANOPY. LARGE CAVITY (OLD) WHERE BRANCH HAS BEEN LOST. ACAULESCENT CO-DOMINANT TRUNKS. SHIPPING CONTAINER PLACED NEAR TREE COVERING A PORTION OF ITS ROOT PLATE. BRANCHES OVERHANGING CONTAINER, REMOVED. <b>THIS TREE WILL NEED TO BE REMOVED.</b>

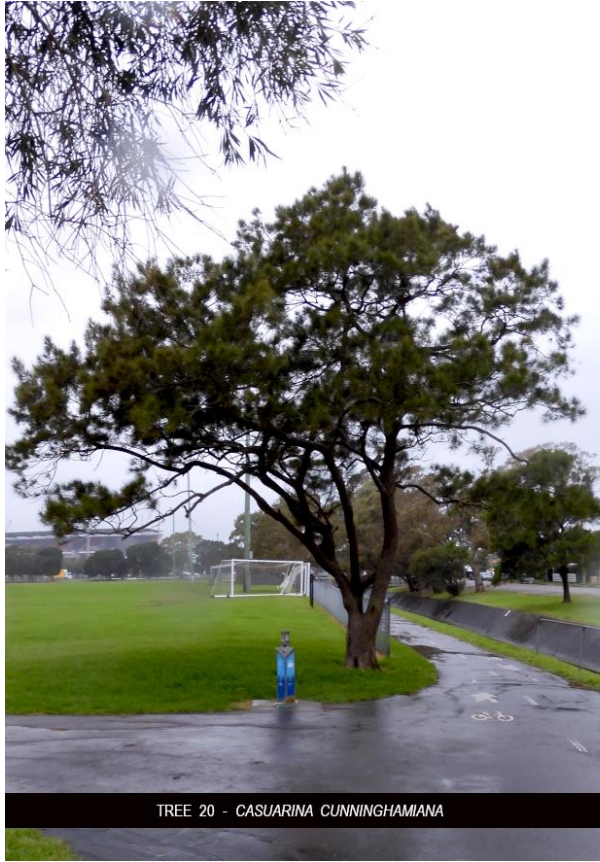
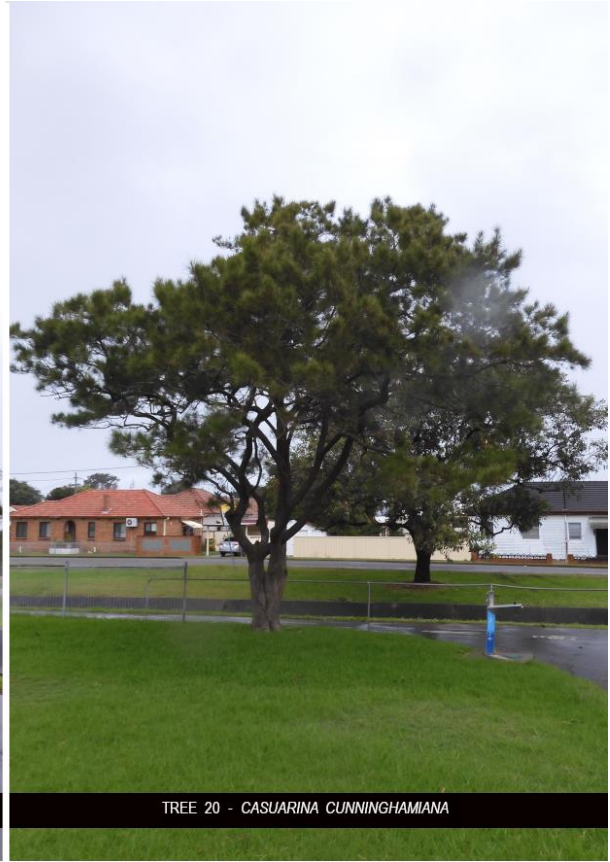
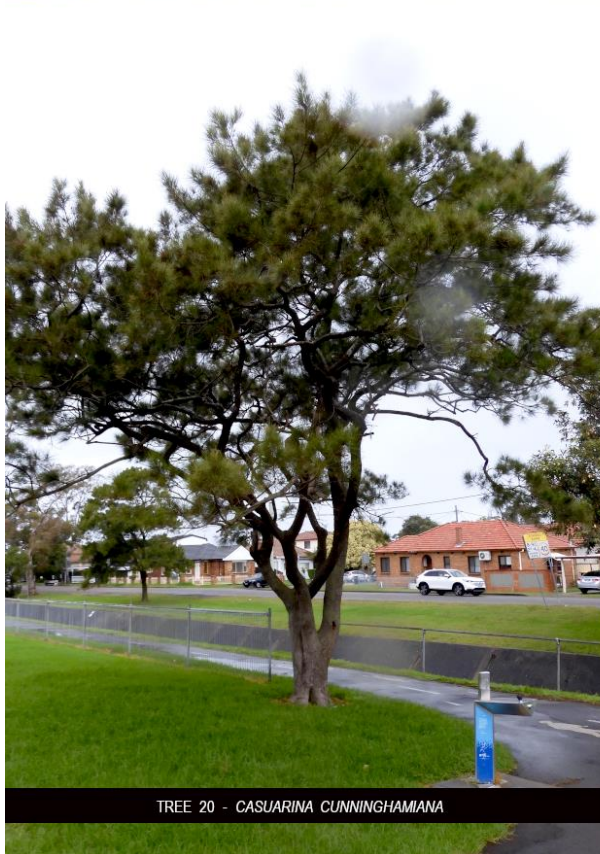
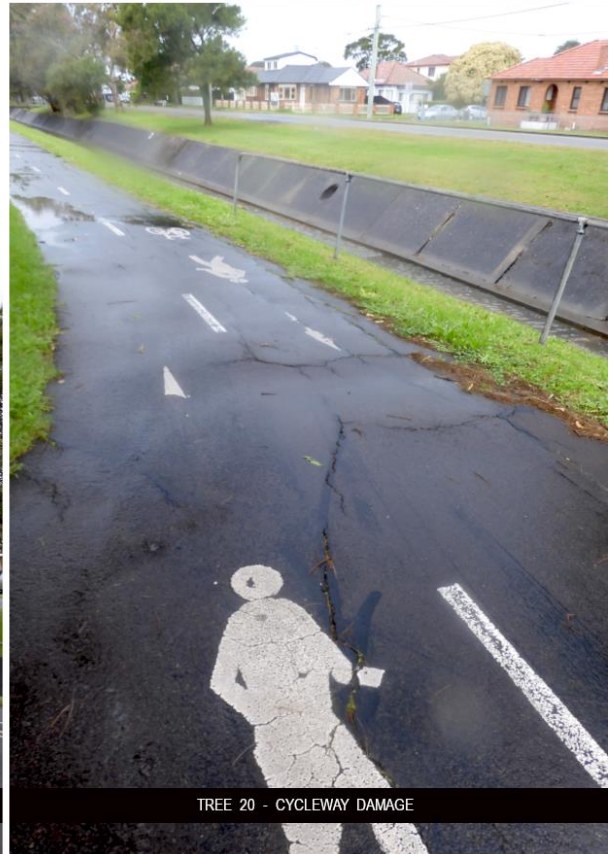
FIGURE A7: Tree 20 (INSPECTED 2025/05/20)

20	<i>Casuarina cunninghamiana</i>	River She-oak	M	11	510 <sup>1</sup>	6.12	540	2.55	+40	F	AV	A1	A7A-D	20. [CoN TREE ID 67091] [DBH: 270/330/320] TREE LOCATED CLOSE TO BITUMEN CYCLEWAY CAUSING MINOR CRACKING TO SURFACE. ASYMMETRIC CANOPY WITH BIAS TO THE NORTH. HERBICIDE BEING USED AT THE BASE THE TREE TO CONTROL GROWTH OF GRASS. MINOR STORM DAMAGE AND DEADWOOD PRESENT IN THE CANOPY. <b>THIS TREE WILL NEED TO BE REMOVED.</b>
21	<i>Callistemon salignus</i>	Willow Bottlebrush	M	8	580	6.96	460	2.39	+40	F	AV	A1	A8A	21. [CoN TREE ID 67087] [DBH: 230/280/330/220/130] MULTI CO-DOMINANT TRUNK. LOCATED ON SIDE-SLOPE TO ADJOINING OVAL. EVIDENCE OF PRIOR PRUNING. <b>THIS TREE WILL NEED TO BE REMOVED.</b>
22	<i>Corymbia citriodora</i>	Lemon-scented Gum	M	17	570	6.84	730	2.90	+40	AV	AV	A1	A8B	22. [CoN TREE ID 67058] OPEN CANOPY. CO-DOMINANT TRUNK @ 3.5M AGL. SOME OLD STORM DAMAGE WITH REMNANT BRANCH STUBS REMAINING WITH INCLUDED BARK. <b>TO BE RETAINED</b>
