# **PRE-CONSTRUCTION CONDITION SURVEY (DILAPIDATION REPORT)**

**REPORT NUMBER:** S26211301 - 001

**PROJECT:** 6 Halifax Street, Macquarie Park NSW 2113

**INSPECTION DATE:** 17<sup>th</sup> April 2026

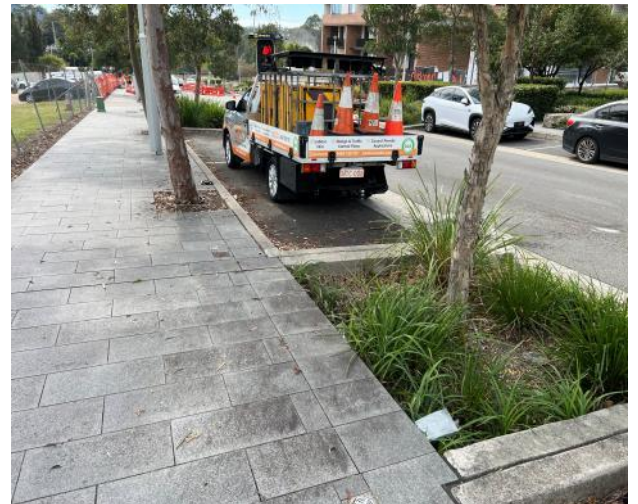
Figure 2 – General view of council footpath.

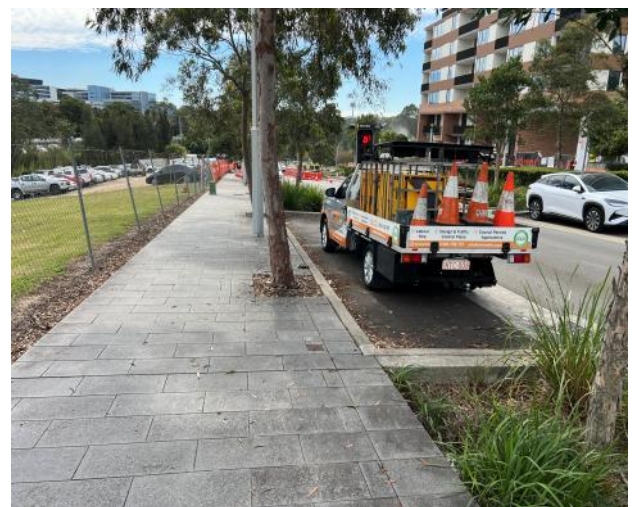
Figure 4 – General view of council footpath.

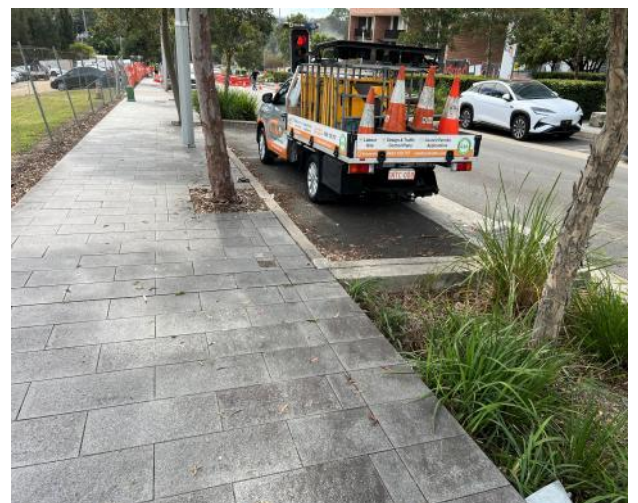
Figure 6 – General view of council footpath.

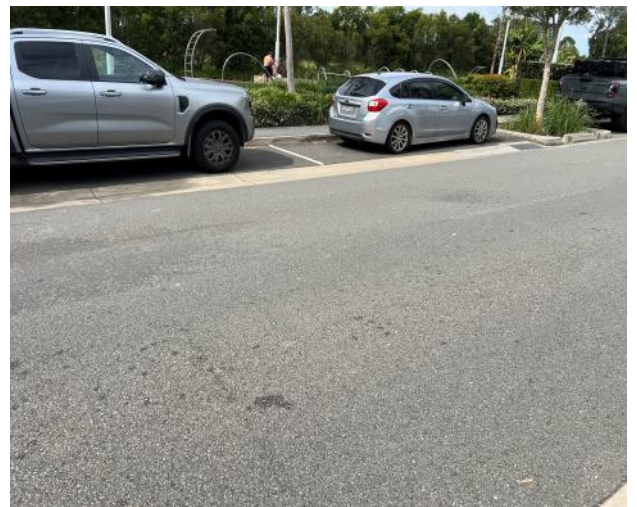
Figure 16 – General view of road pavement.

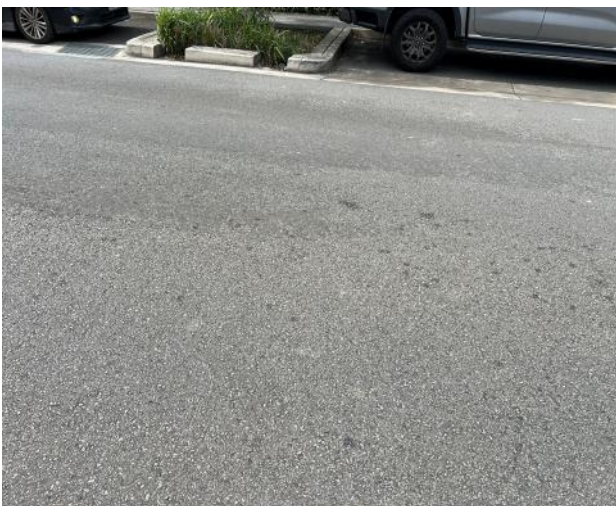
Figure 17 – Current condition of road pavement.

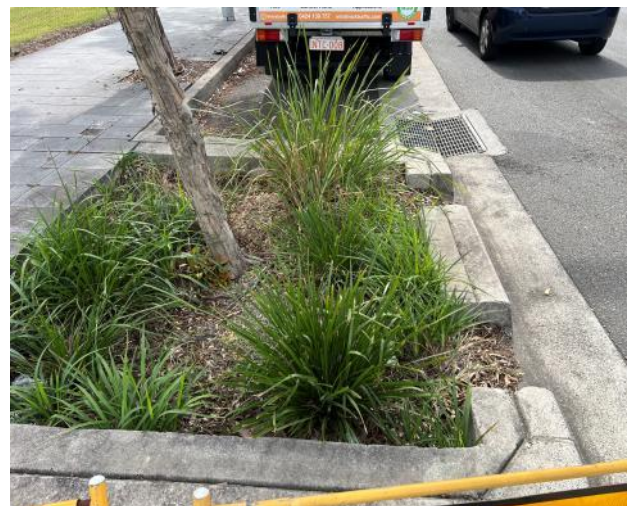
Figure 18 – Current condition of tree pit.

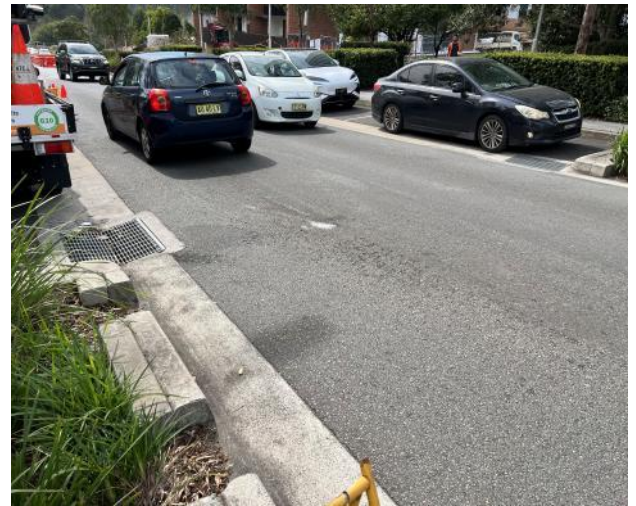
Figure 20 – Current condition of road pavement.

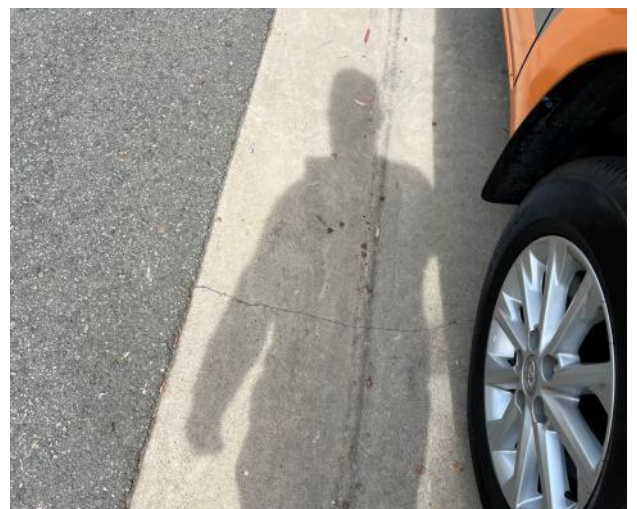
Figure 34 – Cracking to gutter.

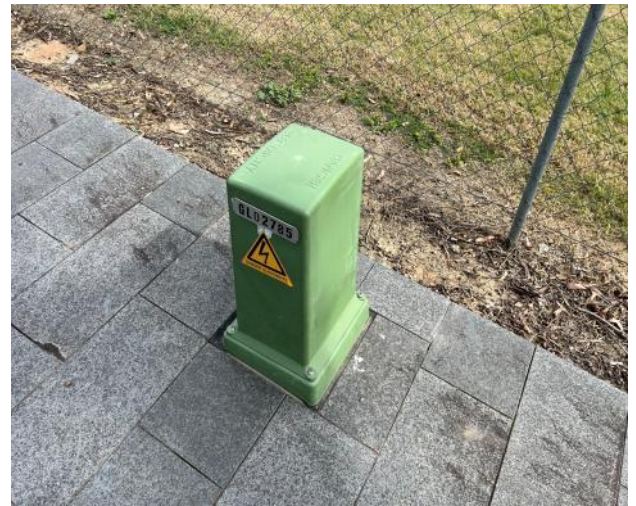
Figure 44 – Current condition of electrical pit/box.

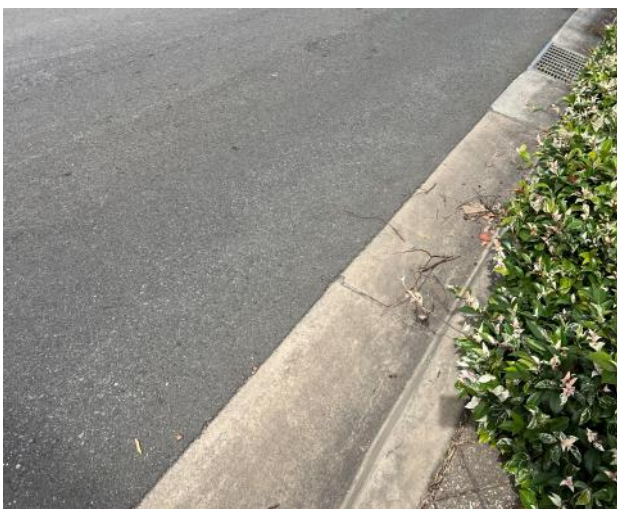
Figure 51 – General view of road pavement. Cracking to gutter.

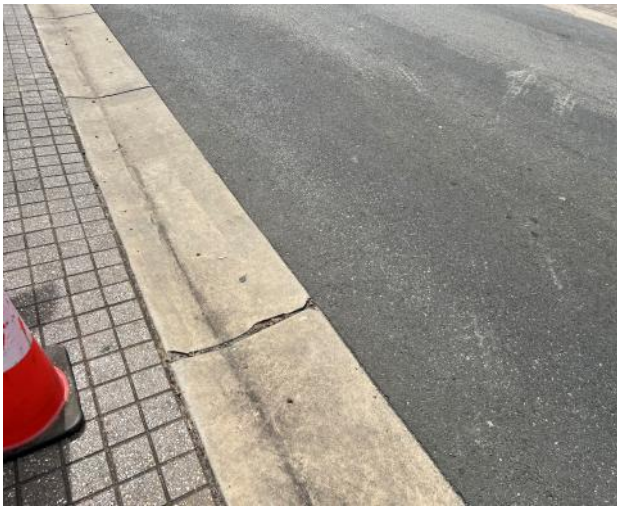
Figure 55 – General view of road pavement. Cracking to gutter.

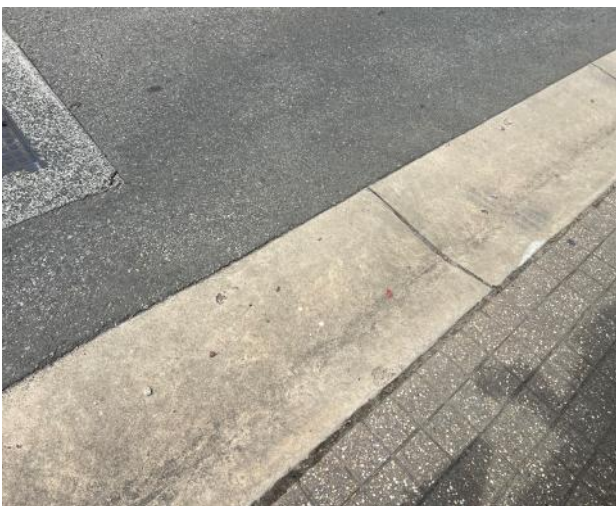
Figure 65 – Current condition of gutter.

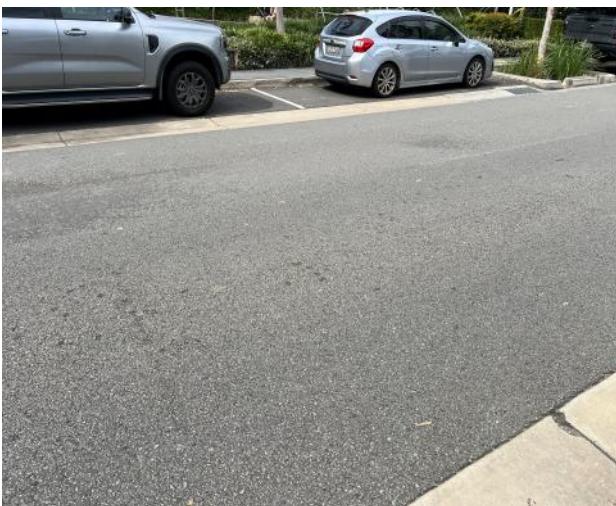
Figure 89 – Current condition of road pavement.

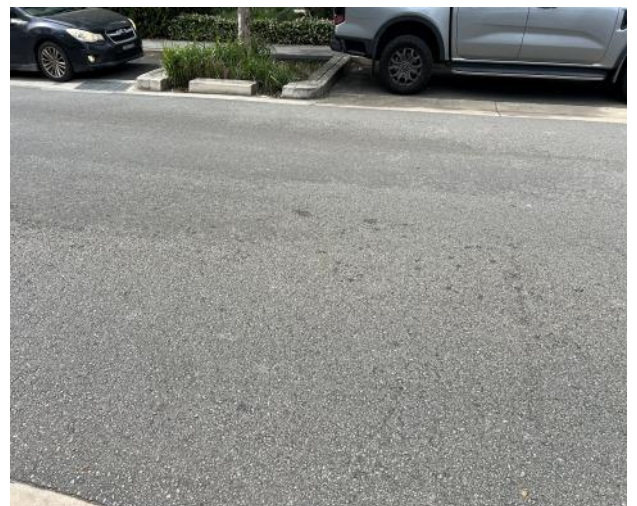
Figure 90 – Current condition of road pavement.

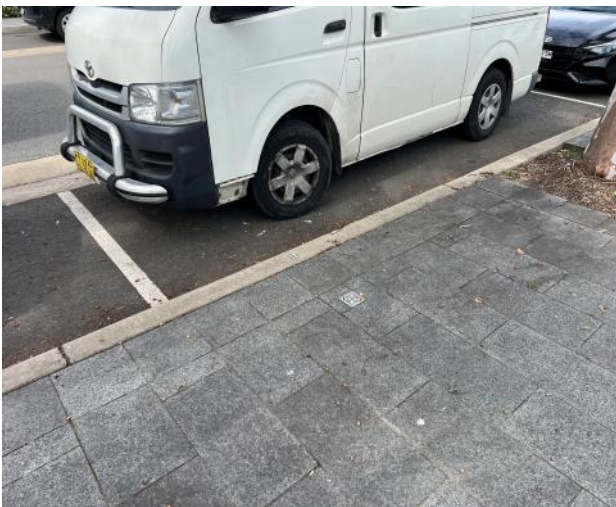
Figure 99 – Current condition of council footpath.

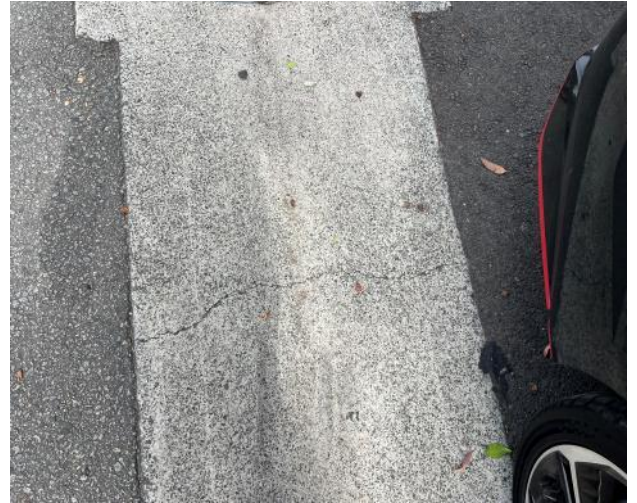
Figure 116 – Cracking to road gutter.

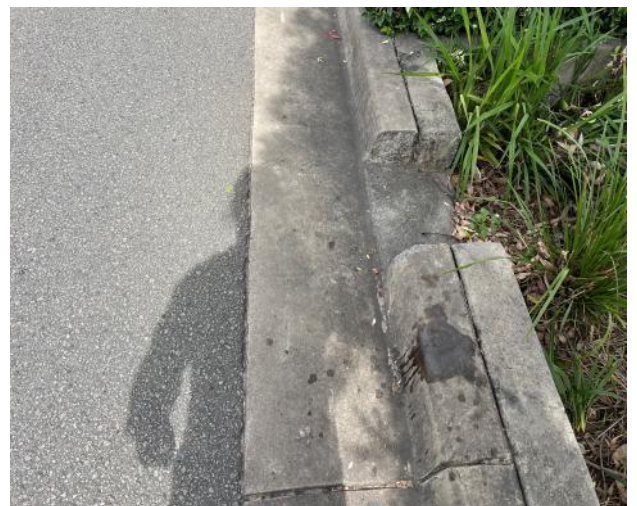
Figure 120 – Cracking to gutter.
