APPENDIX M
Gostwyck Bridge Report

Daracon Group
Gostwyck Bridge BN1461
Summary Strategic Report

Revision 1

November 2020

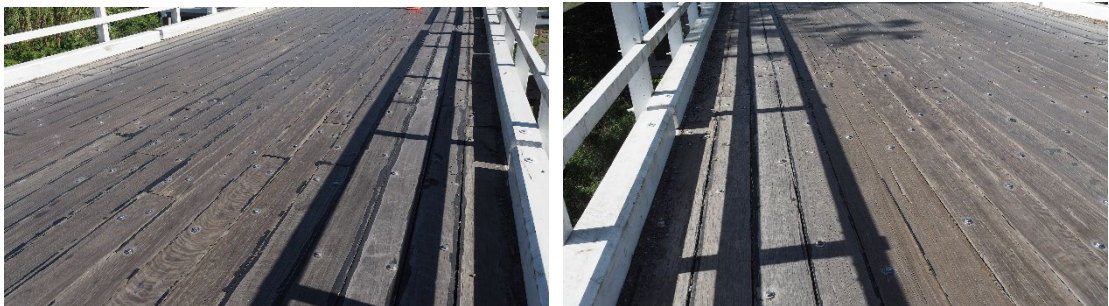
Figure 4-3 Timber bridge decks (Source; FBE)

The timber decks were rated as being in “as-built” condition in the 17 July 2017 L2 inspection. However, it should be noted that the deck planks were rated as being in “fair” condition during the 29 March 2017 L2 inspection and were nominated for further monitoring.

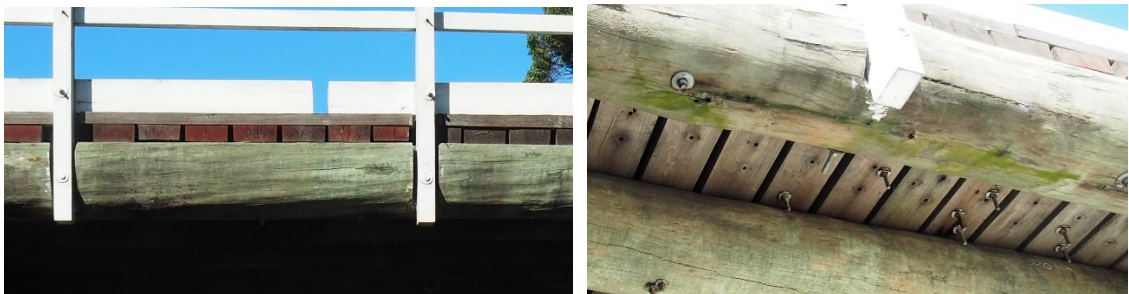
Figure 4-4 Timber bridge decks (Source; FBE)

Figure 4-3 and Figure 4-4 shows the transverse deck planks viewed from the upstream river bank. These were rated as being in “as-built” condition in the July 2017 L2 inspection.

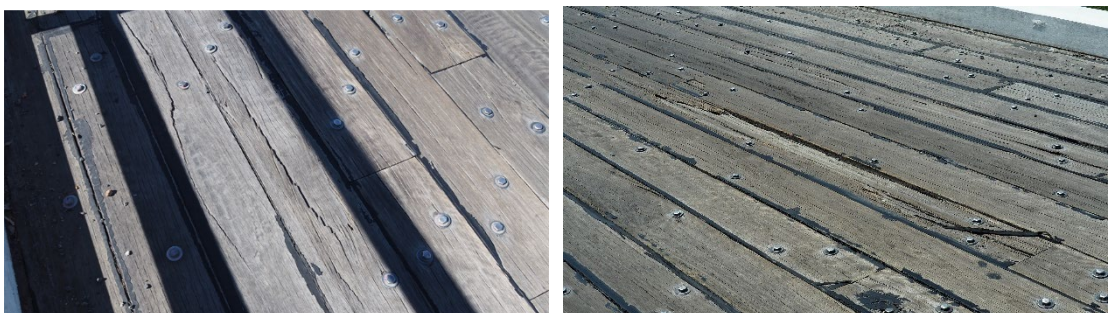
Figure 4-5 Timber bridge deck longitudinal cracking and weathering (Source: FBE)

Some cracking and weathering of longitudinal decking was observed during the FBE inspection. Peeling of the tar-seal between planks was also noted. These are shown in Figure 4-5.

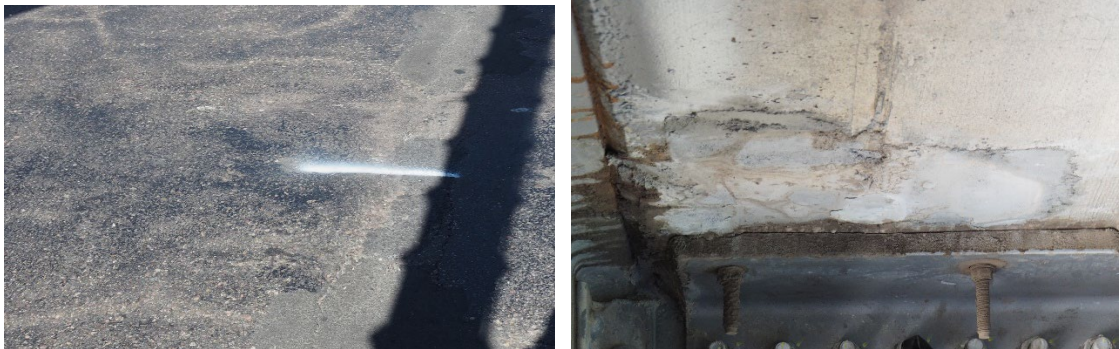
Figure 4-6 Cracks and repairs to concrete deck (Source: FBE)

The steel truss span supports a reinforced concrete deck overlaid with asphalt. There is evidence of concrete cracking and previous repair at each panel point, as shown in Figure 4-6.

The concrete deck has been rated as being in “fair” condition in the 17 July 2017 L2 inspection.

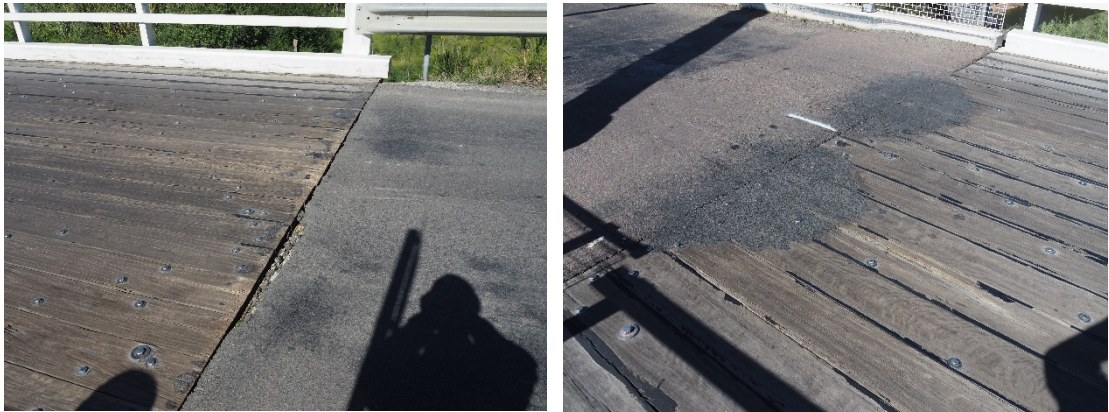
Figure 4-9 Typical condition of unsealed deck joints (Source: FBE)

The unsealed deck joints are shown in Figure 4-9. The left image shows the joint between the bridge and the approach carriageway and the right image the joint between the timber spans and the steel truss span.

TfNSW has rated the unsealed deck joints as being in “fair” condition. Spalling and deterioration of the wearing course at these locations was noted during the FBE inspection.

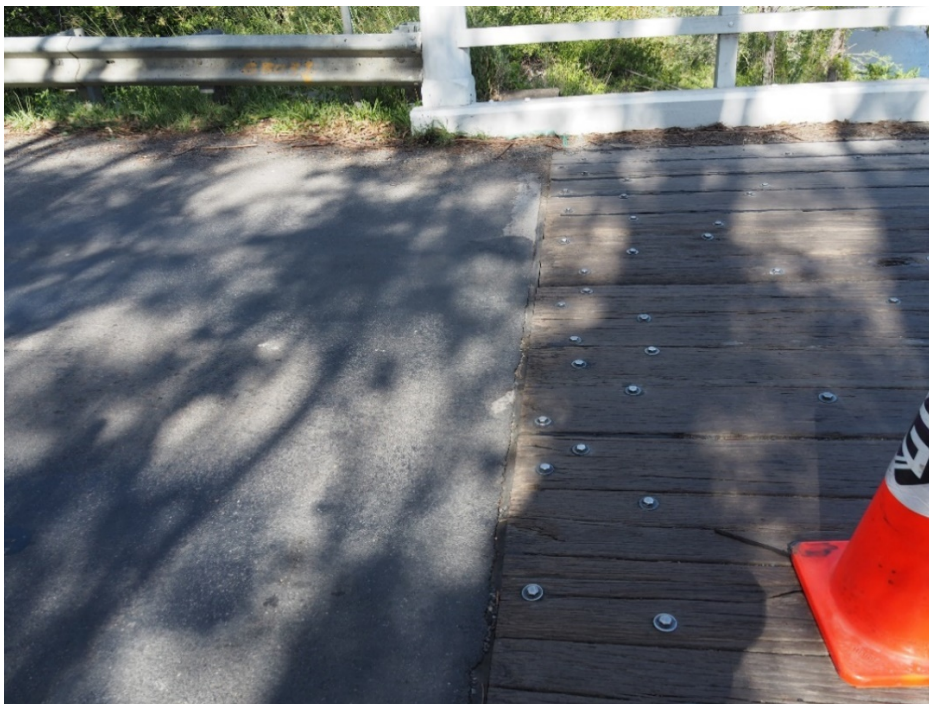
Figure 4-10 Sealed deck joint (Source: FBE)

The sealed joint, likely installed during the recent replacement of Abutment B, is shown in Figure 4-10. This joint shows no signs of deterioration or wear.

The condition of the sealed joint is not noted in the last L2 inspection but appears to be in “good” condition.

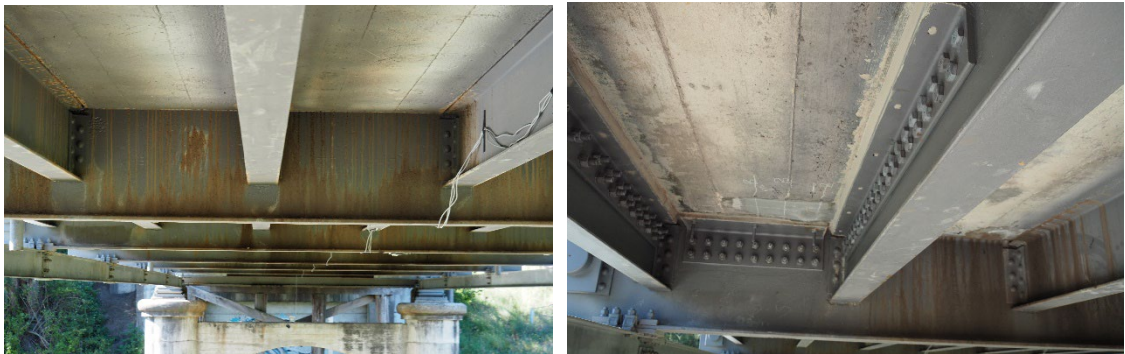
Figure 4-16 Typical steel cross girders (Source: FBE)

The steel cross-girders and stringers, shown in Figure 4-16, were rated as being in “as-built” condition in the latest L2 inspection by TfNSW.

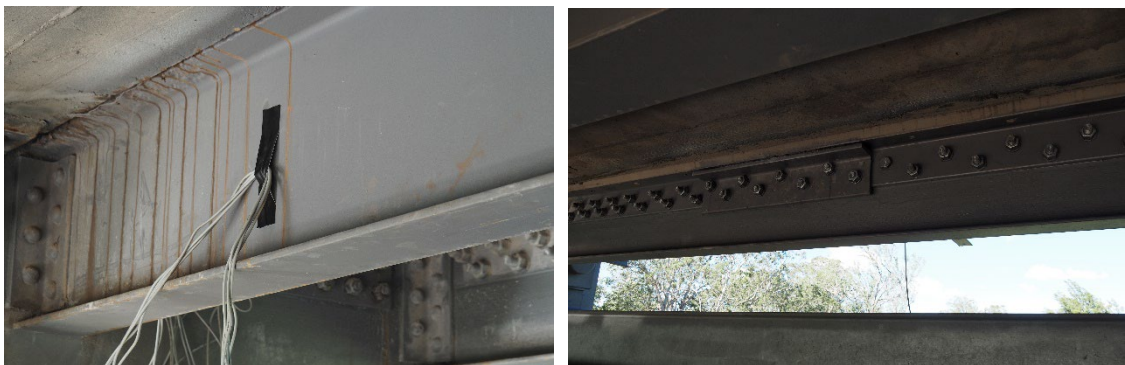
Figure 4-17 Typical steel stringers (Source: FBE)

Some steel strengthening plate work and repairs have been conducted on the cross-girders and stringers, as shown in the right image in Figure 4-16 and in Figure 4-17.

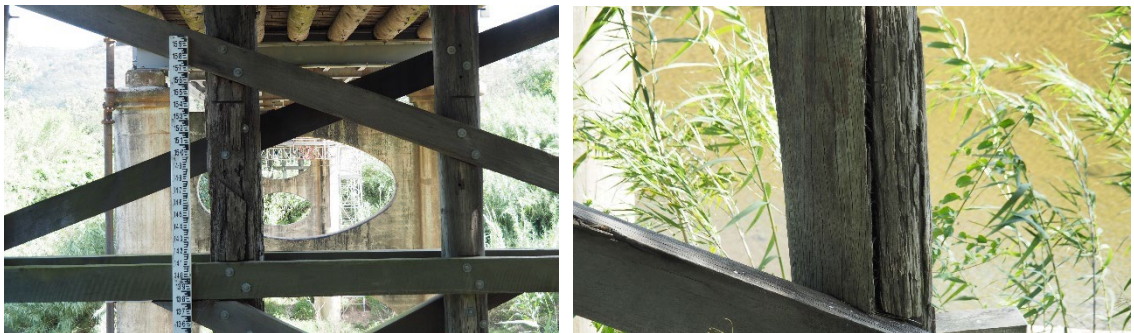
Figure 4-24 **Deterioration of Pier 6 piles (Source: FBE)**

Figure 4-24 shows longitudinal cracking and deterioration of the Pier 6 piles.

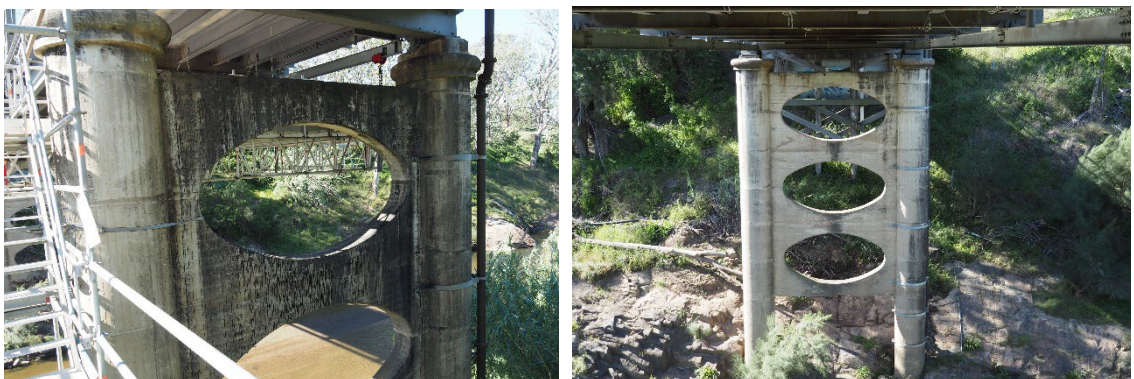
Figure 4-25 **Typical condition of concrete piers (Source: FBE)**

Piers 4 and 5 are reinforced concrete cylinders joined with an oval voided diaphragm and Figure 4-25 shows the typical condition of these concrete piers. The July 2017 L2 inspection lists the concrete piers as generally being in “fair” condition.

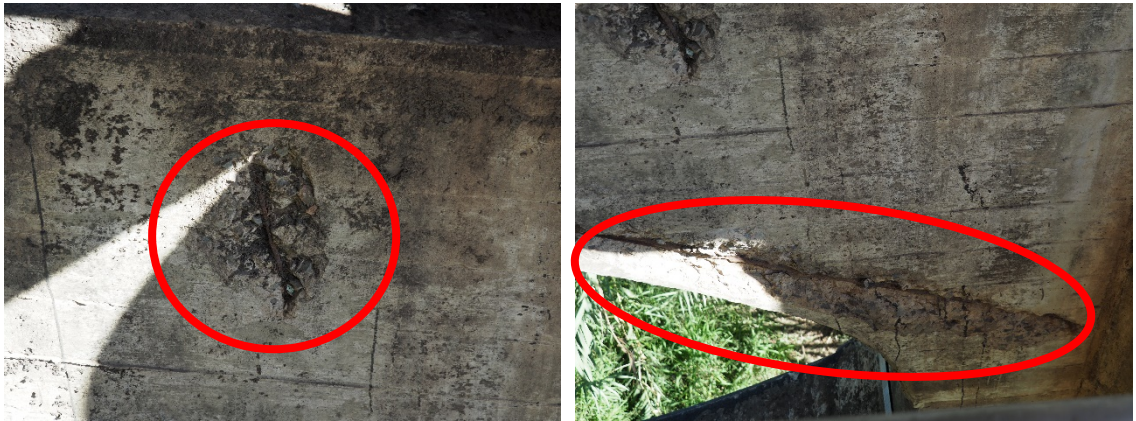
Figure 4-26 Spalling of concrete and exposed reinforcement on Pier 4 (Source: FBE)

Figure 4-26 shows spalling and exposed reinforcement observed on Pier 4. These damaged patches are on the diaphragm, above the top oval void.

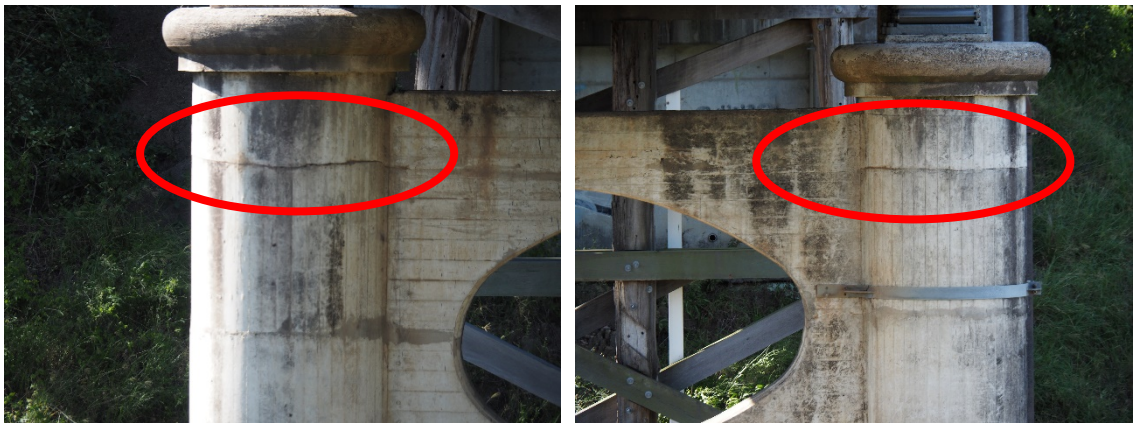
Figure 4-27 Cracks near top of Pier 5 (Source: FBE)

Some cracking of the concrete cylinders was observed on Pier 5. Figure 4-27 shows the cracks as viewed from Pier 4.

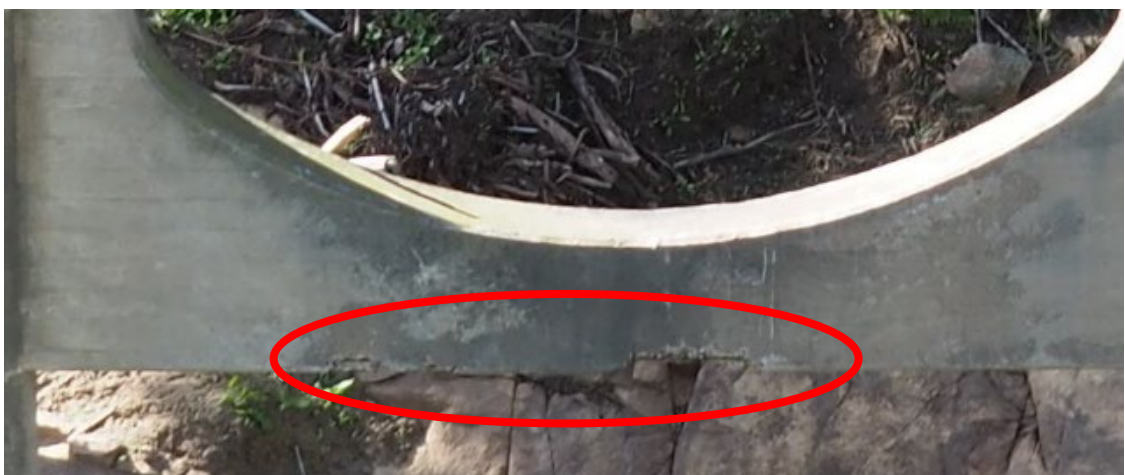
Figure 4-28 Damage to bottom of reinforce concrete diaphragm on Pier 5 (Source: FBE)

Damage to the bottom of the concrete diaphragm on Pier 5 was observed. This is shown in Figure 4-28.

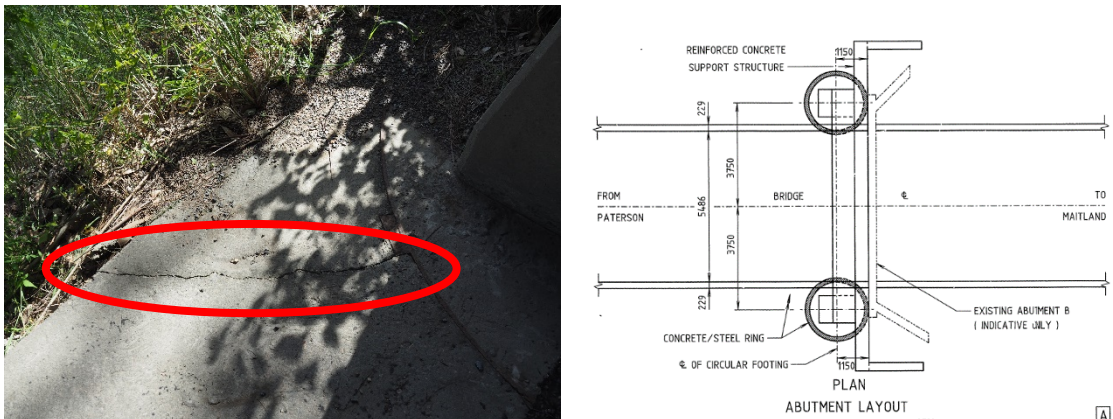
Figure 4-30 Cracking of abutment inspection platform (Source: FBE)

The inspection observed cracking of the abutment inspection platform, shown in Figure 4-30. Driven steel casings were used in the construction of the replacement abutment and the crack appears to emanate from the remnants of one of these casings. The platform is not a structural element of the bridge and the cracking is not considered detrimental to the bridge’s performance.
