**BASELINE RIPARIAN CONDITION
REPORT (2022)**

Martins Creek Quarry

Prepared by
Umwelt (Australia) Pty Limited
on behalf of
Daracon

Project Director: Barbara Crossley
Project Manager: Kirsty Davies
Technical Director: Darren Lyons
Technical Manager: Matilda Mathieu
Report No. 3957C/R23
Date: June 2022

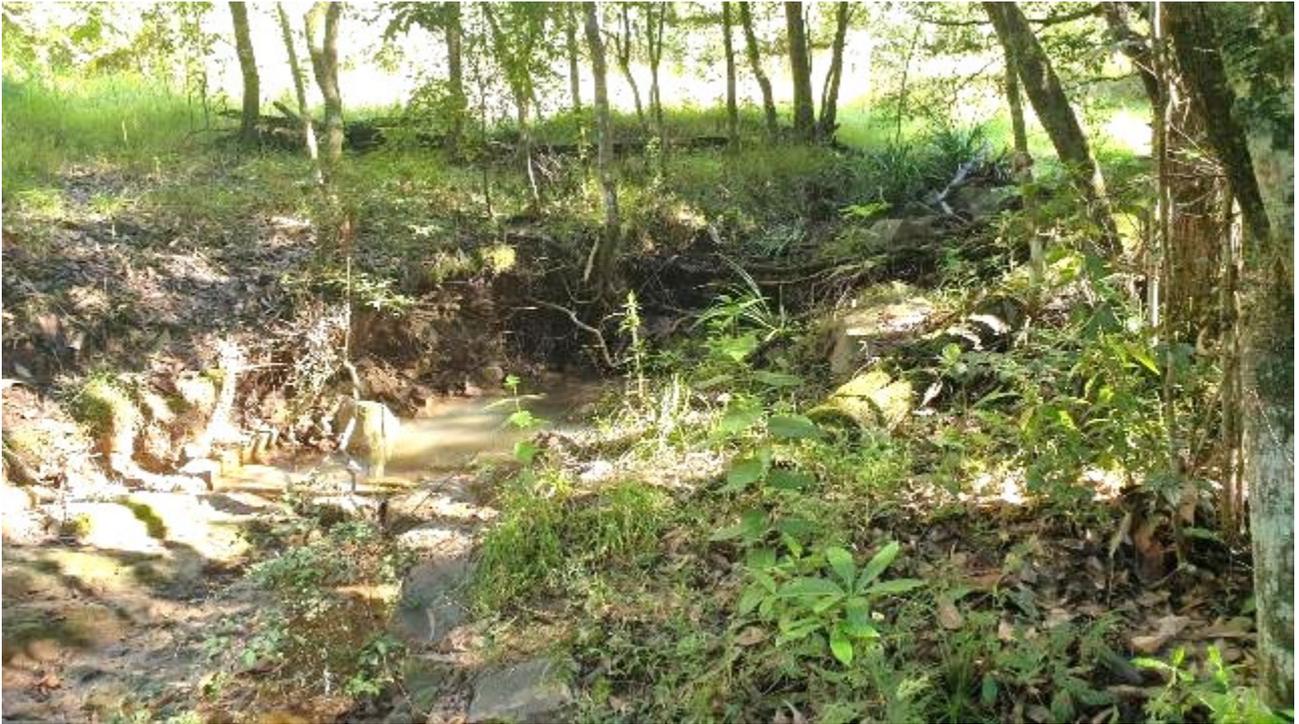
Photo 3.1 **Reach 1 – Monitoring Location 1-1. Looking Upstream.**

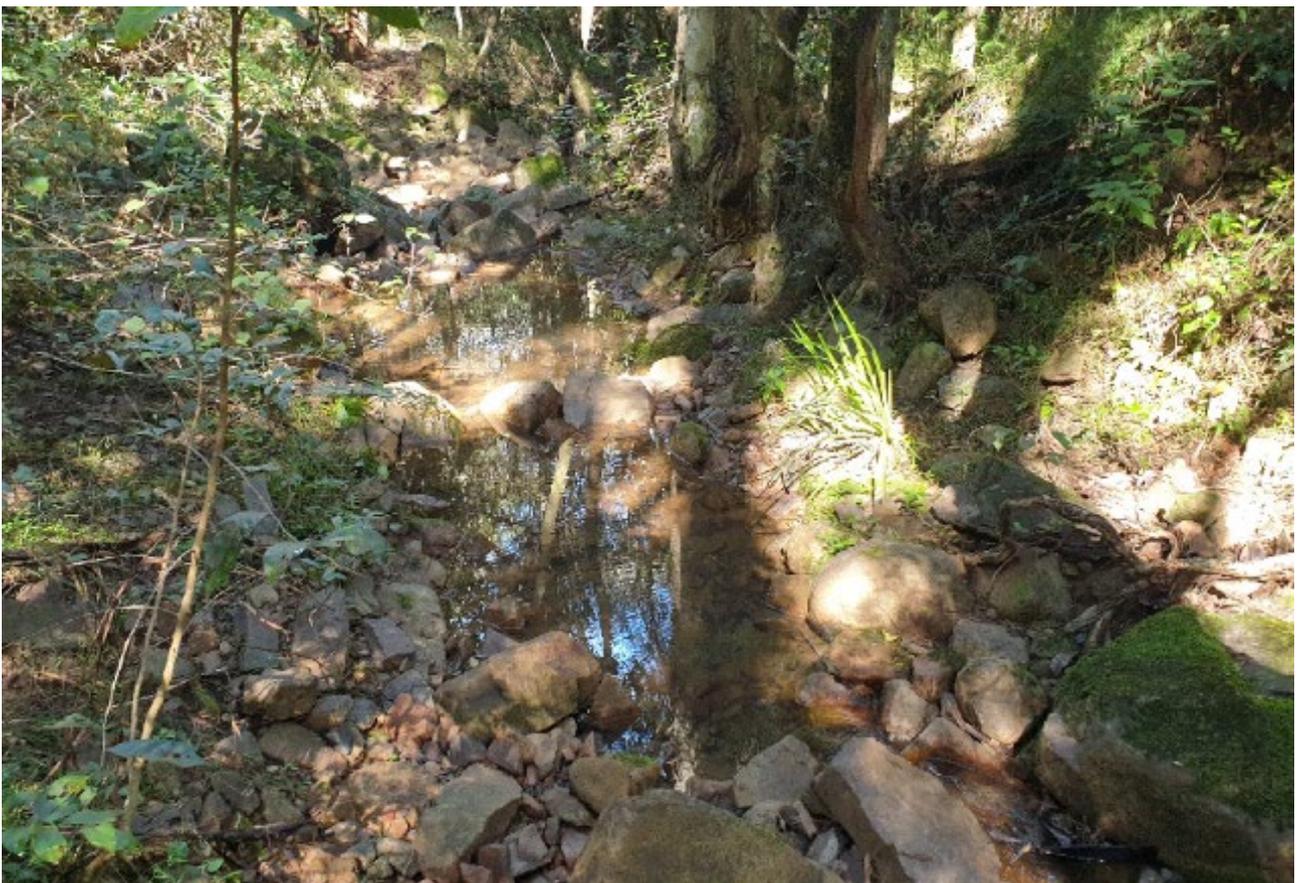
Photo 3.2 **Reach 1 – Monitoring Location 1-2. Looking Downstream.**

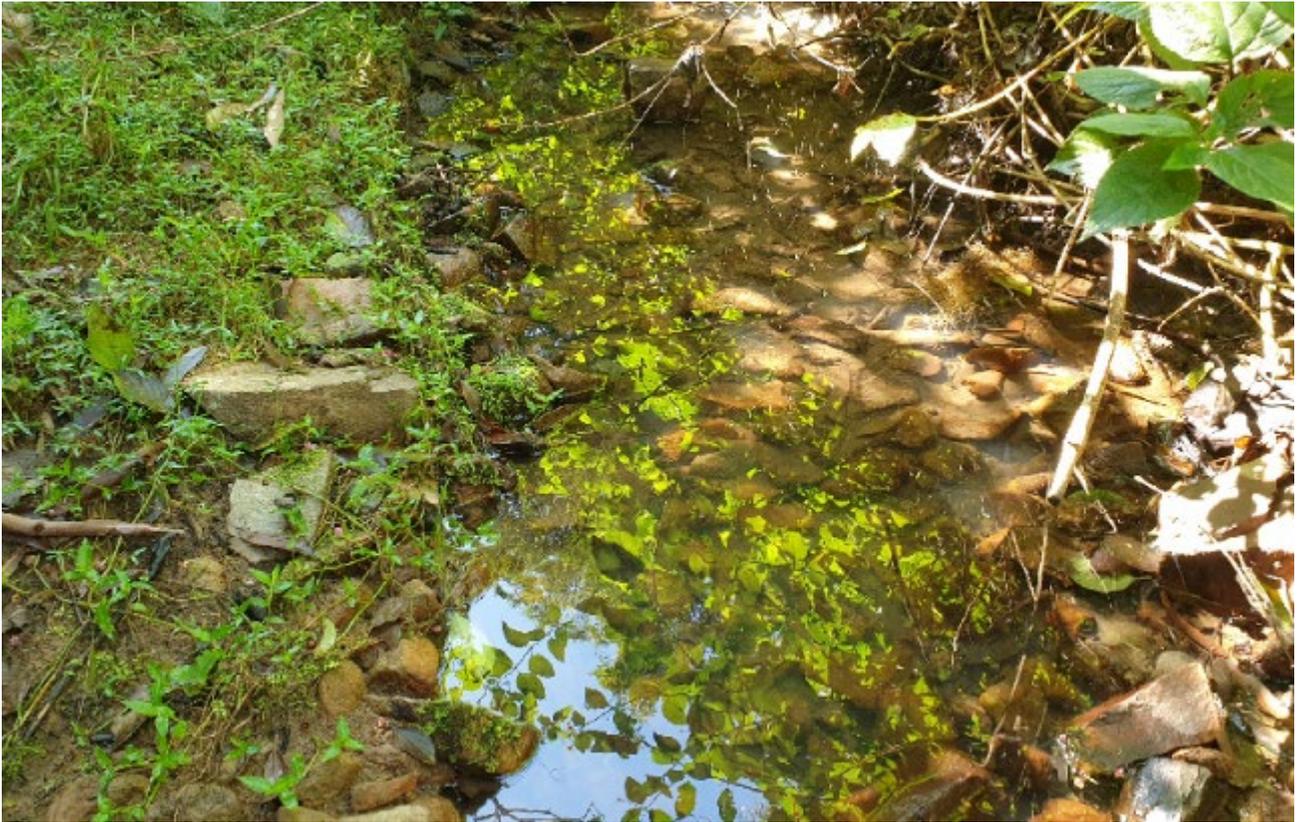
Photo 3.3 **Reach 1 – Monitoring Location 1-3. Looking Upstream.**

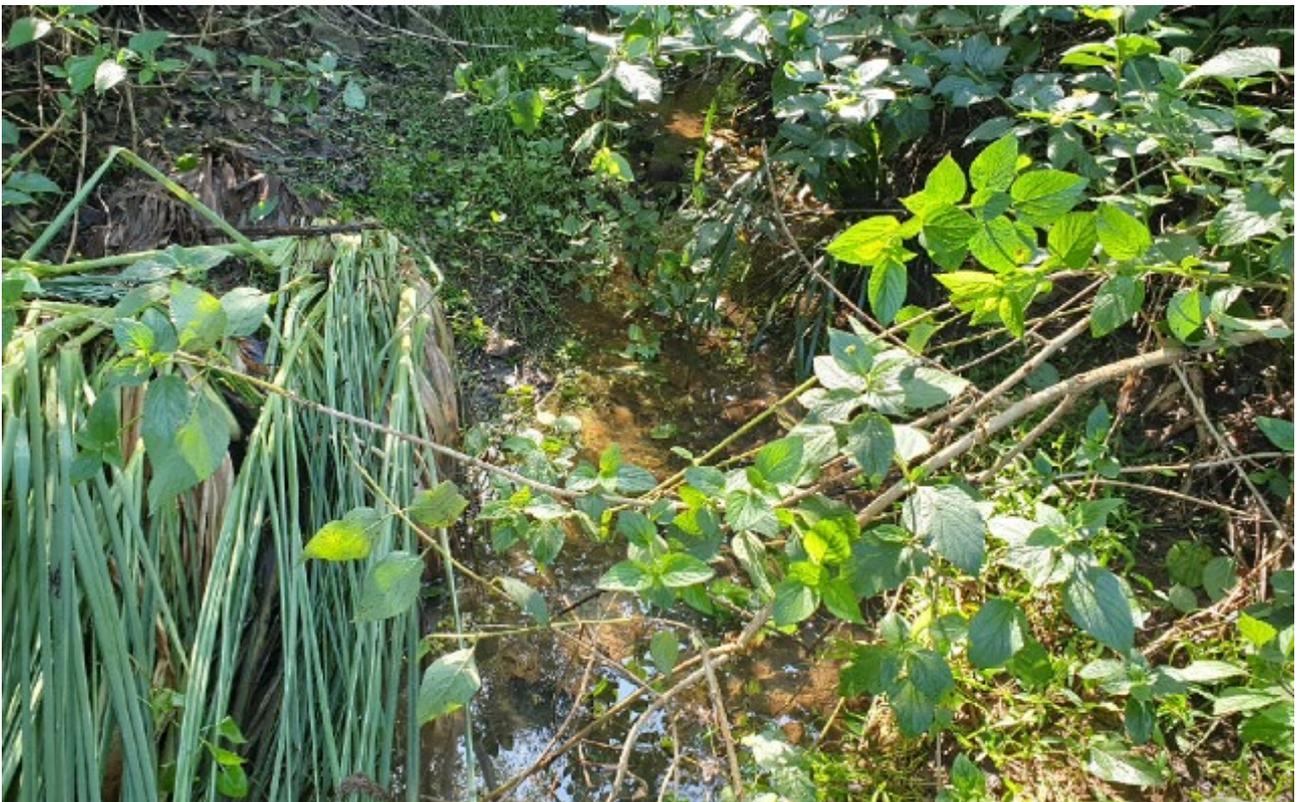
Photo 3.4 **Reach 1 – Monitoring Location 1-4. Looking Upstream.**

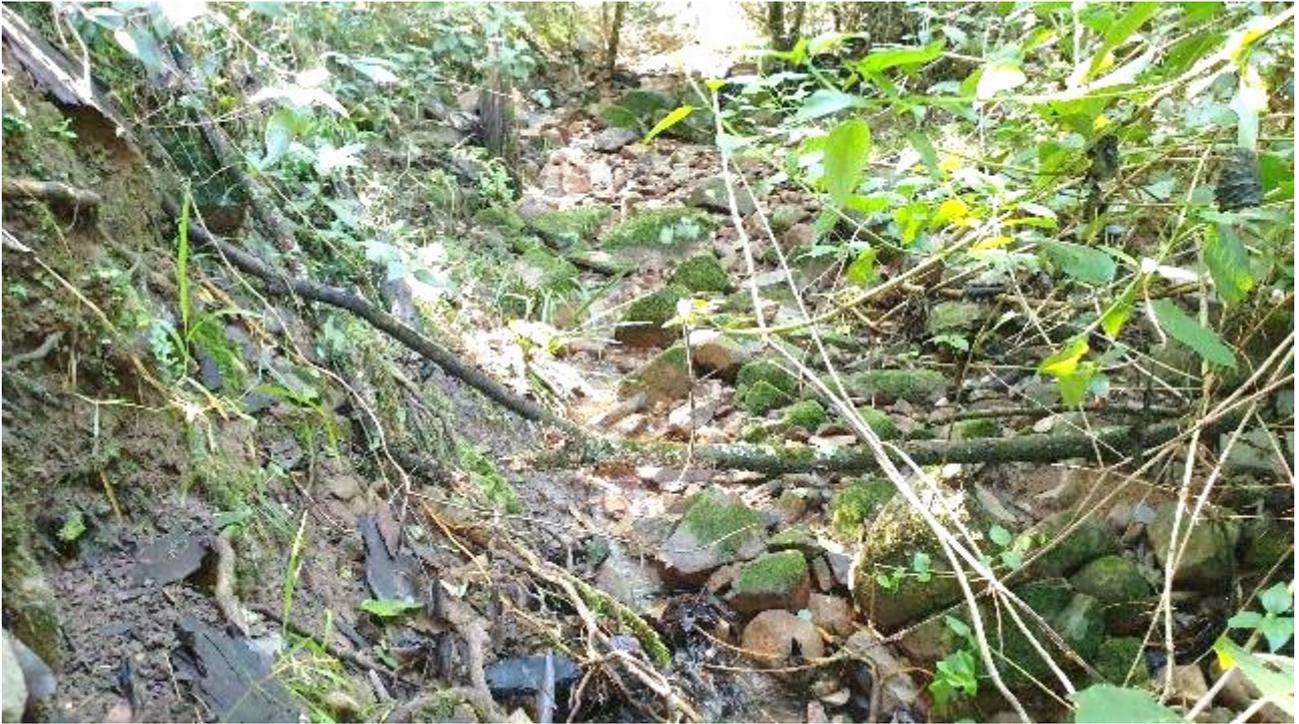
Photo 3.5 **Reach 2 – Monitoring Location 2-1. Looking Upstream.**

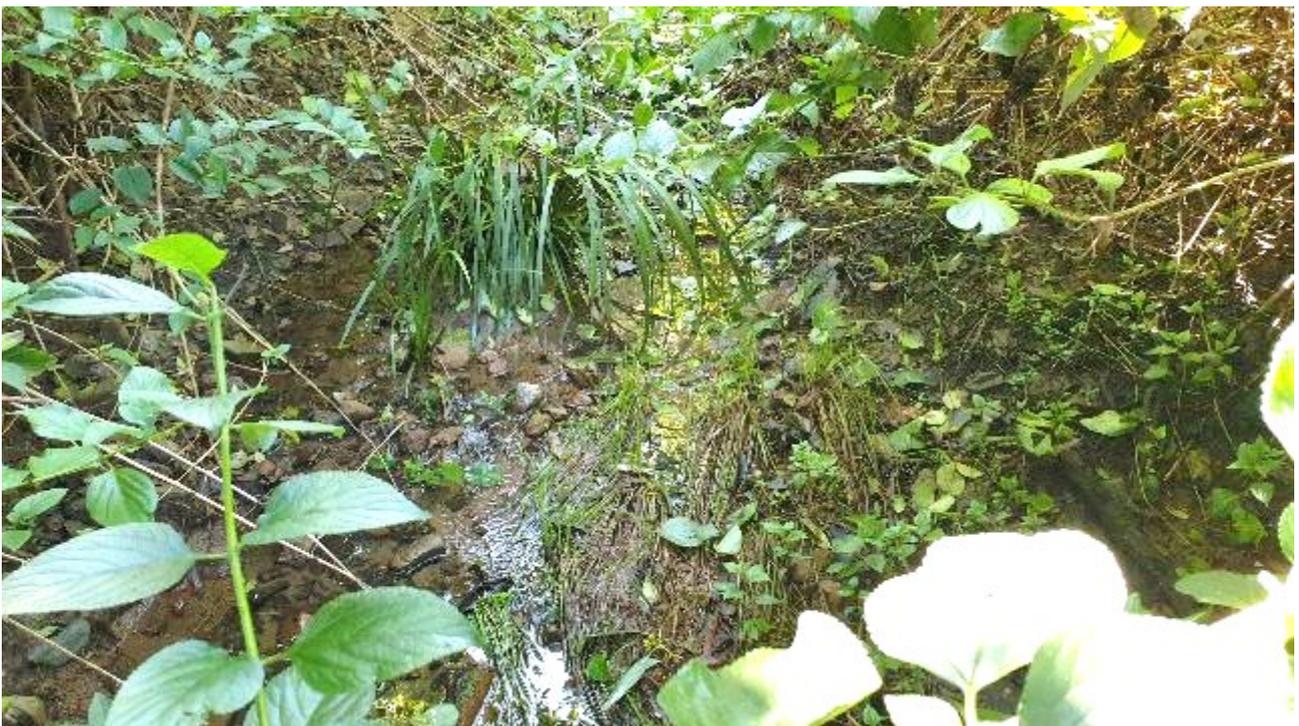
Photo 3.6 **Reach 2 – Monitoring Location 2-2. Looking Upstream.**

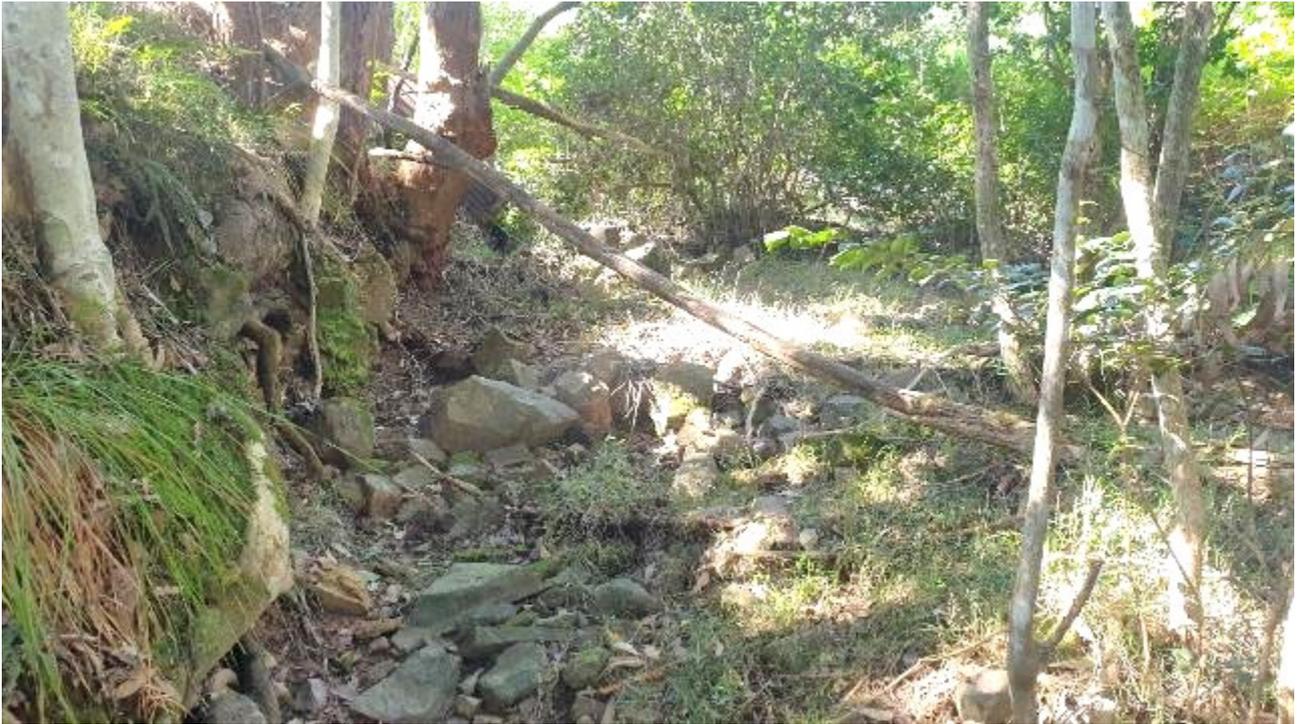
Photo 3.7 **Reach 5 – Monitoring Location 5-1. Looking Upstream.**

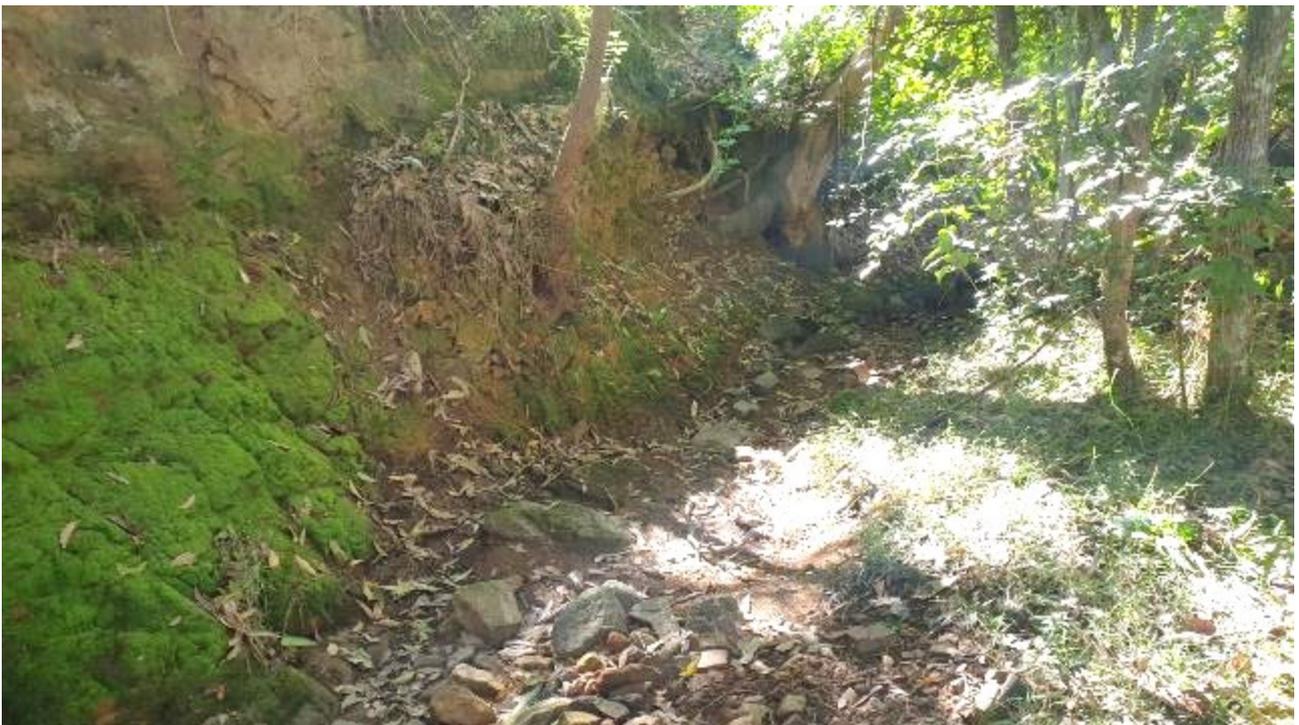
Photo 3.8 **Reach 5 – Monitoring Location 5-2. Looking Upstream.**

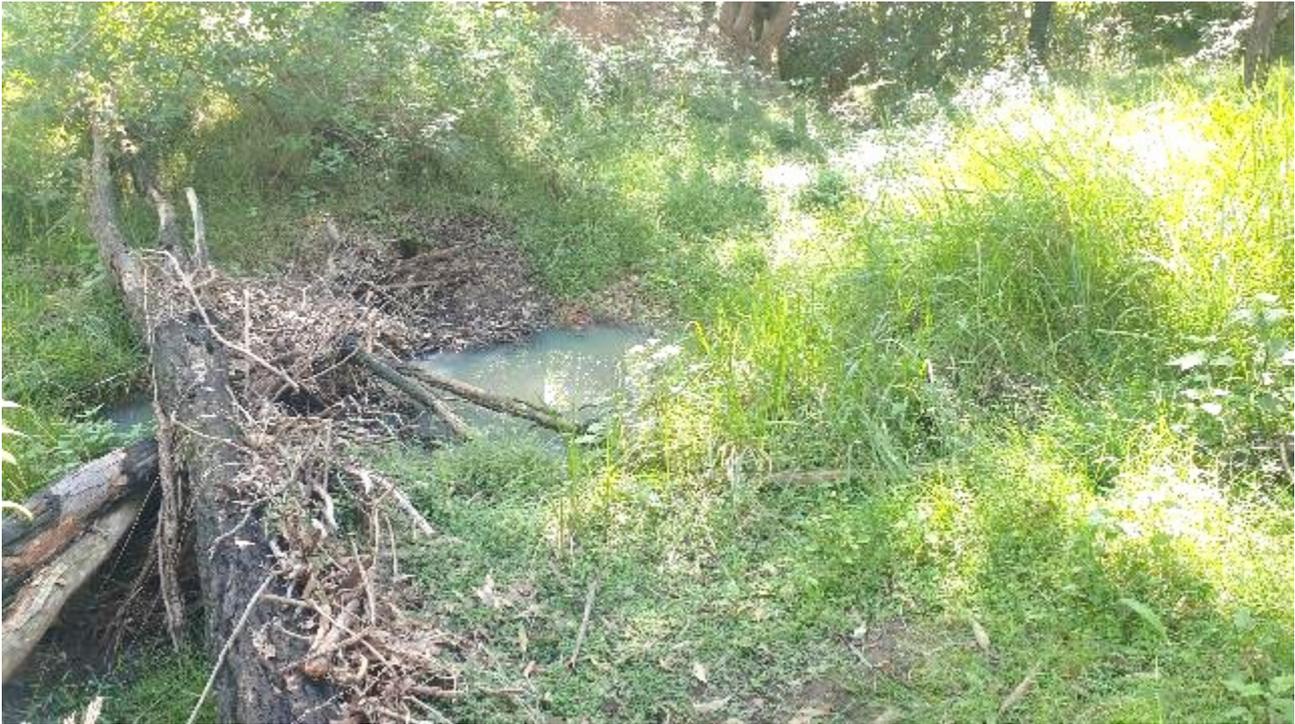
- An example of fallen vegetation across the channel was noted in Reach 5 (Monitoring Location 5-3). These types of instances can impede streamflow and create local vortices initiating streambank erosion. In-stream snags (woody debris) along the watercourse should be monitored for influence on local stream stability.

Photo 3.9 Reach 5 – Monitoring Location 5-3. Looking towards Western bank. Flow from Right to Left.

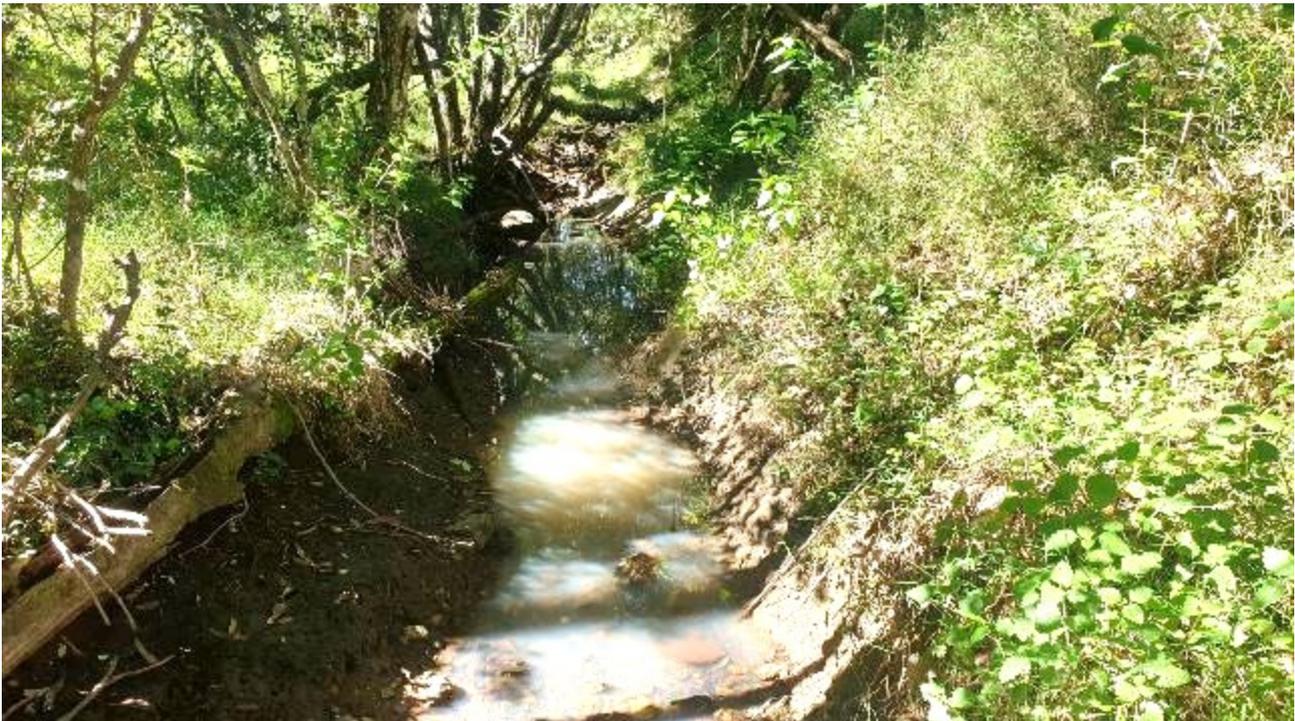
Photo 3.10 Reach 5 – Monitoring Location 5-4. Looking Upstream.

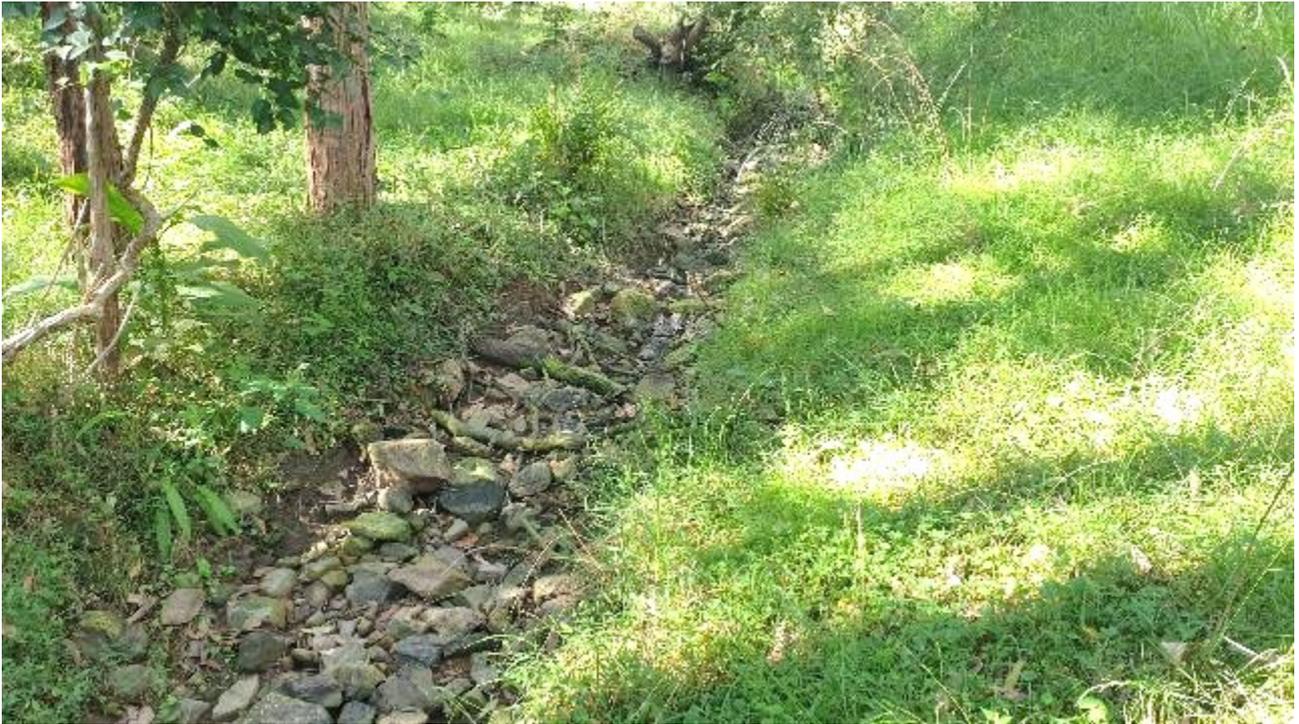
Photo 3.11 Reach 5 – Monitoring Location 5-5. Looking Upstream.

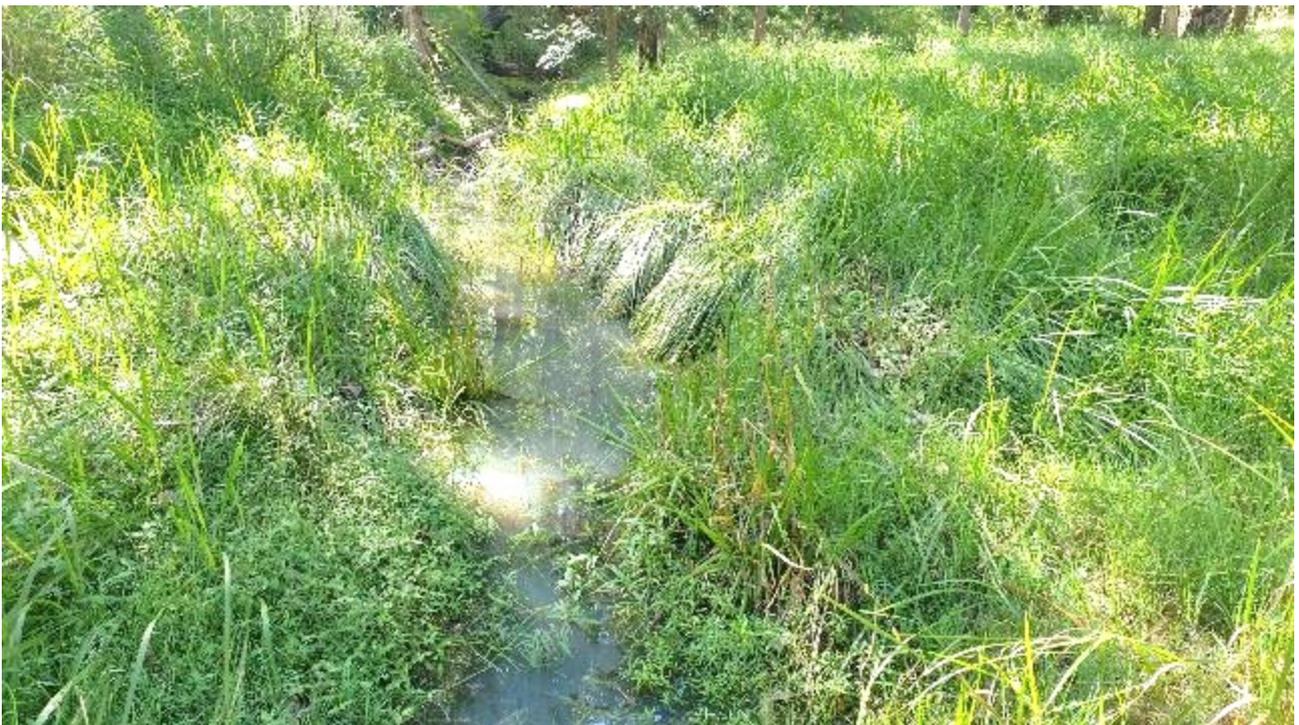
Photo 3.12 Reach 5 – Monitoring Location 5-6. Looking Upstream.

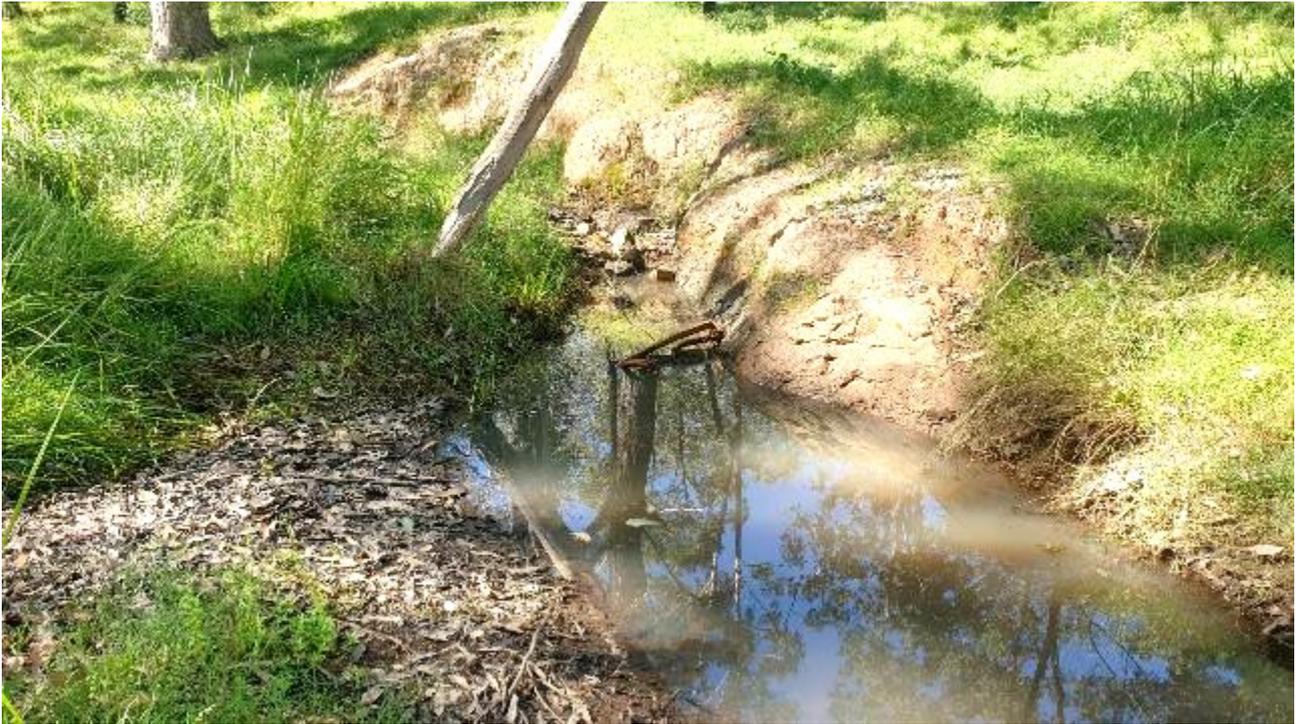
Photo 3.13 **Reach 5 – Monitoring Location 5-7. Looking Downstream.**

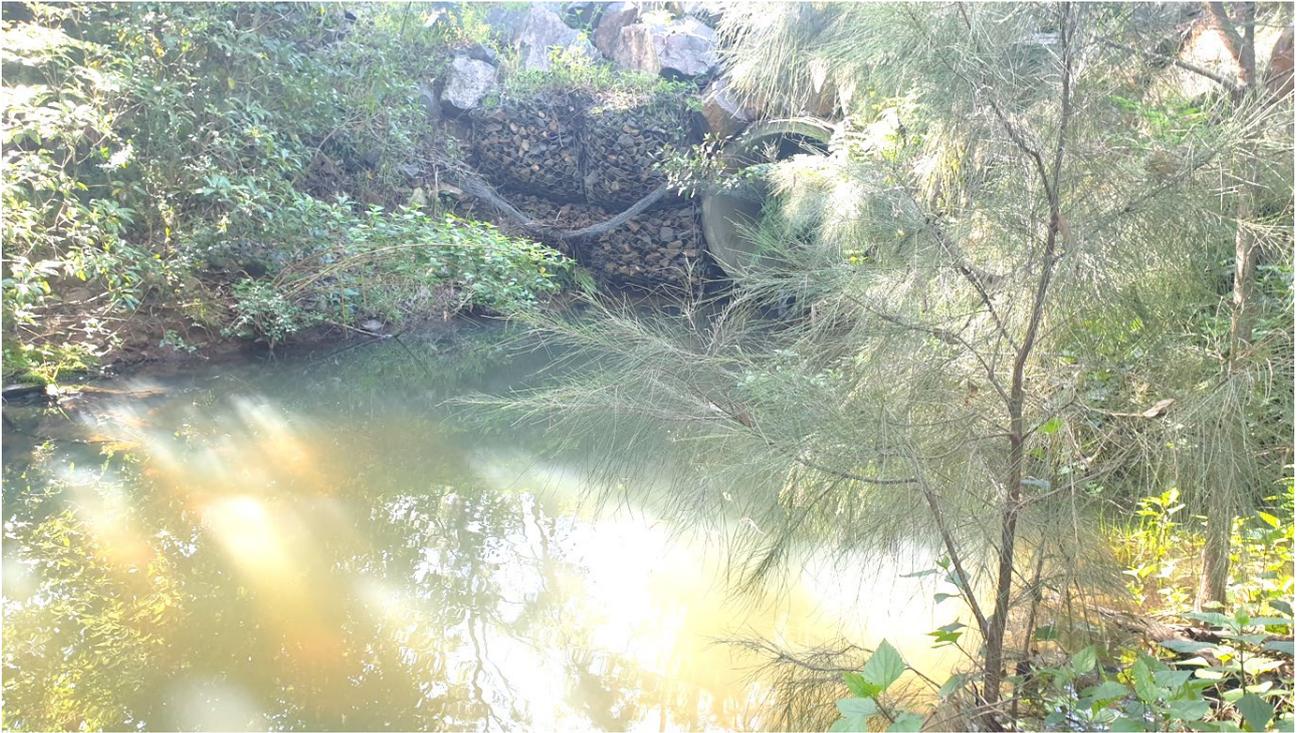
Photo 3.14 **Reach 3 – Location 3-1. At LDP 6, Looking Upstream at Discharge Point Pool.**

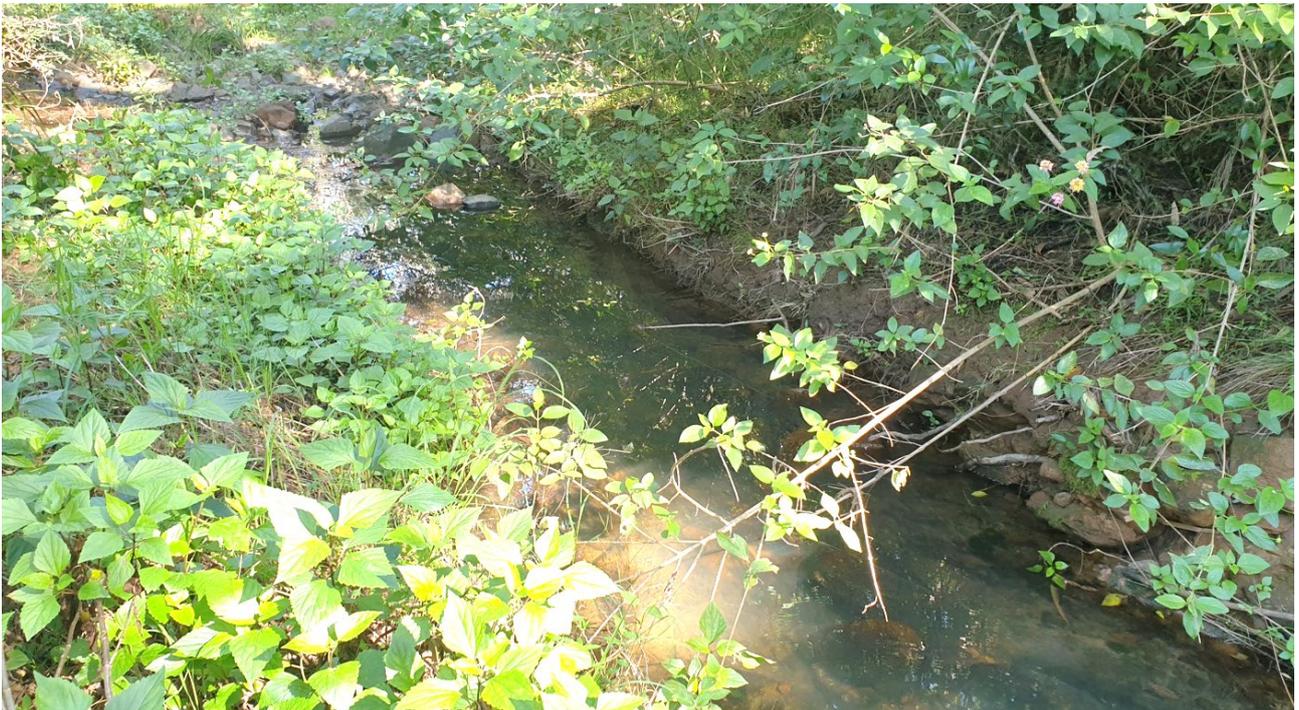
Photo 3.15 **Reach 3 – Location 3-1. At LDP 6, Looking Downstream.**

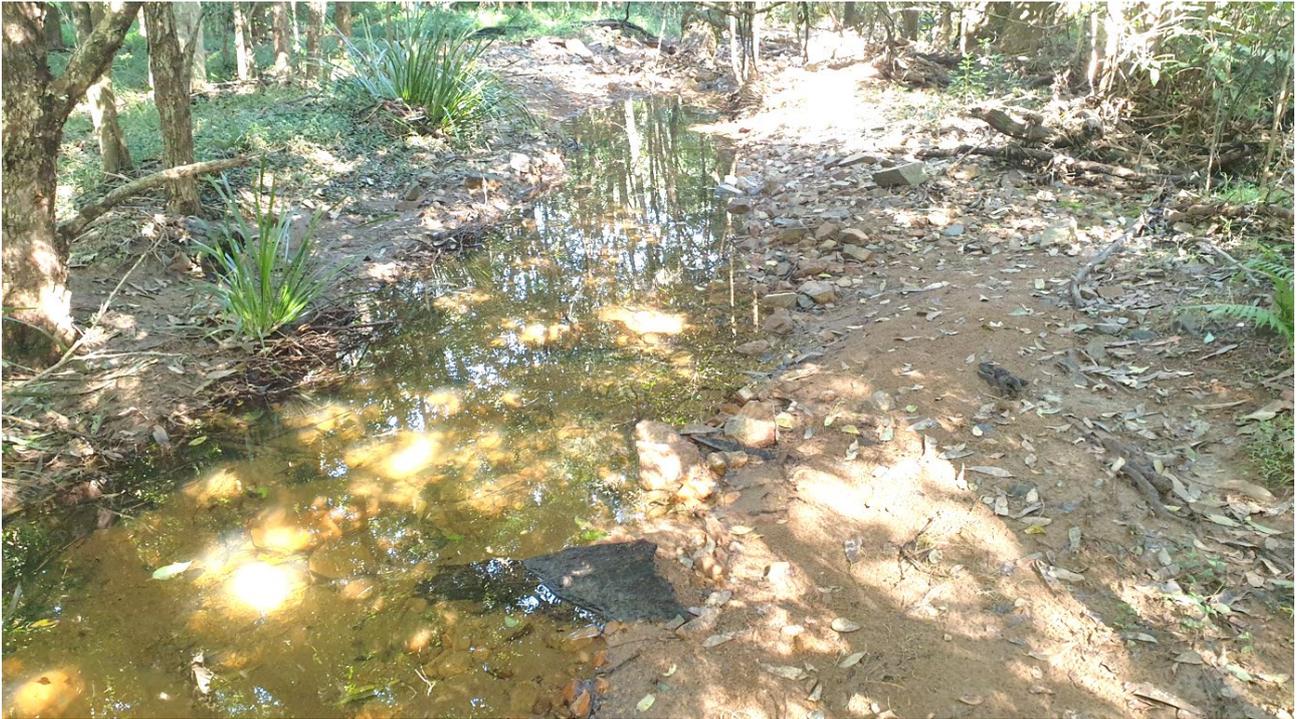
Photo 3.16 Reach 3 – Location 3-2. Looking Upstream.

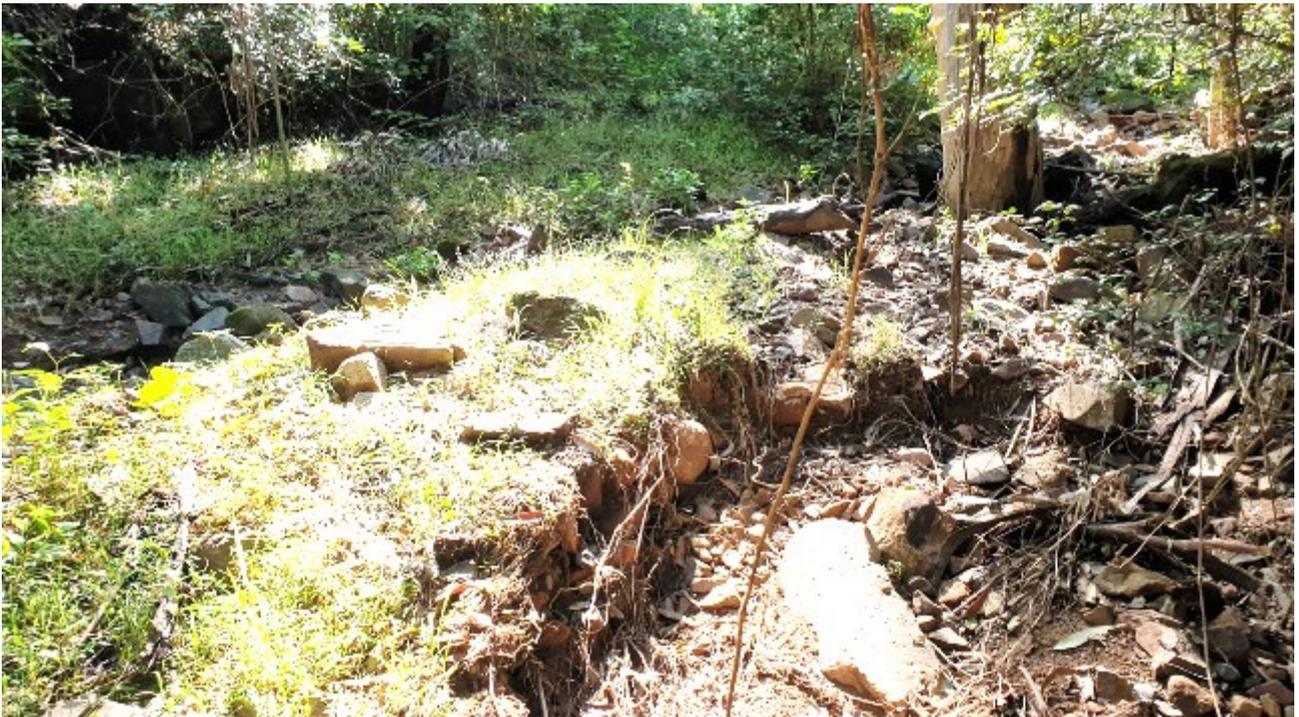
Photo 3.17 Reach 3 – Location 3-3. Looking Upstream.

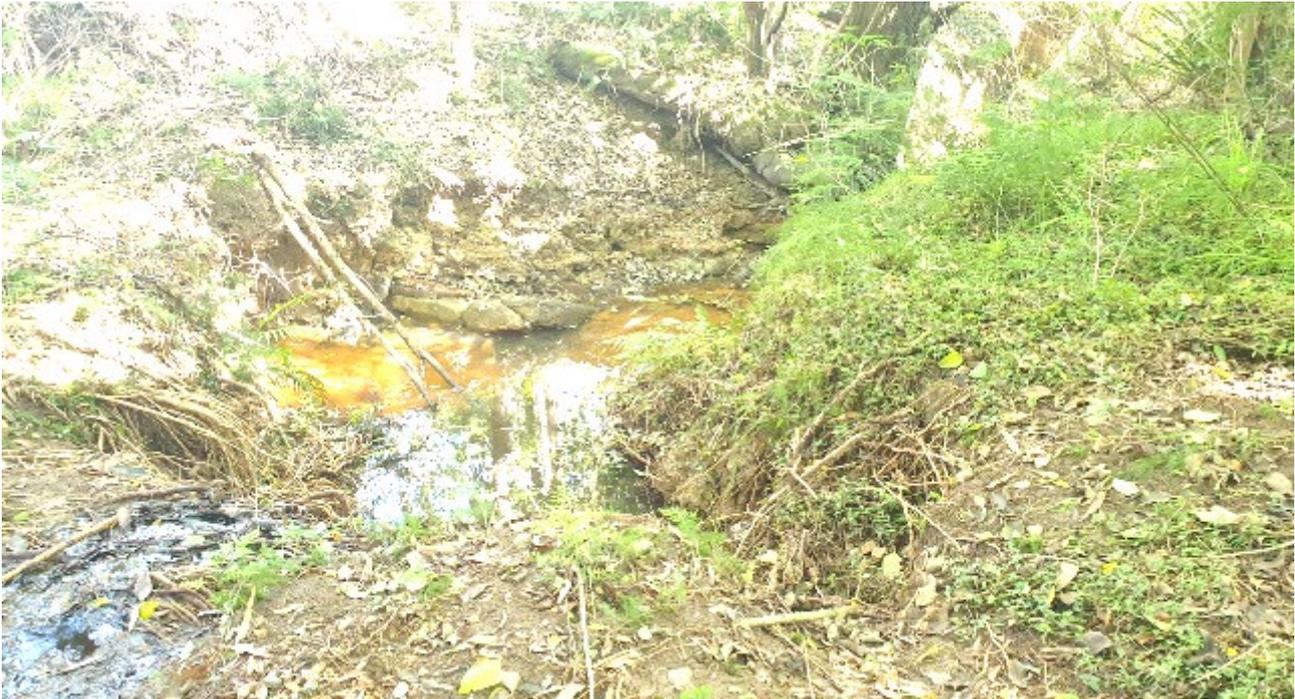
Photo 3.18 **Reach 3 – Location 3-4. Looking Downstream Towards Eastern Bank.**

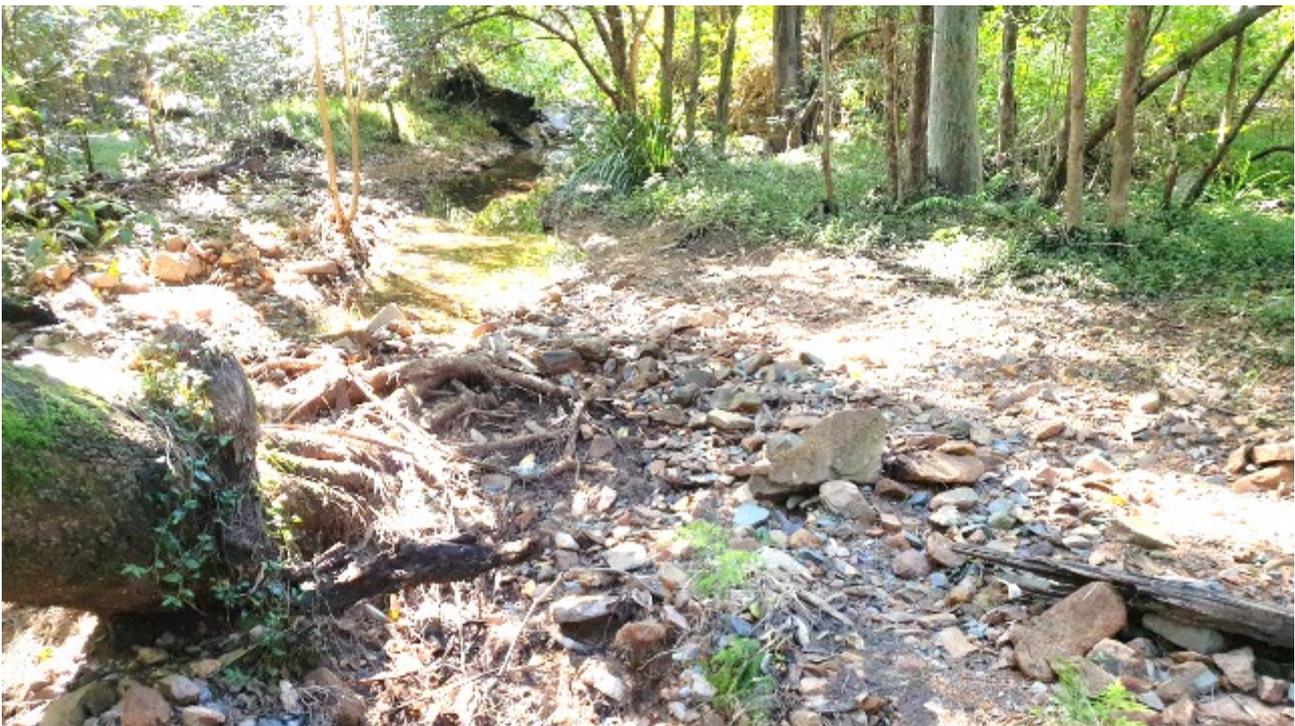
Photo 3.19 **Reach 3 – Location 3-5. Looking Upstream.**

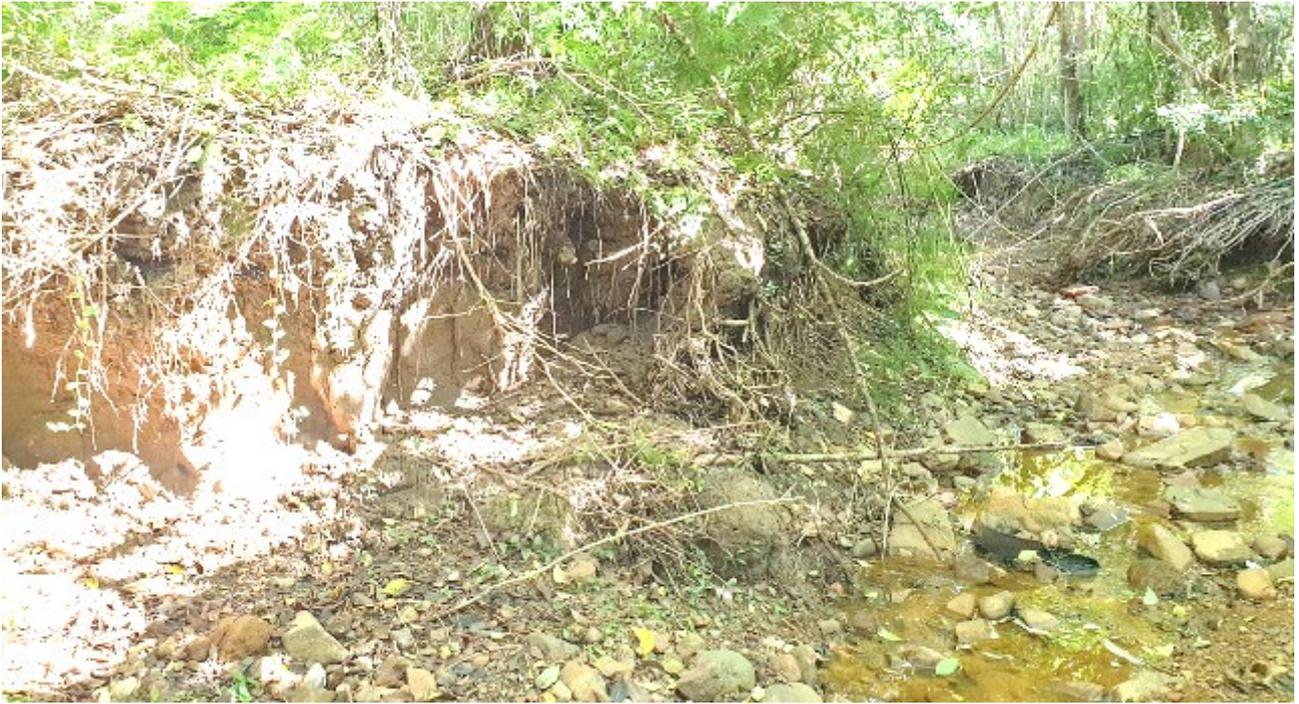
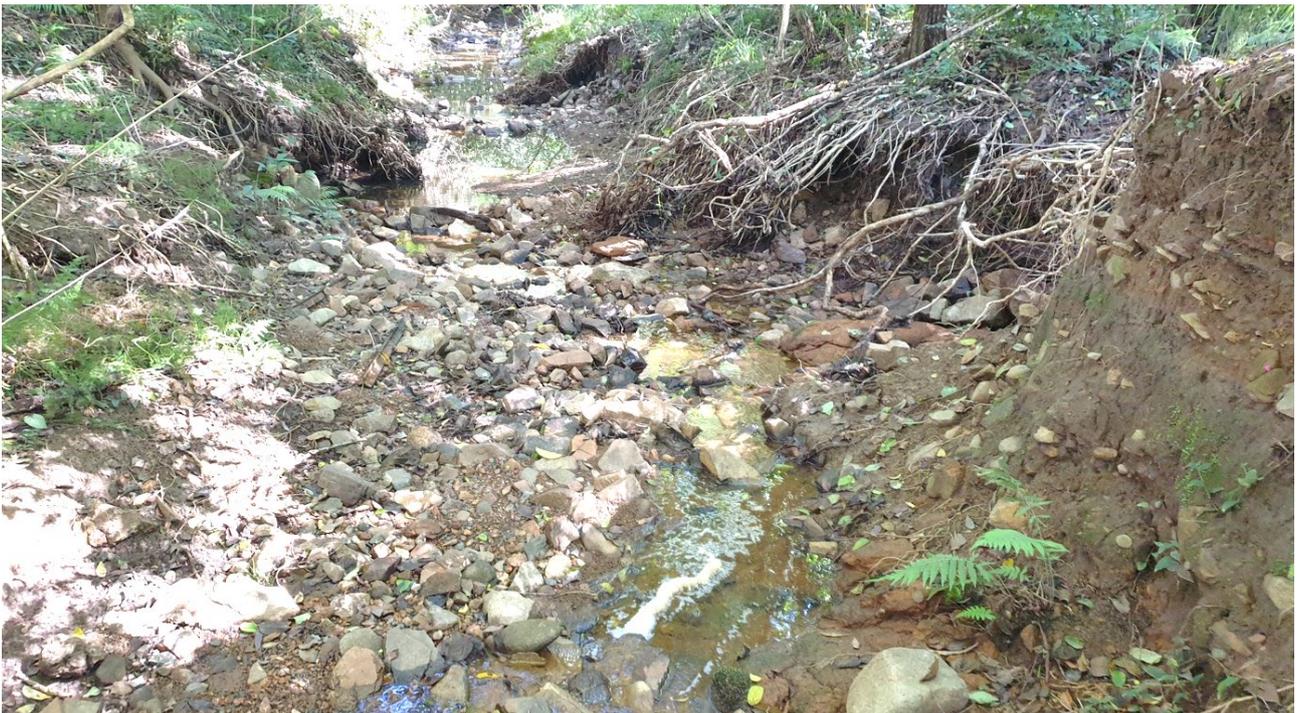
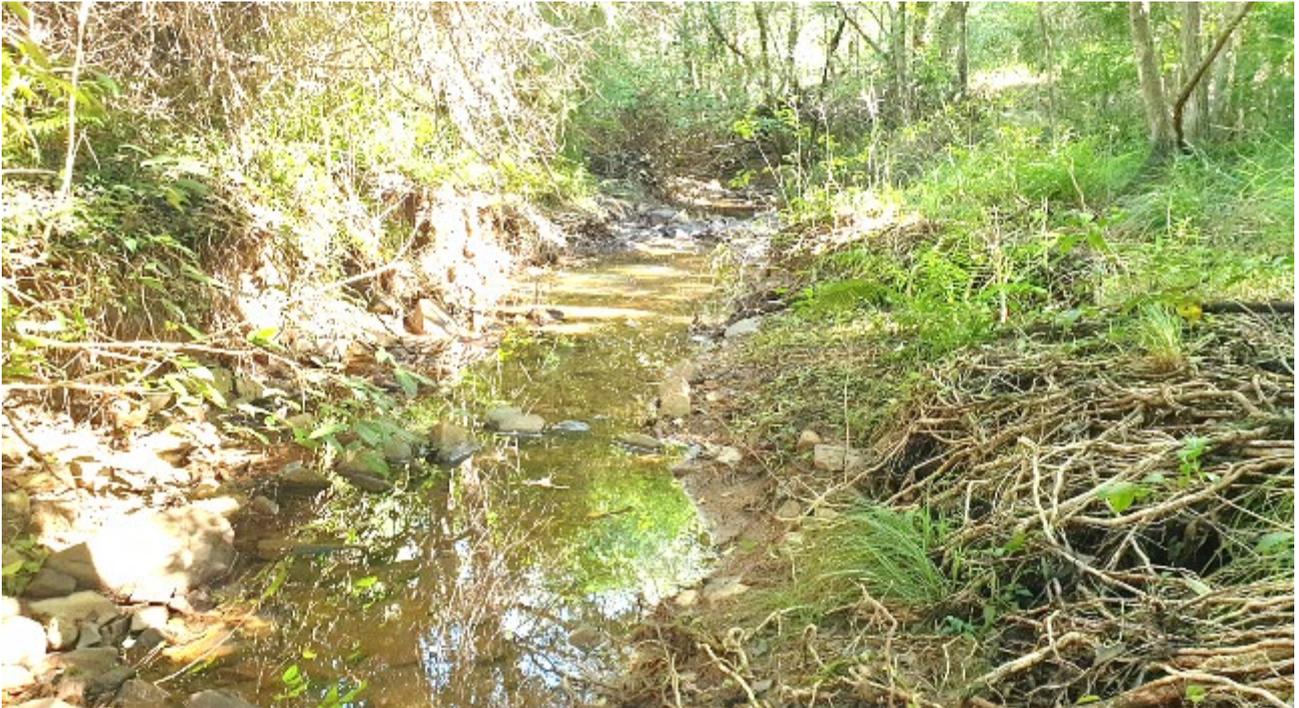
- All of the reaches appeared generally stable with no significant deterioration of bed and bank condition. Some limited localised bank erosion, specifically around Monitoring Location 3.6 was observed. The scale and nature of the erosion do not represent any significant risk of further extensive degradation, however, would be a key location for ongoing monitoring. Heavy rainfall across the catchment in recent months is the potential cause of this localised erosion. It is noted that LDP 6 discharged approximately 31 and 25 megalitres (ML) for the first four months of 2021 and 2022 respectively. These discharges would provide only a relatively minor additional flow to the natural flow generated across the full catchment from the rainfall conditions experienced.

In general, Reach 3 was classified as ‘stable’, however an area of localised erosion and scour with bank undercutting was evident on Reach 3 (ID 3-6) and has been classified as ‘potentially stabilising’. The erosion and bank undercutting at this location is likely a result of the flows generated from the natural catchment from recent and persistent wet weather as discussed in **Section 3.2**, rather than a result of quarry produced flow.

Photo 3.20 Reach 3 – Location 3-6. Looking Downstream at Eastern Bank.

Photo 3.21 Reach 3 – Location 3-6. Looking Downstream.

Photo 3.22 **Reach 3 – Location 3-6 (Approximately 10m South). Looking Downstream.**

- Areas of 'potentially stabilising' erosion, on Reach 3 may be monitored on a 6-monthly interval by Daracon, or following significant local catchment rainfall events (providing streamflow response for 50% to 100% bank full condition) until demonstrated as stable, with annual monitoring undertaken by a specialist.
- If monitoring indicates that areas of erosion are becoming less stable, the requirement for remedial works should be reviewed with consideration of the mechanism of the damage (e.g. high streamflow) and relative contribution from the quarry operation.
- Annual channel stability monitoring should be undertaken by a specialist to ensure that any further erosion can be identified and addressed and that any rehabilitation activities are successful.

- Areas of 'potentially stabilising' erosion, on Reach 3 are to be monitored by Daracon on a 6-monthly interval, or following significant local catchment rainfall events until demonstrated as stable, with annual monitoring undertaken by a specialist.
- If monitoring indicates that areas of erosion are becoming less stable, the requirement for remedial works should be reviewed with consideration of the mechanism of the damage (e.g. high streamflow) and relative contribution from the quarry operation.
- Annual channel stability monitoring should be undertaken by a specialist following any remedial works to ensure that any further erosion can be identified and addressed and that any rehabilitation activities are successful.
