**BASELINE RIPARIAN CONDITION
REPORT (2022)**

Martins Creek Quarry

Prepared by
Umwelt (Australia) Pty Limited
on behalf of
Daracon

Project Director: Barbara Crossley
Project Manager: Kirsty Davies
Technical Director: Darren Lyons
Technical Manager: Matilda Mathieu
Report No. 3957C/R23
Date: June 2022

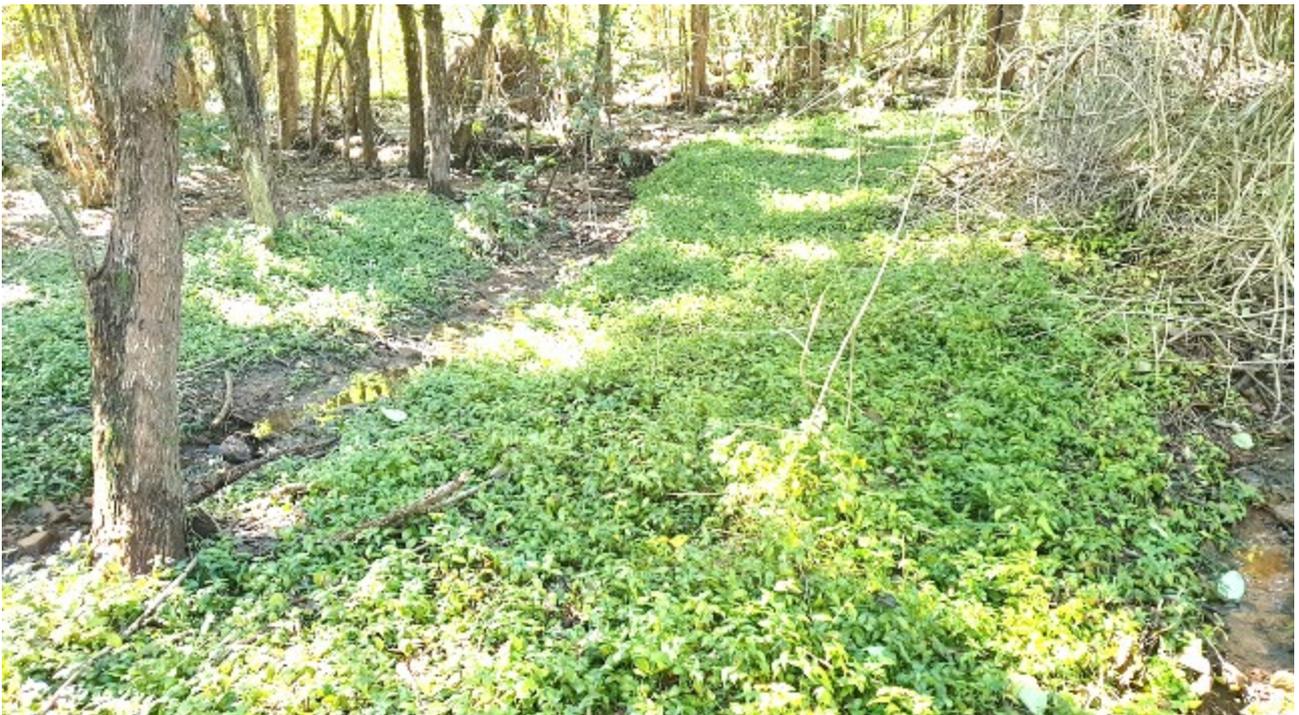
- There is a channel bifurcation at the downstream end of Reach 3 and correspond to Monitoring Locations 3.7 and 3.8. These locations are off the main alignment of the monitoring reach and also pick up some additional catchment area from the north west.

Photo 3.23 **Reach 3 – Location 3-7. Looking Upstream.**

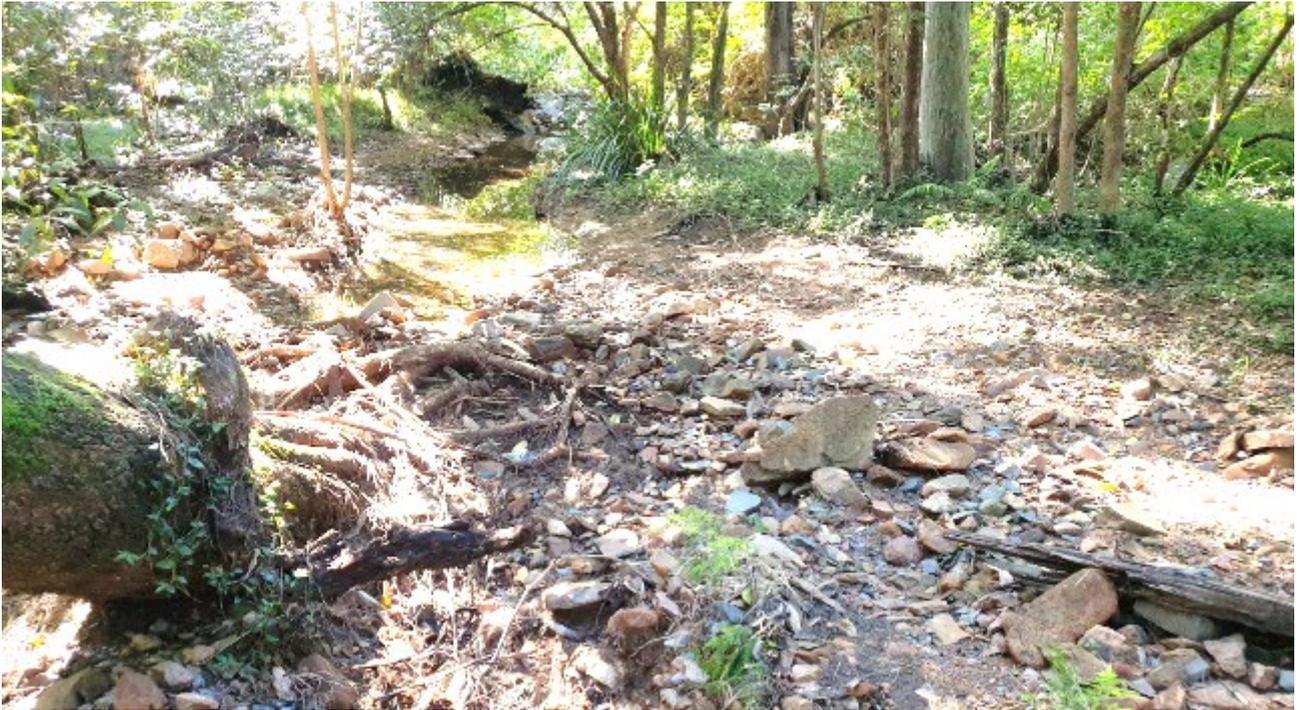
Photo 3.24 **Reach 3 – Location 3-8. Looking Downstream.**

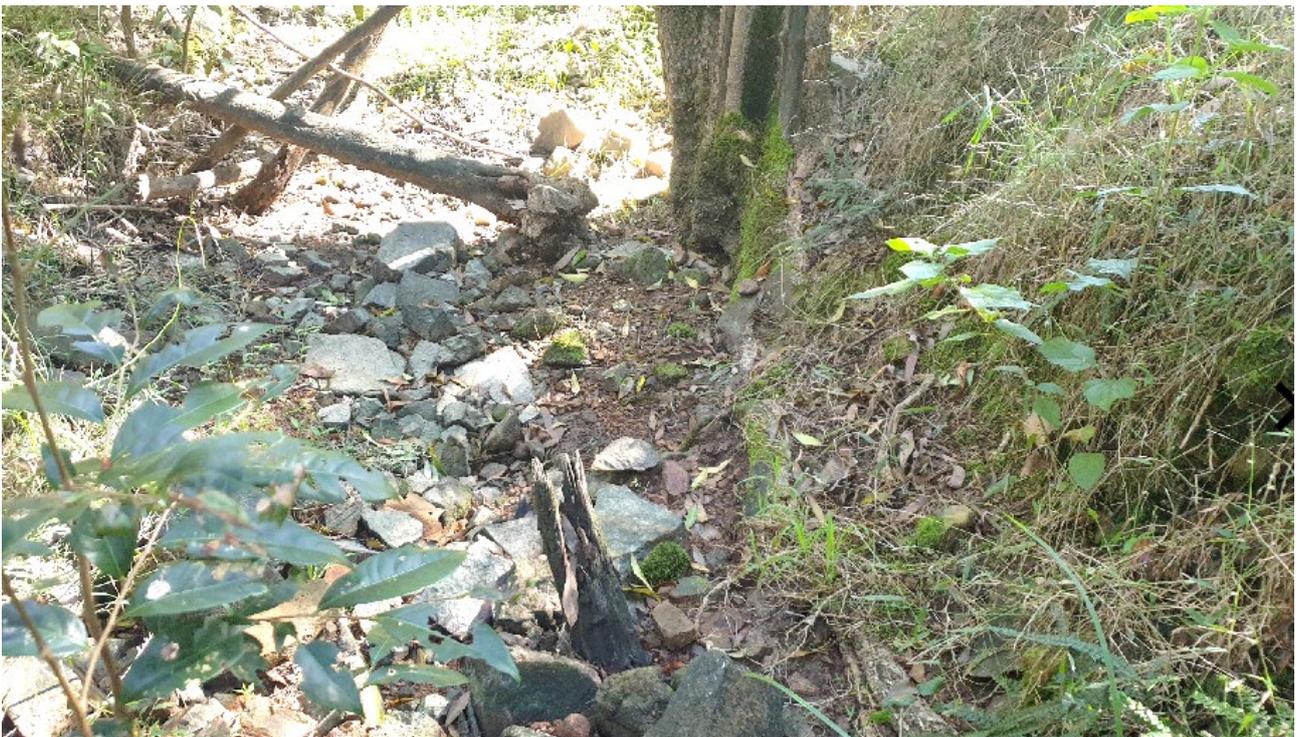
Photo 3.25 **Reach 4 – Location 4-1. Looking Downstream.**

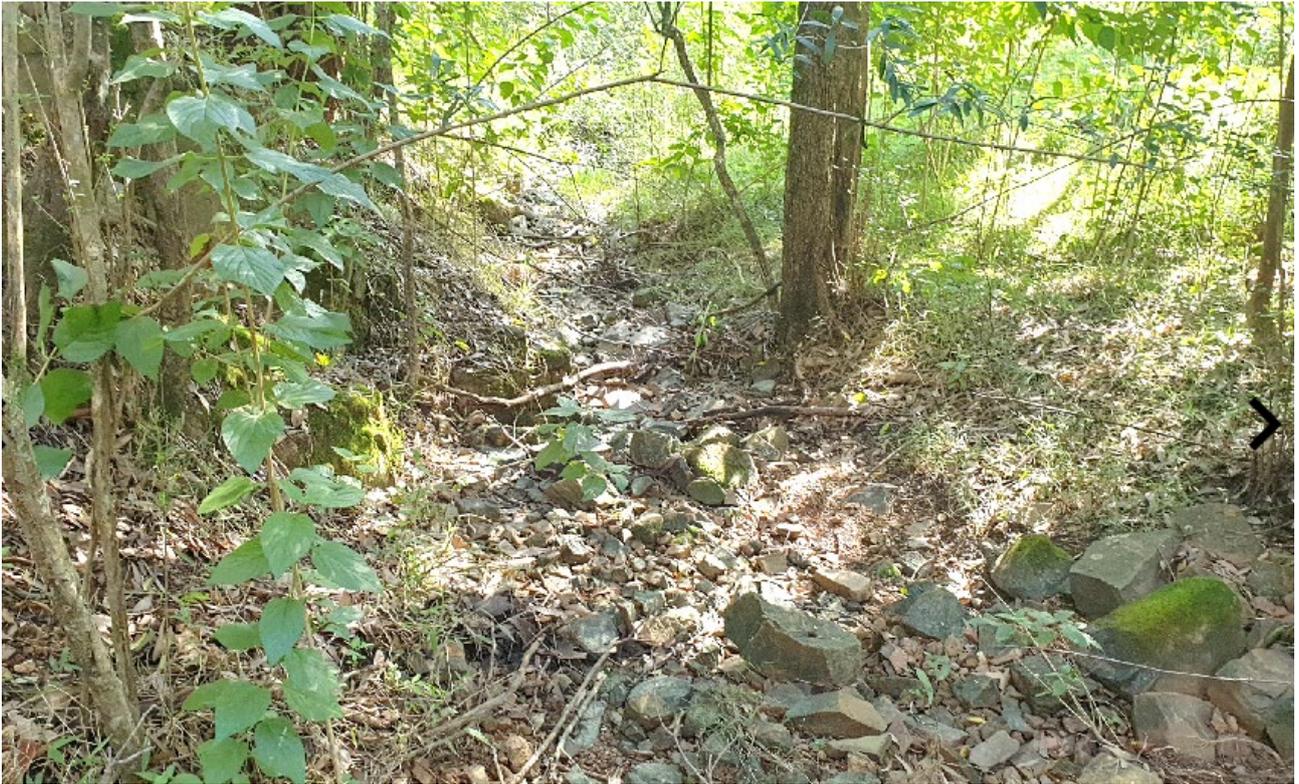
Photo 3.26 **Reach 4 – Location 4-2. Looking Downstream.**

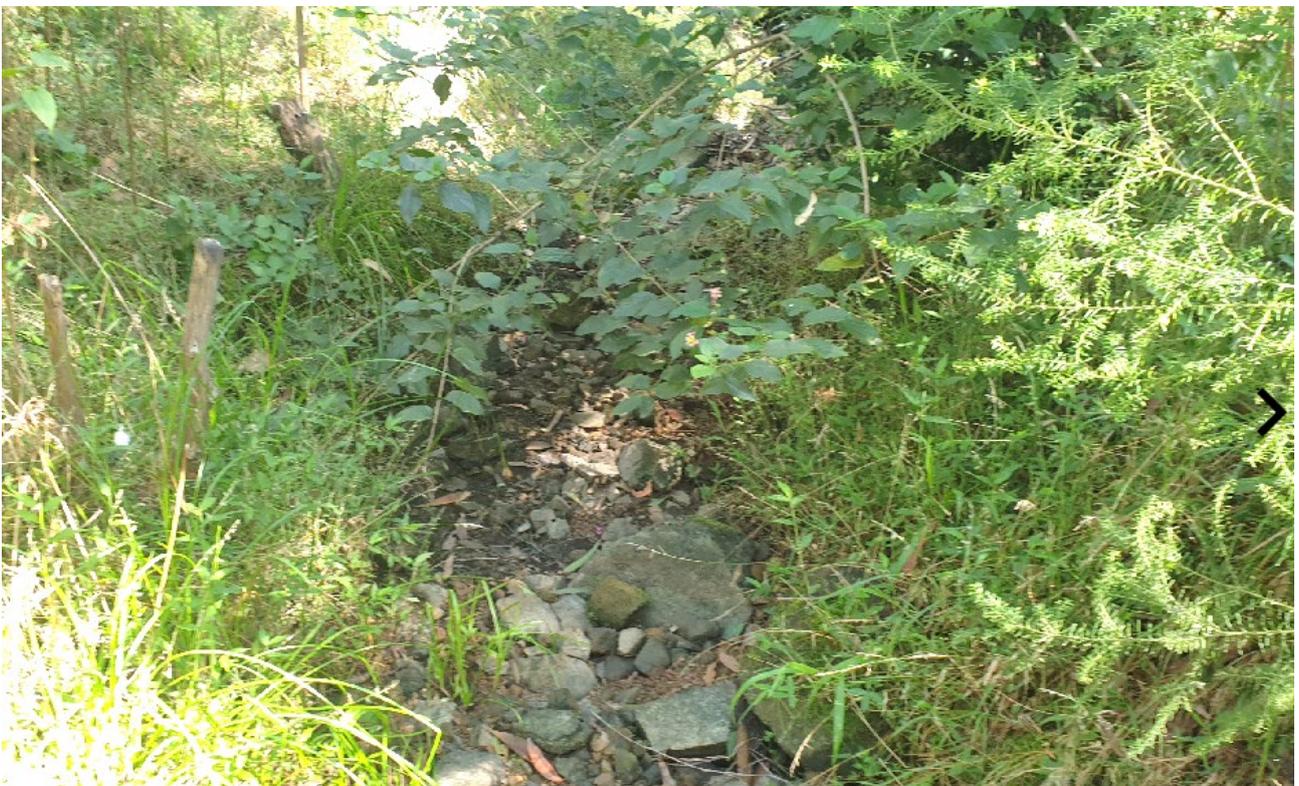
Photo 3.27 **Reach 4 – Location 4-3. Looking Downstream.**

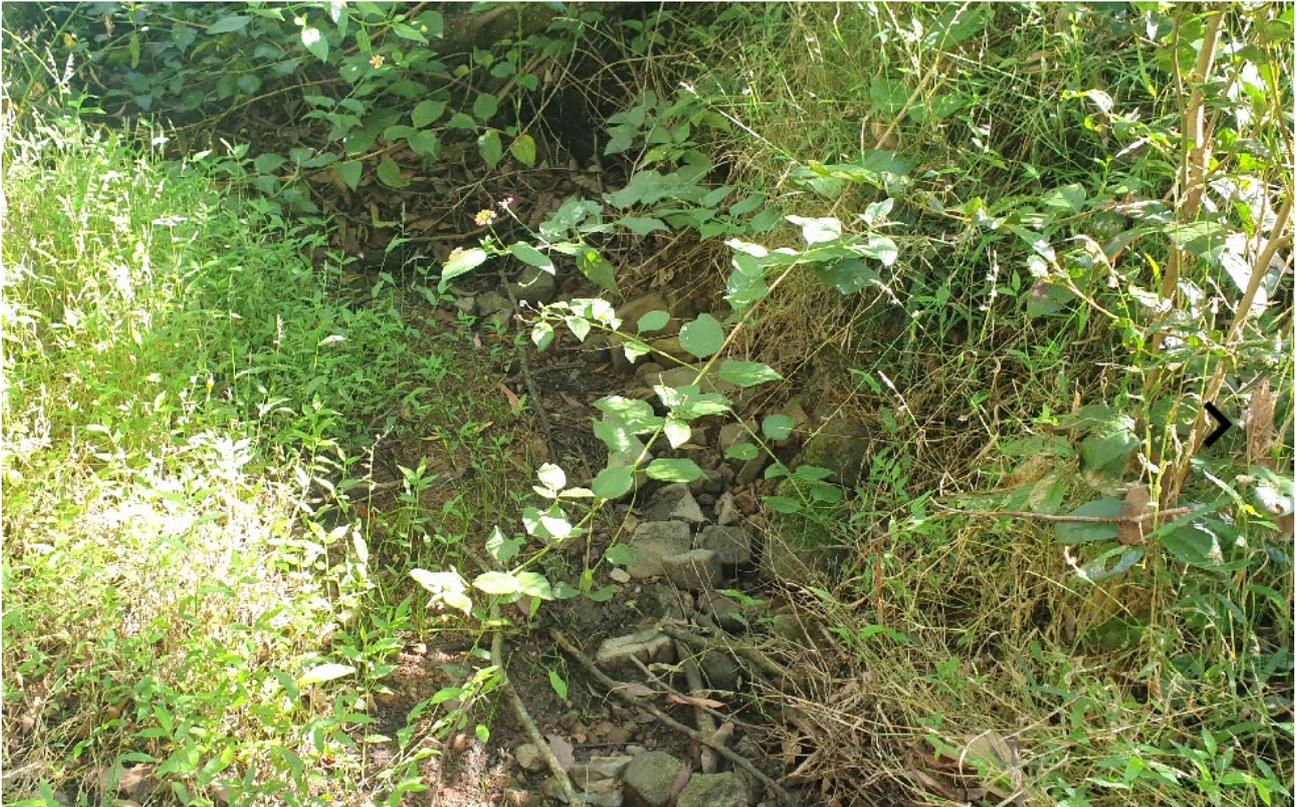
Photo 3.28 Reach 4 – Location 4-4. Looking Downstream.

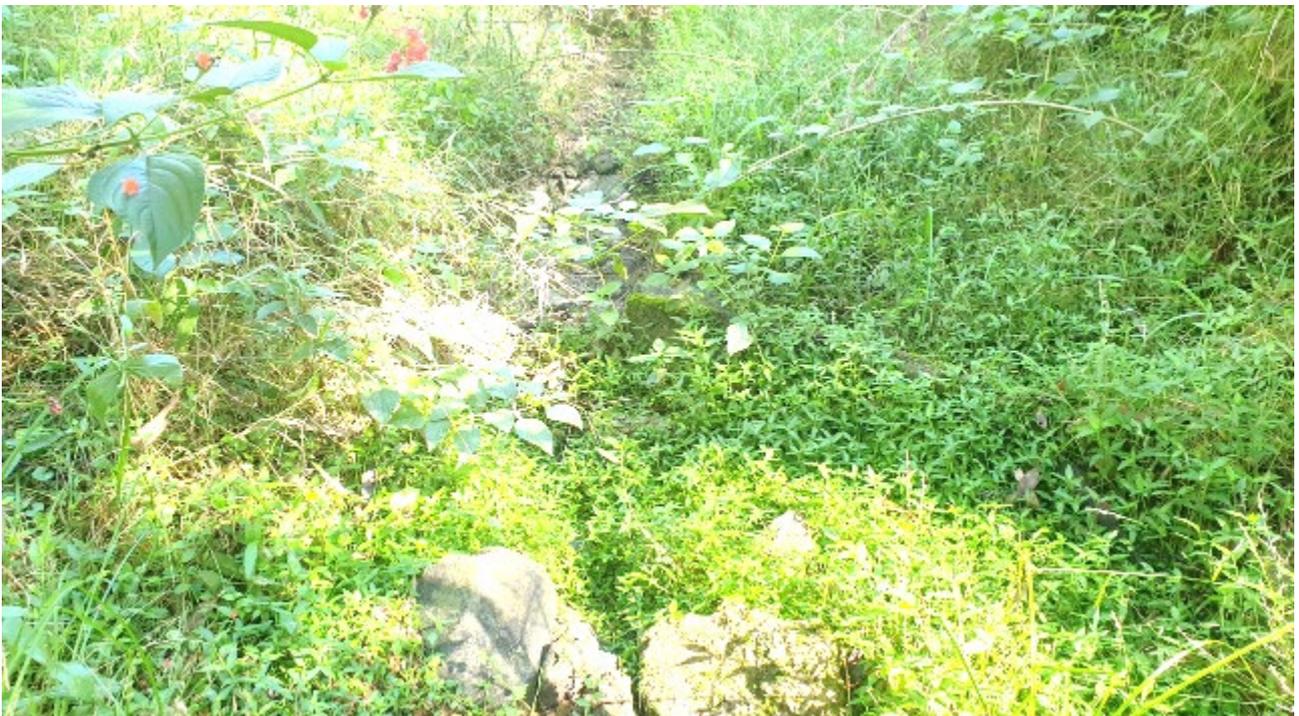
Photo 3.29 Reach 4 – Location 4-5. Looking Downstream.

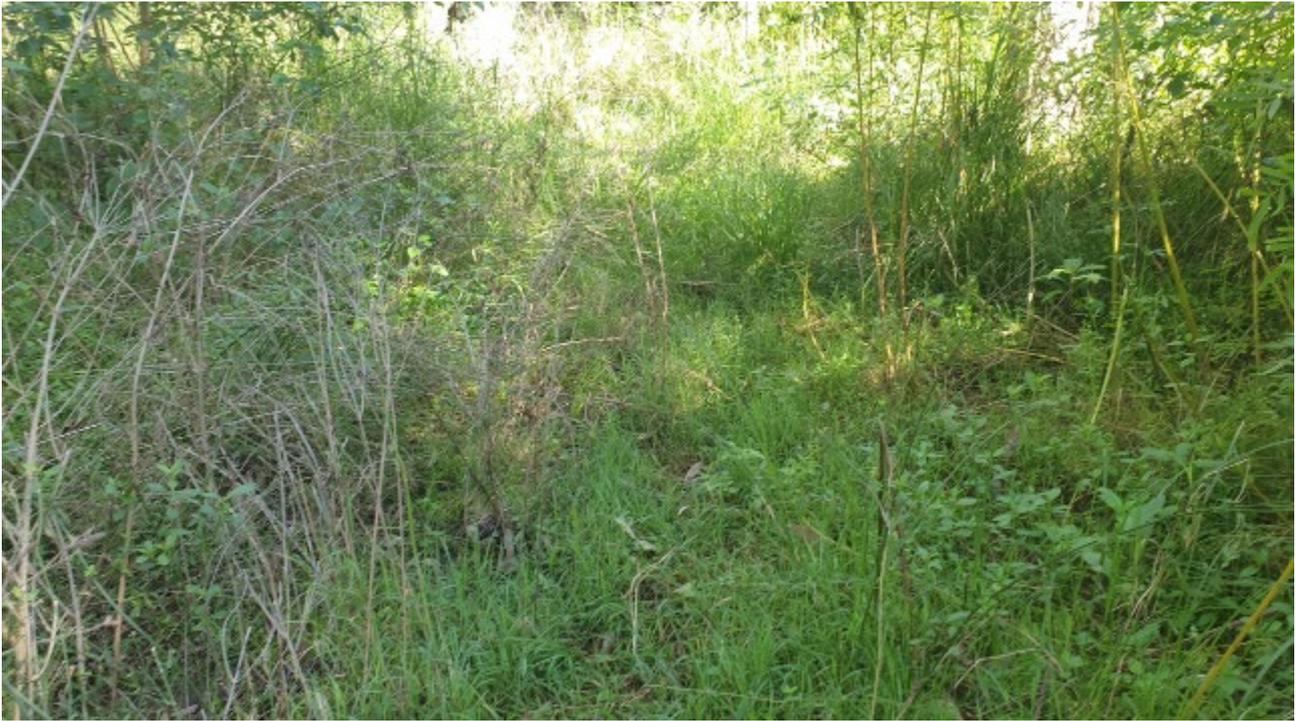
Photo 3.30 **Reach 4 – Location 4-6. Looking Downstream.**
