## **ARBORICULTURAL ASSESSMENT REPORT**

**Barangaroo South – Hickson Road Remediation**

**Lend Lease (Millers Point) Pty Limited**

**10<sup>th</sup> October 2017**

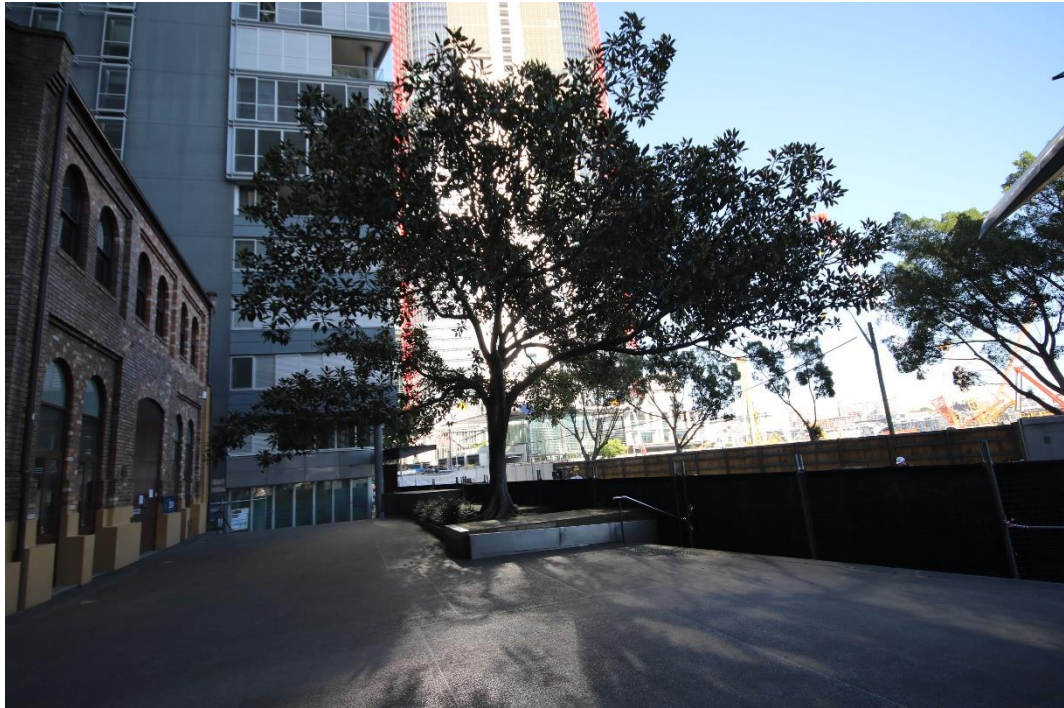
Plate 2: Tree 45

1. Tree 45 *Ficus macrocarpa* shows good vitality and form, being located in a raised planter bed in the forecourt of The Bond – refer plate 2. This tree is required to be removed as part of proposed extension of the Hickson Road Remediation Works into the forecourt area. Remediation works include excavation of the soils and construction of an odour enclosure in this specific area of the tree. Removal is supported on the basis of replacement trees will be planted at the completion of remediation works.

| Tree No | Botanical Name | Age Class | Height – m | Spread - m | D.B.H (cm) | D.R.B (cm) | TPZ & SRZ Rad.m | Condition comments on trees as seen on site | ULE |
|---|---|---|---|---|---|---|---|---|---|
| 45 | <i>Ficus macrocarpa</i><br>(Moreton Bay Fig) | M | 8 | 8 | 42 | 44 | 5.1, 2.3 | G vitality. Located in raised planter bed in the Bond forecourt. | 2 |

- a. The removal of Tree 45 to enable the Hickson Road Remediation works to be extended into a portion of the land at 36 Hickson Road;
- b. Approval to remove Tree 45 is required from the landowner and the relevant authority;

- c. Tree removal work shall be carried out by an experienced tree surgeon in accordance with NSW WorkCover Code of Practice for Amenity Tree Industry (1998);
- d. That the one (1) removed tree be replaced with appropriately advanced tree of the same species at the completion of Option 2 works, or in accordance with any other street tree design approved by the relevant authority; &
- e. The tree location plan can be found on Annexure B.
