391-423 PACIFIC HIGHWAY, CROWSNEST NSW 2065

PRE-DILAPIDATION REPORT

DEICORP PTY LTD

Job No. 240325.4

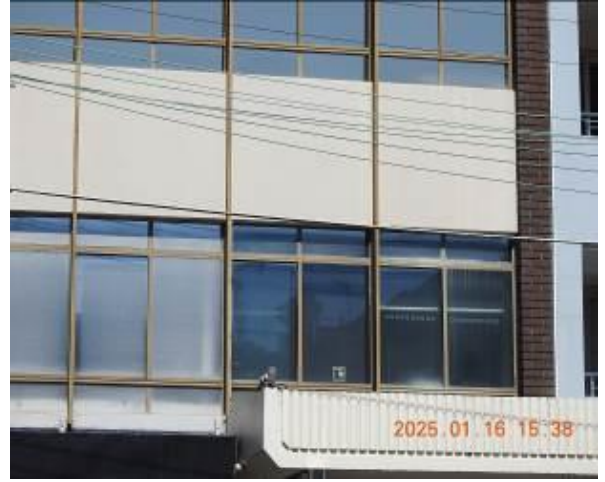
Figure 8 - General condition of external wall

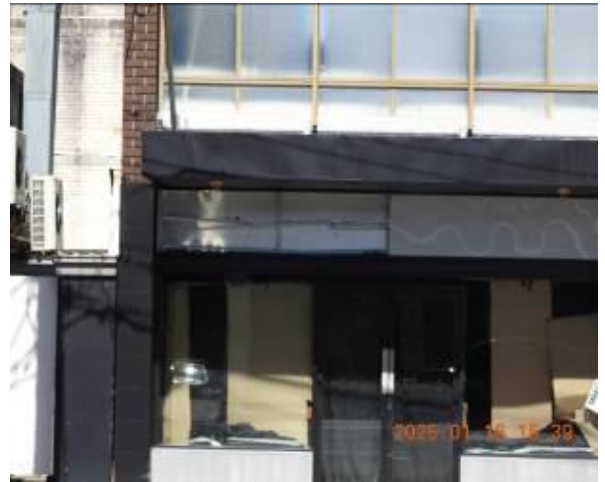
Figure 10 - General condition of external wall

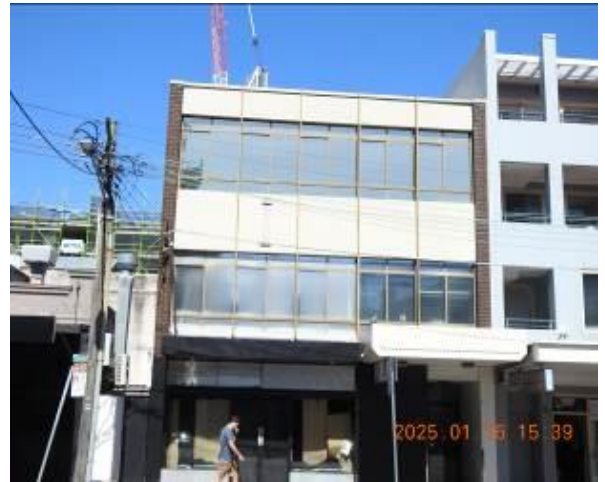
Figure 16 - General condition of external wall

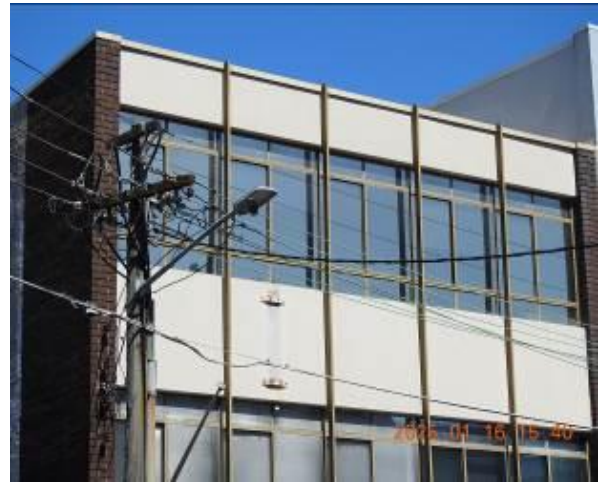
Figure 22 - General condition of external wall

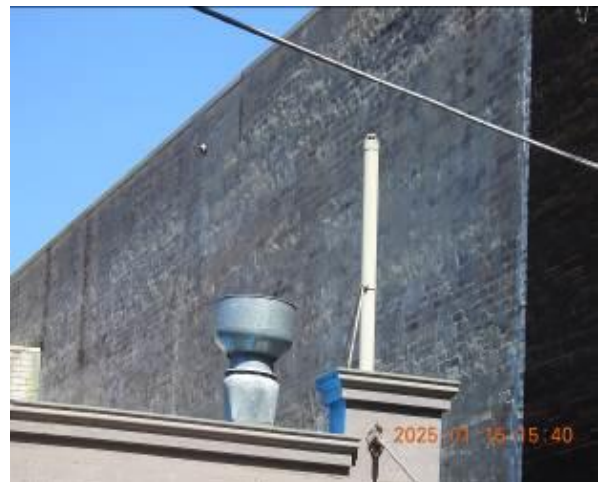
Figure 24 - General condition of external wall

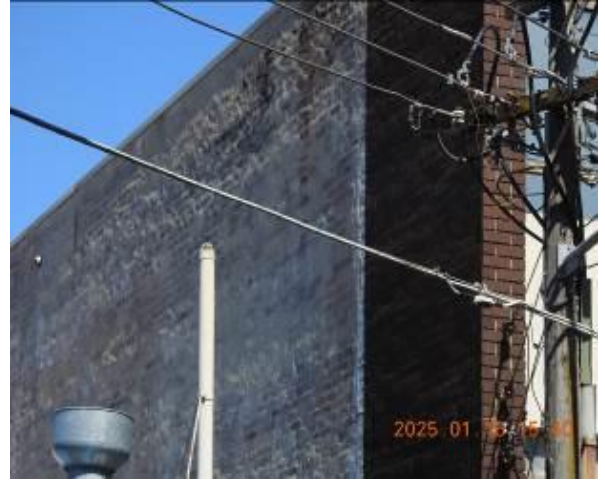
Figure 26 - General condition of external wall

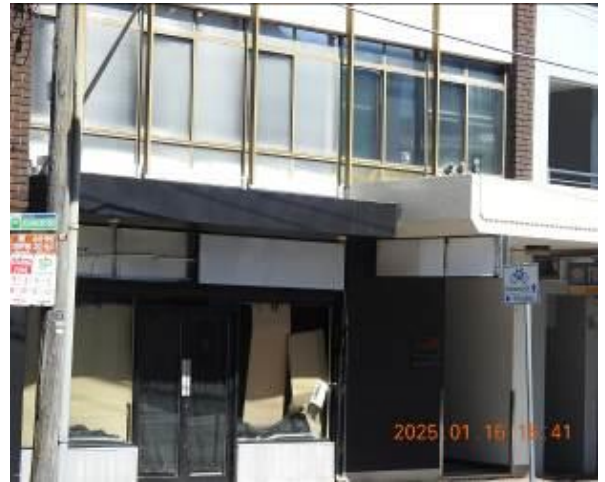
Figure 28 - General condition of external wall

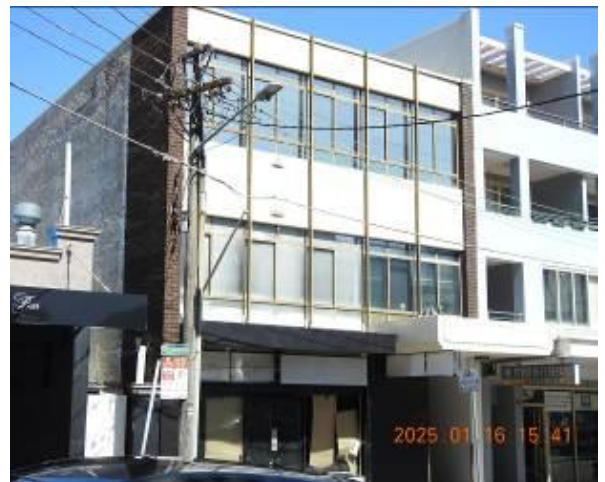
Figure 30 - General condition of external wall

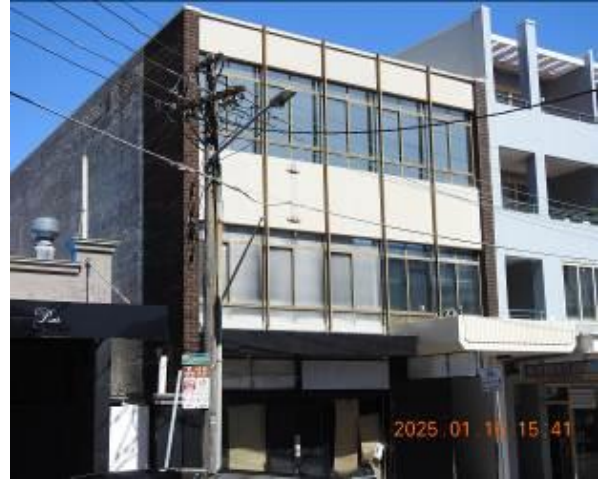
Figure 32 - General condition of external wall

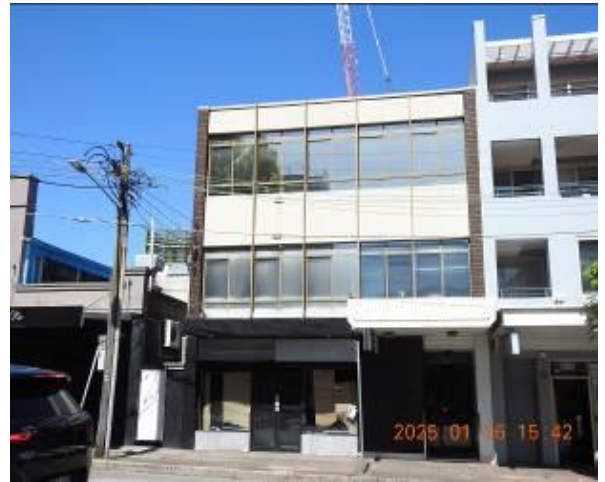
Figure 34 - General condition of external wall

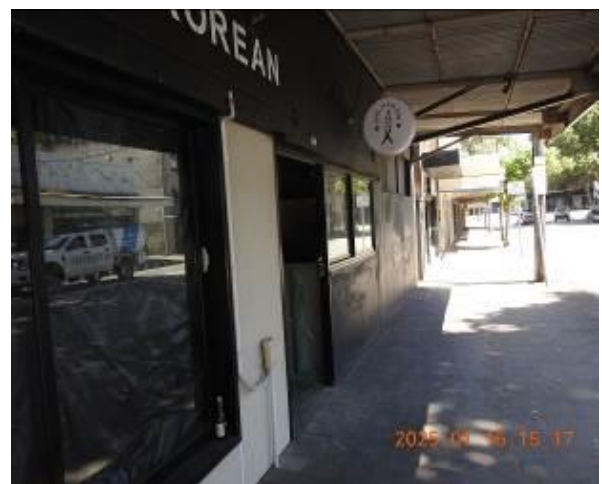
Figure 40 - General condition of external wall

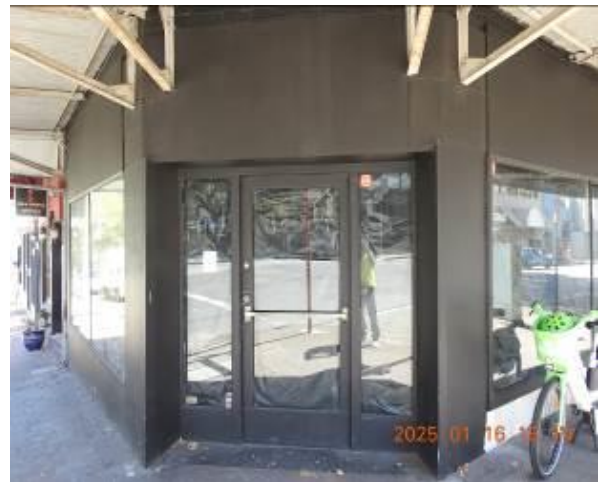
Figure 50 - General condition of external wall

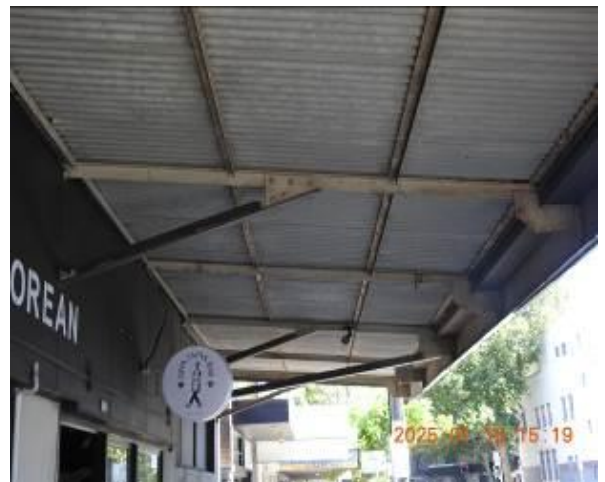
Figure 52 - General condition of awning

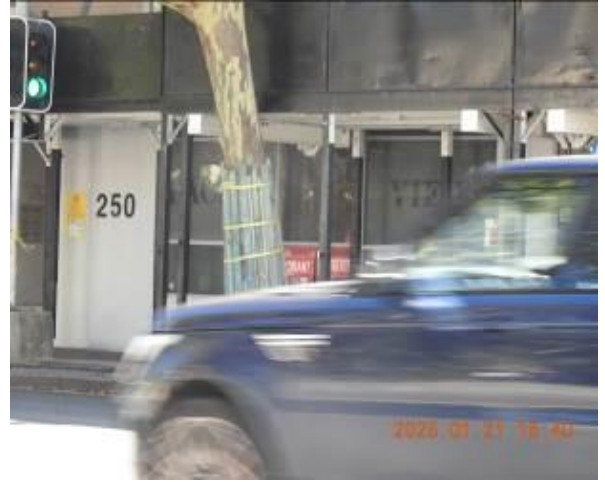
Figure 77 - General condition of external wall

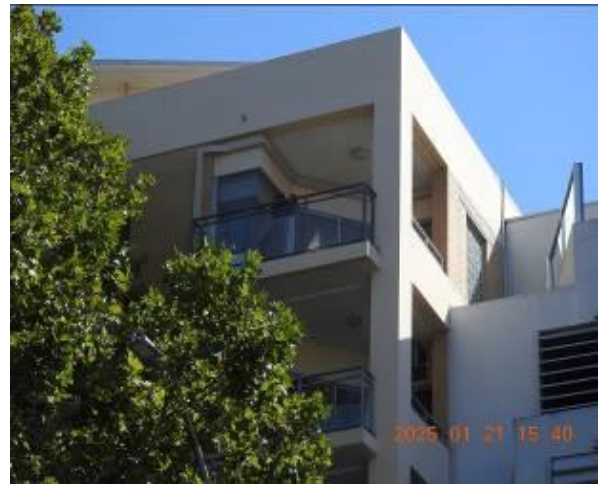
Figure 79 - General condition of external wall

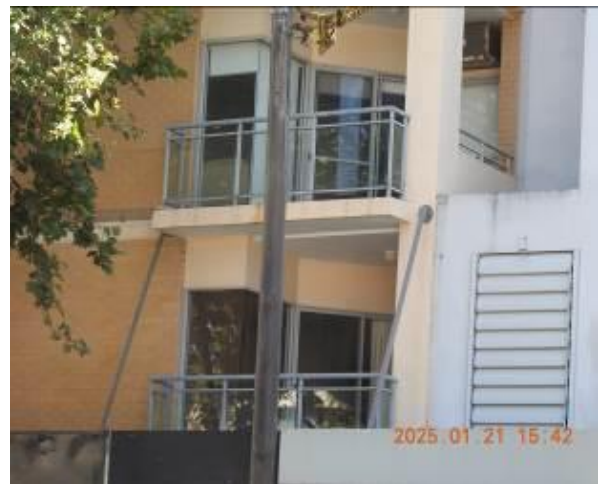
Figure 81 - General condition of external wall

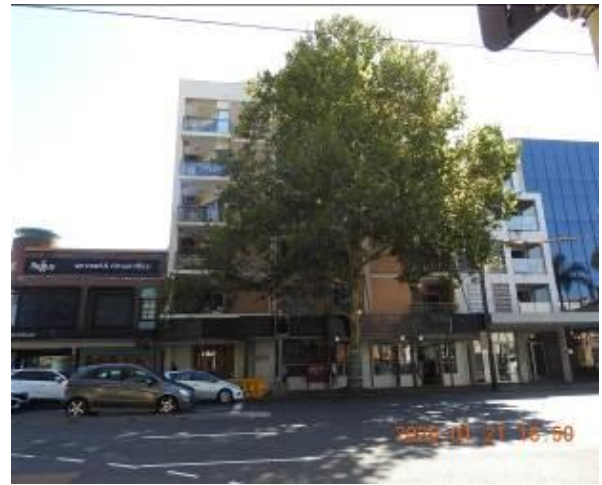
Figure 85 - General condition of external wall

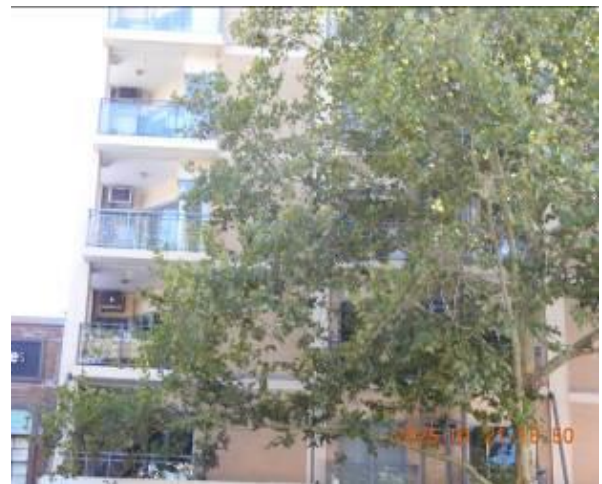
Figure 87 - General condition of external wall

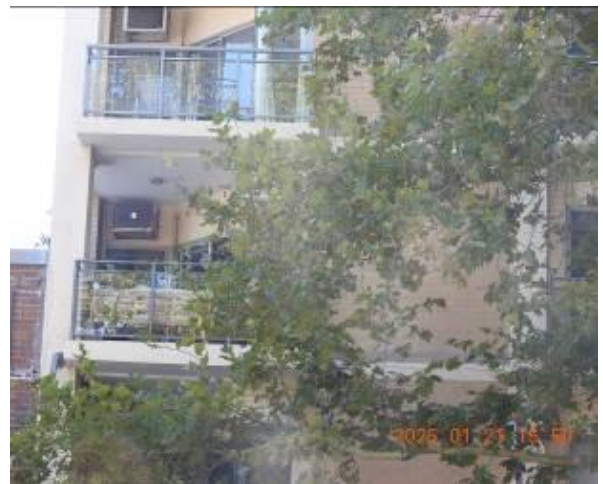
Figure 91 - General condition of external wall

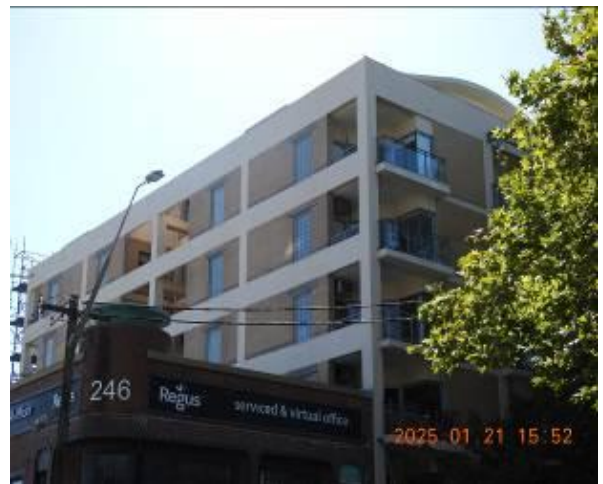
Figure 93 - General condition of external wall

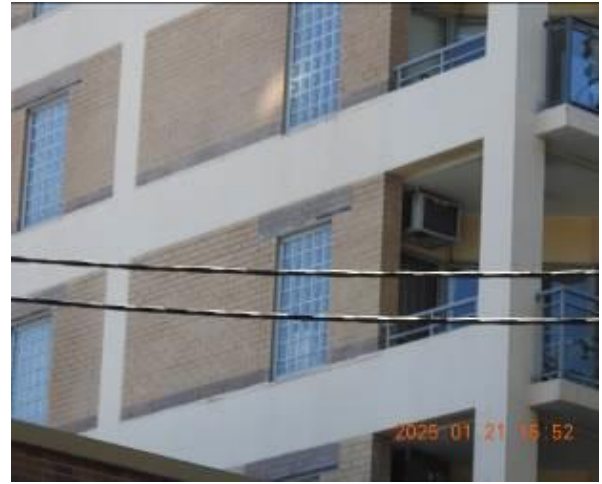
Figure 95 - General condition of external wall

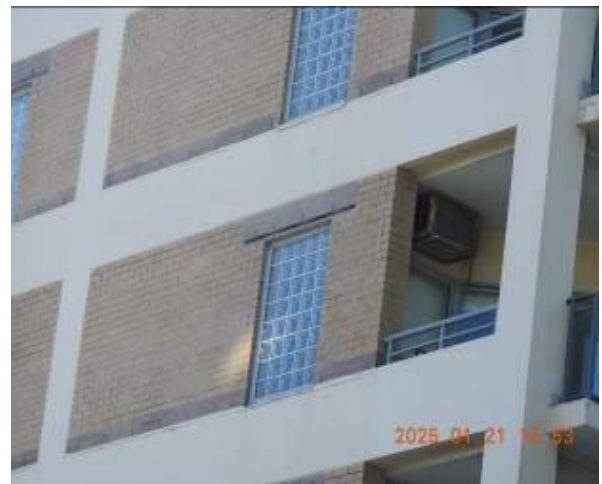
Figure 97 - General condition of external wall

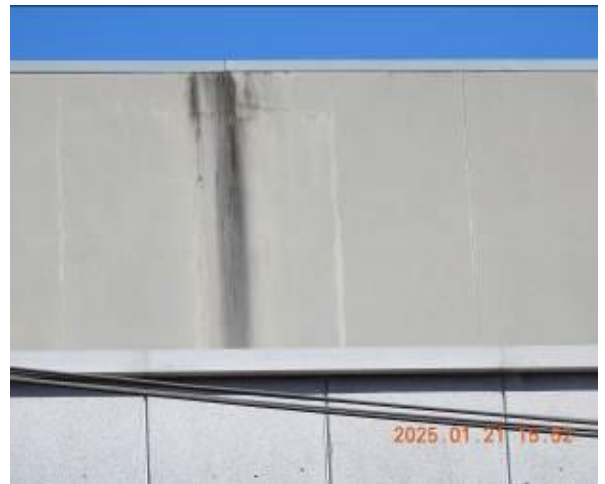
Figure 180 - Crack propagation through external wall

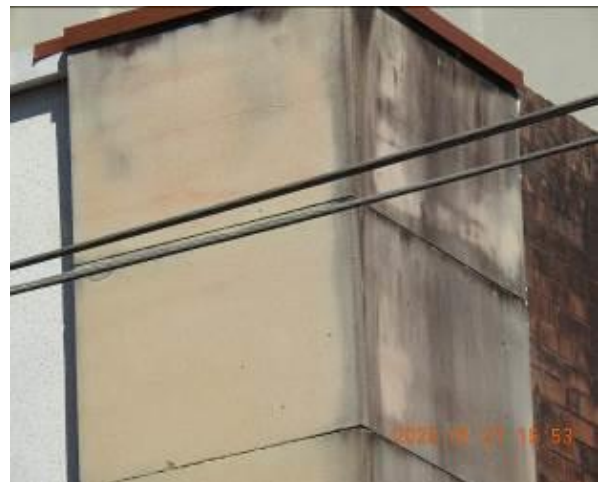
Figure 188 - General condition of external wall

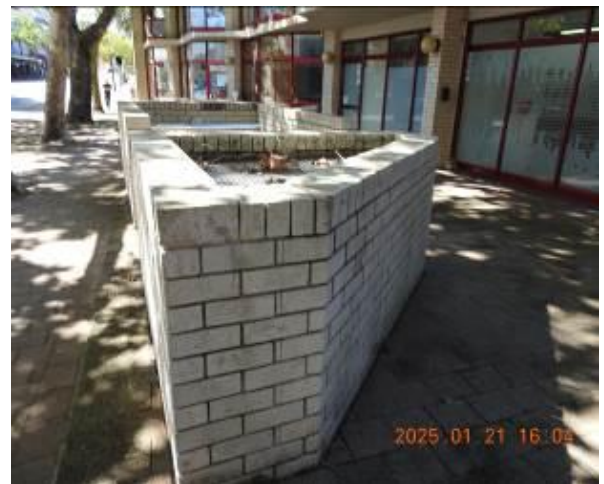
Figure 260 - General condition of retaining wall

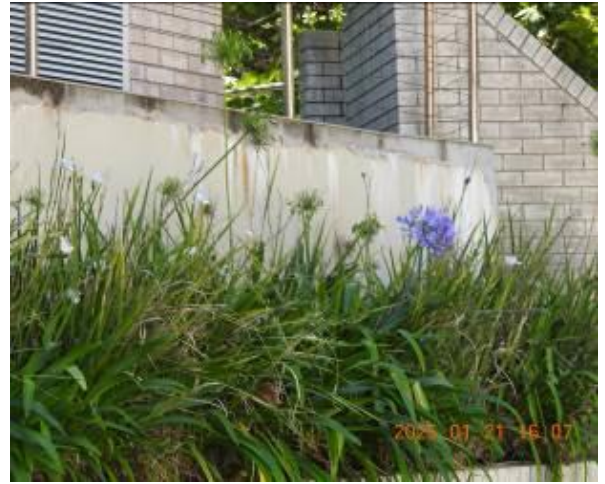
Figure 304 - Crack propagation through external wall
