# External Road Dilapidation Report – Existing Condition

## Uungula Wind Farm

*Prepared for: Uungula Wind Farm Pty Ltd*

| <b>Job Number</b> | 19-142 |

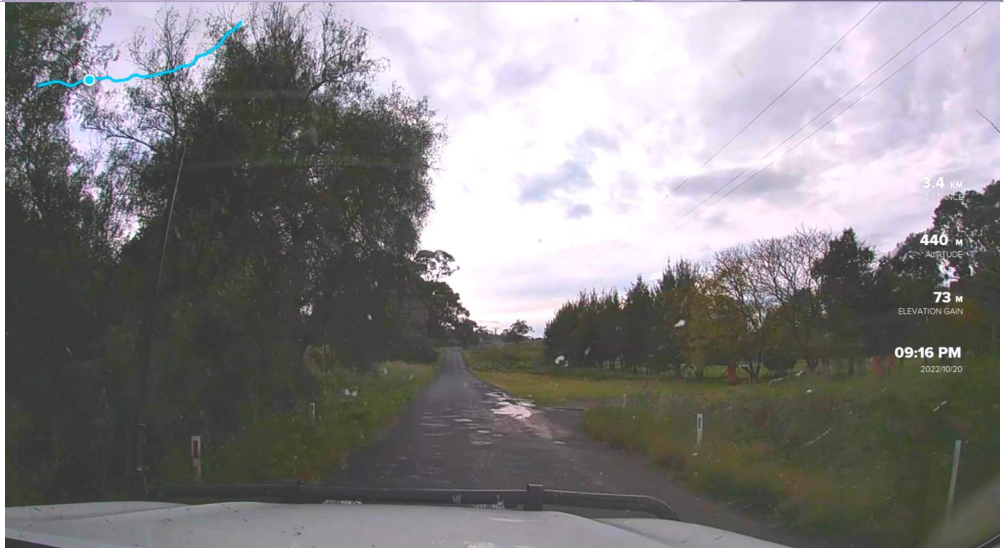
| Defect ID | Start Ch | End Ch | Defect Type (and side of road) | Image |
|---|---|---|---|---|
| 8.0 | 2600 | 3400 | Pothole (RHS)<br>Ravelling/Fretting (RHS)<br>Stripping (RHS)<br>Delamination (CR)<br>Ponding issues | |

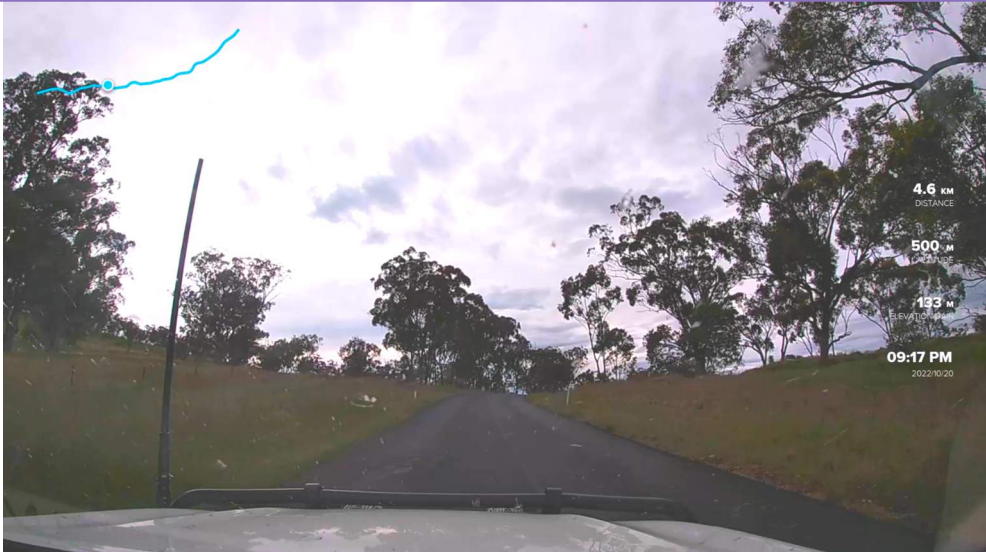
| Defect ID | Start Ch | End Ch | Defect Type (and side of road) | Image |
|---|---|---|---|---|
| 10.0 | 4200 | 4800 | Ravelling/Fretting patched (LHS)<br>Depression (RHS)<br>Stripping (RHS) | |

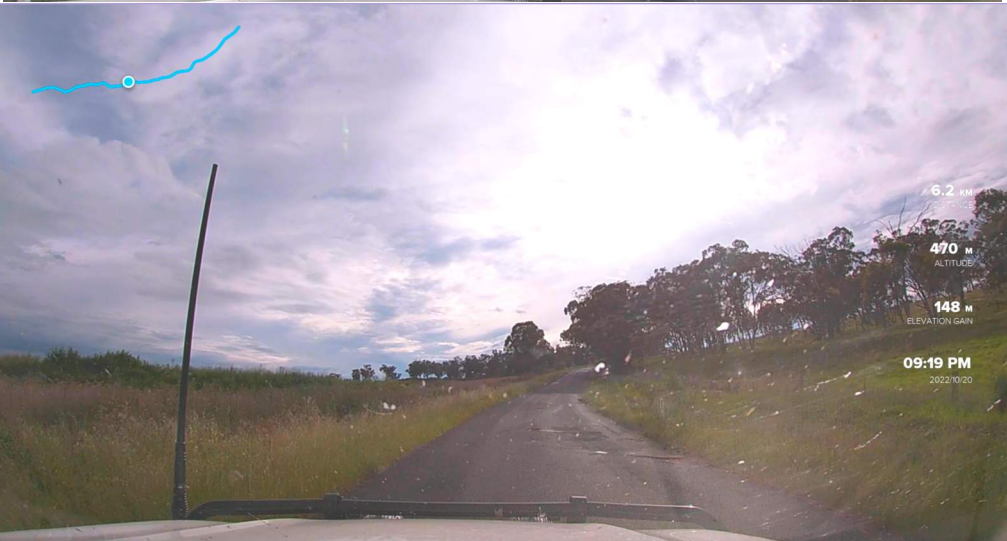
| Defect ID | Start Ch | End Ch | Defect Type (and side of road) | Image |
|---|---|---|---|---|
| 15.0 | 5700 | 6400 | Ravelling/Fretting (RHS)<br>Pothole (CR)<br>Delamination (CR)<br>Edge break (RHS)<br>Stripping (LHS) | |

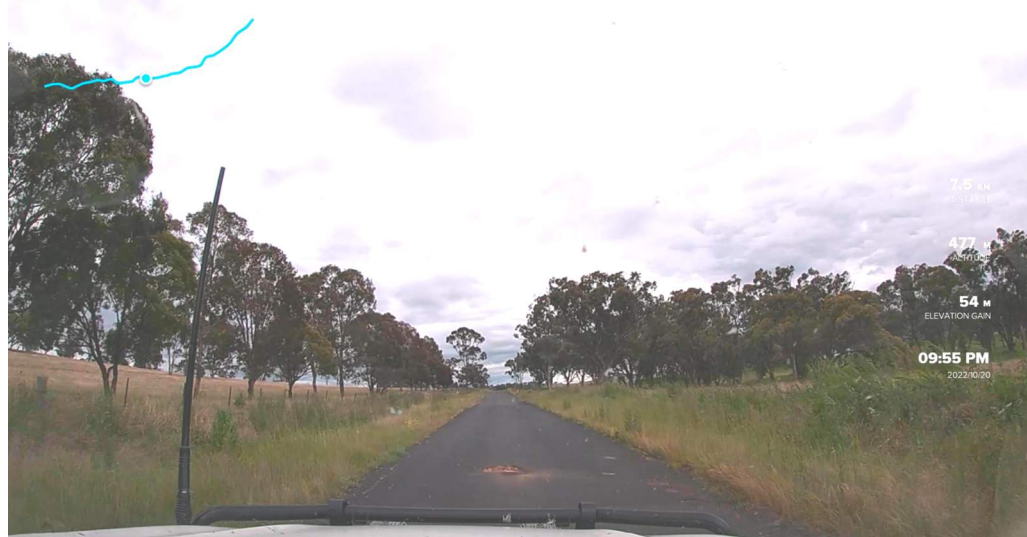
| Defect ID | Start Ch | End Ch | Defect Type (and side of road) | Image |
|---|---|---|---|---|
| 16.0<br>(image looking west.) | 6400 | 7100 | Pothole (CR)<br>Pothole (LHS)<br>Stripping (LHS)<br>Ravelling/Fretting (LHS)<br>Edge break (BS) | |

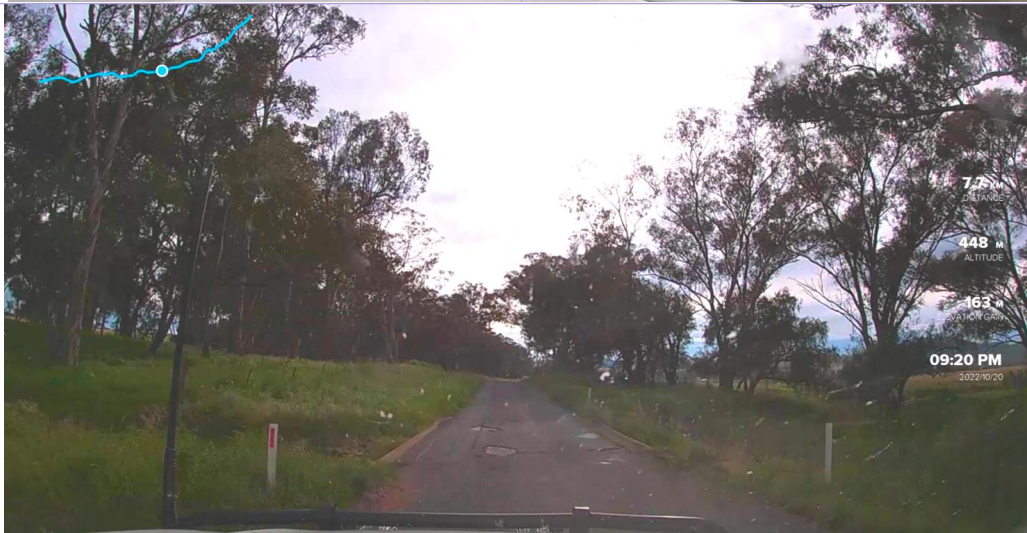
| Defect ID | Start Ch | End Ch | Defect Type (and side of road) | Image |
|---|---|---|---|---|
| 17.0 | 7100 | 7400 | Pothole (LHS)<br>Longitudinal Cracking (BS)<br>Delamination (BS) | |

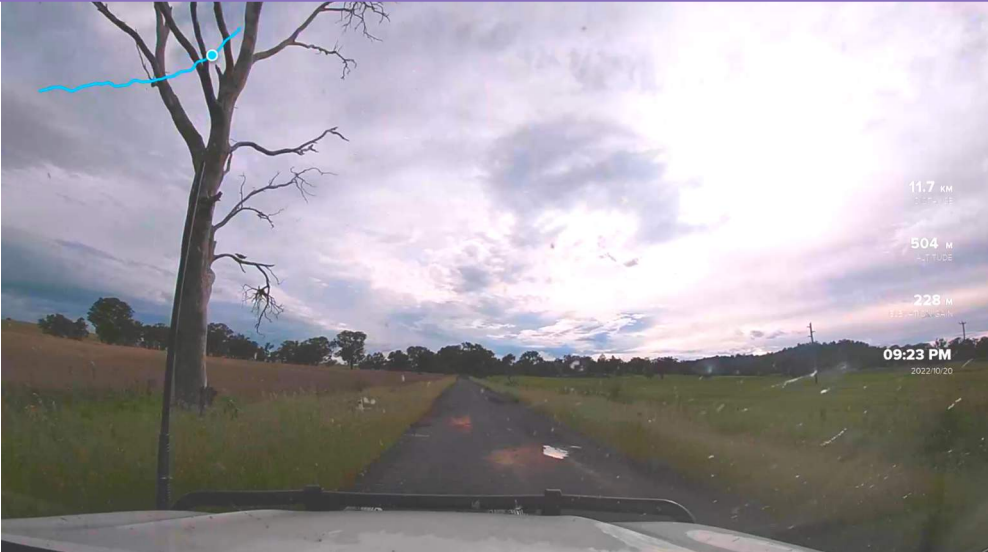
| Defect ID | Start Ch | End Ch | Defect Type (and side of road) | Image |
|---|---|---|---|---|
| 28.0 | 11300 | 11600 | Pothole (RHS)<br>Ravelling/Fretting (BS)<br>Stripping (RHS)<br>Delamination (BS)<br>Edge break (LHS) | |

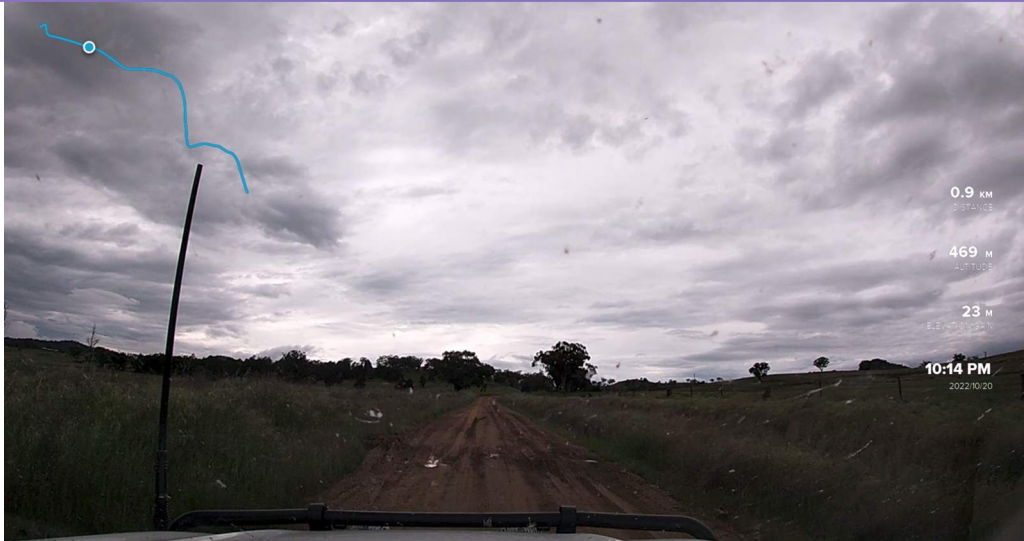
| Defect ID | Start Ch | End Ch | Defect Type (and side of road) | Image |
|---|---|---|---|---|
| 3.0 | 700 | 800 | Rutting (BS)<br>Soft Surface (BS) | |

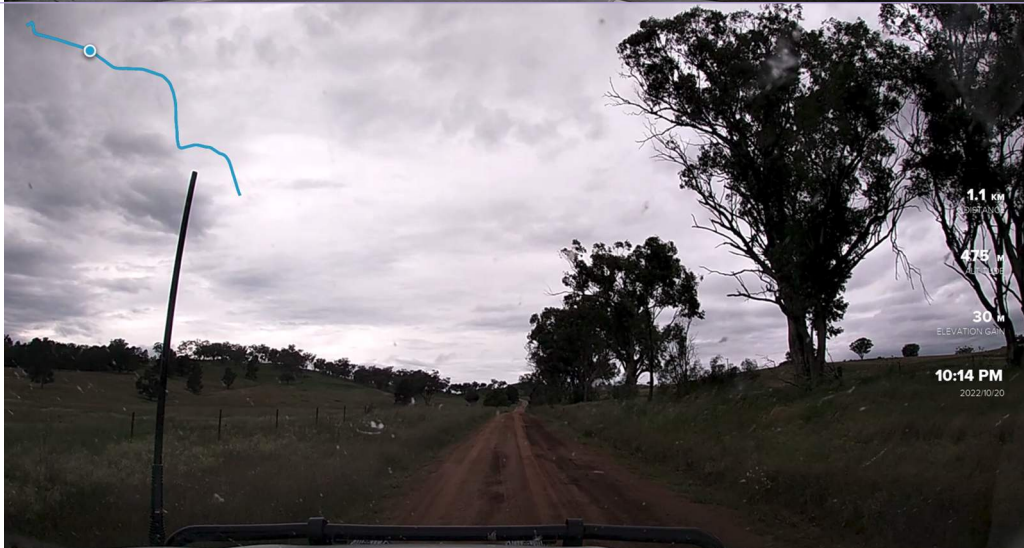
| Defect ID | Start Ch | End Ch | Defect Type (and side of road) | Image |
|---|---|---|---|---|
| 4.0 | 800 | 1000 | Loss of material (RHS) | |

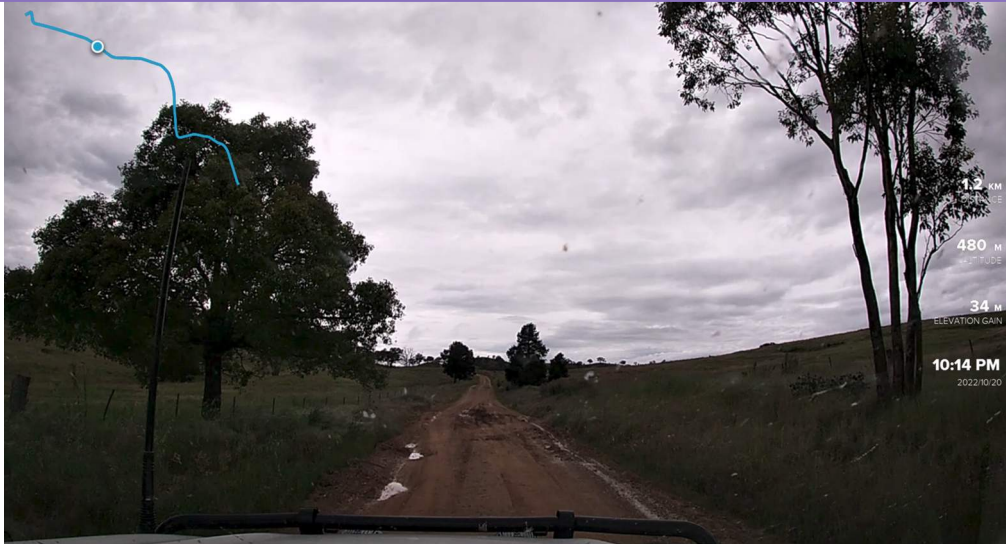
| Defect ID | Start Ch | End Ch | Defect Type (and side of road) | Image |
|---|---|---|---|---|
| 5.0 | 1000 | 1200 | Potholes (LHS)<br>Rutting (CR)<br>Soft Surface (CR)<br>Surface Scour (BS) | |

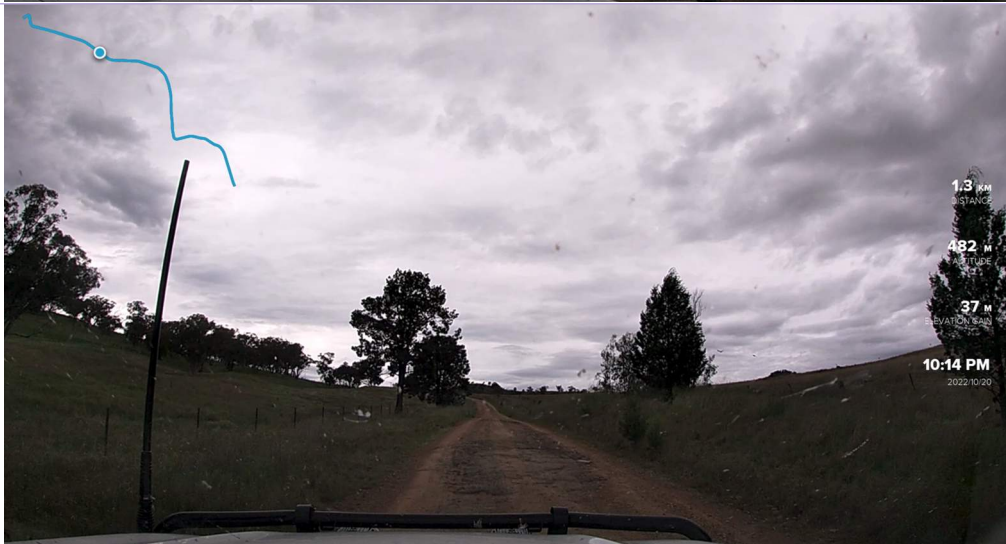
| Defect ID | Start Ch | End Ch | Defect Type (and side of road) | Image |
|---|---|---|---|---|
| 6.0 | 1200 | 1400 | Rough Surface (CR) | |

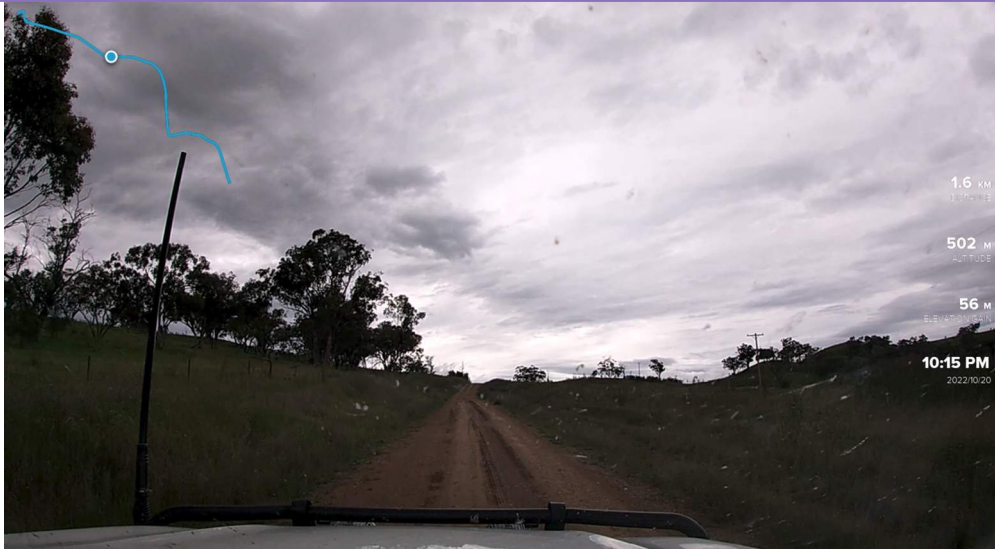
| Defect ID | Start Ch | End Ch | Defect Type (and side of road) | Image |
|---|---|---|---|---|
| 7.0 | 1400 | 1900 | Rutting (CR)<br>Rutting (BS)<br>Loose material | |

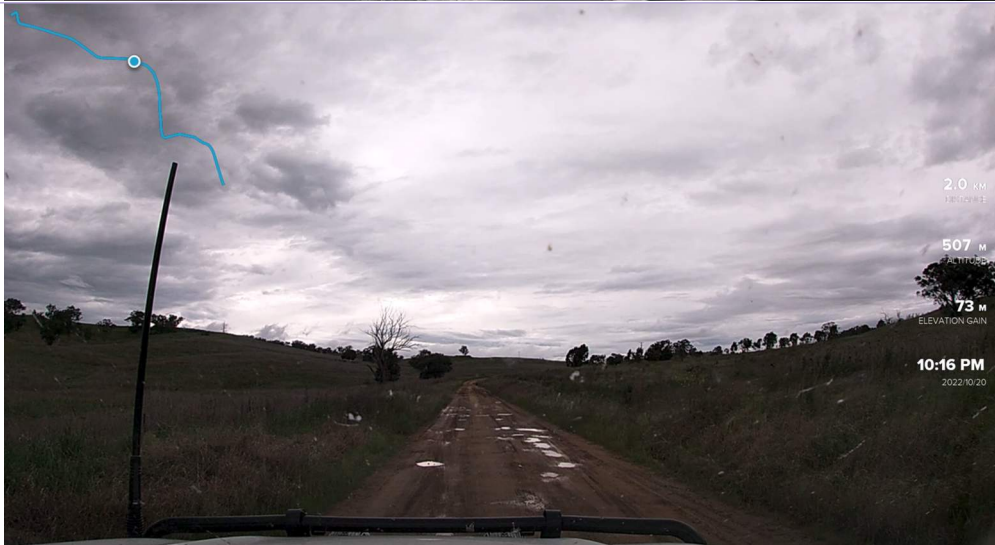
| Defect ID | Start Ch | End Ch | Defect Type (and side of road) | Image |
|---|---|---|---|---|
| 8.0 | 1900 | 2100 | Pothole (BS)<br>Surface Scour (RHS)<br>Soft Surface (BS)<br>Drainage issue | |

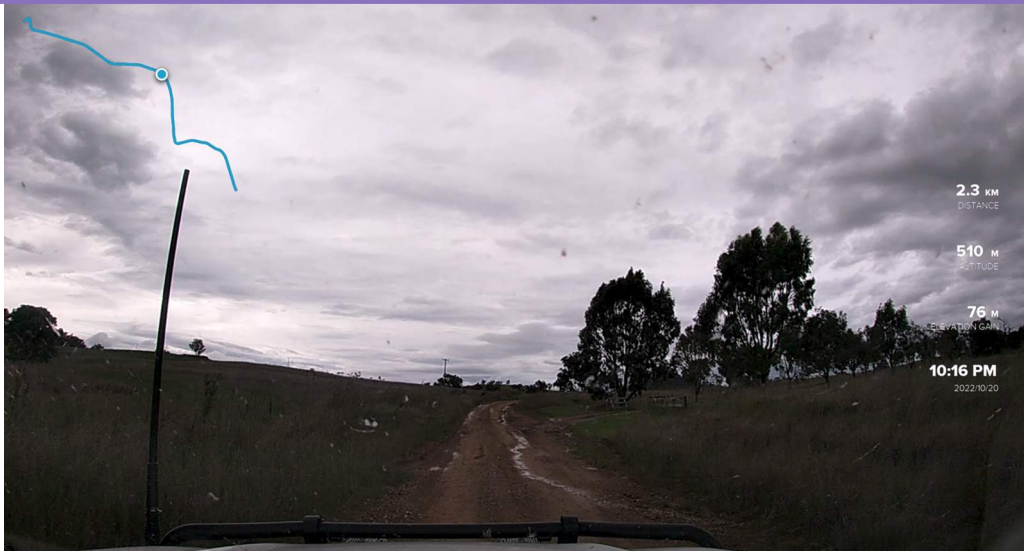
| Defect ID | Start Ch | End Ch | Defect Type (and side of road) | Image |
|---|---|---|---|---|
| 9.0 | 2100 | 2200 | Surface Scour (RHS)<br>Rutting (RHS)<br>Drainage issue | |

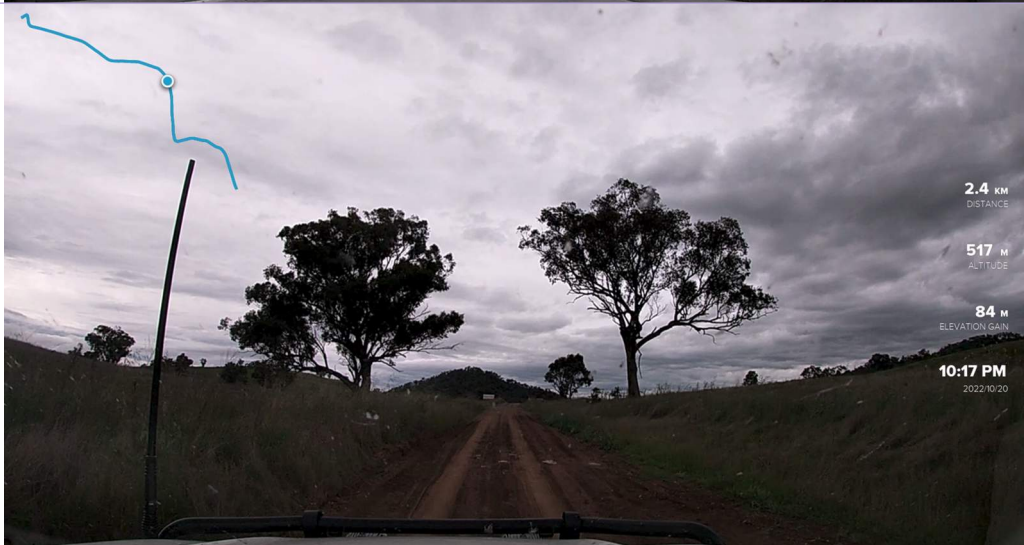
| Defect ID | Start Ch | End Ch | Defect Type (and side of road) | Image |
|---|---|---|---|---|
| 10.0 | 2200 | 2400 | Potholes (CR)<br>Loose material (BS)<br>Loose material (CR) | |

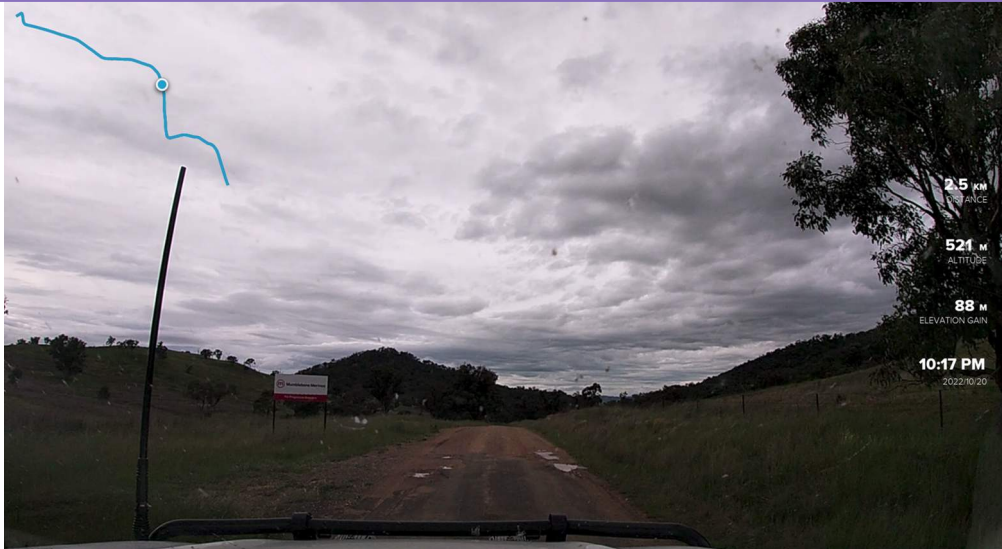
| Defect ID | Start Ch | End Ch | Defect Type (and side of road) | Image |
|---|---|---|---|---|
| 11.0 | 2400 | 2500 | Potholes (BS)<br>Settlement (LHS)<br>Drainage issue at sealed/unsealed interface. | |

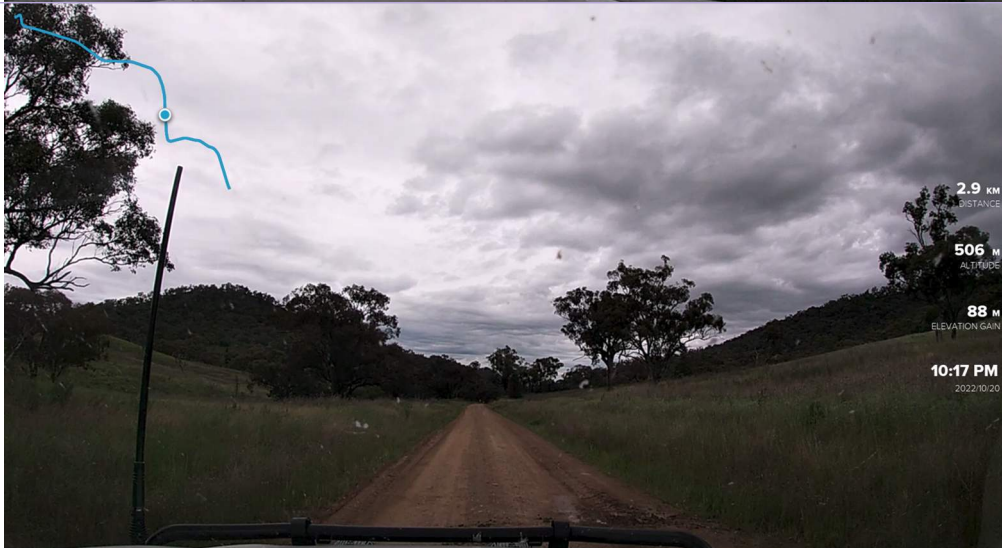
| Defect ID | Start Ch | End Ch | Defect Type (and side of road) | Image |
|---|---|---|---|---|
| 12.0 | 2500 | 3100 | Rutting (RHS)<br>Rough Surface<br>Loose Material | |

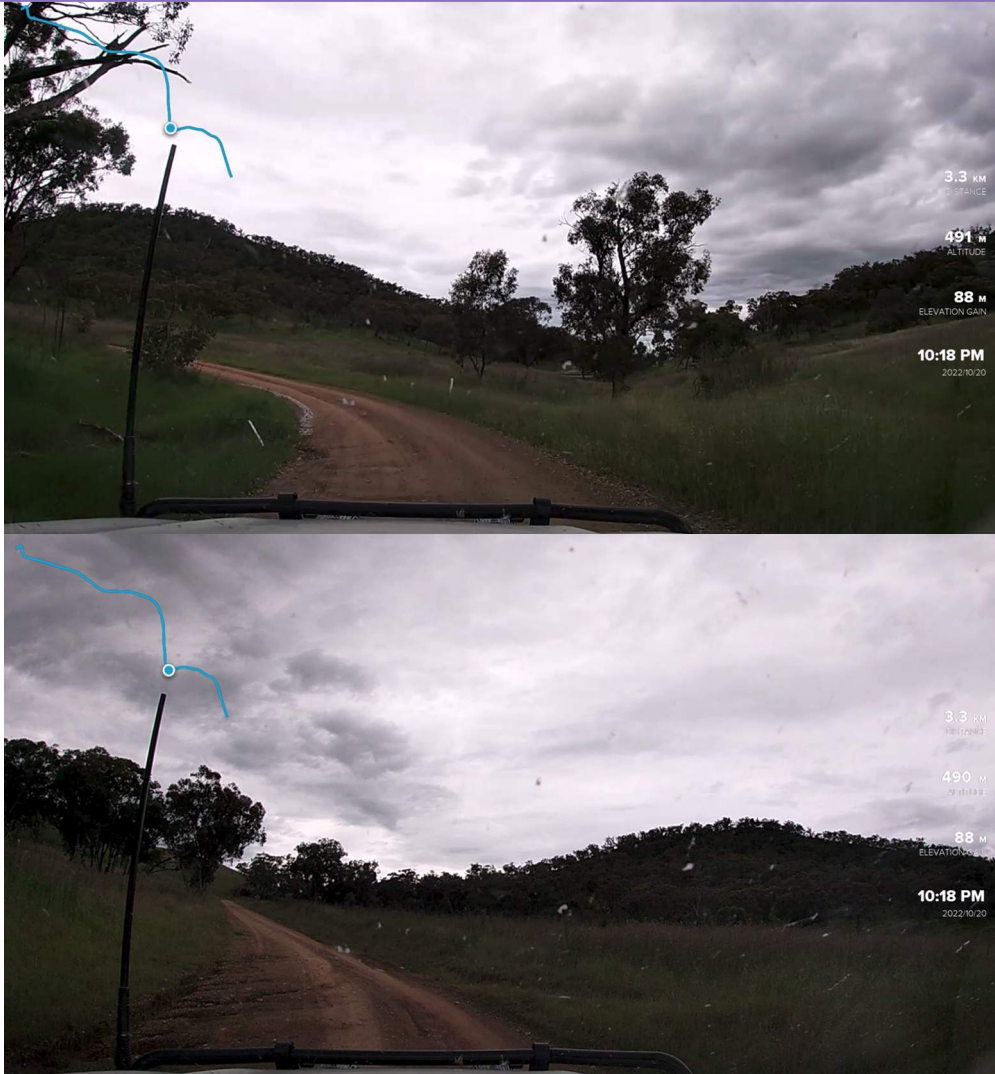
| Defect ID | Start Ch | End Ch | Defect Type (and side of road) | Image |
|---|---|---|---|---|
| 13.0 | 3100 | 3300 | Corrugation (LHS) | |

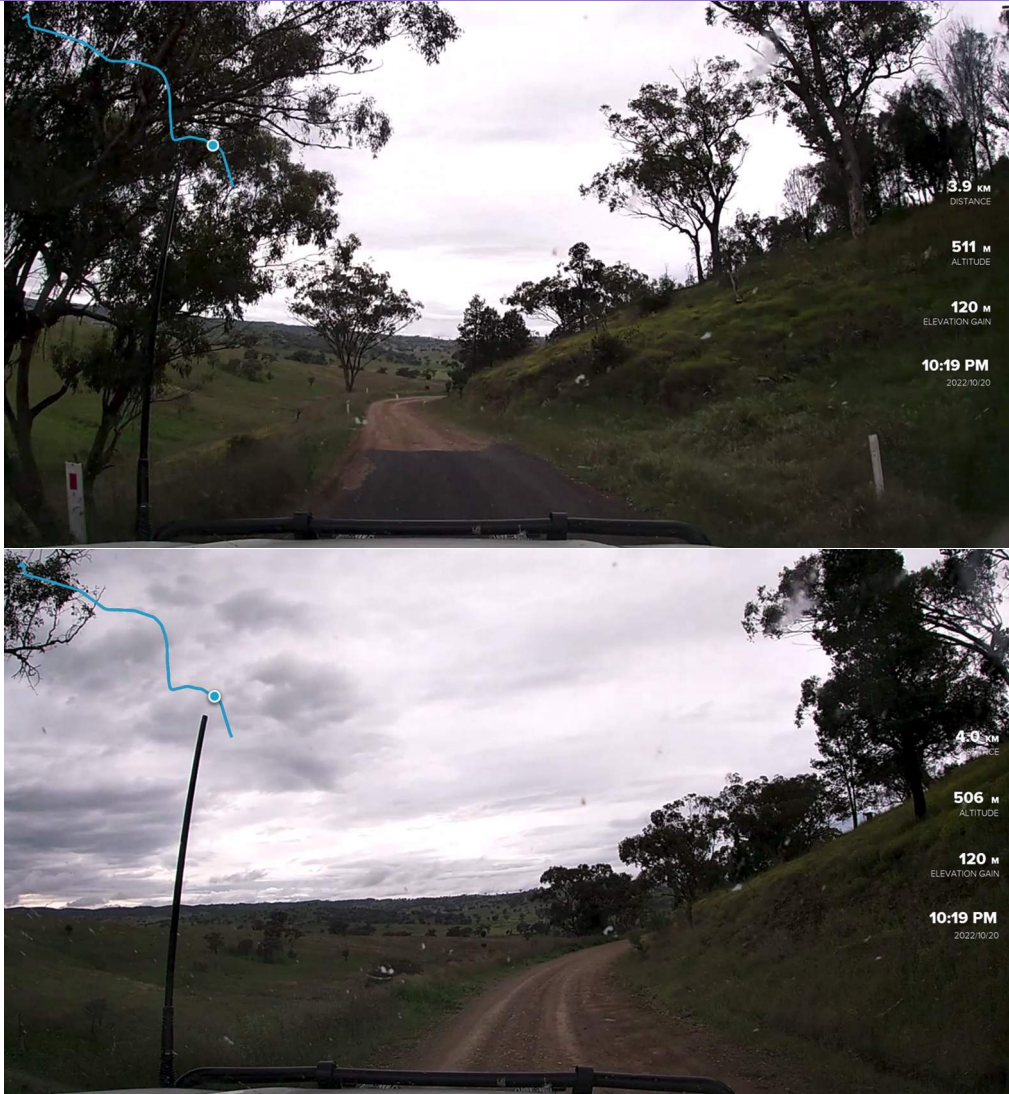
| Defect ID | Start Ch | End Ch | Defect Type (and side of road) | Image |
|---|---|---|---|---|
| 16.0 | 3800 | 4300 | Sealed to unsealed pavement<br>Edge break (LHS)<br>Corrugation (RHS)<br>Surface Scour (RHS)<br>Loose material (RHS) | <p>3.9 KM<br/>DISTANCE</p> <p>511 M<br/>ALTITUDE</p> <p>120 M<br/>ELEVATION GAIN</p> <p>10:19 PM<br/>2022/10/20</p> <p>4.0 KM<br/>DISTANCE</p> <p>506 M<br/>ALTITUDE</p> <p>120 M<br/>ELEVATION GAIN</p> <p>10:19 PM<br/>2022/10/20</p> |

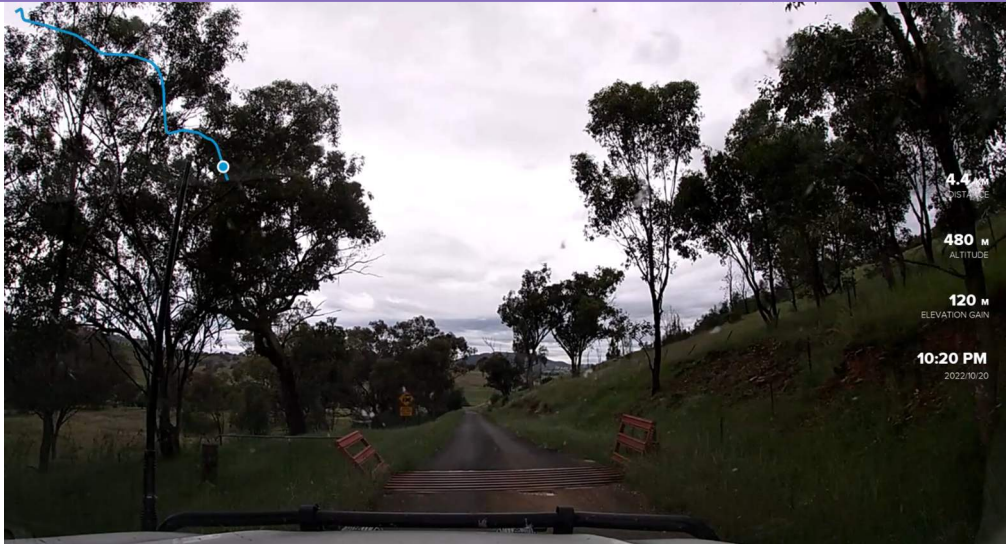
| Defect ID | Start Ch | End Ch | Defect Type (and side of road) | Image |
|---|---|---|---|---|
| 17.0 | 4300 | 4800 | Unsealed to sealed road.<br>Cattle grid at transition.<br>Pothole (RHS)<br>Edge break (RHS) | |

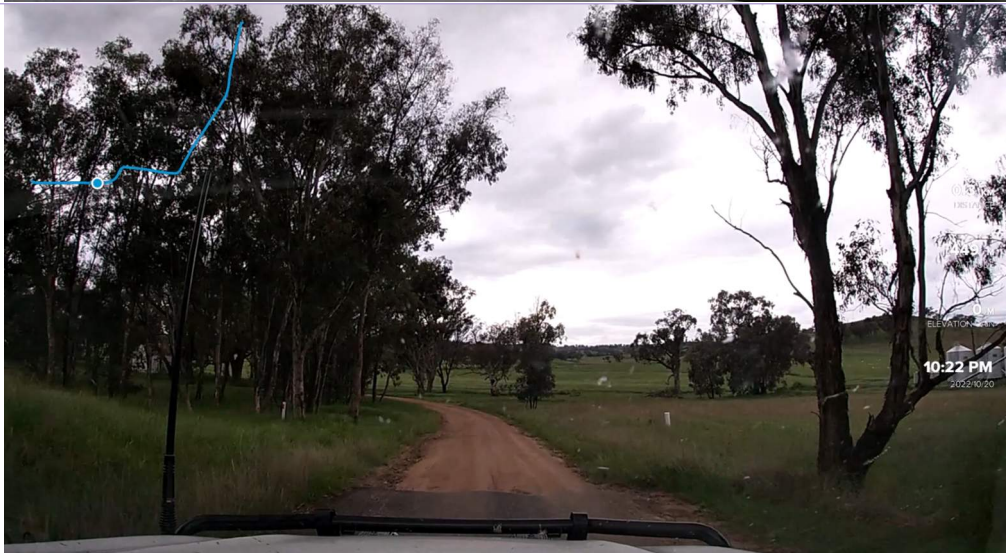
| Defect ID | Start Ch | End Ch | Defect Type (and side of road) | Image |
|---|---|---|---|---|
| 18.0 | 4800 | 4900 | Sealed to unsealed road. | |

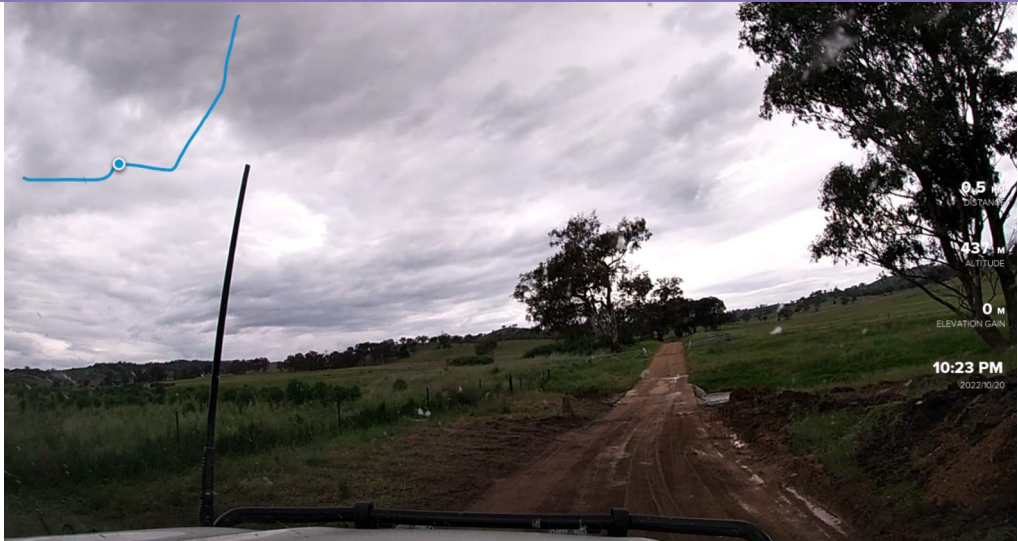
| Defect ID | Start Ch | End Ch | Defect Type (and side of road) | Image |
|---|---|---|---|---|
| 19.0 | 4900 | 5000 | Corrugation (RHS)<br>Surface scour (RHS)<br>Drainage issue<br>Cattle grid at fence line | <p>A photograph of a dirt road winding through a grassy field under a cloudy sky. A blue line with a dot is overlaid on the image, indicating a specific location. On the right side of the road, there is a fence line and a cattle grid. The road surface shows signs of corrugation and surface scour.</p> |

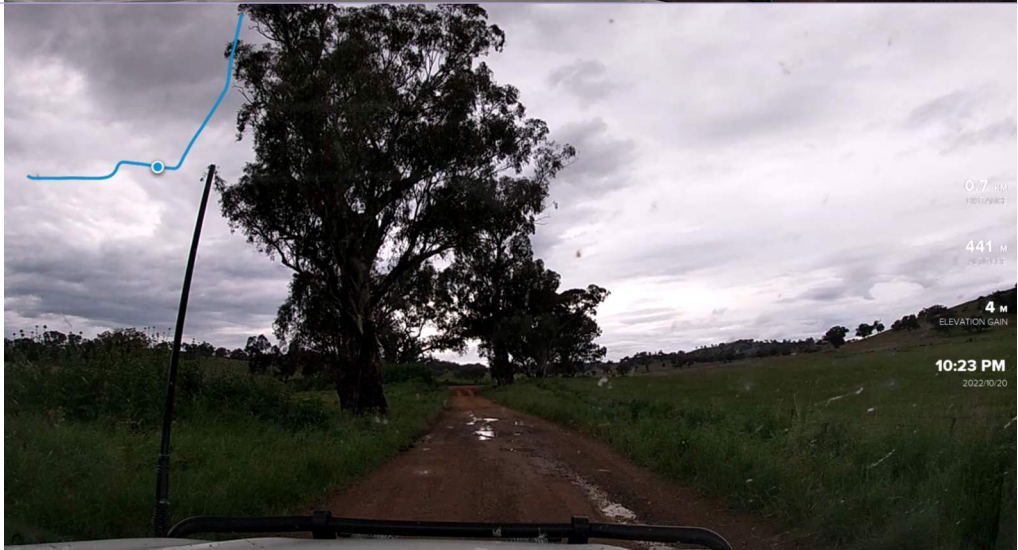
| Defect ID | Start Ch | End Ch | Defect Type (and side of road) | Image |
|---|---|---|---|---|
| 20.0 | 5000 | 5400 | Pothole (CR)<br>Surface scour (BS)<br>Rutting (RHS)<br>Drainage issue | <p>A photograph of a dirt road winding through a grassy field under a cloudy sky. A blue line with a dot is overlaid on the image, indicating a specific location. On the right side of the road, there is a large tree and a fence line. The road surface shows signs of potholes, surface scour, rutting, and drainage issues.</p> |

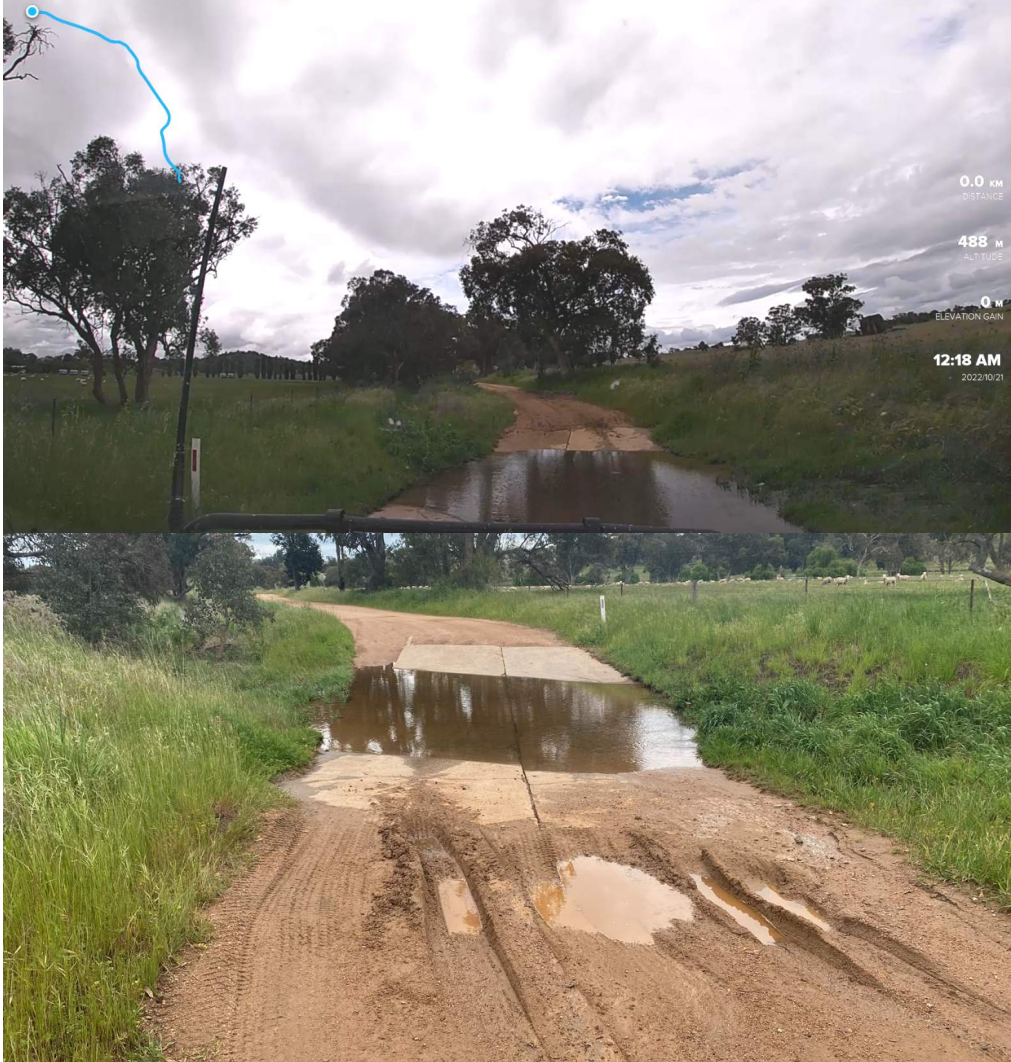
| Defect ID | Start Ch | End Ch | Defect Type (and side of road) | |
|---|---|---|---|---|
| 5.0 | 750 | 800 | Causeway<br>Rutting (BS)<br>Pothole (CR)<br>Drainage Issue | |

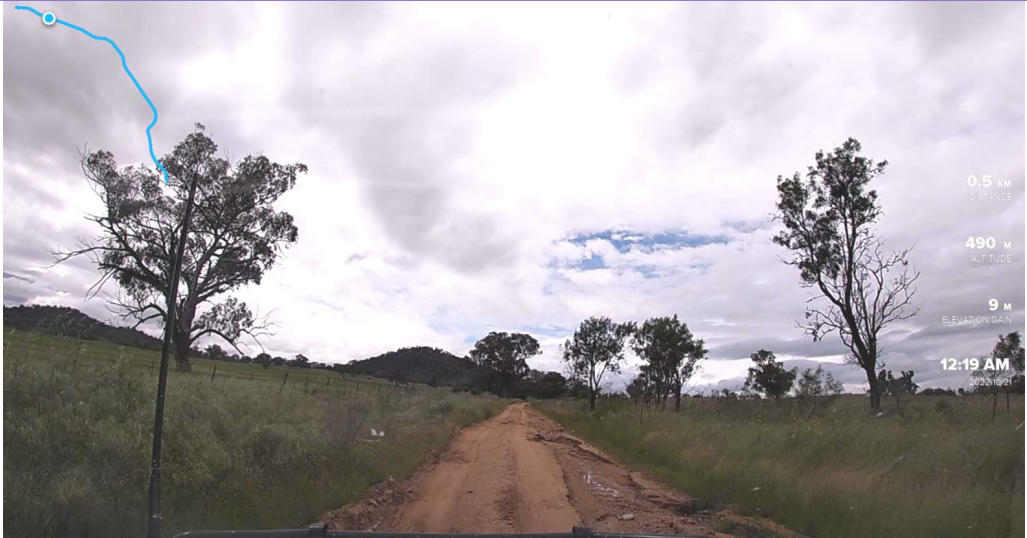
| Defect ID | Start Ch | End Ch | Defect Type (and side of road) | |
|---|---|---|---|---|
| 8.0 | 1200 | 1600 | Surface scour (RHS) for 400m | |

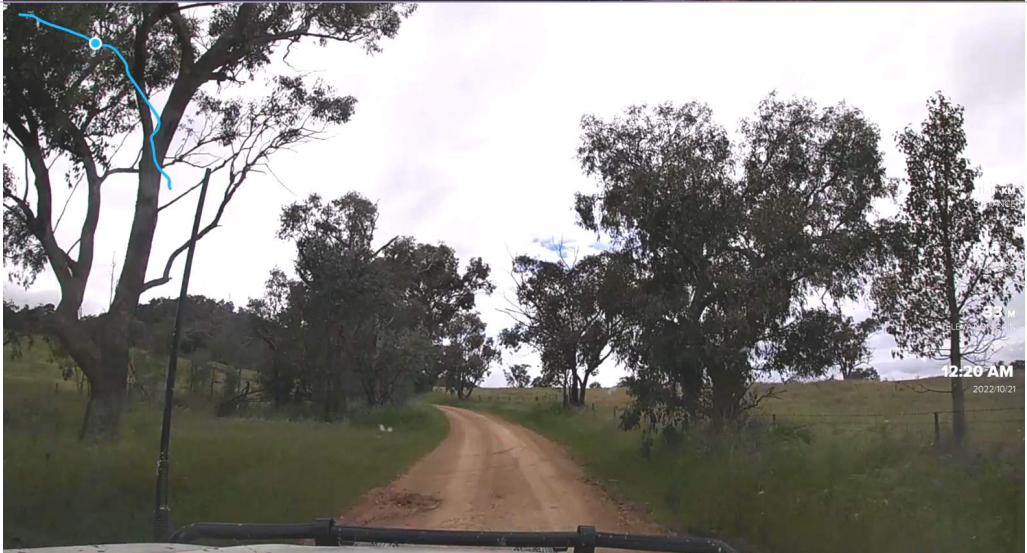
| Defect ID | Start Ch | End Ch | Defect Type (and side of road) | |
|---|---|---|---|---|
| 9.0 | 1600 | 2200 | Rutting (LHS) | |

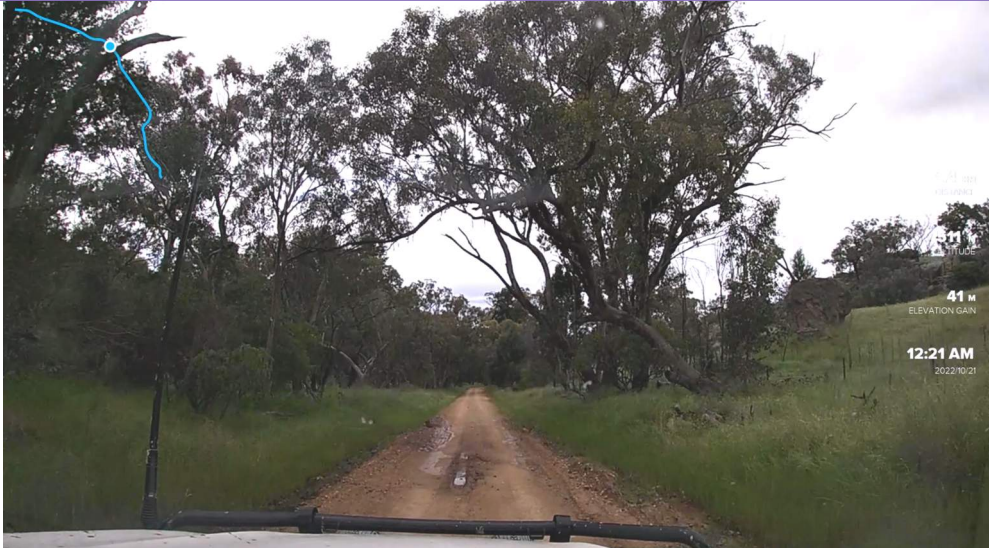
| Defect ID | Start Ch | End Ch | Defect Type (and side of road) | |
|---|---|---|---|---|
| 10.0 | 2200 | 2400 | Rutting (CR)<br>Rutting (BS) | |

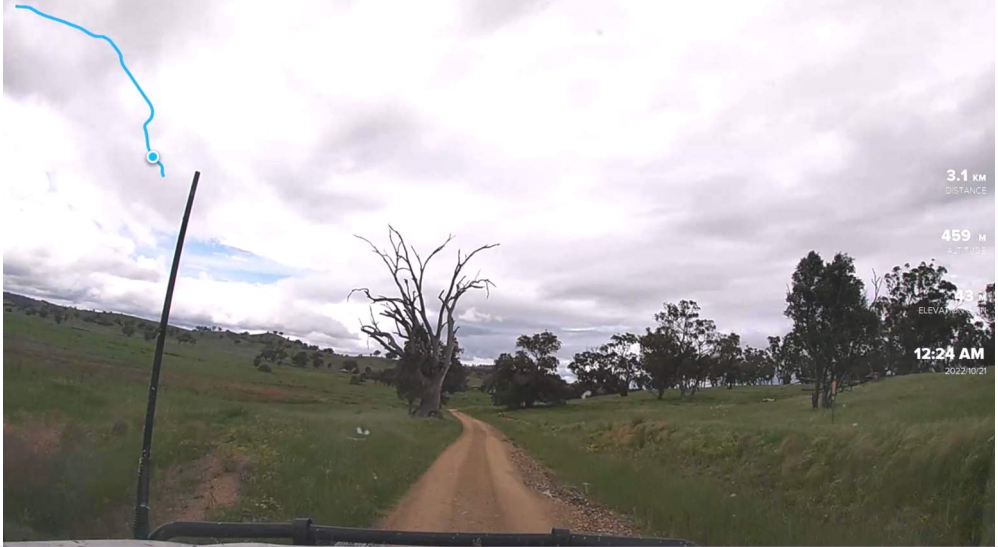
| Defect ID | Start Ch | End Ch | Defect Type (and side of road) | |
|---|---|---|---|---|
| 14.0 | 3600 | 4300 | Edge break (RHS) | |

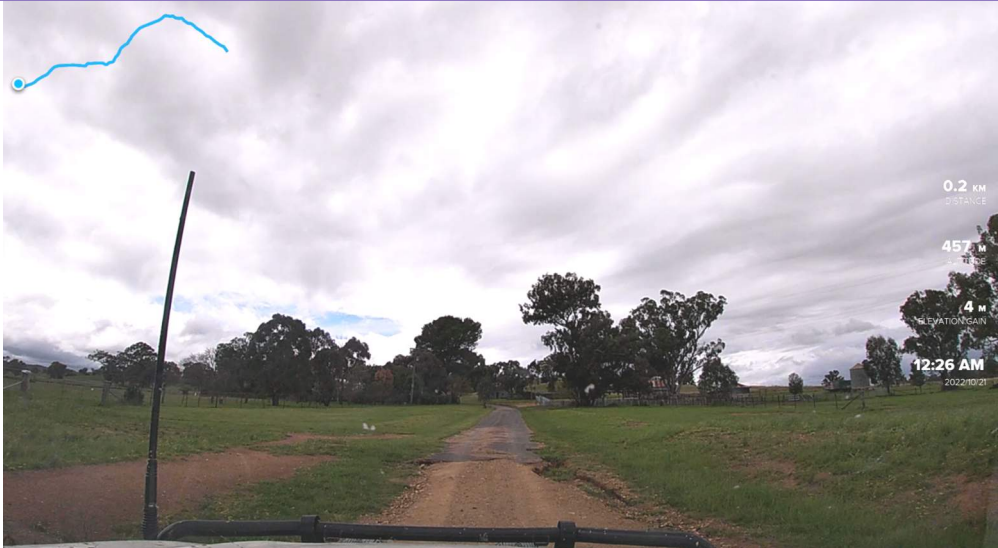
| Defect ID | Start Ch | End Ch | Defect Type (and side of road) | |
|---|---|---|---|---|
| 15.0 | 4300 | 4400 | Surface scour at unsealed to sealed transition. | |

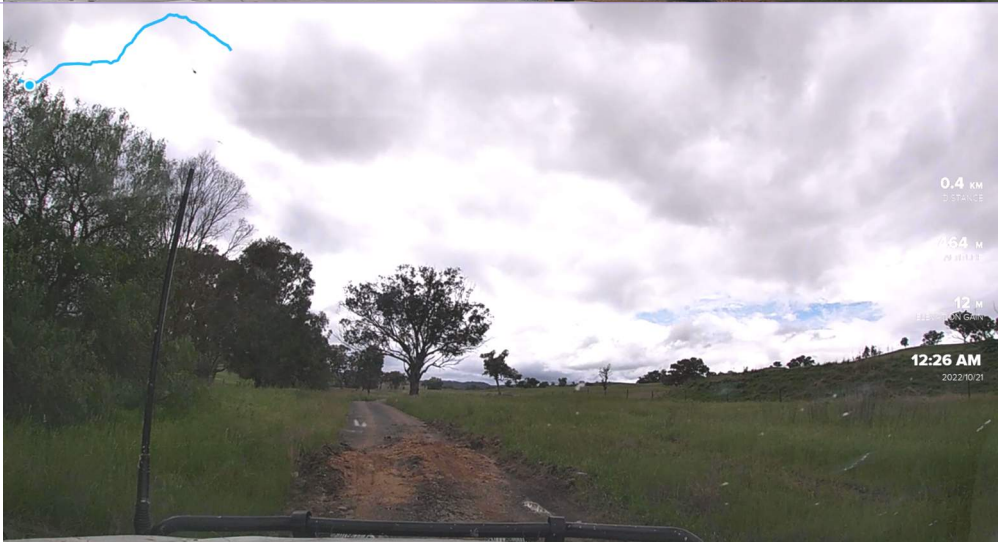
| Defect ID | Start Ch | End Ch | Defect Type (and side of road) | |
|---|---|---|---|---|
| 16.0 | 4400 | 4500 | Rutting (BS)<br>Corrugation (BS) | |

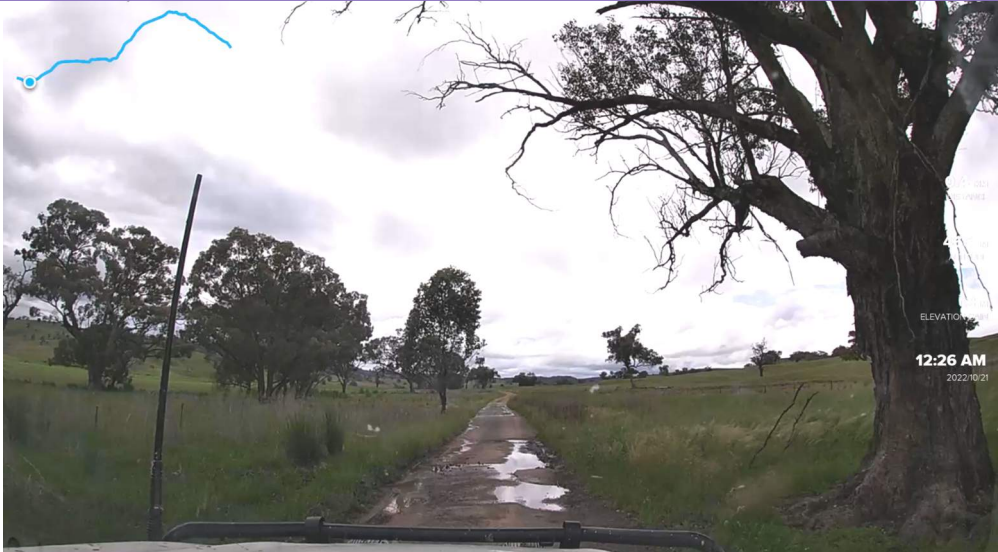
| Defect ID | Start Ch | End Ch | Defect Type (and side of road) | |
|---|---|---|---|---|
| 17.0 | 4600 | 4700 | Rutting (BS)<br>Drainage issue | |

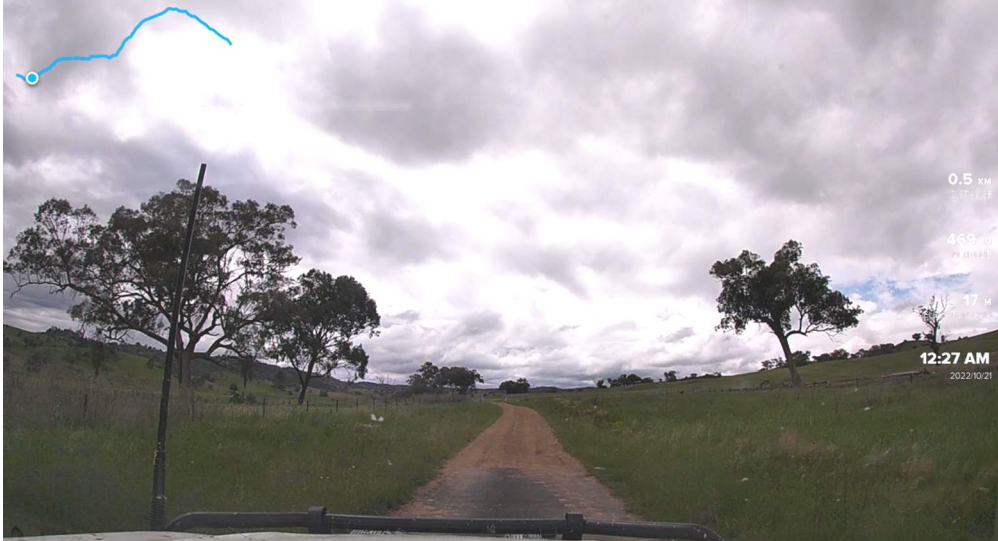
| Defect ID | Start Ch | End Ch | Defect Type (and side of road) | |
|---|---|---|---|---|
| 18.0 | 4700 | 4700 | Transition from sealed to unsealed | |

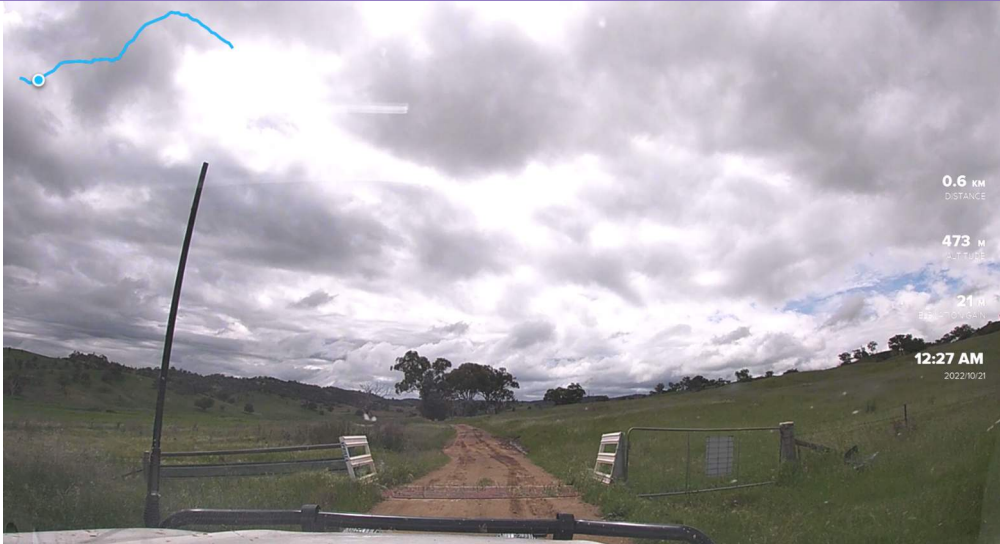
| Defect ID | Start Ch | End Ch | Defect Type (and side of road) | |
|---|---|---|---|---|
| 19.0 | 4700 | 4900 | Cattlegrid Potholes<br>Rutting (BS) | |

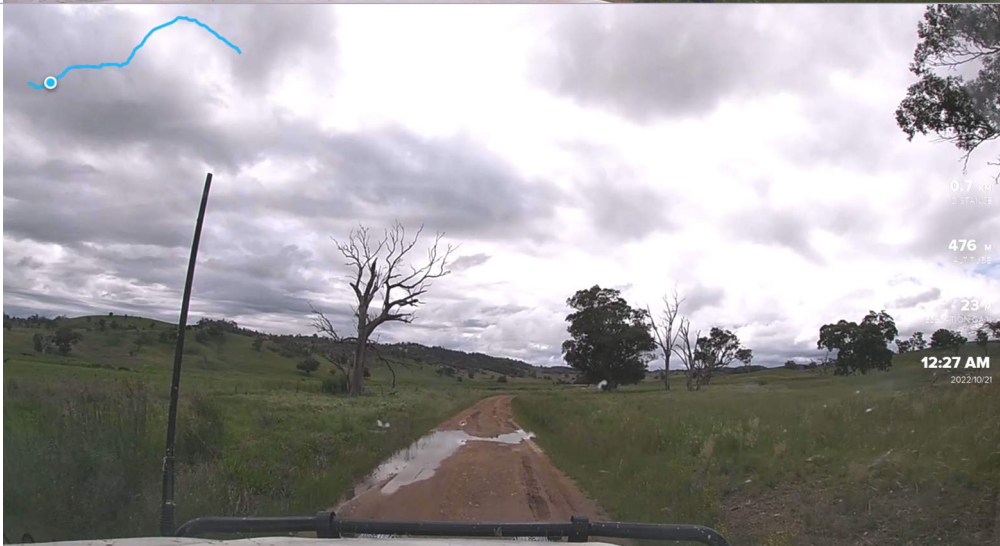
| Defect ID | Start Ch | End Ch | Defect Type (and side of road) | |
|---|---|---|---|---|
| 20.0 | 4900 | 5200 | Depression (CR)<br>Rutting (BS)<br>Drainage issue | |

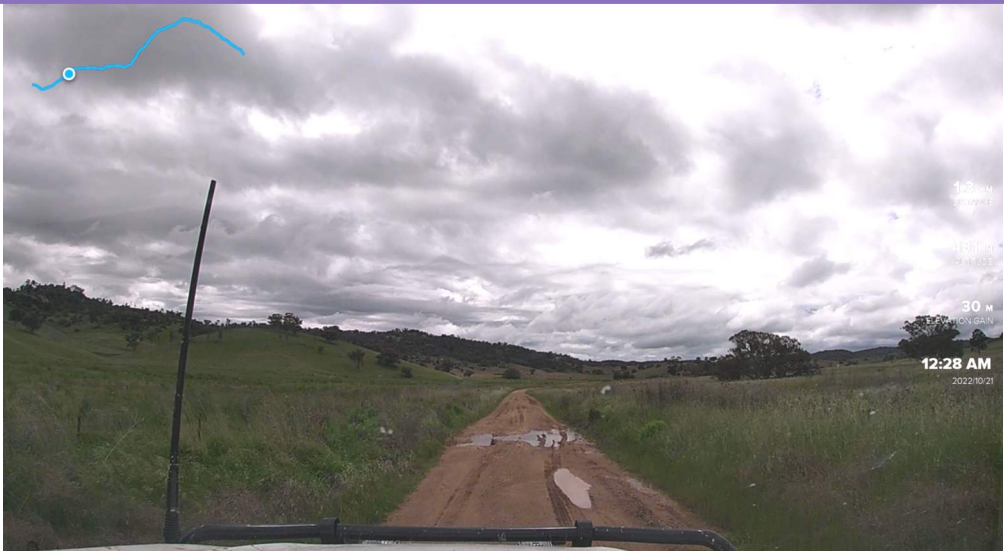
| Defect ID | Start Ch | End Ch | Defect Type (and side of road) | |
|---|---|---|---|---|
| 21.0 | 5200 | 5600 | Depression<br>Rutting (BS) | |

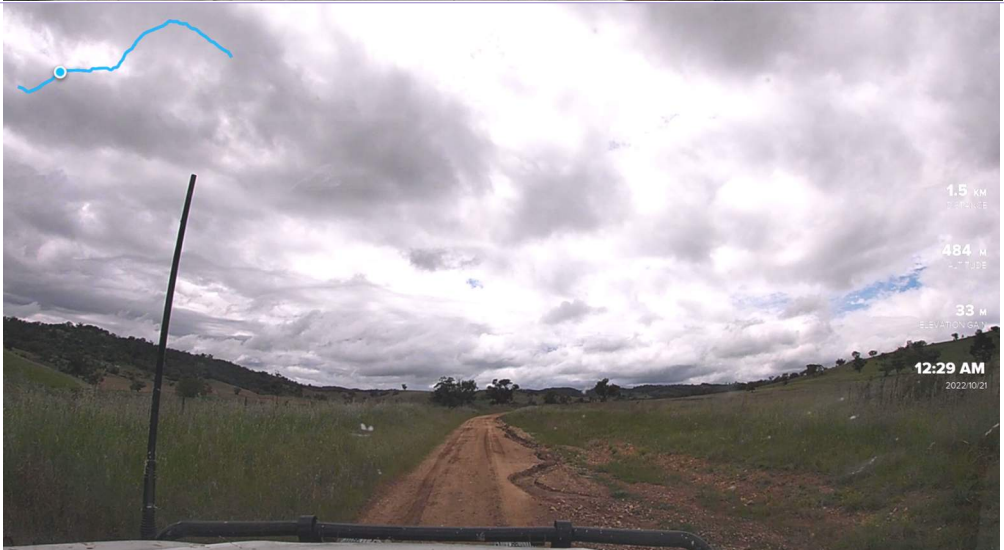
| Defect ID | Start Ch | End Ch | Defect Type (and side of road) | |
|---|---|---|---|---|
| 22.0 | 5600 | 6200 | Surface scour (BS)<br>Edge break (RHS)<br>Rutting (BS) | |
