# External Road Dilapidation Report – Existing Condition

## Uungula Wind Farm

*Prepared for: Uungula Wind Farm Pty Ltd*

| <b>Job Number</b> | 19-142 |

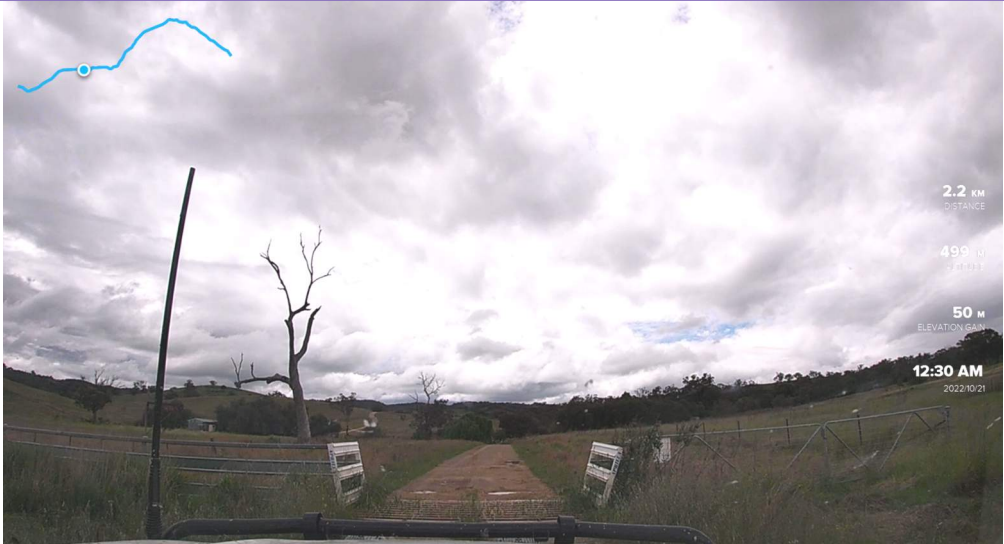
| Defect ID | Start Ch | End Ch | Defect Type (and side of road) | |
|---|---|---|---|---|
| 23.0 | 6200 | 6500 | Rutting<br>Potholes (BS)<br>Cattle grid | |

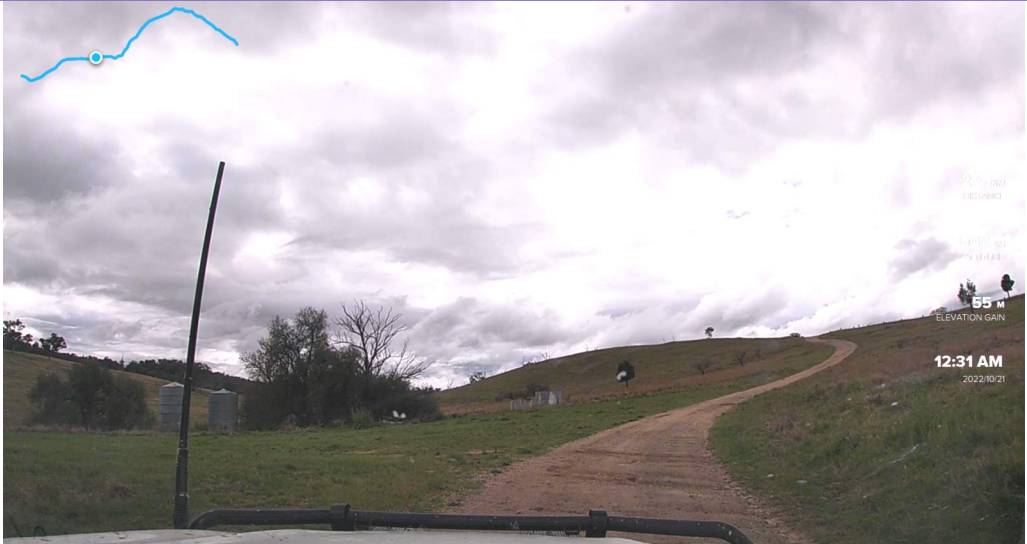
| Defect ID | Start Ch | End Ch | Defect Type (and side of road) | |
|---|---|---|---|---|
| 25.0 | 6600 | 6700 | Corrugation (RHS) | |

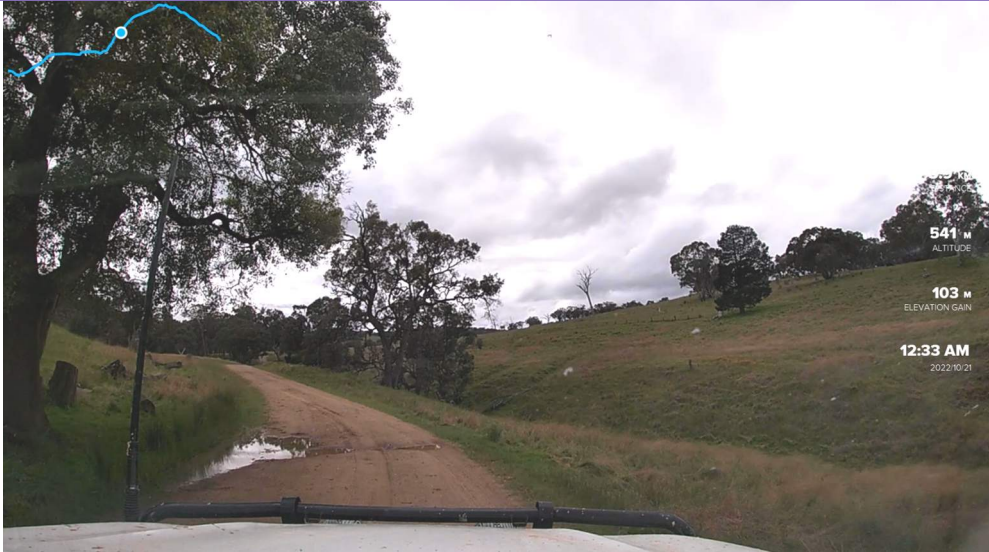
| Defect ID | Start Ch | End Ch | Defect Type (and side of road) | |
|---|---|---|---|---|
| 29.0 | 7700 | 8200 | Rutting (LHS)<br>Drainage issue | |

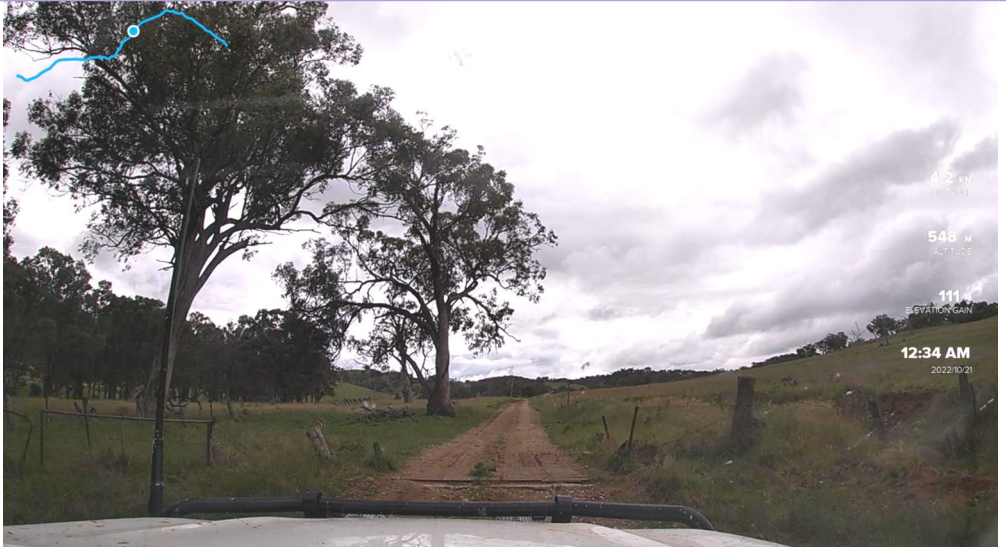
| Defect ID | Start Ch | End Ch | Defect Type (and side of road) | |
|---|---|---|---|---|
| 31.0 | 8300 | 8400 | Cattle grid | |

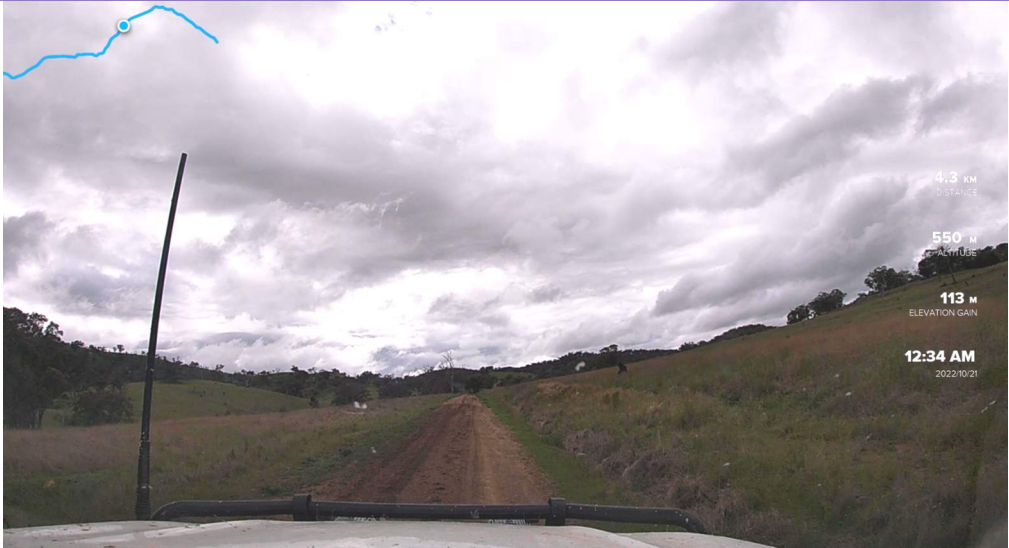
| Defect ID | Start Ch | End Ch | Defect Type (and side of road) | |
|---|---|---|---|---|
| 32.0 | 8400 | 8800 | Soft surface (LHS)<br>Rutting (BS) | |

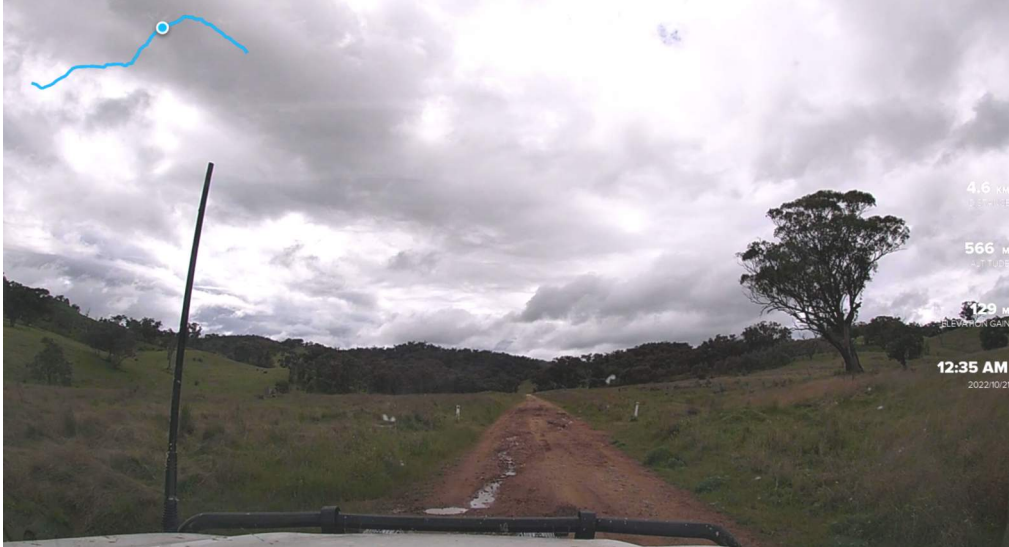
| Defect ID | Start Ch | End Ch | Defect Type (and side of road) | |
|---|---|---|---|---|
| 33.0 | 8800 | 8900 | Surface scour (BS)<br>Pothole (CR) | |

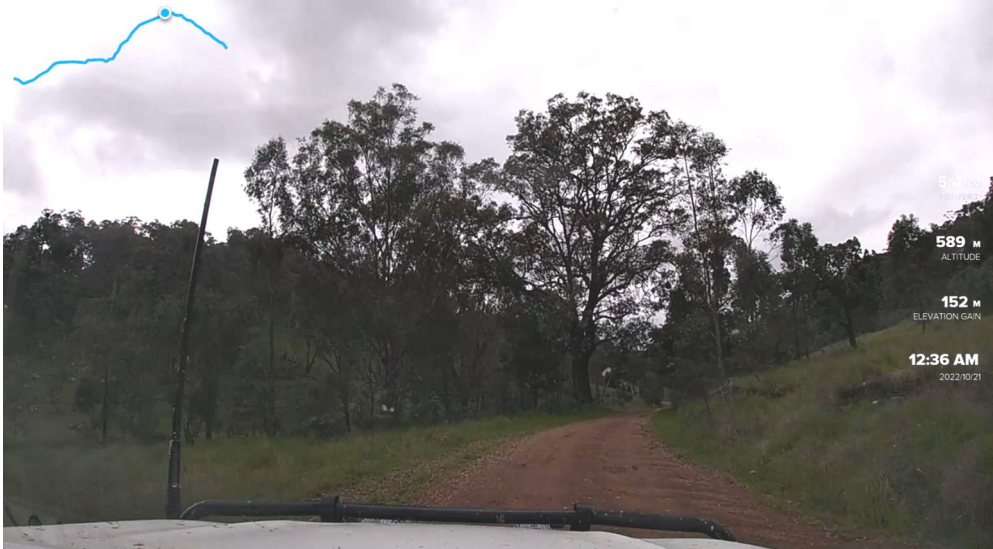
| Defect ID | Start Ch | End Ch | Defect Type (and side of road) | |
|---|---|---|---|---|
| 35.0 | 9500 | 9600 | Surface scour (CR)<br>Corrugation (RHS)<br>Rutting (RHS) | |

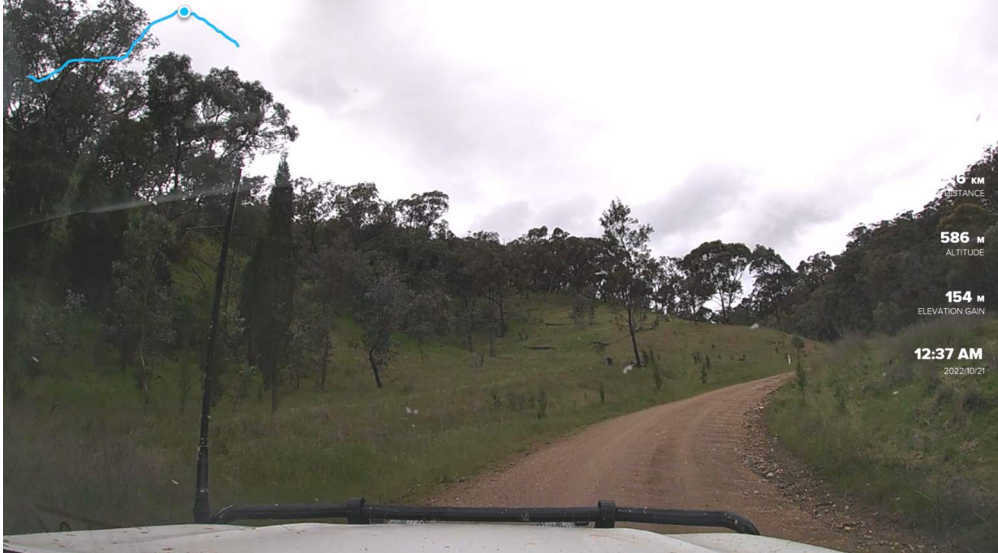
| Defect ID | Start Ch | End Ch | Defect Type (and side of road) | |
|---|---|---|---|---|
| 37.0 | 9700 | 9800 | Corrugation (RHS)<br>Edge break (RHS) | |

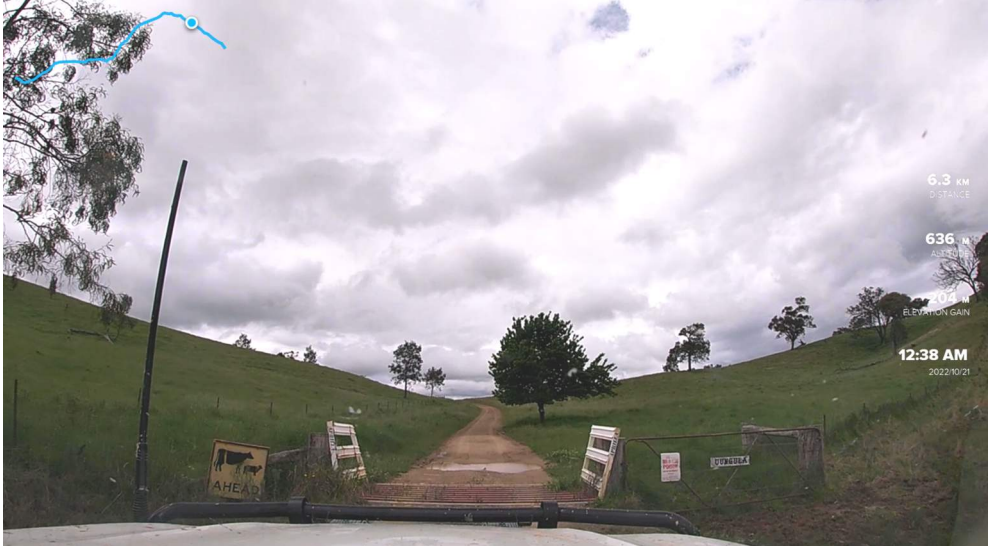
| Defect ID | Start Ch | End Ch | Defect Type (and side of road) | |
|---|---|---|---|---|
| 39.0 | 10300 | 10500 | Edge break (LHS)<br>Depression (CR)<br>Drainage issue<br>Cattle grid | |

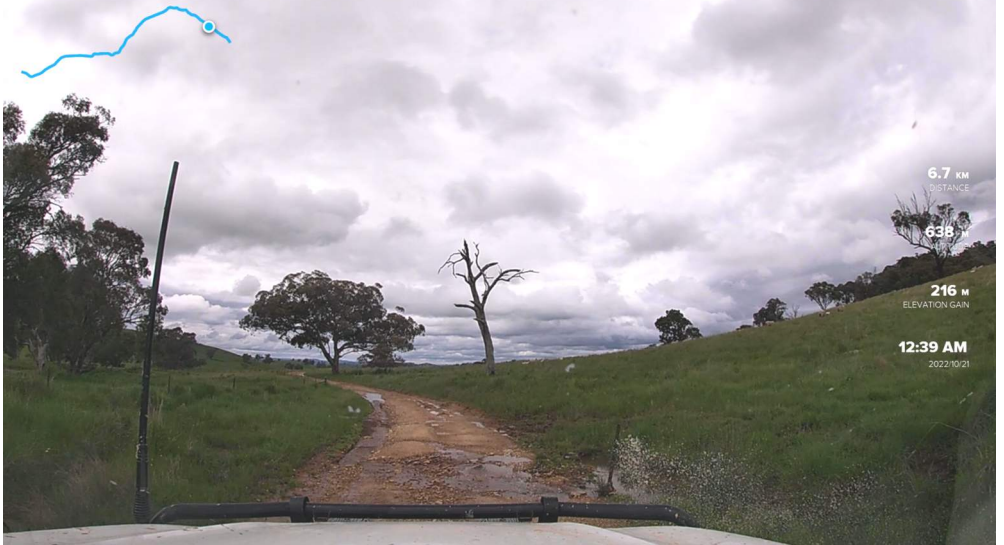
| Defect ID | Start Ch | End Ch | Defect Type (and side of road) | |
|---|---|---|---|---|
| 41.0 | 10800 | 11100 | Surface scour (CR)<br>Rutting (BS)<br>Pothole (LHS)<br>Drainage issue | |

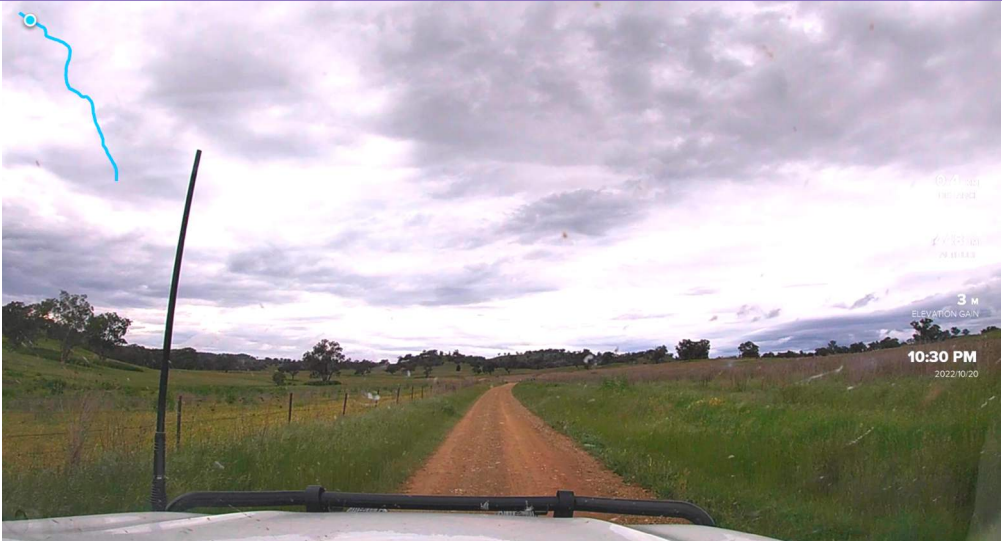
| Defect ID | Start Ch | End Ch | Defect Type (and side of road) | |
|---|---|---|---|---|
| 3.0 | 200 | 500 | Ravelling | |

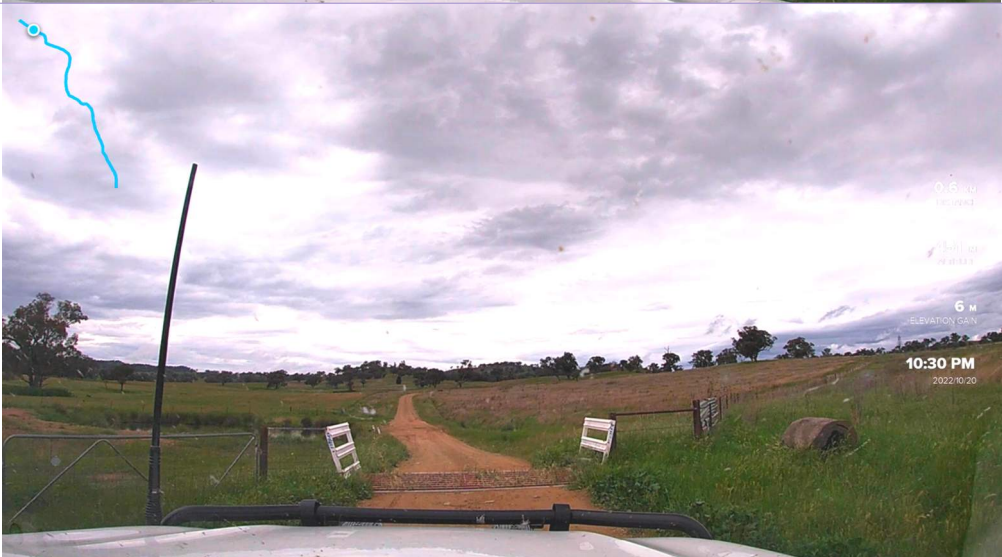
| Defect ID | Start Ch | End Ch | Defect Type (and side of road) | |
|---|---|---|---|---|
| 4.0 | 500 | 600 | Cattle grid | |

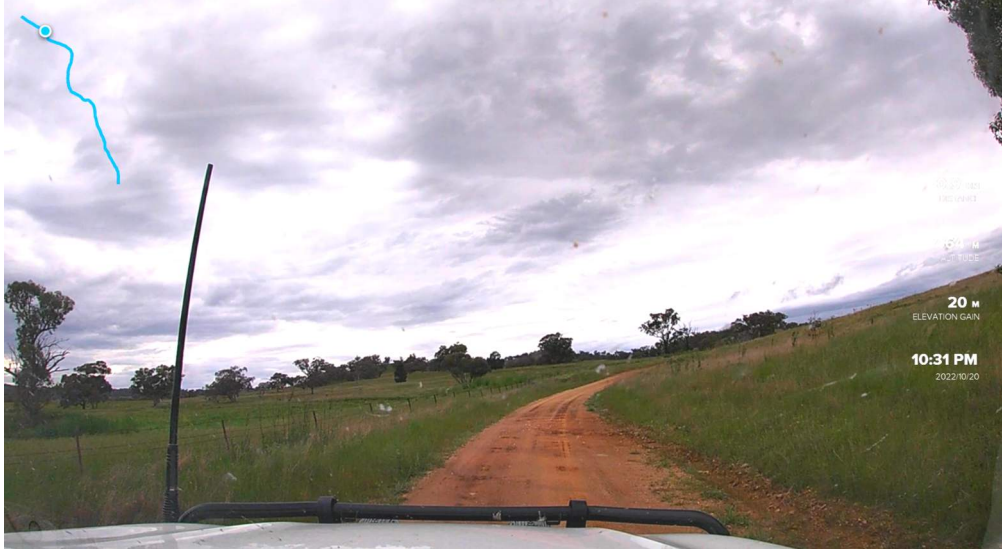
| Defect ID | Start Ch | End Ch | Defect Type (and side of road) | |
|---|---|---|---|---|
| 6.0 | 700 | 1000 | Soft surface<br>Rutting (BS) | |

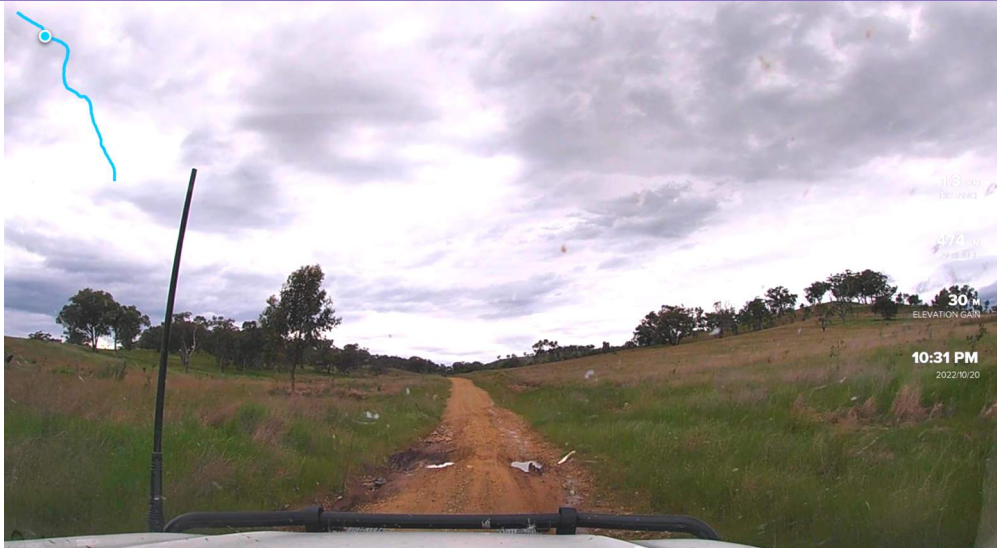
| Defect ID | Start Ch | End Ch | Defect Type (and side of road) | |
|---|---|---|---|---|
| 7.0 | 1000 | 1300 | Rutting (BS) | |

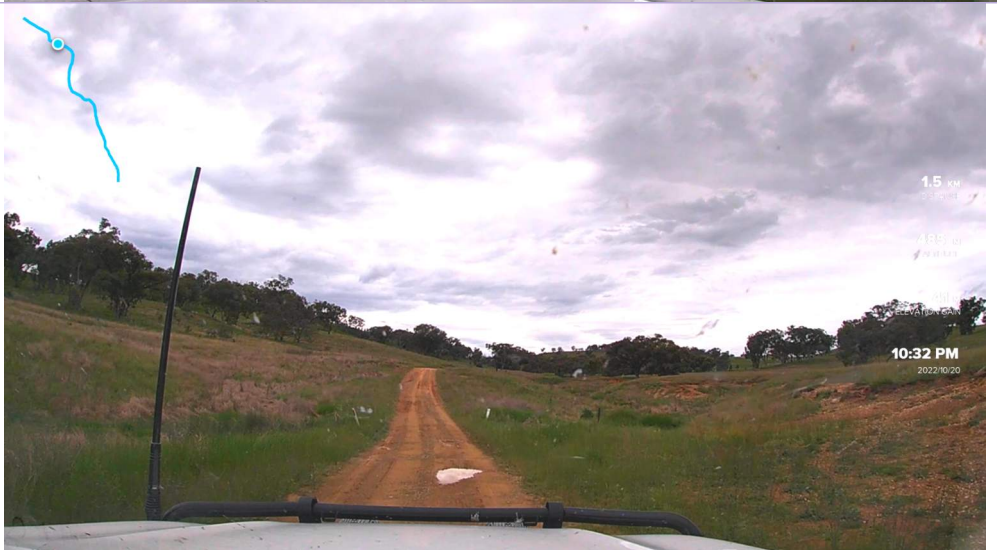
| Defect ID | Start Ch | End Ch | Defect Type (and side of road) | |
|---|---|---|---|---|
| 8.0 | 1300 | 1600 | Pothole (RHS) | |

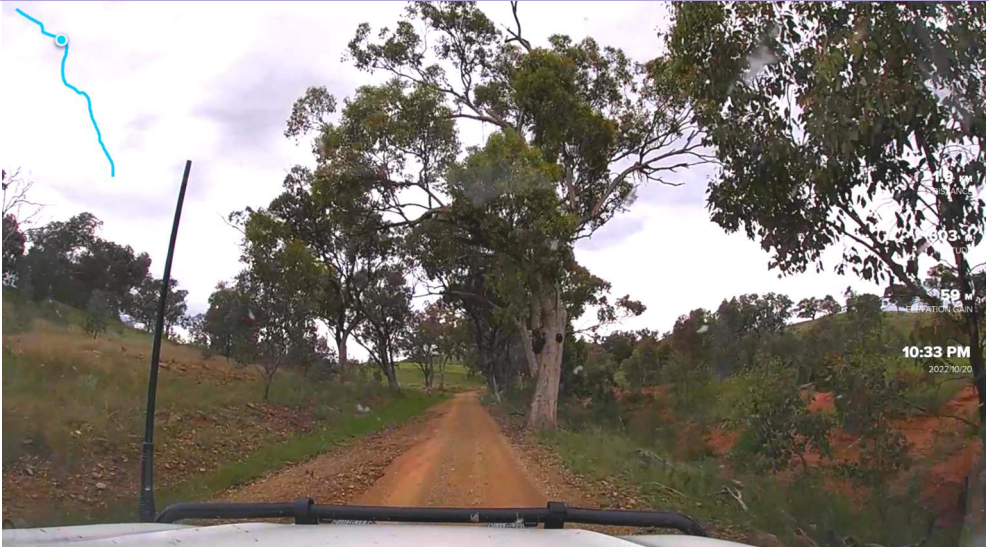
| Defect ID | Start Ch | End Ch | Defect Type (and side of road) | |
|---|---|---|---|---|
| 10.0 | 1800 | 2000 | Edge break (LHS) | |

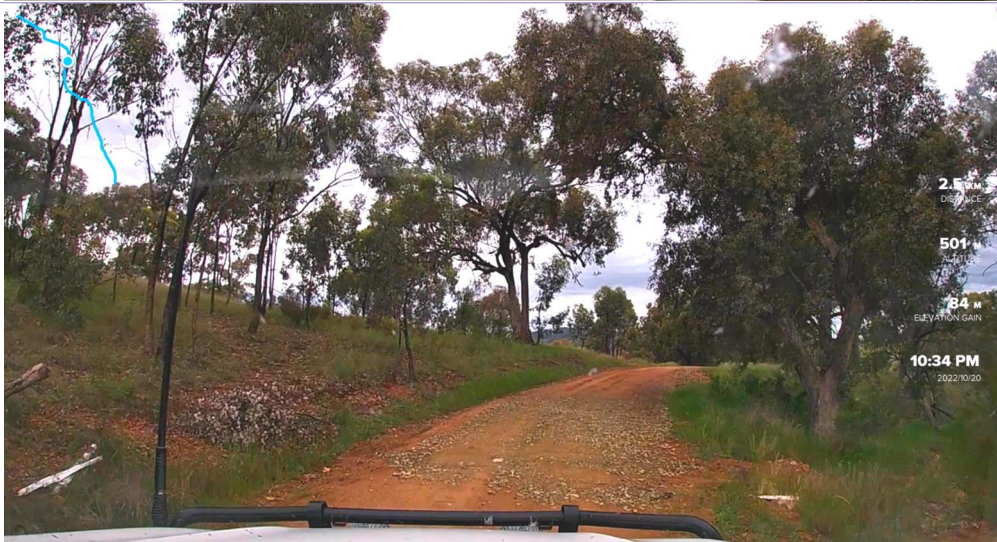
| Defect ID | Start Ch | End Ch | Defect Type (and side of road) | |
|---|---|---|---|---|
| 12.0 | 2300 | 2500 | Poorly graded pavement material | |

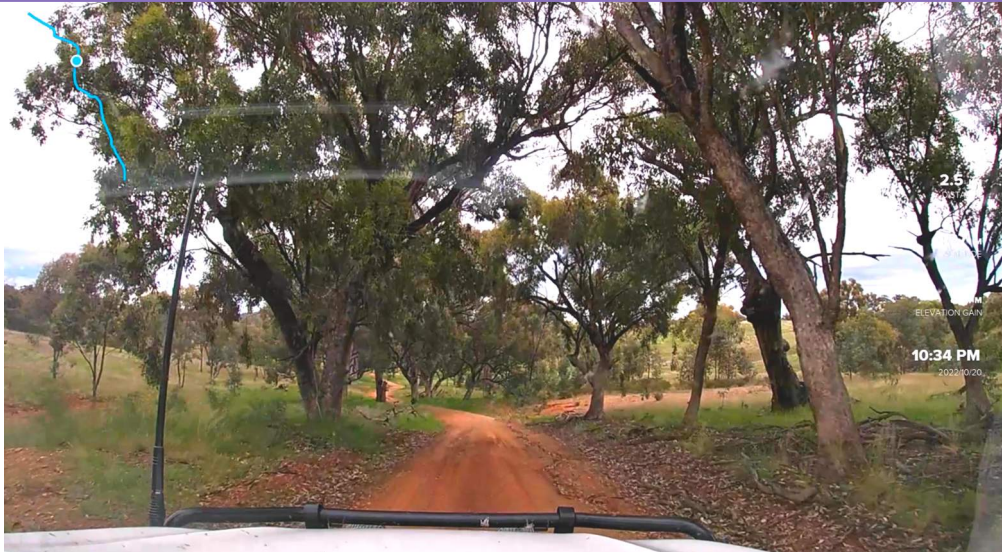
| Defect ID | Start Ch | End Ch | Defect Type (and side of road) | |
|---|---|---|---|---|
| 13.0 | 2500 | 2600 | Pothole (LHS)<br>Surface scour (RHS) | |

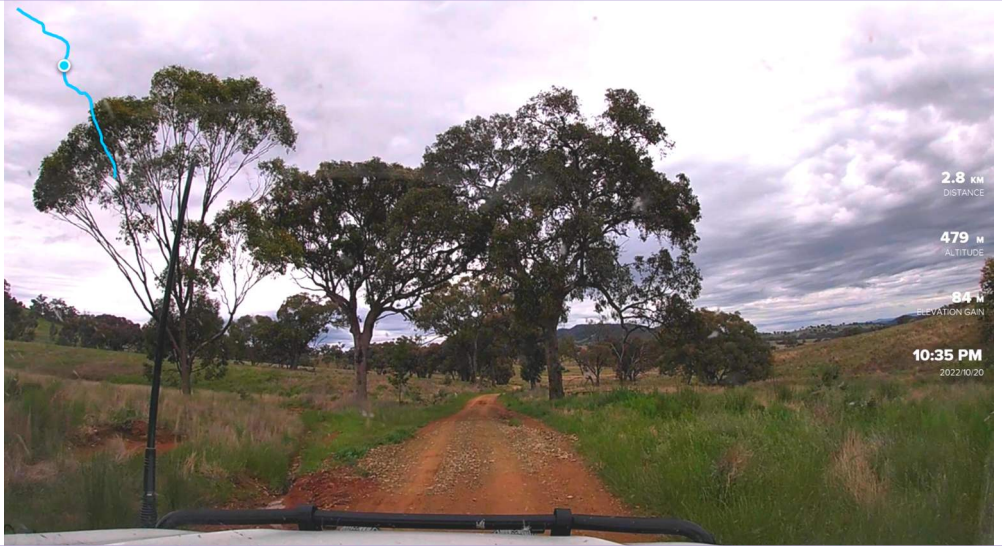
| Defect ID | Start Ch | End Ch | Defect Type (and side of road) | |
|---|---|---|---|---|
| 14.0 | 2600 | 2800 | Poorly graded pavement material<br>Minor rutting (LHS) | |

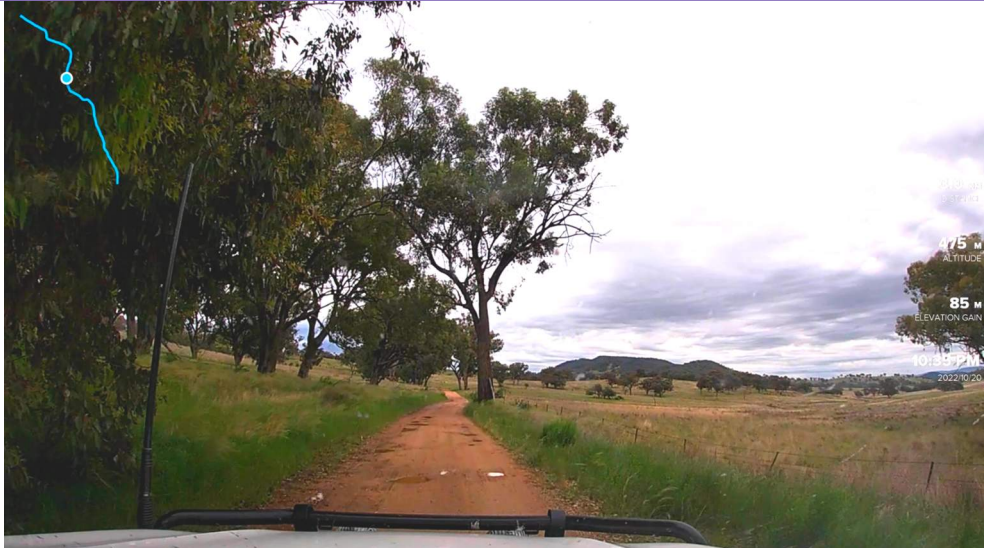
| Defect ID | Start Ch | End Ch | Defect Type (and side of road) | |
|---|---|---|---|---|
| 15.0 | 2800 | 3000 | Pothole (BS)<br>Rutting (LHS) | |

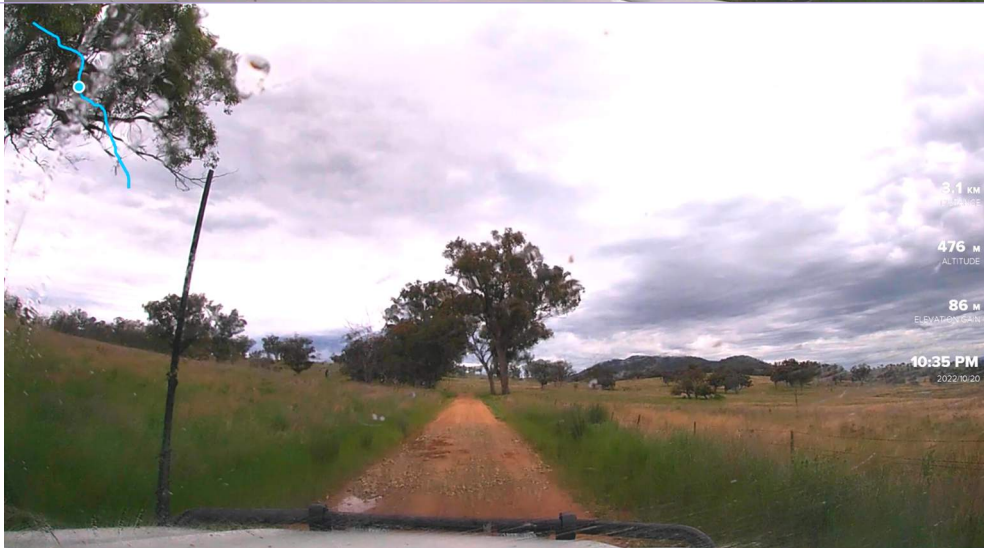
| Defect ID | Start Ch | End Ch | Defect Type (and side of road) | |
|---|---|---|---|---|
| 16.0 | 3000 | 3300 | Pothole (BS)<br>Edge break (LHS)<br>Poorly graded pavement material | |

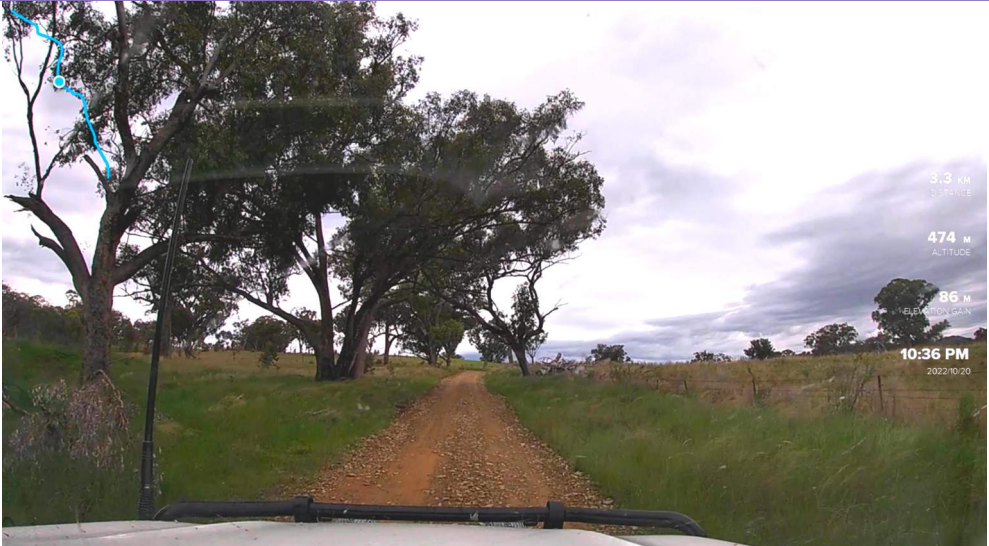
| Defect ID | Start Ch | End Ch | Defect Type (and side of road) | |
|---|---|---|---|---|
| 17.0 | 3300 | 3400 | Poorly graded pavement material | |

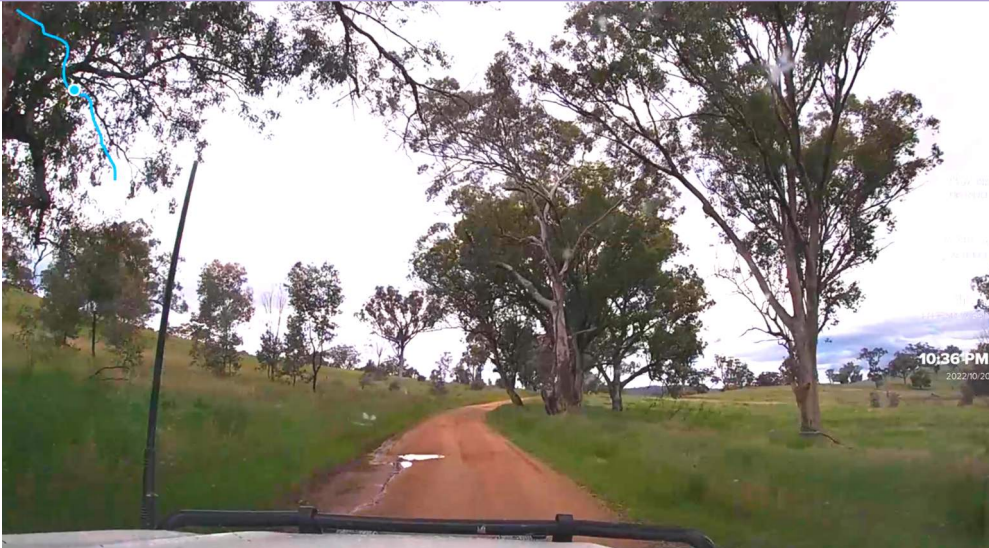
| Defect ID | Start Ch | End Ch | Defect Type (and side of road) | |
|---|---|---|---|---|
| 18.0 | 3400 | 3800 | Pothole (LHS)<br>Corrugation (RHS) | |

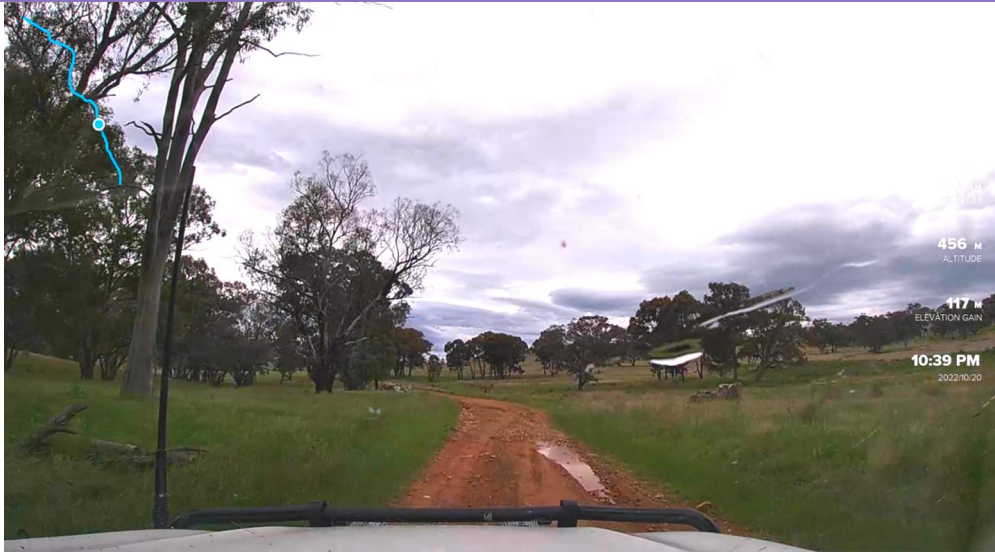
| Defect ID | Start Ch | End Ch | Defect Type (and side of road) | |
|---|---|---|---|---|
| 25.0 | 4900 | 5100 | Rutting (RHS)<br>Surface scour (LHS) | |

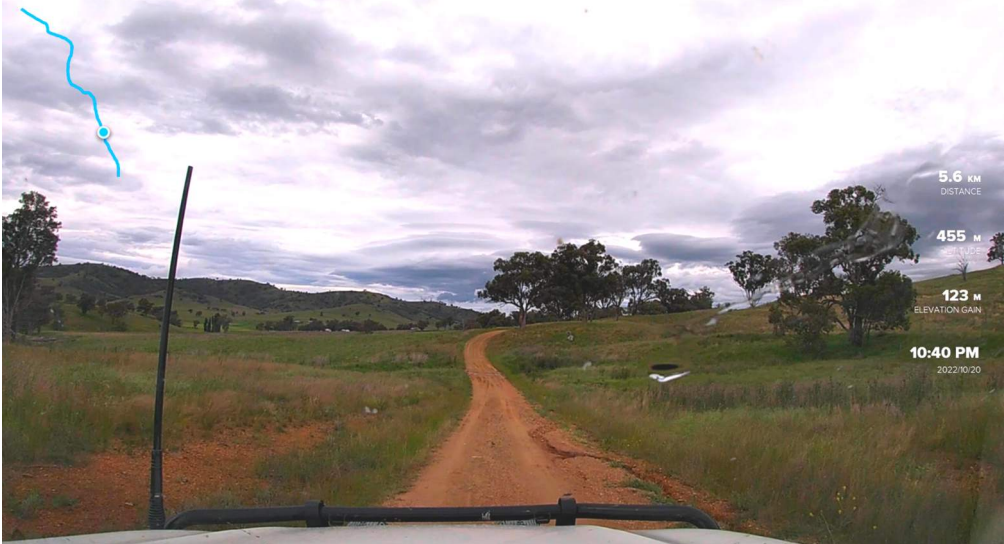
| Defect ID | Start Ch | End Ch | Defect Type (and side of road) | |
|---|---|---|---|---|
| 29.0 | 5200 | 5600 | Surface scour (RHS)<br>Edge break (RHS) | |

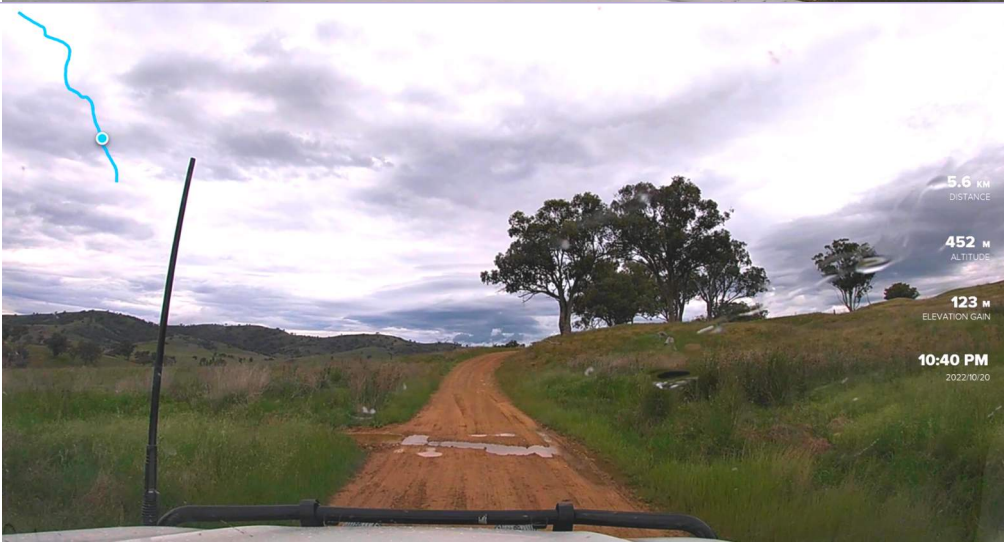
| Defect ID | Start Ch | End Ch | Defect Type (and side of road) | |
|---|---|---|---|---|
| 30.0 | 5600 | 5700 | Depression<br>Drainage issue | |

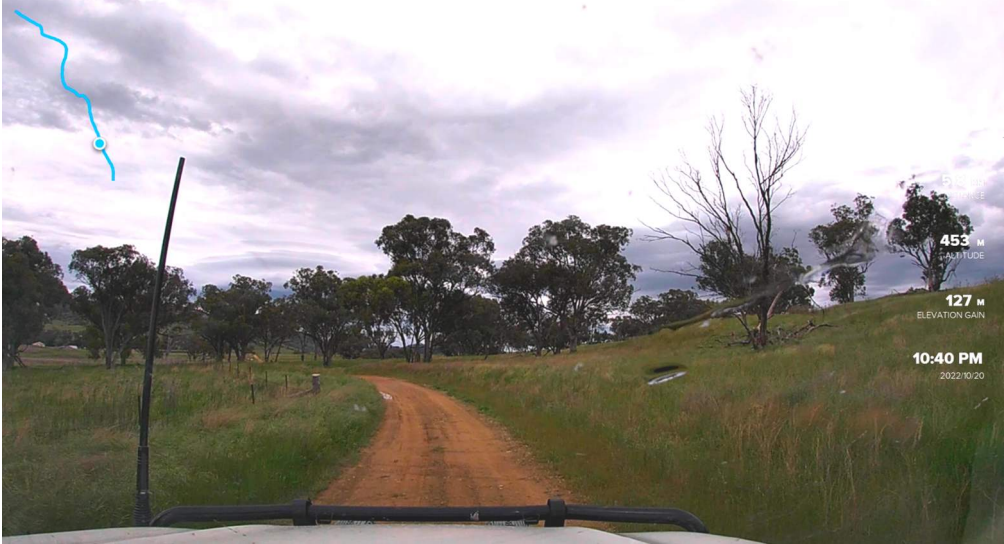
| Defect ID | Start Ch | End Ch | Defect Type (and side of road) | |
|---|---|---|---|---|
| 31.0 | 5700 | 5800 | Corrugation (CR) | |

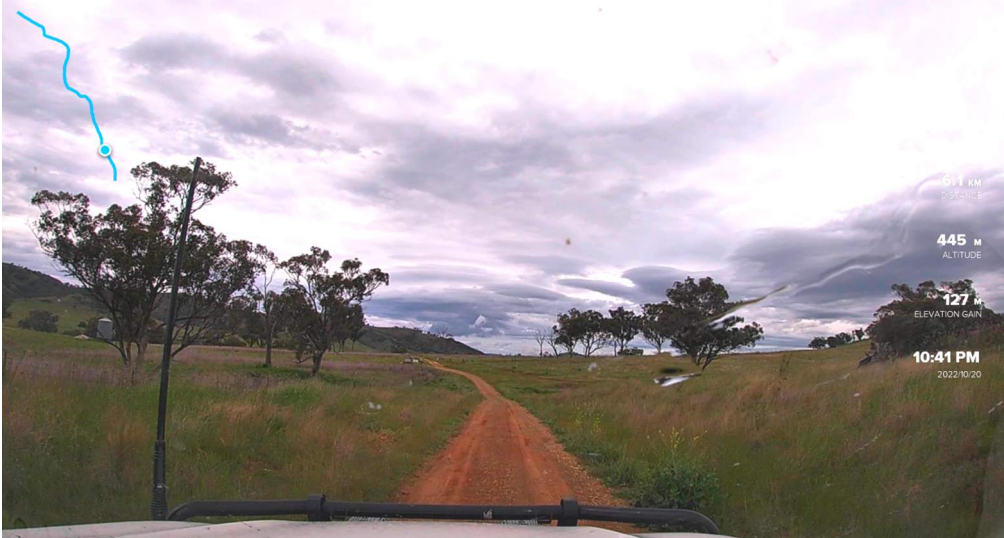
| Defect ID | Start Ch | End Ch | Defect Type (and side of road) | |
|---|---|---|---|---|
| 32.0 | 5800 | 6200 | Rutting (BS) | |

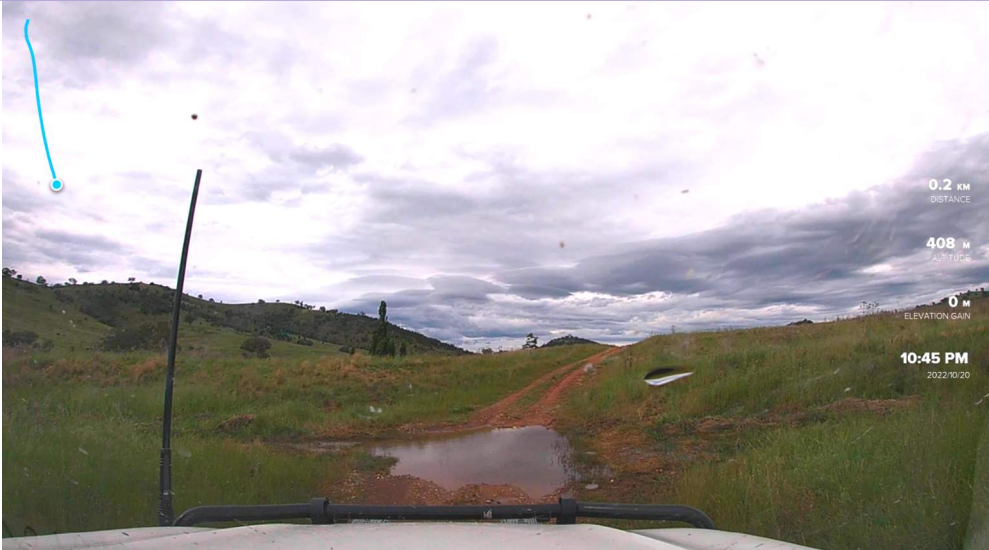
| Defect ID | Start Ch | End Ch | Defect Type (and side of road) | |
|---|---|---|---|---|
| 38.0 | 7100 | 7300 | Drainage issue | |
