**Hazardous Materials Risk Assessment**  
**Joss Group**  
**Berrima Correctional Centre**  
Argyle Street, Berrima NSW 2577

**Site Reference: BCC001**

**Our Reference: C106543 : J145125**

**Date: June 2016**

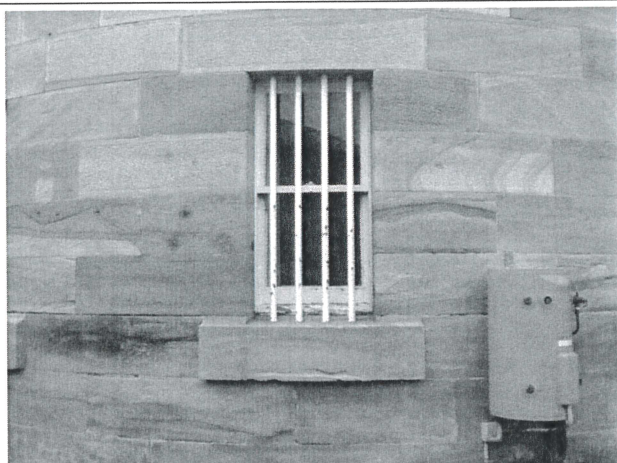
| Site Details | | | | Building Details | | | | | Audit Details | | | | | | | | |
|---|---|--|--|---|---|---|---|---|---|---|---|---|---|---|---|---|---|
| All rooms - Throughout Window Frame - Upper & Lower Paint System/s - White | | | | Lead (Paint) | Previously Sampled Envirolab<br>74021-001-LP01 | Previously Sampled Positive | J145125-BCC 001-Photo007 | 50 m² | Fair | | | | | | | Maintain in good condition and incorporate into a HMMP. Remove under controlled conditions prior to demolition or refurbishment. | |

Photo No: J145125-BCC001-Photo007  
Result: Lead (Paint) - Previously Sampled Positive  
Building/Level: 001 Gatehouse -All Levels  
Room/Location: All rooms-Throughout  
Feature/Material: Window Frame-Upper & Lower Paint System/s

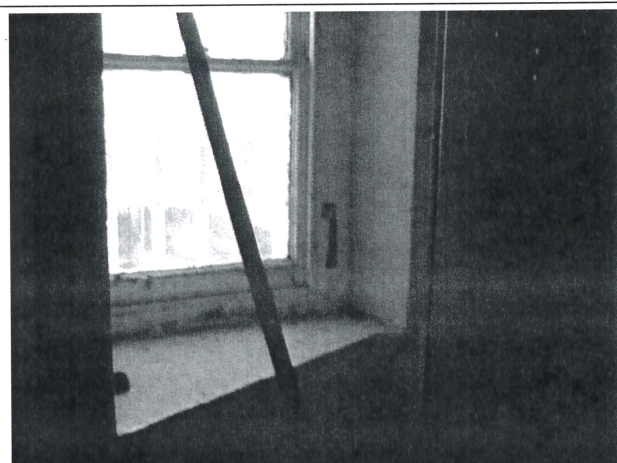
| Site Details | | | | Building Details | | | | | Audit Details | | | | | | | | |
|---|---|--|--|---|---|---|---|---|---|---|---|---|---|---|---|---|---|
| All rooms - Throughout Window Frame - Upper & Lower Paint System/s - White | | | | Lead (Paint) | Previously Sampled Envirolab<br>74021-001-LP01 | Previously Sampled Positive | J145125-BCC 001-Photo003 | 50 m² | Fair | | | | | | | Maintain in good condition and incorporate into a HMMP. Remove under controlled conditions prior to demolition or refurbishment. | |

Photo No: J145125-BCC001-Photo003  
Result: Lead (Paint) - Previously Sampled Positive  
Building/Level: 001 Gatehouse -All Levels  
Room/Location: All rooms-Throughout  
Feature/Material: Window Frame-Upper & Lower Paint System/s

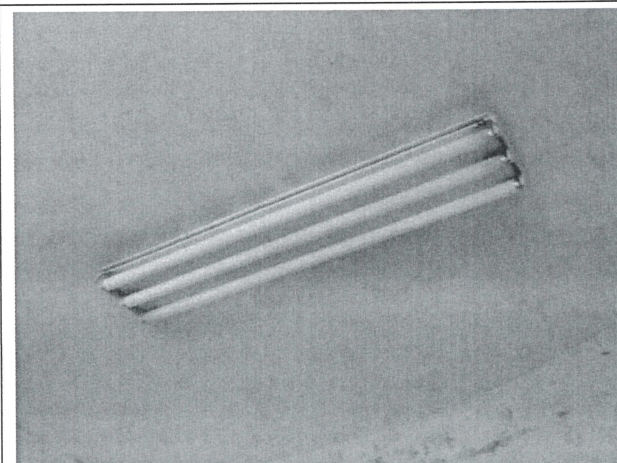
| Site Details | | | | Building Details | | | | | Audit Details | | | | | | | | |
|---|---|--|--|---|---|---|---|---|---|---|---|---|---|---|---|---|---|
| All rooms - Throughout Fluorescent Light Fitting - Triple Tube - Capacitor | | | | PCB | | Presumed Positive | J145125-BCC 001-Photo004 | 4 Unit/s | Good | | | | | | | Confirm status and maintain in good condition and incorporate into a HMMP. Remove under controlled conditions and dispose of in accordance with environmental protection requirements prior to demolition or refurbishment. | |

Photo No: J145125-BCC001-Photo004  
Result: PCB - Presumed Positive  
Building/Level: 001 Gatehouse -Level One  
Room/Location: All rooms-Throughout  
Feature/Material: Fluorescent Light Fitting - Triple Tube-Capacitor

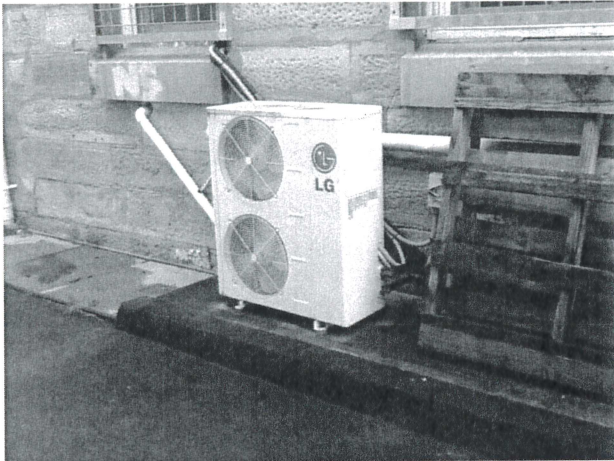
| Site Details | | | | Building Details | | | | Audit Details | | | | | | | | | |
|---|---|--|--|---|---|---|---|---|---|---|---|---|---|---|---|---|---|
| South Side A/C Unit - R22 - Chlorodifluoromethane - LG | ODS | | | Presumed Positive | J145125-BCC 001-Photo010 | 1 Unit/s | | | | | | | | | Maintain in good condition and incorporate into a HMMP. Ensure air-conditioning maintenance contractors conduct appropriate recovery and recycling of refrigerants. | | |

Photo No: J145125-BCC001-Photo010  
Result: ODS - Presumed Positive  
Building/Level: 002 Sterile Zone, Outer Wall -Ground Level  
Room/Location: South Side-  
Feature/Material: A/C Unit-R22 - Chlorodifluoromethane

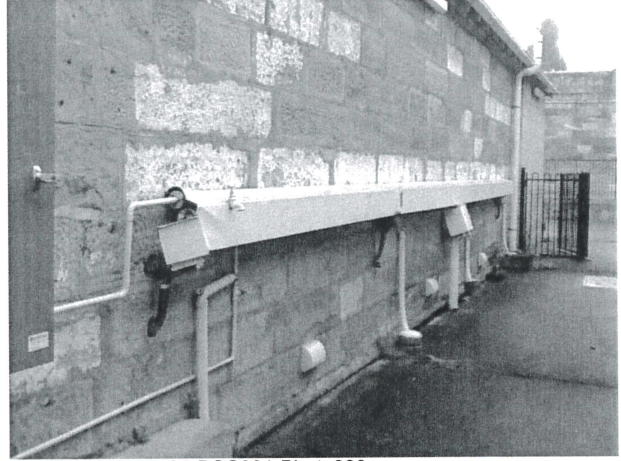
| Site Details | | | | Building Details | | | | Audit Details | | | | | | | | | |
|---|---|--|--|---|---|---|---|---|---|---|---|---|---|---|---|---|---|
| Throughout Pipework Insulation - Insulation Material | SMF | | | Positive | J145125-BCC 001-Photo008 | 200 m | Fair | Bonded (SMF) | | | | | | | Maintain in good condition and incorporate into a HMMP. Remove under controlled conditions prior to demolition or refurbishment. | | |

Photo No: J145125-BCC001-Photo008  
Result: SMF - Positive  
Building/Level: 002 Sterile Zone, Outer Wall -Ground Level  
Room/Location: Throughout-  
Feature/Material: Pipework Insulation-Insulation Material

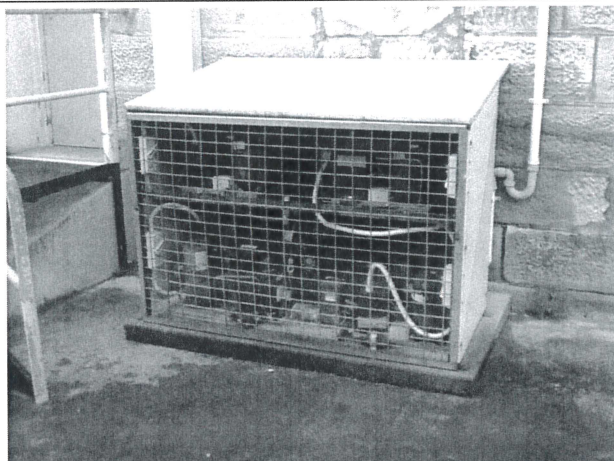
| Site Details | | | | Building Details | | | | Audit Details | | | | | | | | | |
|---|---|--|--|---|---|---|---|---|---|---|---|---|---|---|---|---|---|
| West Side Fridge - R22 - Chlorodifluoromethane | ODS | | | Positive | J145125-BCC 001-Photo011 | 4 Unit/s | Good | | Good | | | | | | Maintain in good condition and incorporate into a HMMP. Ensure air-conditioning maintenance contractors conduct appropriate recovery and recycling of refrigerants. | | |

Photo No: J145125-BCC001-Photo011  
Result: ODS - Positive  
Building/Level: 002 Sterile Zone, Outer Wall -Ground Level  
Room/Location: West Side-  
Feature/Material: Fridge-R22 - Chlorodifluoromethane

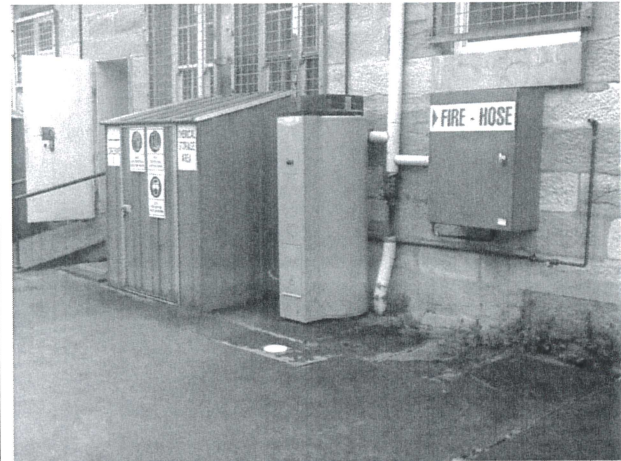
| Site Details | | | | Building Details | | | | Audit Details | | | | | | | | | |
|---|---|--|--|---|---|---|---|---|---|---|---|---|---|---|---|---|---|
| West Side Hot Water Heater - Insulation Material | SMF | | | Presumed Positive | J145125-BCC 001-Photo009 | 1 Unit/s | Good | Bonded (SMF) | | | | | | | Maintain in good condition and incorporate into a HMMP. Remove under controlled conditions prior to demolition or refurbishment. | | |

Photo No: J145125-BCC001-Photo009  
Result: SMF - Presumed Positive  
Building/Level: 002 Sterile Zone, Outer Wall -Ground Level  
Room/Location: West Side-  
Feature/Material: Hot Water Heater-Insulation Material

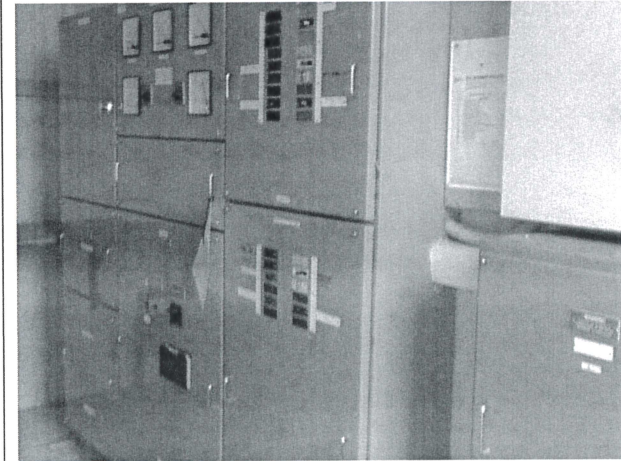
Photo No: J145125-BCC001-Photo019  
Result: Asbestos - Presumed Positive  
Building/Level: 003 MDI/DEP GOV/BOX VISITS-Ground Level  
Room/Location: Main Switchroom-Throughout  
Feature/Material: Electrical Distribution Board-Compressed Bituminous Electrical Panel

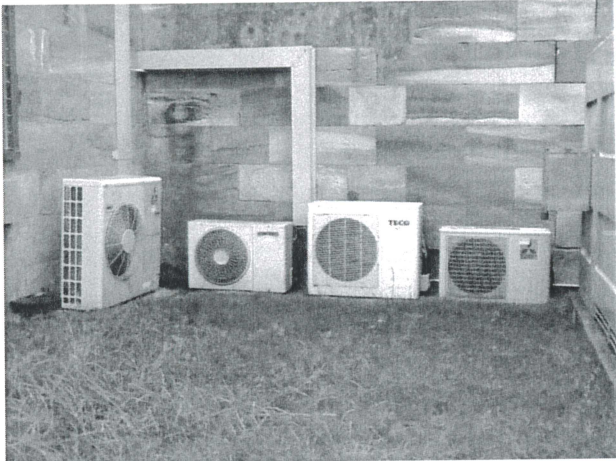
Photo No: J145125-BCC001-Photo015  
Result: ODS - Positive  
Building/Level: 003 MDI/DEP GOV/BOX VISITS-Ground Level  
Room/Location: South Side-  
Feature/Material: A/C Unit-R22 - Chlorodifluoromethane

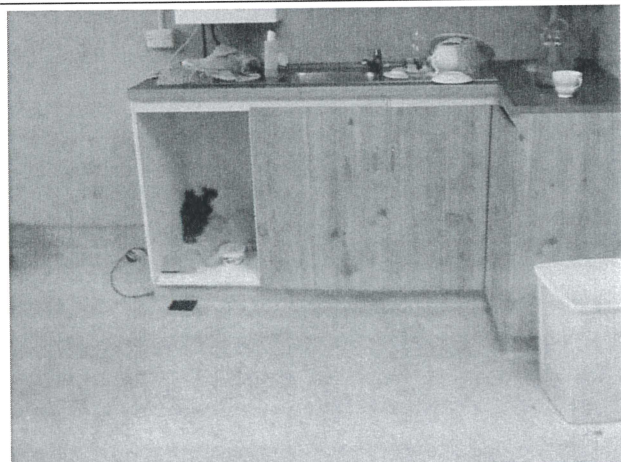
Photo No: J145125-BCC001-Photo021  
Result: Asbestos - Previously Sampled Positive  
Building/Level: 003 MDI/DEP GOV/BOX VISITS-Level One  
Room/Location: Kitchen-Under Sink  
Feature/Material: Sink Pad-Bituminous Material

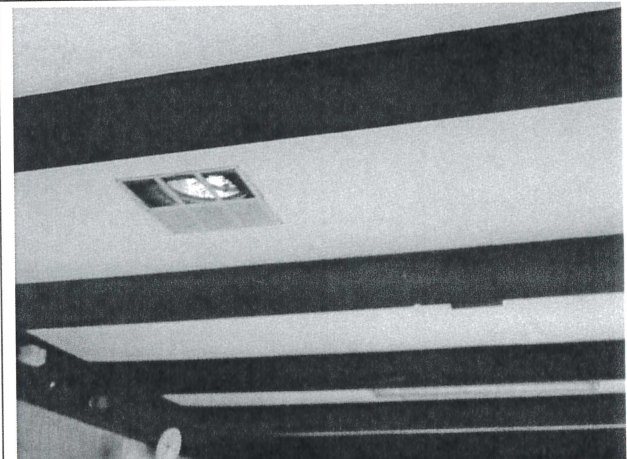
Photo No: J145125-BCC001-Photo014  
Result: SMF - Presumed Positive  
Building/Level: 004 Visitors Facility-Ground Level  
Room/Location: Visitors Room-Ceiling Space  
Feature/Material: Insulation-Sarking Insulation

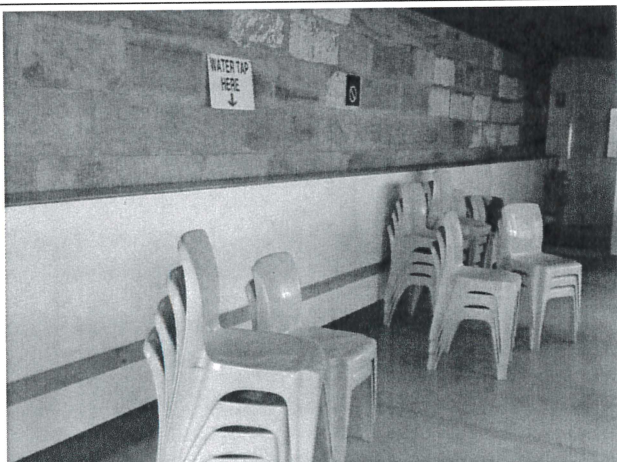
Photo No: J145125-BCC001-Photo013  
Result: SMF - Positive  
Building/Level: 004 Visitors Facility-Ground Level  
Room/Location: Visitors Room-Western Side in Wall  
Feature/Material: Pipework Insulation-Insulation Material

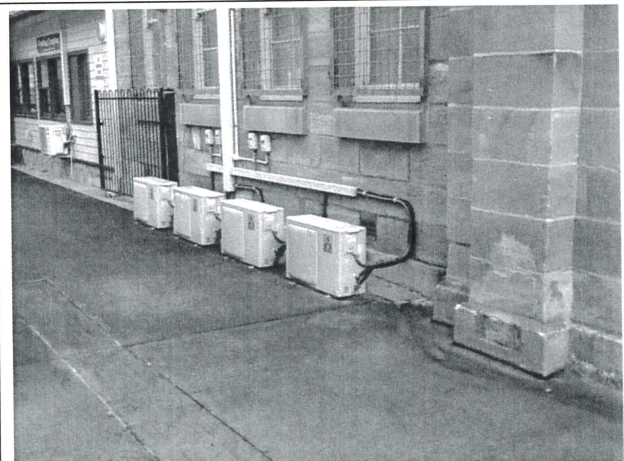
Photo No: J145125-BCC001-Photo023  
Result: ODS - Positive  
Building/Level: 005 Clinic-Ground Level  
Room/Location: Exterior-Surrounding  
Feature/Material: A/C Unit-R22 - Chlorodifluoromethane

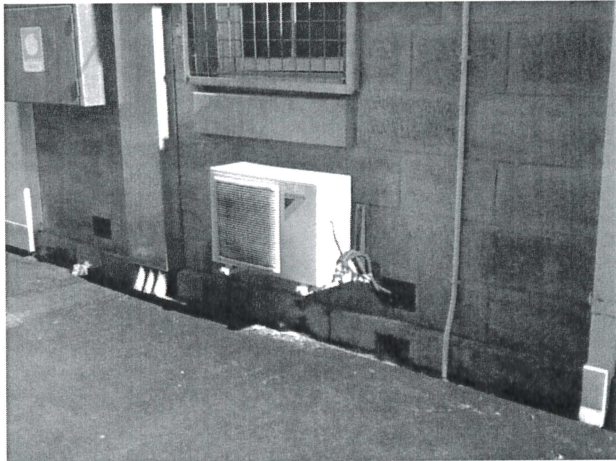
Photo No: J145125-BCC001-Photo026  
Result: ODS - Positive  
Building/Level: 007 Area Case Manager-Ground Level  
Room/Location: Exterior-East  
Feature/Material: A/C Unit-R22 - Chlorodifluoromethane

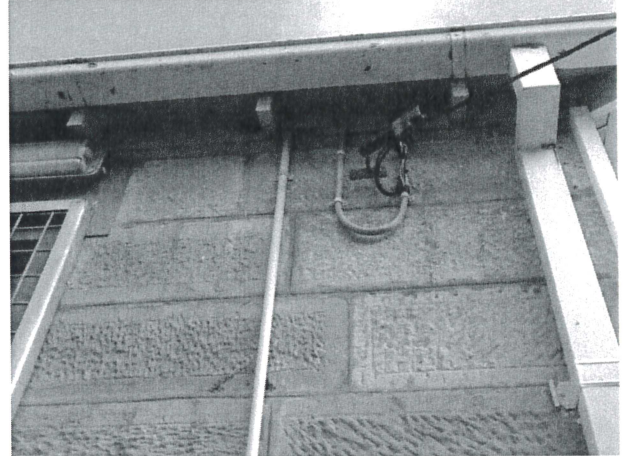
Photo No: J145125-BCC001-Photo024  
Result: Asbestos - Presumed Positive  
Building/Level: 007 Area Case Manager-Ground Level  
Room/Location: Exterior-Infill panels between rafters  
Feature/Material: Eaves-Fibre Cement Sheetting

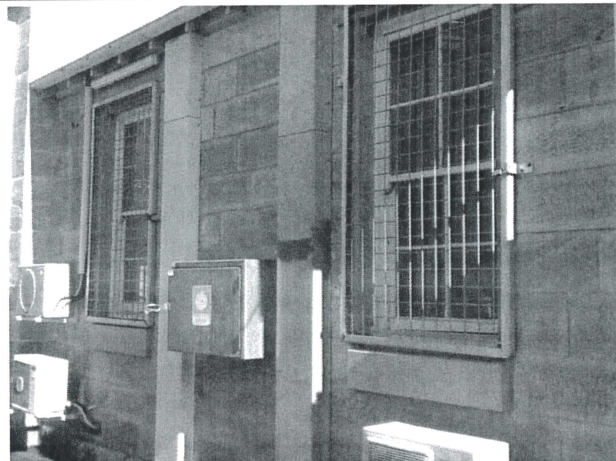
Photo No: J145125-BCC001-Photo025  
Result: Lead (Paint) - Previously Sampled Positive  
Building/Level: 007 Area Case Manager-Ground Level  
Room/Location: Exterior-Surrounding  
Feature/Material: Window Frame-Upper & Lower Paint System/s

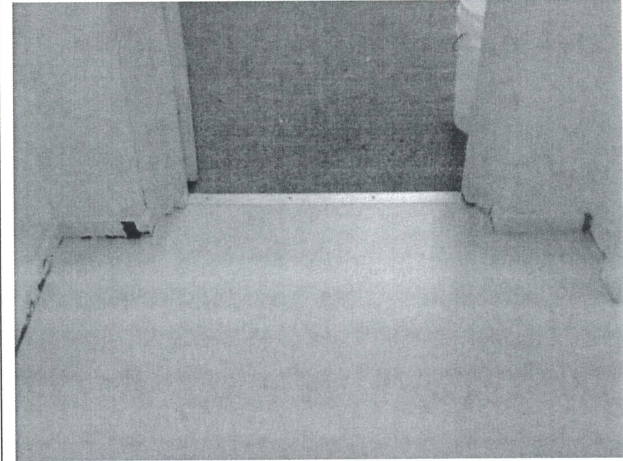
Photo No: J145125-BCC001-Photo027  
Result: Asbestos - Previously Sampled Positive  
Building/Level: 007 Area Case Manager-Ground Level  
Room/Location: Hallway & Office-Floor under carpet  
Feature/Material: Floor Covering-Rigid Vinyl Tiles

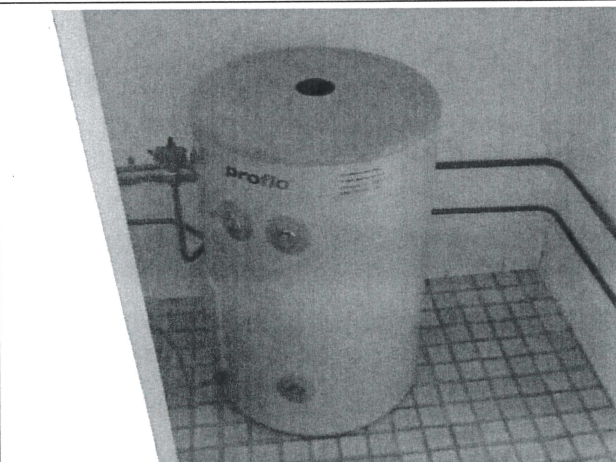
Photo No: J145125-BCC001-Photo028  
Result: SMF - Presumed Positive  
Building/Level: 007 Area Case Manager-Ground Level  
Room/Location: Toilet-  
Feature/Material: Hot Water Heater-Insulation Material

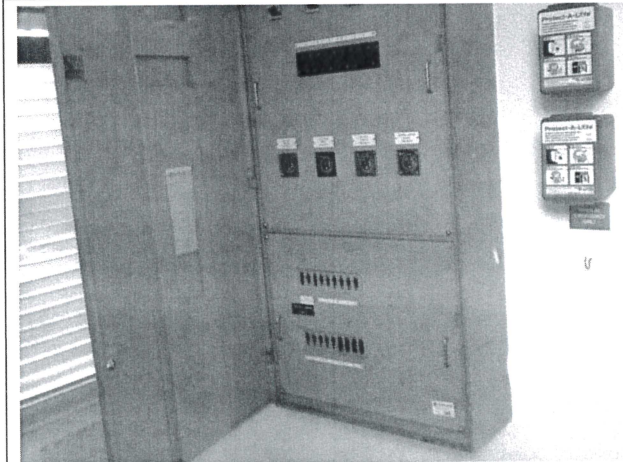
Photo No: J145125-BCC001-Photo029  
Result: Asbestos - Presumed Positive  
Building/Level: 009 Compound Office-Ground Level  
Room/Location: Main Room-North  
Feature/Material: Electrical Distribution Board-Compressed Bituminous Electrical Panel

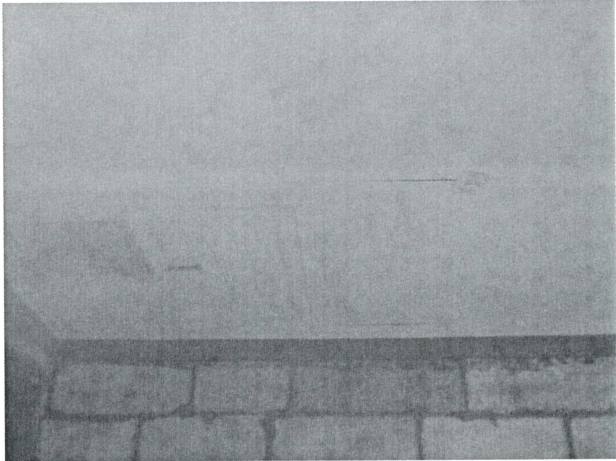
Photo No: J145125-BCC001-Photo045  
Result: Asbestos - Previously Sampled Positive  
Building/Level: 012 Block E Cells 1 to 17-Ground Level  
Room/Location: Northwest Room-Throughout  
Feature/Material: Ceiling-Fibre Cement Sheetting

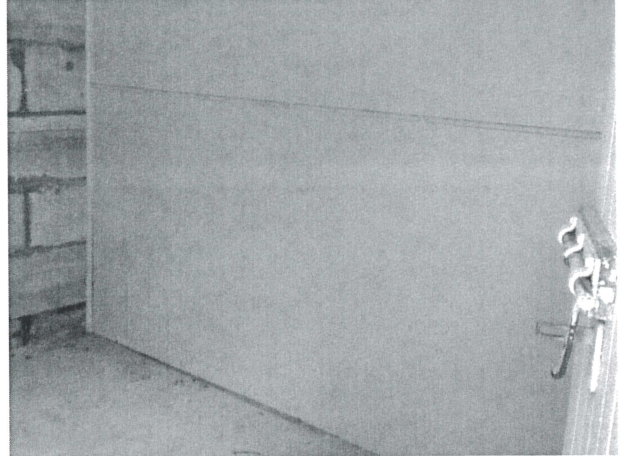
Photo No: J145125-BCC001-Photo044  
Result: Asbestos - Previously Sampled Positive  
Building/Level: 012 Block E Cells 1 to 17-Ground Level  
Room/Location: Northwest Room-Throughout  
Feature/Material: Wall Covering-Fibre Cement Sheetting

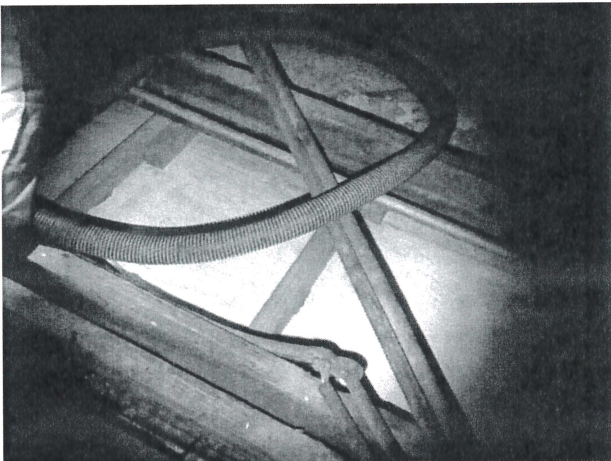
Photo No: J145125-BCC001-Photo033  
Result: Asbestos - Previously Sampled Positive  
Building/Level: 013 Kitchen/Dining/Activities-Ground Level  
Room/Location: Ceiling Space-Throughout  
Feature/Material: Ceiling-Compressed Cement Sheetting

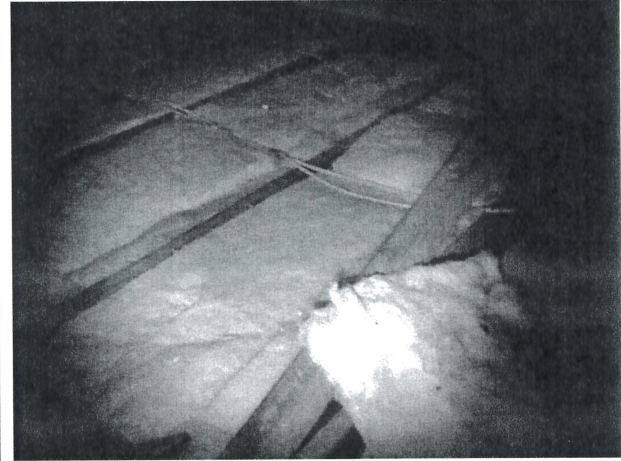
Photo No: J145125-BCC001-Photo035  
Result: SMF - Positive  
Building/Level: 013 Kitchen/Dining/Activities-Ground Level  
Room/Location: Ceiling Space-Throughout  
Feature/Material: Insulation-Insulation Battis

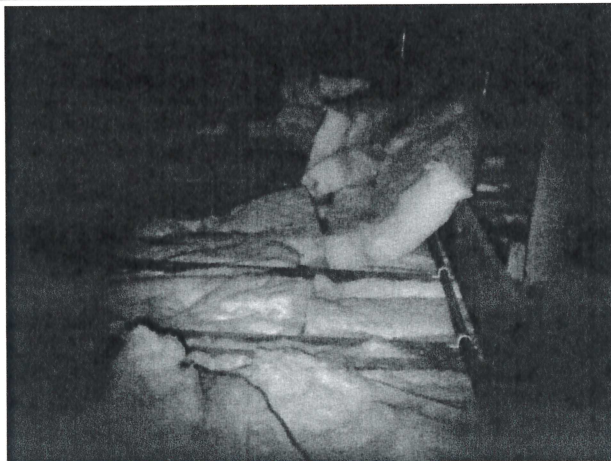
Photo No: J145125-BCC001-Photo036  
Result: SMF - Positive  
Building/Level: 013 Kitchen/Dining/Activities-Ground Level  
Room/Location: Ceiling Space-Throughout  
Feature/Material: Pipework Insulation-Insulation Material

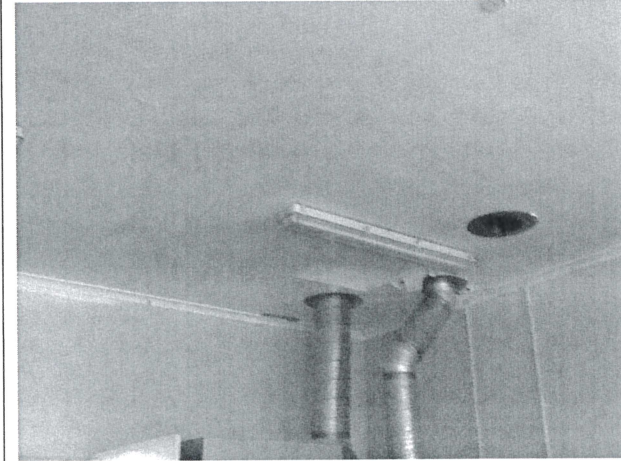
Photo No: J145125-BCC001-Photo032  
Result: Asbestos - Previously Sampled Positive  
Building/Level: 013 Kitchen/Dining/Activities-Ground Level  
Room/Location: Laundry-Throughout  
Feature/Material: Ceiling-Fibre Cement Sheetting

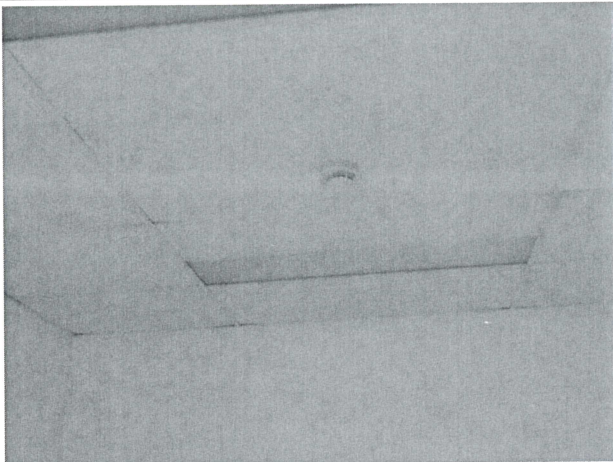
Photo No: J145125-BCC001-Photo031  
Result: Asbestos - Previously Sampled Positive  
Building/Level: 013 Kitchen/Dining/Activities-Ground Level  
Room/Location: Psychiatrist Office-Throughout  
Feature/Material: Ceiling-Fibre Cement Sheetting

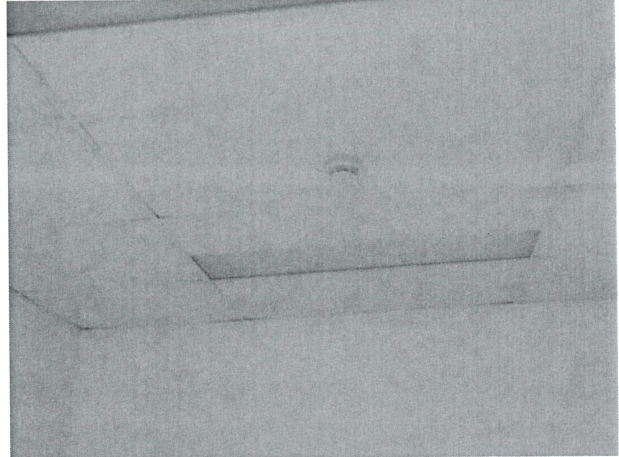
Photo No: J145125-BCC001-Photo034  
Result: SMF - Positive  
Building/Level: 013 Kitchen/Dining/Activities-Ground Level  
Room/Location: Psychiatrist Office-Throughout  
Feature/Material: Ceiling Tiles-Compressed Ceiling Tiles

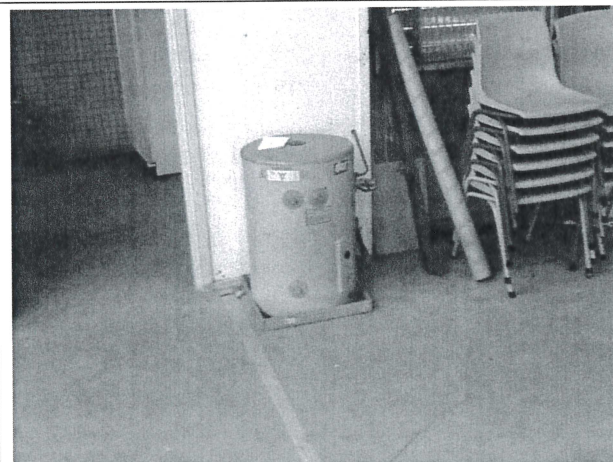
Photo No: J145125-BCC001-Photo040  
Result: SMF - Presumed Positive  
Building/Level: 016 Industries Building-Ground Level  
Room/Location: Main Workshop-West  
Feature/Material: Hot Water Heater-Insulation Material

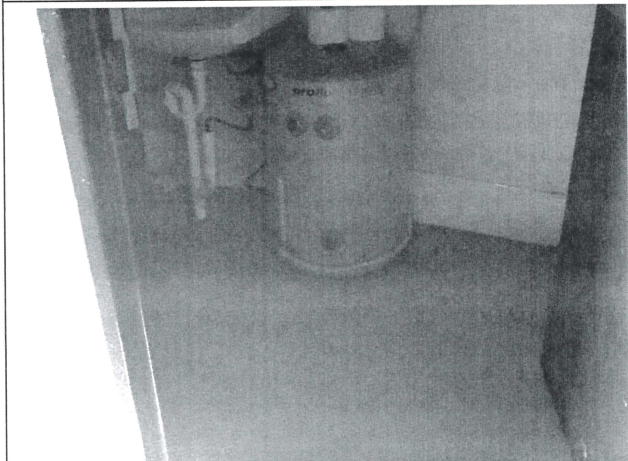
Photo No: J145125-BCC001-Photo038  
Result: SMF - Presumed Positive  
Building/Level: 016 Industries Building-Ground Level  
Room/Location: Officers Toilet-Throughout  
Feature/Material: Hot Water Heater-Insulation Material

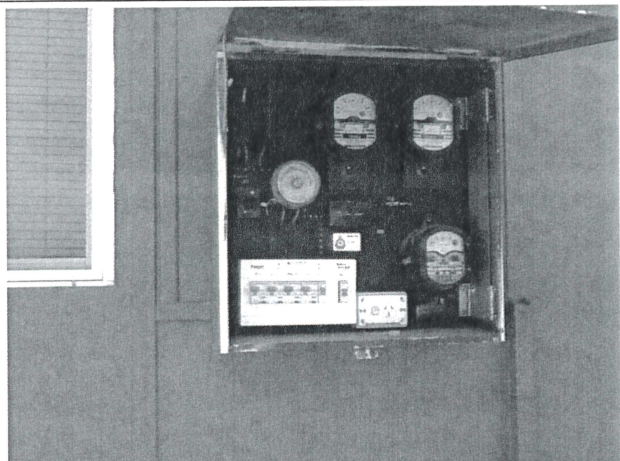
Photo No: J145125-BCC001-Photo084  
Result: Asbestos - Previously Sampled Positive  
Building/Level: 017 Officers Amenities Building-Ground Level  
Room/Location: House-East Side  
Feature/Material: Electrical Distribution Board-Compressed Bituminous Electrical Panel

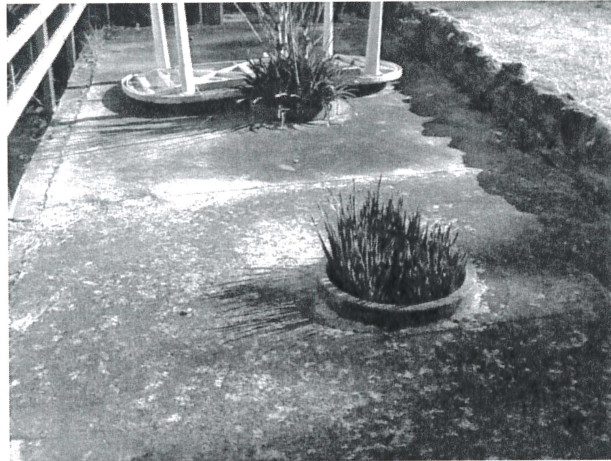
Photo No: J145125-BCC001-Photo085  
Result: Asbestos - Previously Sampled Positive  
Building/Level: 017 Officers Amenities Building-Ground Level  
Room/Location: House-North Garden  
Feature/Material: Pit-Moulded Fibre Cement

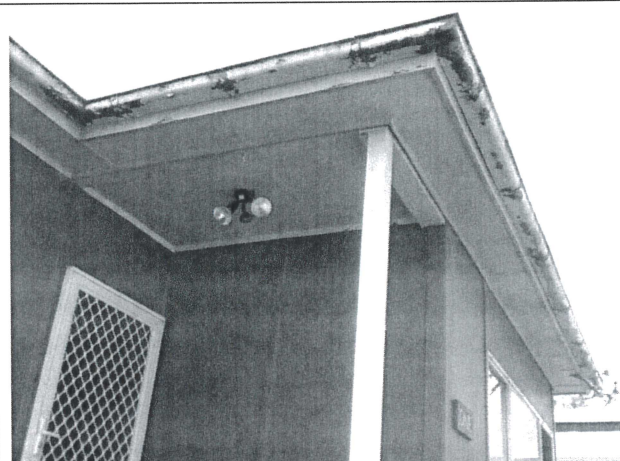
Photo No: J145125-BCC001-Photo083  
Result: Asbestos - Previously Sampled Positive  
Building/Level: 017 Officers Amenities Building-Ground Level  
Room/Location: House-Surrounding  
Feature/Material: Eaves-Fibre Cement Sheetting

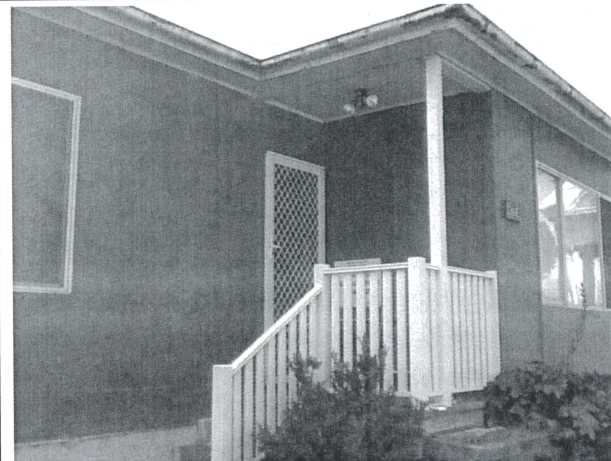
Photo No: J145125-BCC001-Photo086  
Result: Asbestos - Previously Sampled Positive  
Building/Level: 017 Officers Amenities Building-Ground Level  
Room/Location: House-Surrounding  
Feature/Material: Wall Cladding-Fibre Cement Sheetting

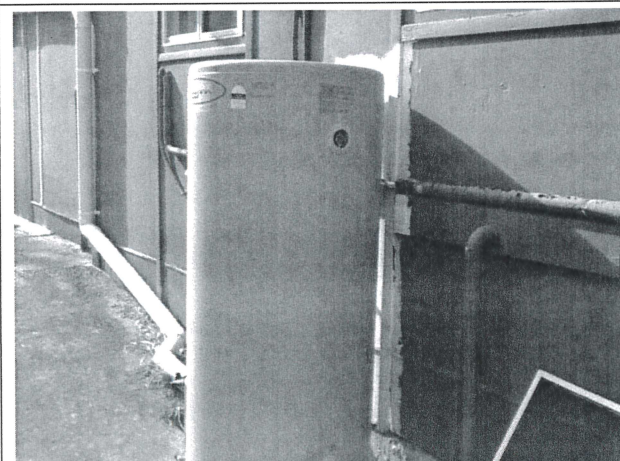
Photo No: J145125-BCC001-Photo087  
Result: SMF - Presumed Positive  
Building/Level: 017 Officers Amenities Building-Ground Level  
Room/Location: House-Western Side  
Feature/Material: Hot Water Heater-Insulation Material

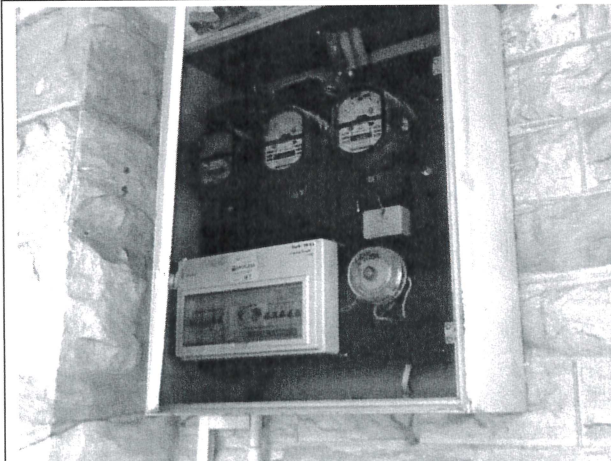
Photo No: J145125-BCC001-Photo073  
Result: Asbestos - Previously Sampled Positive  
Building/Level: 018 Oberon House-Ground Level  
Room/Location: Electrical Cupboard-  
Feature/Material: Electrical Distribution Board-Compressed Bituminous Electrical Panel

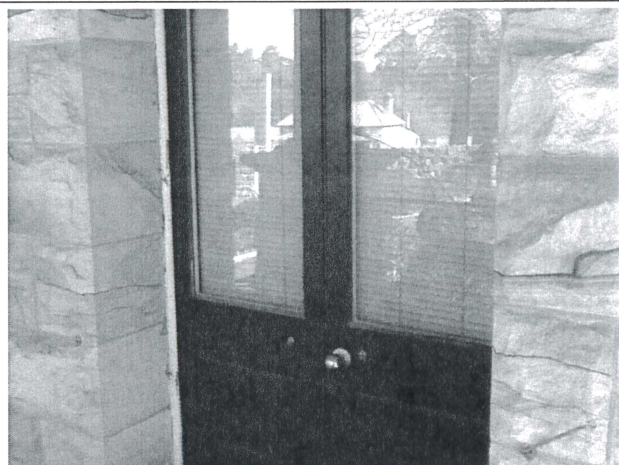
Photo No: J145125-BCC001-Photo070  
Result: Lead (Paint) - Previously Sampled Positive  
Building/Level: 018 Oberon House-Ground Level  
Room/Location: Throughout-Doors  
Feature/Material: Door & Frame-Lower Paint System/s

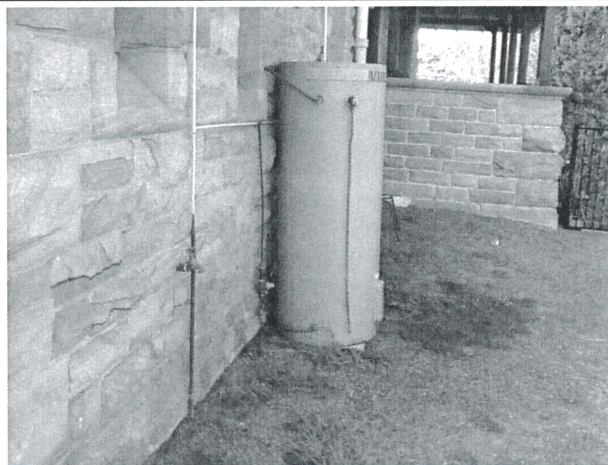
Photo No: J145125-BCC001-Photo074  
Result: SMF - Presumed Positive  
Building/Level: 018 Oberon House-Level One  
Room/Location: West Side-  
Feature/Material: Hot Water Heater-Insulation Material

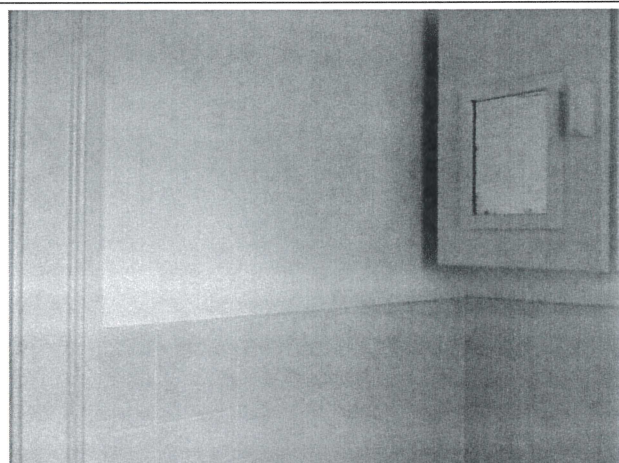
Photo No: J145125-BCC001-Photo071  
Result: Asbestos - Previously Sampled Positive  
Building/Level: 018 Oberon House-Level One  
Room/Location: Bathroom-Bath surrounding  
Feature/Material: Wall Covering-Fibre Cement Sheetting

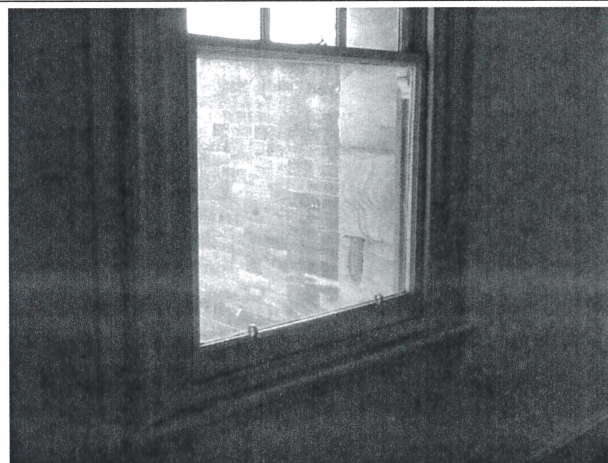
Photo No: J145125-BCC001-Photo072  
Result: Lead (Paint) - Previously Sampled Positive  
Building/Level: 018 Oberon House-Level One  
Room/Location: Throughout-Windows  
Feature/Material: Window Frame-Lower Paint System/s

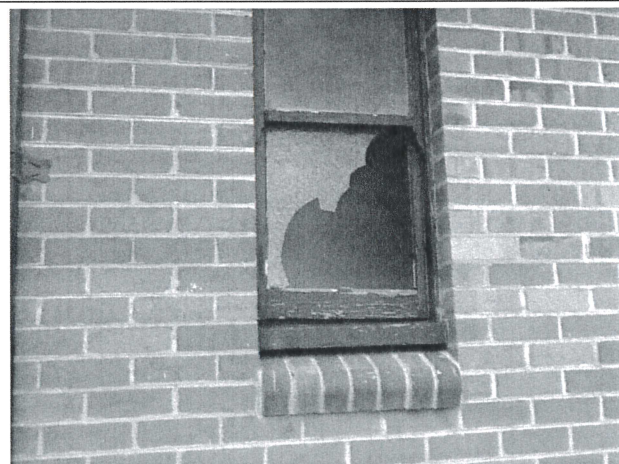
Photo No: J145125-BCC001-Photo075  
Result: Lead (Paint) - Previously Sampled Positive  
Building/Level: 019 Dangerous Goods Store-Ground Level  
Room/Location: Exterior-Windows  
Feature/Material: Window Frame-Lower Paint System/s

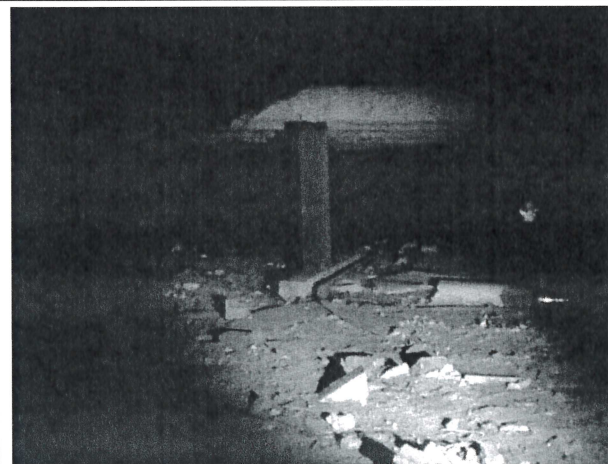
Photo No: J145125-BCC001-Photo076  
Result: Lead (Dust) - Previously Sampled Positive  
Building/Level: 019 Dangerous Goods Store-Ground Level  
Room/Location: Ceiling Space-Throughout  
Feature/Material: On Top of Ceiling-Dust - Lead

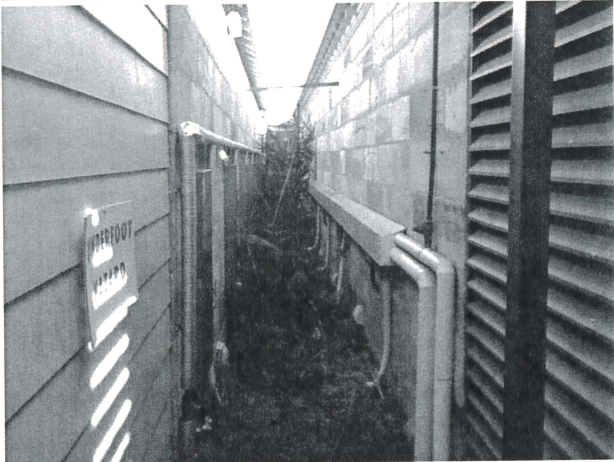
Photo No: J145125-BCC001-Photo043  
Result: SMF - Positive  
Building/Level: 031 Diesel Generator Room-Ground Level  
Room/Location: Service Corridor adj. Diesel Room-Throughout  
Feature/Material: Pipework Insulation-Insulation Material

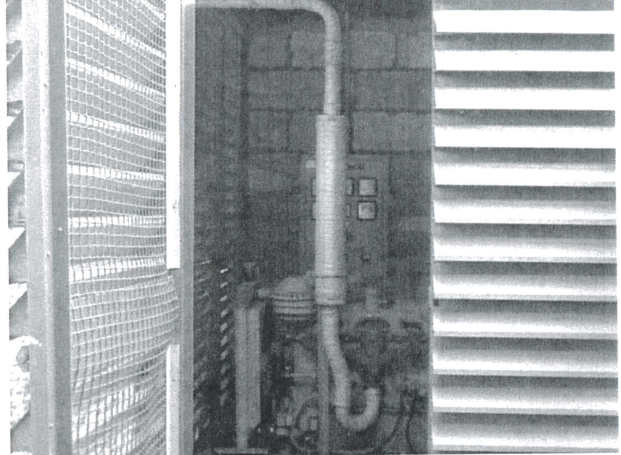
Photo No: J145125-BCC001-Photo041  
Result: Asbestos - Previously Sampled Positive  
Building/Level: 031 Diesel Generator Room-Ground Level  
Room/Location: Diesel Room-Exhaust Pipe  
Feature/Material: Pipework Insulation-Woven Rope

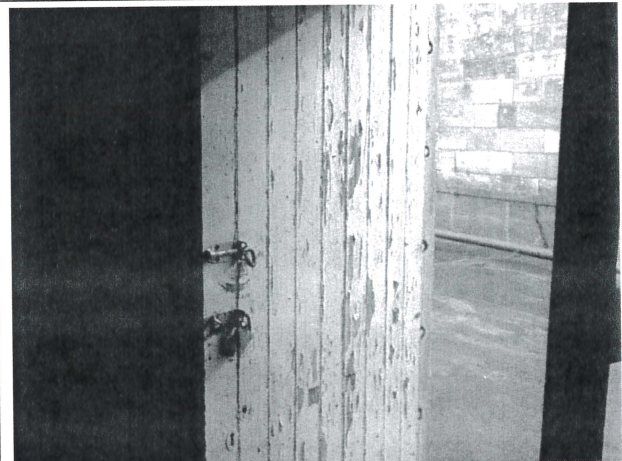
Photo No: J145125-BCC001-Photo057  
Result: Lead (Paint) - Positive  
Building/Level: 032 Store-Ground Level  
Room/Location: Entry Door-  
Feature/Material: Door & Frame-Upper & Lower Paint System/s

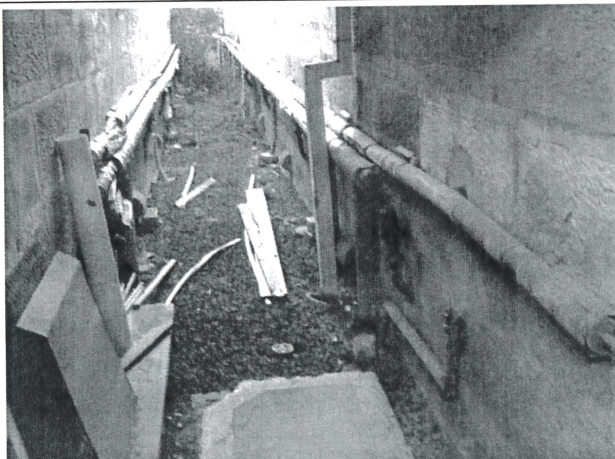
Photo No: J145125-BCC001-Photo050  
Result: SMF - Positive  
Building/Level: 033 Maintenance/Teach/Welfare/P&P etc-Ground Level  
Room/Location: Maintenance-Northern Service Corridor  
Feature/Material: Pipework Insulation-Insulation Material

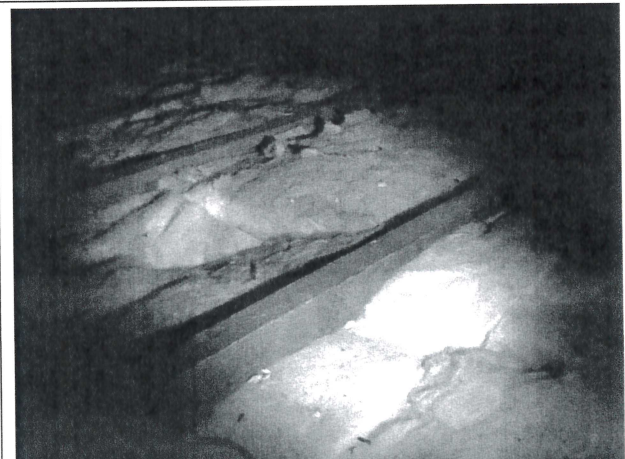
Photo No: J145125-BCC001-Photo052  
Result: SMF - Positive  
Building/Level: 033 Maintenance/Teach/Welfare/P&P etc-Ground Level  
Room/Location: Maintenance-Ceiling Space  
Feature/Material: Insulation-Insulation Batt/s

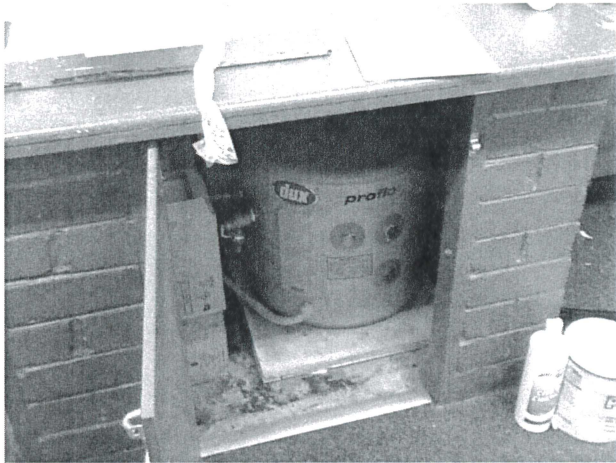
Photo No: J145125-BCC001-Photo051  
Result: SMF - Presumed Positive  
Building/Level: 033 Maintenance/Teach/Welfare/P&P etc-Ground Level  
Room/Location: Maintenance-Office  
Feature/Material: Hot Water Heater-Insulation Material

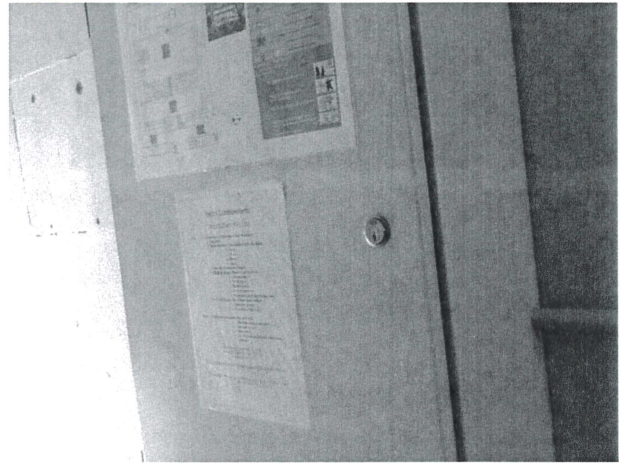
Photo No: J145125-BCC001-Photo056  
Result: Asbestos - Presumed Positive  
Building/Level: 033 Maintenance/Teach/Welfare/P&P etc-Ground Level  
Room/Location: Teachers Room-Office  
Feature/Material: Electrical Distribution Board-Compressed Bituminous Electrical Panel

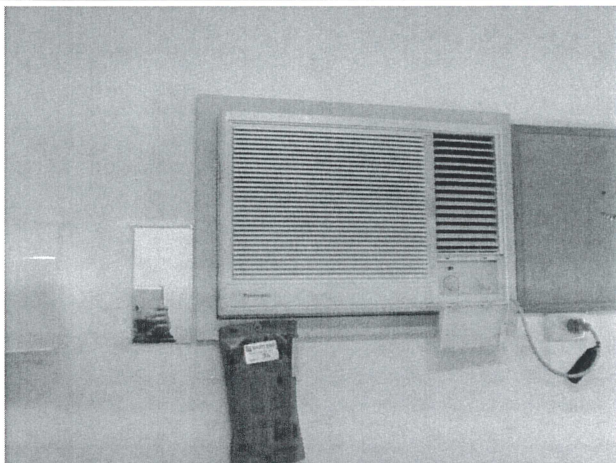
Photo No: J145125-BCC001-Photo063  
Result: ODS - Presumed Positive  
Building/Level: 036 Recept/Roster/Segro-Ground Level  
Room/Location: Exterior-North  
Feature/Material: A/C Unit-R22 - Chlorodifluoromethane

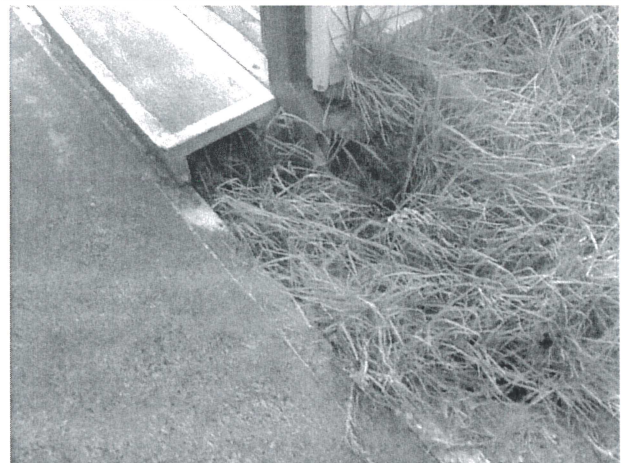
Photo No: J145125-BCC001-Photo065  
Result: Asbestos - Previously Sampled Positive  
Building/Level: 036 Recept/Roster/Segro-Ground Level  
Room/Location: In Ground-Drainage Pipe  
Feature/Material: Pipe-Moulded Fibre Cement

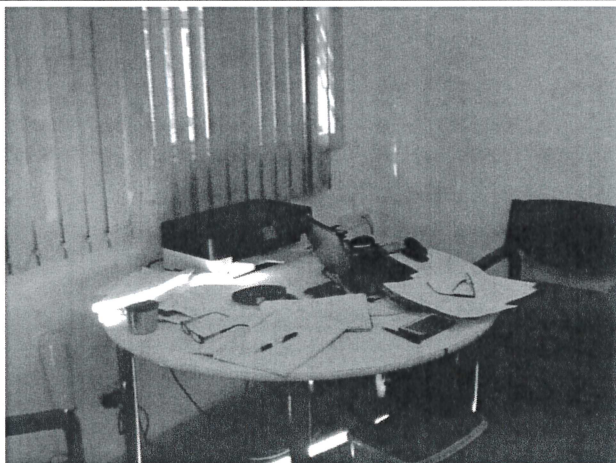
Photo No: J145125-BCC001-Photo064  
Result: SMF - Positive  
Building/Level: 036 Recept/Roster/Segro-Ground Level  
Room/Location: Reception-Wall Cavity  
Feature/Material: Insulation-Insulation Batts

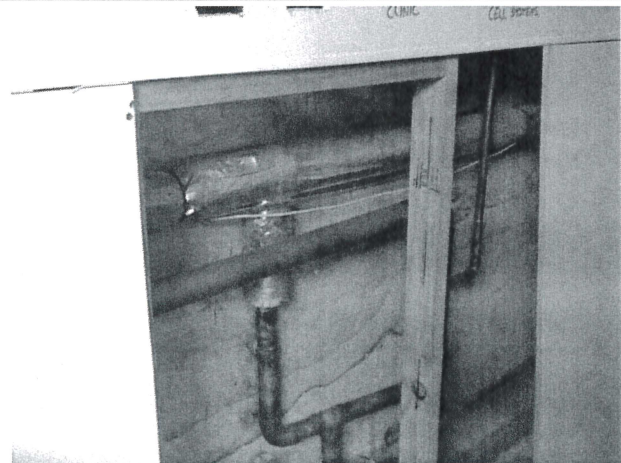
Photo No: J145125-BCC001-Photo062  
Result: SMF - Positive  
Building/Level: 036 Recept/Roster/Segro-Ground Level  
Room/Location: Reception-Wall Cavity  
Feature/Material: Pipework Insulation-Insulation Material
