## JONES LANG LASALLE

# HAZARDOUS MATERIALS REINSPECTION 155 GEORGE STREET, SYDNEY, NSW 2000

**REFERENCE No. S6184**

**APRIL 2010**

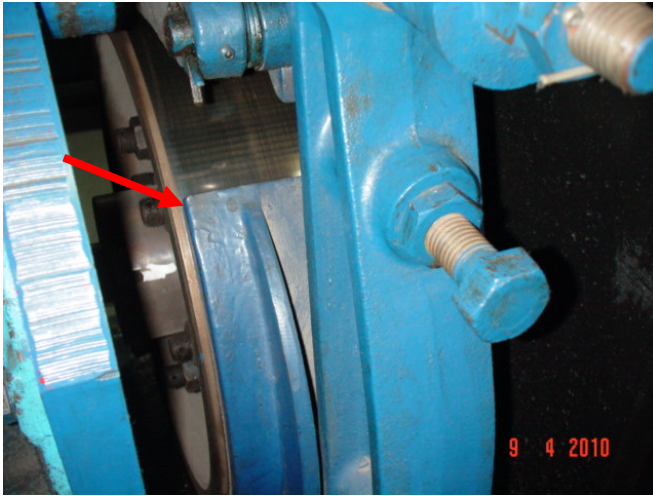
**Photograph 1**

- vi) Lift Motor Room - The friction material lining the brake shoes on the lift motors may contain asbestos. It was not possible to examine or sample this material due to the inherent mechanical hazard and the inaccessibility of the brakes. No remedial action is required at this stage. Refer to Photograph 1 in Appendix 3.

Lift Motor Room

Arrow points to the lift motor brake shoe that is covered by a metal pad (not visible in the photograph). The lift brake shoes may contain asbestos.

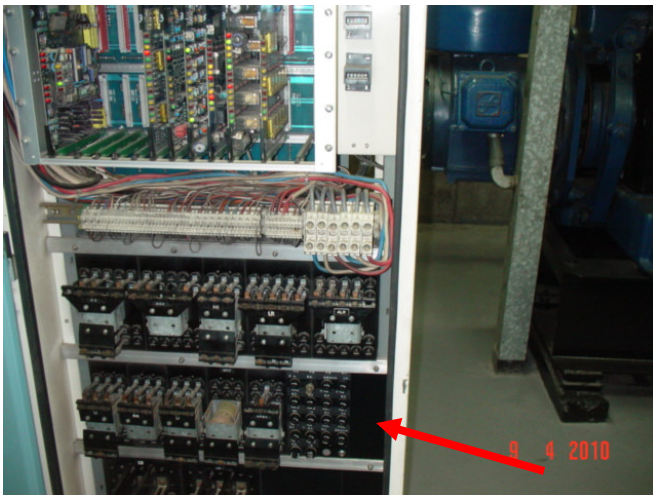
**Photograph 2**

Lift Motor Room

Arrow points to black backing board in lift control cabinet that may contain asbestos.

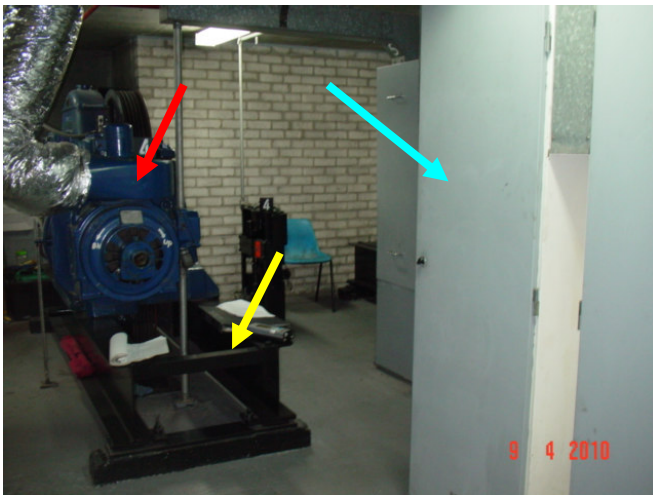
**Photograph 3**

Lift Motor Room

Yellow arrow points to black paint system that contains lead.

Note foil covered flexible duct, likely SMF insulated.

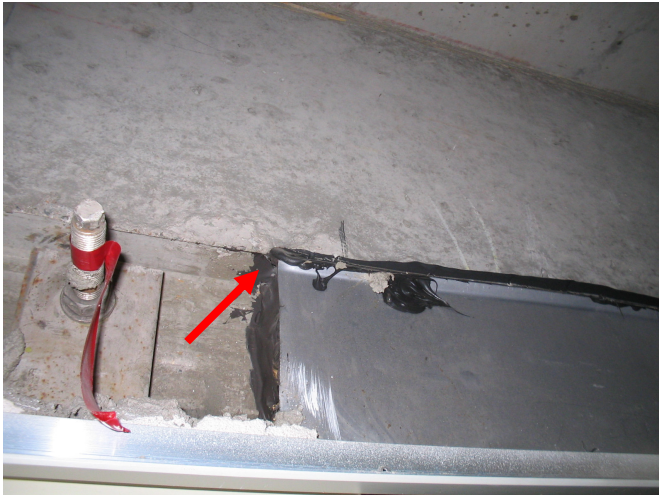
**Photograph 4**

<sup>1</sup> Hazardous Materials Survey Report, ERMA May 2006 (Refer to Sample P21, Table 1 of 2 in Appendix 1 and Photograph 4 in Appendix 3)

Levels 6 – South west ceiling cavity along the south perimeter wall

Arrow points to the gap underneath the black material and the metal sheeting. The insulation material located in the gap does not contain asbestos (Hazardous Materials Survey Report, ERMA May 2006).

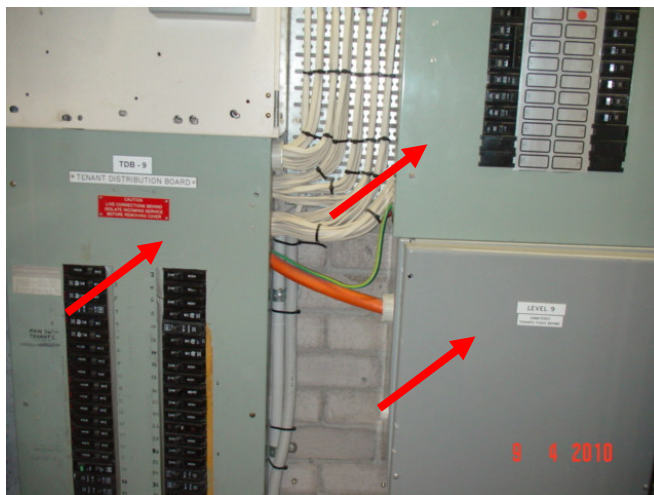
**Photograph 5**

Level 9 – Electrical Cupboard

Arrows point to metal cabinets that may house asbestos containing backing boards.

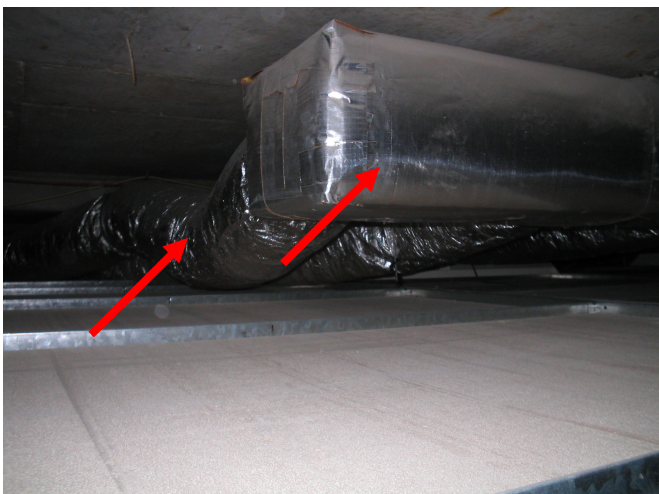
**Photograph 6**

- ii) Ceiling Cavity (South West), Level 6 – The air conditioning ducts are insulated with SMF underneath the foil. Refer to Photograph 6 in Appendix 3.

Levels 6 – Ceiling Cavity (South West)

Arrows point to rigid and flexible air conditioning ducts insulated with SMF and covered in foil.

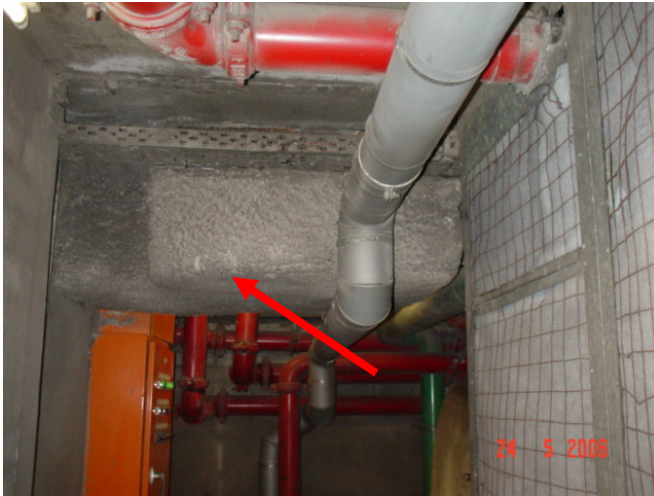
**Photograph 7**

Car Park Level B1 (SE) - Car Park Supply Air Fan Room

Arrow points to SMF insulated duct.

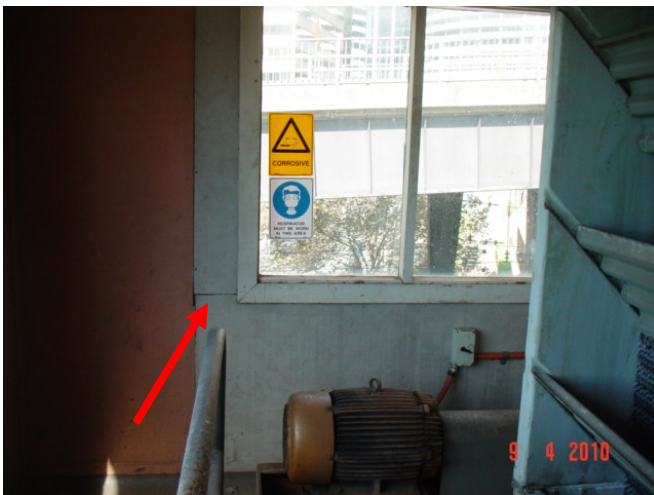
**Photograph 8**

<sup>3</sup> Hazardous Materials Survey Report, ERMA August 2004 (Refer to Sample 155G/1 -Table 2 of 2 in Appendix 1 and Photograph 8 in Appendix 3).

Terraces, Roof Level - Cooling Tower Room

Arrow points to fibre cement wall sheeting that does not contain asbestos (Hazardous Materials Survey Report, ERMA August 2004).

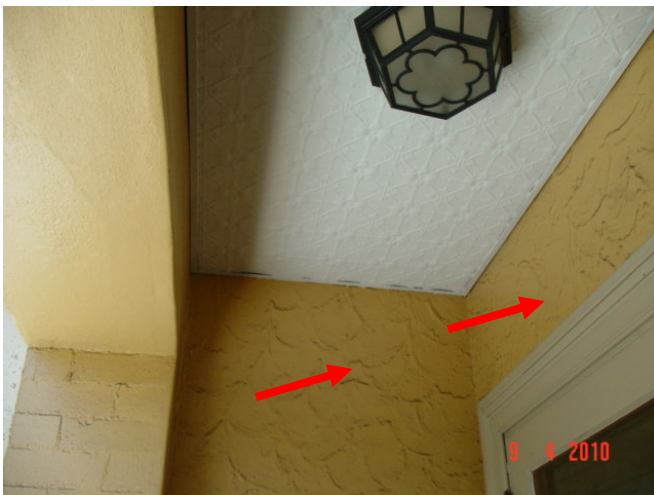
**Photograph 9**

<sup>4</sup> Hazardous Materials Survey Report, ERMA August 2004 (Refer to Sample 155G/2 -Table 2 of 2 in Appendix 1 and Photograph 9 in Appendix 3)

Terraces, Balcony (George Street) - Level between Ground and Level 1

Arrows point to fibre cement wall panels that did not contain asbestos (Hazardous Materials Survey Report, ERMA August 2004).

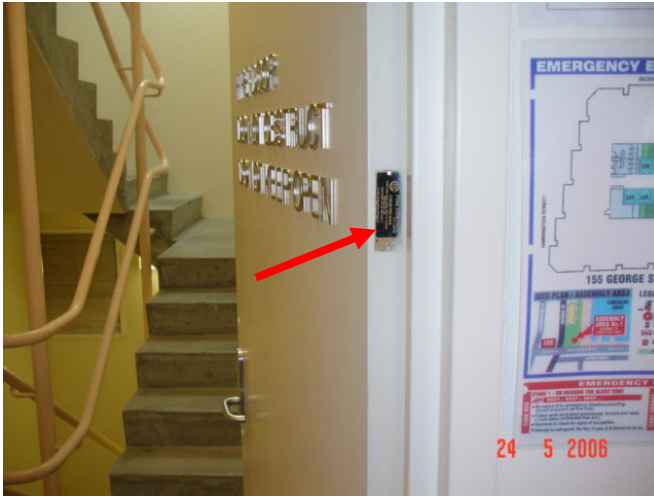
**Photograph 10**

Level 9 - Fire Stairs North

Arrow points to 'Fire Control' fire door.

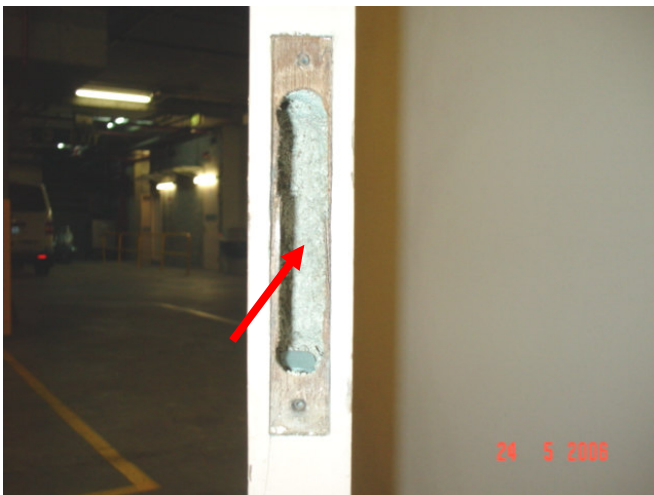
**Photograph 11**

Lower Ground - Fire Stairs South

Arrow points to core of 'Masterbilt Industries' fire door.

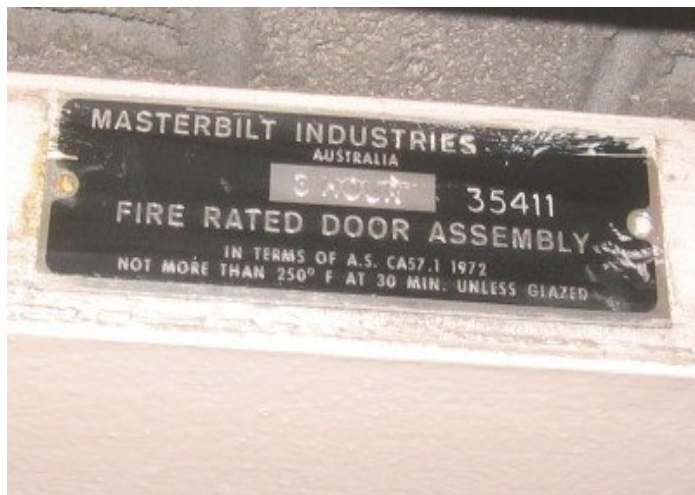
**Photograph 12**

Older type of 'Masterbilt Industries' fire door with no installed or manufacturing date on the compliance label.
