Asbestos Materials Survey

Prepared for:	Catholic Schools Broken Bay
Prepared by:	Alex Tam Senior Occupational Hygienist Trinitas Group
Site	St Peter's Catholic College, Tuggerah
Address:	84 Gavenlock Road, Tuggerah NSW 2259
Date:	Tuesday, 20 June 2023

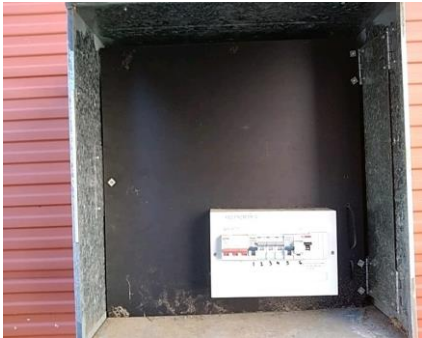
Photo No: 230620-095900
Result: Asbestos - Presumed Positive
Location-Level: Exterior - Ground Floor
Room-Location: Western elevation of the building - electrical distribution board
Feature-Material: Bituminous-like material
Item No - Risk Rating: 4 - Low

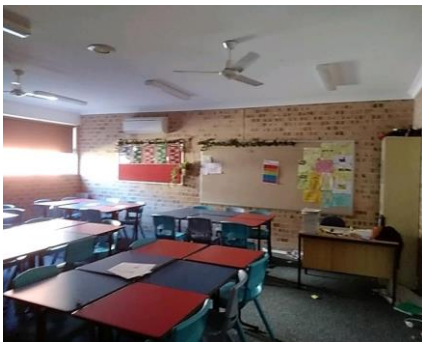
Photo No: 230620-100809
Result: Asbestos - Presumed Positive
Location-Level: Interior - Ground Floor
Room-Location: All elevation of the floor: classrooms - internal walls
Feature-Material: Brick
Item No - Risk Rating: 1 - Low

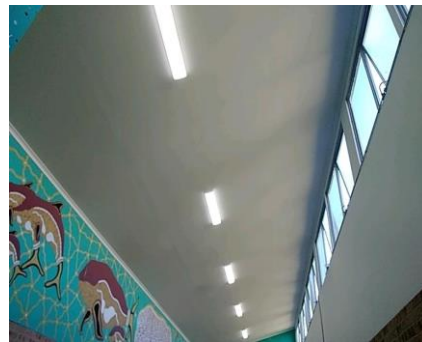
Photo No: 230620-100947
Result: Asbestos - Presumed Positive
Location-Level: Interior - 1st Floor
Room-Location: All elevation of the floor - ceilings
Feature-Material: Plaster-like material
Item No - Risk Rating: 3 - Low

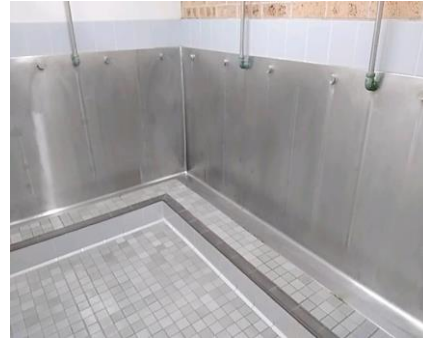
Photo No: 230620-113804
Result: Asbestos - Presumed Positive
Location-Level: Interior - Ground Floor
Room-Location: Male toilet - urinal
Feature-Material: Internal insulation
Item No - Risk Rating: 5 - Low

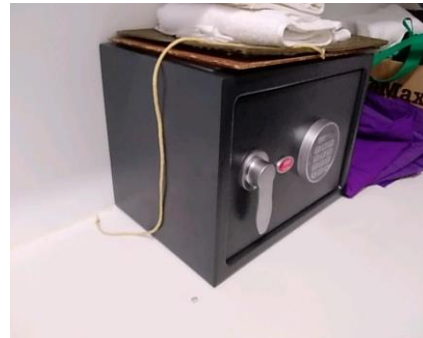
Photo No: 230621-093922
Result: Asbestos - Presumed Positive
Location-Level: Interior - 1st Floor
Room-Location: Scarcity - safe
Feature-Material: Internal insulation
Item No - Risk Rating: 10 - Low

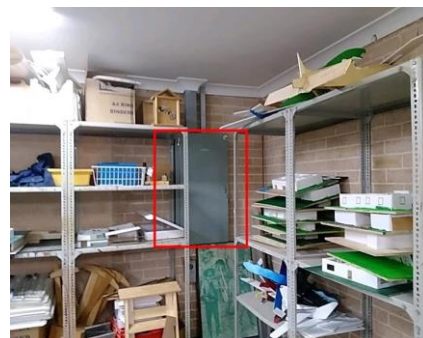
Photo No: 230621-100251
Result: Asbestos - Presumed Positive
Location-Level: Interior - Ground Floor
Room-Location: Electrical distribution cupboard
Feature-Material: Internal insulation
Item No - Risk Rating: 3 - Low

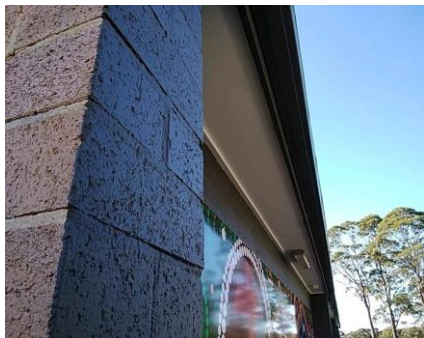
Photo No: 230621-103026
Result: Asbestos - Presumed Positive
Location-Level: Exterior - Ground Floor
Room-Location: All elevation of the building - eaves
Feature-Material: NA
Item No - Risk Rating: 5 - Low

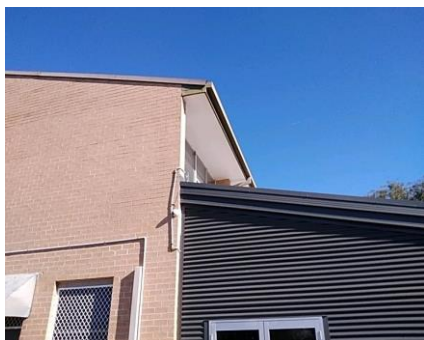
Photo No: 230621-102234
Result: Asbestos - Presumed Positive
Location-Level: Exterior - 1st Floor
Room-Location: All elevation of the building - eaves
Feature-Material: FC sheeting
Item No - Risk Rating: 12 - Low

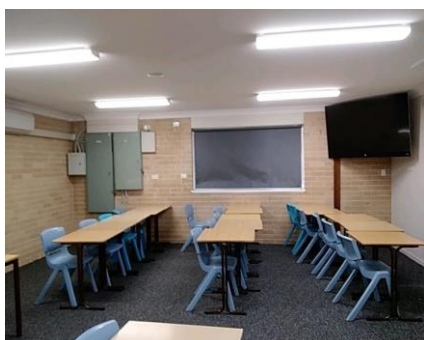
Photo No: 230621-103345
Result: Asbestos - Presumed Positive
Location-Level: Interior - Ground Floor
Room-Location: Electrical distribution cupboard
Feature-Material: Internal insulation
Item No - Risk Rating: 2 - Low

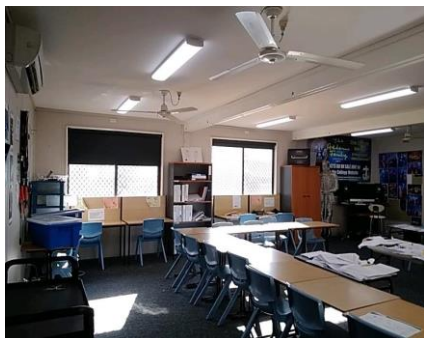
Photo No: 230620-095355
Result: Asbestos - Negative
Location-Level: Interior - Ground Floor
Room-Location: Classroom - internal walls
Feature-Material: Timber

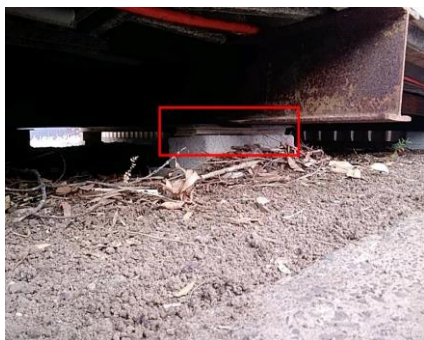
Photo No: 230620-095652
Result: Asbestos - Negative
Location-Level: Exterior - Sub-floor
Room-Location: All elevation of the floor - packer to support column
Feature-Material: FC sheeting

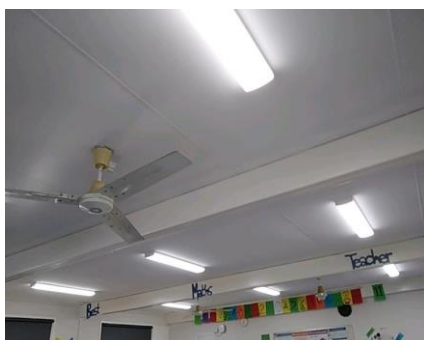
Photo No: 230620-100435
Result: Asbestos - Negative
Location-Level: Interior - Ground Floor
Room-Location: All elevation of the floor - ceilings
Feature-Material: Plaster-like material

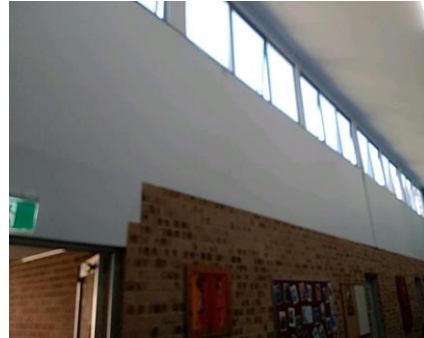
Photo No: 230620-102755
Result: Asbestos - Negative
Location-Level: Interior - 1st Floor
Room-Location: All elevation of the floor - infill panels to walls
Feature-Material: Plaster-like material

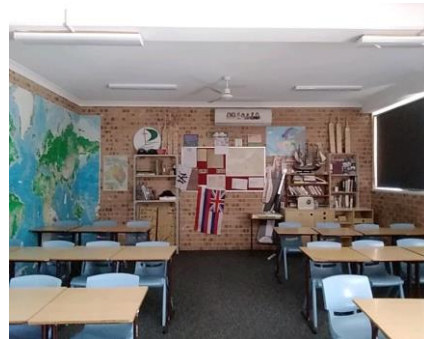
Photo No: 230620-103050
Result: Asbestos - Negative
Location-Level: Interior - Ground Floor
Room-Location: All elevation of the floor - internal walls
Feature-Material: Brick

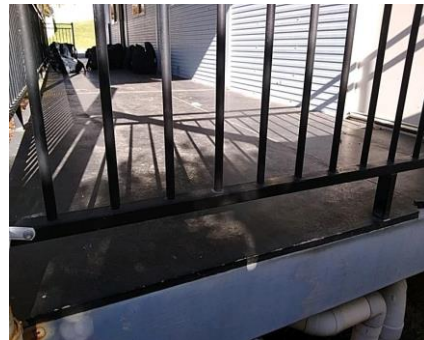
Photo No: 230620-103753
Result: Asbestos - Negative
Location-Level: Exterior - Ground Floor
Room-Location: Landing - flooring
Feature-Material: FC sheeting

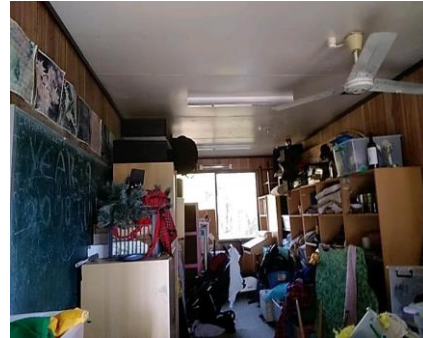
Photo No: 230620-111753
Result: Asbestos - Negative
Location-Level: Interior - Ground Floor
Room-Location: Storage room - internal walls and ceiling
Feature-Material: Timber

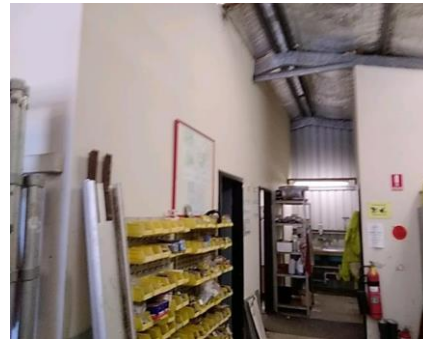
Photo No: 230620-104750
Result: Asbestos - Negative
Location-Level: Interior - Ground Floor
Room-Location: All elevation of the floor - division walls
Feature-Material: Plaster-like material

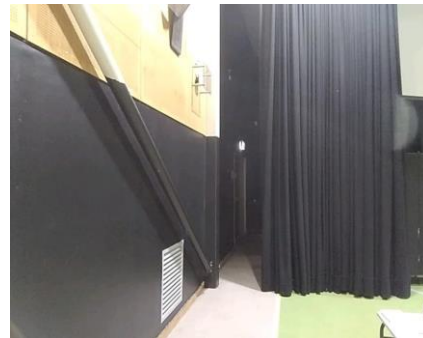
Photo No: 230620-105529
Result: Asbestos - Negative
Location-Level: Interior - Ground Floor
Room-Location: Hall - internal walls
Feature-Material: FC sheeting

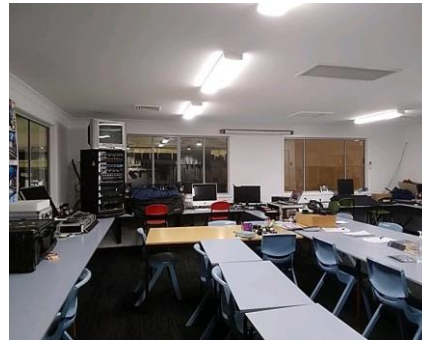
Photo No: 230620-110138
Result: Asbestos - Negative
Location-Level: Interior - 1st Floor
Room-Location: All elevation of the floor - internal walls and ceiling
Feature-Material: Plaster-like material

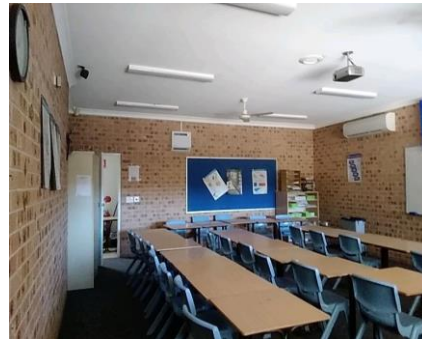
Photo No: 230620-110409
Result: Asbestos - Negative
Location-Level: Interior - Ground Floor
Room-Location: All elevation of the floor: classrooms - internal walls
Feature-Material: Brick

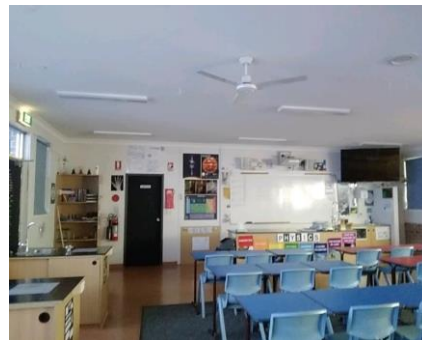
Photo No: 230620-110808
Result: Asbestos - Negative
Location-Level: Interior - Ground Floor
Room-Location: Walls
Feature-Material: Plaster material

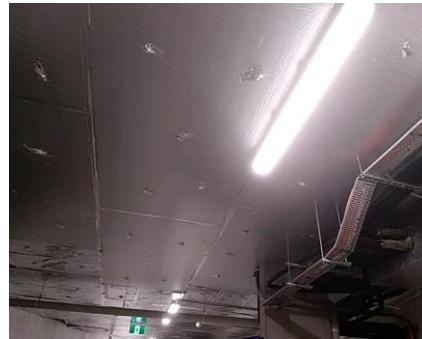
Photo No: 230620-112447
Result: Asbestos - Negative
Location-Level: Interior - Ground Floor
Room-Location: Storage area - ceilings
Feature-Material: Concrete

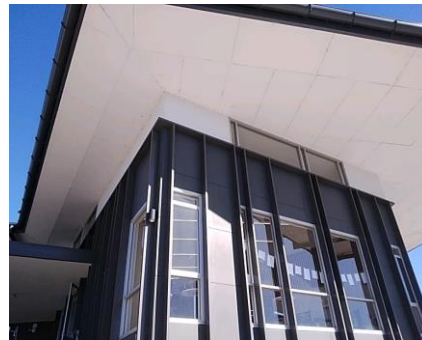
Photo No: 230620-112721
Result: Asbestos - Negative
Location-Level: Interior - Roof
Room-Location: All elevation of 1st and roof - eaves
Feature-Material: FC sheeting

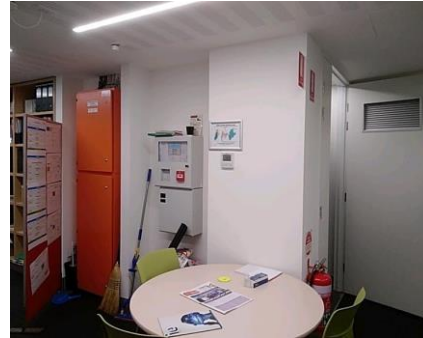
Photo No: 230620-113155
Result: Asbestos - Negative
Location-Level: Interior - 1st Floor
Room-Location: All elevation of the floor - division walls and walls
Feature-Material: Plaster-like material

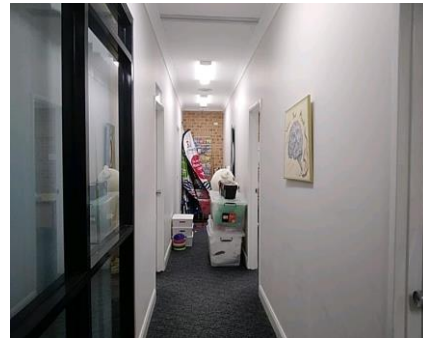
Photo No: 230620-113538
Result: Asbestos - Negative
Location-Level: Interior - Ground Floor
Room-Location: All elevation of the floor - division walls
Feature-Material: Plaster-like material

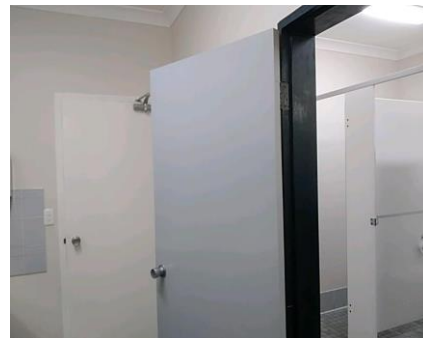
Photo No: 230620-114124
Result: Asbestos - Negative
Location-Level: Interior - Ground Floor
Room-Location: Staff male toilet - internal walls
Feature-Material: FC sheeting

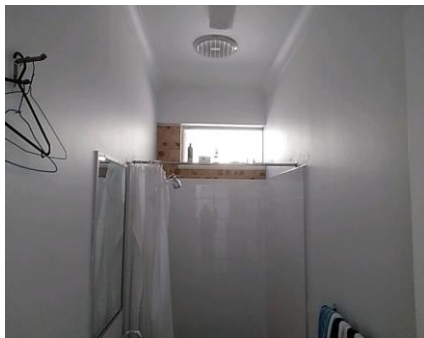
Photo No: 230620-114225
Result: Asbestos - Presumed Negative
Location-Level: Interior - Ground Floor
Room-Location: Disabled toilet - internal walls
Feature-Material: FC sheeting

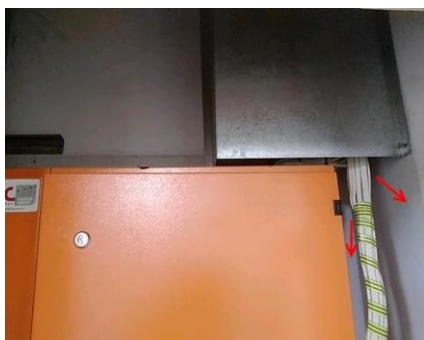
Photo No: 230620-114519
Result: Asbestos - Negative
Location-Level: Interior - Ground Floor
Room-Location: Electrical distribution cupboard - internal walls
Feature-Material: FC sheeting

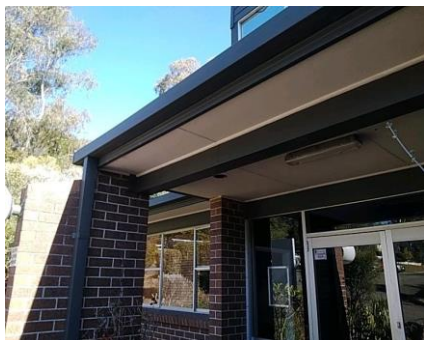
Photo No: 230620-115055
Result: Asbestos - Negative
Location-Level: Exterior - Ground Floor
Room-Location: All elevation of the building - eaves
Feature-Material: FC sheeting

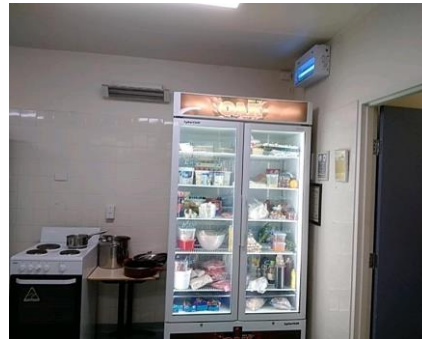
Photo No: 230620-120542
Result: Asbestos - Negative
Location-Level: Interior - Ground Floor
Room-Location: Canteen - internal walls
Feature-Material: Brick

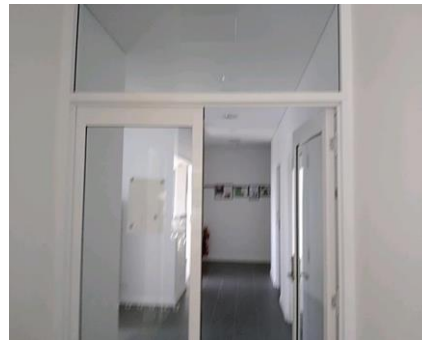
Photo No: 230620-121101
Result: Asbestos - Negative
Location-Level: Interior - 1st Floor
Room-Location: All elevation of the floor - division walls
Feature-Material: Plaster-like material
