Geotechnical Investigation Report

Proposed New K-12 School

**Eileen O'Connor School,
84 Gavenlock Road, Mardi NSW**

Report No. R23169. Rev2

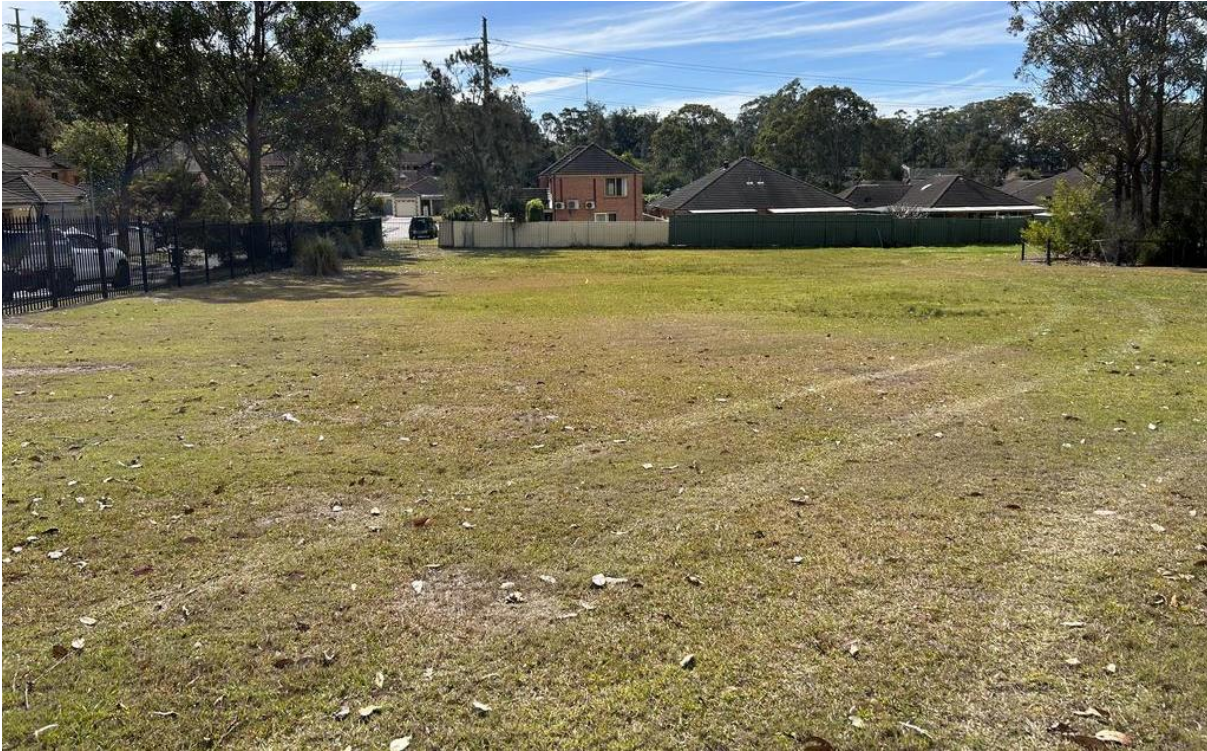
Photograph 1 – General site conditions, looking north

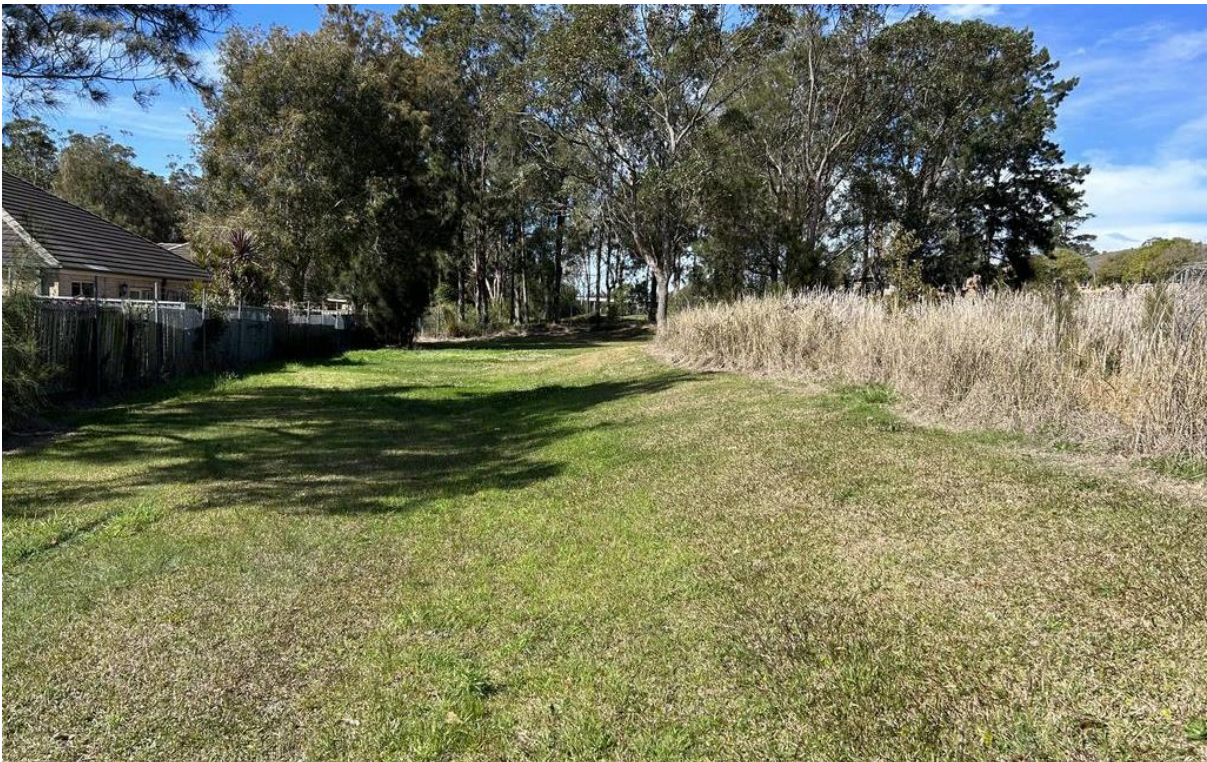
Photograph 2– Location of BH2 – looking east

Significant water seepage was observed at approximate depth of 2.8 m in BH2 at the northern portion of the existing dam. The subsurface material in BH1 and BH3 appeared dry to moist. However, the granular soils below a depth of 2.5 m in BH4 appeared moist to wet. The observed seepage may be attributed to the recent rainfall prior to the investigation or some leakage from the existing dam. It is noted that the groundwater level in granular soils may vary from time to time and depending on the climatic conditions.

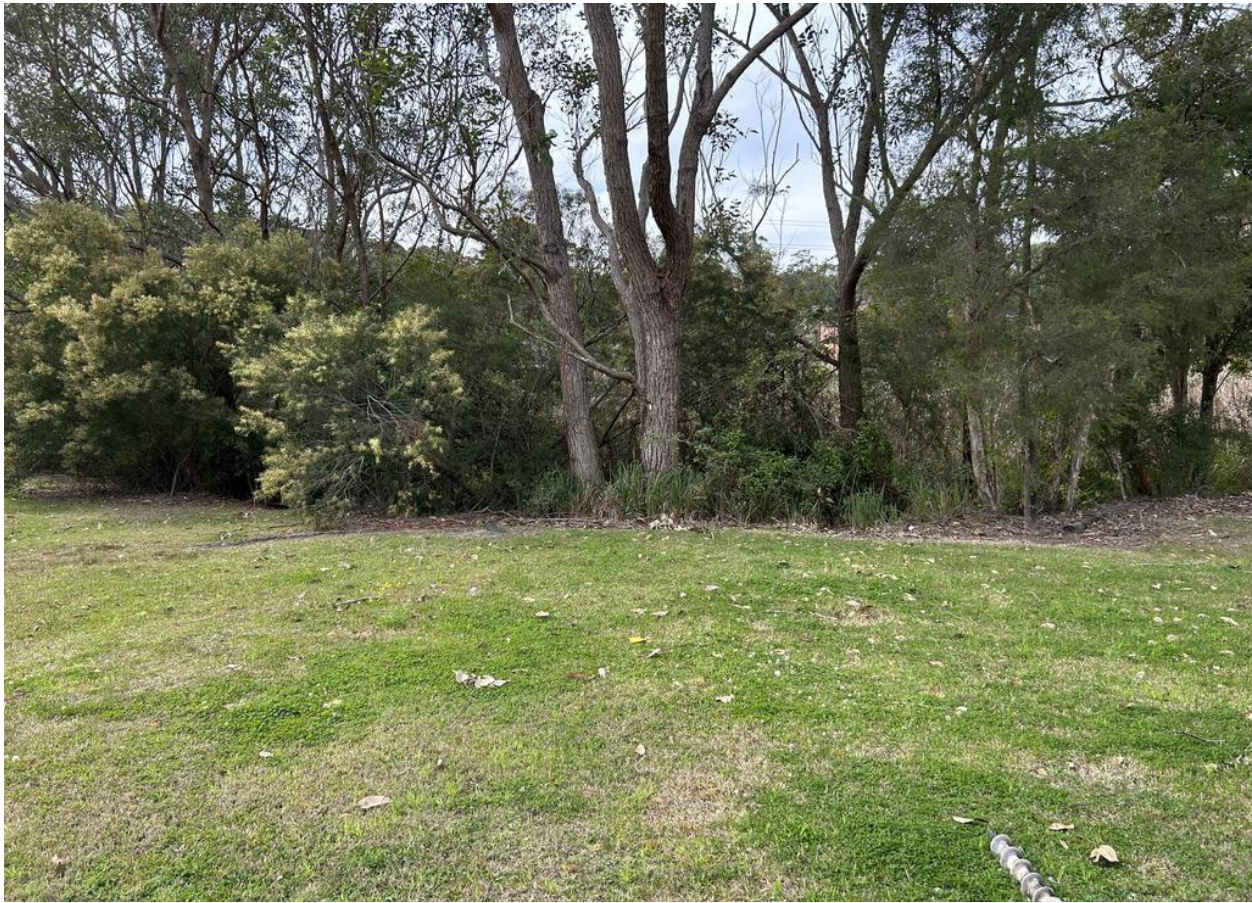
Photograph 3– A view of the existing dams and vegetation – looking north

Due to presence of existing dam and trees and a potential for abnormal moisture conditions, the site will be classified 'Class P' in accordance with AS2870 – 2011 '*Residential Slabs & Footings*'. Based on the subsurface material encountered and laboratory test result, a ground surface movement equivalent to 'Class M – Moderately Reactive' may be considered for the site in accordance with AS2870 – 2011 '*Residential Slabs & Footings*', provided the footings are extended into the natural soils or controlled fill material placed in a controlled manner.

Backfill material shall be placed under level 1 supervision as outlined in AS3798. Site won material may be used for backfilling the dam area. However, any organic materials/topsoils or saturated material from the dam shall be spread and dried out. These materials may be used for landscaping purposes after moisture conditioning.

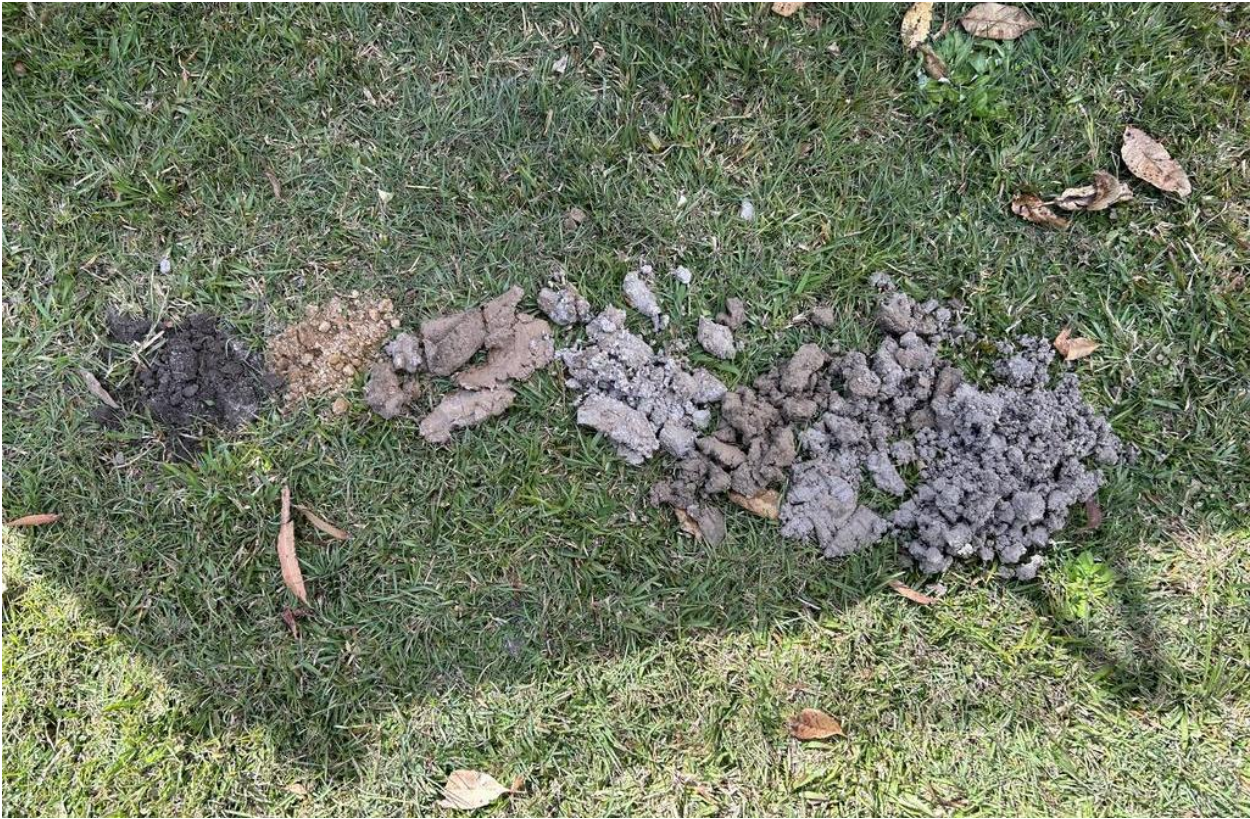
Samples of Subsurface Material - BH1

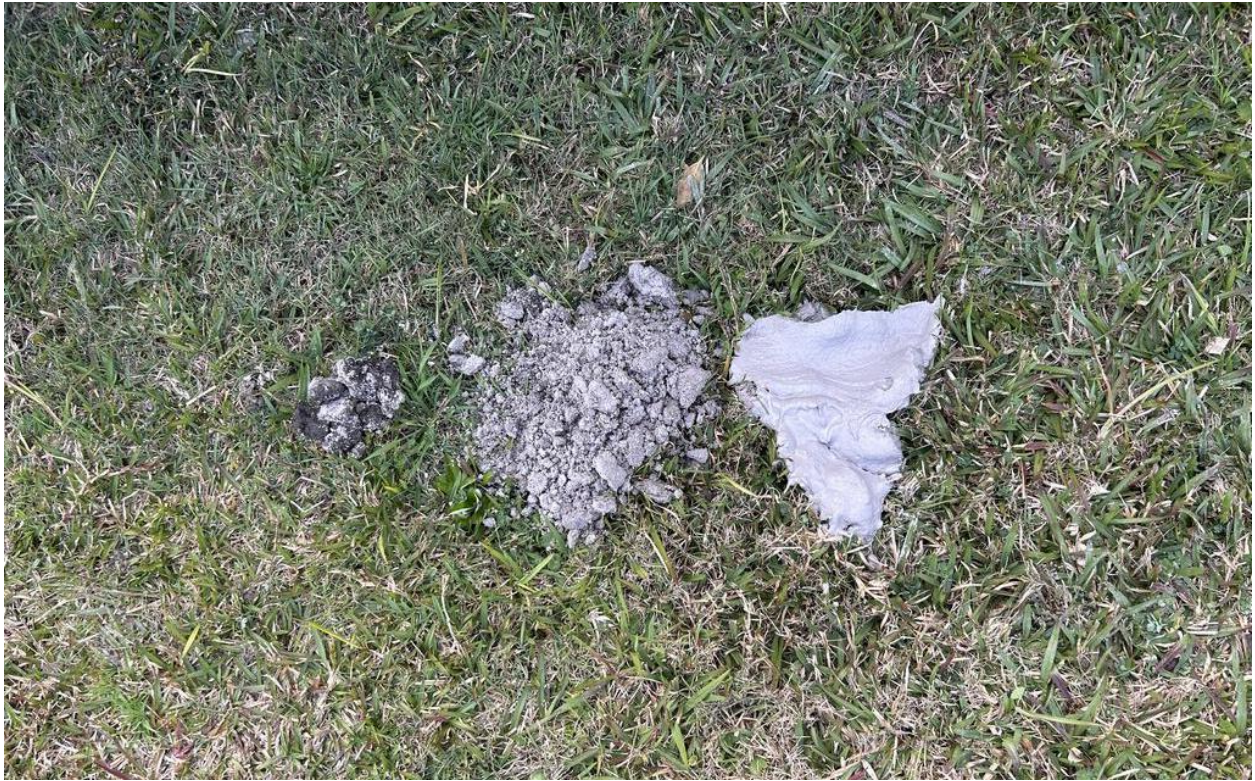
Water Observations: seepage below 2.8 m

Samples of Subsurface Material – BH2

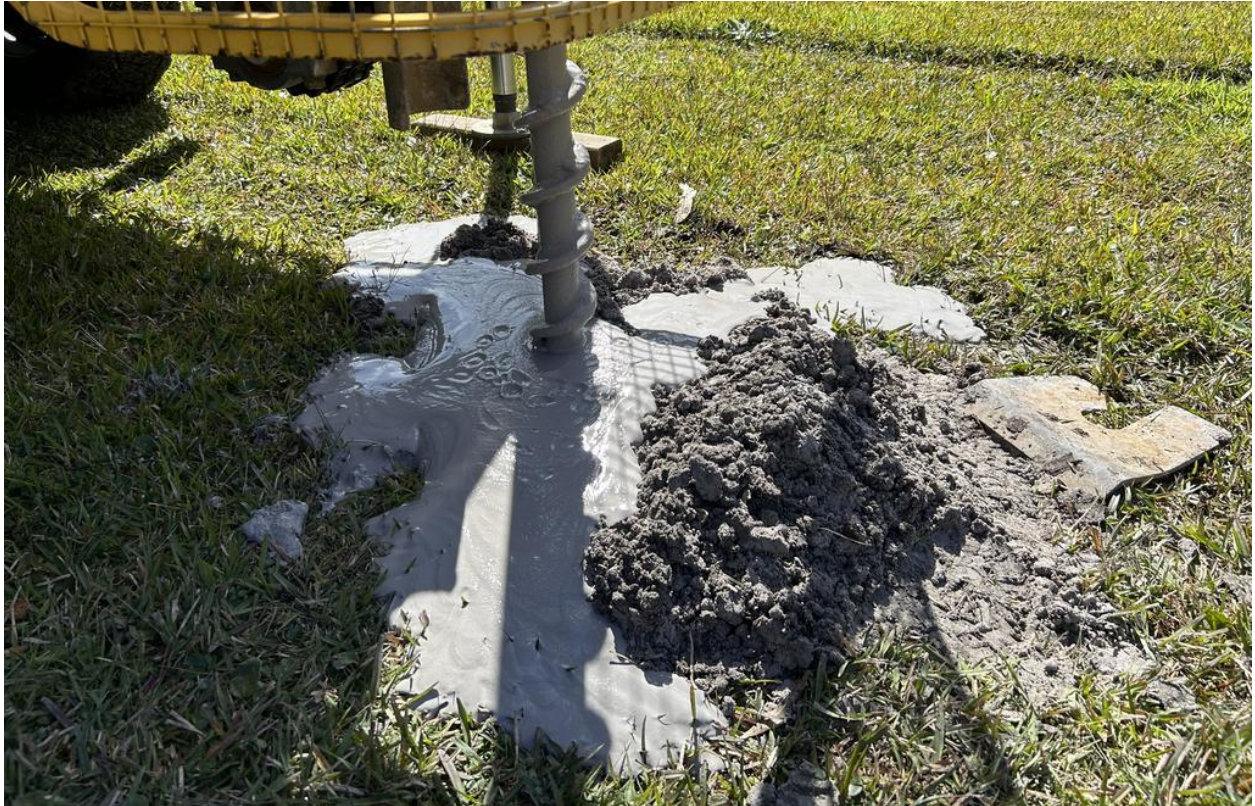
Seepage was encountered at approximate depth of 2.8 m in BH2 and may be encountered during the drilling of piles through the granular soils at the northern portion of the site. Due to presence of loose granular soils and potential for seepage in parts of the site, cast in-site bored piles may not be suitable option and consideration should be given to alternative piling techniques such as steel screw piles or continuous flight auger (CFA) piles.

Subsurface Material and seepage conditions– BH2

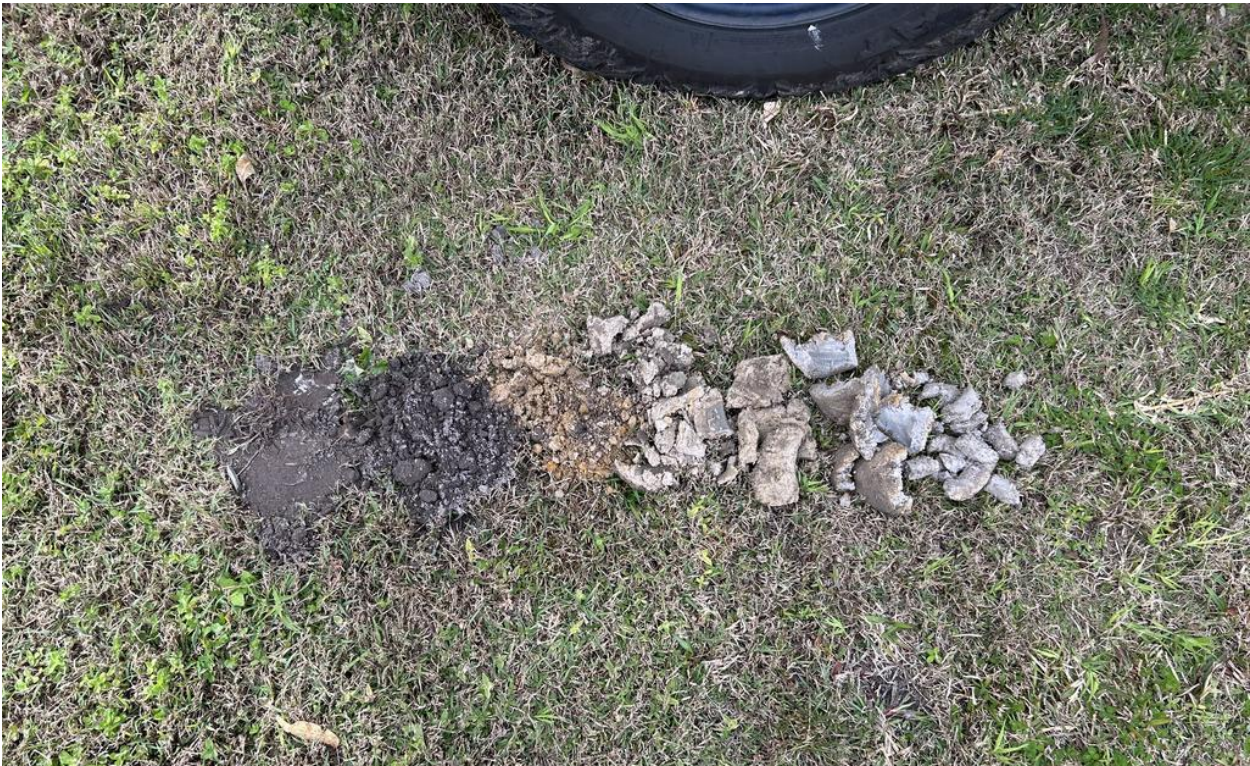
Samples of Subsurface Material – BH3

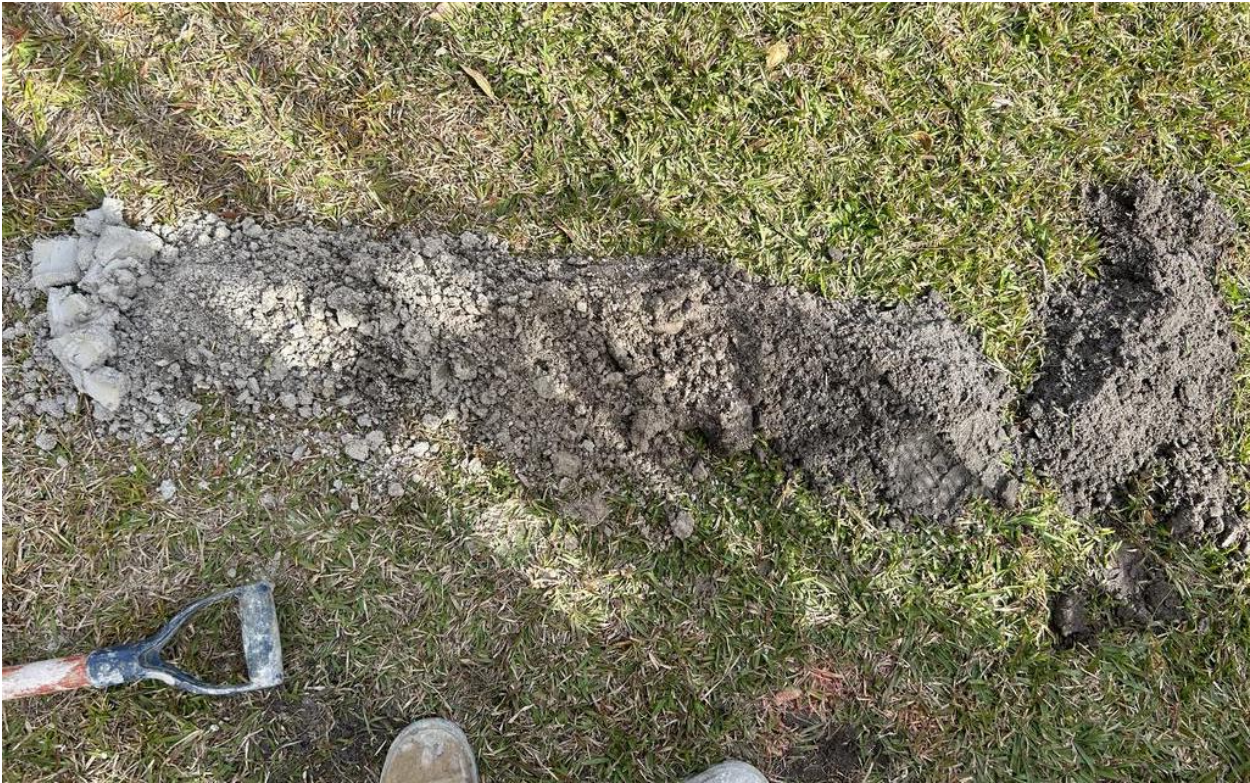
Water Observations: seepage below 2.2 m

Samples of Subsurface Material – BH4
