# LIMITED DESTRUCTIVE HAZARDOUS MATERIALS SURVEY REPORT

15-21 BRITTON ST SMITHFIELD

SENVERSA PTY LTD

| Job Number: | J02203 |

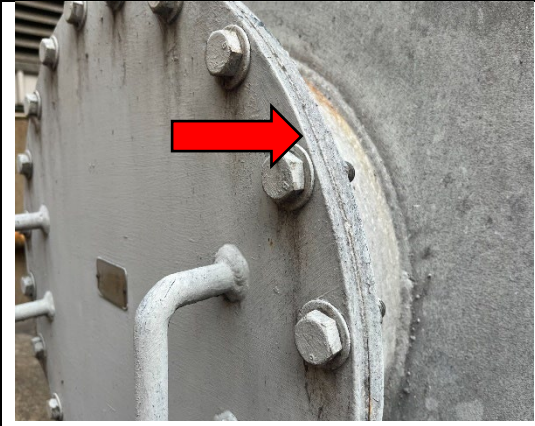
| Sample No.: J02203-AS003 | | |
|---|---|---|
| | Asb Detected: | Yes |
| | Friability: | Friable |
| | Material Condition: | Good |
| | Extent: | 1 unit |

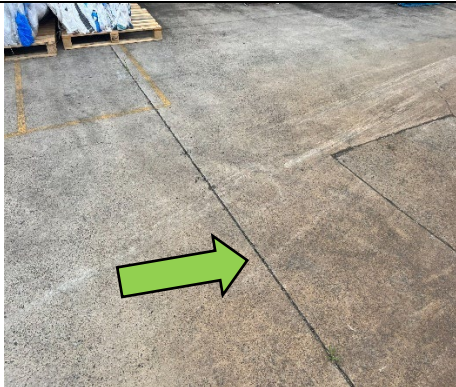
| | Sample No.: J02203-AS001 | |

| | Asb Detected: | No |
| | Ground Level, Snackbrands, surrounding, on ground, expansion joint, mastic material. | |

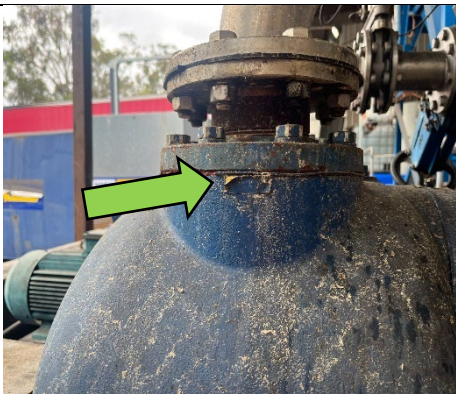
| | Sample No.: J02203-AS002 | |

| | Asb Detected: | No |
| | Ground Level, Snackbrands, east side, S3 pit plant work area, rubber gasket material. | |

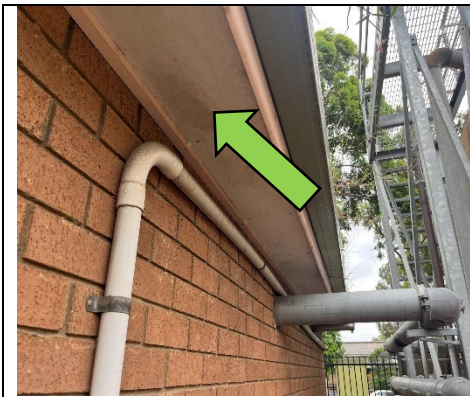
Sample No.: J02203-AS004

Asb Detected: No

Ground Level, Snackbrands, fire hydrant room, north side, eaves, fibre cement sheeting.

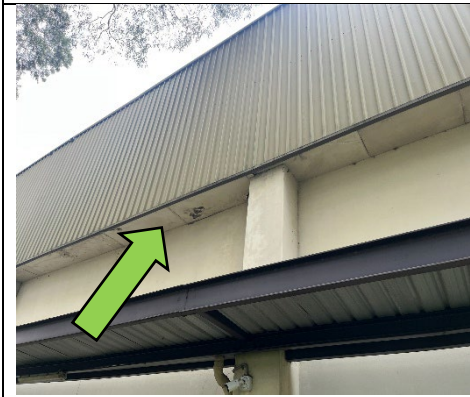
Sample No.: J02203-AS005

Asb Detected: No

Ground Level, Snackbrands, Ground Level, west side, eaves, fibre cement sheeting.

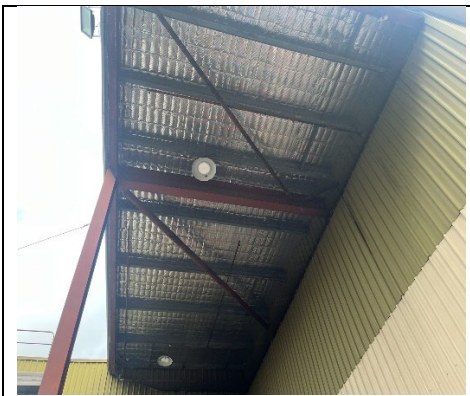
SMF Identified: Assume Yes

Extent: 50 sqm

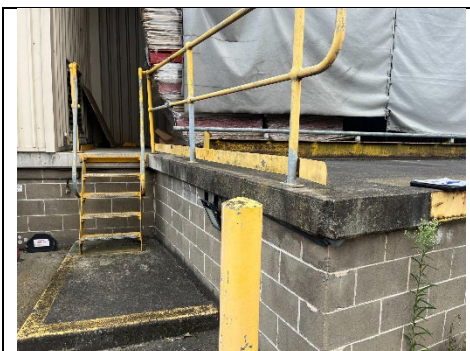
Sample No.: J02203-LCP01

Lead Detected: No 0.03% w/w

Snackbrands, Ground Level, surrounding, bollards & handrails, yellow paint.

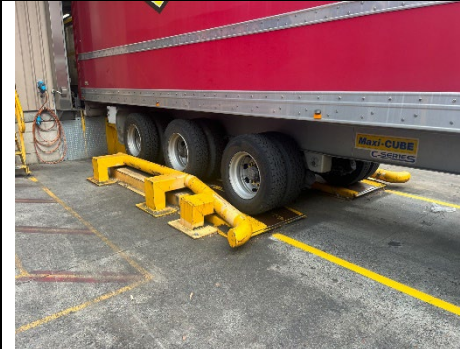
Sample No.: Similar to: J02203-LCP01

| | Lead Detected: | No 0.03% w/w |
| | Snackbrands, Ground Level, surrounding, bollards & handrails, yellow paint. | |

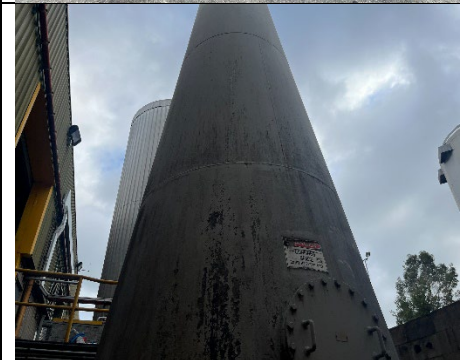
| | Sample No.: J02203-LCP02 | |

| | Lead Detected: | No <0.005% w/w |
| | Snackbrands, Ground Level, north of boiler room, large flue, grey paint. | |

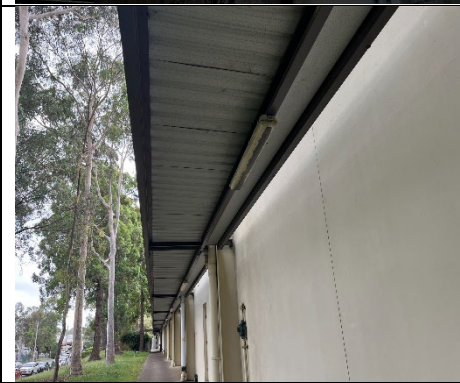
| | Sample No.: J02203-LCP03 | |

| | Lead Detected: | No 0.04% w/w |
| | Snackbrands, Ground Level, west side, throughout, walls, cream paint. | |

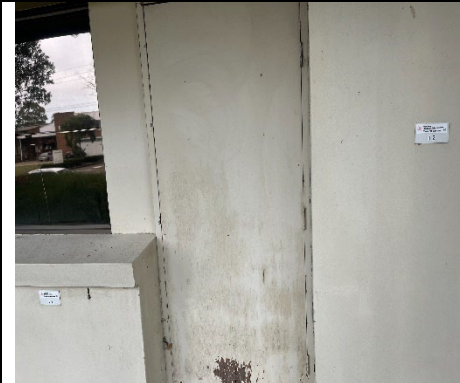
| | Sample No.: Similar to: J02203-LCP03 | |

| | Lead Detected: | No 0.04% w/w |
| | Snackbrands, Ground Level, west side, throughout, doors & door frames, cream paint. | |

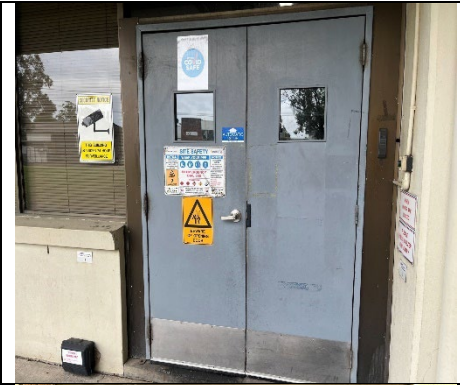
| | Sample No.: J02203-LCP04 | |

| | Lead Detected: | No <0.005% w/w |
| | Snackbrands, Ground Level, west side, adjacent outdoor lunch area, door & door frames, grey/red/green paint. | |

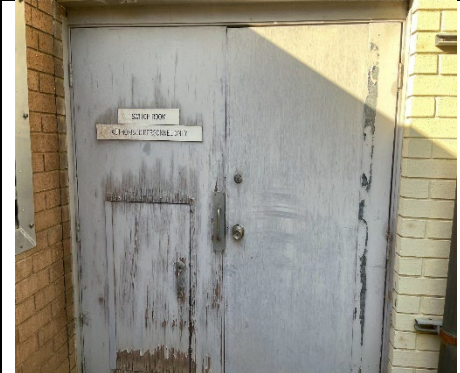
| | Sample No.: J02203-LCP030 | |

| | Lead Detected: | No <0.07% w/w |
| | Snackbrands, Ground Level, main switch room, double door, grey paint. | |

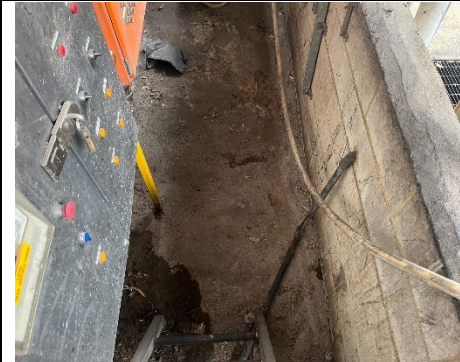
| | Sample No.: J02203-LCD01 | |

| | Lead Detected: | No 56 mg/kg |
| | Extent: | ~1 sqm |

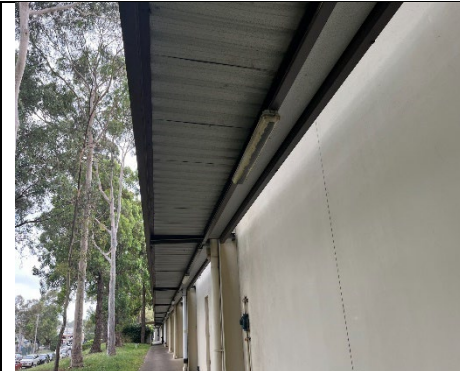
| | PCBs Identified: | Assume No |
| | Snackbrands, Ground Level, west side, awning, throughout, Fluorescent light - double tube. | |
| | Extent: | ~15 units |

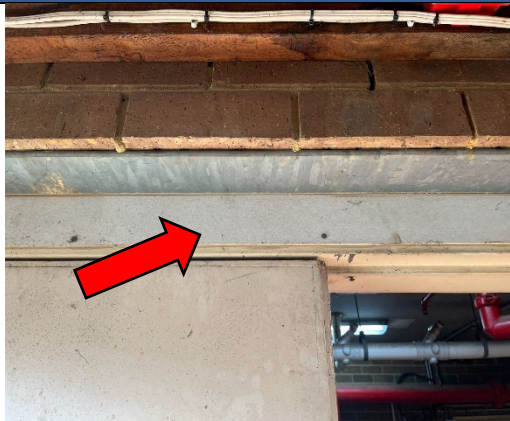
| Sample No.: J02203-AS043 | |

| Sample No.: J02203-AS043 | |
|---|---|
| | Asb Detected: Yes |
| | Friability: Non-Friable |
| | Material Condition: Good |
| Extent: | 1 sqm |

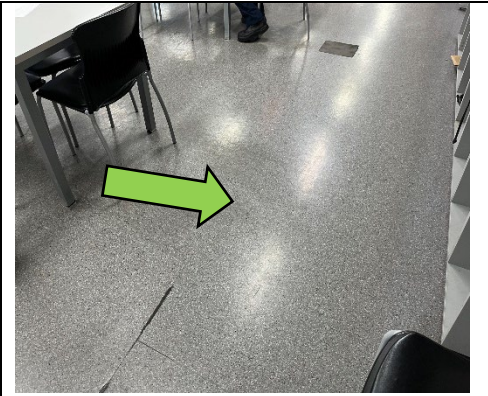
| Asb Detected: | No | | | | | | | | |
| Ground Level, Snackbrands, Office admin, staff room, throughout, floor coverings, sheet vinyl and grey adhesive. | | | | | | | | | |

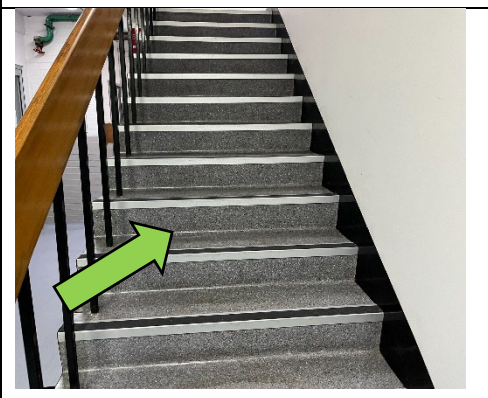
| Asb Detected: | No | | | | | | | | |
| Ground Level, Snackbrands, Office admin, south-east stairs, floor covering, sheet vinyl and grey and amber adhesive. | | | | | | | | | |

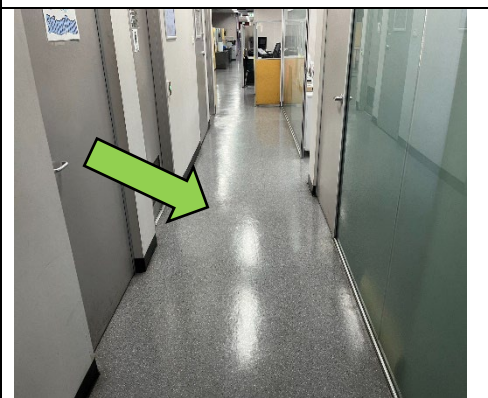
| Asb Detected: | No | | | | | | | | |
| Level 1, Snackbrands, Office admin, throughout, floor covering, sheet vinyl and grey adhesive. | | | | | | | | | |

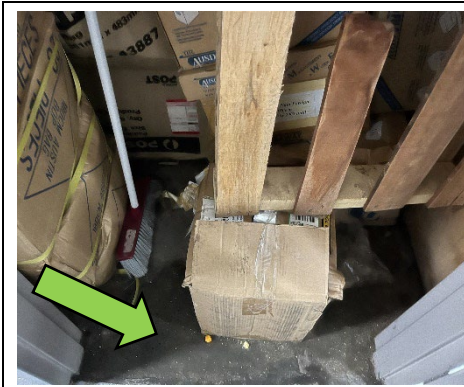
Sample No.: J02203-AS040

Asb Detected: No

Ground Level, Snackbrands, Office admin, storage room, on ground, adhesive material.

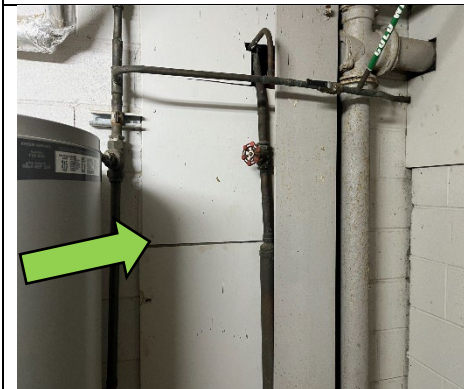
Sample No.: J02203-AS041

Asb Detected: No

Ground Level, Snackbrands, Office admin, contractors' room, north-west, infill panels, fibre cement sheeting.

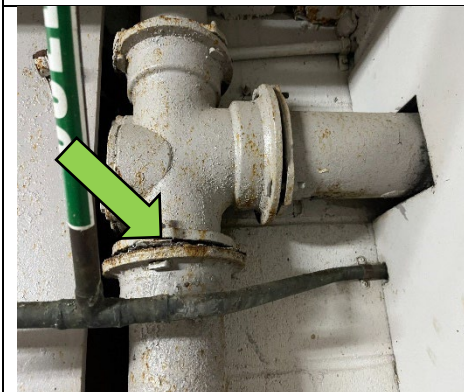
Sample No.: J02203-AS042

Asb Detected: No

Ground Level, Snackbrands, Office admin, contractors' room, north-west, gasket material.

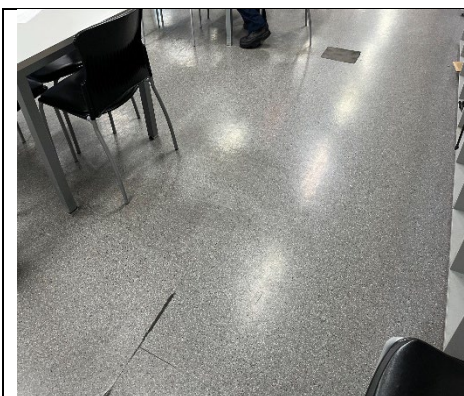
Sample No.: J02203-AS037

SMF Identified: Yes

Ground Level, Snackbrands, Office admin, staff room, throughout, floor coverings, sheet vinyl.

Extent: 100 sqm

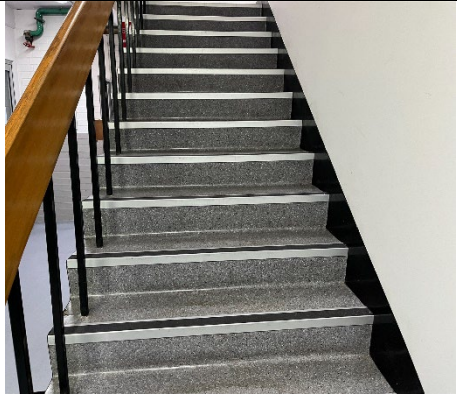
| | Sample No.: J02203-AS038 | |

| | SMF Identified: | Yes |

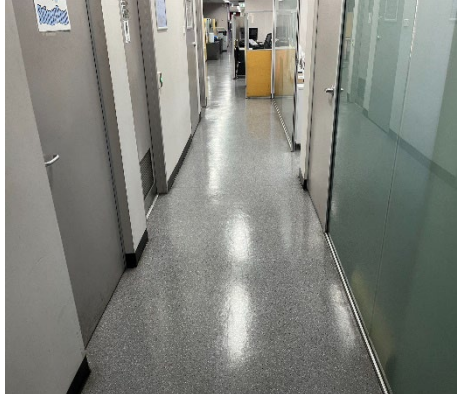
| | Sample No.: J02203-AS039 | |

| | SMF Identified: | Yes |
| | Level 1, Snackbrands, Office admin, throughout, floor covering, sheet vinyl. | |

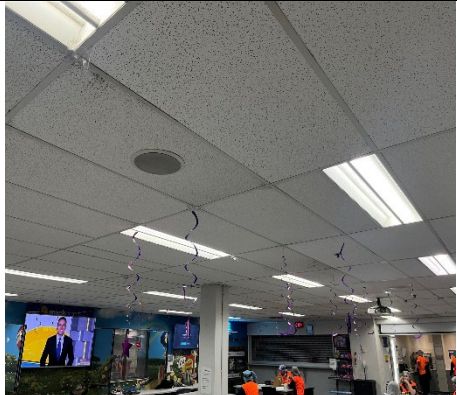
| | SMF Identified: | Assume Yes |
| | Ground Level, Snackbrands, Office admin, staff room, ceiling, compressed ceiling tiles. | |
| | Extent: | 100 sqm |

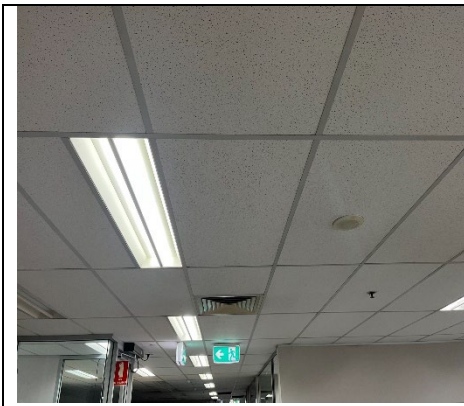
SMF Identified: Assume Yes

Level 1, Snackbrands, Office admin, throughout, ceiling, compressed ceiling tiles.

Extent: 1000 sqm

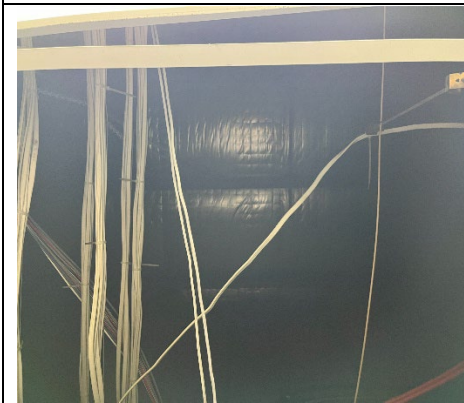
SMF Identified: Assume Yes

Extent: 1000 sqm

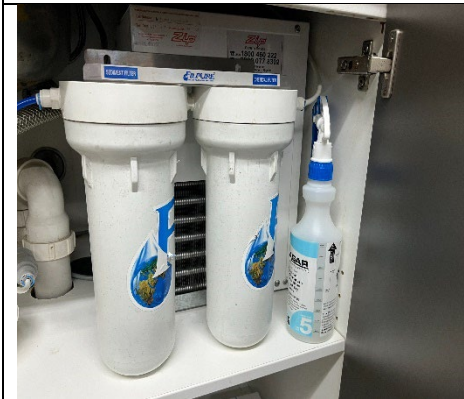
SMF Identified: Assume Yes

Extent: 1 unit

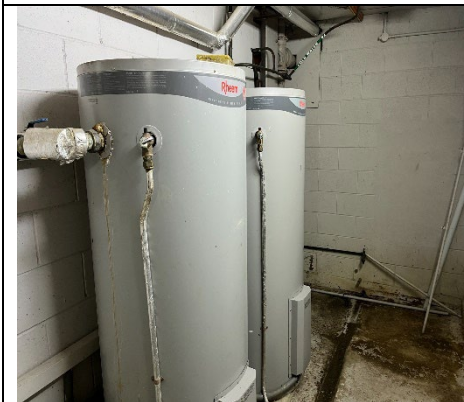
SMF Identified: Assume Yes

Extent: 2 units

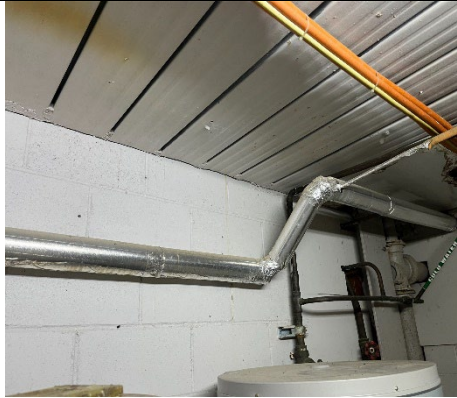
| | SMF Identified: | Assume Yes |
| | Extent: | 5 lm |

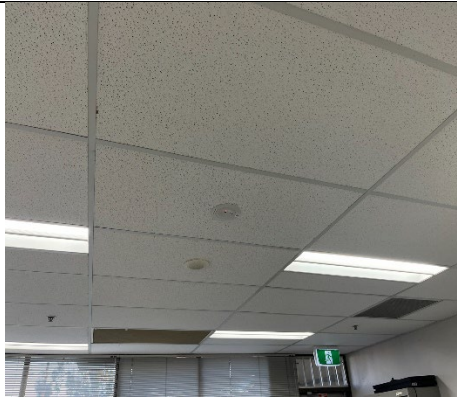
| | SMF Identified: | Assume Yes |
| | Extent: | 60 sqm |

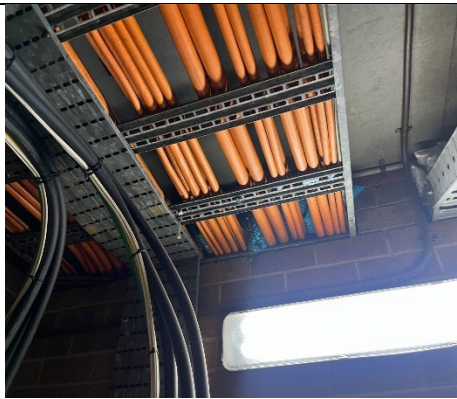
| | SMF Identified: | Assume Yes |
| | Extent: | 20 units |

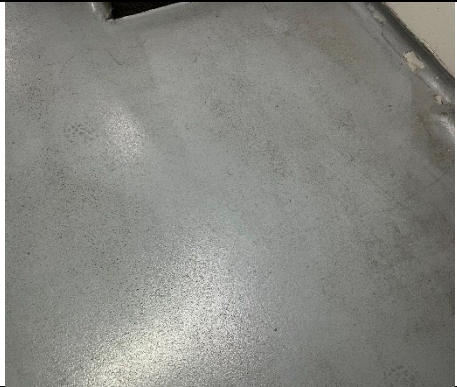
| | Sample No.: J02203-LCP029 | |

| | Lead Detected: | No <0.005% w/w |

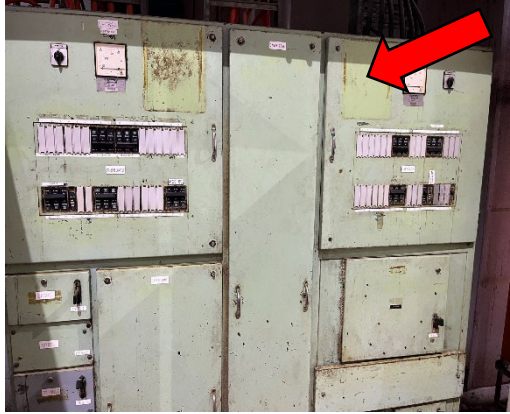
| Not Sampled: Electrical Hazard | |
|---|---|
| | Asb Detected: Assume Yes |
| | Friability: Non-Friable |
| | Material Condition: Good |
| Not Sampled: Manufacturing Area (food may be potentially contaminated). | |

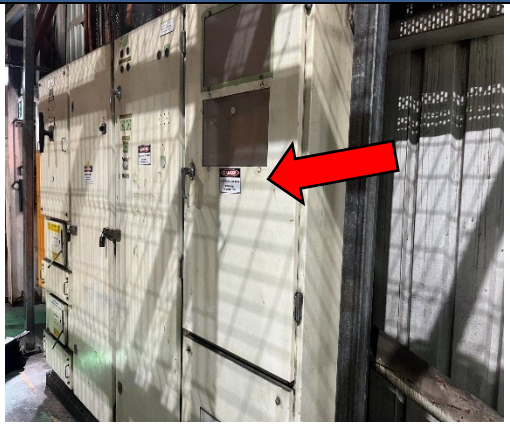
| Not Sampled: Electrical Hazard | |
|---|---|
| | Asb Detected: Assume Yes |
| | Friability: Non-Friable |
| | Material Condition: Good |

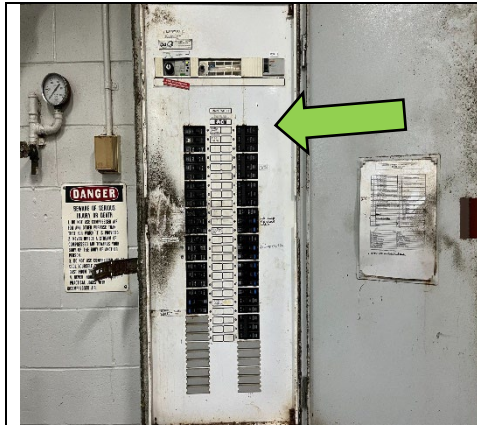
Asb Detected: Assume No - due to age of manufacturing date (2005)

Ground Level, Snackbrands, Potato Packaging, north-east, electrical distribution board, bituminous backing board.

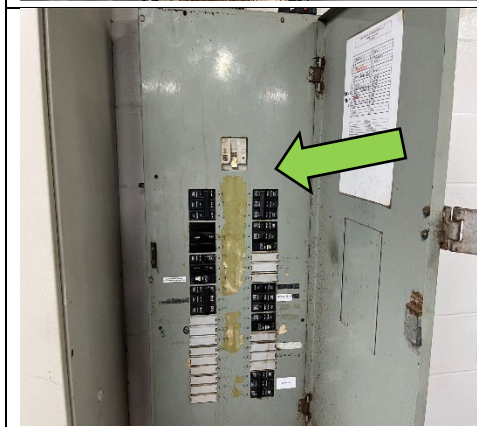
Asb Detected: Assume No - due to age of manufacturing date (2005)

Ground Level, Snackbrands, Potato Packaging, north, electrical distribution board, bituminous backing board.

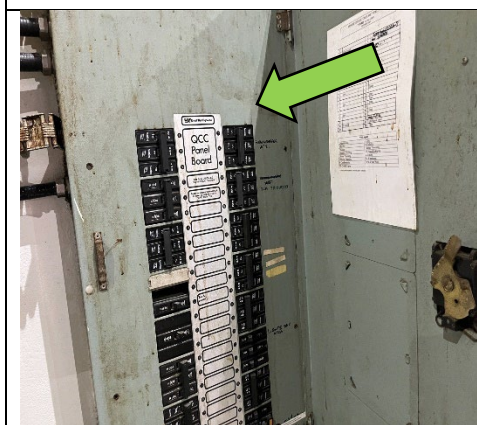
Asb Detected: Assume No - due to age of manufacturing date (2005)

Ground Level, Snackbrands, Variety, west, electrical distribution board, bituminous backing board.

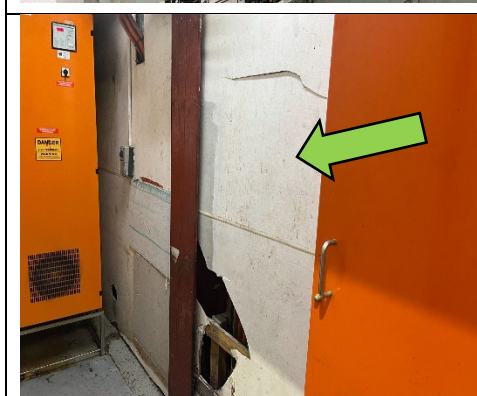
## Sample No.: J02203-AS044

Asb Detected: No

Mezzanine Level, Snackbrands, Corn Processing, north-west switch room, throughout, walls, fibre cement sheeting.

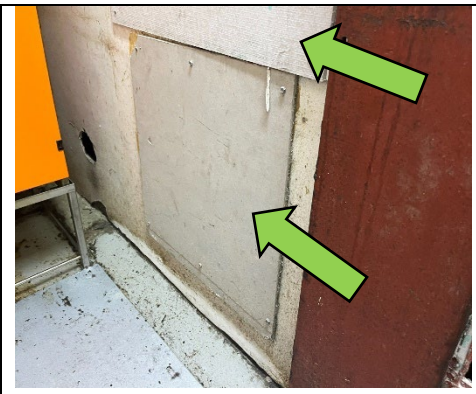
| Asb Detected: | No | | | | | | | | |
| Mezzanine Level, Snackbrands, Corn Processing, north-west switch room, north, infill panels, fibre cement sheeting. | | | | | | | | | |

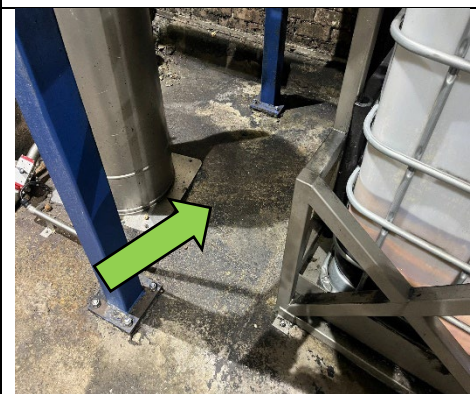
| Asb Detected: | No | | | | | | | | |
| Mezzanine Level, Snackbrands, Potato Storage, adjacent blue tank, on ground, bituminous membrane. | | | | | | | | | |

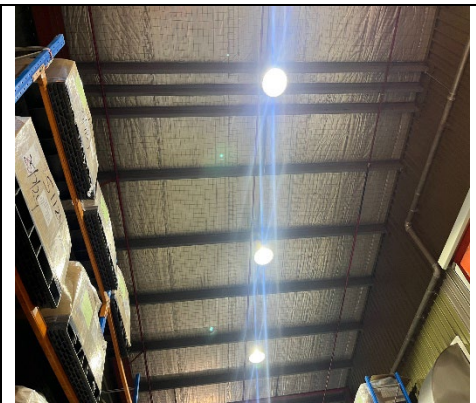
| Visual Inspection | | SMF Identified: | Assume Yes | Location: | Internal | Ground Level, Snackbrands, Maintenance, ceiling, sarking insulation, insulation material. | | Extent: | 200 sqm |
| Visual Inspection | | | | | | | | | | | |
| SMF Identified: | Assume Yes | | | | | | | | | | |
| Location: | Internal | | | | | | | | | | |
| Ground Level, Snackbrands, Maintenance, ceiling, sarking insulation, insulation material. | | | | | | | | | | | |
| Extent: | 200 sqm | | | | | | | | | | |

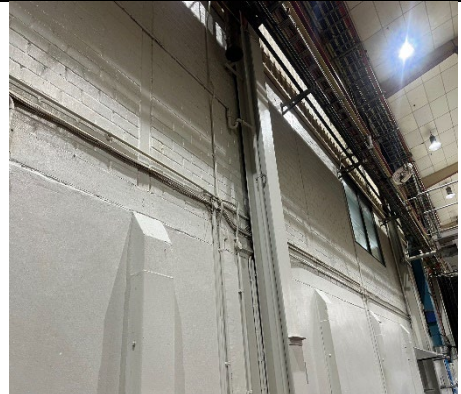
| | <b>Sample No.: J02203-LCP031</b> | |

| | <b>Lead Detected:</b> | No <0.06% w/w |
| | Snackbrands, Ground Level, Cereal Packaging, west wall, concrete & brickwork, white paint. | |

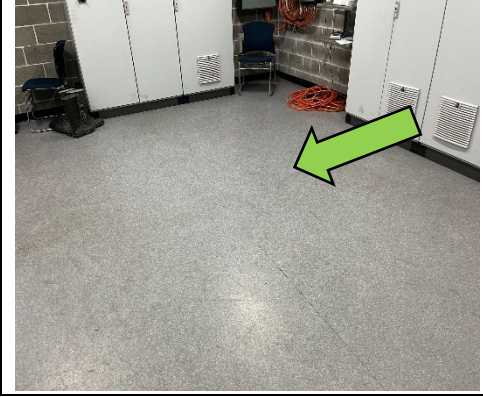
| | Not Sampled: Electrical Hazard | |
| | Asb Detected: | No |
