Hazardous Materials Management Survey and Register 1 Apollo Place, Lane Cove West, NSW 2066

JOB NUMBER: JN04987
ISSUED DATE: 9 April 2024
PREPARED FOR: EMKC AUSTRALIA PTY LTD
CLIENT ADDRESS: Level 11, 37 York Street Sydney NSW 2000 Australia
INSPECTED BY: Faz Jalali, Occupational Hygienist
REPORT BY: Faz Jalali, Occupational Hygienist
APPROVED BY: Alex Clark, Senior Hazmat Consultant
ISSUE NUMBER: Rev_0

Hazardous Materials Management Survey and Register 2 Apollo Place, Lane Cove West, NSW 2066

JOB NUMBER: JN04987
ISSUED DATE: 21 March 2024
PREPARED FOR: EMKC AUSTRALIA PTY LTD
CLIENT ADDRESS: Level 11, 37 York Street Sydney NSW 2000 Australia
INSPECTED BY: Faz Jalali, Occupational Hygienist
REPORT BY: Faz Jalali, Occupational Hygienist
APPROVED BY: Alex Clark, Senior Hazmat Consultant
ISSUE NUMBER: Rev_0

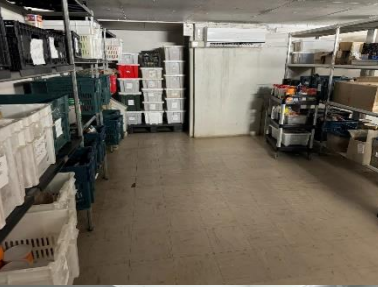
Material Identification		Risk Assessment			Risk Management & Corrective Actions			Photo
Location of Material	Description	Sample No.	Hazmat Detected / Identified	Quantity sqm, Lm, Unit	Friability	Risk Rating (H,M,L,N)		
Building Description: The building is a 2-storey office and food processing block with brick external walls with cement render to the facade of the building, concrete flooring throughout. The building's interior consists mostly of plaster walls and fitted vinyl sheeting with limited access above a suspended ceiling, behind installed cool rooms and refrigerators and under the fitted carpets.								
Lower ground floor	Thermoplastic plastic floor tiles in store room	A1	NAD	NA	NA	NA	No further action required.

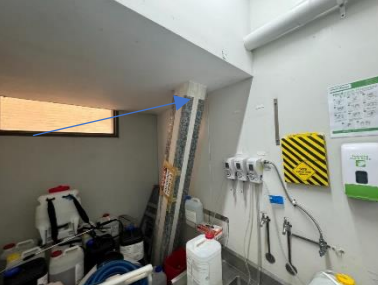
Lower ground floor	Soft insulation board in Chem store	A2	NAD	NA	NA	NA	No further action required.

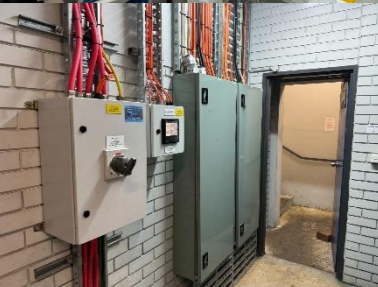
Lower ground	Presumed asbestos backing board to fuse boxes	P1	Presumed Asbestos	3 units	NF	Negligible	Inspect by a competent person prior to planned demolition works

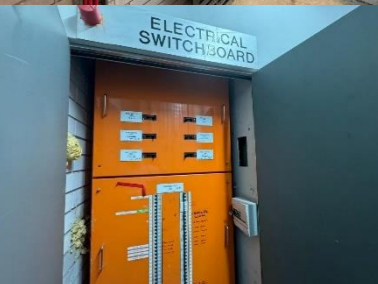
Lower ground	Presumed asbestos backing board to switch board	P2	Presumed Asbestos	1 unit	NF	Negligible	Inspect by a competent person prior to planned demolition works

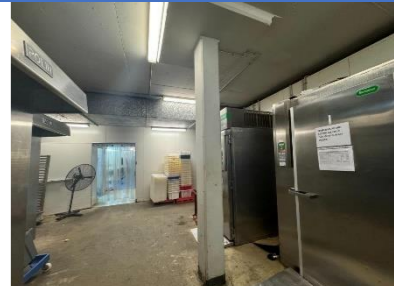
Material Identification		Risk Assessment				Risk Management & Corrective Actions		Photo
Location of Material	Description	Sample No.	Hazmat Detected / Identified	Quantity sqm, Lm, Unit	Friability	Risk Rating (H,M,L,N)		
Lower ground	White paint on walls and ceiling	L1	<0.1%	TH	NA		No further action required.

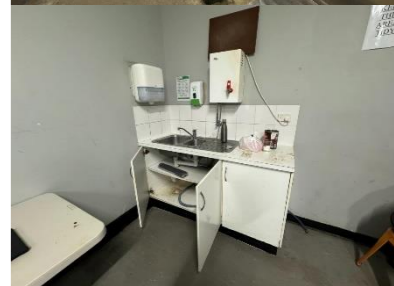
Lower ground floor	Bitumen pad under sink in staff room	A3	NAD	NA	NA	NA	No further action required.

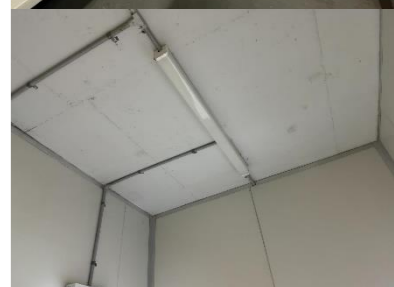
Lower ground level	Presumed PCB capacitor to ceiling mounted fluorescent light	PCB1	Presumed PCB	1 unit	NA	Negligible	Inspect and remove and dispose of in accordance with EPA requirements prior to demolition

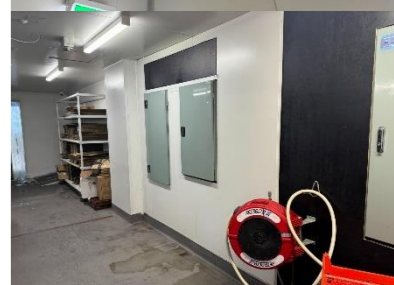
Lower ground	Presumed asbestos backing board to fuse boxes	P3	Presumed Asbestos	2 units	NF	Negligible	Inspect by a competent person prior to planned demolition works

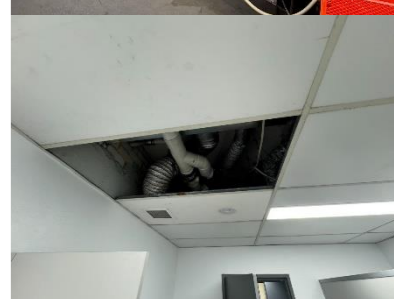
Lower ground level	Flexible insulation ducts above suspended ceiling in toilets	SMF1	SMF	TH	F	Negligible	Remove under controlled conditions during or before demolition works by competent persons

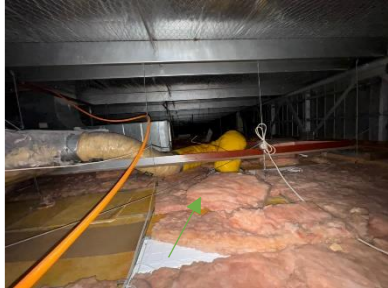
Material Identification		Risk Assessment				Risk Management & Corrective Actions		Photo
Location of Material	Description	Sample No.	Hazmat Detected / Identified	Quantity sqm, Lm, Unit	Friability	Risk Rating (H,M,L,N)		
Ground floor	Loose insulation batts above suspended ceiling	SMF4	SMF	TH	F	Low	Remove under controlled conditions during or before demolition works by competent persons

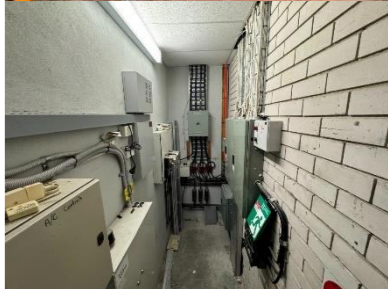
Ground level	Presumed asbestos backing board to fuse boxes	P4	Presumed Asbestos	2 units	NF	Negligible	Inspect by a competent person prior to planned demolition works

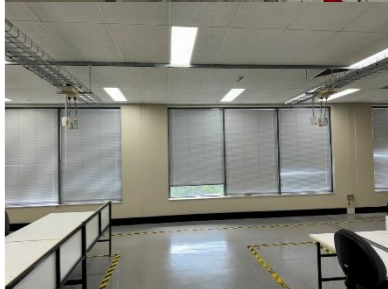
Ground floor	Mastic seal to aluminium windows	A6	NAD	NA	NA	NA	No further action required.

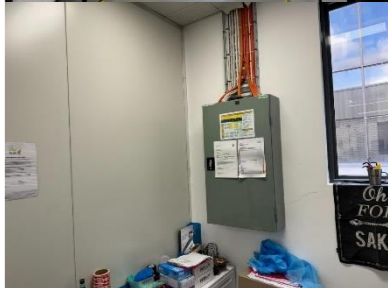
Ground level	Presumed asbestos backing board to fuse box in office	P5	Presumed Asbestos	2 units	NF	Negligible	Inspect by a competent person prior to planned demolition works

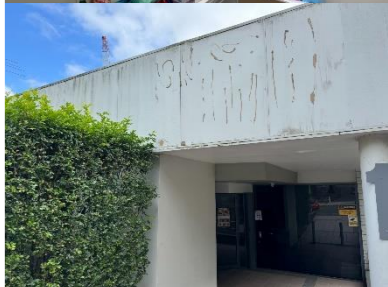
External	Fibre cement awing to entrance	A7	NAD	NA	NA	NA	No further action required.

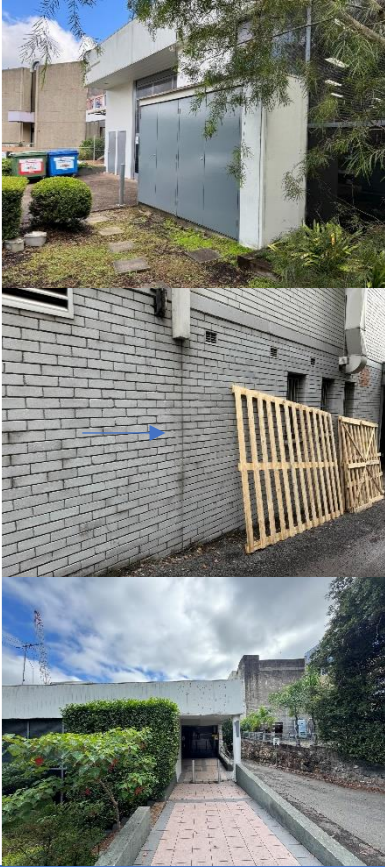
Material Identification		Risk Assessment					Risk Management & Corrective Actions	Photo
Location of Material	Description	Sample No.	Hazmat Detected / Identified	Quantity sqm, Lm, Unit	Friability	Risk Rating (H,M,L,N)		
External	Wall lining to external store	A8	NAD	NA	NA	NA	No further action required. No access internally
