Hazardous Materials Survey

25-27 Leeds Street, Rhodes NSW

Project No. 22148
Version 1

21 June 2024

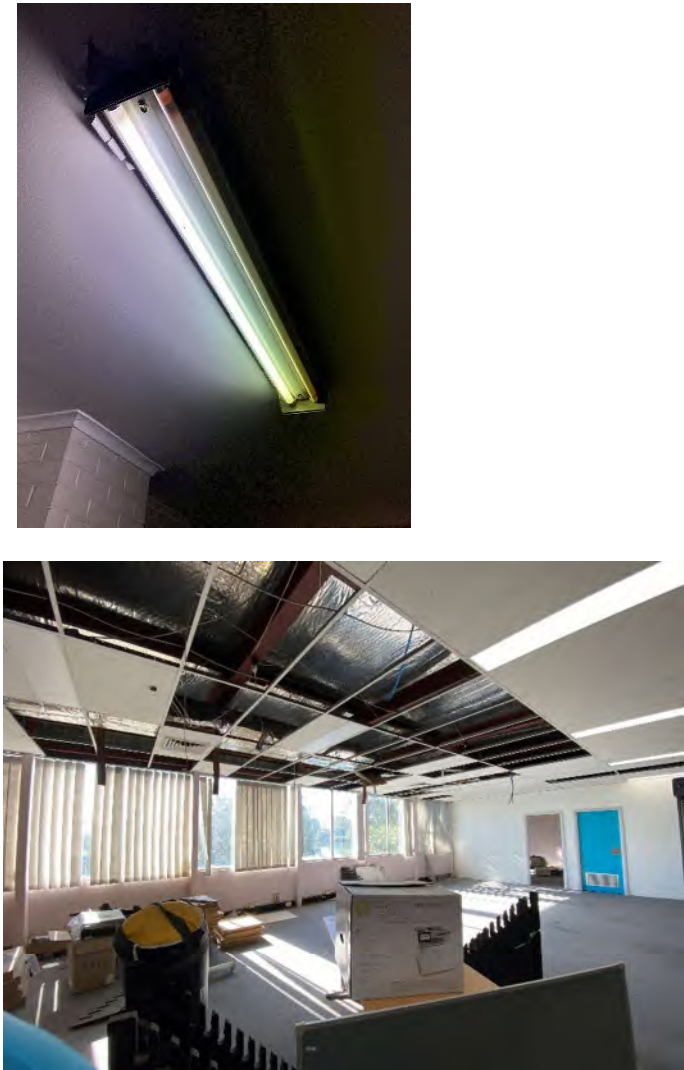
ITEM	DESCRIPTION
Location	Within each partitioned unit.
Material Type	Fluorescent light fittings.
Material Condition	N/A
Sample ID	N/A – Potential electrical hazard (no electrical isolation).
Approximate Extent	Approximately 300 units.
Laboratory Results	Light fittings across the site are assumed to be a mixture of LED and fluorescent light fittings. Not accessible due to safety concerns (height and live electricity).
Photograph

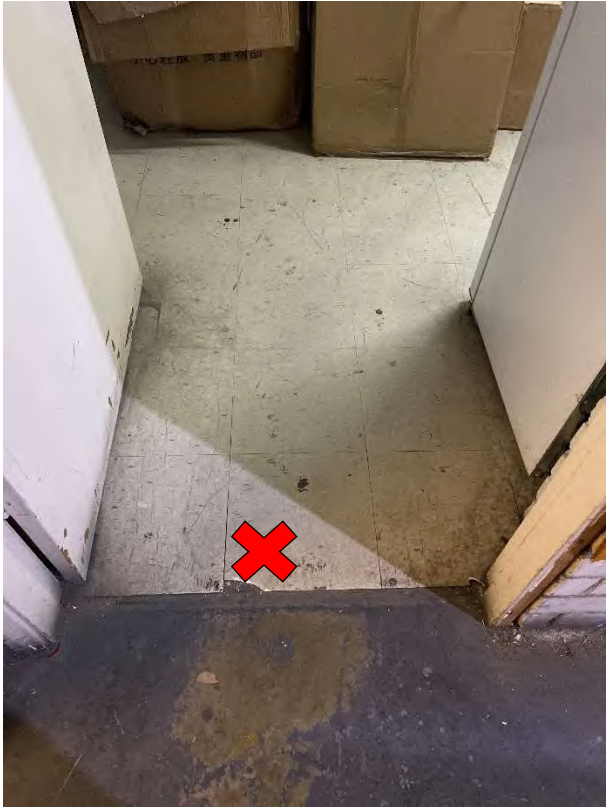
ITEM	DESCRIPTION
Location	Pet supply warehouse.
Material Type	Speckled white floor tile.
Material Condition	Moderately weathered.
Sample ID	A2
Approximate Extent	20m ²
Laboratory Results	Tile contains Chrysotile asbestos.
Photograph

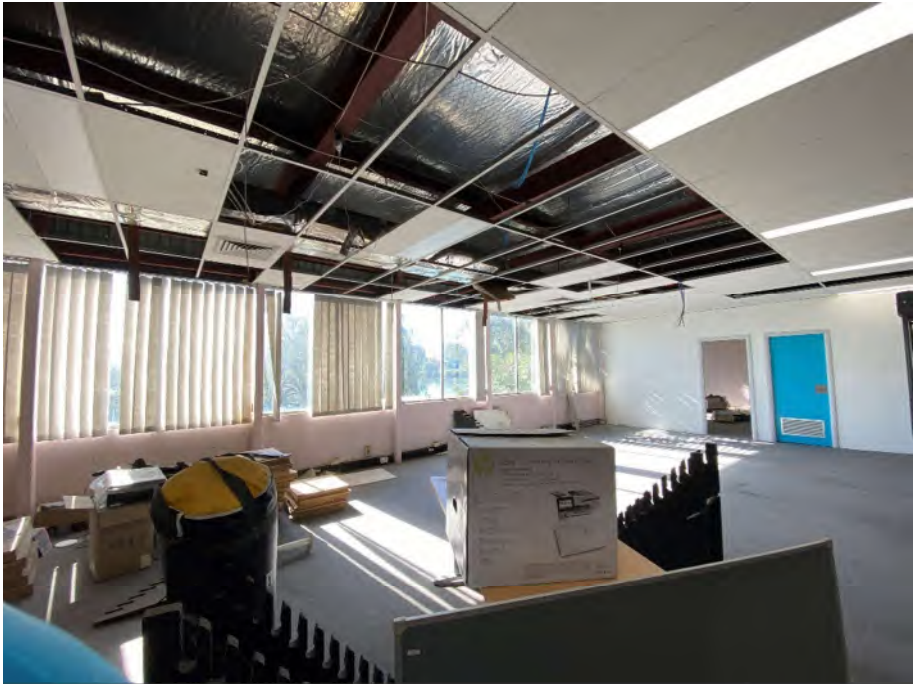
ITEM	DESCRIPTION
Location	Flooring supply warehouse – stairwell to disused upstairs office.
Material Type	Cement floor tiles.
Material Condition	Moderately weathered.
Sample ID	A5
Approximate Extent	20m ²
Laboratory Results	Floor tiles contain Chrysotile asbestos.
Photograph	<p>No specific photograph available. Tiles are located on steps within stairwell to the space in photograph below.</p>

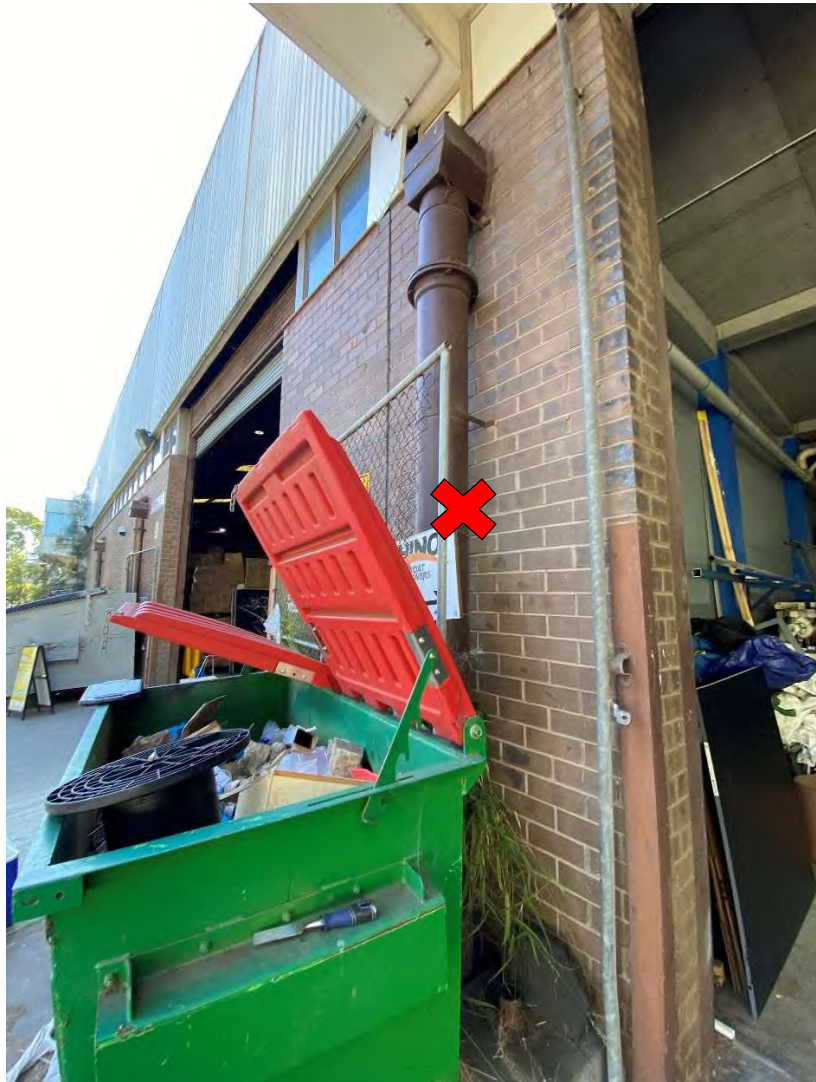
Photograph

ITEM	DESCRIPTION
Location	External façade of warehouse buildings.
Material Type	Brown paint.
Material Condition	Moderately weathered.
Sample ID	P1
Approximate Extent	<10m ²
Laboratory Results	Lead in paint = 0.22% w/w, exceeds 0.1% w/w criteria.

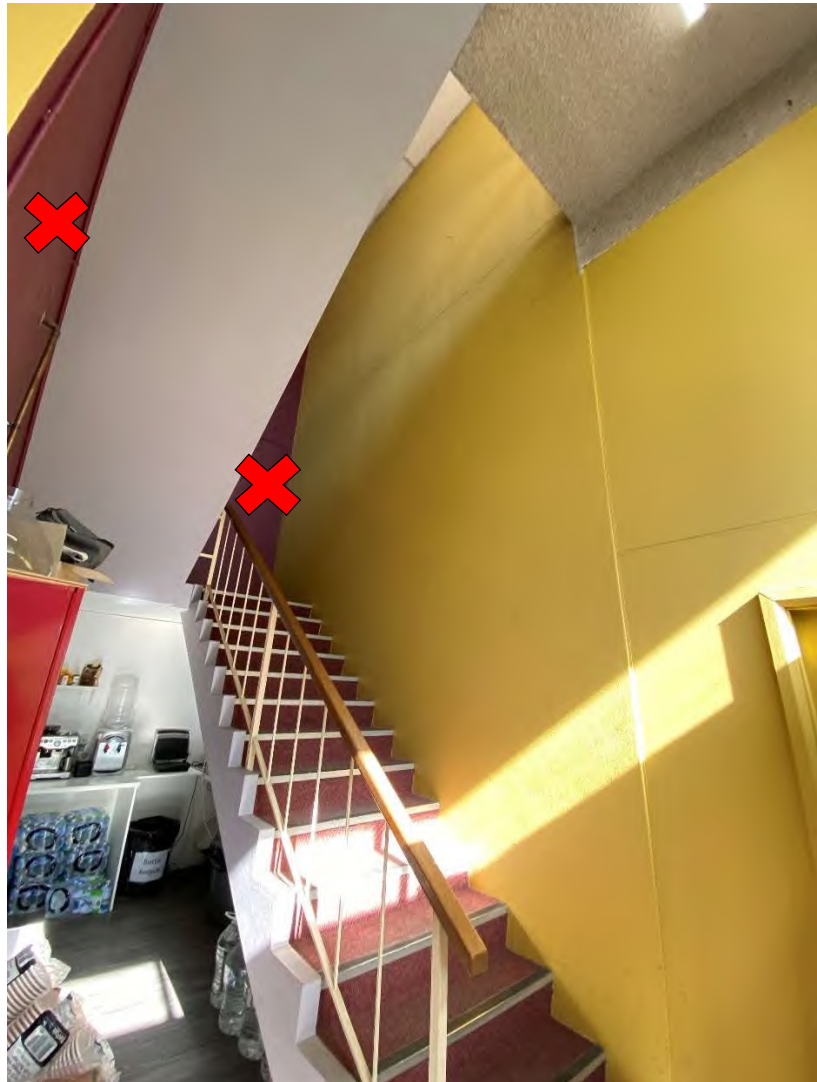
Photograph

ITEM	DESCRIPTION
Location	Flooring supply warehouse – ground floor hallway and stairwell.
Material Type	Reddish/purple paint.
Material Condition	Not weathered.
Sample ID	P11
Approximate Extent	55m ²
Laboratory Results	Lead in paint = 0.1% w/w, equals 0.1% w/w criteria.

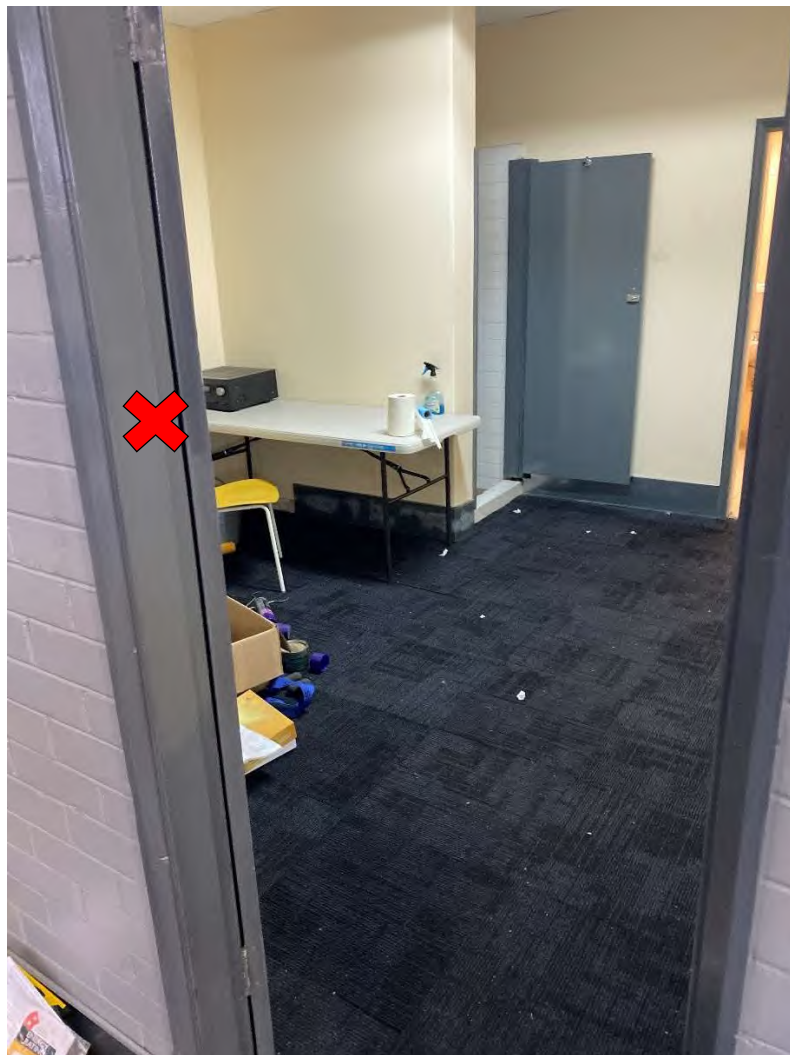
Photograph

ITEM	DESCRIPTION
Location	Fabrication shop – interior.
Material Type	Dark grey paint.
Material Condition	Not weathered.
Sample ID	P19
Approximate Extent	50m ²
Laboratory Results	Lead in paint = 0.14% w/w, greater than 0.1% w/w criteria.

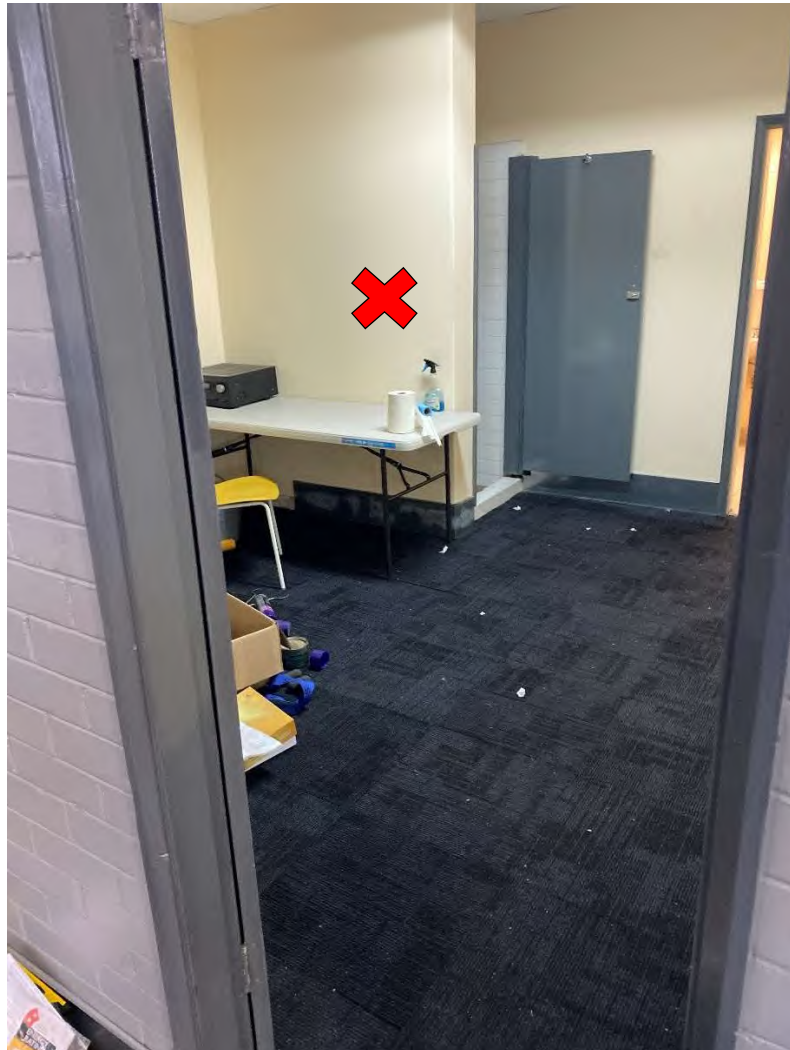
Photograph

ITEM	DESCRIPTION
Location	Fabrication shop – interior – bathroom.
Material Type	Cream/white paint.
Material Condition	Not weathered.
Sample ID	P20
Approximate Extent	30m ²
Laboratory Results	Lead in paint = 0.19% w/w, greater than 0.1% w/w criteria.

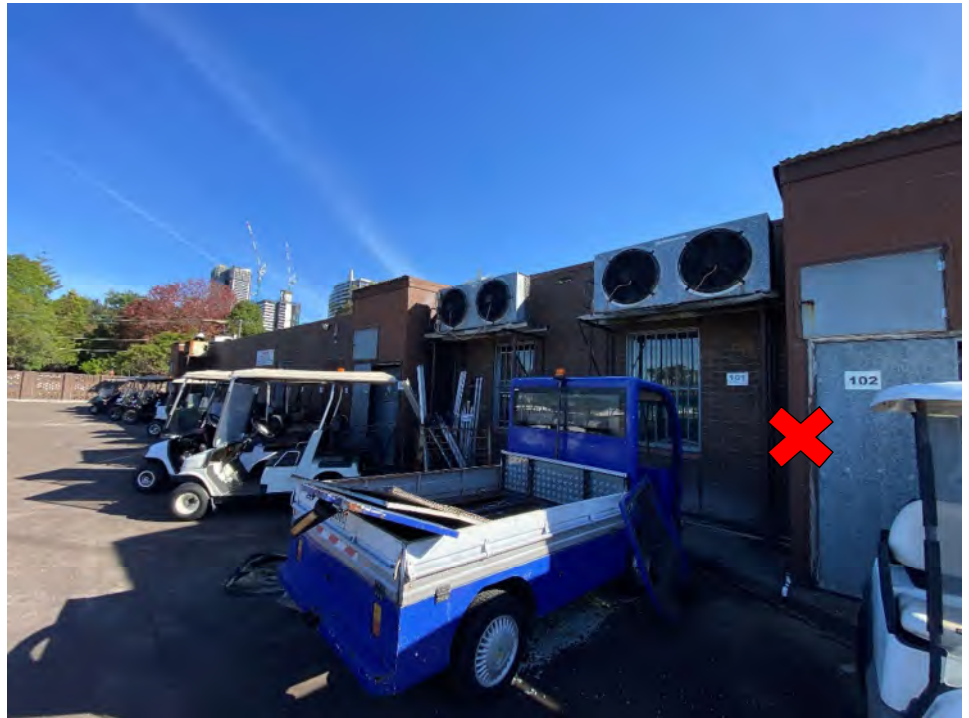
Photograph

ITEM	DESCRIPTION
Location	Golf cart workshop – External facades of upstairs carpark.
Material Type	Brown paint.
Material Condition	Very weathered.
Sample ID	P26
Approximate Extent	20m ²
Laboratory Results	Lead in paint = 0.16% w/w, greater than 0.1% w/w criteria.

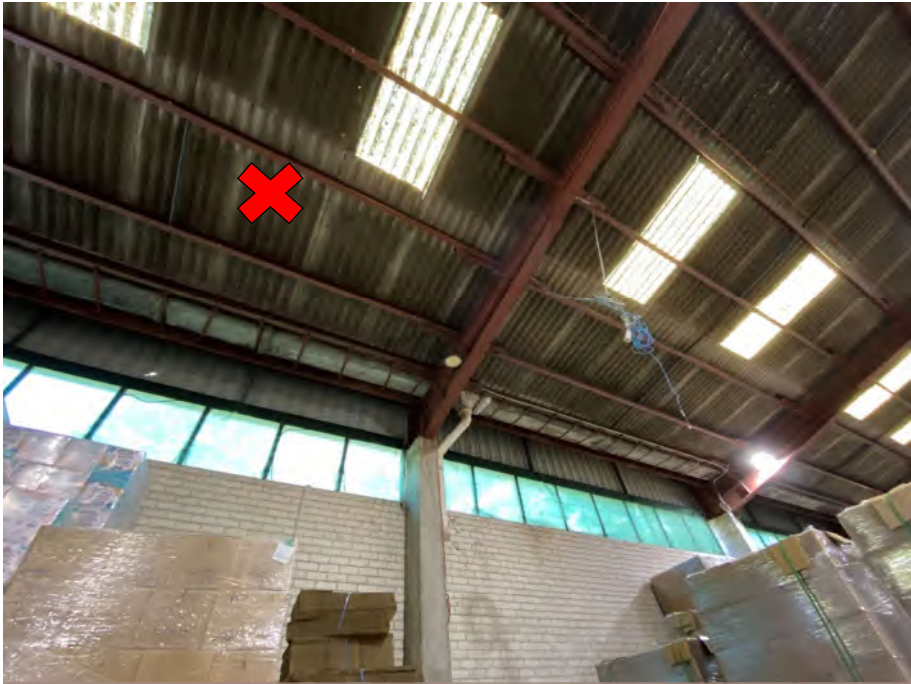
ITEM	DESCRIPTION
Location	Warehouse roofing.
Material Type	Corrugated roofing.
Material Condition	Moderately weathered.
Sample ID	Not sampled due to height and safety concerns.
Approximate Extent	2,500m ²
Laboratory Results	Potentially asbestos containing material. Signage indicates that roofing may potentially contain asbestos.
Photograph

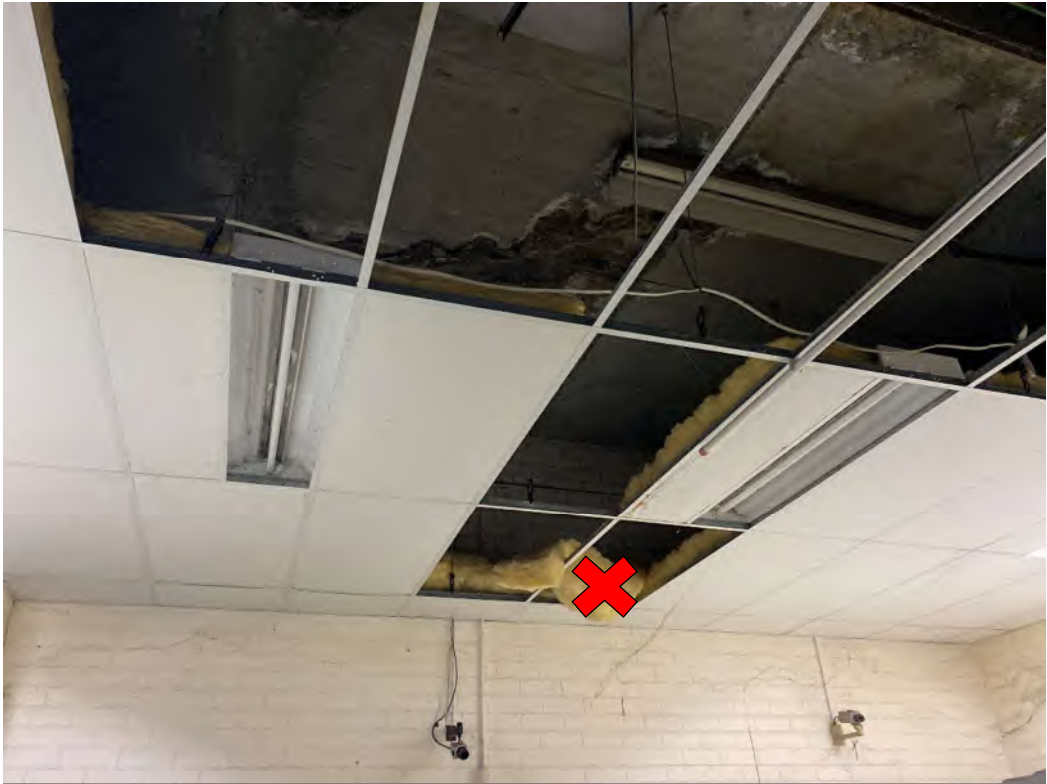
ITEM	DESCRIPTION
Location	Golf cart workshop. Likely present throughout other parts of site.
Material Type	Insulation.
Material Condition	Moderate.
Sample ID	Not sampled due to height and safety concerns.
Approximate Extent	100m ²
Laboratory Results	Not sampled due to height – assumed to contain synthetic mineral fibre.
Photograph

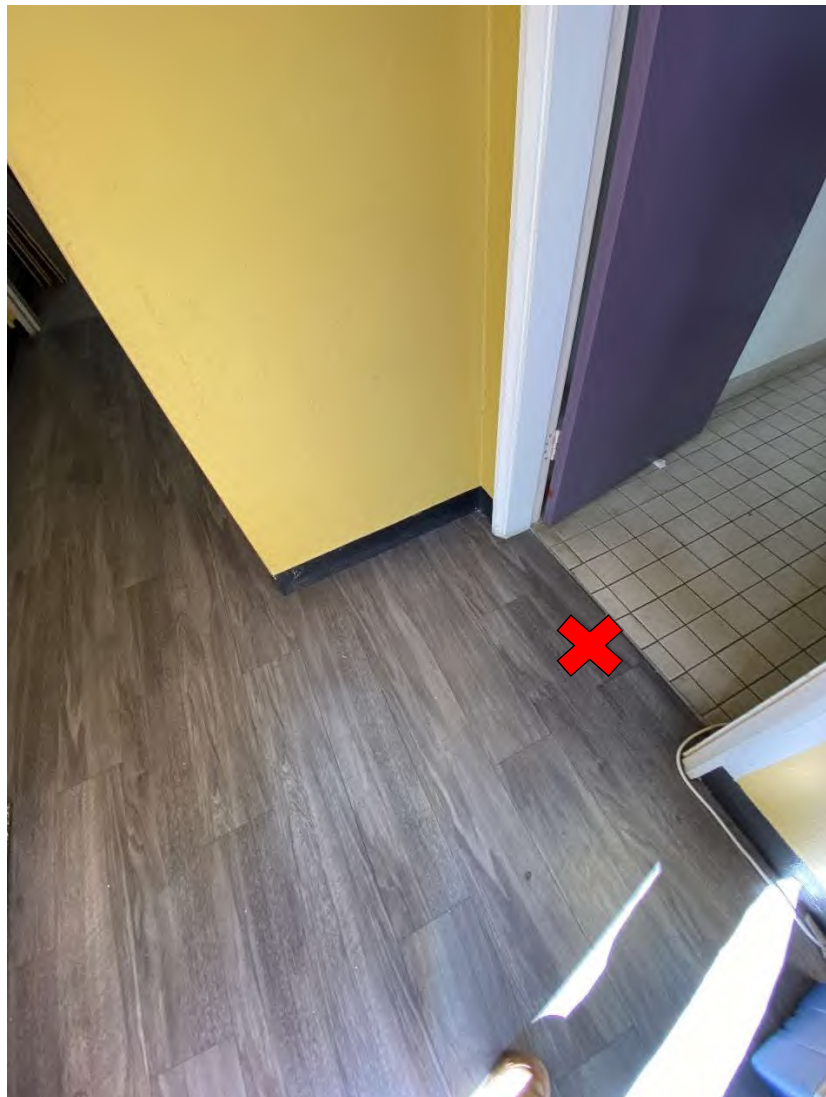
Photograph

ITEM	DESCRIPTION
Location	Flooring supply warehouse – ground floor.
Material Type	Grey wooden style floor tile.
Material Condition	Moderately weathered.
Sample ID	A7
Approximate Extent	20m ²
Laboratory Results	Contains synthetic mineral fibres.

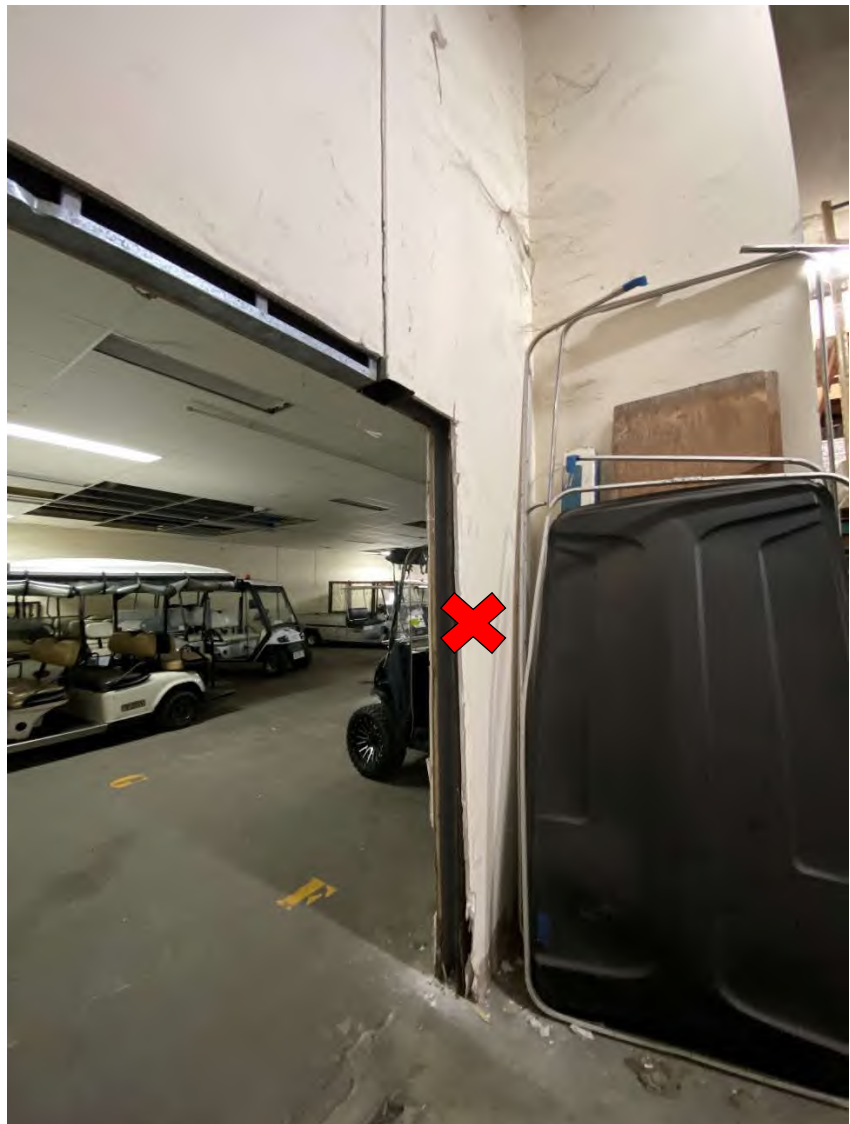
Photograph

ITEM	DESCRIPTION
Location	Golf cart workshop – cart storage room.
Material Type	Fibrous cement sheeting.
Material Condition	Very weathered.
Sample ID	P22/A9
Approximate Extent	100m ²
Laboratory Results	Contains synthetic mineral fibres.

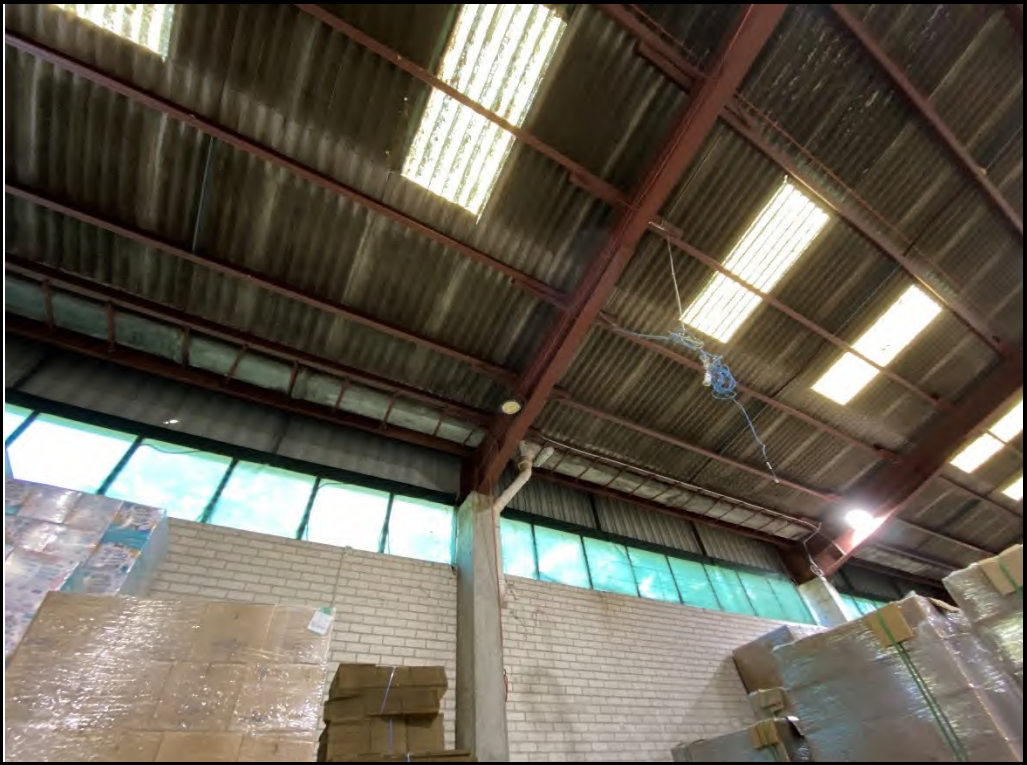
Photo No. 39	Date 23/5/2024
Direction Facing -	
Description ACM roofing. Some translucent corrugated fiberglass paneling also present for light ingress
