## Pre-Construction Dilapidation Survey of 25-27 Leeds St, Rhodes - Roads and Council Assets – Blaxland Road

MAJ-20240111-DS-REP-001-1A-R01

RE: 25-27 LEEDS STREET, RHODES  
PRE-CONSTRUCTION DILAPIDATION SURVEY OF ROADS AND COUNCIL ASSETS – BLAXLAND ROAD

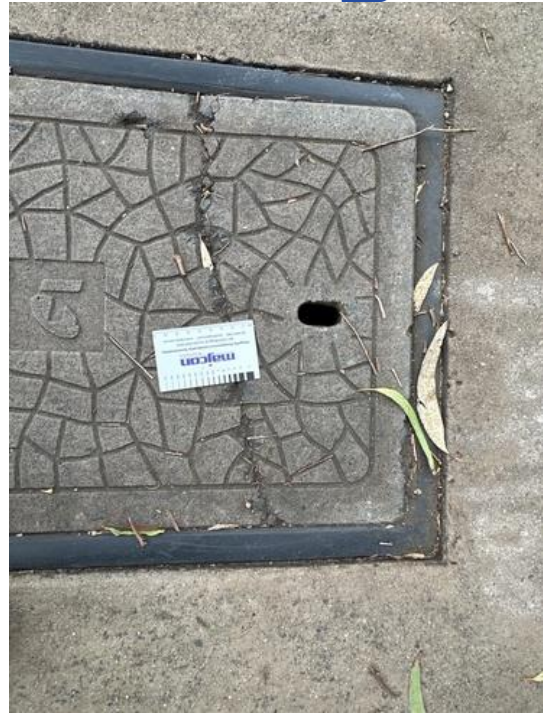
Photo 19

| Number of cracks | 1 |
| Average length of crack (mm) | 350 |
| Width of Crack | Category 3; $2.0 < \alpha < 4.0$ mm |
| Location | Service cover |

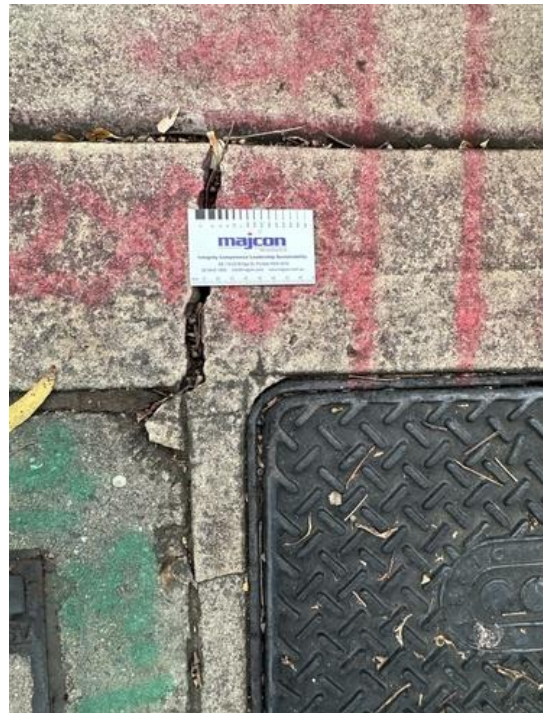
Photo 21

| Number of cracks | Typical |
| Average length of crack (mm) | 200 |
| Width of crack | Category 4; $4.0 < \alpha < 10.0$ mm |
| Location | Kerb |

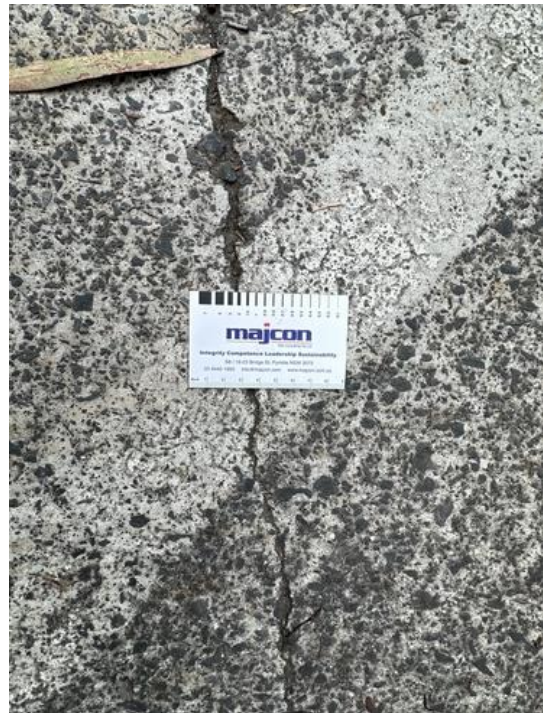
Photo 49

Number of cracks

1

Average length of crack (mm)

2000

Width of Crack

Category 3;  $2.0 < \alpha < 4.0$  mm

Location

Foot path

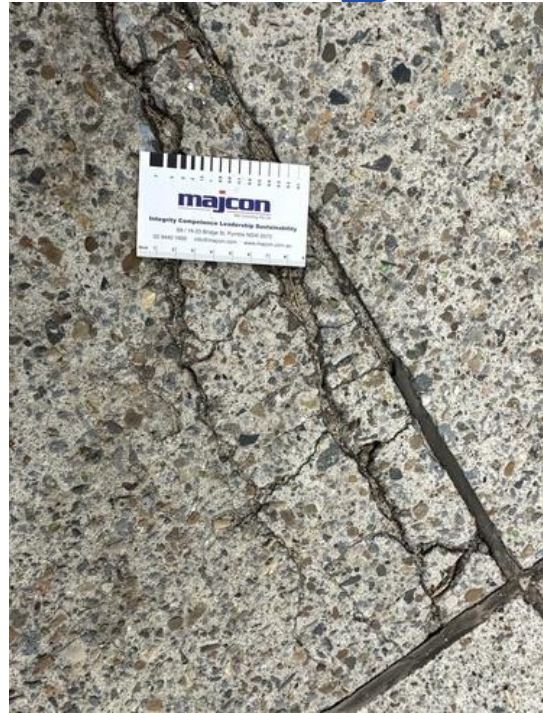
Photo 67

Number of cracks

Cracking

Average length of cracks (mm)

300

Width of Cracks

Category 4;  $4.0 < \alpha < 10.0$  mm

| Location | Road | | |

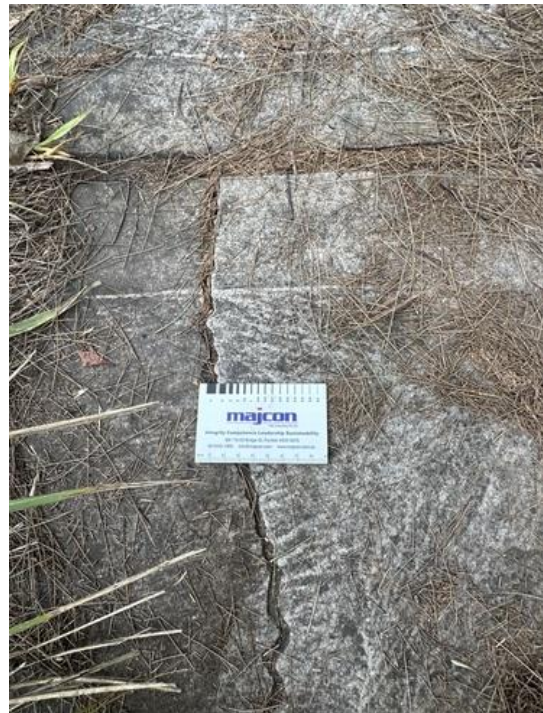
Photo 69

| Number of cracks | Cracking | | |
| Average length of crack (mm) | 3000 | | |
| Width of crack | Category 4; $4.0 < \alpha < 10.0$ mm | | |
| Location | Foot path | | |

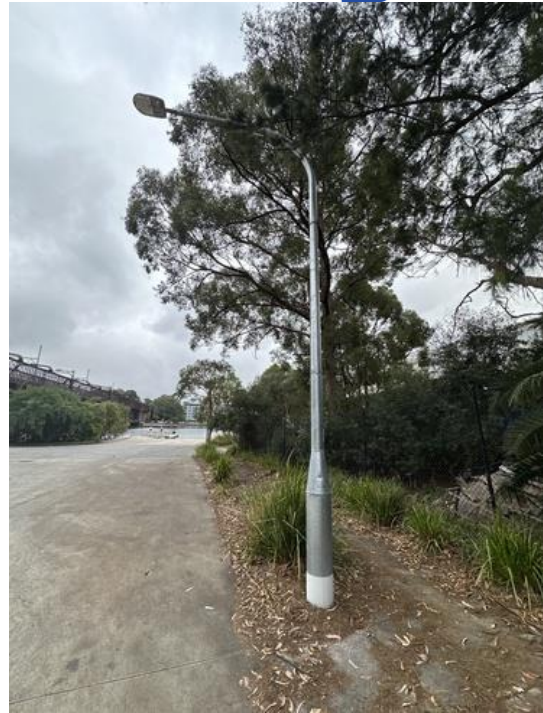
Photo 75

| Number of cracks | 1 |
| Average length of crack (mm) | 400 |
| Width of Crack | Category 4; $4.0 < \alpha < 10.0$ mm |
| Location | Road |

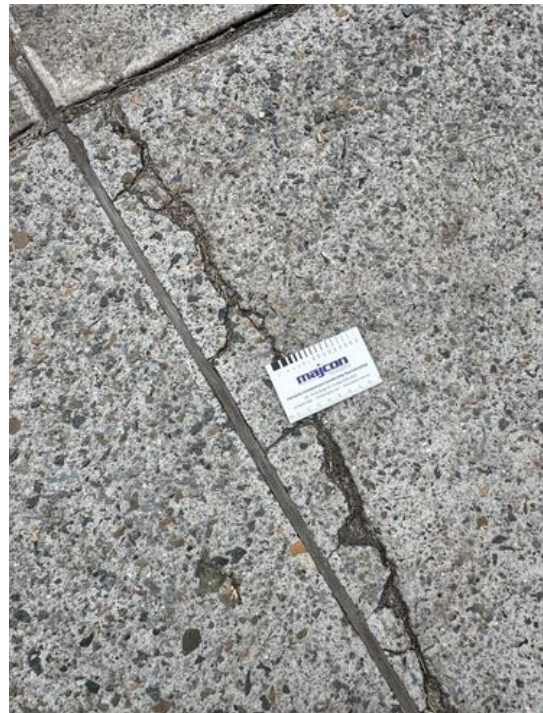
Photo 77

| Number of cracks | Cracking |
| Average length of cracks (mm) | 150 |
| Width of Cracks | Category 4; $4.0 < \alpha < 10.0$ mm |
| Location | Road |

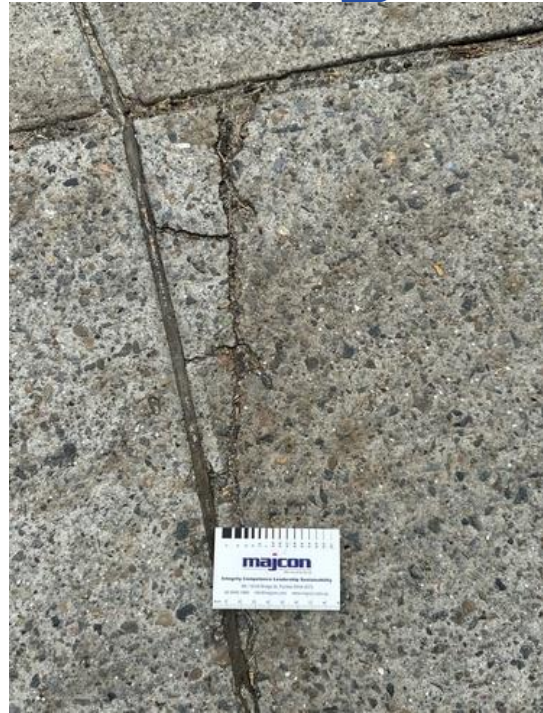
Photo 83

Number of cracks

Cracking

Average length of cracks (mm)

350

Width of Cracks

Category 4;  $4.0 < \alpha < 10.0$  mm

Location

Road

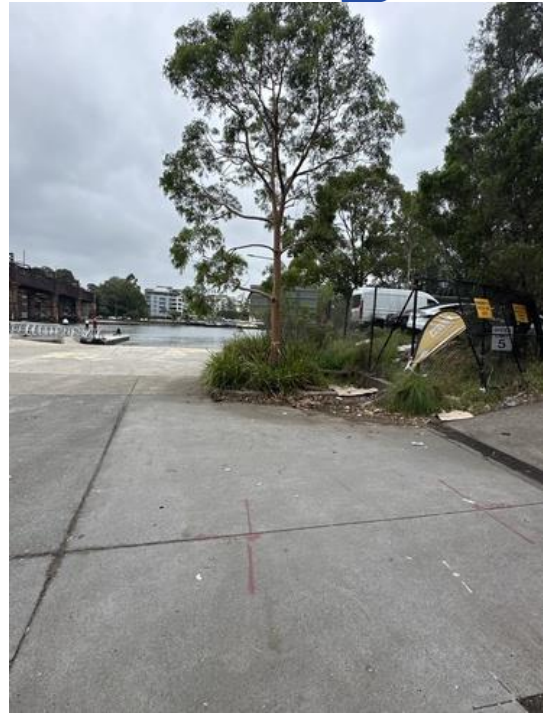
Photo 91

| Number of cracks | 1 |
| Average length of crack (mm) | 4000 |
| Width of Crack | Category 3; $2.0 < \alpha < 4.0$ mm |
| Location | Road |
