Pre-Construction Dilapidation Survey of 25-27 Leeds St, Rhodes -  
Roads and Council Assets - Leeds St

| MAJ-20240111-DS-REP-001-1C-R01 | | Complete |

RE: 25-27 LEEDS STREET, RHODES  
PRE-CONSTRUCTION DILAPIDATION SURVEY OF ROADS AND COUNCIL ASSETS – LEEDS STREET

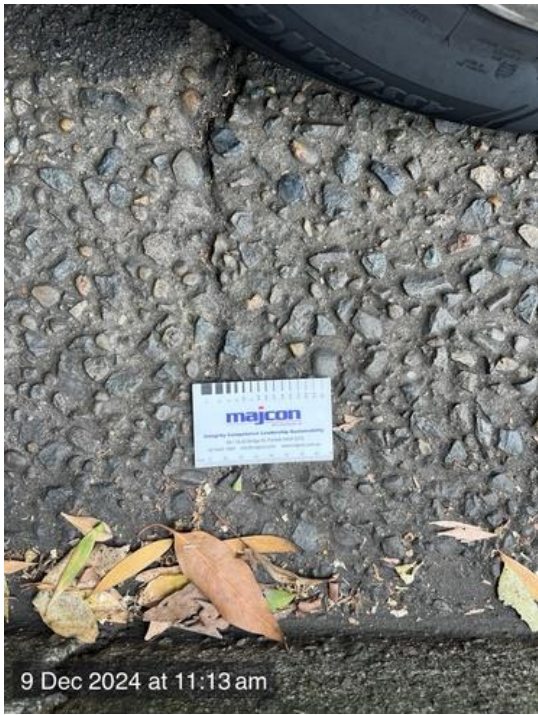
Photo 4

Category 4;  $4.0 < \alpha < 10.0$  mm

Gutter

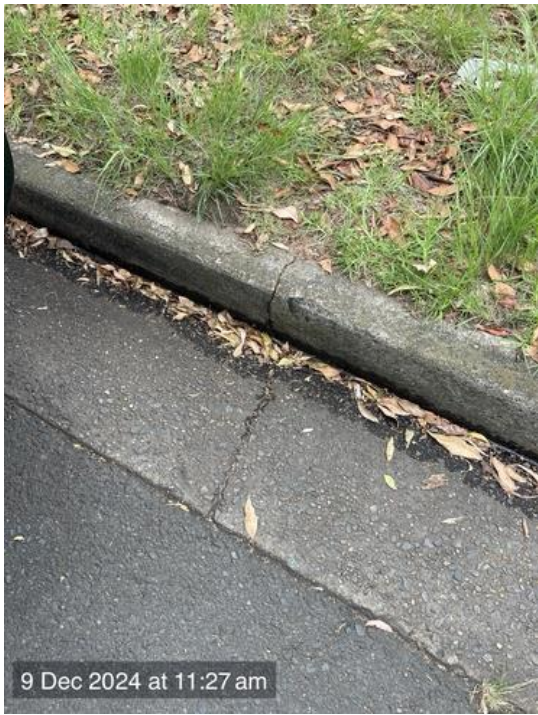
Photo 6

Category 4;  $4.0 < \alpha < 10.0$  mm

Kerb

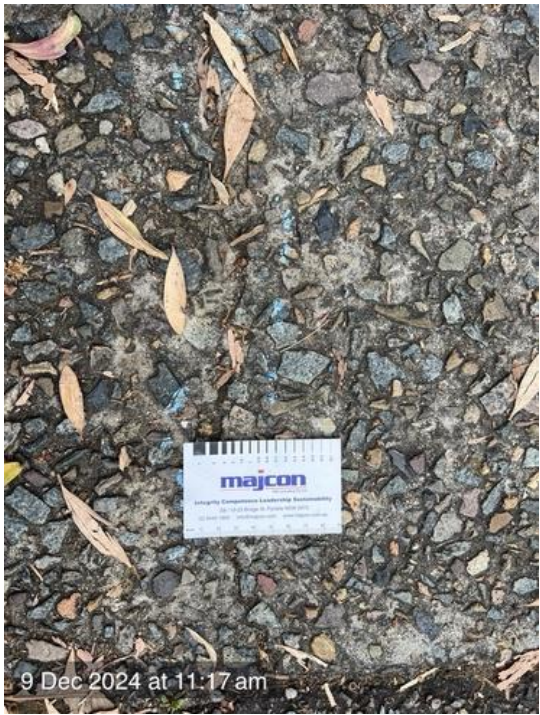
Photo 12

Category 4;  $4.0 < \alpha < 10.0$  mm

Driveway

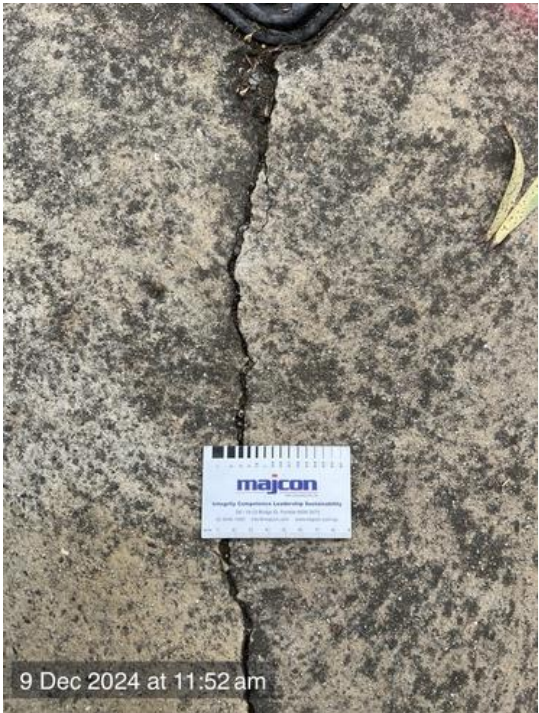
Photo 85

Number of cracks 3

Average length of crack 1 (mm) 500

Width of crack 1 Category 3;  $2.0 < \alpha < 4.0$  mm

Location Foot path

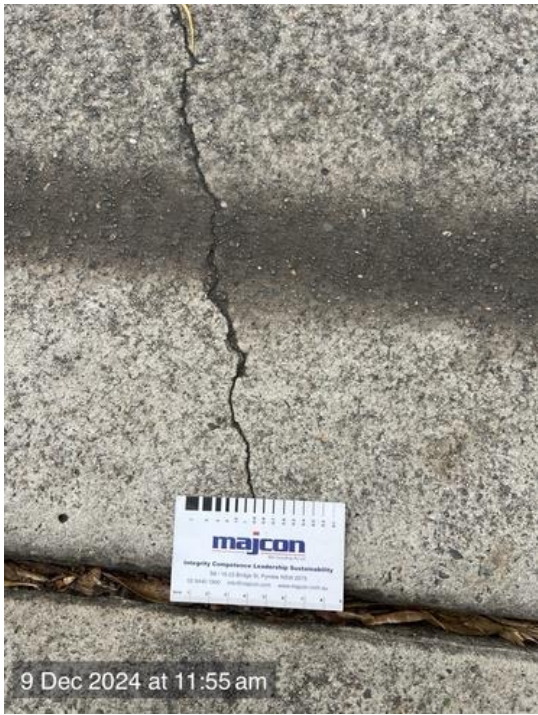
Photo 94

2

Category 2;  $1.0 < \alpha < 2.0$  mm

Category 3;  $2.0 < \alpha < 4.0$  mm

Gutter

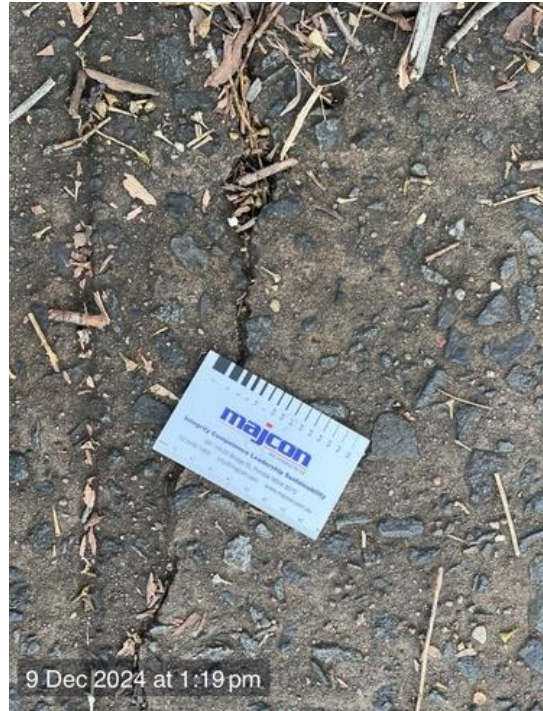
Photo 117

Number of cracks 1

Average length of crack (mm) 300

Width of Crack Category 3;  $2.0 < \alpha < 4.0$  mm

Location Foot path

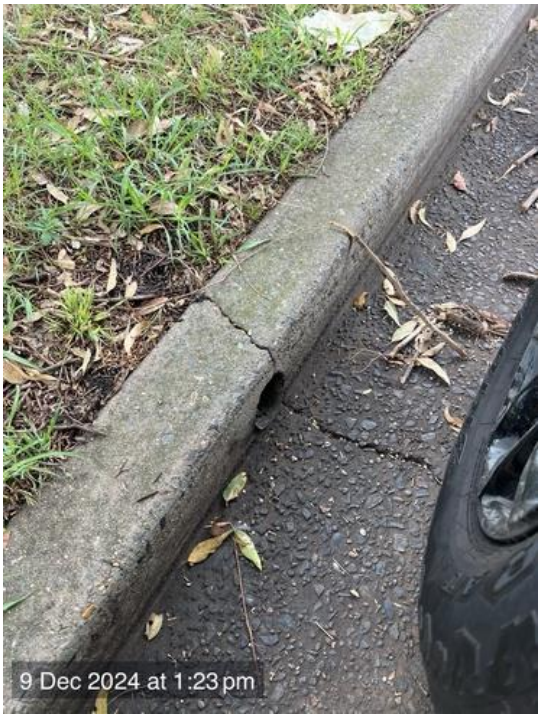
Photo 127

| Number of cracks | Typical |
| Average length of crack (mm) | 500 |
| Width of crack | Category 3; 2.0 < α < 4.0 mm |

| Kerb | Gutter |

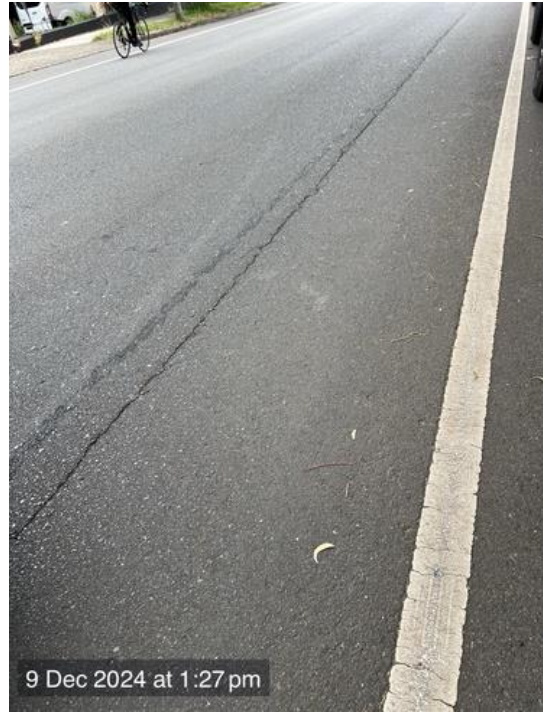
Photo 133

Number of cracks1

Average length of crack (mm)500

Width of CrackCategory 3; 2.0 <  $\alpha$  < 4.0 mm

LocationFoot path

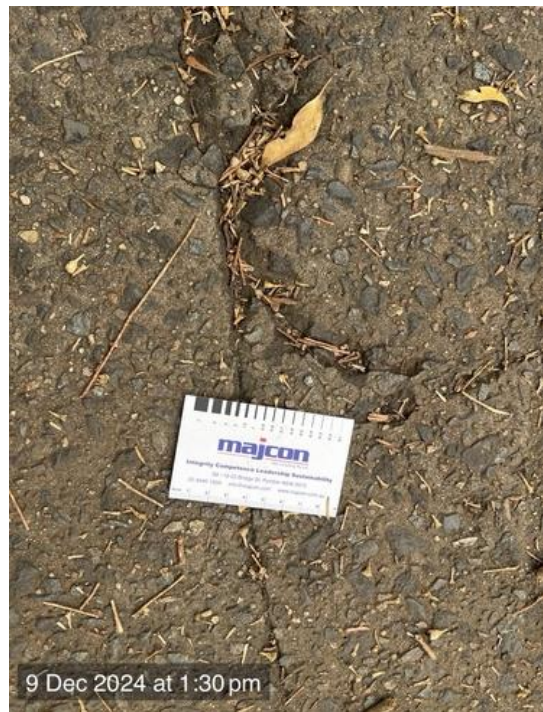
Photo 143

3

Category 3; 2.0 <  $\alpha$  < 4.0 mm

Foot path

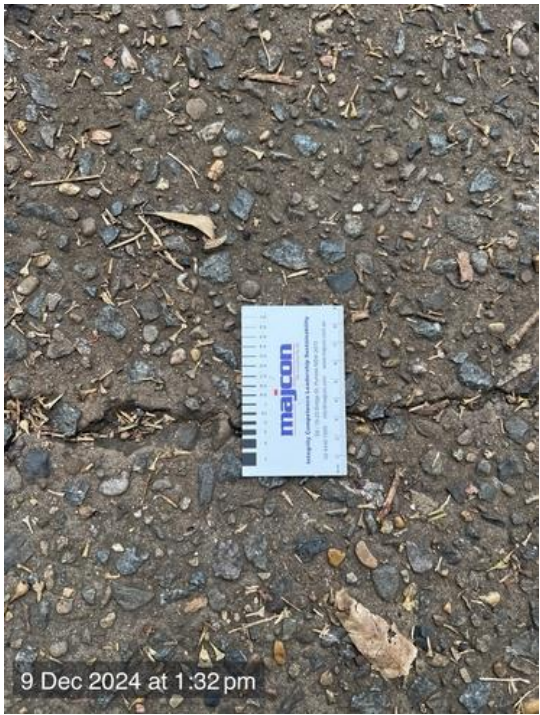
Photo 146

Number of cracks Typical

Average length of crack (mm) 2500

Width of crack Category 3;  $2.0 < \alpha < 4.0$  mm

Location Driveway

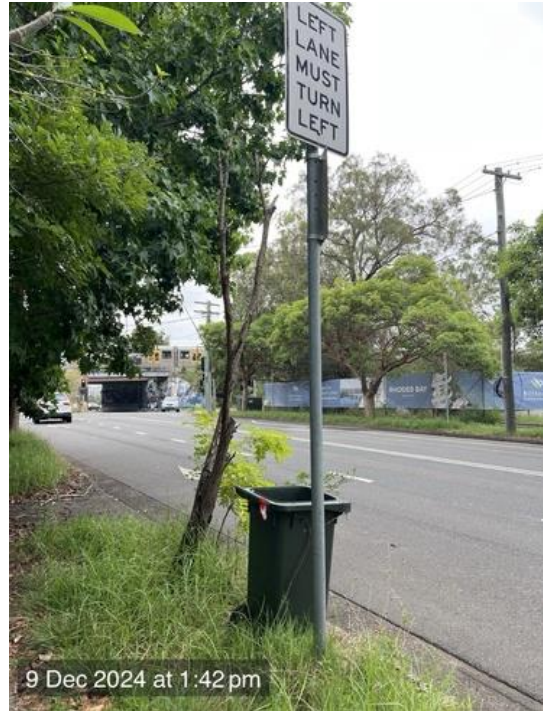
Photo 167

Damage

Road

Service cover

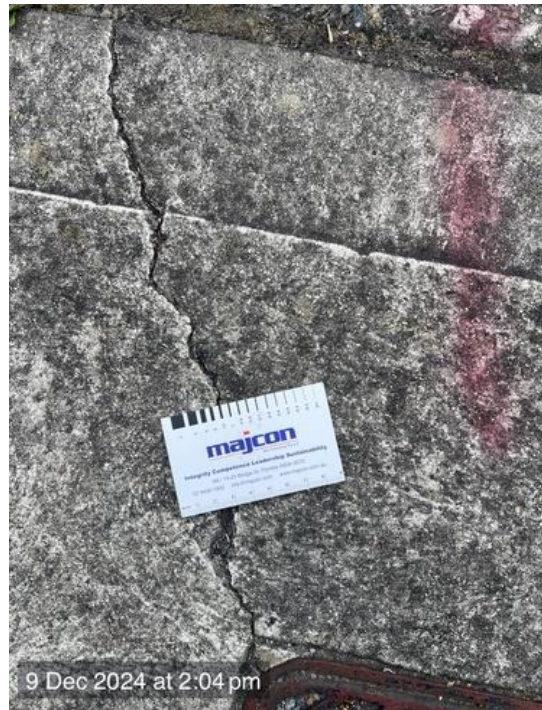
Photo 237

- A. Cracks to gutter (example Photo 4-5, category 4; Photo 94-96, category 2 & 3)
- B. Cracks to kerb (example Photo 6-10, category 4)
- C. Typical crack to driveway (example Photo 12-13, category 4; Photo 146-148, category 3)
- D. Cracks to Road (example Photo 64-67, category 3; Photo 228, category 3)
- E. Cracks to footpath (example Photo 85-88, category 3; Photo 132-133, category 3)
- F. Cracks to kerb and gutter (example Photo 214-217, category 3)
- G. Cracks to service cover (example Photo 237-239, category 3)
