## 20240111 25-27 Leeds Street, Rhodes - Pre-Demolition Dilapidation Survey of External Elevations and Common Areas at 21 Leeds Street, Rhodes

MAJ-20240111-DS-REP-001-2D-R01

Re: 25-27 LEEDS STREET, RHODES  
PRE-CONSTRUCTION DILAPIDATION SURVEY OF EXTERNAL ELEVATIONS AND COMMON AREAS  
AT 21 LEEDS STREET, RHODES

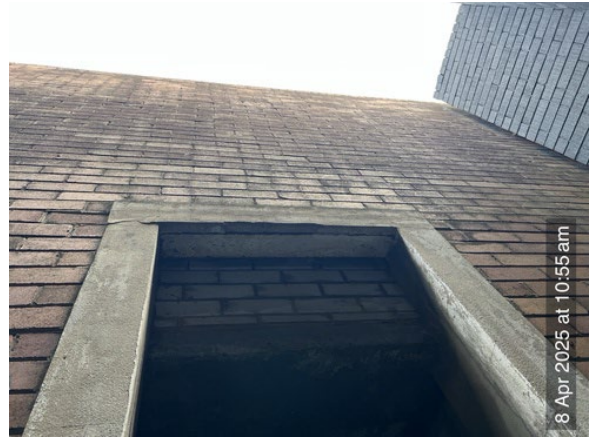
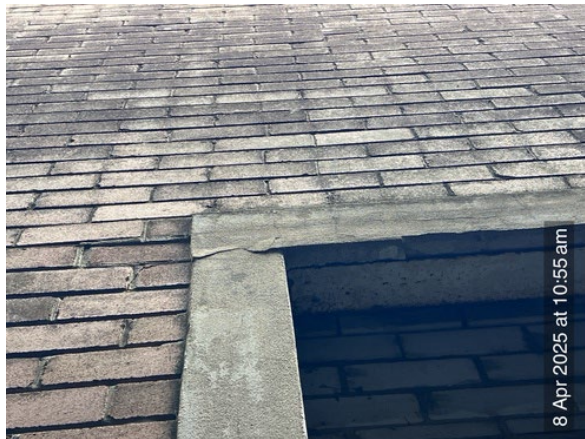
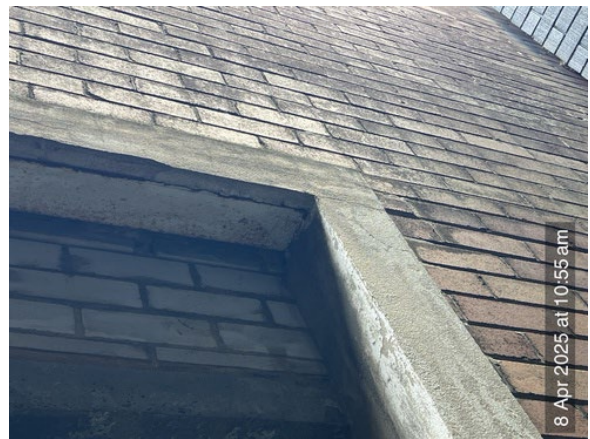
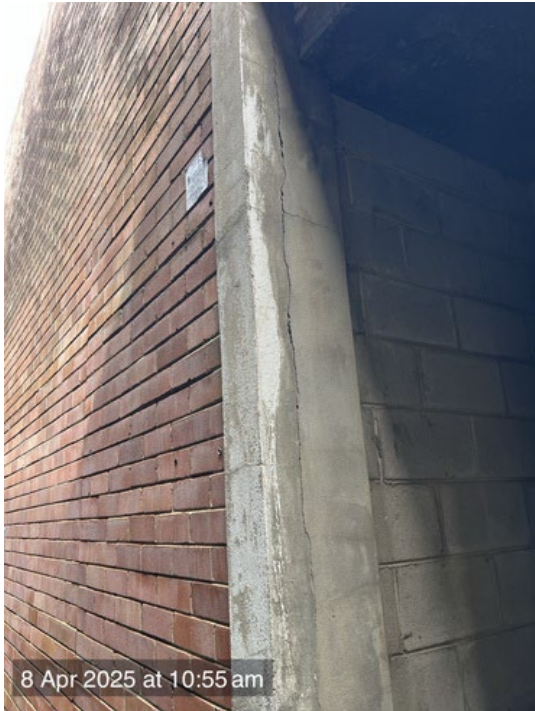
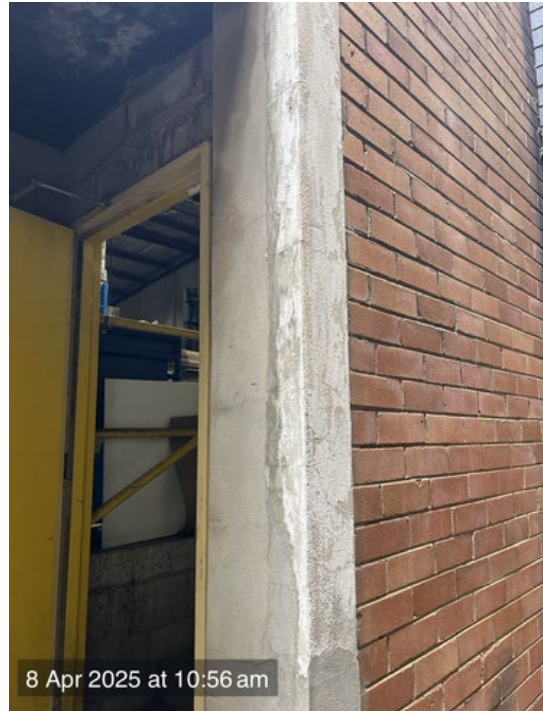
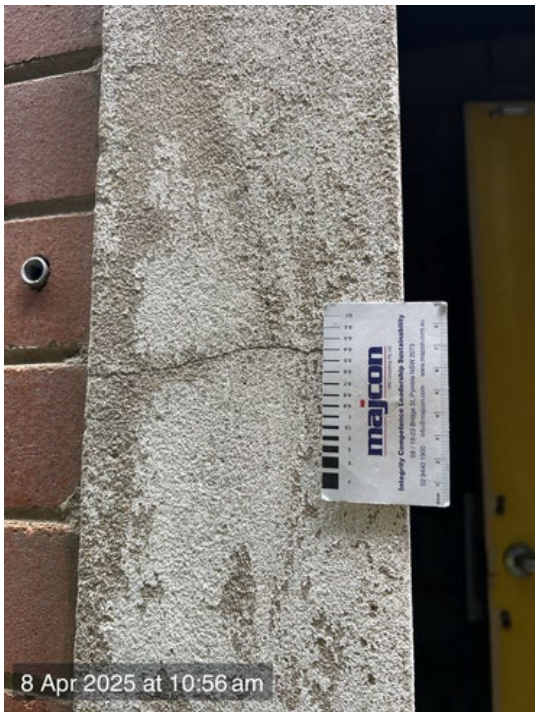
Category 0;  $a < 0.3 \text{ mm}$

Hairline cracks on architrave

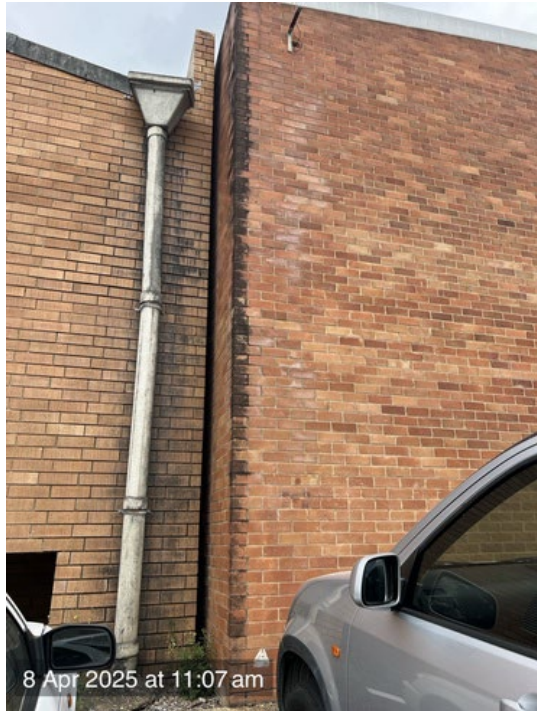
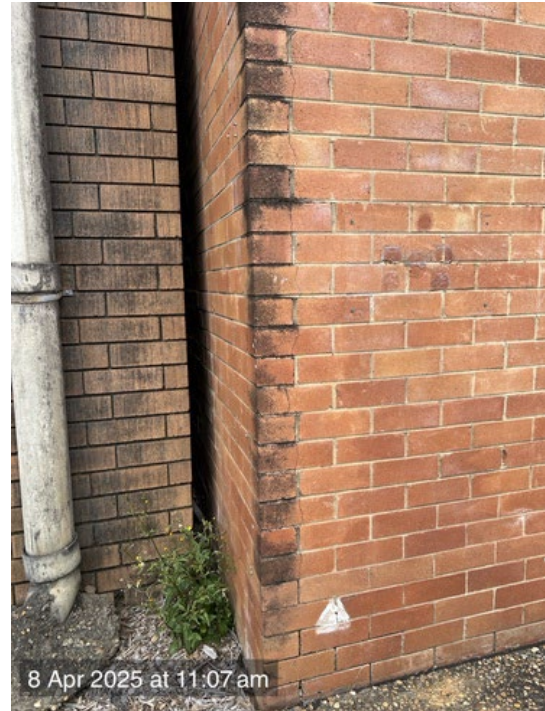
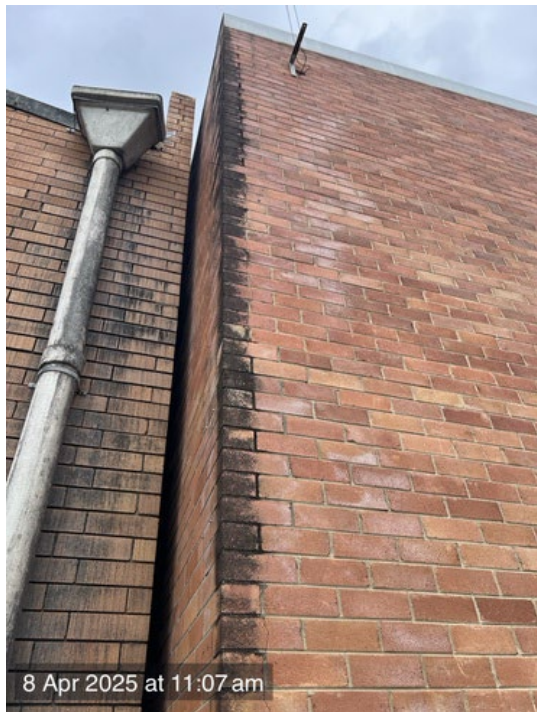
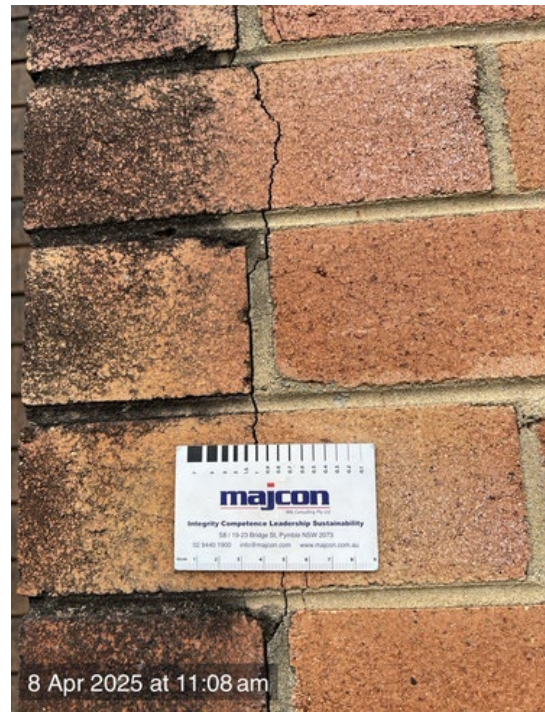
- i. Cracks on external brick wall (Example photos 49-52 - Category 1)
- ii. Typical cracks on coffee shop entry area floor (Example photos 94 – Category 1; photos 69, 85-90 – Category 2; photo 118 – Category 3)
- iii. Movement of floor slab (Example photo 72)
- iv. Movement at planter box (Example photo 77)

Wall

Category 1;  $0.1 \text{ mm} < \alpha < 1.0 \text{ mm}$

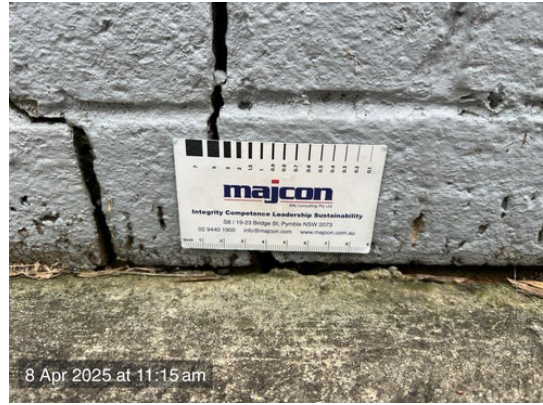
Boundary wall

| Width of Crack | Category 4; $4.0 < a < 10.0$ mm |

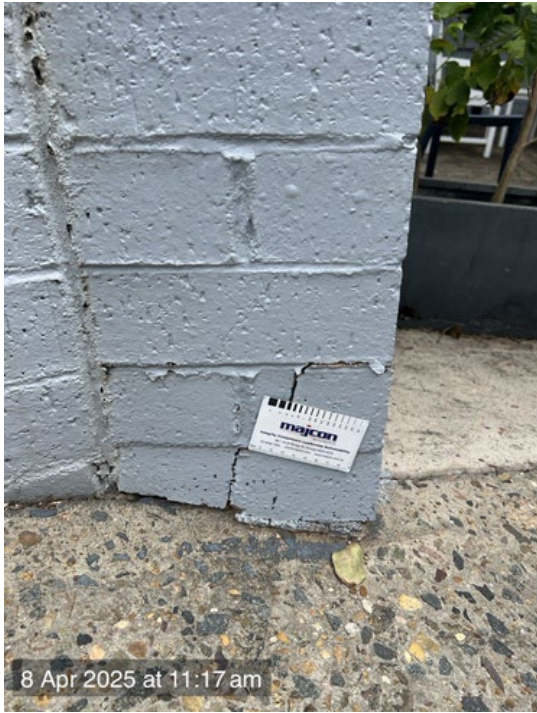
| Width of Crack | Category 3; $2.0 < a < 4.0$ mm |

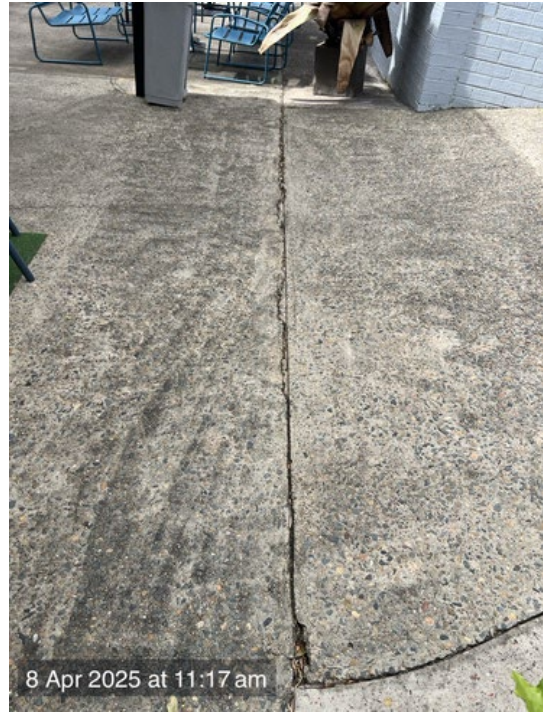
| Type of Photo | Damage |
| Location | Floor |

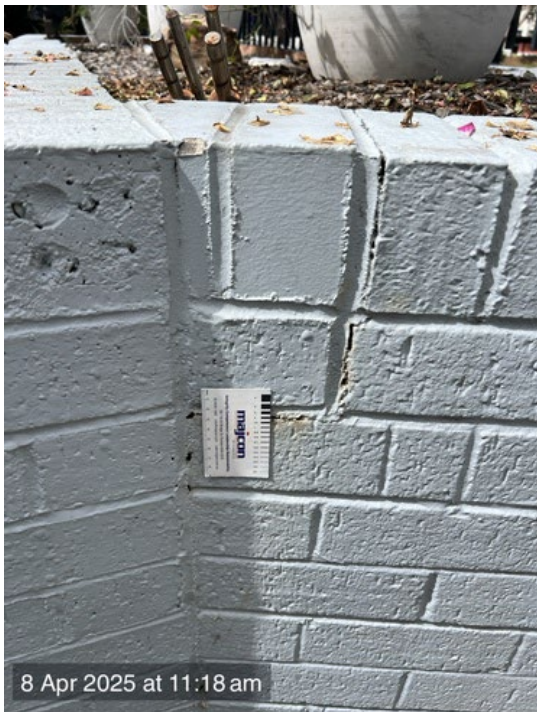
Category 2;  $1.0 < a < 2.0$  mm

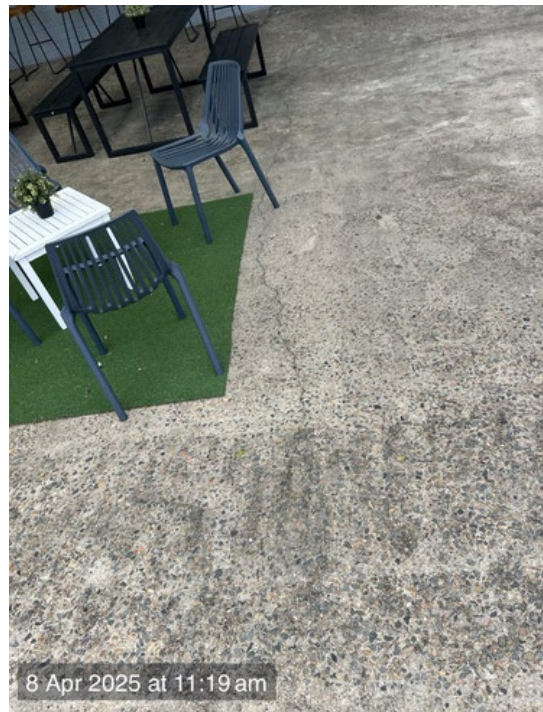
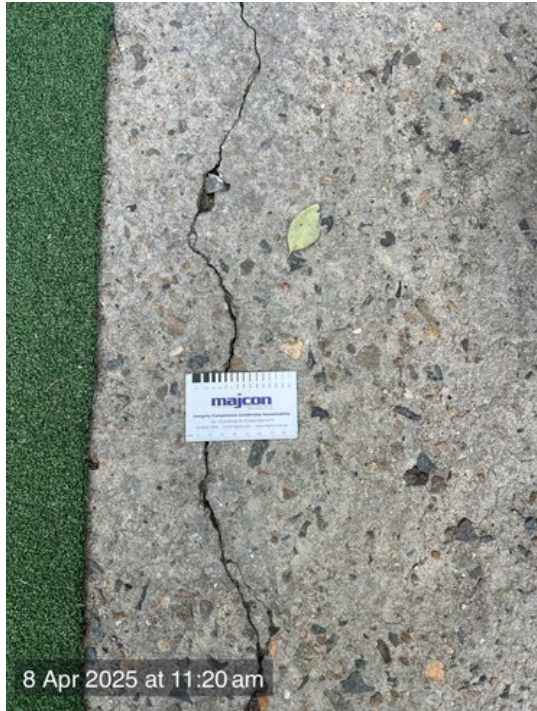
Floor

Category 2;  $1.0 < a < 2.0$  mm

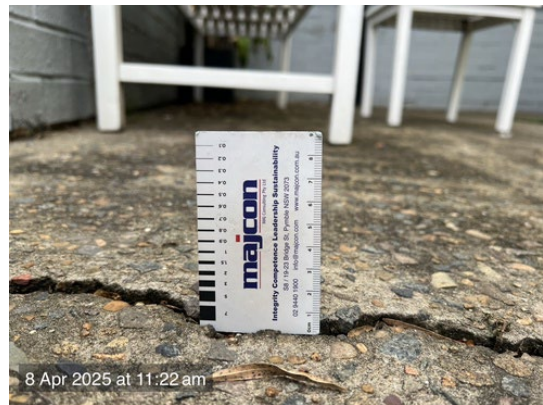
| Location | Floor |
| Distance (mm) | 10 |

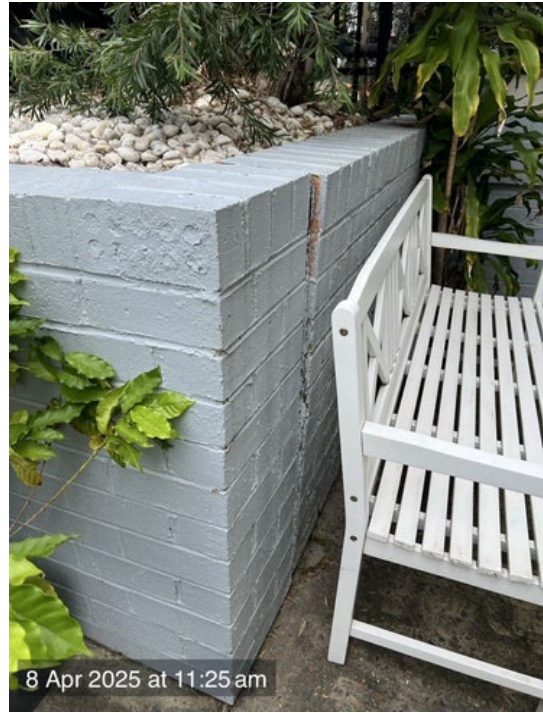
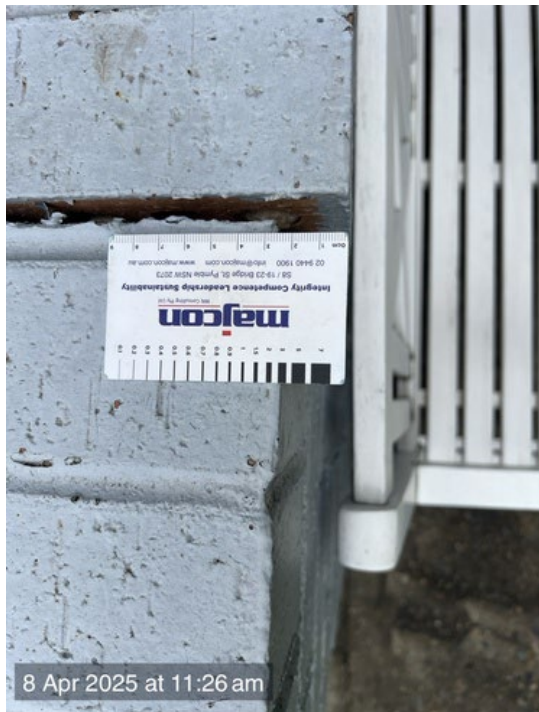
| Details | Movement at planter box |
| Distance (mm) | 30 |

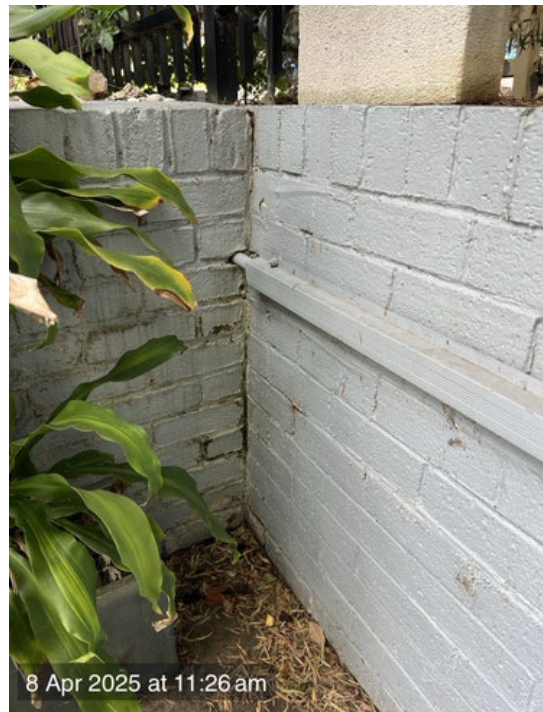
| Details | Stain on planter box |
| Type of Stain | Water |

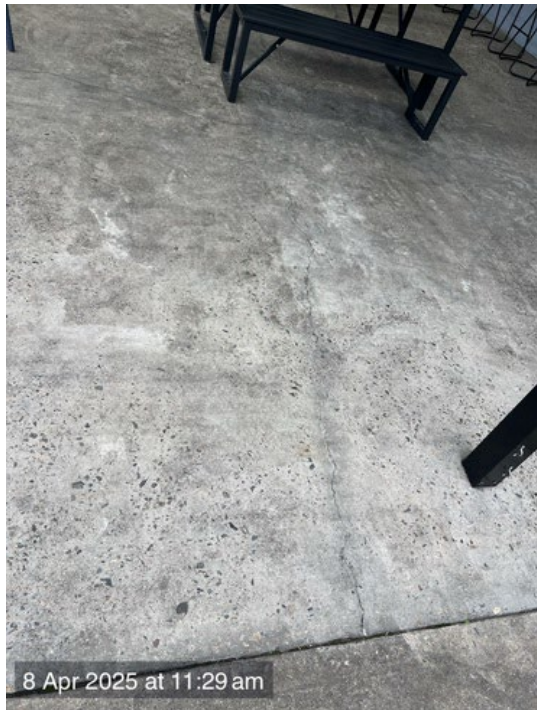
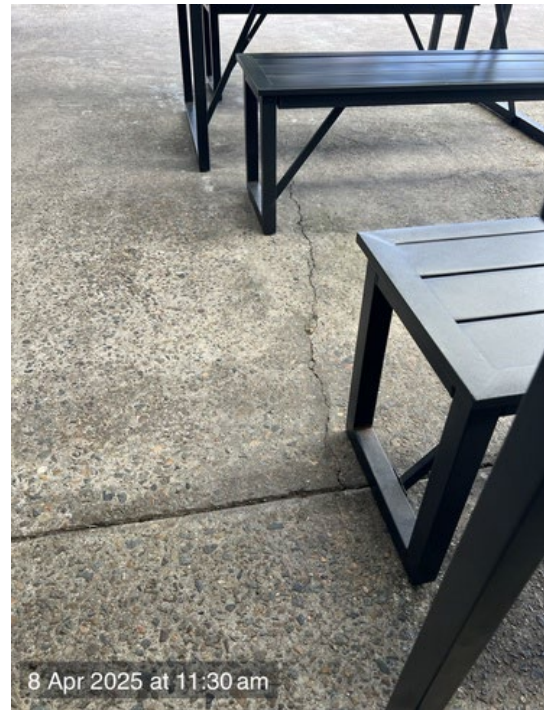
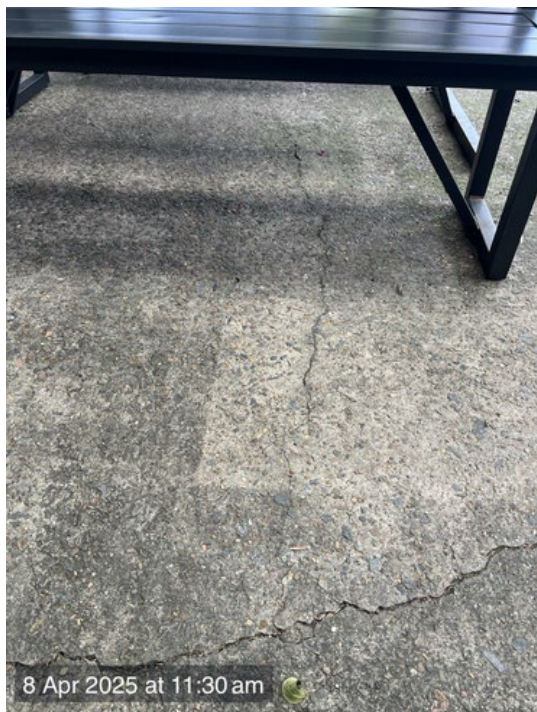
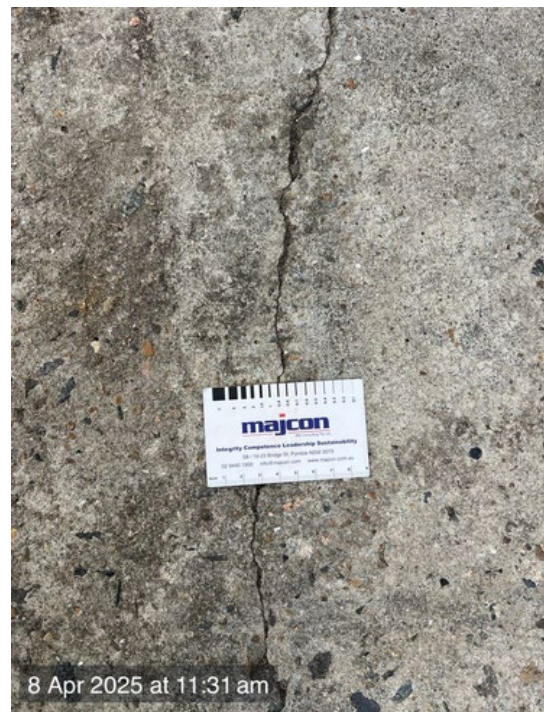
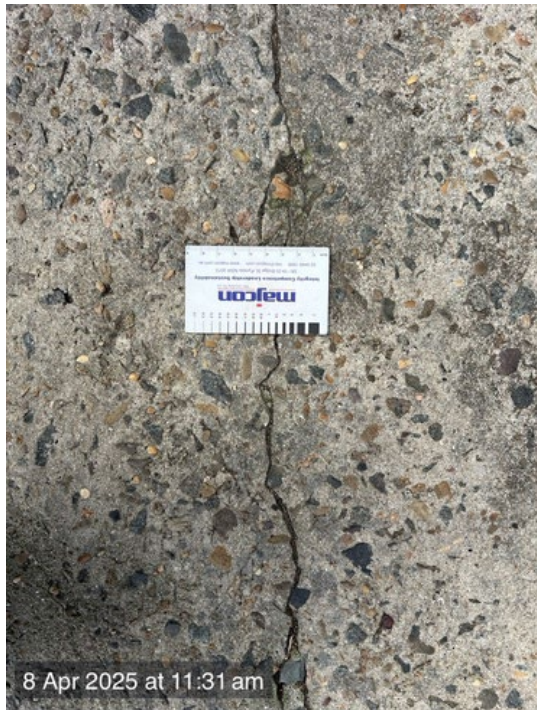
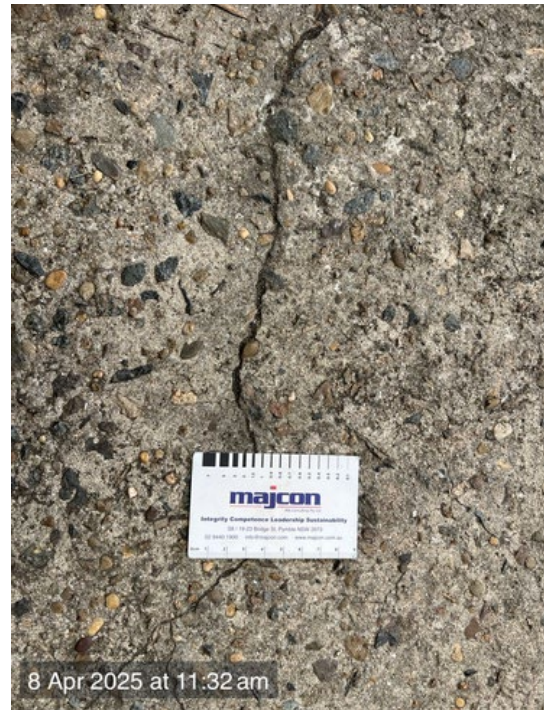
Floor

Category 2; 1.0 < a < 2.0 mm

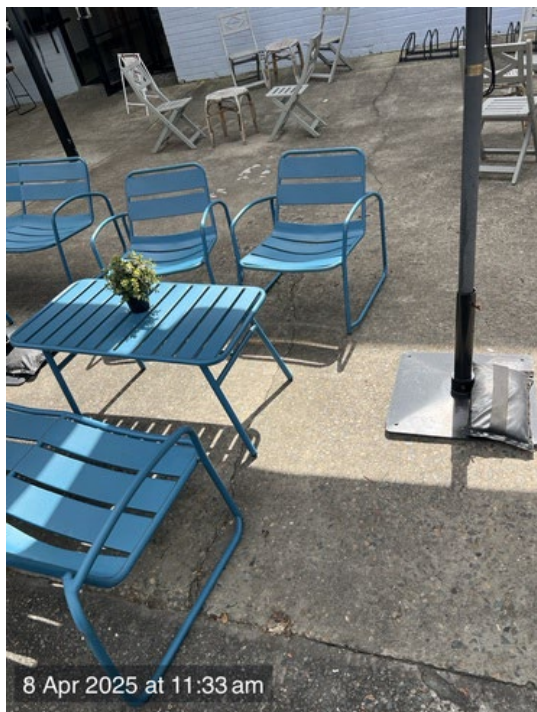
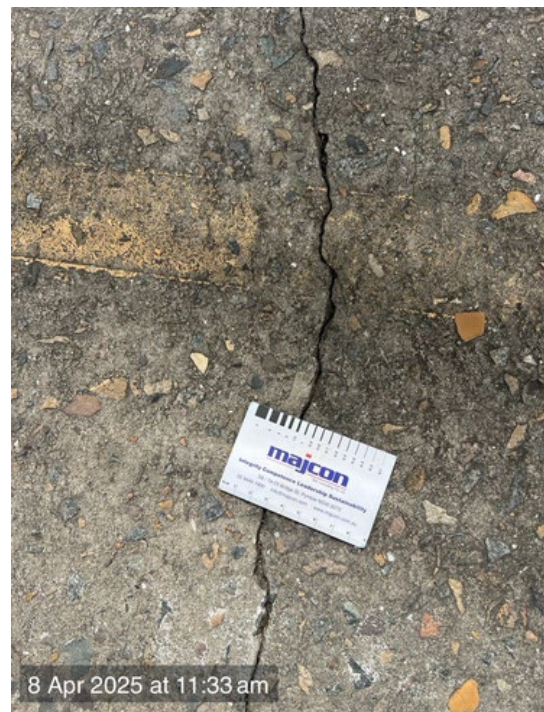
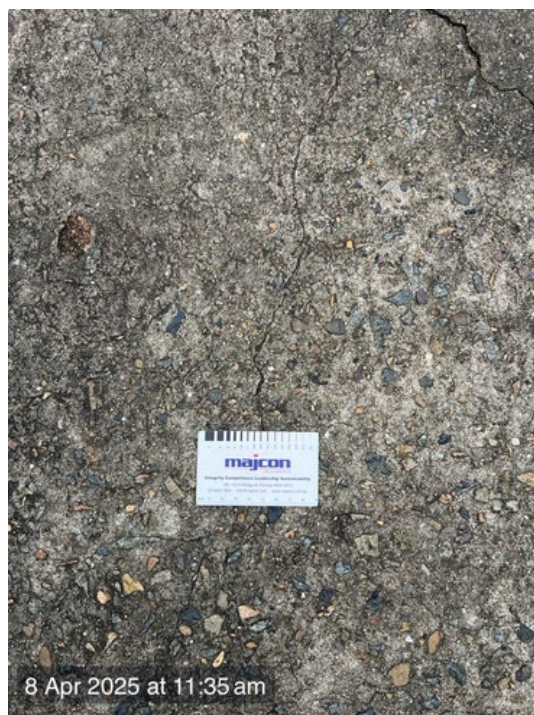
Category 2; 1.0 < a < 2.0 mm

| Width of Crack 2 | Category 1; $0.3 < a < 1.0$ mm |

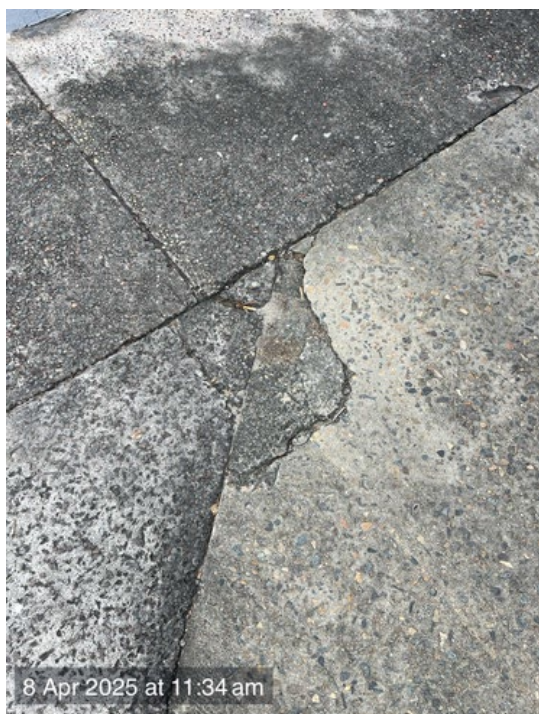
| Damage on the external floor | |

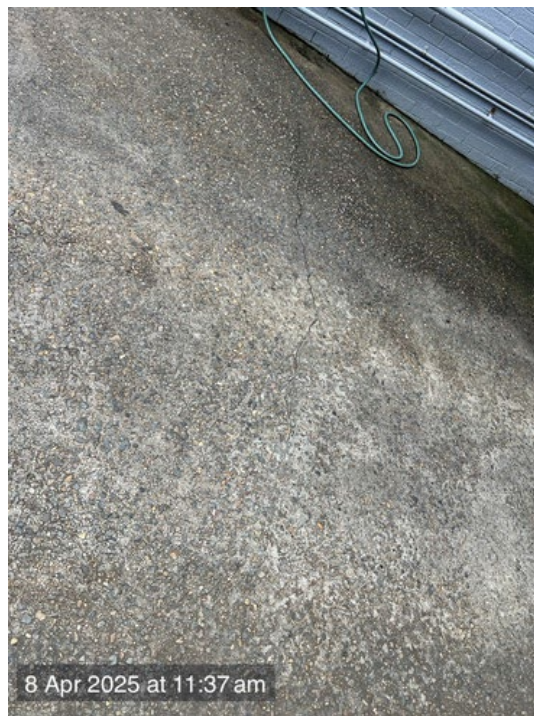
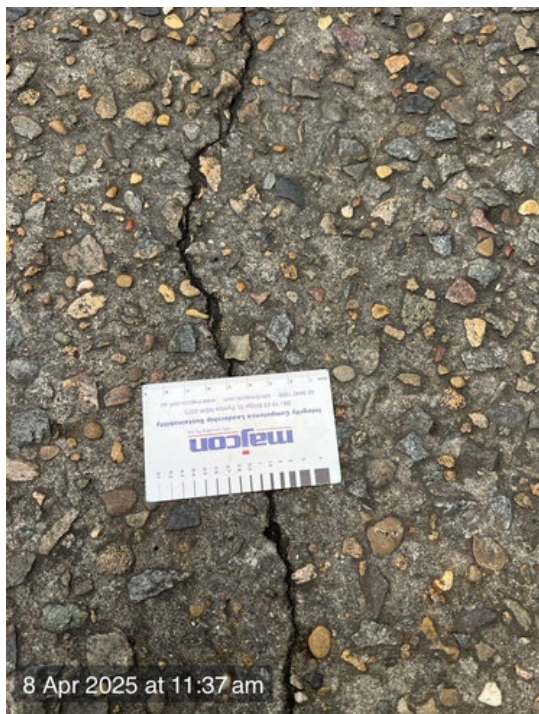
| Width of Crack | Category 2; $1.0 < a < 2.0$ mm |

Cracks on driveway

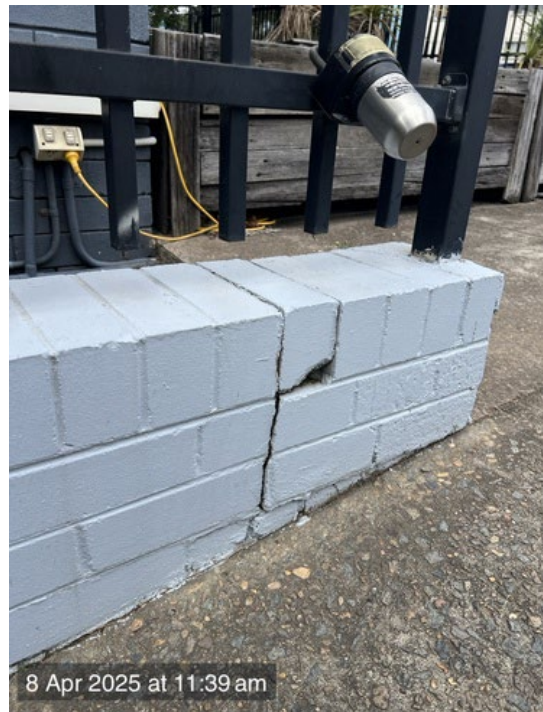
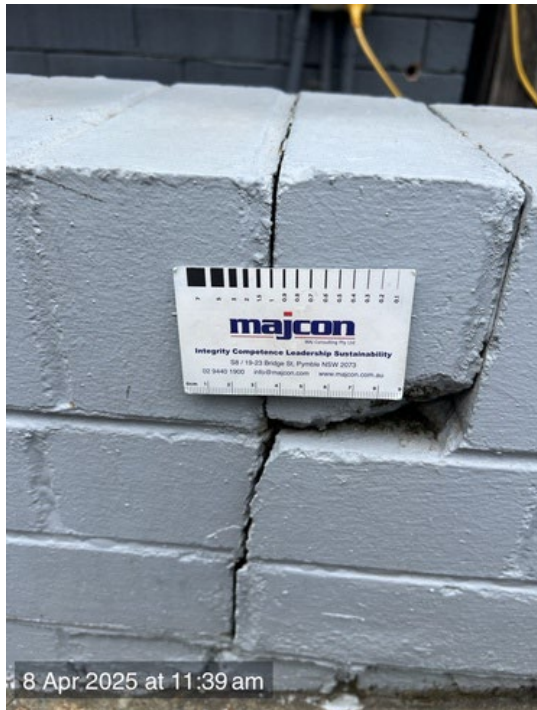
Width of CrackCategory 1; 0.3 < a < 1.0 mm

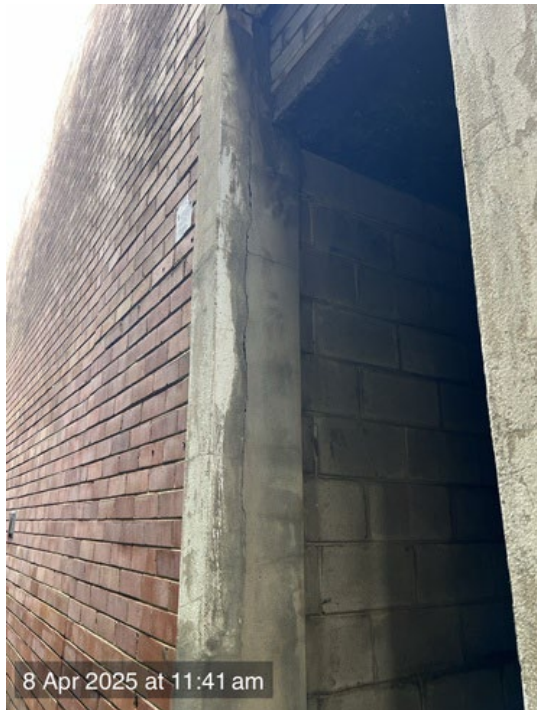
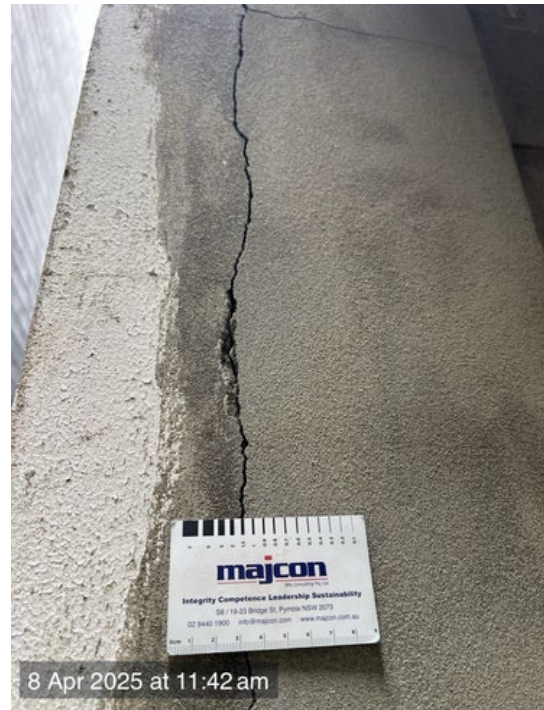
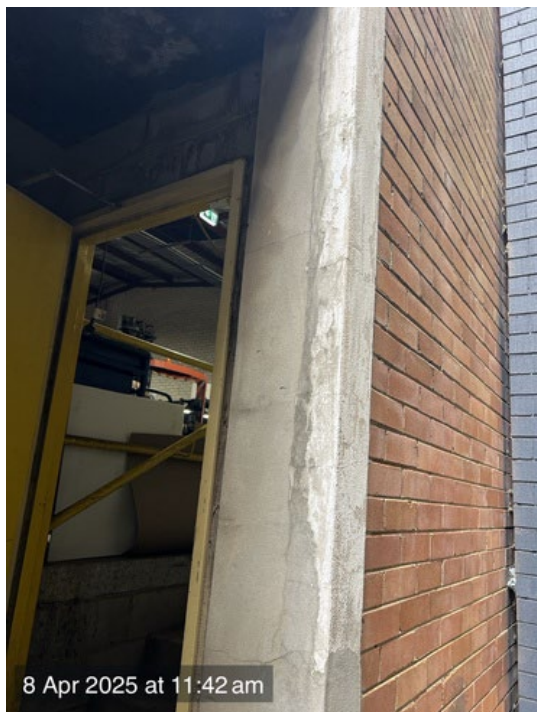
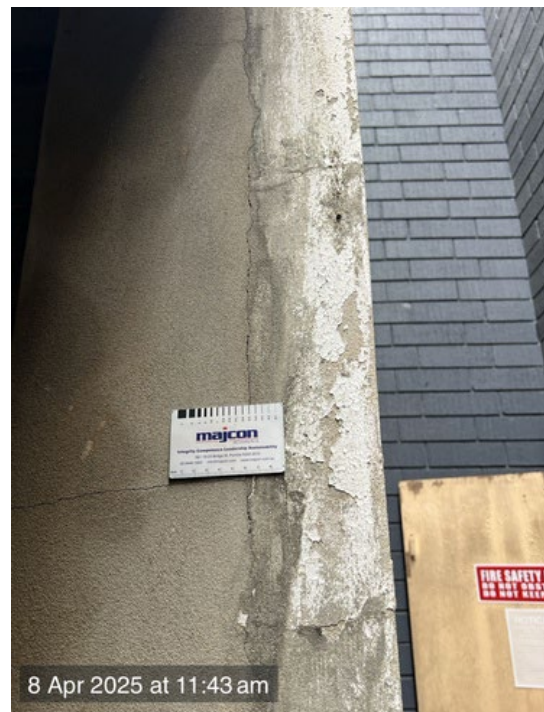
| Width of Crack 1 | Category 2; $1.0 < a < 2.0$ mm |
| Width of Crack 2 | Category 1; $0.3 < a < 1.0$ mm |
| Other Details | Cracks on architrave render |

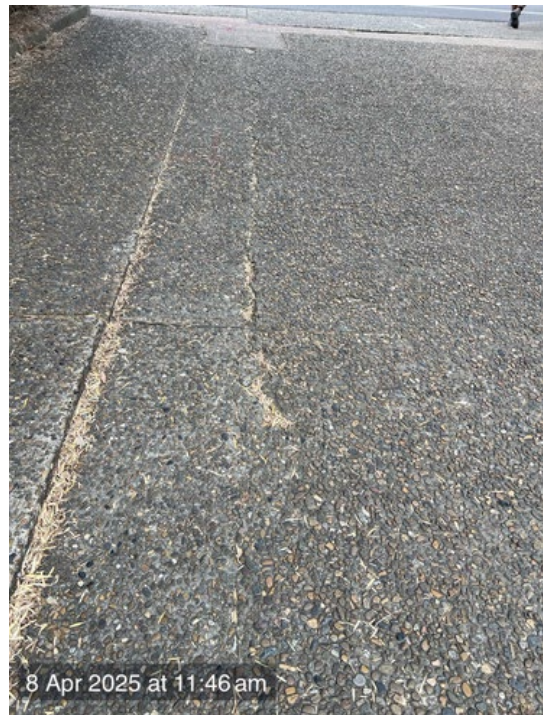
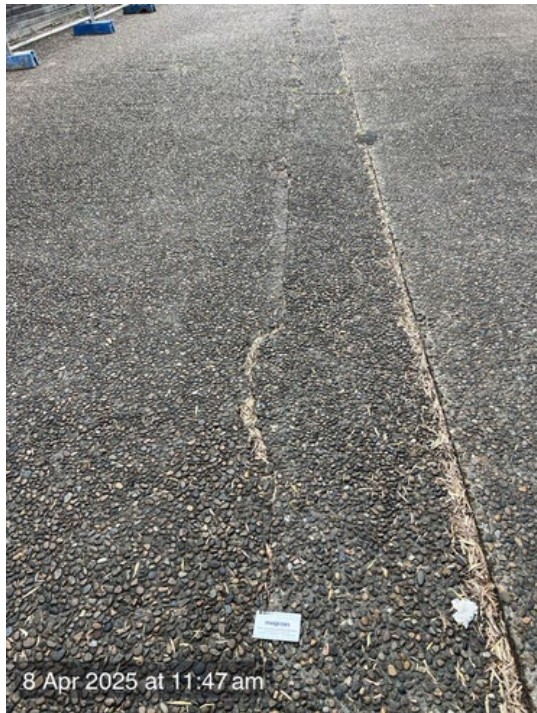
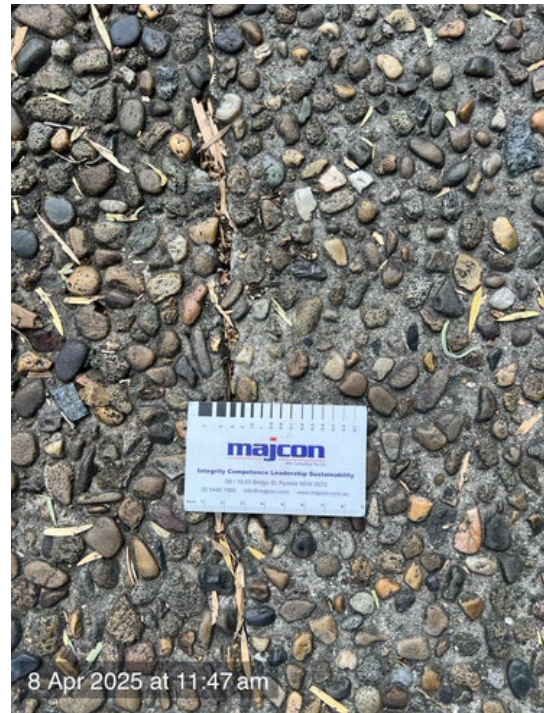
Category 3;  $2.0 < a < 4.0$  mm

Cracks on common driveway

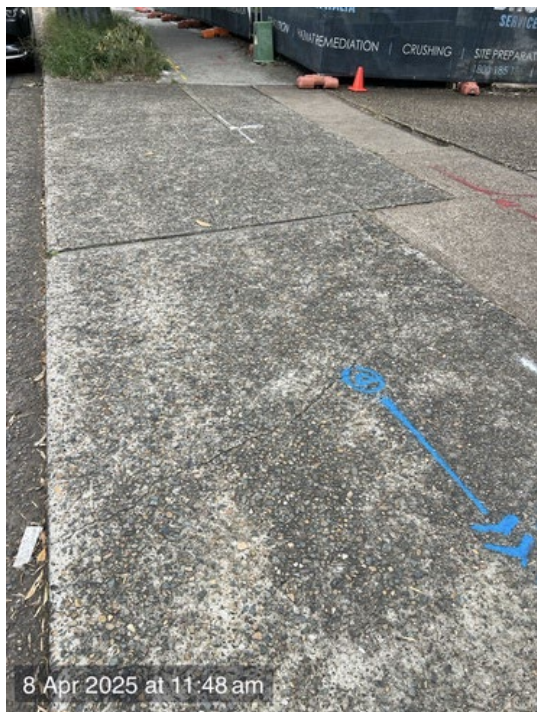
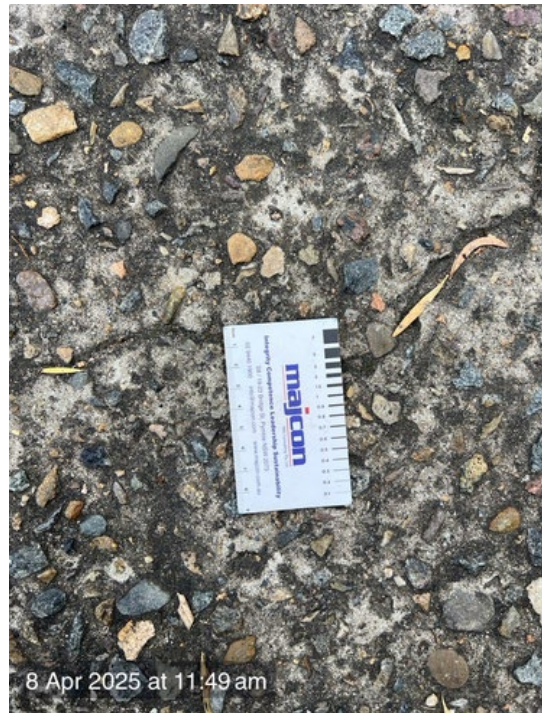
| Width of Crack | Category 3; 2.0 < a < 4.0 mm | | | |
| Other Details | Cracks on common driveway | | | |

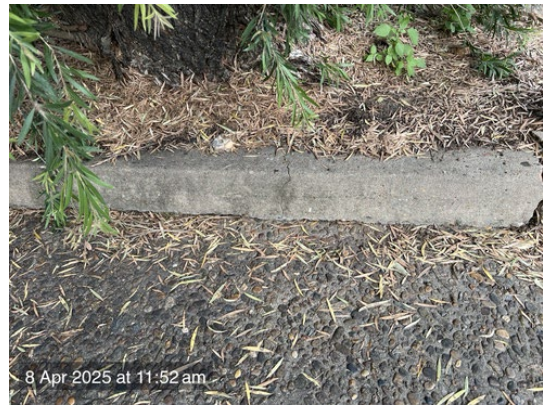
| Width of Crack | Category 1; 0.3 < a < 1.0 mm | | | |
| Other Details | Typical cracks on kerb | | | |
