## 20240111 25-27 Leeds Street, Rhodes - Pre-Demolition Dilapidation Survey of External Elevations and Carpark Area at 23 Leeds Street, Rhodes

MAJ-20240111-DS-REP-001-1E-R01

RE: 25-27 LEEDS STREET, RHODES  
PRE-DEMOLITION DILAPIDATION SURVEY OF EXTERNAL ELEVATIONS AND CARPARK AREA AT  
23 LEEDS TREET, RHODES

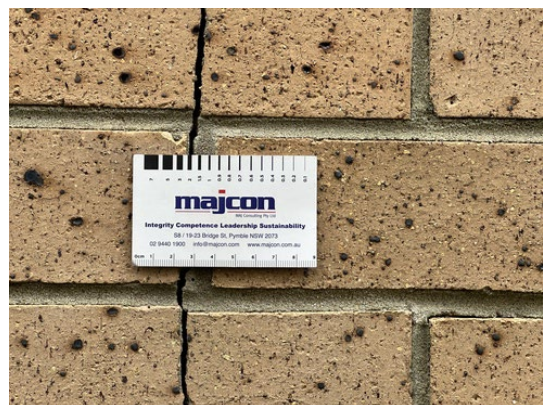
Photo 13

Crack

Wall

1000 mm

Category 2;  $1.0 \text{ mm} < \alpha < 5.0 \text{ mm}$

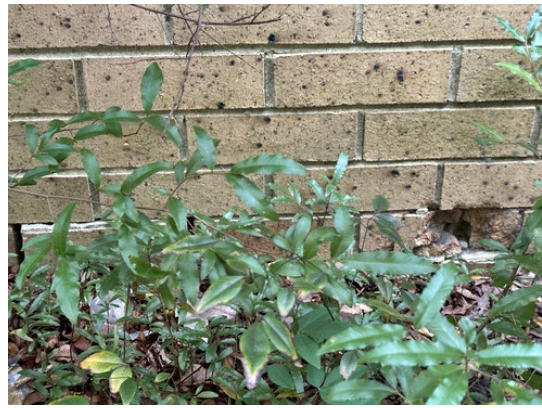
Photo 24

| Type of Photo | Movement |

| Location | Wall |
| Distance (mm) | 5 |
| Other Details | Outward movement of brick wall |

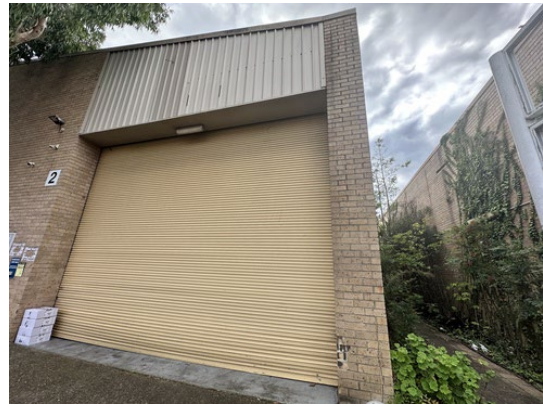
Photo 31

| Type of Photo | Damage |

| Location | Wall |
| Details | Missing a piece of brick on the wall |

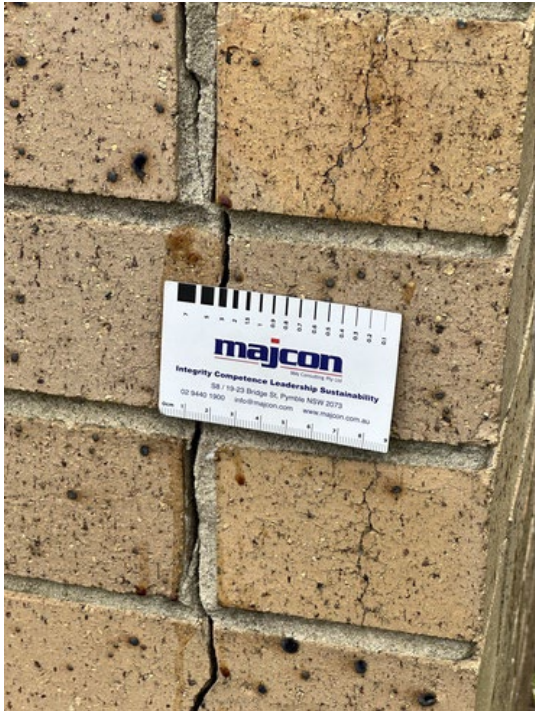
Photo 34

Crack

Wall

2500 mm

Category 2;  $1.0 \text{ mm} < \alpha < 5.0 \text{ mm}$

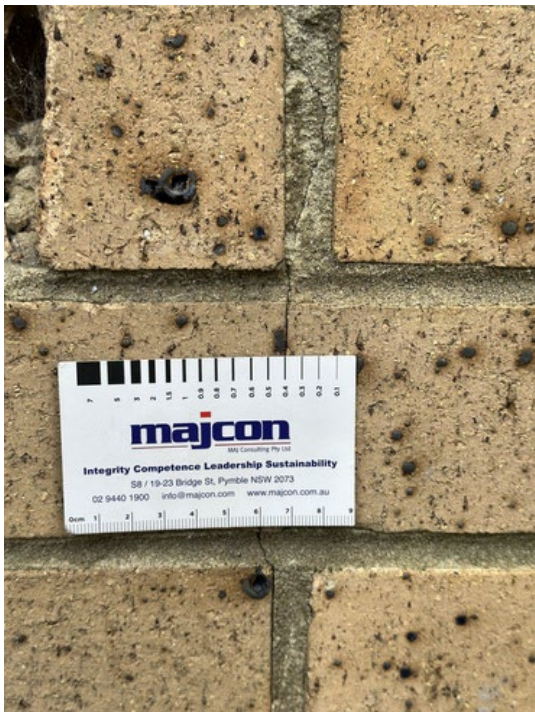
Photo 36

Crack

Wall

1000 mm

Category 1;  $0.1 \text{ mm} < \alpha < 1.0 \text{ mm}$

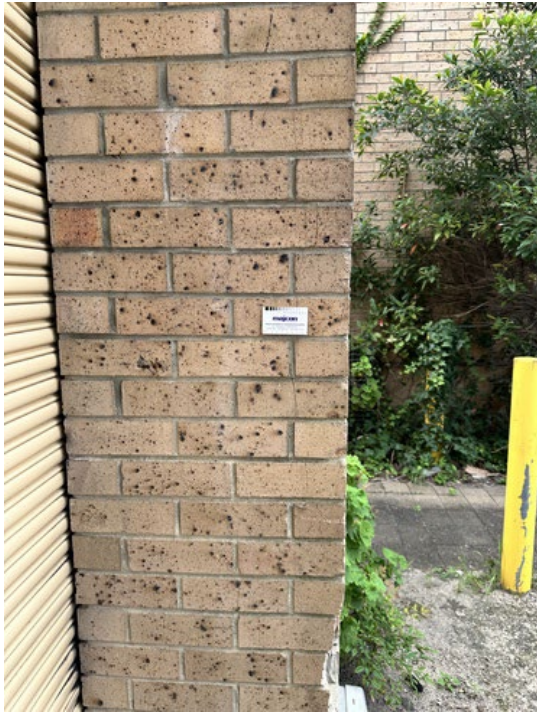
Photo 38

Damage

Wall

Damage to brick wall

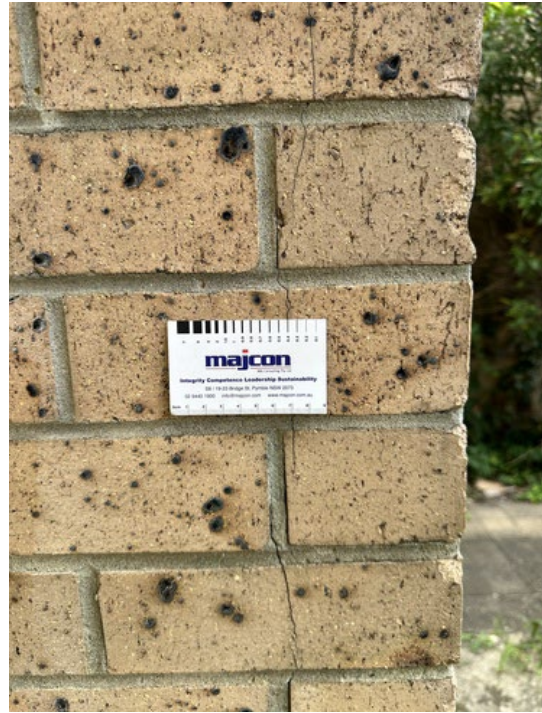
Photo 39

Crack

Wall

1000 mm

Category 1;  $0.1 \text{ mm} < \alpha < 1.0 \text{ mm}$

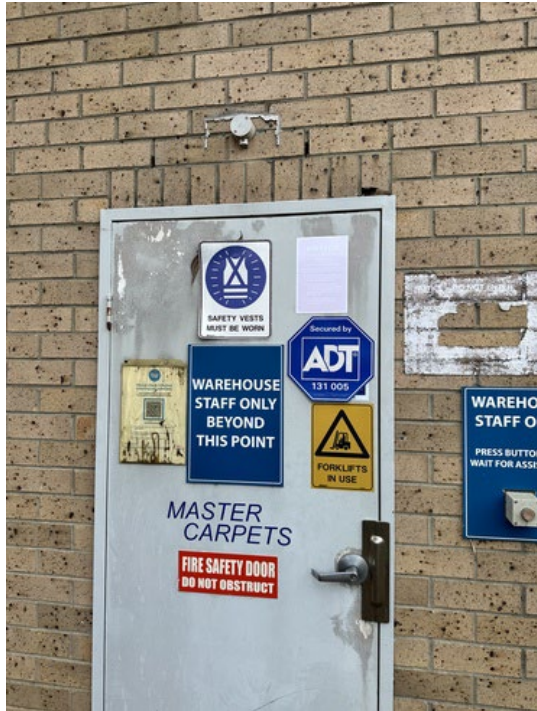
Photo 42

Damage

Wall

Damage to brick wall

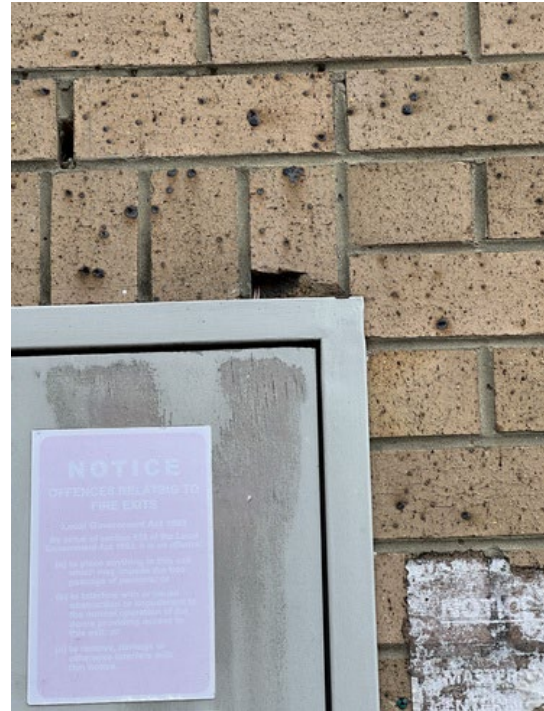
Photo 43

Damage

Wall

Damage to brick wall on top of the fire safety door

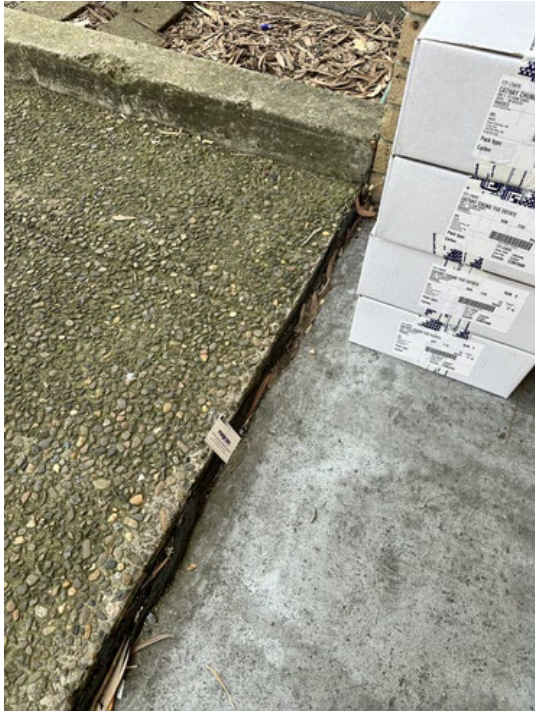
Photo 66

Damage

| Other Details | Damage to kerb |

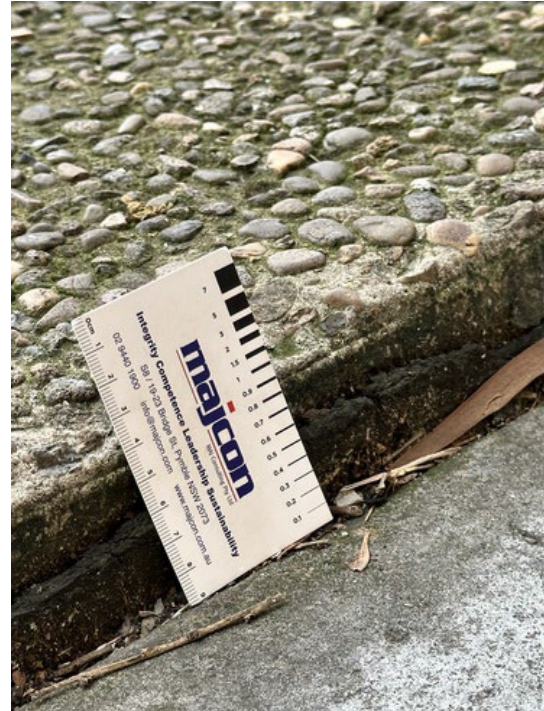
Photo 67

| Type of Photo | Movement |

| Location | Slab |
| Distance (mm) | 50 |

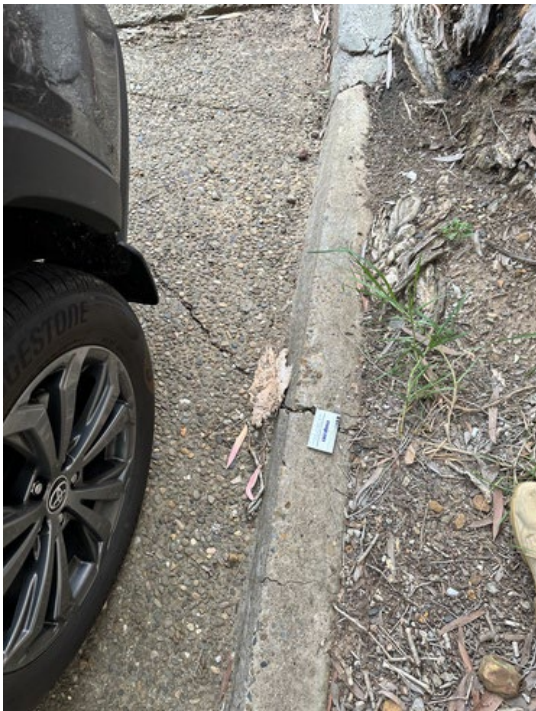
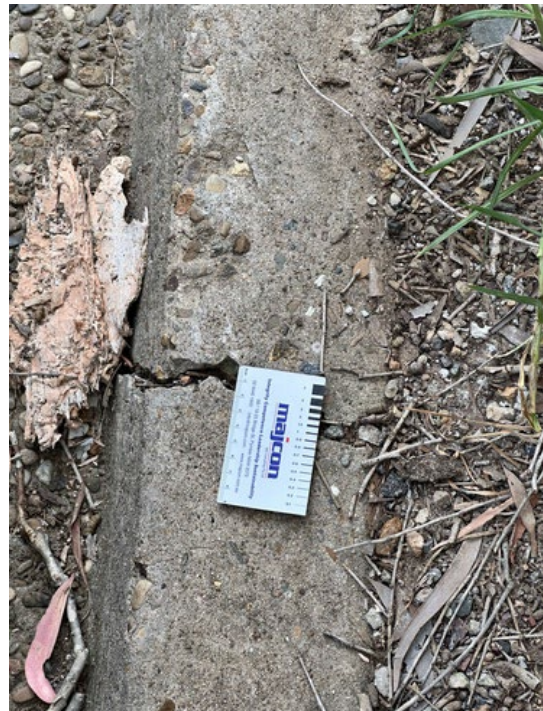
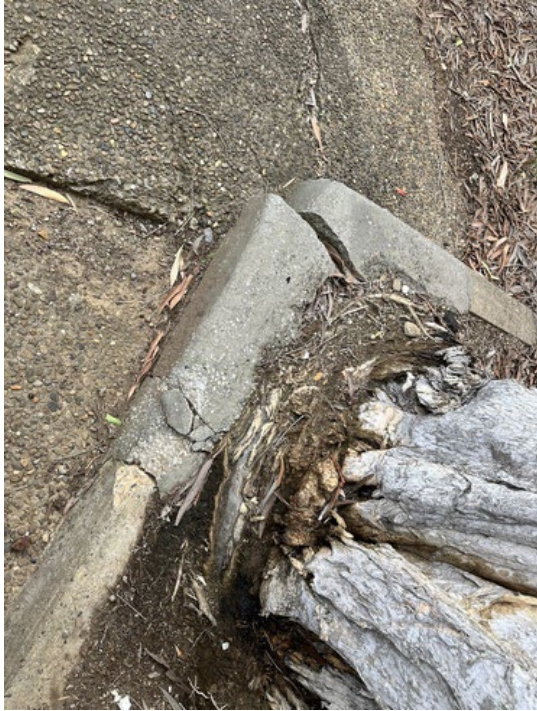
| Type of Photo | Crack |

| Location | Other |

| Average Length of Crack | 250 mm |

| Width of Crack | Category 3; $2.0 < a < 4.0$ mm |

| Other Details | Typical cracks to kerb |

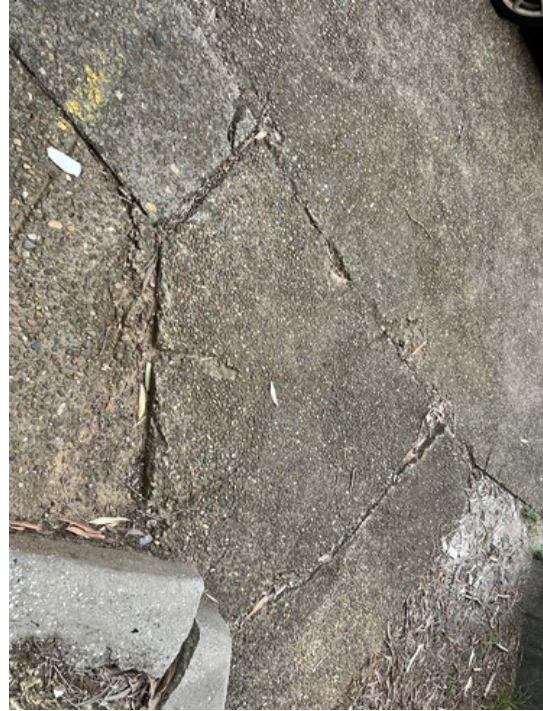
Photo 79

| Type of Photo | Damage |

| Location | Slab |

| Other Details | Crack and damage to kerb and driveway slab |

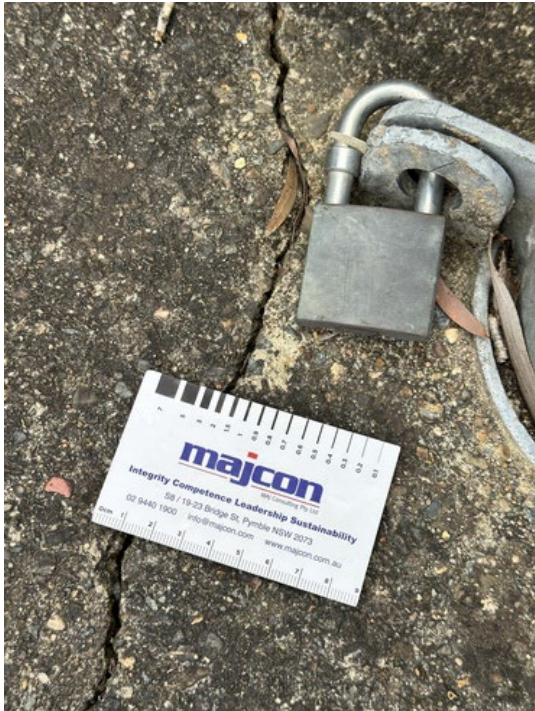
Photo 88

| Type of Photo | Crack |

| Location | Slab |

| Average Length of Crack | 500 mm |

Category 3;  $2.0 < a < 4.0$  mm

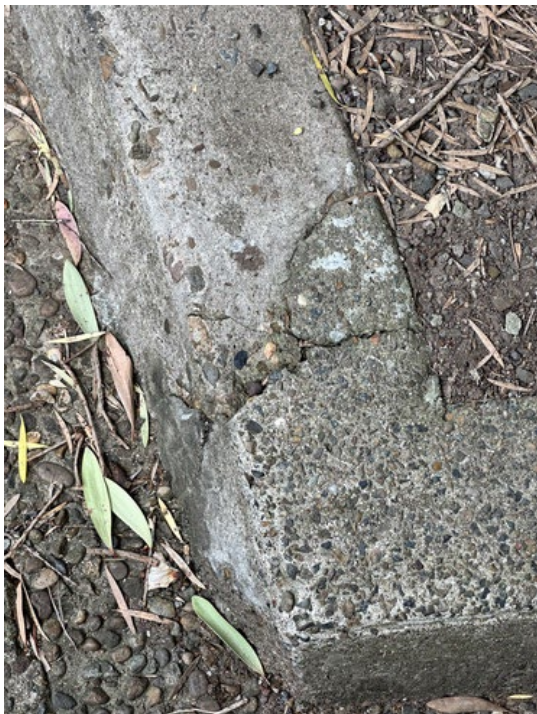
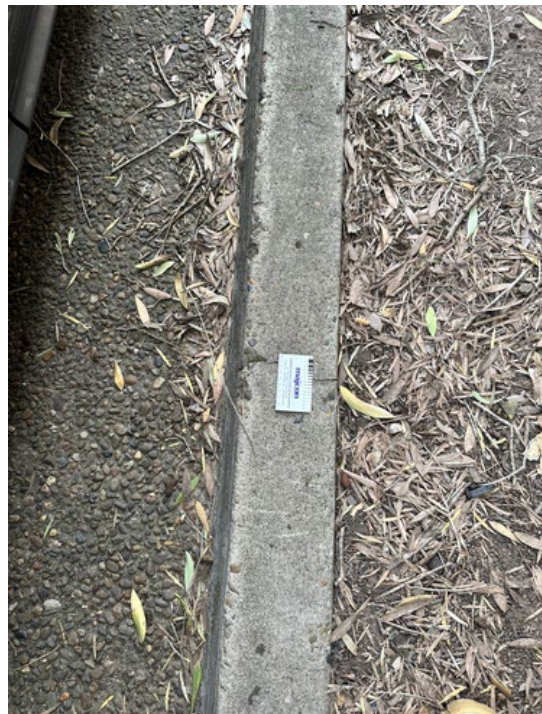
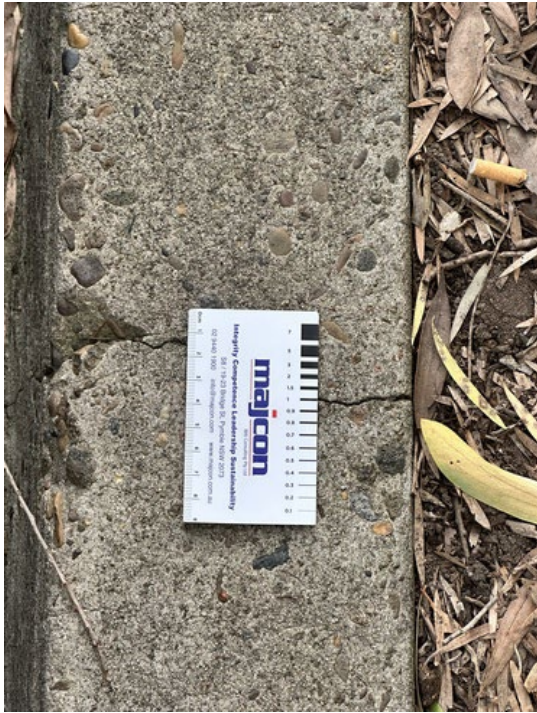
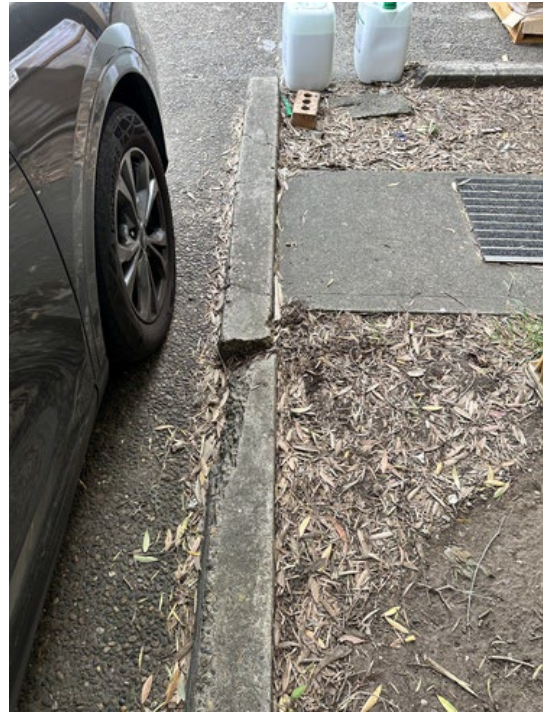
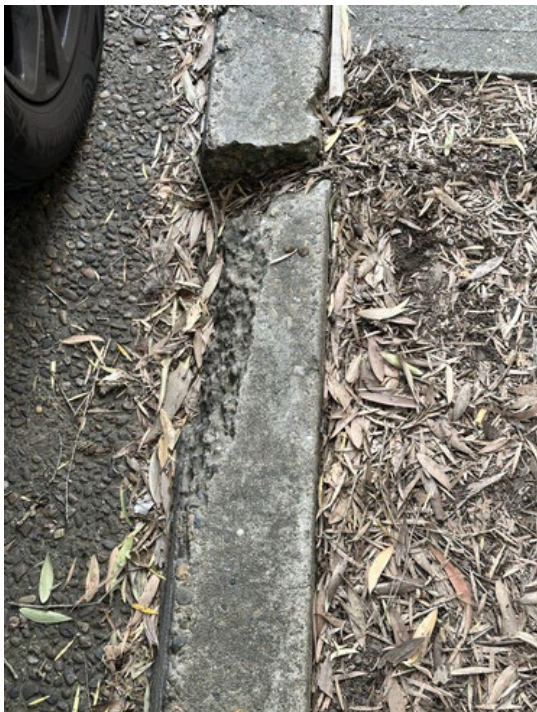
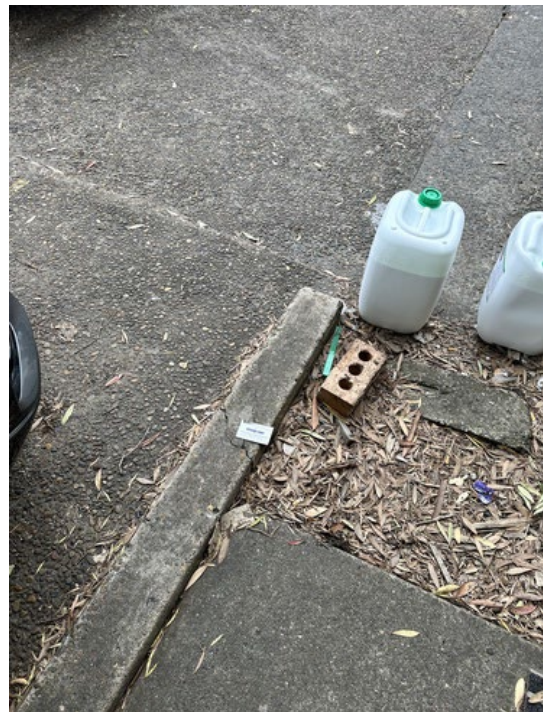
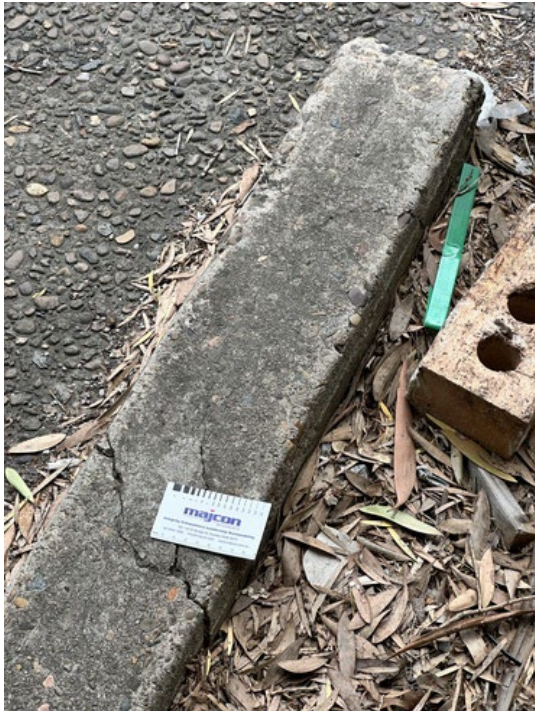
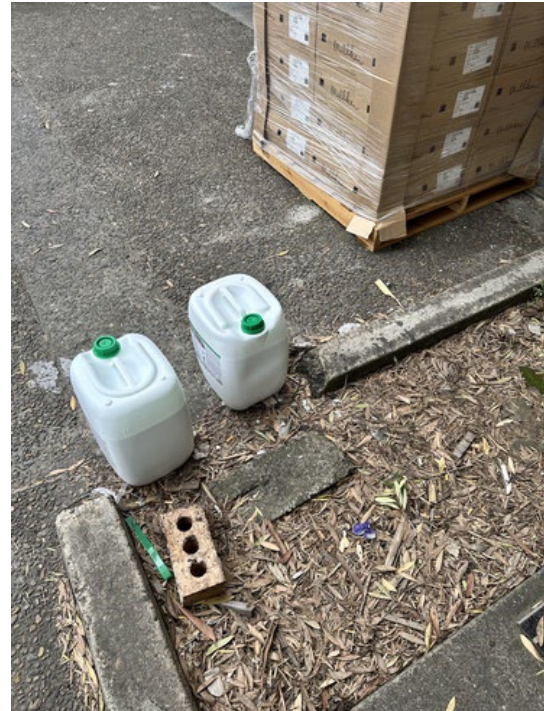
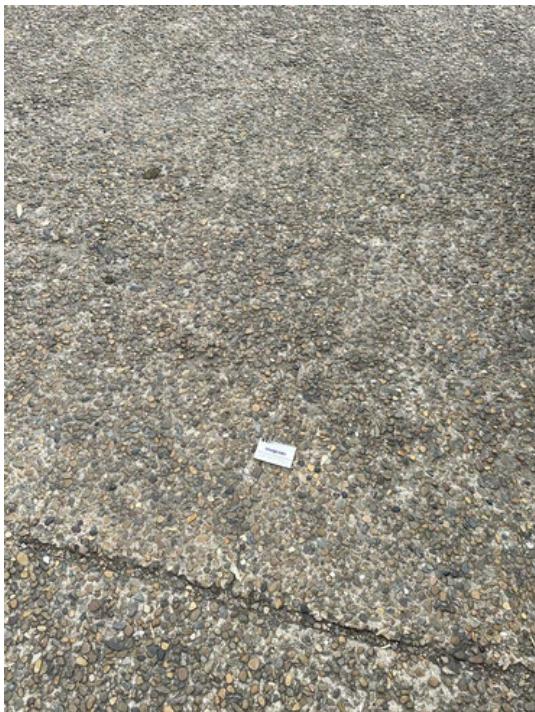
Crack

| Location | Other |
| Average Length of Crack | 500 mm |
| Width of Crack | Category 4; $4.0 < a < 10.0$ mm |

Typical crack and damage to kerb

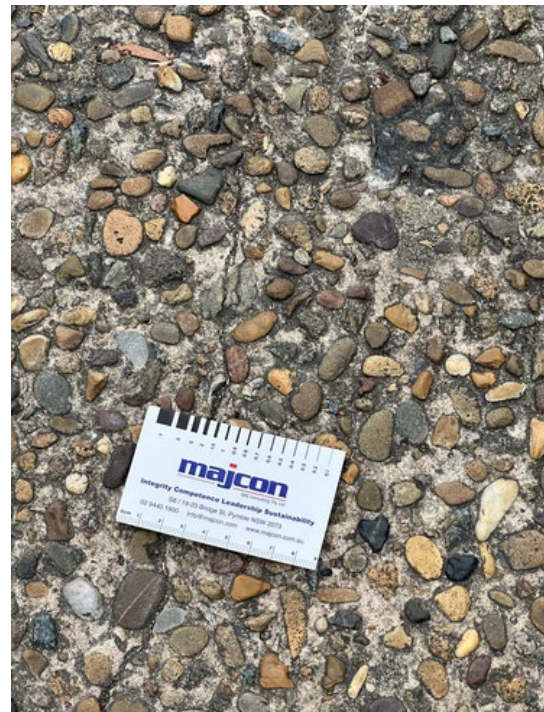
Photo 114

Crack

Slab

1500 mm

Category 4;  $4.0 < a < 10.0$  mm

Typical crack to driveway slab

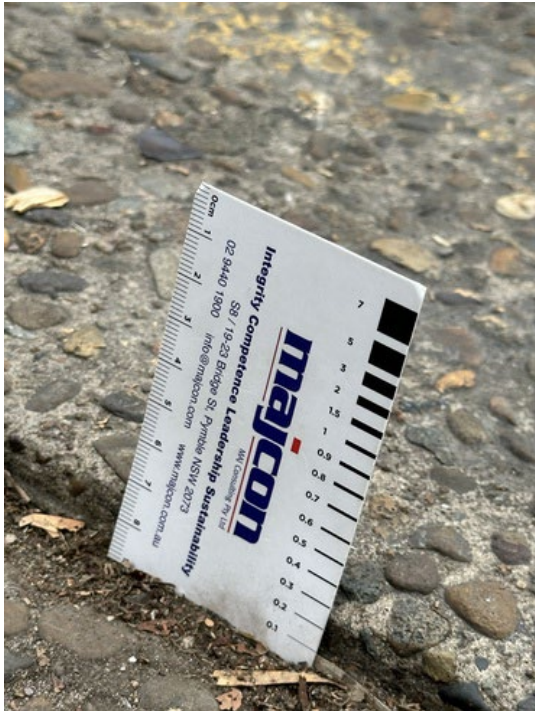
Photo 120

Movement

LocationSlab

Distance (mm)20

Other DetailsTypical movement of slab on the driveway

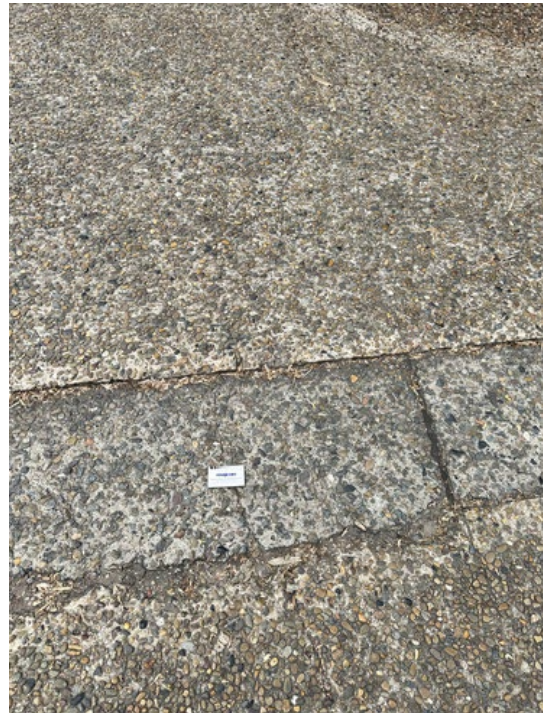
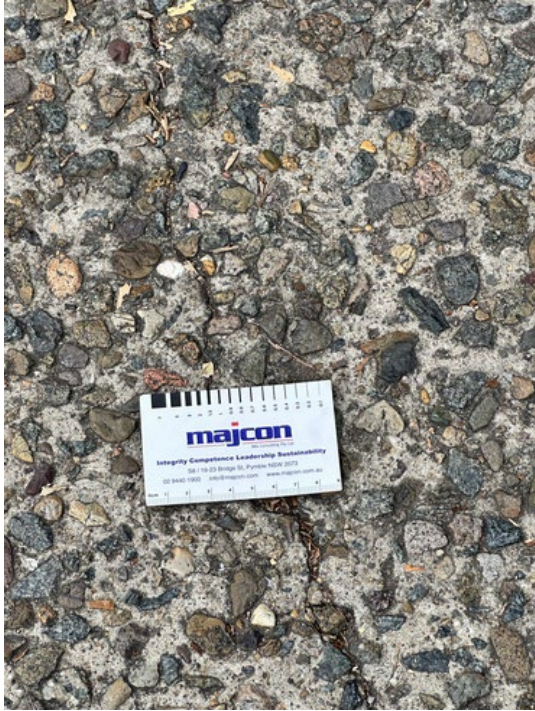
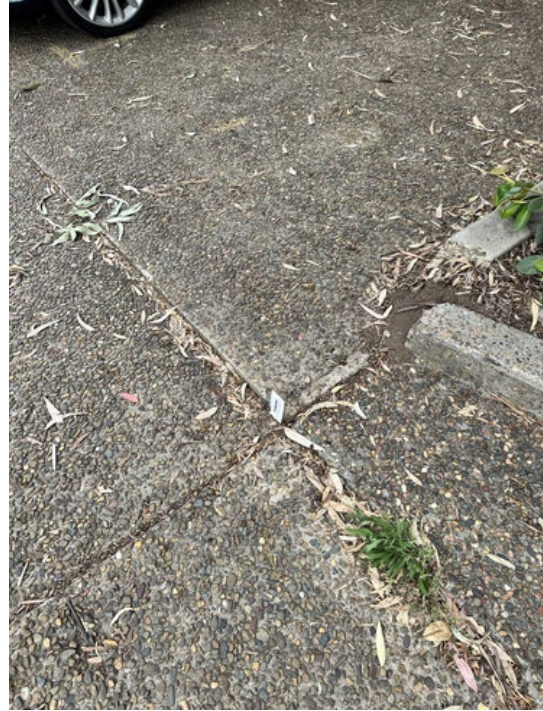
Type of PhotoCrack

LocationSlab

Average Length of Crack1000 mm

Width of CrackCategory 4; 4.0 < a < 10.0 mm

Other DetailsTypical cracks to driveway

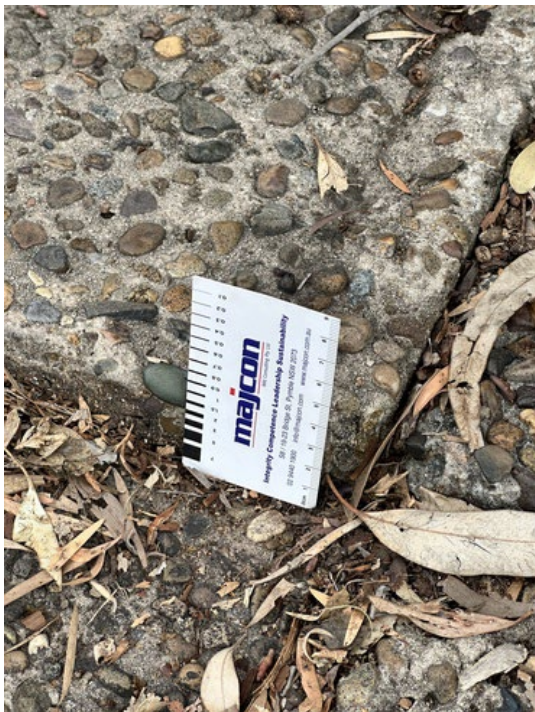
Photo 132

Type of PhotoMovement

Slab

30

Typical movement of driveway slab

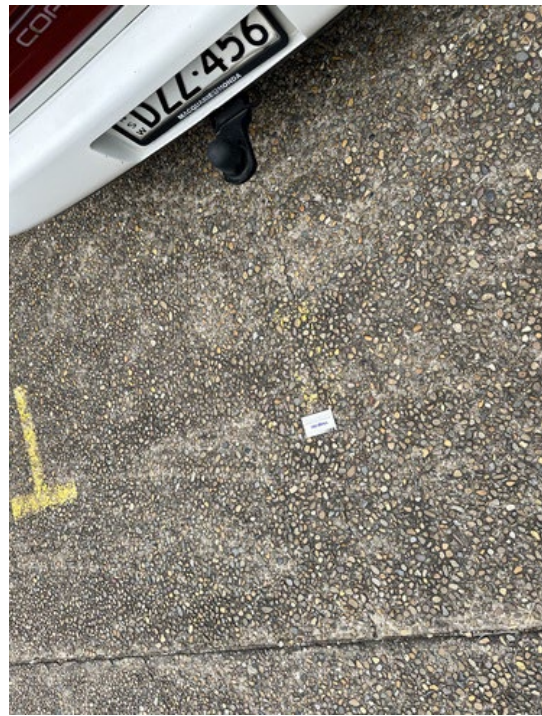
Photo 150

Crack

Slab

1200 mm

Category 3;  $2.0 < a < 4.0$  mm

Crack to driveway slab

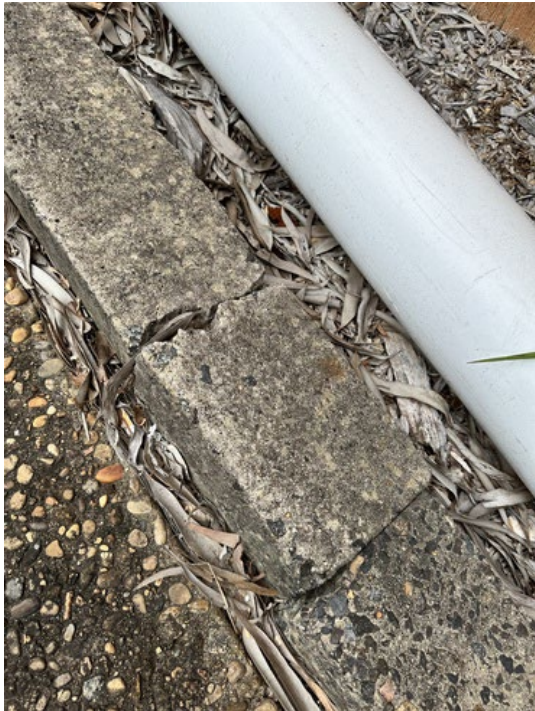
Photo 154

Damage

Other

Typical damage to kerb of the driveway

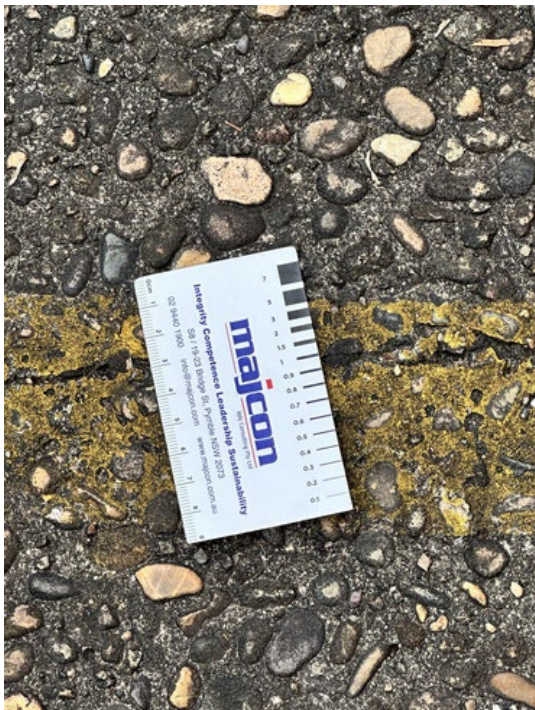
Photo 156

Crack

Slab

500 mm

Category 3;  $2.0 < a < 4.0$  mm

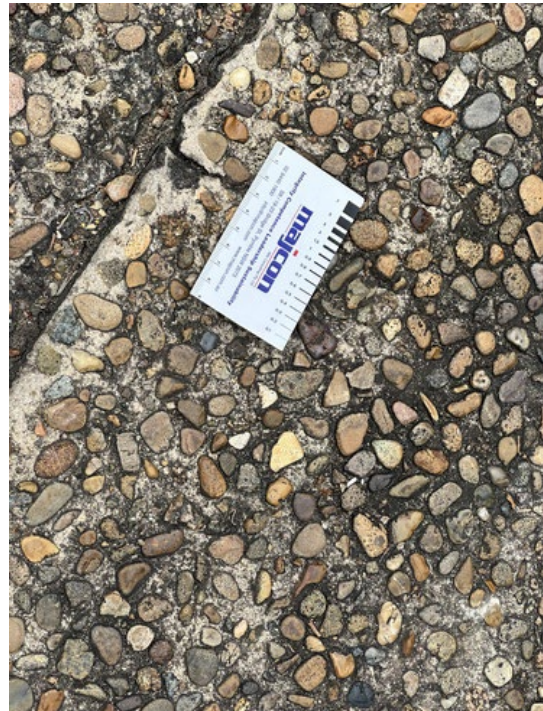
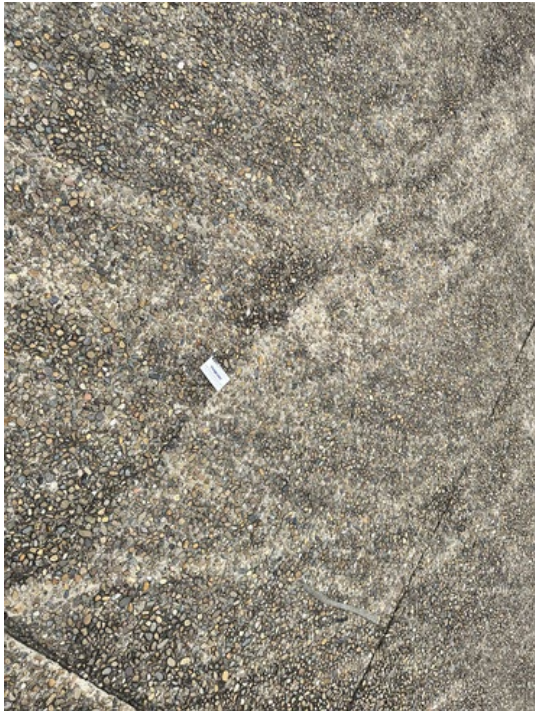
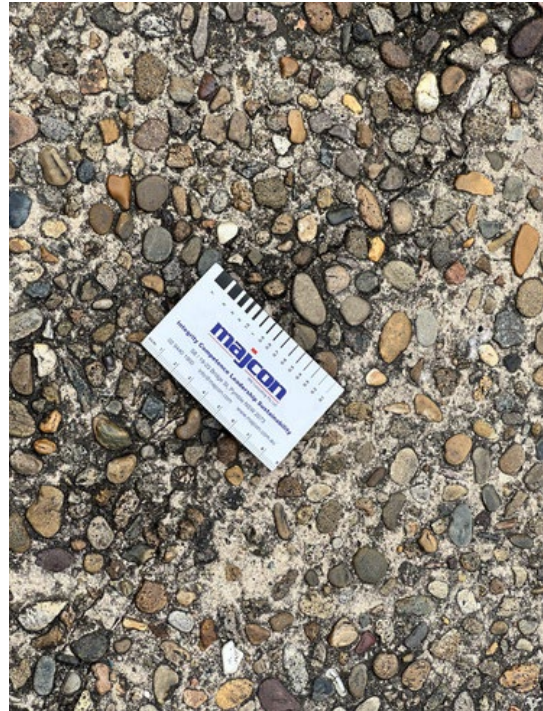
Crack

Slab

2500 mm

Category 3; 2.0 < a < 4.0 mm

Typical cracks to driveway slab
