ELEMENT / ZONE	DESCRIPTION / BACKGROUND	SIGNIFICANCE	CONDITION	RECOMMENDATIONS
----------------	--------------------------	--------------	-----------	-----------------

For room numbers see 2013 floor plans in Section 7.34 pp.193-200.

(See also Section 5: Heritage Management Policies & Guidelines)

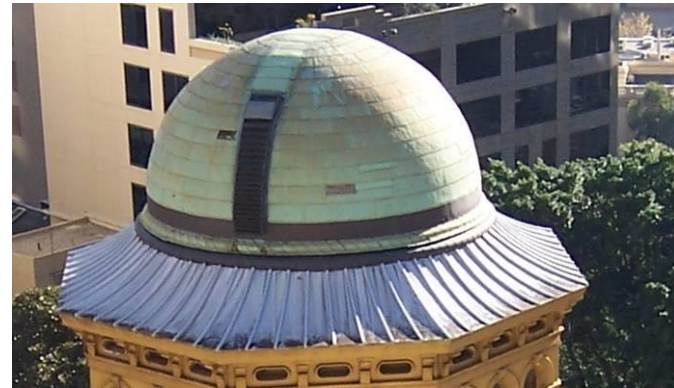
Rotating Observatory dome

The copper observatory dome atop the northern tower is a riveted copper sheet dome with a telescope opening slot. The dome is able to be rotated on an original cannon ball track. The dome was repaired in 1995. The slot has been louvered to exclude water entry.

Exceptional significance
Good

Cyclic repair of the dome and track as required.

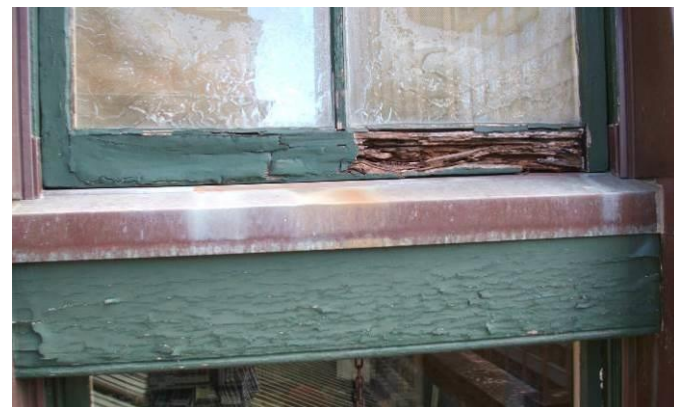
Rot in dome window sash

Exceptional
Rot in windows
Very Poor
Windows generally
Fair

The sashes and sills need immediate repair with extensive rot in some elements. Repairs to be undertaken to retain the remaining intact portions of the windows.

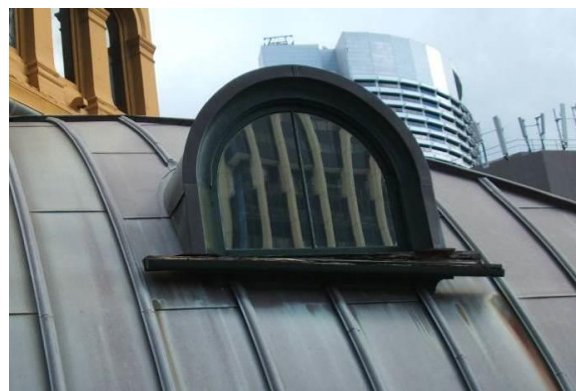
Split and rotted sill loose and dislodged

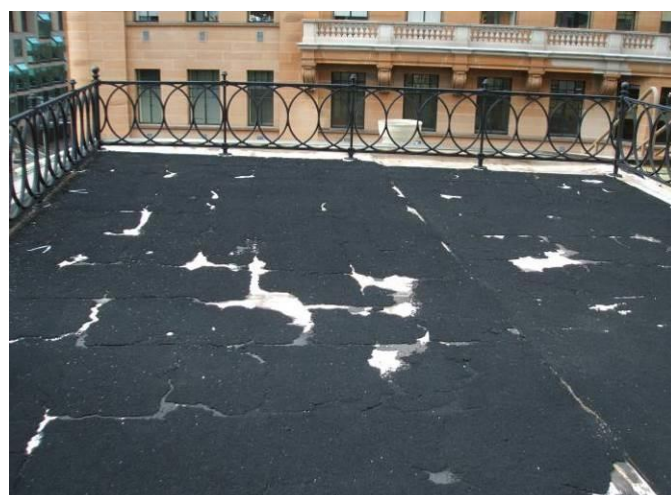
Membrane east of northern dome

The membranes are of varying age condition and product. Some are nearing the end of their expectancy. Generally They all appear to be watertight at the time of inspection to the areas we were able to access. The top trafficable coating is breaking down and is unsightly to some of the membranes. The membrane over room G28 is a recent installation and has only biological growth on the surface due to the location within the internal lightwell.

Replace old deteriorated membranes at roof level in the short term. Repair and clean membranes still with a serviceable life in light wells.

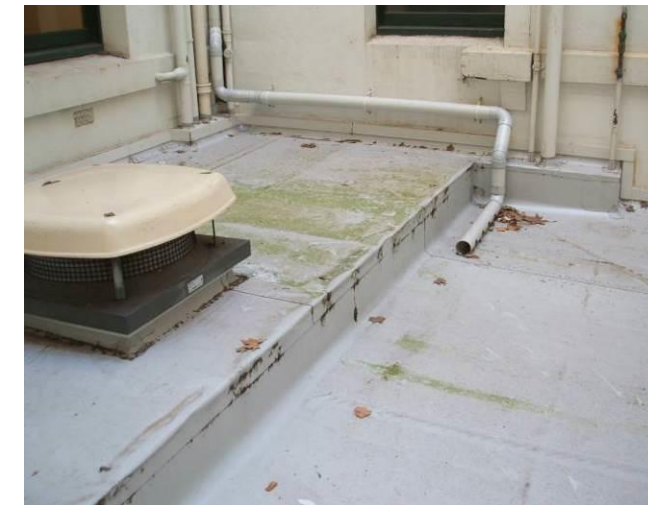
Membrane roof over room G28 cleaning required

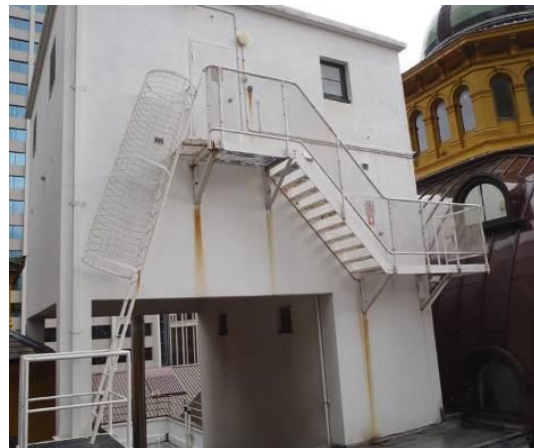
Some rusting has developed in the steel members of the steel stairs and ladder.

The steel members are currently in acceptable structural condition, however the rust should be cleaned/repaired and corrosion protection (e.g. via painting) added in the short term to stop further corrosion. Also, any corroded anchors, fixing the steelwork to the walls, should be similarly protected, or replaced in the short term with equivalent corrosion-protected anchors, to prevent the steel expanding and cracking the wall.

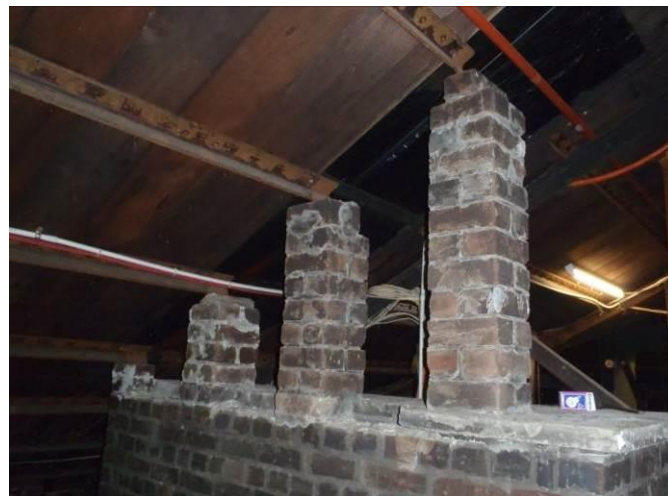
Chimney terminated in roof space

Generally chimneys have been dismantled and removed above roof level and capped off within the roof void. These chimneys originally supported the iron roof purlins. The original outline for the chimney can be seen where the timber boarding is missing at the roof level. Brick piers have been built to support the roof purlins. This method of support does not comply with the current Australian Standard for seismic stabilisation.

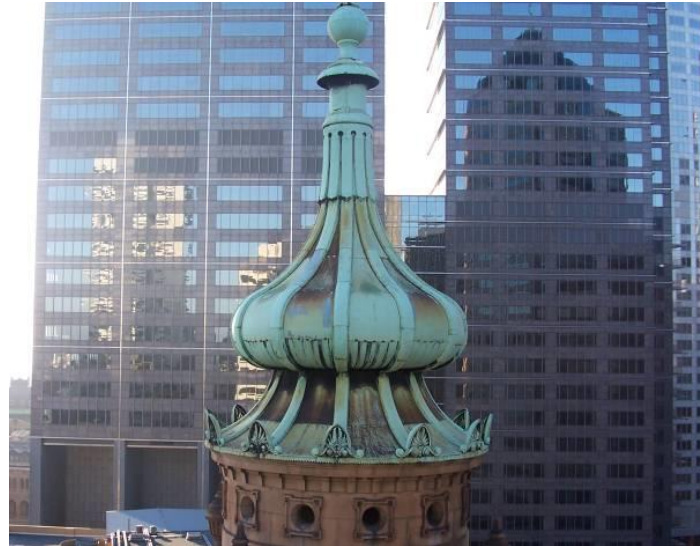
At the top of the tower is an elegant onion shaped dome, which is copper clad with a ring of ornate copper acrotera at the base.
The dome structure consists of numerous timber brackets radiating out from a vertical cast iron centering pin.
Work was completed on the tower in 1891. The then Minister for Lands, Hon. James N. Brunner, laid a stone at the top of the tower bearing an inscribed plaque on January 5th 1891.
In 2007 during an inspection of the tower by Government Architect's Office (GAO) observed that the copper sheeting required minor repair, many copper screws attaching the copper cladding to the timber frame were missing allowing water ingress into the tower and potentially causing the sheeting to become loose. No work has been undertaken since this inspection.

Exceptional Fair / poor

Repair to the tower copper sheeting is required in the short term to prevent water damage to timber frame and to secure the sheeting.
Use traditional methods of repair when repairing copperwork.

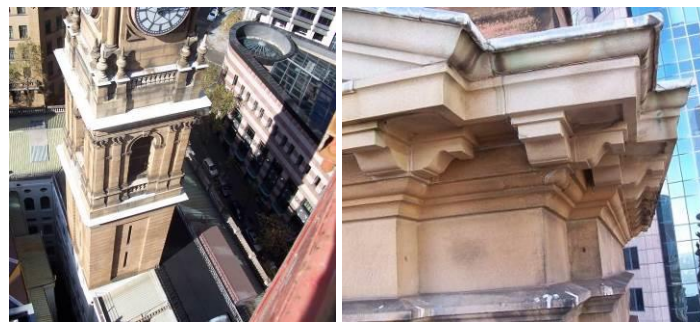
In 2007 during an inspection of the tower by GAO it was observed that some of the stonework that was retained during the last repair works in 1978 - 1980 had degraded to a point where it required replacement. Elastomeric sealant used in 1980 was failing and required replacement with mortar pointing to prevent breakdown of the stonework at all the joints. It was advised that if this was done it would prevent considerable loss of original fabric.

Exceptional Fair / Poor

The clock tower generally requires attention in the short term. Deferred maintenance work exists.
Refer to Lands Building Façade Condition Report September 2007 report number HG 07/49

- Some cracks in stone require pinning
- Salt activity in underside faces need desalination
- Leadwork on top weathering faces need replacement to provide a drip edge
- Repoint stonework to prevent water ingress and stone deterioration
- Some loose synthetic stone repairs were found not to have reinforcement replace these items with sympathetic repairs.

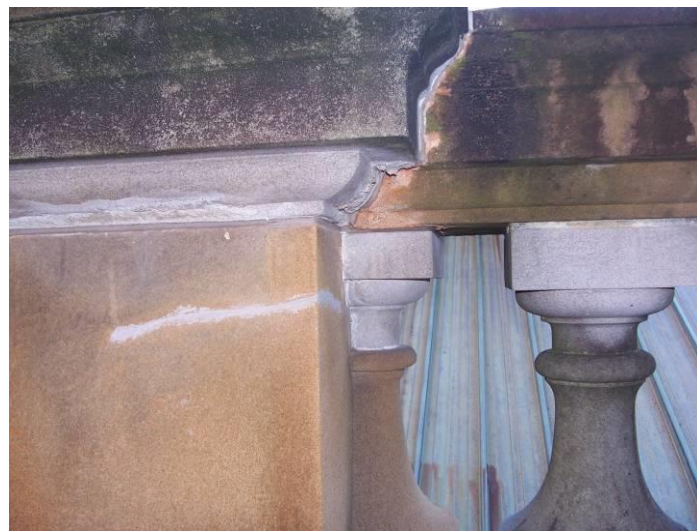
Parapet cracking, past stone replacement

Stonework has degraded since the repairs over 30 years ago with stones cracking and exfoliating with salt activity

Repair of stonework required in the short term

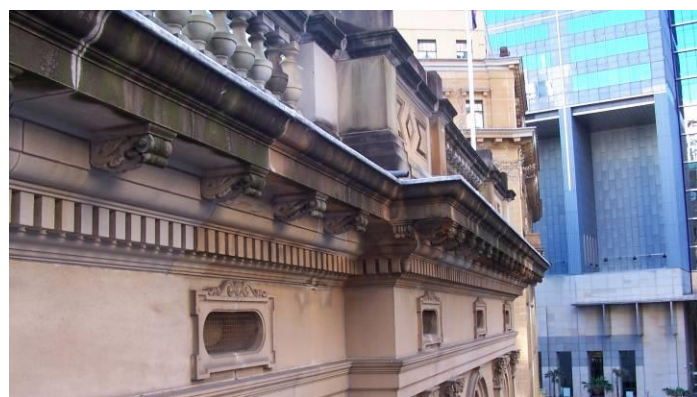
Projecting cornice stones with brackets below

Stonework has degraded since the repairs over 30 years ago with stones cracking and exfoliating with salt activity. Potentially dangerous loose stone may exist in this area.

Stonework to be retained in this area is recommended for desalination to remove substantial amounts of damaging salt from stonework a process not available in the last repair works.

Repair of stonework required in the short term

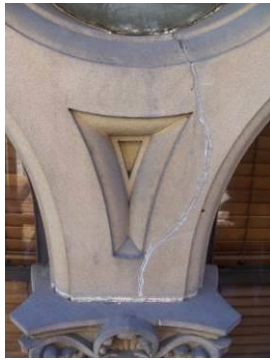
<p>Crack in stone above the Loftus Street entrance</p>	<p>Refer to engineers report in Public Works report HG 07/49</p> <p>Cracking exists in all elevation of the building these are fully identified and evaluated in the report. The only cracking identified as requiring rectification works was the cracking over the bent street entrance. This was repaired in 2008 by NSW Public Works Stonemasons & GAO.</p>	<p>Stonework: High</p>	<p>Fair</p>	<p>(See also Section 5: Heritage Management Policies & Guidelines)</p> <p>Refer to Lands Building Façade Condition Report September 2007 Public Works Report HG 07/49</p> <p>Stonework safety inspections to monitor potentially dangerous stonework required in the short term.</p> <p>Repair of stonework required in the short term by sealing cracks with elastomeric sealant</p>

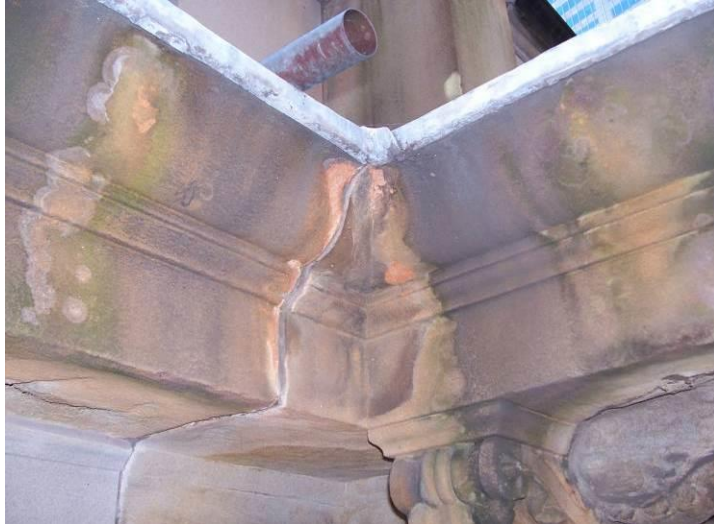
<p>Past application of lead weatherings on top of the cornices have had some impact at protecting the stonework on top surfaces but allowed water to flow onto the front and underside faces.</p> <p>Advances in new leadwork detailing with the front drip edge sheading water away from the building would considerably reduce the weathering effect on the stone.</p> <p>Some leadwork has split, underside faces of leadwork are damp and not venting due to detailing</p>	<p>Stonework Exceptional/High</p> <p>Leadwork Neutral</p>	<p>Stonework Fair / Poor</p> <p>Leadwork Poor</p>	<p>Refer to Lands Building Façade Condition Report September 2007 Public Works Report HG 07/49</p> <p>Replace lead weatherings in the short term</p>
<p>METAL INSERTS IN STONE</p>

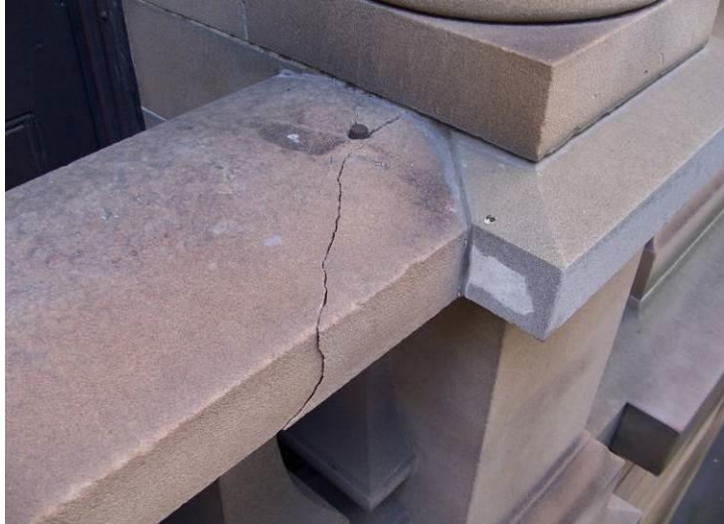
<p>Cracking in balustrade coping stone</p>	<p>Refer to Public Works report HG 07/49</p> <p>Metal inserts are present in all stone facades of the building. They are past fixing points for various activities such as buntings and light displays and services. As the fixings corrode and expand within the stone they crack the stonework.</p> <p>Metal fixings are at different stages of condition in this process. Some have cracked the stone causing potential safety issues, some are just starting to corrode and if removed will prevent costly repair and loss of heritage fabric.</p>	<p>Stonework High</p> <p>Metal inserts generally Intrusive</p> <p>Note some inserts have heritage significance (e.g. fixing for old tram wires), a heritage architect should assess each fixing to determine significance.</p>	<p>Stonework Poor to Good</p>	<p>Refer to Lands Building Façade Condition Report September 2007 Public Works Report HG 07/49</p> <p>Repair of stonework with the removal of corroding inserts in the short term. Fill holes with approved synthetic stone repair mortar.</p>

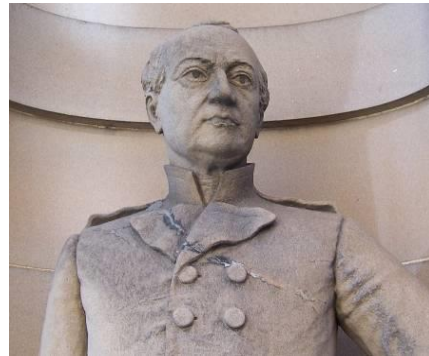
Lawson statue with crack through chest

Most of the status are in good condition with the exception of the Lawson statue which has cracking through the body

Refer to Lands Building Façade Condition Report September 2007 Public Works Report HG 07/49
Repair of stonework in the short term.
Do not remove these significant statues from the building.

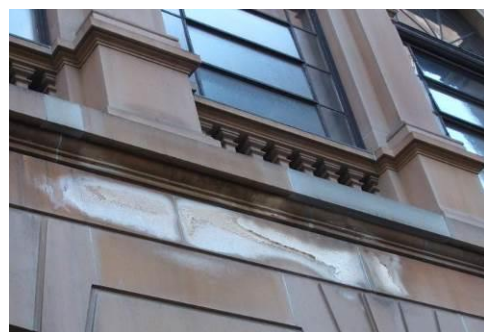
Wall outside room 107 indicates that a drainage problem exists in either the kitchen or adjacent en-suite water damage and salt activity. White salt crystals forming on stone causing stone to breakdown.

Salt damp damage outside rooms 107A & B

Repair drainage in rooms 107 A & B desalinate external wall outside room, all in the short term.

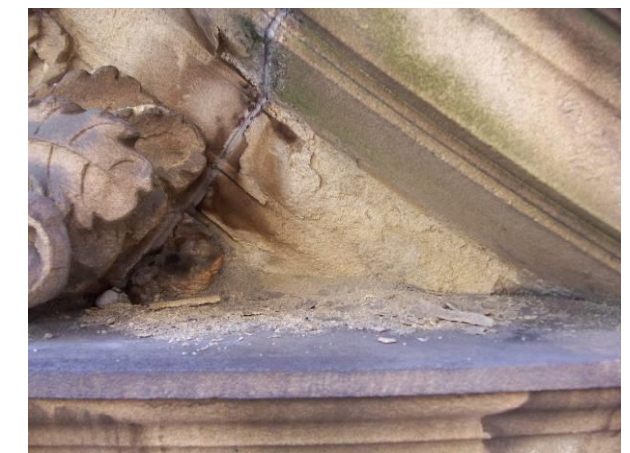
Salt contamination and damage to Loftus Street entrance carvings

Carvings require desalination and conservation in the short term to prevent loss of significance.

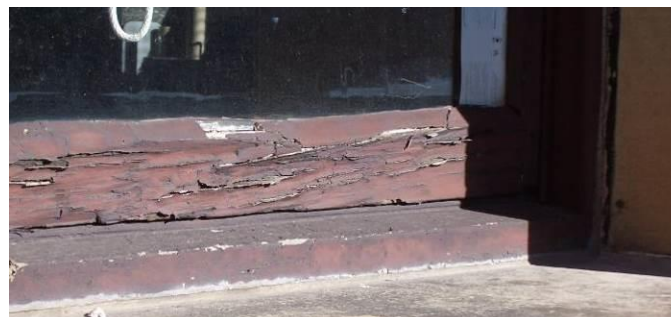
Bottom rail rot & failing paint

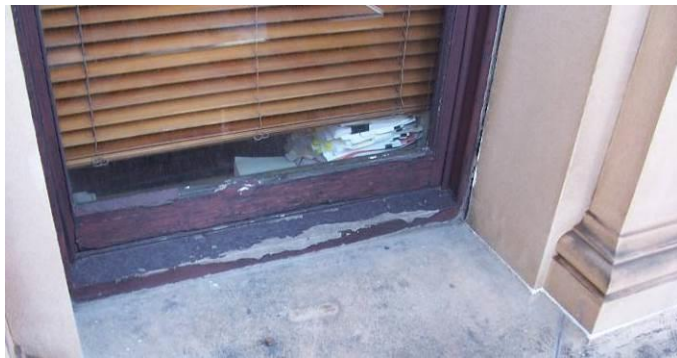
Sills cracking, some rot & failing paint

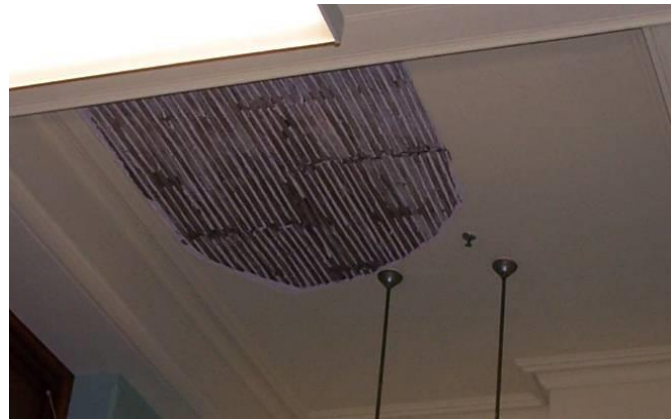
Lath and plaster ceiling failure in 2007

where defects occur.
 Record past colour schemes and keep records for future use.
 Investigate original paint colour schemes and gain approvals / exemptions as required by the Heritage Act.
 Repair concrete ceilings to engineer's requirements.
