ELEMENT / ZONE	DESCRIPTION / BACKGROUND	SIGNIFICANCE	CONDITION	RECOMMENDATIONS
For room numbers see 2013 floor plans in Section 7.34 pp.193-200.				(See also Section 5: Heritage Management Policies & Guidelines)

7.18 FIREPLACES

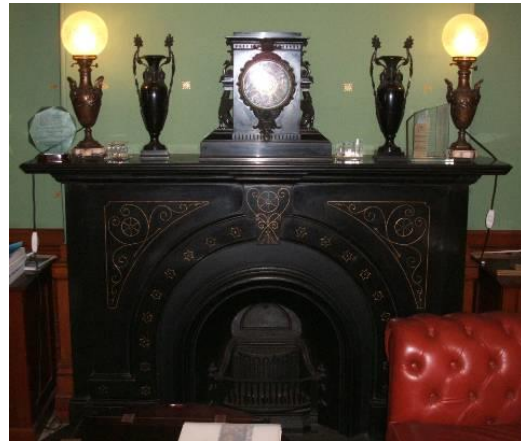
Room 107

One interesting feature of the office area decor is the different fire place surrounds. They are different in design (although some are similar) and colour and are of the various types of New South Wales marbles used at the time. The cast iron register grates are also of considerable value and detail. Generally the offices are graded in importance and the fireplaces and finishes within the rooms are graded accordingly. Offices of greater importance generally occupy the north east and north west corners of the building.

Good / Excellent

Clean and retain all fire places and equipment. When possible open up fire places that have been blocked over to reveal the original cast iron registers. Reinstall the hearth if it has been concealed under carpet or other finishes. Fire places are generally non-functioning within the building with chimneys capped off. Any future use of chimneys should be part of an approved engineered approach to fire safety. Only reinstall missing detail if sufficient evidence is available.

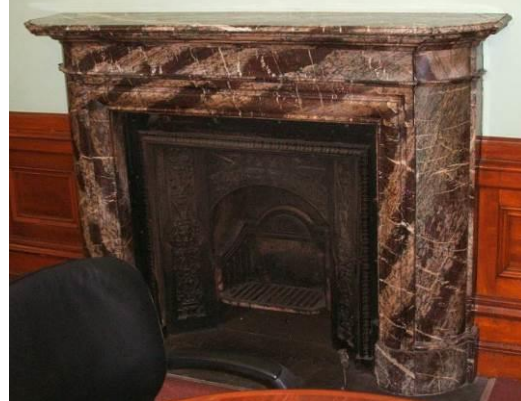
Room 207

Unfortunately, some of the fireplace surrounds have been removed in the past "to make more space". Some of the fireplaces have been blocked over in the registers. At roof level some of the chimneys have been removed above roof level and capped off in the roof space.

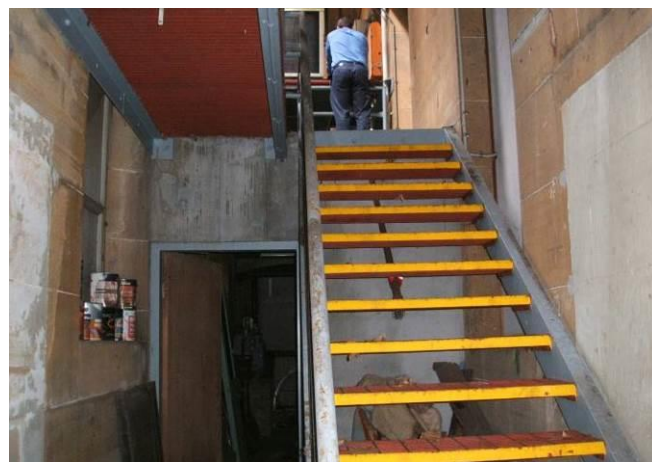
View of plant rooms in Room G31 with mezzanines. This area was the previous caretaker's work rooms with evidence of stored original windows, doors and other material.

Several mezzanine rooms have been placed between the ground and first floors. This was possible due to the 19 foot approx. floor heights between the original floors. The mezzanine floors are generally reinforced concrete and have been supported on steel framing. The slab edges are supported on an additional 230 mm thick brick wall placed internally within rooms. These walls are un-rendered, rough finished and painted. Some original windows have been blocked up / covered over. Corridor door lights have been painted to hide the mezzanine floor / wall above. The mezzanine floors appear to have been added for storage / file rooms and for additional toilet / change rooms. Generally these levels can be removed to reinstate the original layout without affecting the structure.

Fair

Many compliance issues exist in these areas such as fire egress, fire ratings, stairs, step heights and storage of flammable material under stairs. Fire engineered approach for building is required to assess these areas in relation to their intended use. Reinstall the original floor layout where possible by removing intrusive mezzanine floors. Minor alterations to the Lands Building, particularly those that recover significance, can be undertaken as long as the original internal configuration, external character and significant fabric (particularly that of Exceptional and High significance) are retained, as these are integral to the heritage significance of the place. Retain the original pattern of internal spaces without further subdivision or demolishing walls to increase the size of spaces. Do not insert false ceilings for services such as lighting and air conditioning. When next upgrading services do so with the intent to

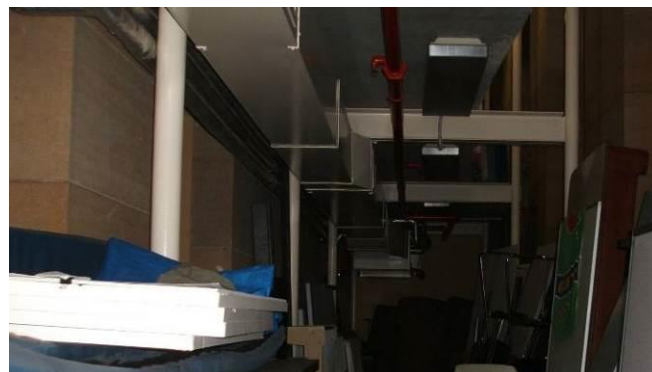
Steel supports for mezzanine slab room G17b

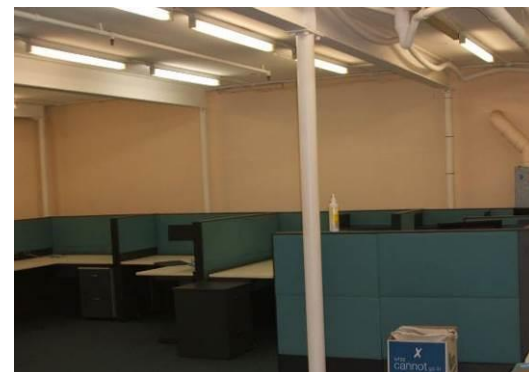
View of room G16 with steel framing and reinforced concrete mezzanine floor slab

increase the efficiency and reduce the size of service equipment and its impact on the heritage in the building. Use smaller and more efficient fire services equipment. Reduce pipe and cable diameters and place in concealed runs. Run new service in already altered or damaged fabric and reduce opening up, drilling through and damaging original fabric.

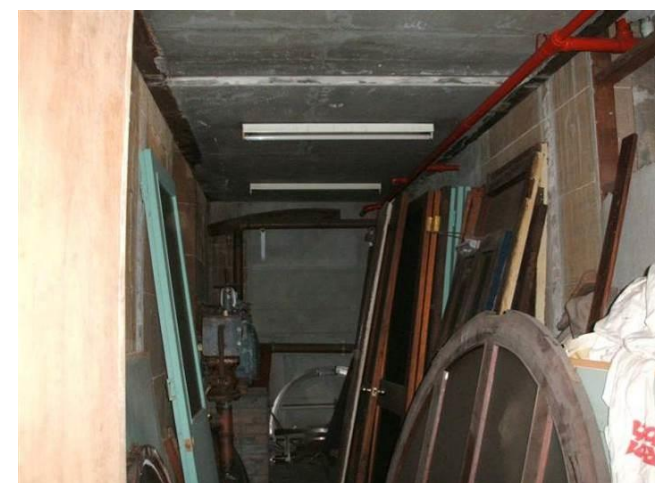
Room G31

Some spaces are well maintained and in good condition

Some spaces are poorly finished with holes and voids compromising fire ratings and degrading heritage fabric.

Recommend the continued use of the roof void for services and prohibit use of any A/C or other services on the roof areas to maintain the heritage significance of the building.

When next upgrading services do so with the intent to increase the efficiency and reduce the size of service equipment and its impact on the heritage in the building. Use small floor mounted A/C units in lieu of large ducted systems. Reduce pipe and cable diameters and place in concealed runs. Run new service in already altered or damaged fabric and reduce opening up, drilling through and damaging original fabric.

Repaint deteriorated wall in the short term.

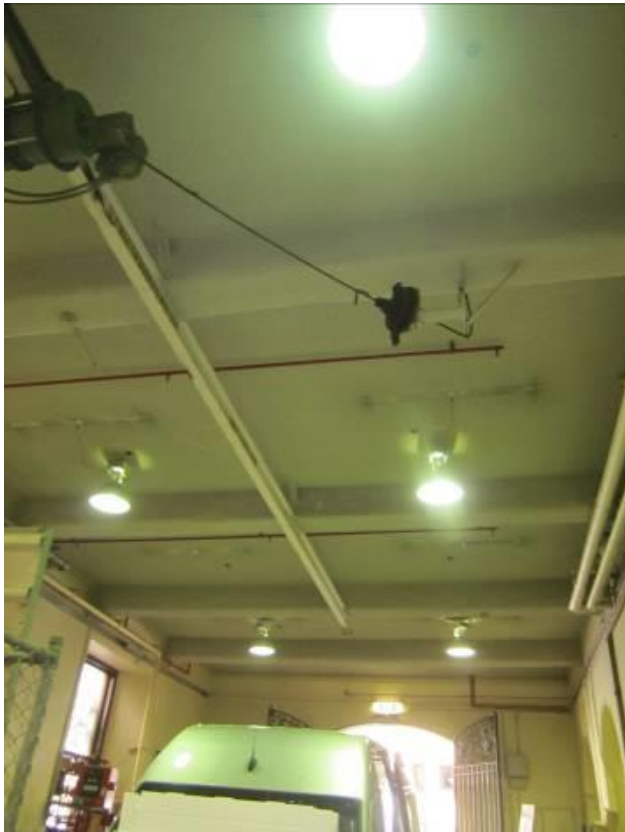
<p>Room G26</p>	<p>In some areas of the cart dock / loading dock bituminous paving blocks still exist, dating from the 1890's. These were used in the cart dock area and internal courtyards.</p> <p>The space is substantially unaltered with the original gates opening onto Gresham Street. This area contains fire services equipment which is considered non-compliant; refer to Hydraulic services in this report. The ceiling was not accessible but appears to have a spray on fire rated treatment to prevent spread of fire through the iron beams and timber floor above. The adequacy of this treatment will need to be assessed in a fire engineered assessment of the building.</p>

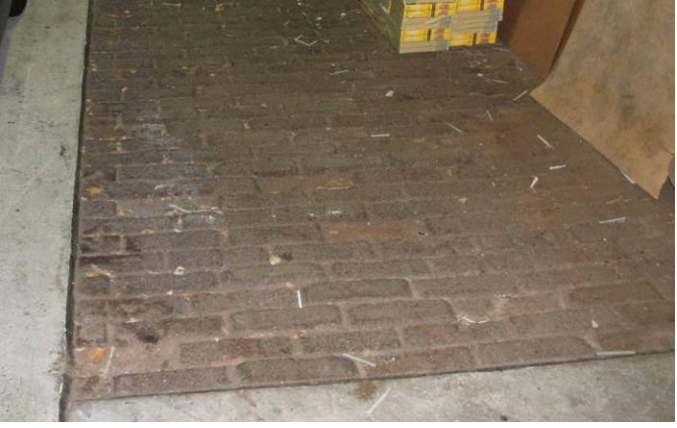
<p>Original paving portion Room G26</p>	<p>The former cart dock zone High</p> <p>The original paving blocks High</p> <p>Fire service equipment in room Intrusive</p> <p>Old redundant gas meter Little</p>	<p>The room is in fair condition the walls require repainting some windows are broken. Fair</p>	<p>(See also Section 5: Heritage Management Policies & Guidelines)</p> <p>Undertake a fire engineered assessment of the building and determine and implement appropriate and sympathetic methods of fire rating between service areas in heritage fabric.</p> <p>When next upgrading services do so with the intent to increase the efficiency and reduce the size of service equipment and its impact on the heritage in the building. Use smaller and more efficient fire services equipment. Reduce pipe and cable diameters and place in concealed runs. Run new service in already altered or damaged fabric and reduce opening up, drilling through and damaging original fabric.</p> <p>Do not add new elements where they will negatively impact significance</p> <p>Retain the remnant portions of the original floor</p> <p>Retain the existing pattern of internal spaces without further subdivision or demolishing walls to increase the size of spaces.</p> <p>Engage a competent heritage professional to manage new services design, heritage approval application and installations.</p> <p>Repaint walls in the short term; replace broken window glass with new compliant glass.</p>

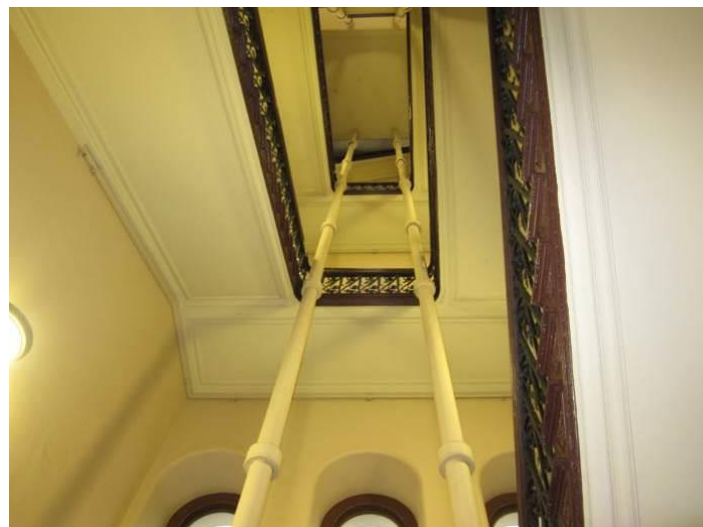
Stair with remnant of lift structure

The staircases are constructed of cast iron, with a curved tread detail. An extra handrail has been erected over the original handrail to increase the height of the balustrade however this is not fully compliant. The stair flights are quite long since the building has approx. 18'0" high floors, almost the equivalent of two storeys in modern office buildings.

The ground floor paving is missing a portion of the marble tiles where the original lift structure one occupied.

Upgrade and repair the fire doors (assess & tag), automatic door closing systems and control measures on the primary fire egress routes from the Bridge, Bent, Loftus and Gresham Street stairs and remove stored combustible materials in the immediate term. This is to be done in conjunction with the fire engineered approach.

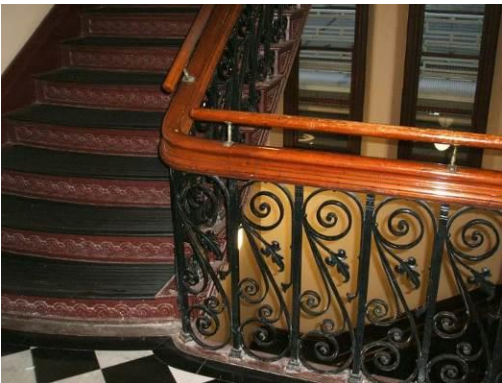
<p>Wrought iron balustrade, cast iron treads</p>			<p>Upgrade the stair balustrade in the immediate term by adding an extra continuous brass handrail similar to the existing and in accord with an approved fire engineered assessment. Assess the untagged fire doors / frame for fire resistance rating. Drawings are available from NSW Public Works plan room.</p> <p>Upgrade and repair the fire doors (assess & tag), automatic door closing systems and control measures on the primary fire egress routes from the Bridge, Bent, Loftus and Gresham Street stairs and remove stored combustible materials in the immediate term. This is to be done in conjunction with the fire engineered approach.</p> <p>Engage a competent heritage professional to manage new design, heritage approval application and installations.</p> <p>Repaint walls and underside of stair landings and flights in the short term.</p>

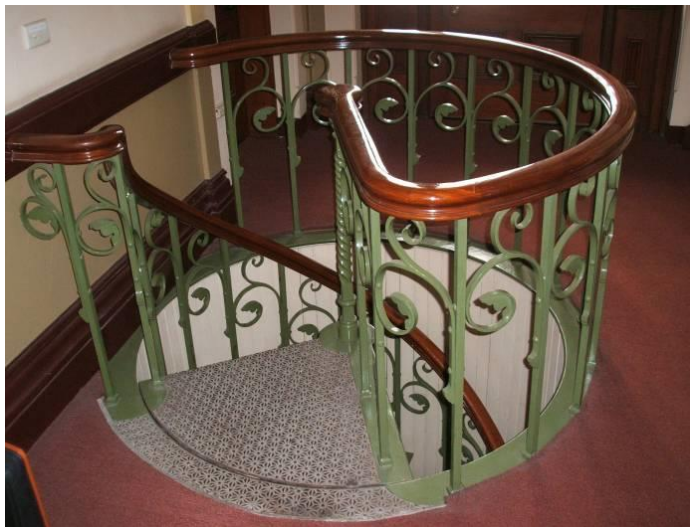
Termination at Level 2: Spiral stairs between Ground and level 2

spaces between the corridor ceiling and the floor structure over. The handrail to the upper level of the one giving access to the Minister for Lands suite is not original. This is because when two Ministries were housed in the building above each other on the First and Second Floors in the 1950's the stair between the two upper levels was sealed off. When it was again opened the original handrail which had been taken away could not be found and was replicated. It should be noted that under present fire code conditions these stair wells are considered a potential fire hazard because they are continuous through three floors.

Given the heritage significance of the building assess these stairs and other non-compliance issues with a site specific fire engineered strategy. This strategy will need to consider the buildings intended future use.

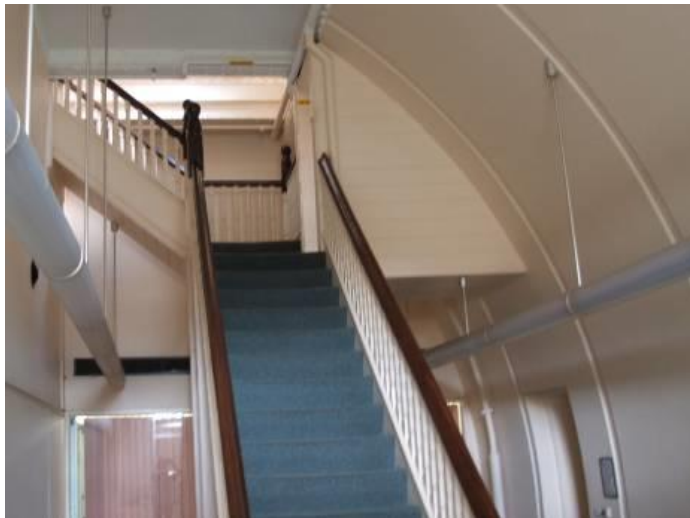
Timber stair eastern dome

Several original timber stairs of exceptional significance are located at the top levels of the Eastern and Western domes. These stairs are the only means of access to the upper levels. The upper levels are to be assessed with a fire engineered approach to determine their safety and subsequently if they can be occupied as a habitable space.

The stair is not compliant, stair in good condition.
Good

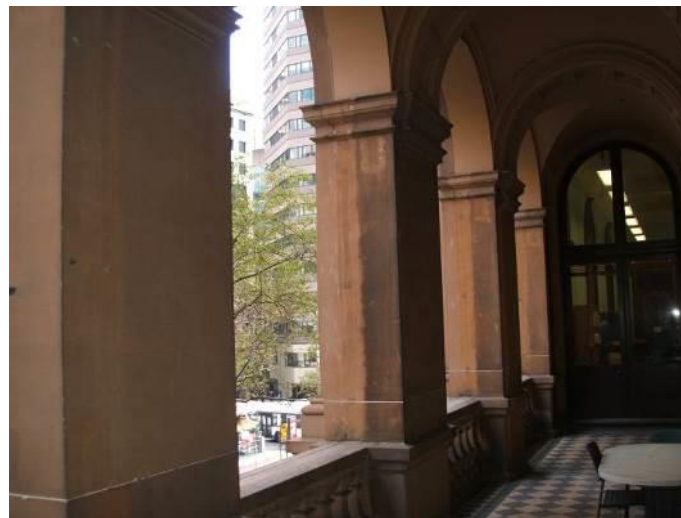
Verandah off Gresham Street

Remaining enclosed verandahs can be seen on the Bridge Street Elevation. These verandahs currently house kitchenettes and en-suites. Some of these areas are currently causing damage to the external stone wall. Located by the large white salt bloom on the external wall face caused by leaking drainage.

<p>Exceptional</p> <p>Verandah enclosures are considered intrusive.</p> <p>Intrusive</p>	<p>The previously opened up verandahs</p> <p>Good</p> <p>Currently enclosed verandahs are in a poor condition with leaking drainage causing damage to the significant fabric.</p> <p>Poor</p>	<p>Where possible open up the remaining verandahs.</p> <p>Repair the leaking drainage in the short term.</p> <p>Repair the damage to the stonework in the short term.</p> <p>Desalinate stonework and monitor for future re-occurrence.</p>
--	---	---

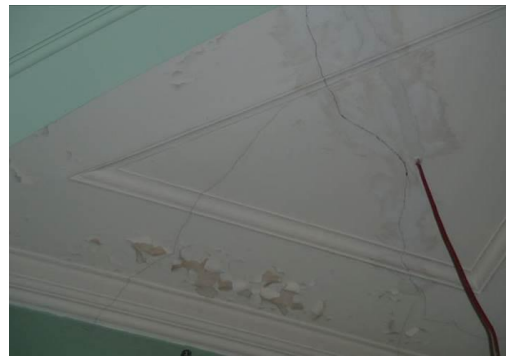
Room 316 cracking to corner transition to dome

Some minor cracking has occurred in the upper concrete dome which has been assessed as requiring minor patching and monitoring at this stage. Refer to structural engineers report.

- Consider the removal of intrusive fabric within the space.
- Consider repairing the roof light umbrella and window shutters and make operable.
- Repaint the dome and repair minor cracking in the short term

- Monitor the cracks with "tell-tale" indicators (or similar) once every 2 years (short term).
- New lighting and services must be installed in a reversible and sympathetic manner with as little damage to significant fabric as possible.

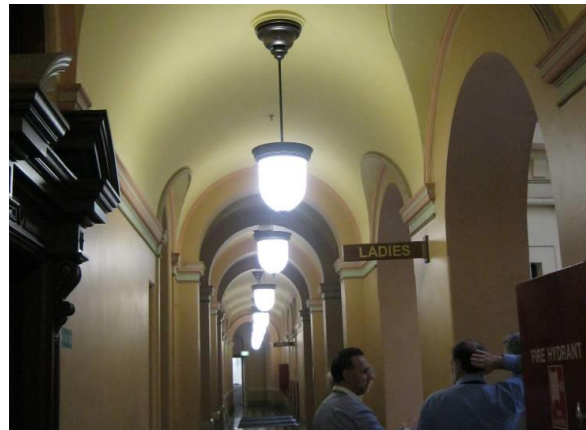
Period style lighting, in all hallways and general use staircases, in good condition

Retain luminaires as condition seems to be adequate with adequate lighting levels.

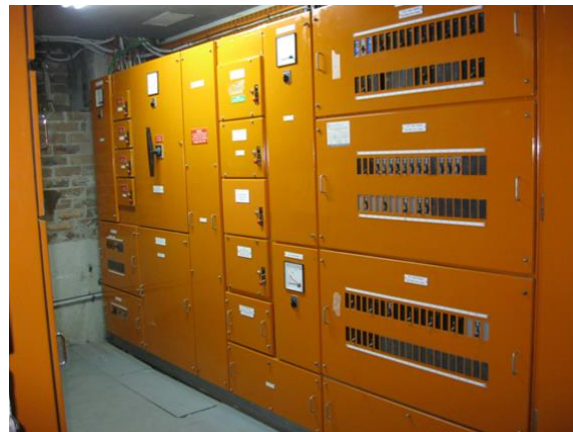
In central core area, ground floor, Main Switch Room. The main switchboard is a Quicklag board and is past its economic life. There is also no service protection device. Fire rating of this room needs to be checked, and water proofing due to numerous penetrations.

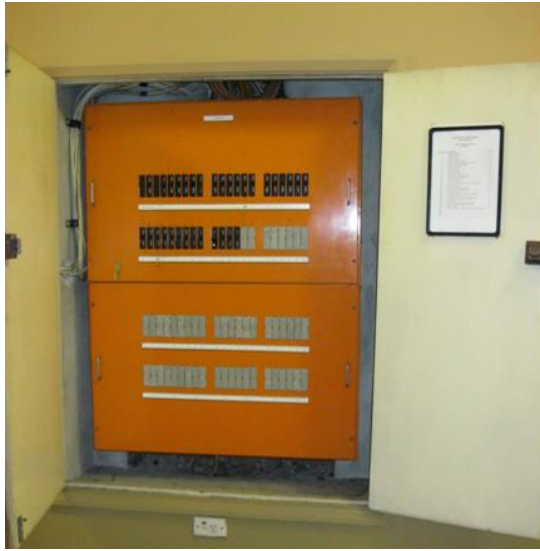
Sub-mains from the main switchboard supply distribution boards at all four corners of the central core with risers to all main floors.	Neutral / Intrusive	Poor	Replace Distribution boards with new by February 2015, complete with RCD protection to all socket and lighting circuits. Insure Distribution Board enclosures meet BCA code in reference to smoke detection, fire seals and fire ratings.
GENERAL POWER

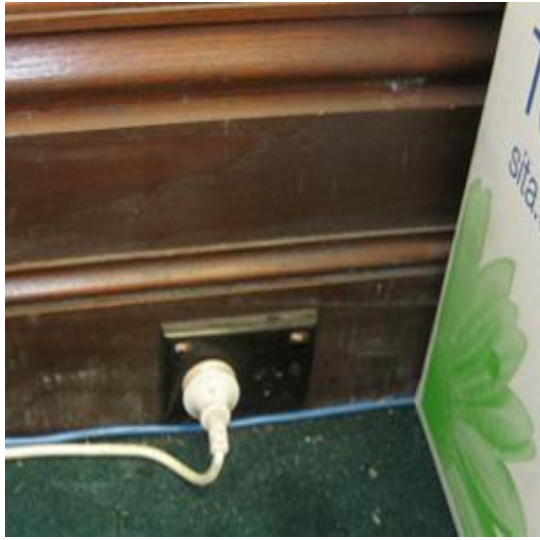
Socket outlets throughout the building	Neutral / Intrusive	Generally Good Some older units Poor	Accessories such as socket outlets, light switches and voice/data outlets are generally satisfactory although in many cases the cover plates are quite old and it would be advisable to replace with new in the short term. It is recommended that the location, distribution and quantity of socket outlets be re-assessed based on usage in each area.

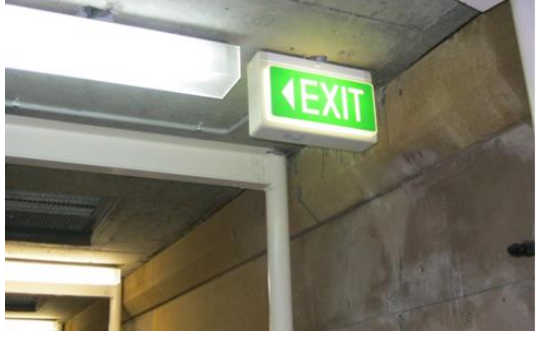
Exit lights located throughout the building, comprise cold cathode tubes with "EXIT" wording.	Neutral / Intrusive	Generally Good	An electrical consultant should review the location and placement of exit signs and identify any defects this review should be in conjunction with an engineered alternative solution to be developed to address this non-compliance in the Immediate to Short term.
