# 2024 Channel Stability Monitoring Report

Wilpinjong Coal Mine

Wilpinjong Coal Pty Ltd

Project Name: 2024 WCPL Channel Stability Monitoring Report

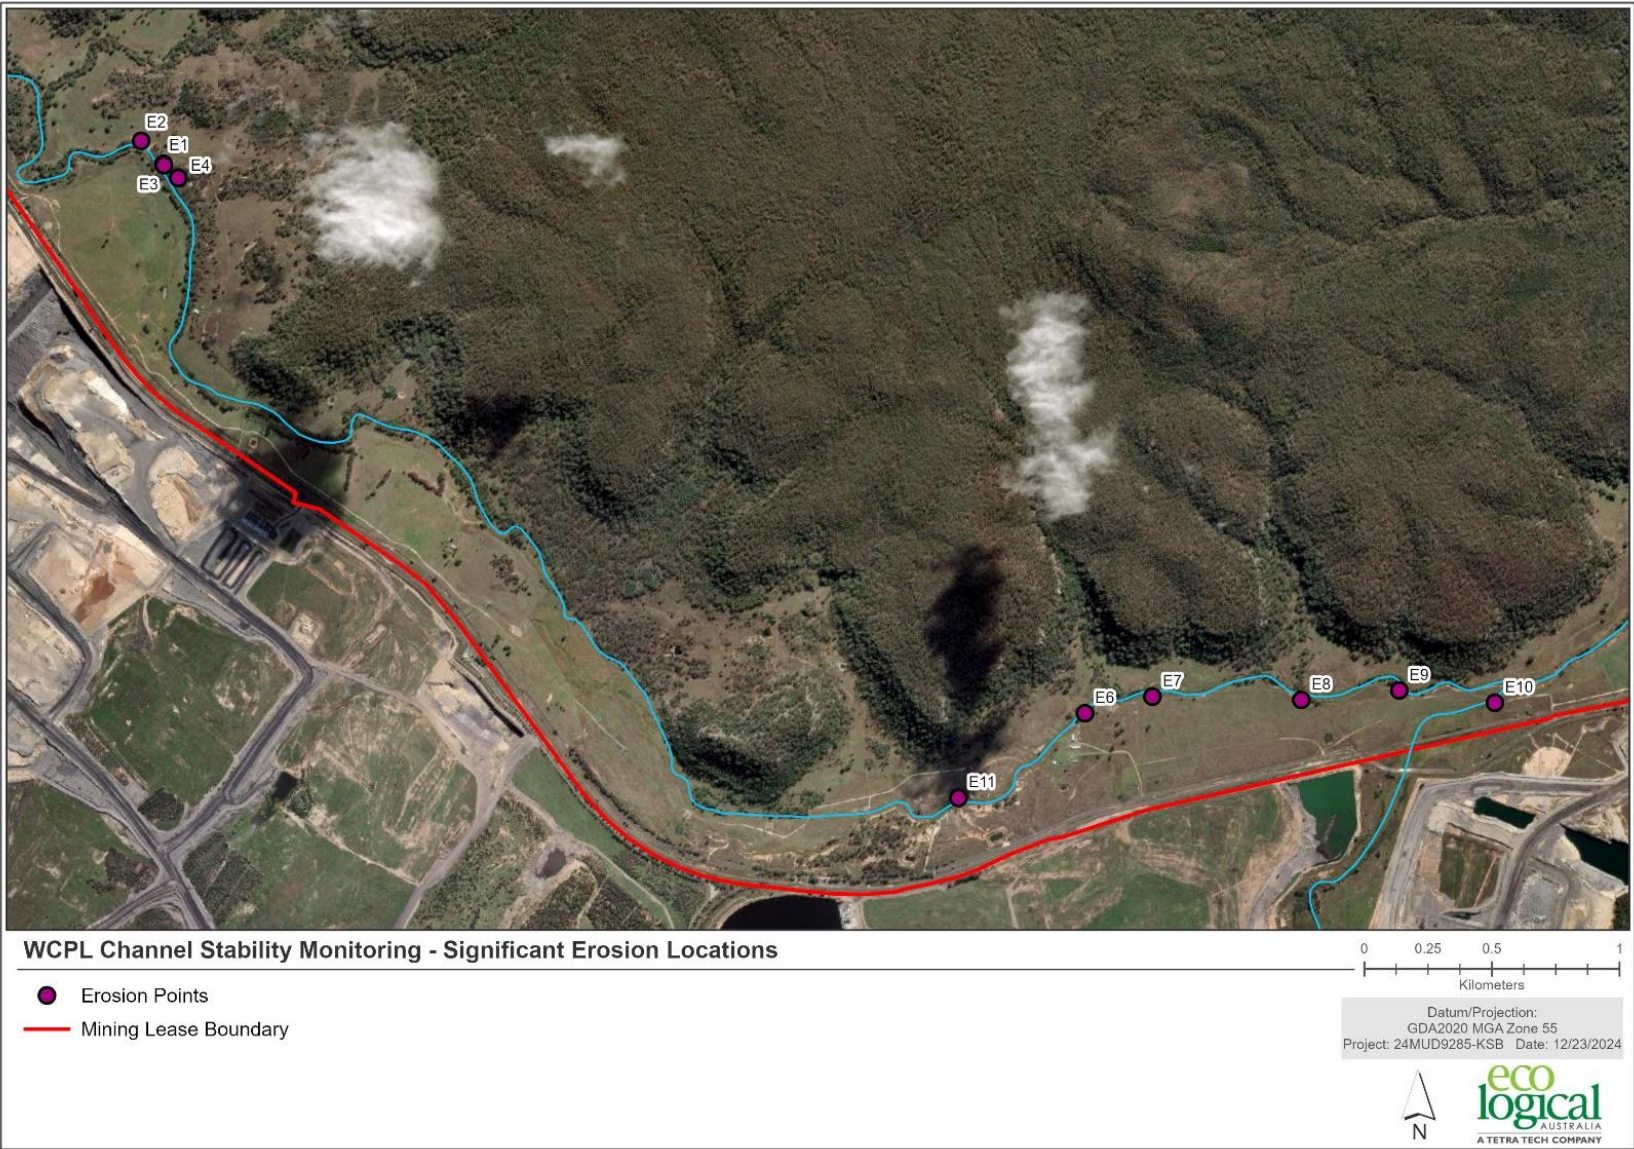
Figure 2: Significant erosion locations along Wilpinjong Creek

Table 2 provides photos of the significant erosion points along Wilpinjong and Cumbo Creeks (see Figure 2 above). These sites were identified as having moderate to severe historical erosion and the potential for continued erosion during times of downstream and lateral flow. Progression of erosion was minimal and only observed at seven of the 2024 monitoring points, with all sites stable at the time of monitoring. Sites E1, E3, E4, E7, and E9 showed evidence of ongoing mass wasting. Both Sites E7 and E9 displayed riling and undercutting, with further mass wasting observed. Sites E2, E6, E8, E10, and E11 all displayed

evidence of erosion; however, they had largely stabilised over the previous years and showed no signs of obvious erosion progression at the time of monitoring.

Revegetation work is recommended to target most of the erosion points, except for E8. The establishment of riparian vegetation can assist in stabilising banks and slow surface runoff (Abernathy and Rutherford 1999). Sites E1, E3, E4, E6 and E9 have very steep and exposed banks, which without intervention will continue to erode. This erosion can range from minor activity to gully retreat, bank collapse, and further root exposure. As these banks become higher, and the bank angle becomes greater, which will lead to further erosion. Therefore, it is recommended that these banks are initially reshaped to reduce the overall bank angle, before undertaking revegetation works.

Meanwhile, with site E2 showing evidence of rill erosion, the application of a native groundcover seed mix and mulch to the bank sides (including hydro-mulch) is recommended to assist stabilisation until vegetation establishes, along with the installation of coarse-rock, large-woody debris, coir logs and/or hay bale check dams to reduce water flow in designated erosion points. Seeding and mulching is also

recommended for sites E10, and E11. Temporary fencing works in all areas will also assist in excluding native and introduced fauna from revegetation and remediation areas, it is recommended that the existing fencing around sites E1 to E4 be assessed and reinstated where required.

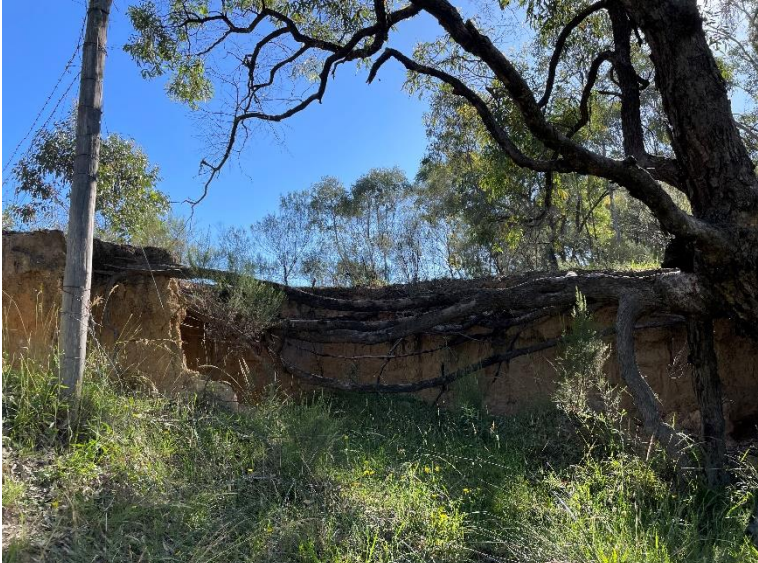
Erosion point	Image	Notes / suggested works
<p>E3 (768558, 6422432)</p>

<p>Evidence of continued mass wasting at top of bank and around tree roots.</p> <p>Reshaping and contouring of bank to ease water flowing through the erosion and revegetation (Section 4.3).</p>
<p>E4 (768614, 6422382)</p>

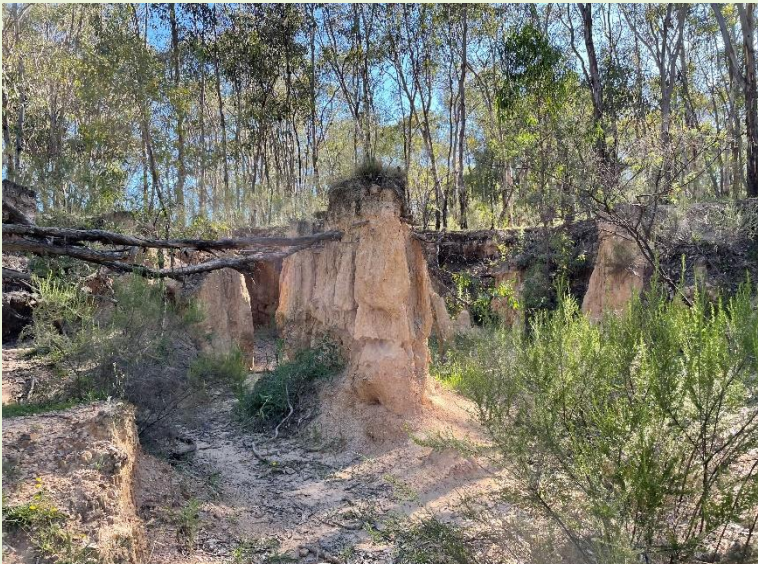
<p>Erosion has continued over the past year with some mass wasting evident at top of bank.</p> <p>Reshaping and contouring of bank to ease water flowing through the erosion and revegetation (Section 4.3).</p>
<p>E6 (772166, 6420287)</p>

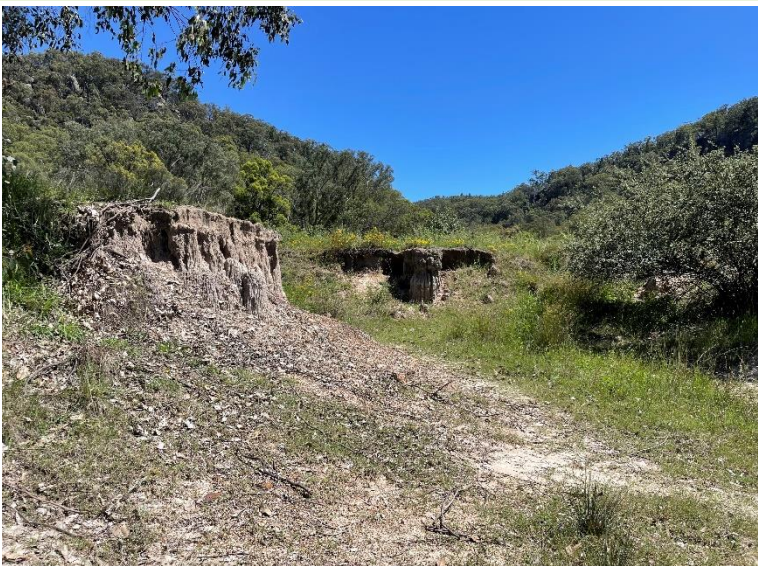
<p>Erosion appears stable on the steep banks with no further mass wasting or undercutting observed at the time of monitoring.</p> <p>Reshaping and contouring of bank to ease water flowing through the erosion and revegetation (Section 4.3).</p>

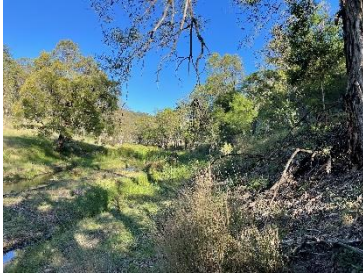
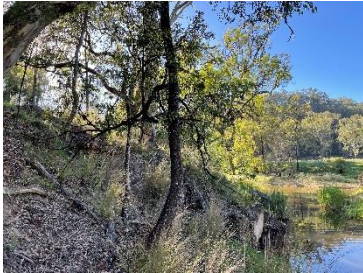
**WCK 49**

One site recorded increase stability along Wilpinjong Creek in 2024. WCK49 had increased groundcover vegetation reflective of the increased rainfall. Increased vegetation cover is directly linked to increased scores for Streambank Protection and associated increased scores for Unconsolidated Material.
