# **Wilpinjong Coal Mine**

## **2025 Nest Box Monitoring**

Wilpinjong Coal Pty Ltd

| Project Name: | Wilpinjong Coal Mine: 2025 Nest Box Monitoring |

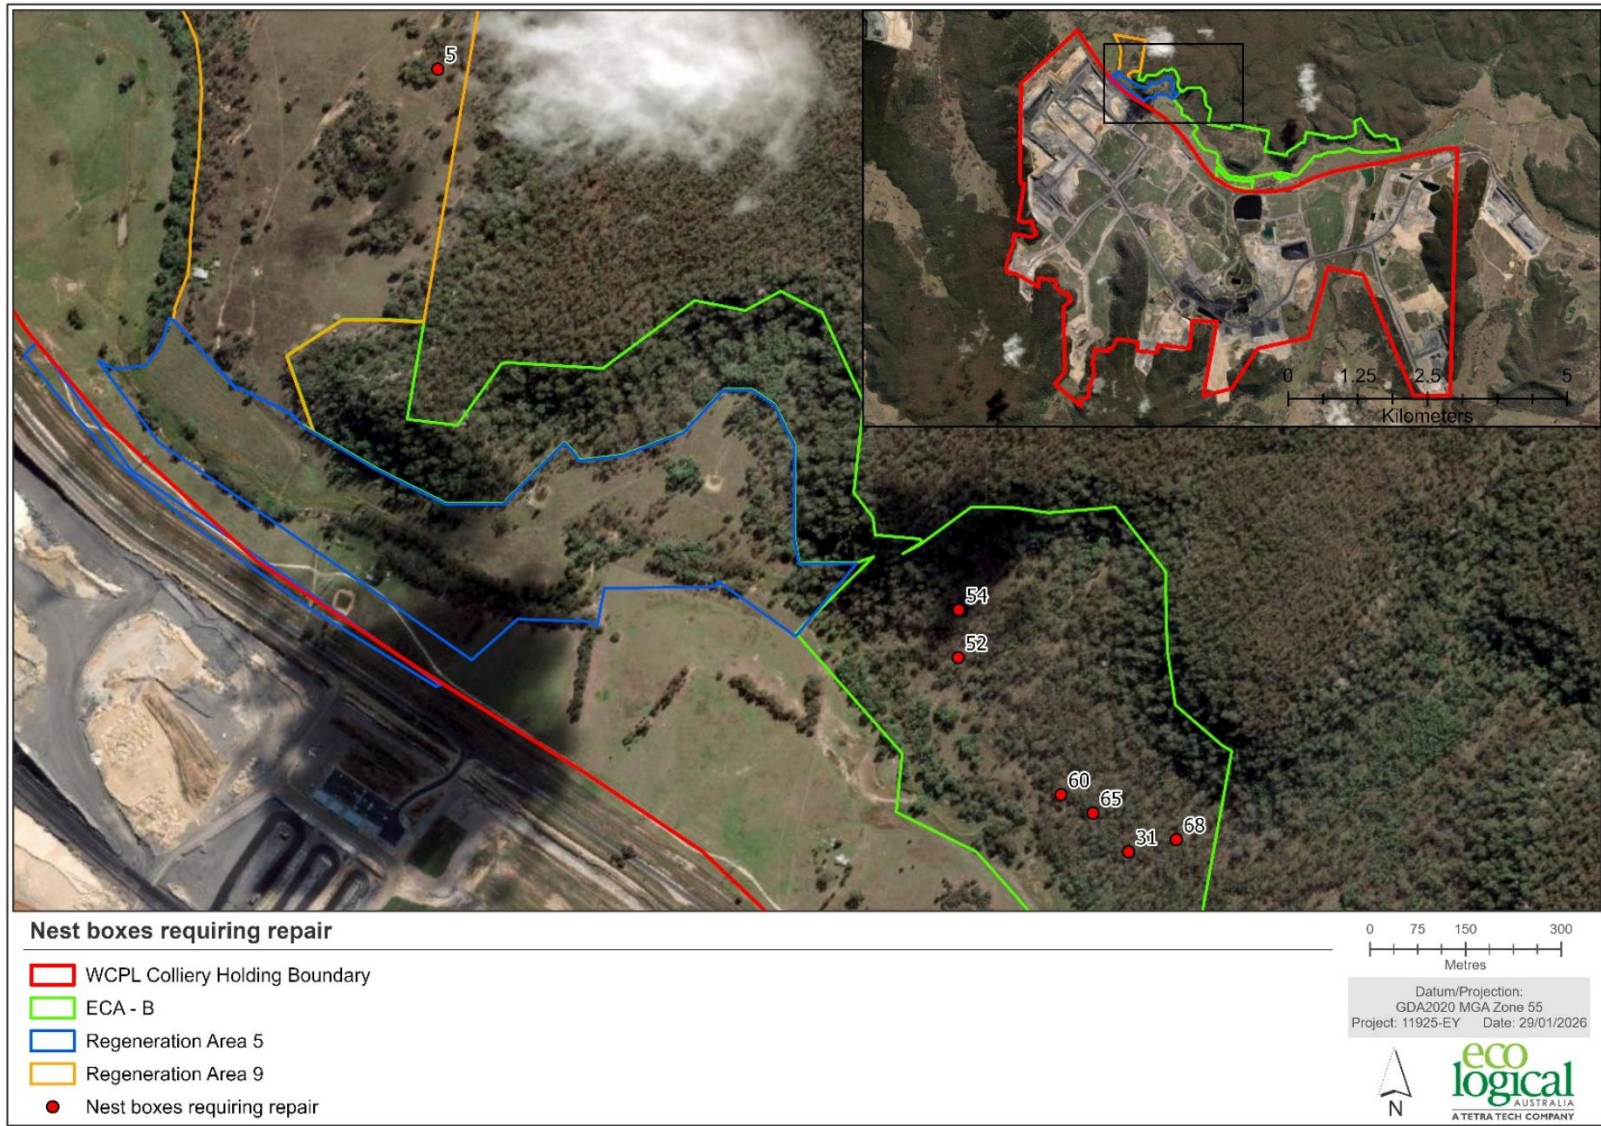
Figure 2: Nest boxes requiring repair

Locations of the nest boxes requiring repair are shown below in Figure 2.

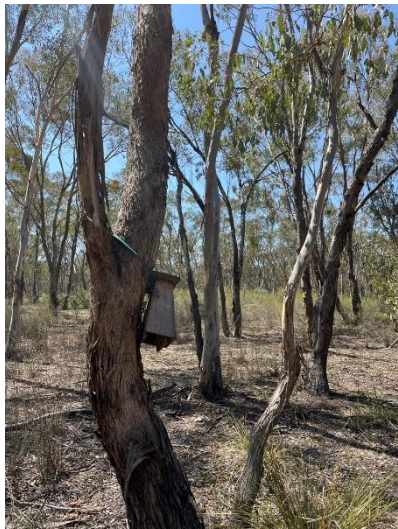
- Nest box 31 has fallen down the trunk of the tree from its original position, however, is still positioned in a lower fork in the tree, though appears potentially unstable
- Nest box 68 has fallen completely off the tree and onto the ground
- The side of nest box 65 is partially open
- Nest box 60 has broken apart and is lying on the ground
- The side of nest box 52 is partially open
- Side door on nest box 54 needs to be closed and re-screwed
- Nest box 5 has fallen forward on the tree, is potentially unstable and its tie-wire requires tightening.

| Area | Nest Box ID | Northing | Easting | Condition | Fauna present |
|---|---|---|---|---|---|
| ECA-B | 31 | 6420952.539 | 770137.1832 | Repair | None |

Repairs and maintenance as per the suggestions above is recommended, as well as the continuation of annual inspections.

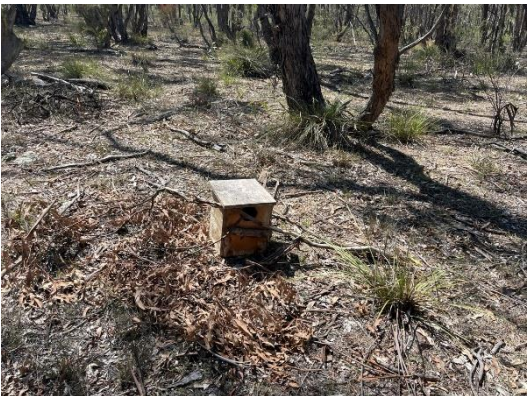
Nest box 68

| Area | Nest Box ID | Northing | Easting | Condition | Fauna present |
|---|---|---|---|---|---|
| ECA-B | 68 | 6420975.7 | 770217.6 | Repair | |

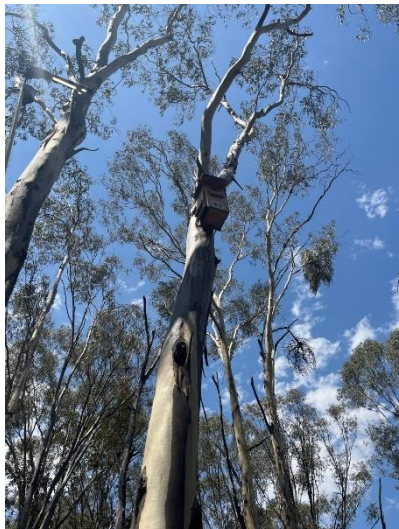
Nest box 65

| Area | Nest Box ID | Northing | Easting | Condition | Fauna present |
|---|---|---|---|---|---|
| ECA-B | 65 | 6421020.824 | 770082.2747 | Repair | None |

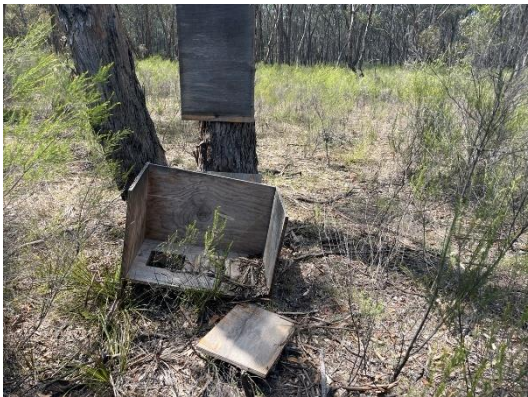
Nest box 60

| Area | Nest Box ID | Northing | Easting | Condition | Fauna present |
|---|---|---|---|---|---|
| ECA-B | 60 | 6421044.956 | 770030.801 | Unserviceable | None |

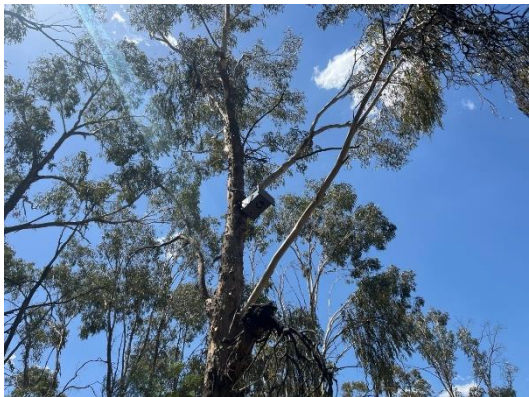
Nest box 5

| Area | Nest Box ID | Northing | Easting | Condition | Fauna present |
|---|---|---|---|---|---|
| regen 9 | 5 | 6422184.9 | 769056.5 | Repair | None |
