## PRE-CONSTRUCTION DILAPIDATION REPORT

### 6-20 HINKLER AVENUE & 319-333 TAREN POINT ROAD, CARINGBAH

| PRE-CONSTRUCTION DILAPIDATION REPORT<br>6-20 Hinkler Avenue & 319-333 Taren Point Road,<br>Caringbah NSW 2229 | | | | | Project Number: 21039 |

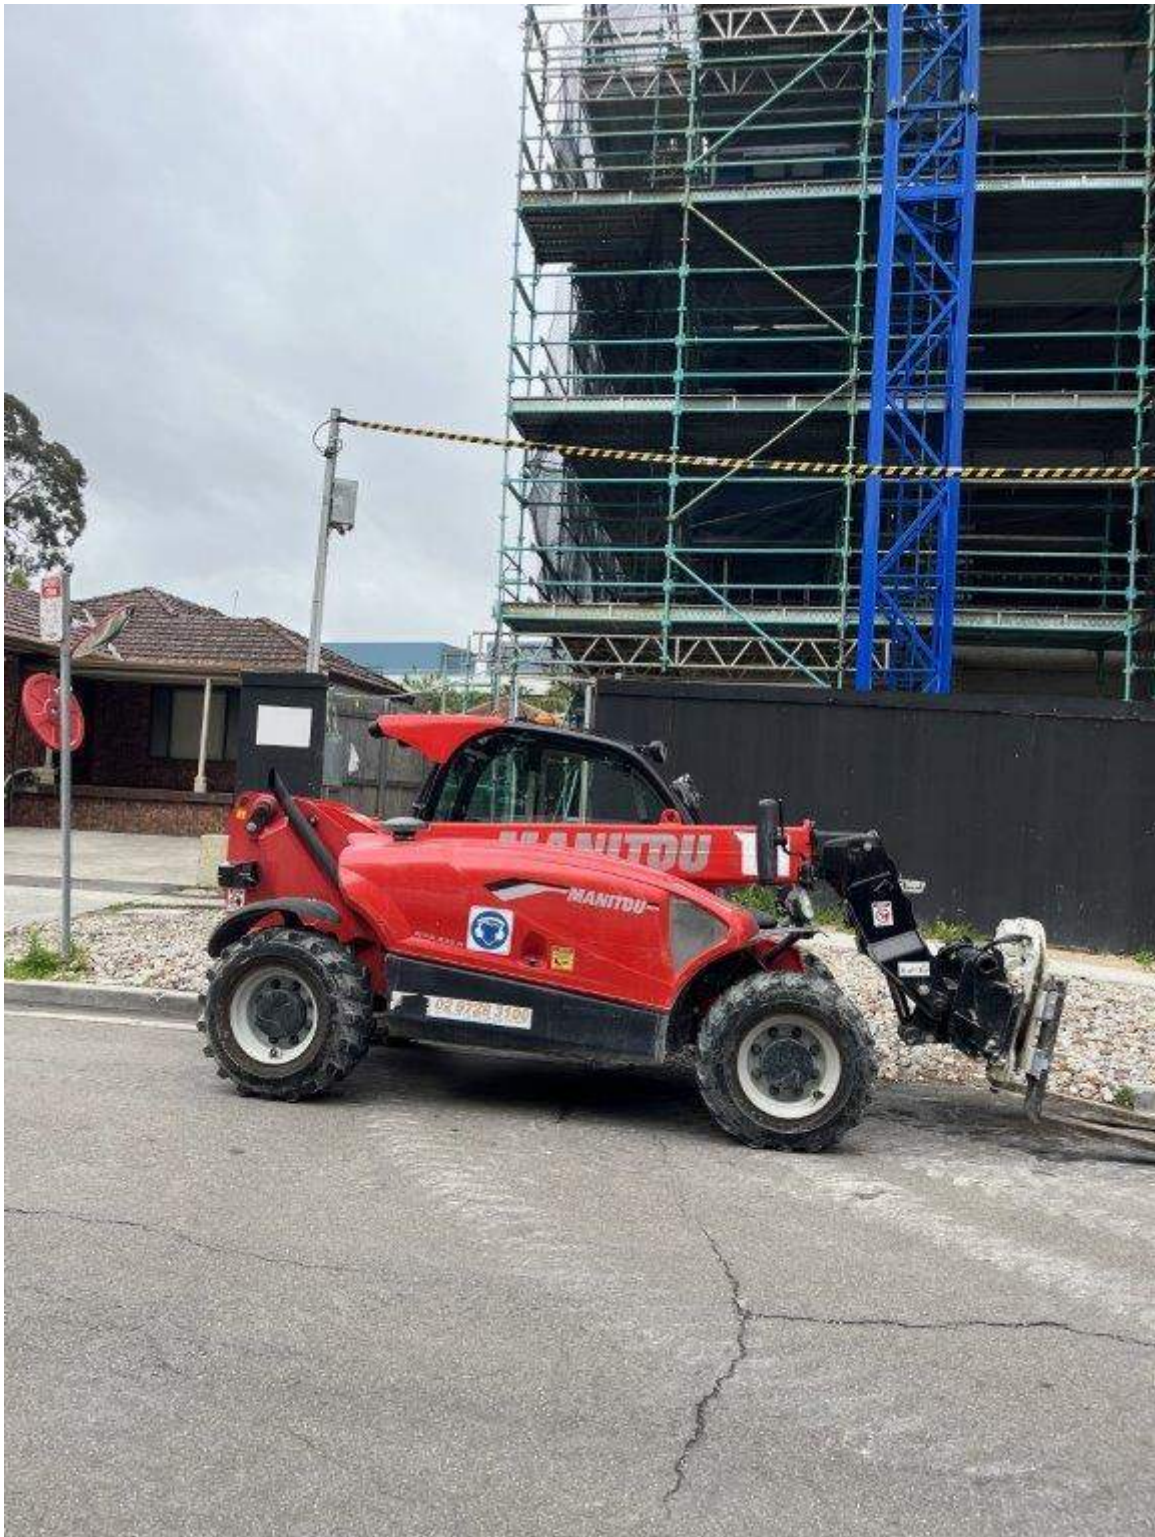
Photo 7 - Hinkler Avenue - Cracking of kerb and pavement

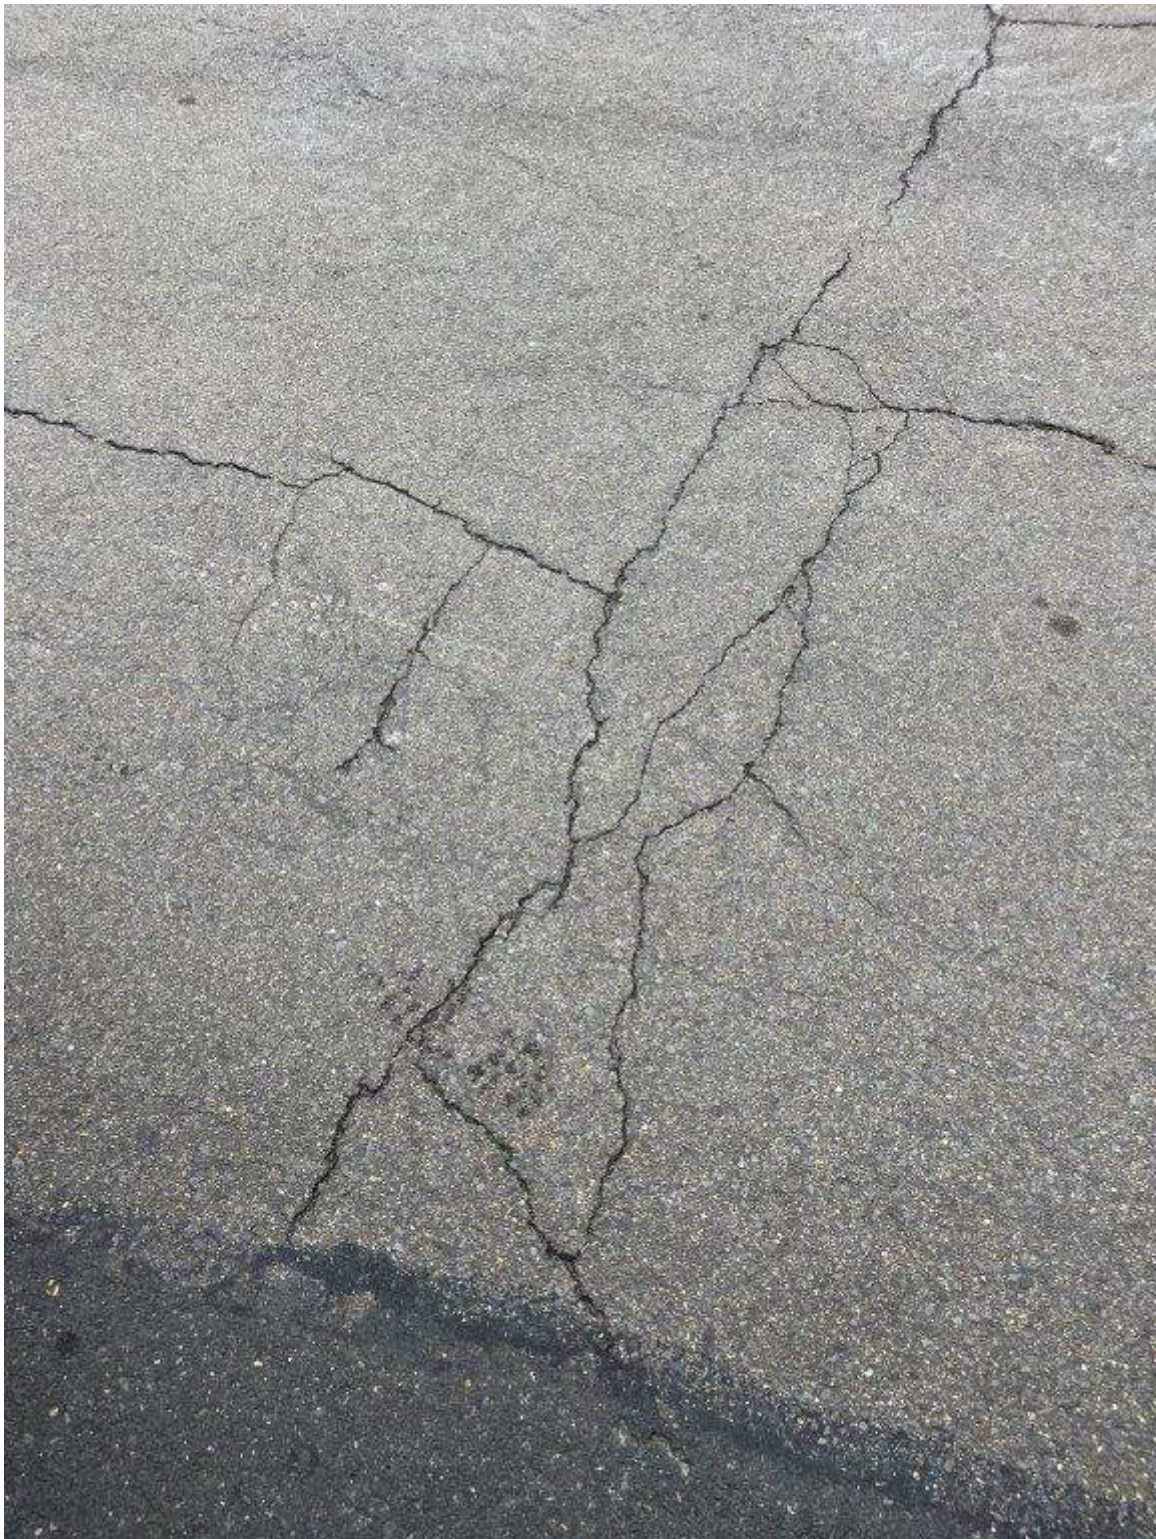
Photo 8 - Hinkler Avenue - Cracking of pavement

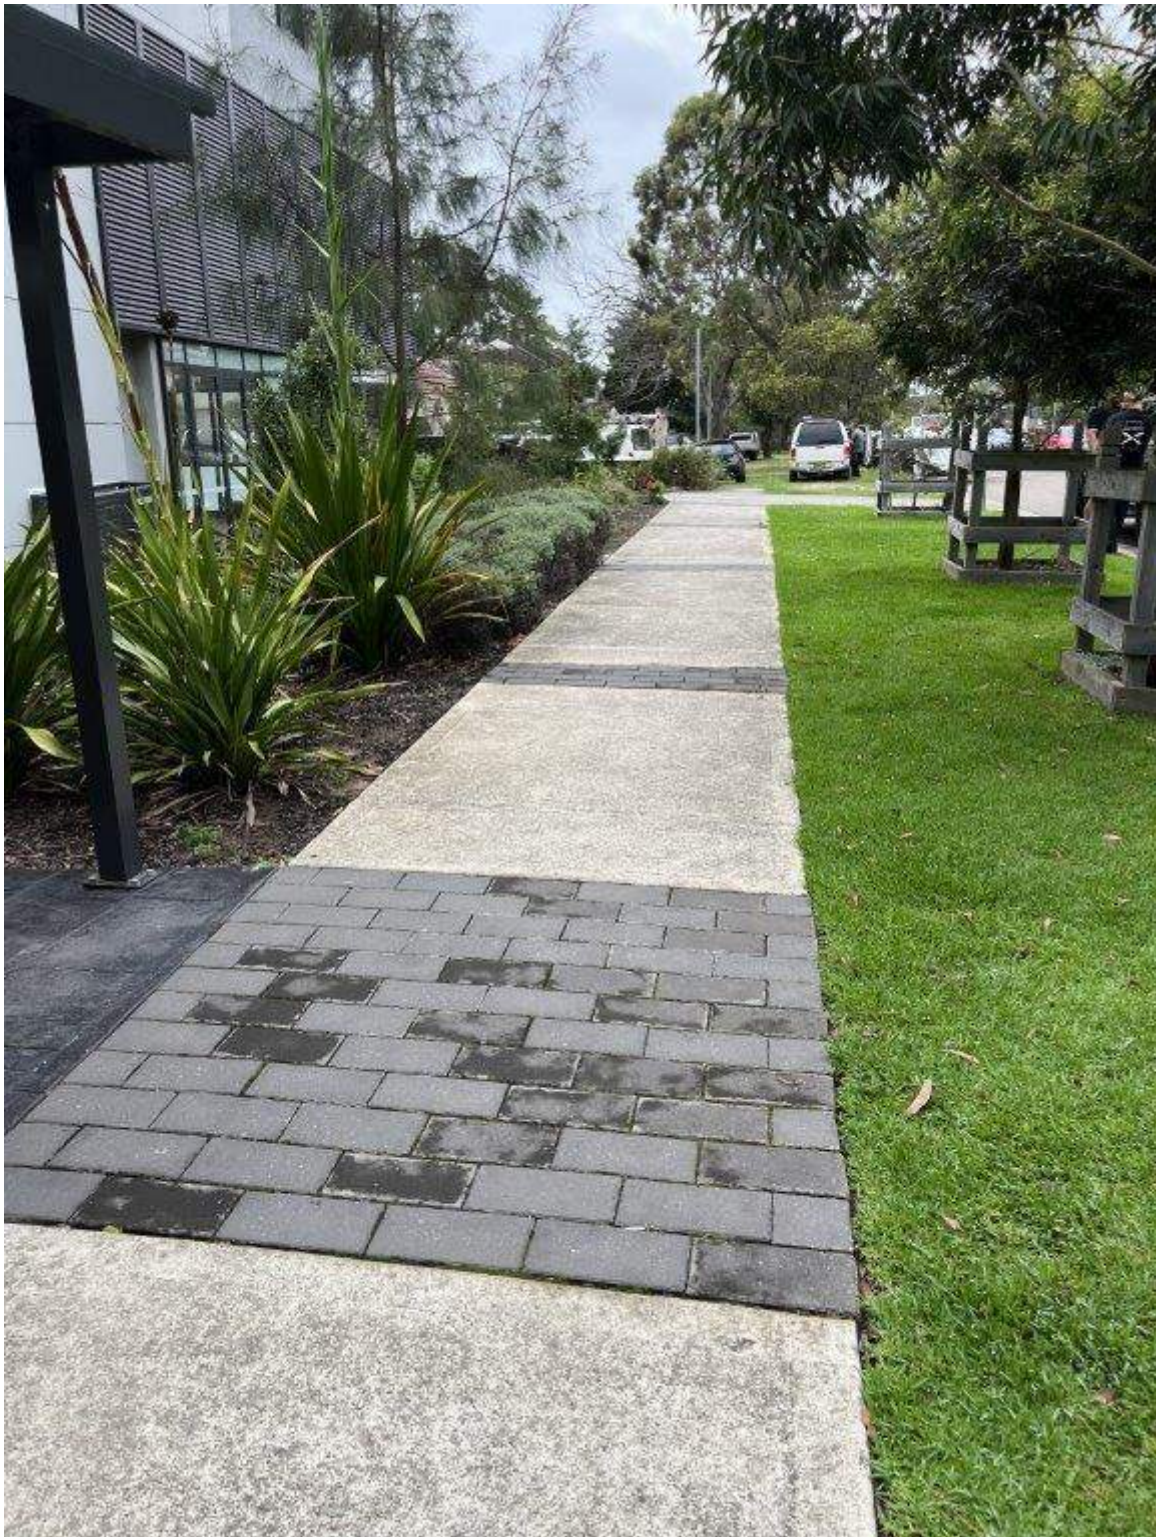
Photo 11 - Hinkler Avenue - Cracking of pavement

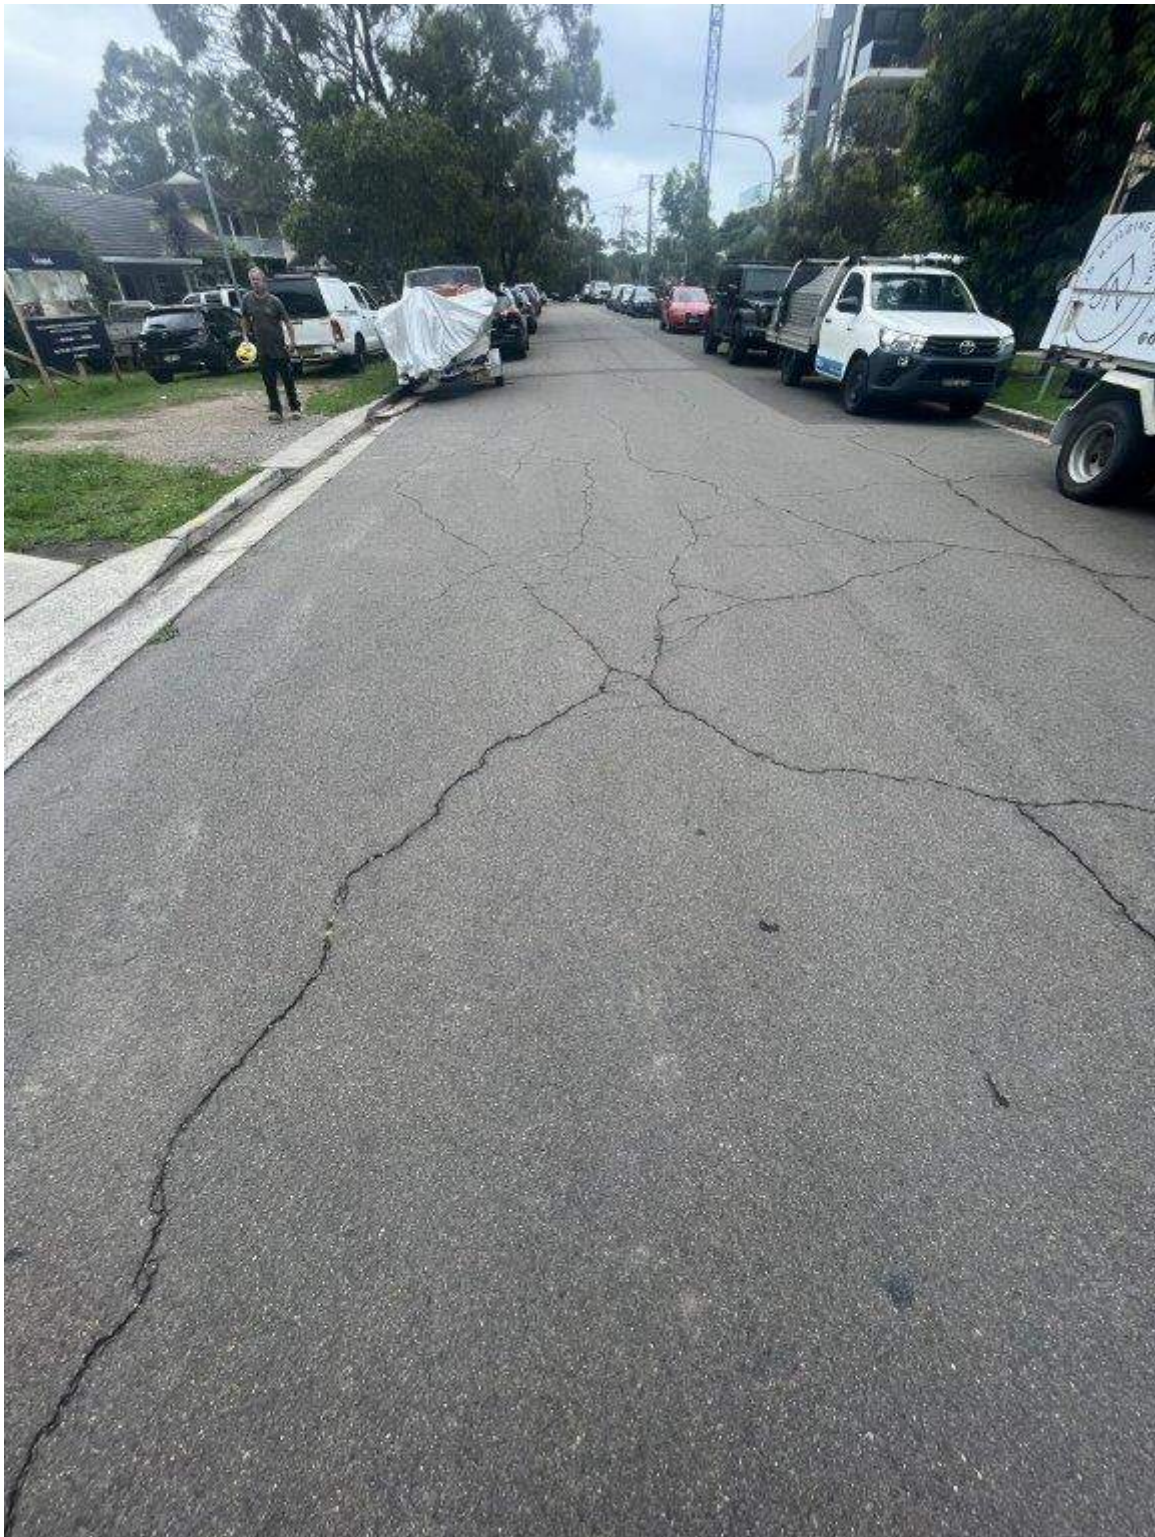
Photo 18 - Hinkler Avenue - Cracking of pavement

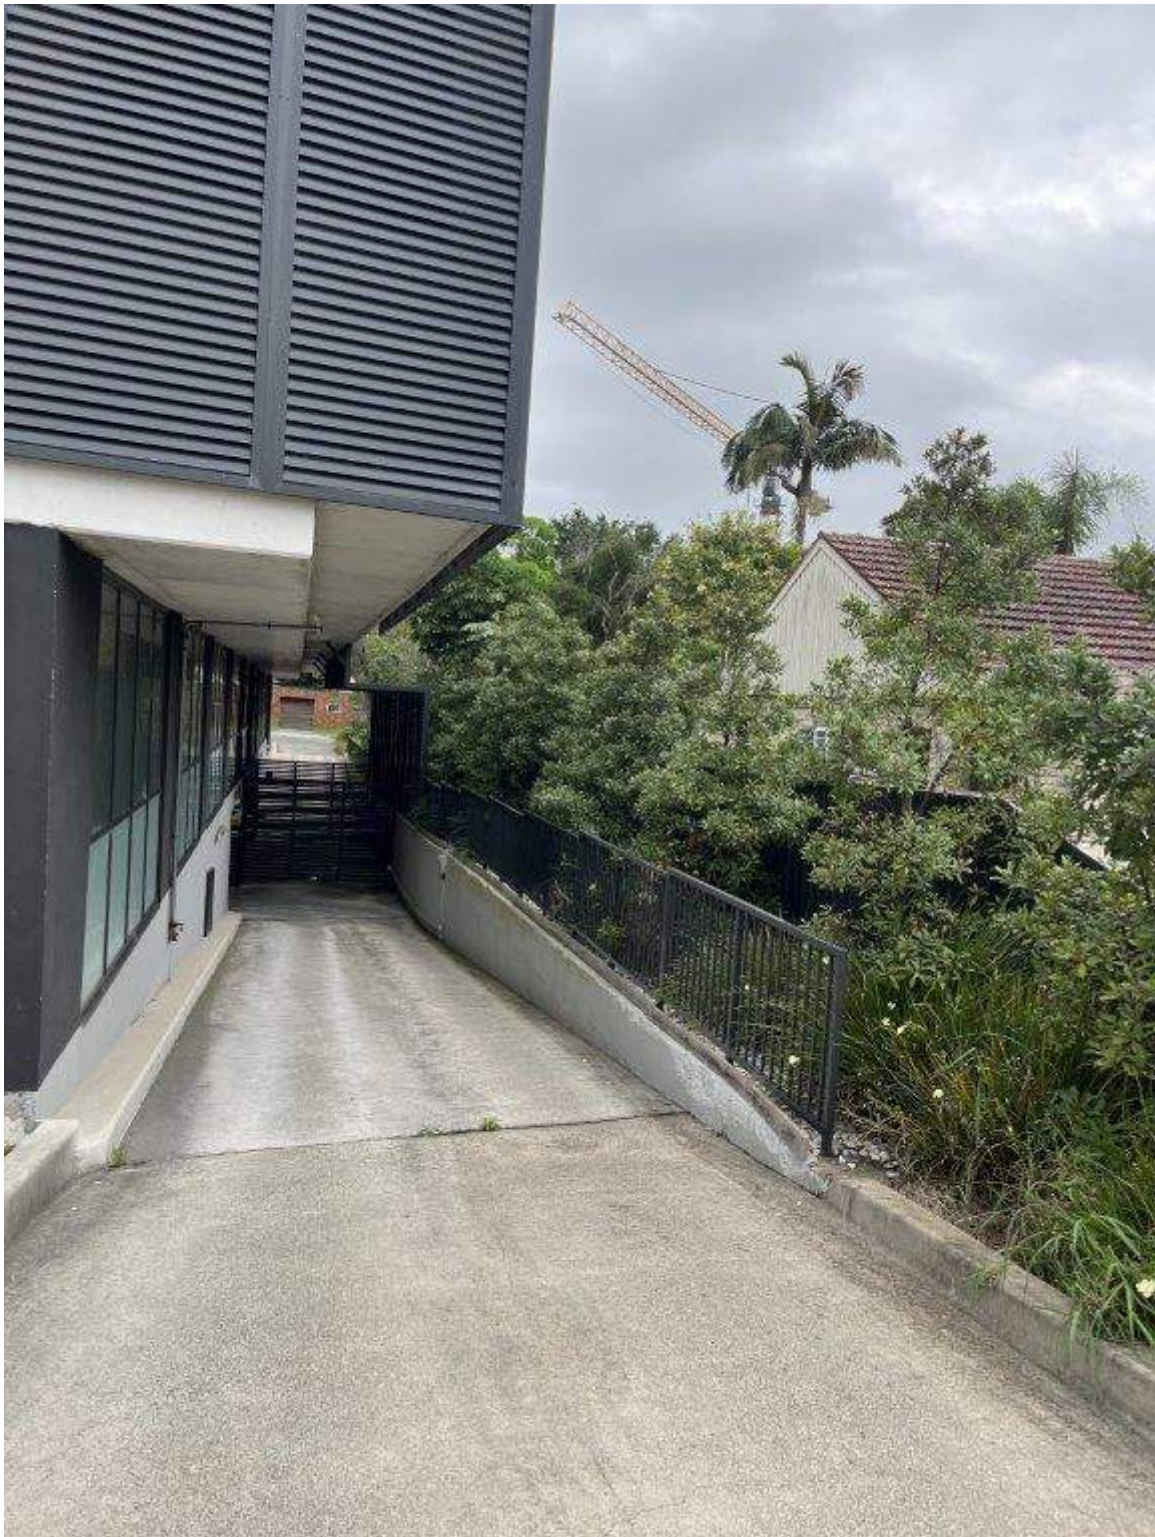
Photo 23 - Hinkler Avenue - Cracking of pavement

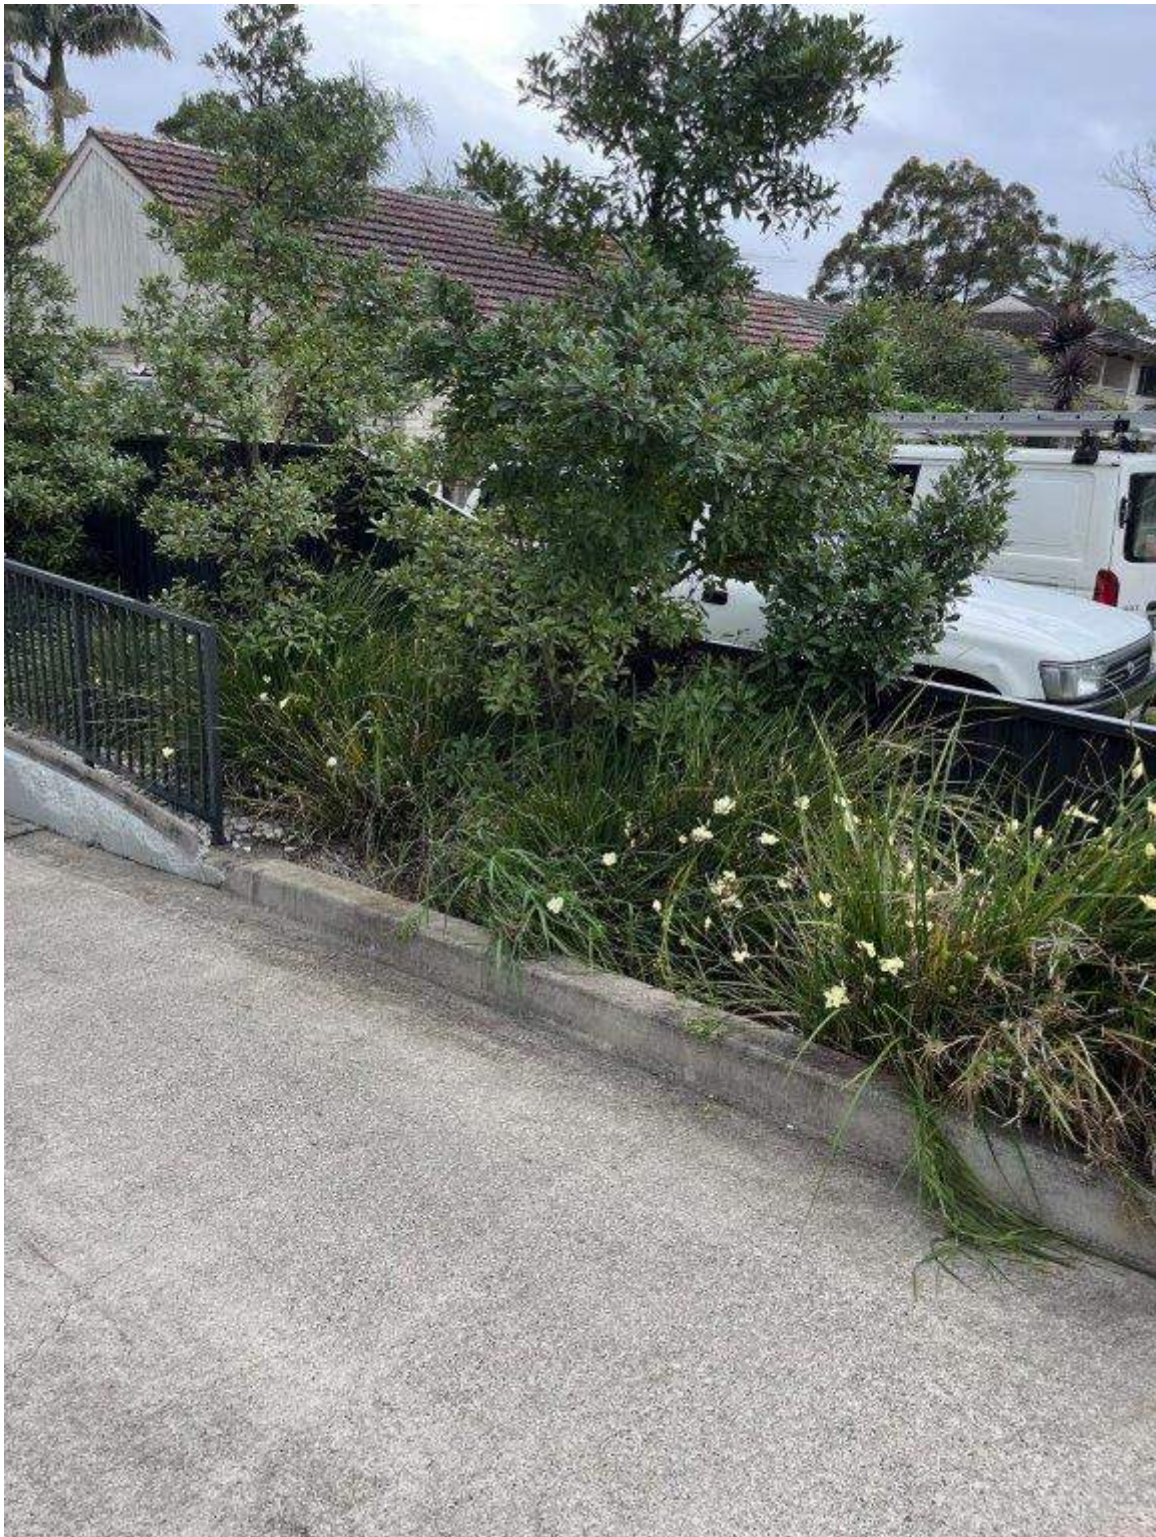
Photo 25 - Hinkler Avenue - Cracking of pavement

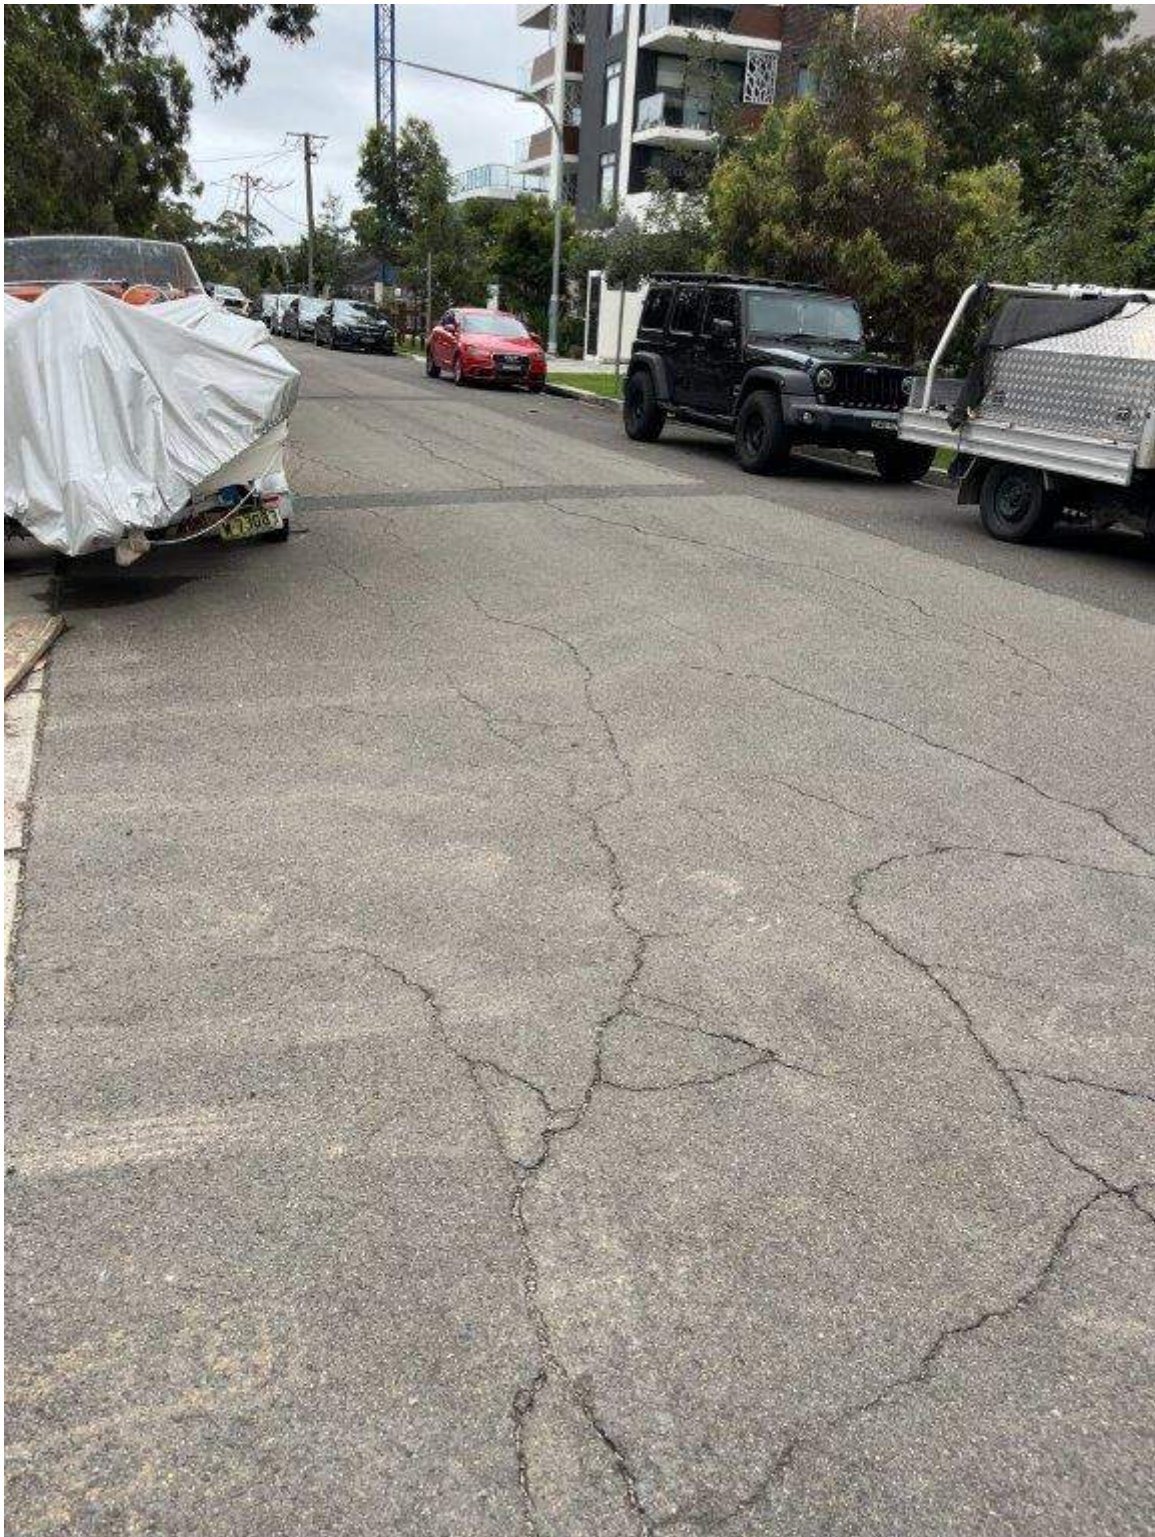
Photo 28 - Hinkler Avenue - Cracking of pavement

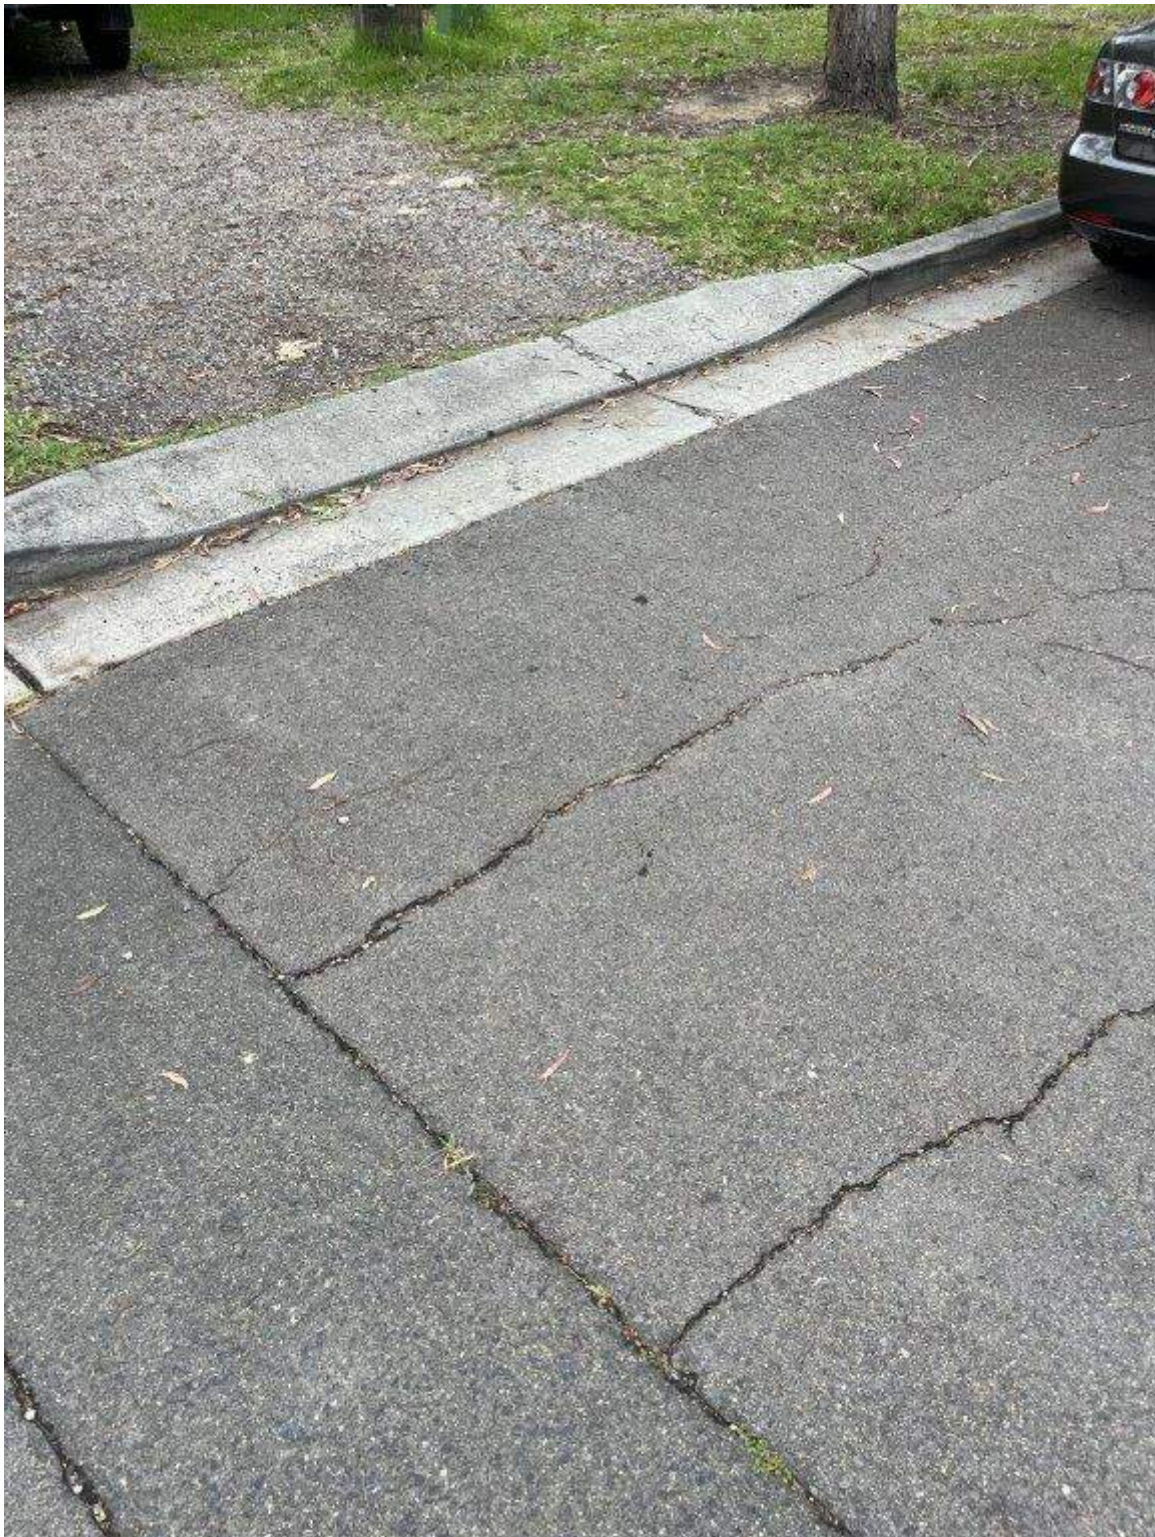
Photo 33 - Hinkler Avenue - Cracking of pavement

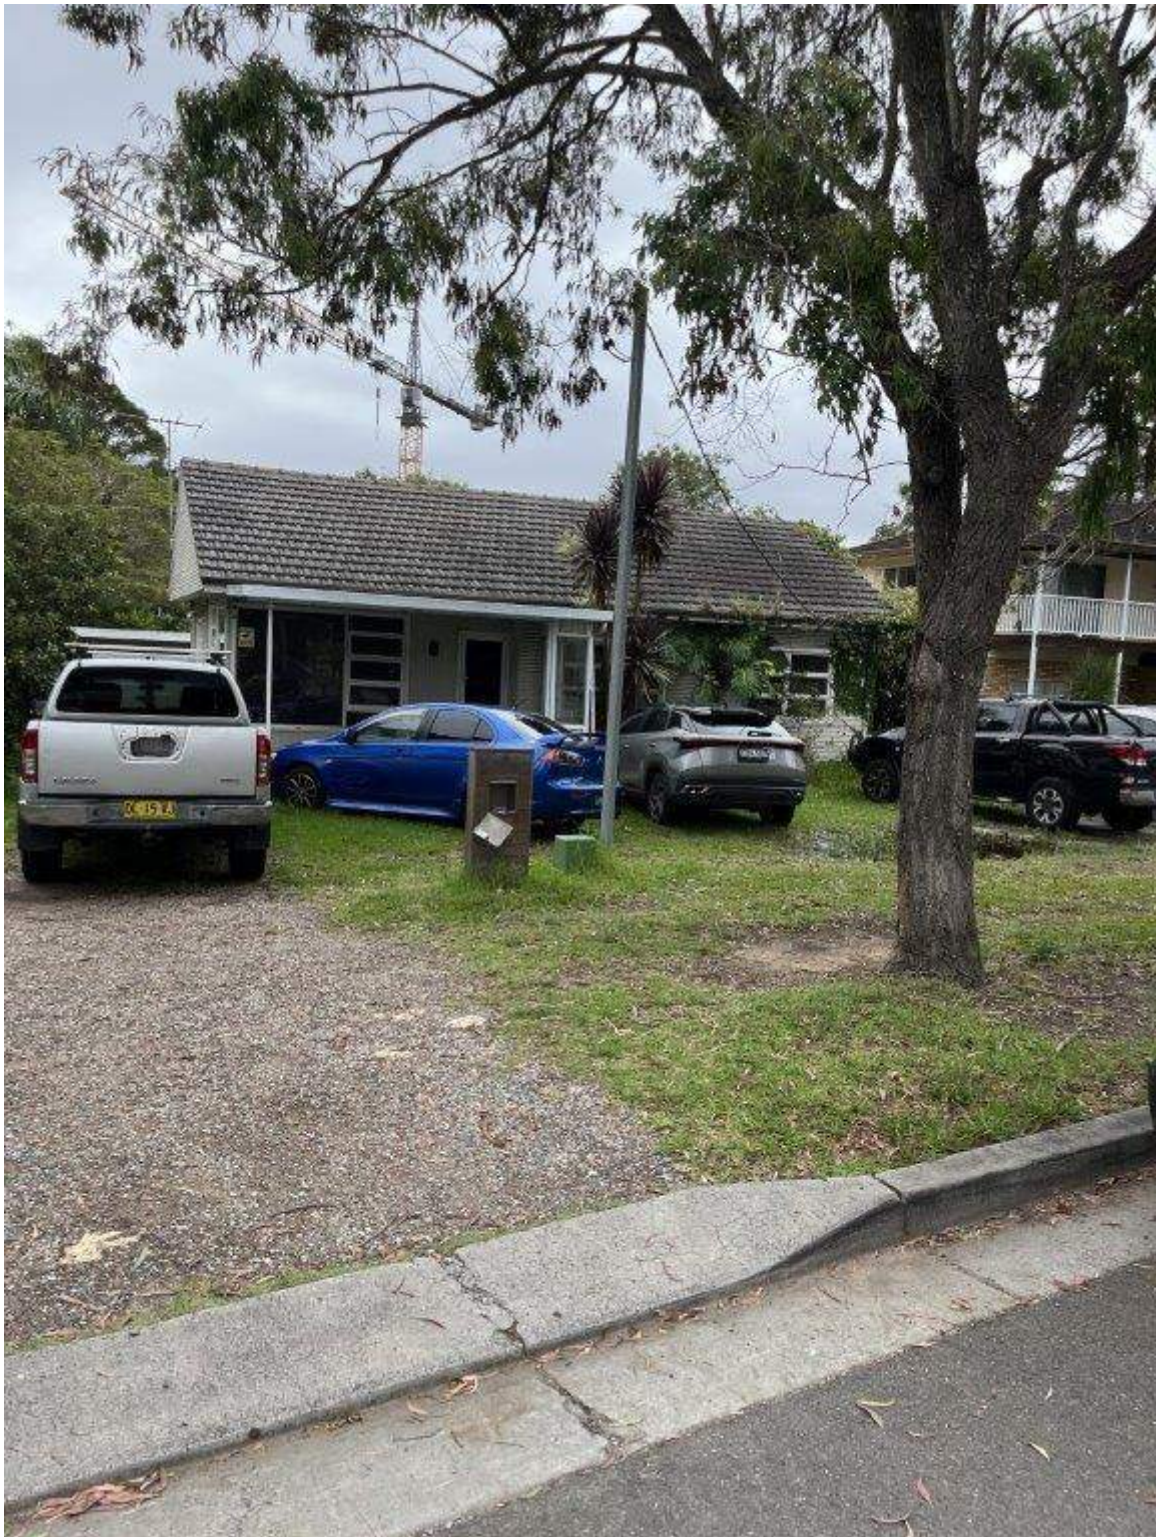
Photo 34 - Hinkler Avenue - Cracking of pavement

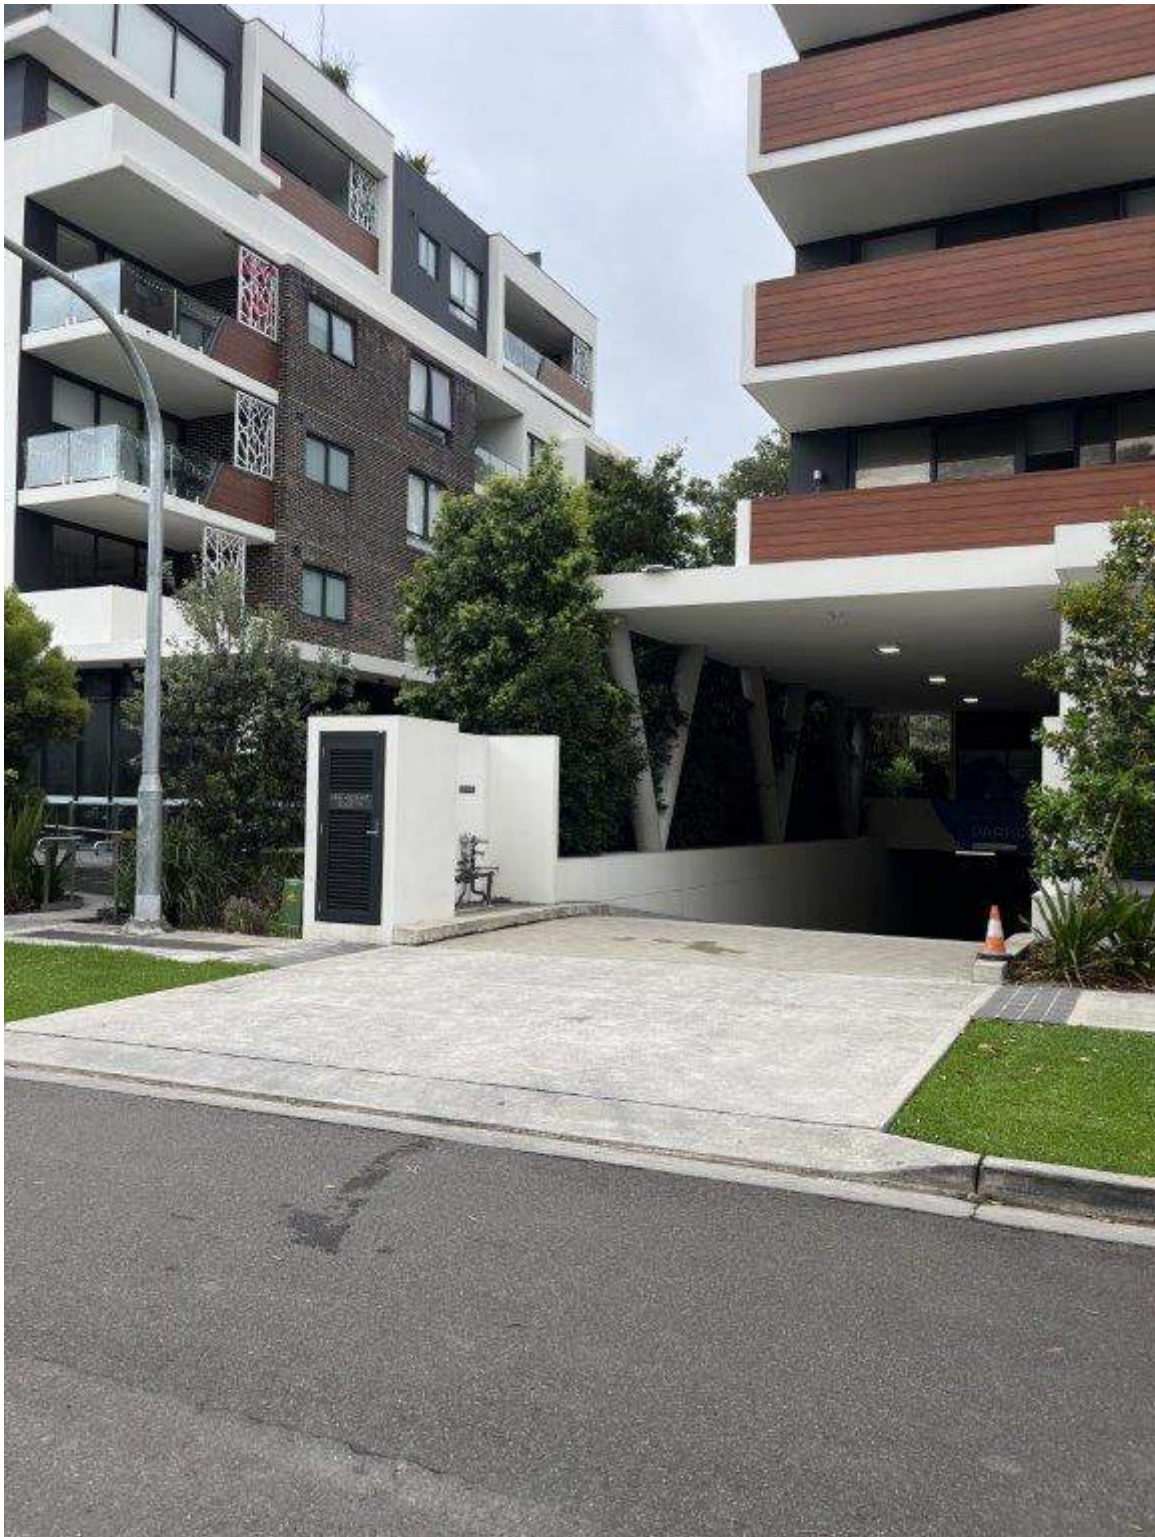
Photo 35 - Hinkler Avenue - Cracking of pavement

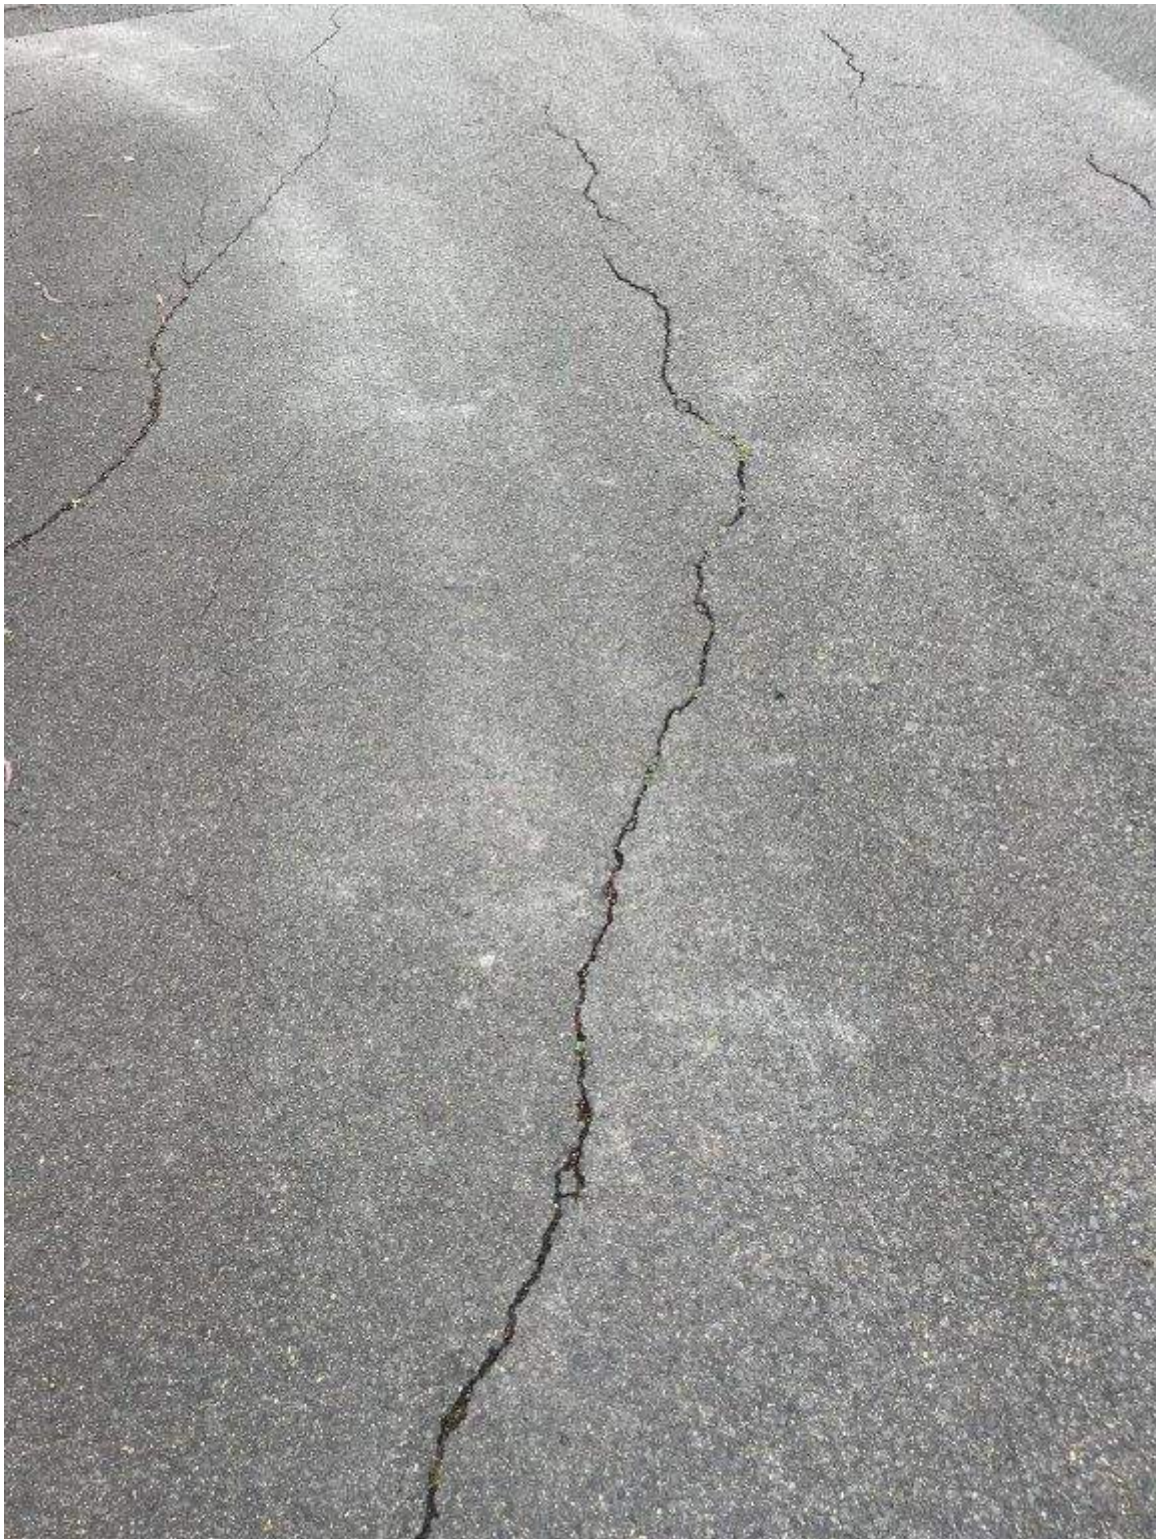
Photo 37 - Hinkler Avenue - Cracking of pavement

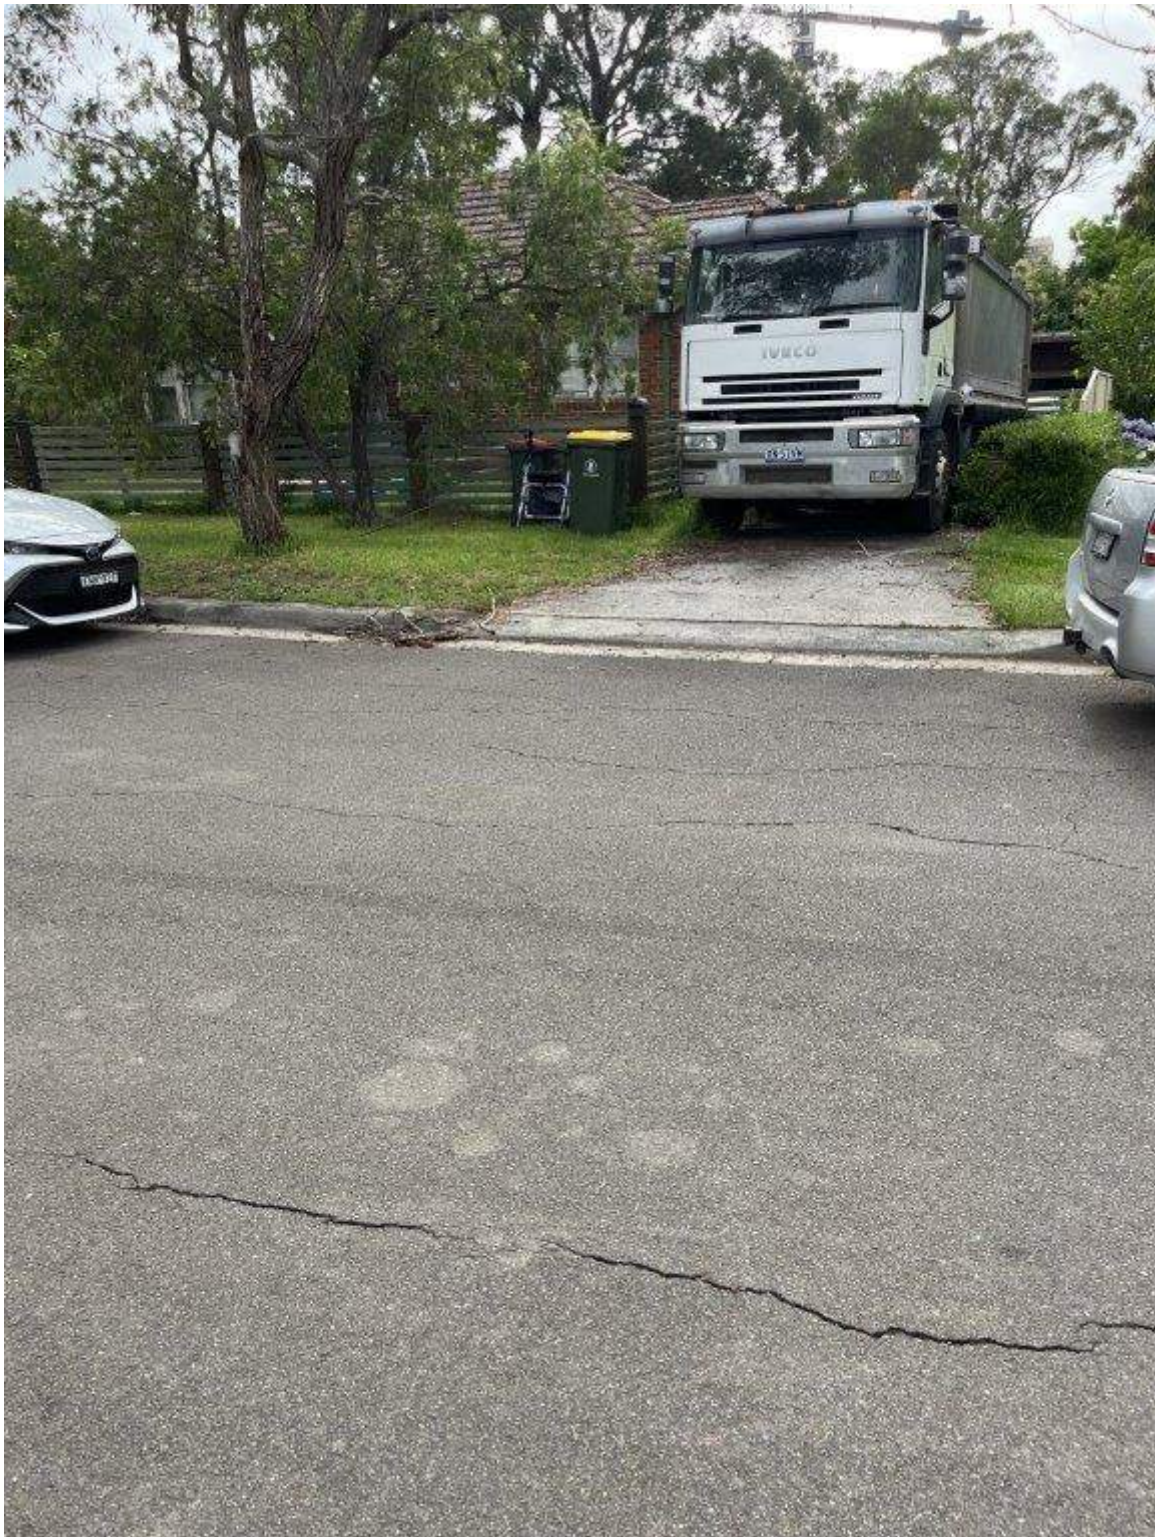
Photo 74 - Hinkler Avenue - Cracking of pavement

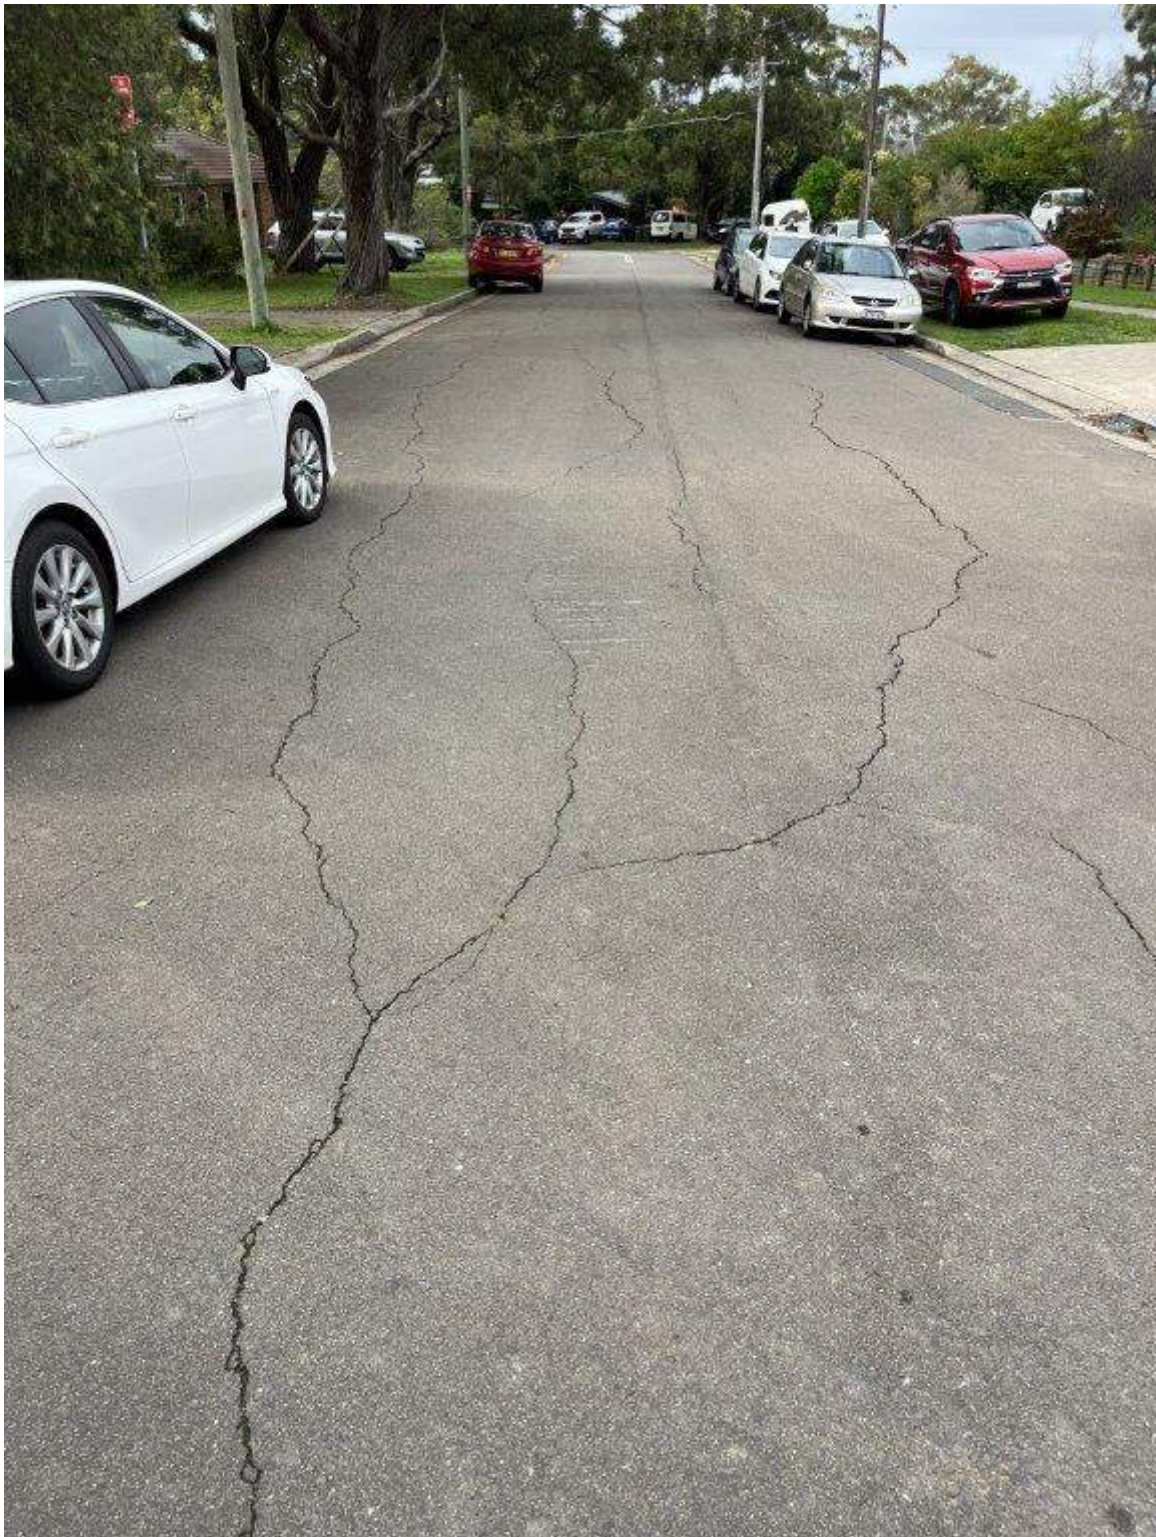
Photo 80 - Hinkler Avenue - Cracking of kerb and pavement
