## PRE-CONSTRUCTION DILAPIDATION REPORT

### 6-20 HINKLER AVENUE & 319-333 TAREN POINT ROAD, CARINGBAH

| PRE-CONSTRUCTION DILAPIDATION REPORT<br>6-20 Hinkler Avenue & 319-333 Taren Point Road,<br>Caringbah NSW 2229 | | | | | Project Number: 21039 |

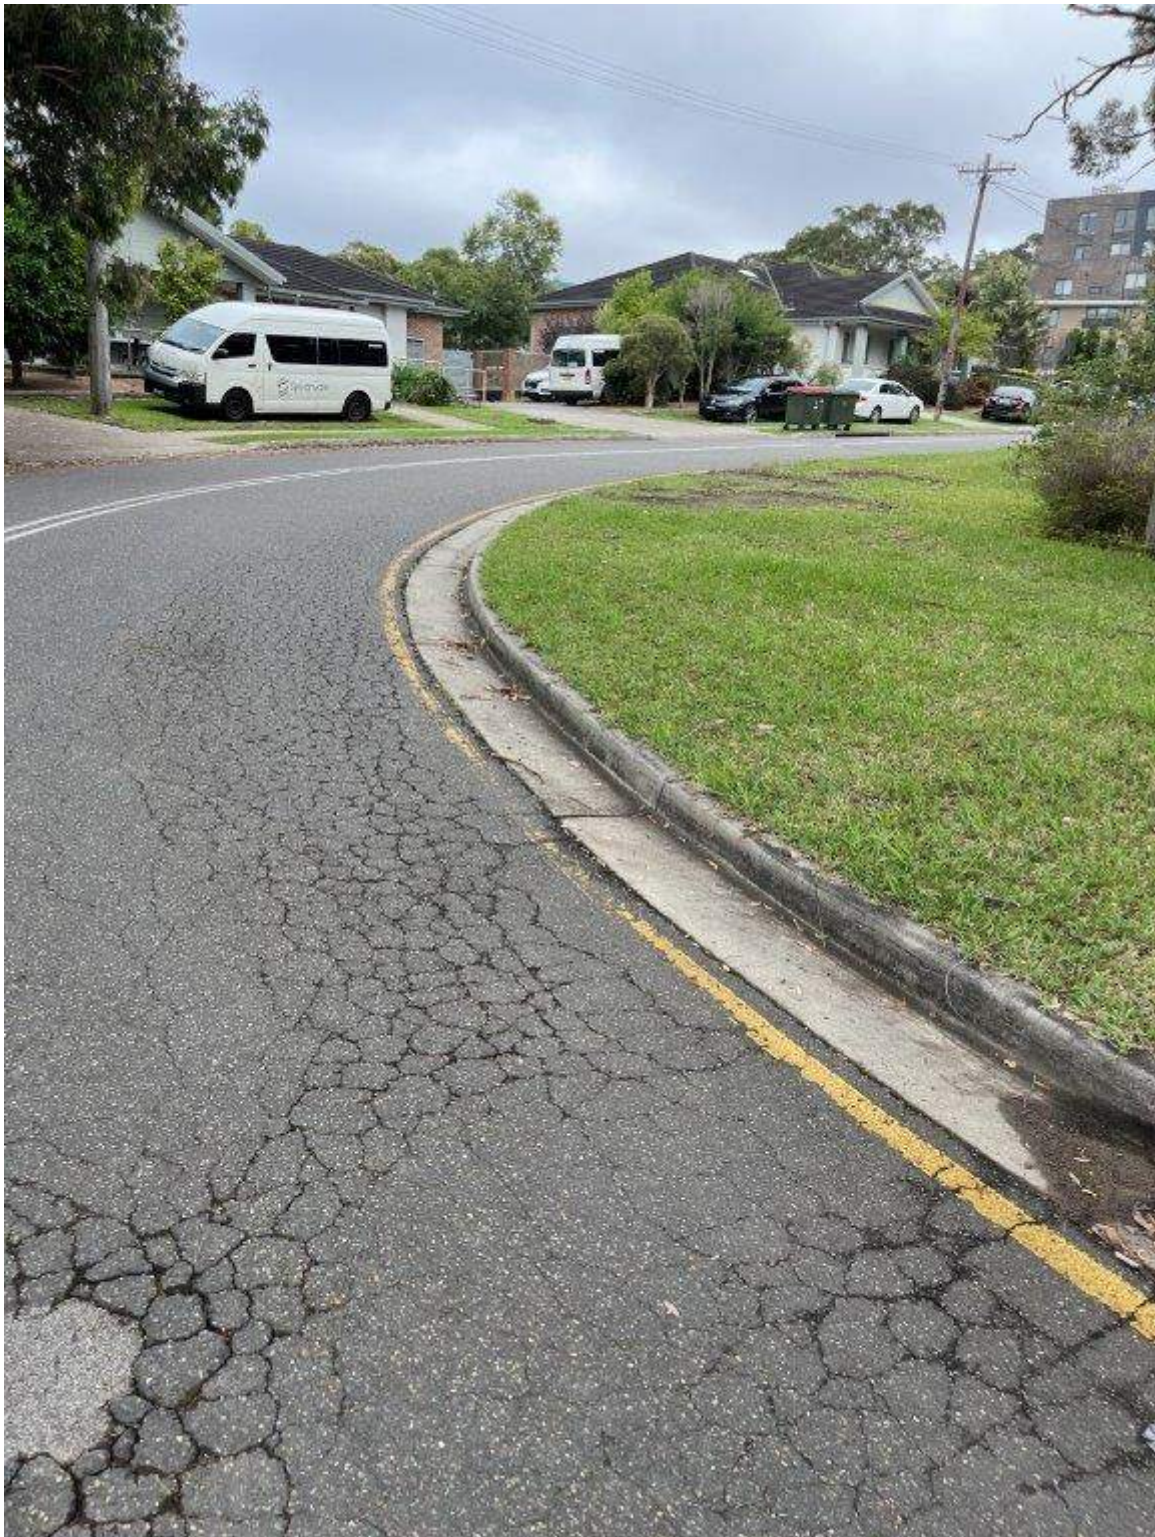
Photo 121 - Hinkler Avenue - Cracking of pavement and patching

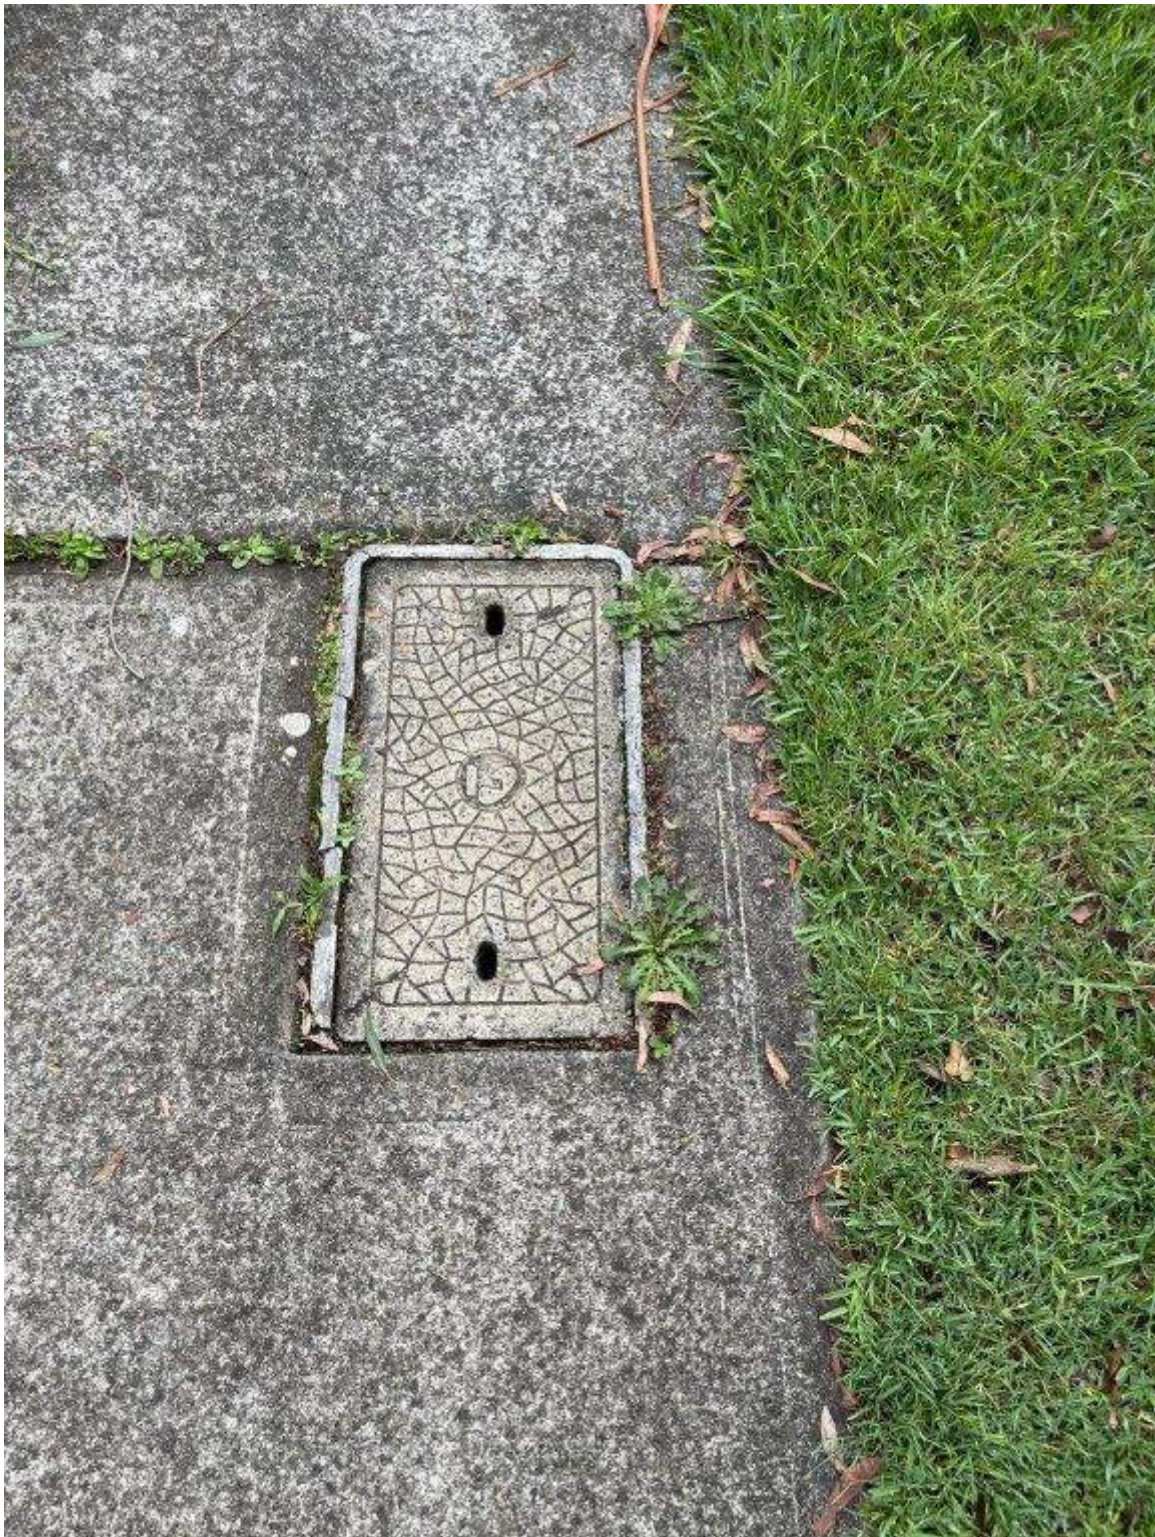
Photo 127 - Hinkler Avenue - Differential settlement of pavement

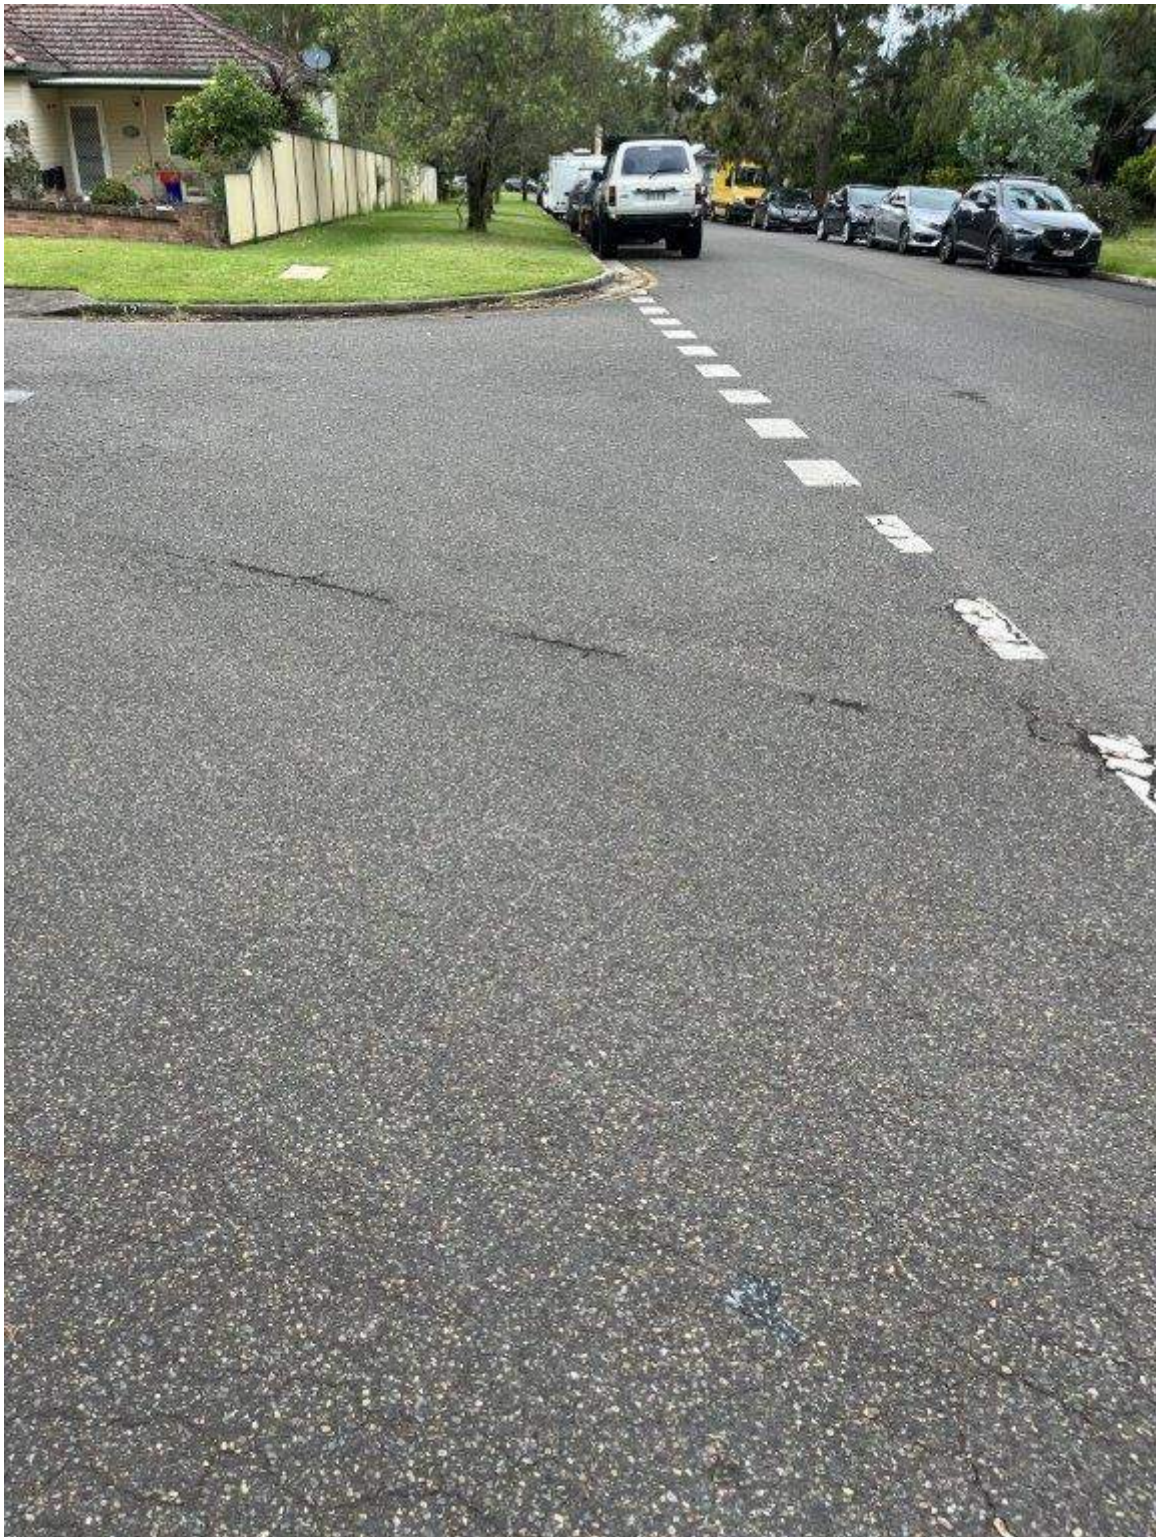
Photo 201 - Taren Point Road – Patching of pavement

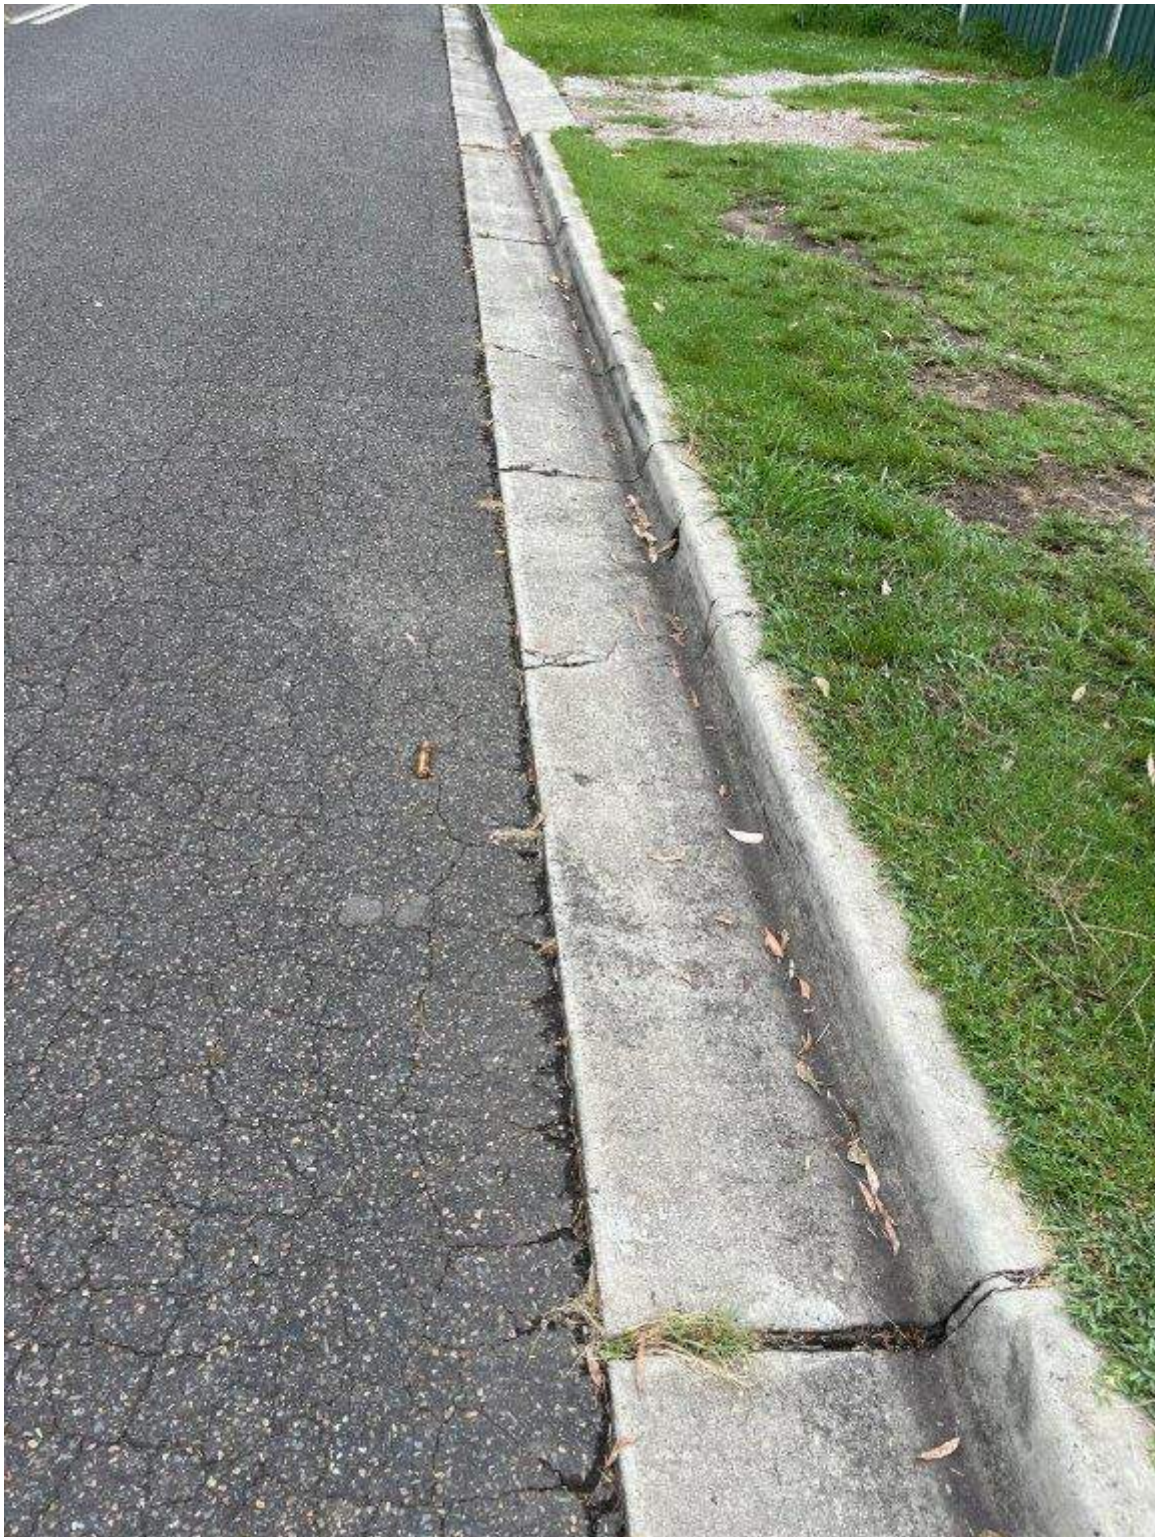
Photo 214 - Taren Point Road - Cracking of pavement
