# **Council Assets Dilapidation Report**

Address: 6-20 Hinkler Ave, Caringbah

Project No: 7235

DATE: 1<sup>st</sup> July, 2025

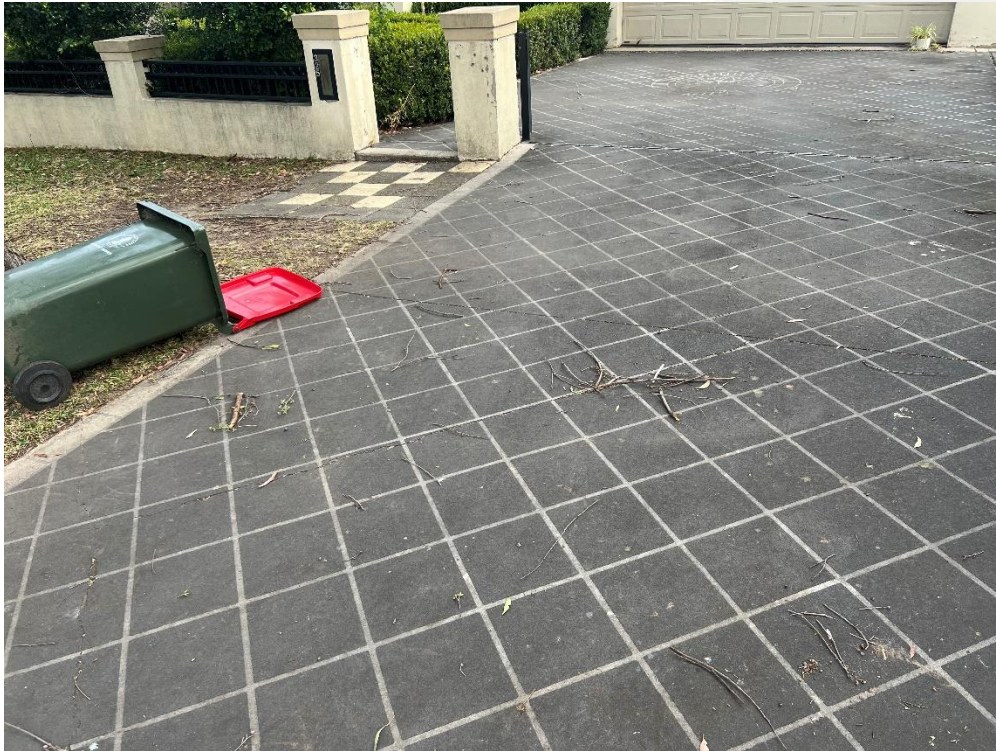
13

| 1 – 75 | <p>Existing condition of nature strip on Taren Point Road and Hinkler Avenue including footpaths, driveways, kerb ramps, trees and telegraph poles.</p> <p>Defects observed in:</p> <ul style="list-style-type: none"> <li>• Photos 13, 16, 17, 43, 46, 51, 59, 73 – Cracks in driveway</li> <li>• Photo 72 – Cracks in Footpath</li> </ul> |
