Client Name Aurora Projects	Site Location Lismore Base Hospital Uralba Street, Lismore, NSW	Document Ref: CUS000/ 00006107F
---------------------------------------	--	--

Introduction

Hazardous Materials Survey Report

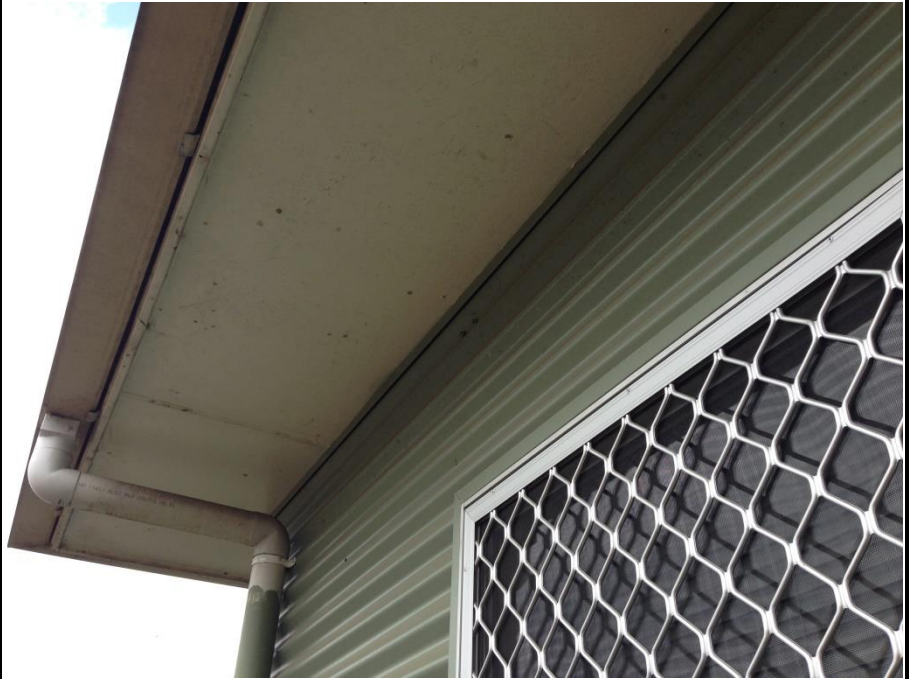
Photo No. 1	Date 19/11/2014
Location External – Soffit lining	
Sample Reference 00006107D-001	
ACM / NAD ACM	Nature of ACM Non-friable
Comments Soffit linings on all elevations of the house. In good condition and painted. Paint flaking in areas.

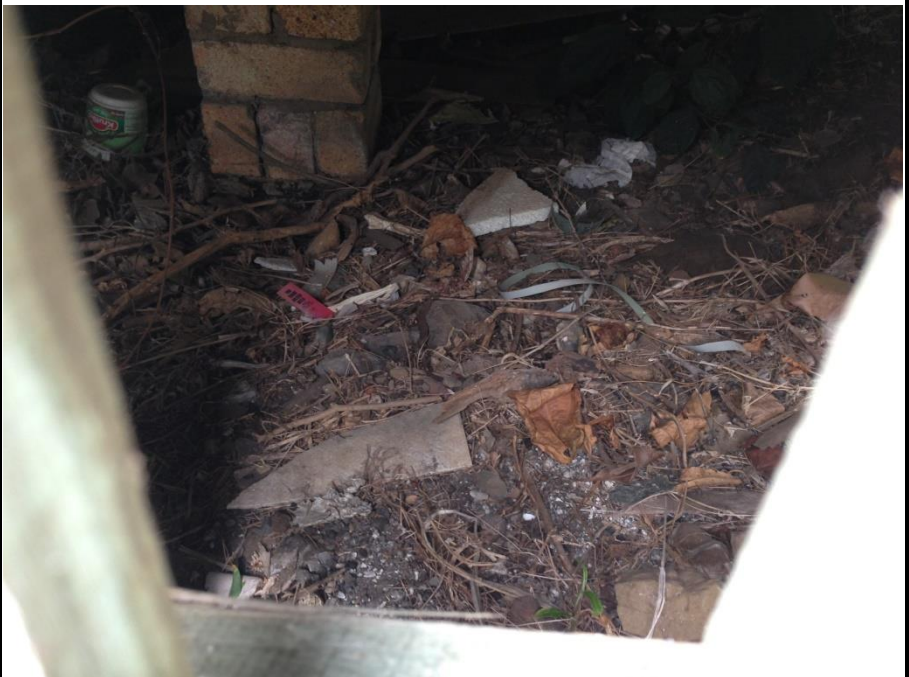
Photo No. 2	Date 19/11/2014
Location Under house - Debris	
Sample Reference Presumed	
ACM / NAD Presumed ACM	Nature of ACM Non-friable
Comments Suspected ACM debris visible beneath the house on the Eastern side. Access beneath the house was not possible therefore a sample could not be collected and the extent is unknown. The debris was visually consistent with non-friable fibre cement sheeting.

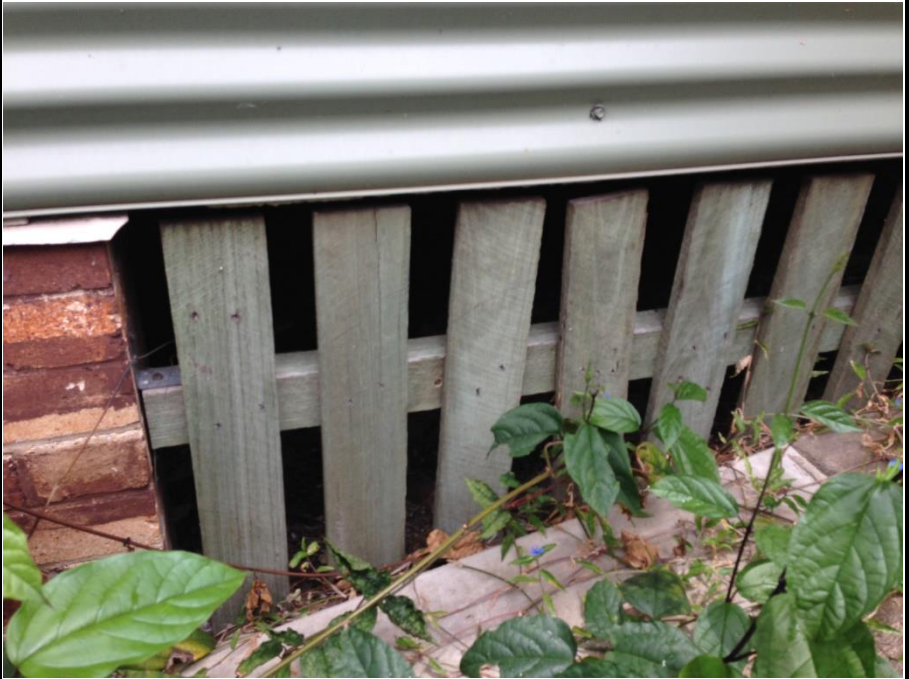
Photo No. 3	Date 19/11/2014
Location External, Eastern elevation	
Sample Reference -	
ACM / NAD -	Nature of ACM -
Comments Access beneath the house restricted. Suspected ACM debris visible beyond fence on the Eastern elevation. (Refer to photo 2).

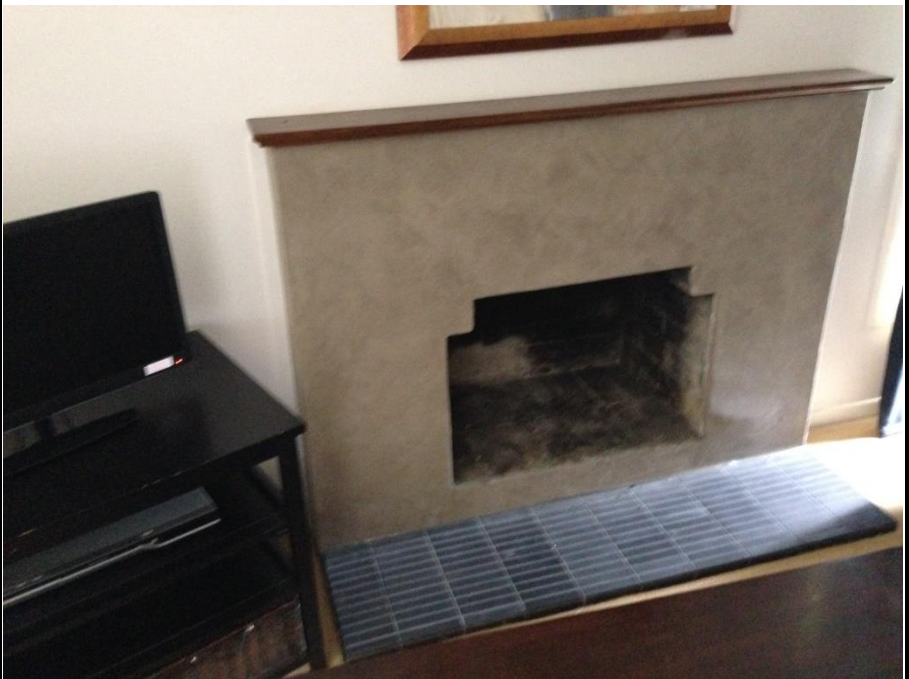
Photo No. 4	Date 19/11/2014
Location Living room – Chimney	
Sample Reference 00006107D-002	
ACM / NAD NAD	Nature of ACM -
Comments Insulation material within the chimney. Sample collected from directly above the fireplace. Result of analysis is No Asbestos Detected (NAD)

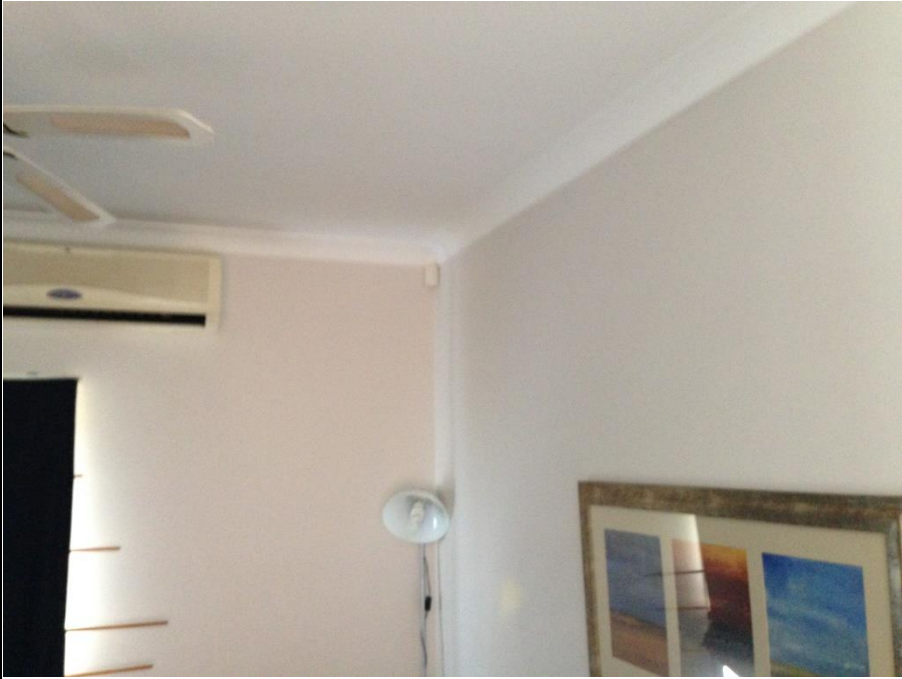
Photo No. 5	Date 19/11/2014

Location Internal – All rooms		
Sample Reference -		
ACM / NAD NAD	Nature of ACM -	
Comments Wall and ceiling linings throughout the house were visually identified on-site as non-asbestos-containing plasterboard material.

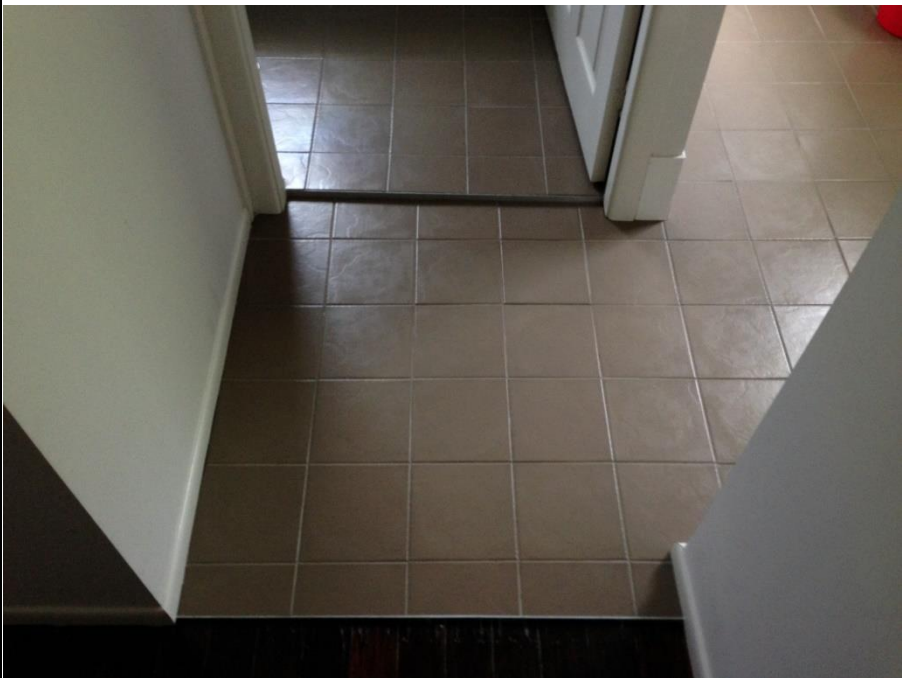
Photo No. 6	Date 19/11/2014

Location Internal – Wet areas		
Sample Reference -		
ACM / NAD NAD	Nature of ACM -	
Comments Flooring in bathroom and laundry visually identified on-site as being non-asbestos-containing ceramic tiles. Although access beneath the tiles was not possible, there was no evidence to suggest that ACMs were present beneath the tiles.

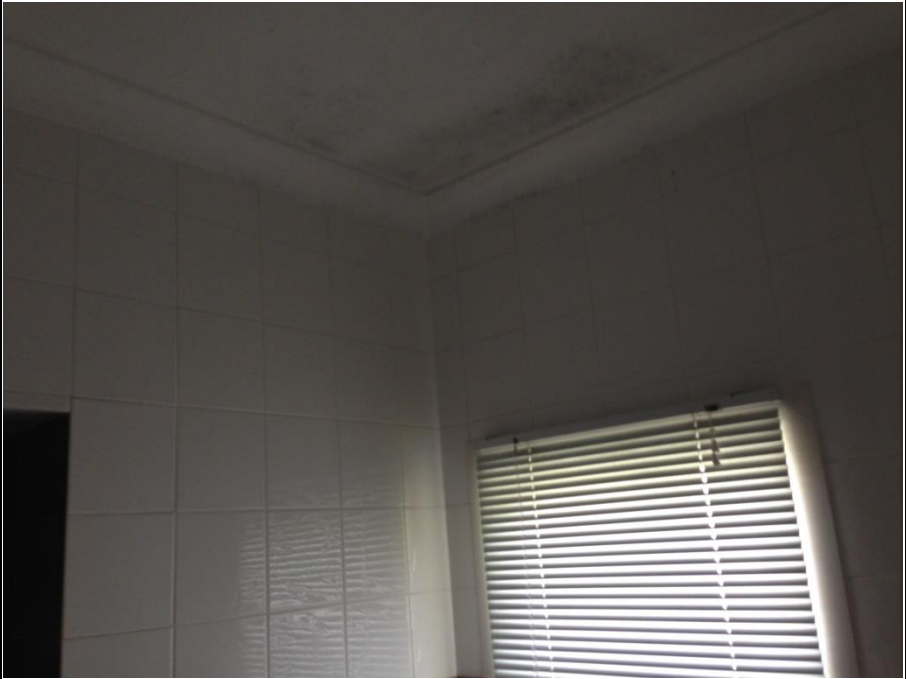
Photo No. 7	Date 19/11/2014

Location Bathroom		
Sample Reference -		
ACM / NAD -	Nature of ACM -	
Comments Wall linings in the bathroom covered with tiles from floor to ceiling. Access to wall linings was therefore restricted, however given the absence of ACM wall linings throughout the rest of the house, the likelihood of the bathroom wall linings being ACM is low.

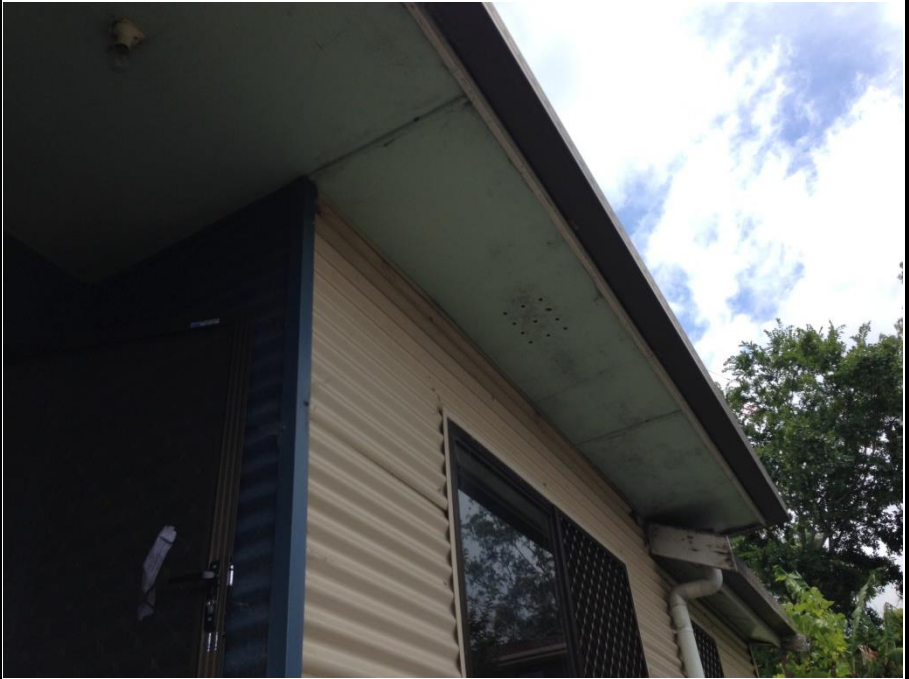
Photo No. 8	Date 19/11/2014
Location External – Soffit lining	
Sample Reference 00006107C-002	
ACM / NAD ACM	Nature of ACM Non-friable
Comments Soffit linings on all elevations of the house. In good condition and painted. Paint flaking in areas.

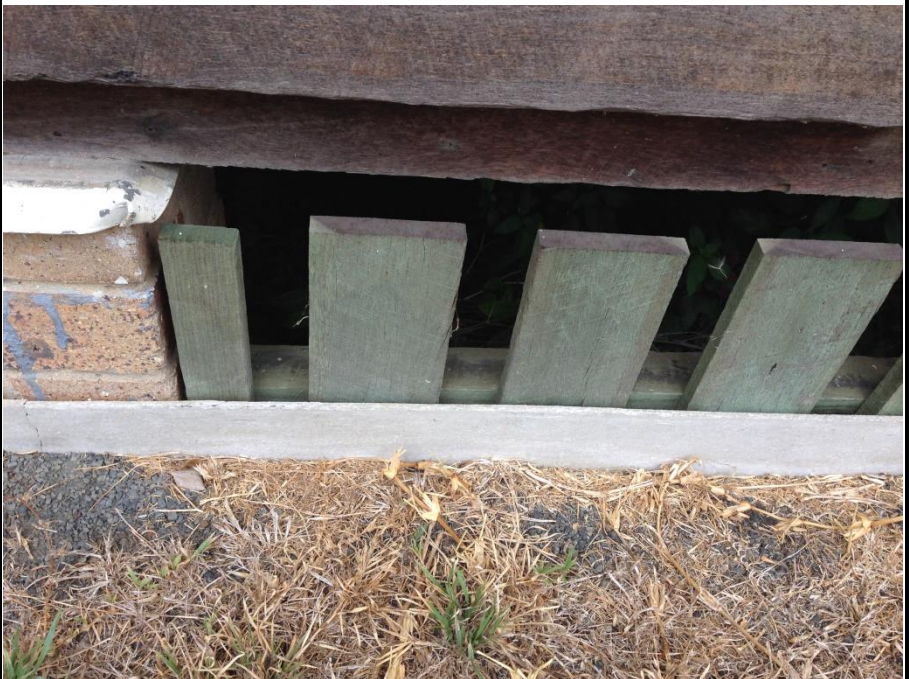
Photo No. 9	Date 19/11/2014
Location External, rear of house – Retaining wall	
Sample Reference 00006107C-003	
ACM / NAD NAD	Nature of ACM -
Comments Fibre cement sheeting used as part of a retaining wall between the rear (North) elevation of the house and adjoining soil. Result of analysis is No Asbestos Detected (NAD).

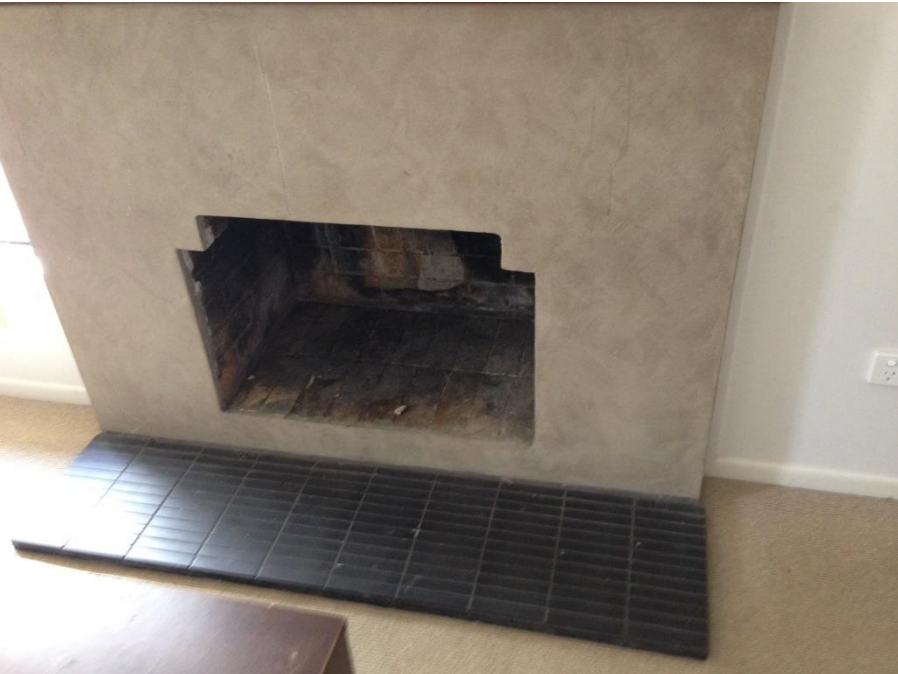
Photo No. 10	Date 19/11/2014

Location Living room - Chiney		
Sample Reference 00006107C-001		
ACM / NAD NAD	Nature of ACM -	
Comments Insulation material within the chimney. Sample collected from directly above the fireplace. Result of analysis is No Asbestos Detected (NAD).

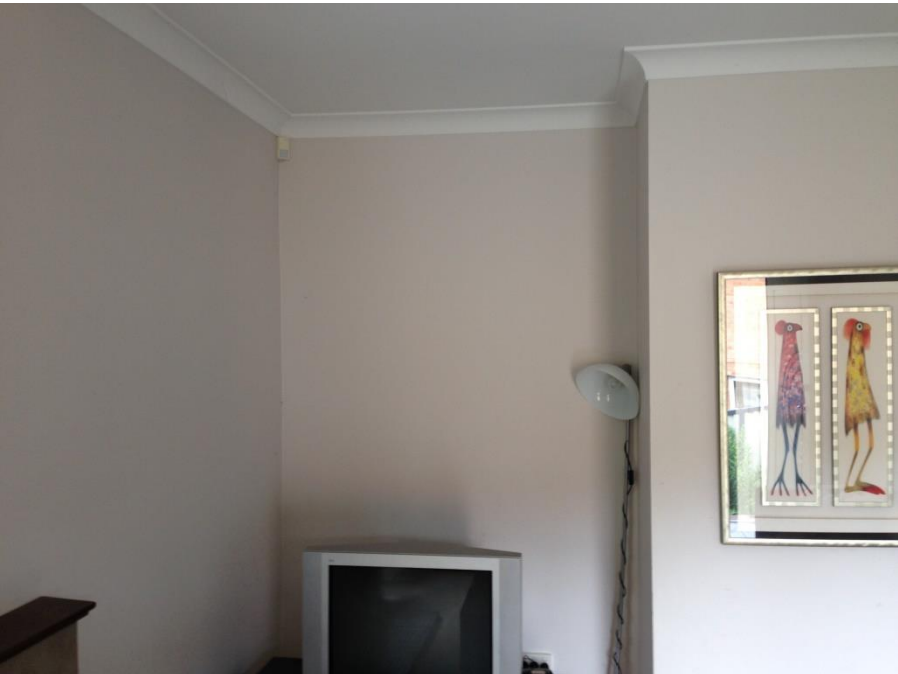
Photo No. 11	Date 19/11/2014

Location Internal – All rooms		
Sample Reference -		
ACM / NAD NAD	Nature of ACM -	
Comments Wall and ceiling linings throughout the house were visually identified on-site as non-asbestos-containing plasterboard material.

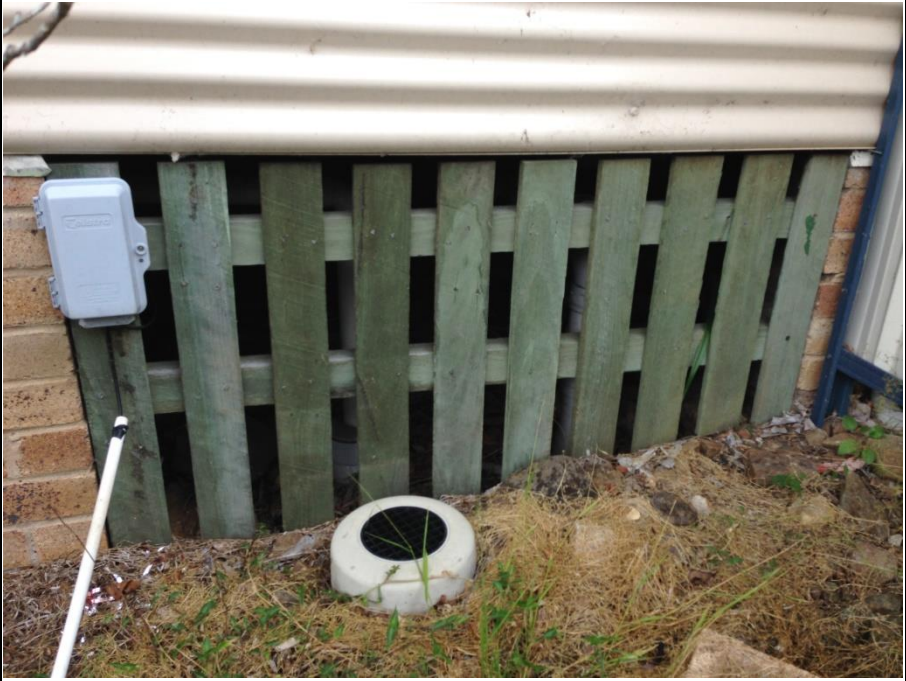
Photo No. 14	Date 19/11/2014

Location External		
Sample Reference -		
ACM / NAD -	Nature of ACM -	
Comments Access beneath the house restricted.

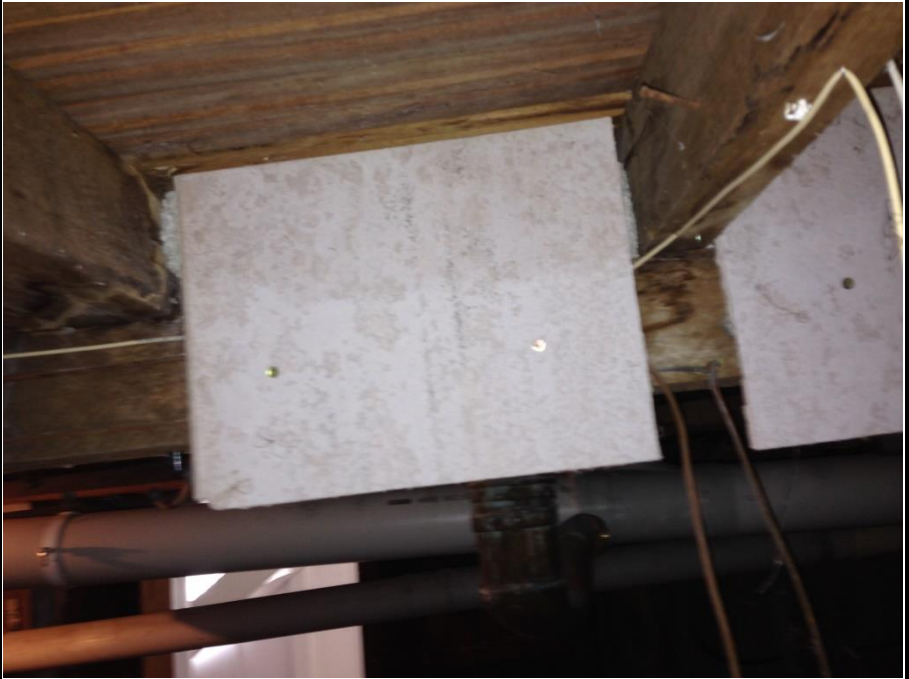
Photo No. 15	Date 19/11/2014
Location Sub-floor – Infill panels	
Sample Reference 00006107A-005	
ACM / NAD NAD	Nature of ACM -
Comments Fibre cement panels within the sub-floor space, situated around concrete used for flooring above. Result of analysis is No Asbestos Detected (NAD).

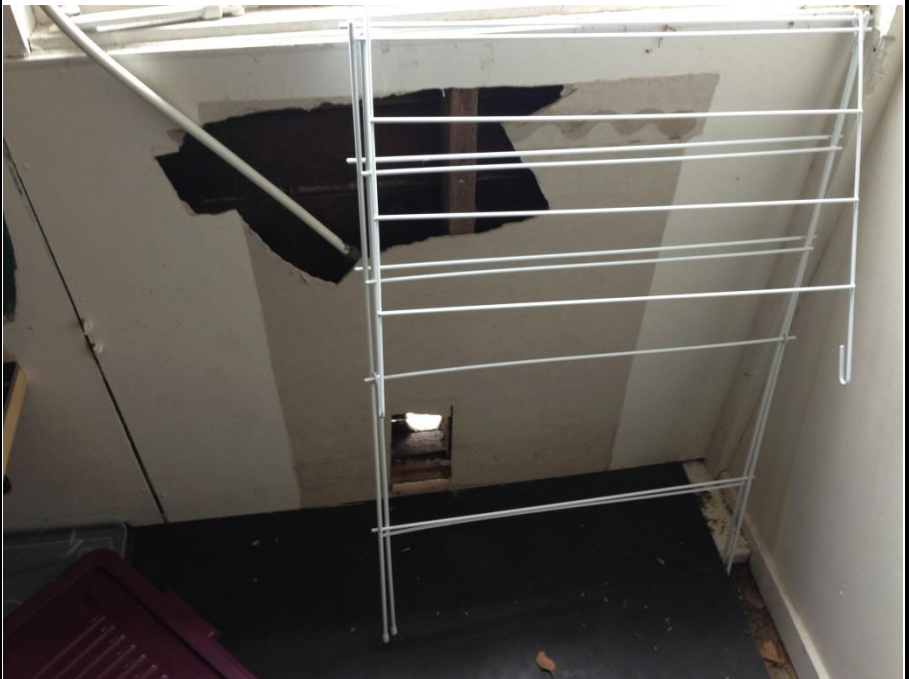
Photo No. 16	Date 19/11/2014
Location Downstairs – Storage room	
Sample Reference 00006107A-004	
ACM / NAD NAD	Nature of ACM -
Comments Wall linings on the South and West walls are visually consistent with each other. Sample collected from South wall. Wall linings on the North and East walls visually identified on-site as being non-asbestos-containing Masonite material.

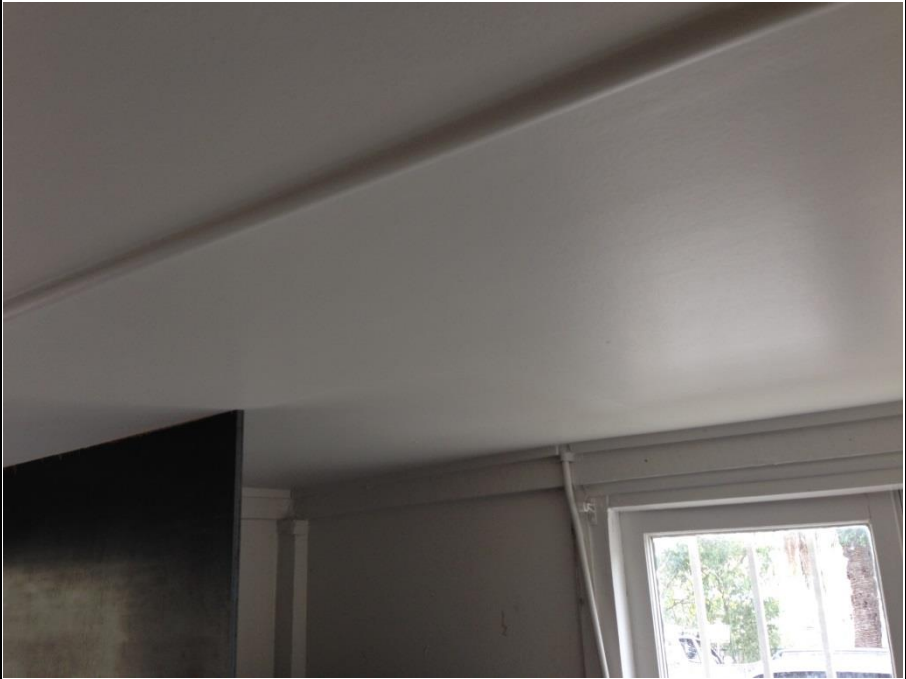
Photo No. 17	Date 19/11/2014
Location Downstairs – Storage room	
Sample Reference 00006107A-003	
ACM / NAD ACM	Nature of ACM Non-friable
Comments Ceiling lining in the storage room confirmed as being non-friable ACM. In good condition and painted.

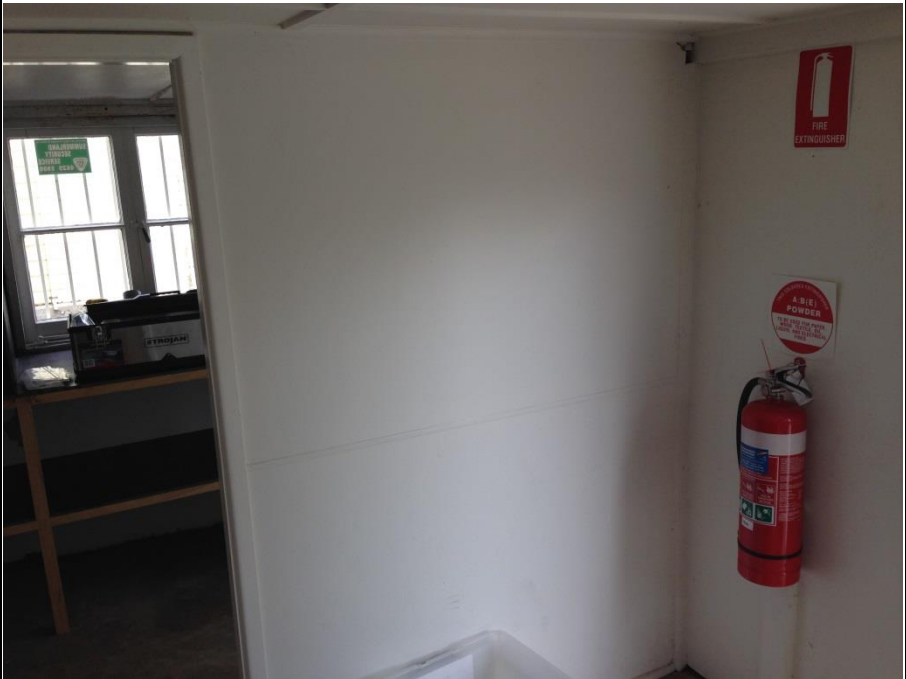
Photo No. 18	Date 19/11/2014
Location Downstairs - Rear entrance	
Sample Reference 00006107A-001	
ACM / NAD NAD	Nature of ACM -
Comments Fibre cement wall linings on the East wall. Results of analysis NAD. Linings on remaining walls visually identified on-site as being non-asbestos-containing Masonite material.

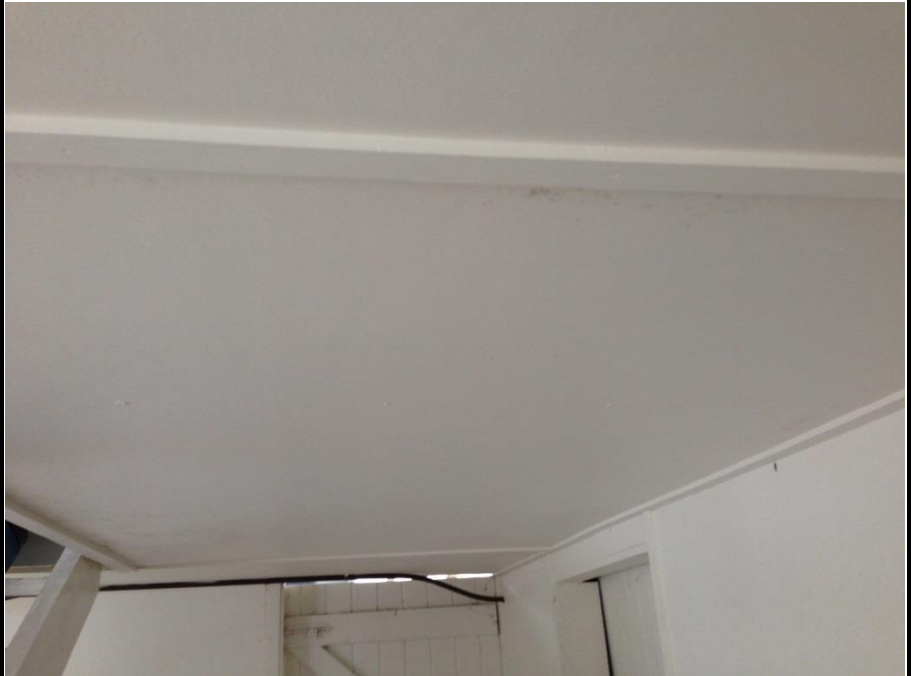
Photo No. 19	Date 19/11/2014
Location Downstairs – Rear entrance	
Sample Reference 00006107A-002	
ACM / NAD ACM	Nature of ACM Non-friable
Comments Ceiling lining in the rear entrance confirmed by analysis as being non-friable ACM. In good condition and painted.

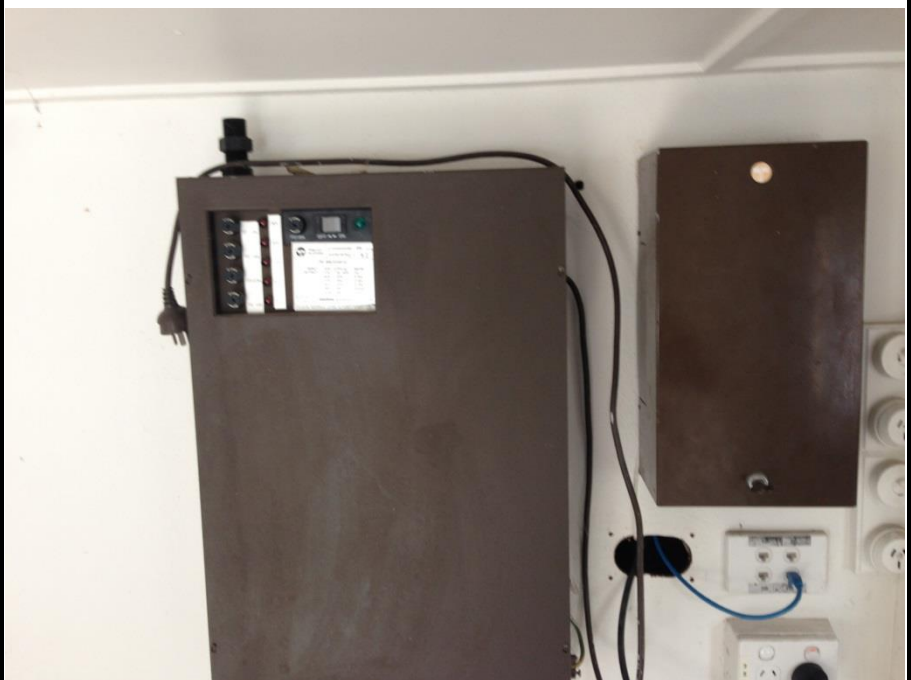
Photo No. 20	Date 19/11/2014
Location Downstairs – Rear entrance	
Sample Reference -	
ACM / NAD	Nature of ACM
Comments Access to electrical box located in the rear entrance not possible due to live power.

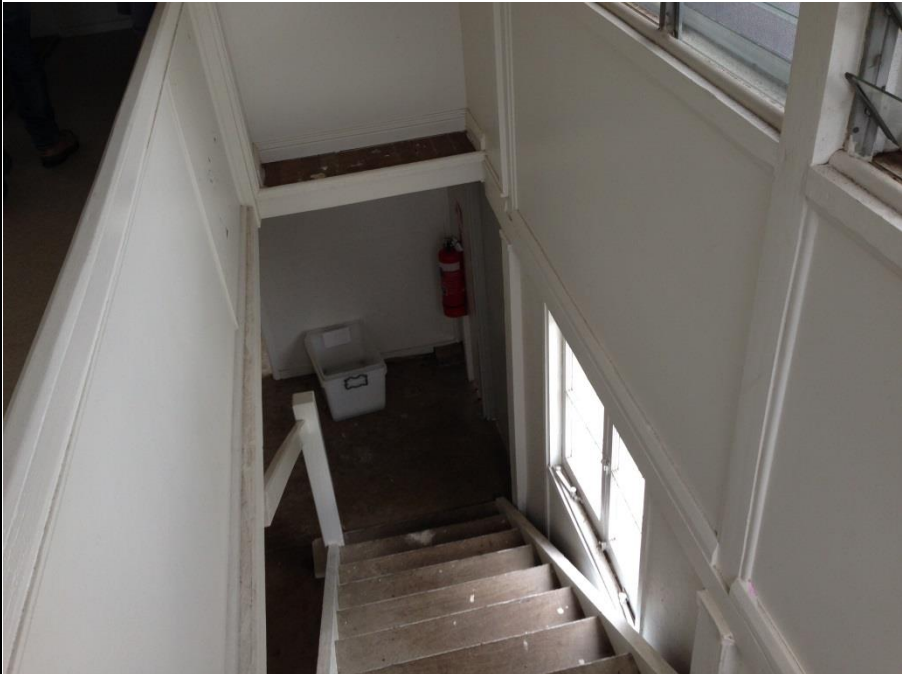
Photo No. 21	Date 19/11/2014

Location Staircase wall linings		
Sample Reference 00006107A-006		
ACM / NAD ACM	Nature of ACM Non-friable	
Comments Wall panels surrounding the staircase at the rear of the house confirmed by analysis as being non-friable ACM. All panels are in good condition and painted.

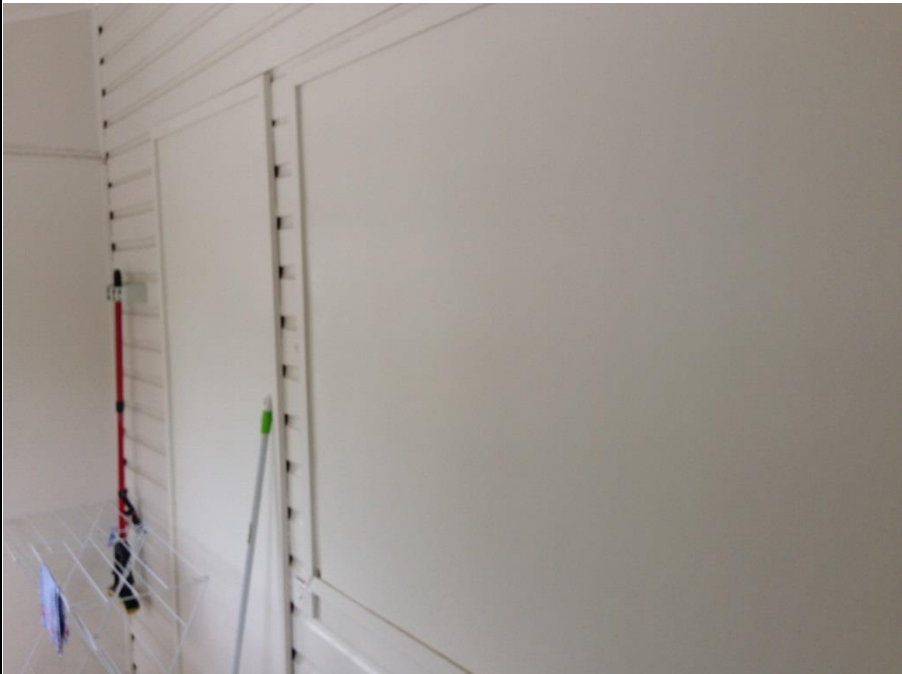
Photo No. 22	Date 19/11/2014

Location Upstairs – stair landing		
Sample Reference 00006107A-009		
ACM / NAD NAD	Nature of ACM -	
Comments X2 infill panels on the North wall of the stair landing area. Results of analysis NAD.

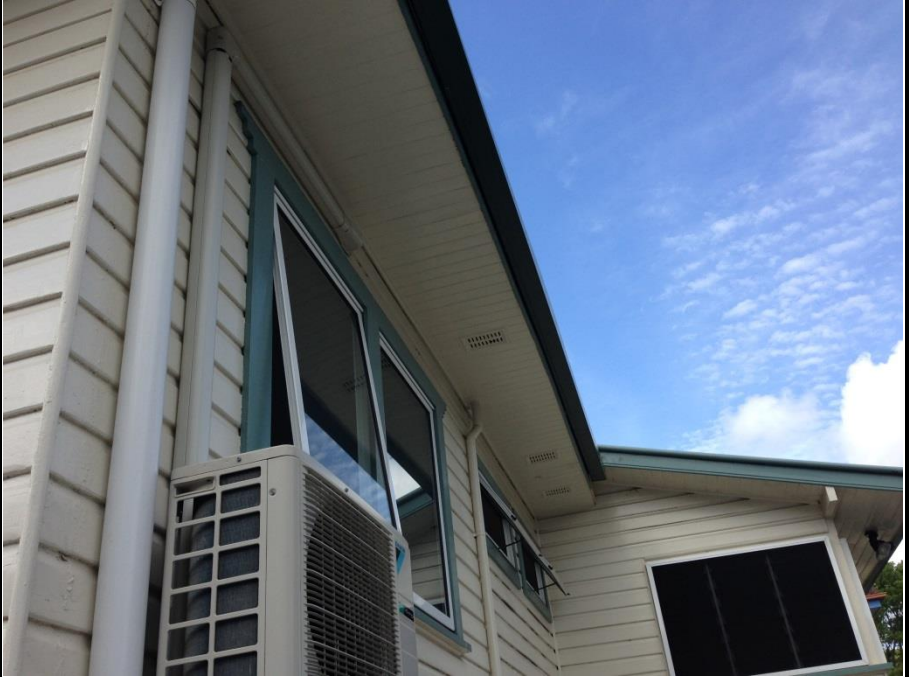
Photo No. 29	Date 19/11/2014
Location External - soffits	
Sample Reference -	
ACM / NAD NAD	Nature of ACM -
Comments Soffit linings on all elevations visually identified on site as being non-asbestos-containing timber.

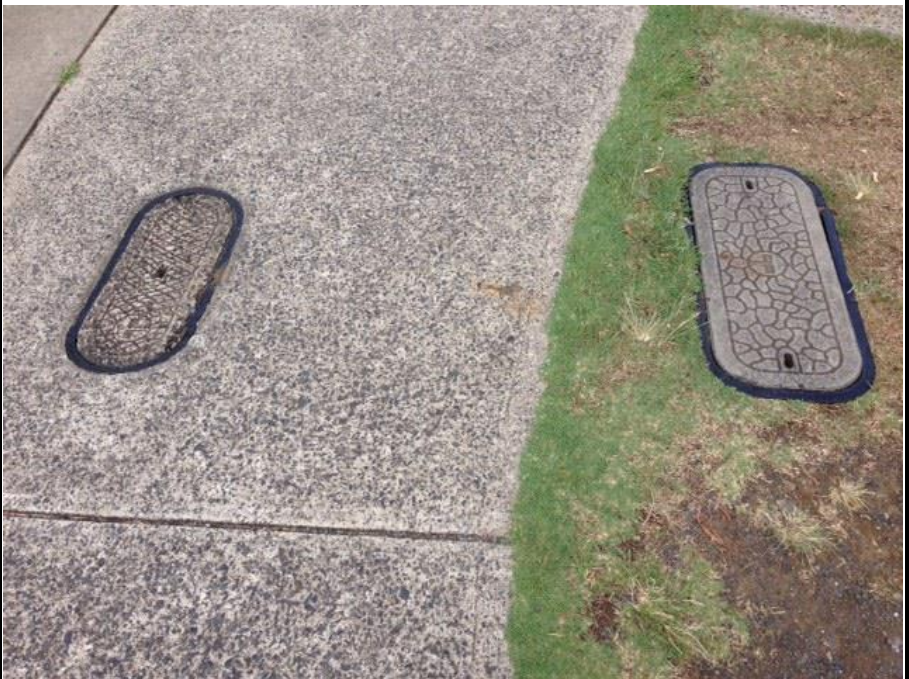
Photo No. 30	Date 19/11/2014
Location External – service pits	
Sample Reference -	
ACM / NAD -	Nature of ACM -
Comments x2 service pits on footpath outside 67 Uralba Street not able to be accessed during the survey.

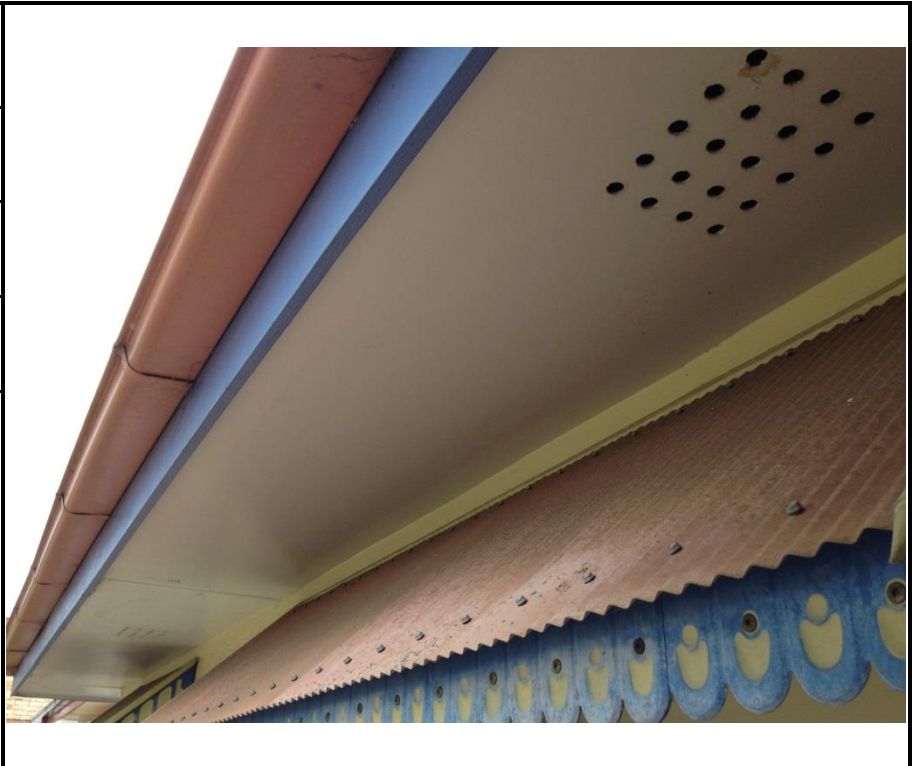
Photo No. 31	Date 19/11/2014
Location External - soffits	
Sample Reference 00006107B-005	
ACM / NAD ACM	Nature of ACM Non-friable
Comments Soffit linings on all elevations confirmed by analysis as being non-friable ACM.

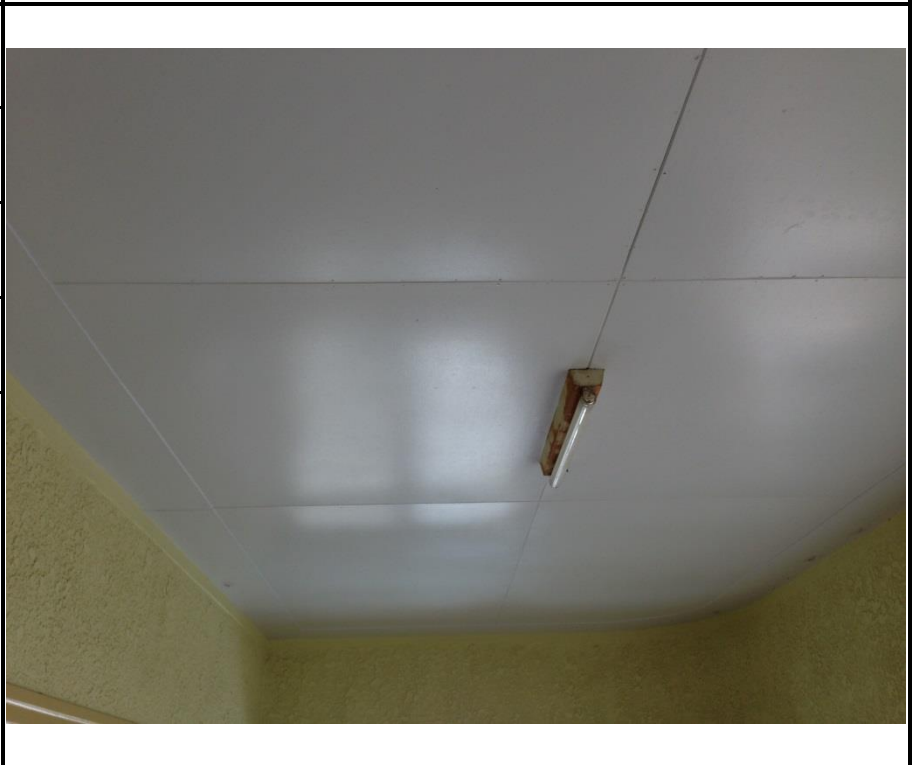
Photo No. 32	Date 19/11/2014
Location External – Front porch	
Sample Reference -	
ACM / NAD NAD	Nature of ACM -
Comments Ceiling linings visually identified on site as being non-asbestos-containing wood material.

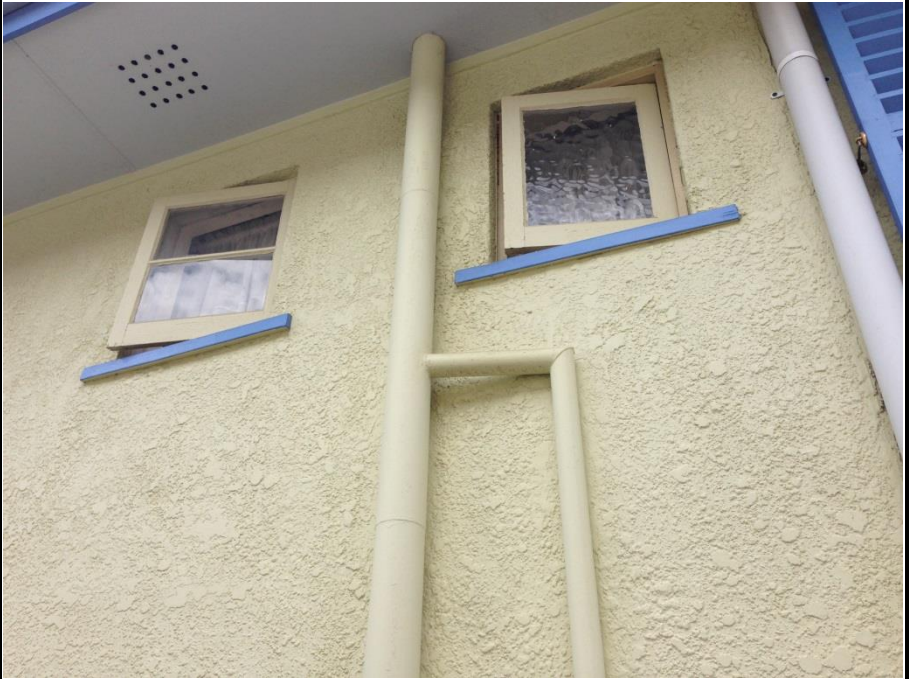
Photo No. 33	Date 19/11/2014
Location External – vent pipe	
Sample Reference 00006107B-003	
ACM / NAD ACM	Nature of ACM Non-friable
Comments Vent pipe on Eastern elevation confirmed by analysis as being non-friable ACM.

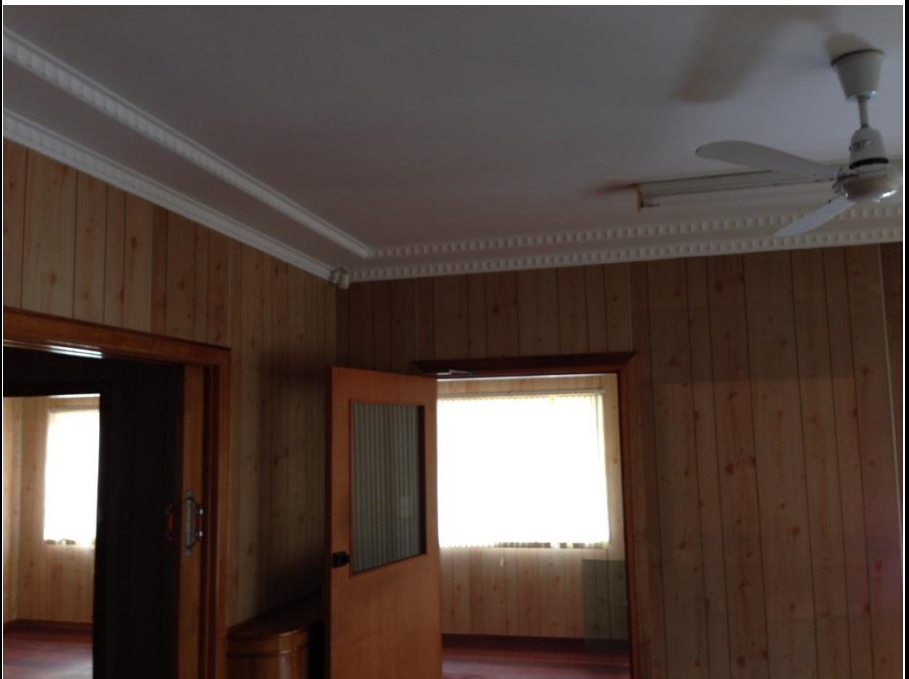
Photo No. 34	Date 19/11/2014
Location Upstairs	
Sample Reference -	
ACM / NAD NAD	Nature of ACM -
Comments Wall and ceiling linings throughout the upstairs of the house visually identified on site as being a mixture of non-asbestos-containing plasterboard, timber veneer and Masonite materials.

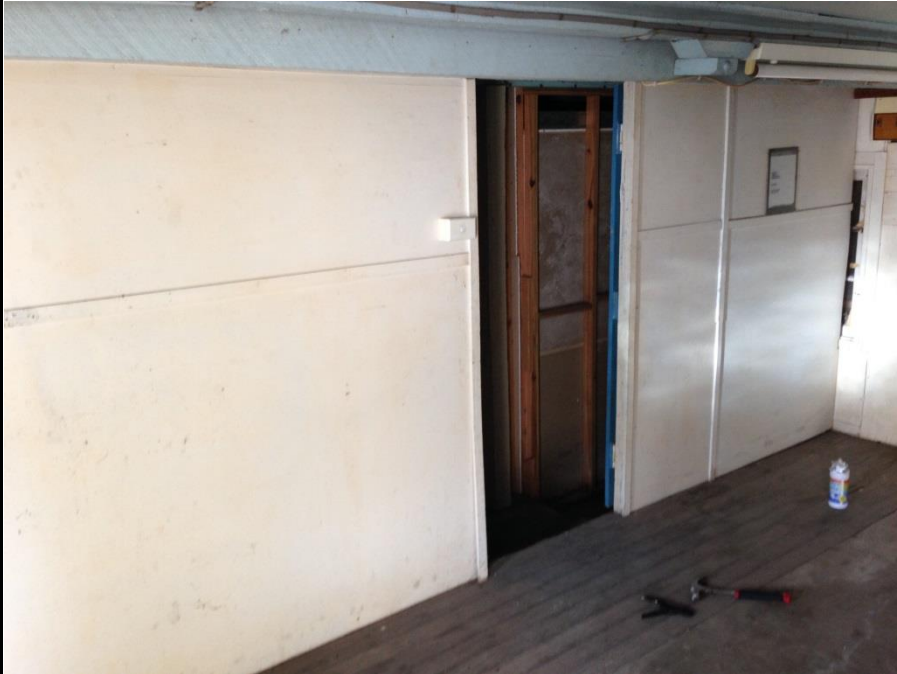
Photo No. 39	Date 19/11/2014

Location Garage		
Sample Reference 00006107B-001		
ACM / NAD ACM	Nature of ACM Non-friable	
Comments Wall linings on the Eastern wall in the garage confirmed by analysis as being non-friable ACM. In good condition and painted.

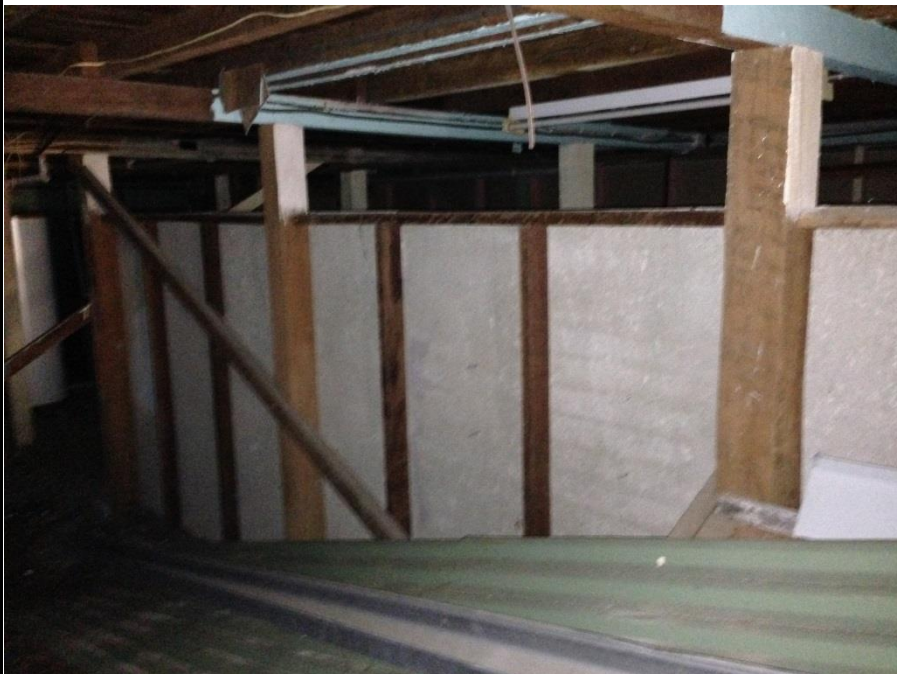
Photo No. 40	Date 19/11/2014

Location Sub floor		
Sample Reference 00006107B-004		
ACM / NAD ACM	Nature of ACM Non-friable	
Comments Wall panels within the sub floor confirmed by analysis as being non-friable ACM. In good condition. Rear side unpainted.

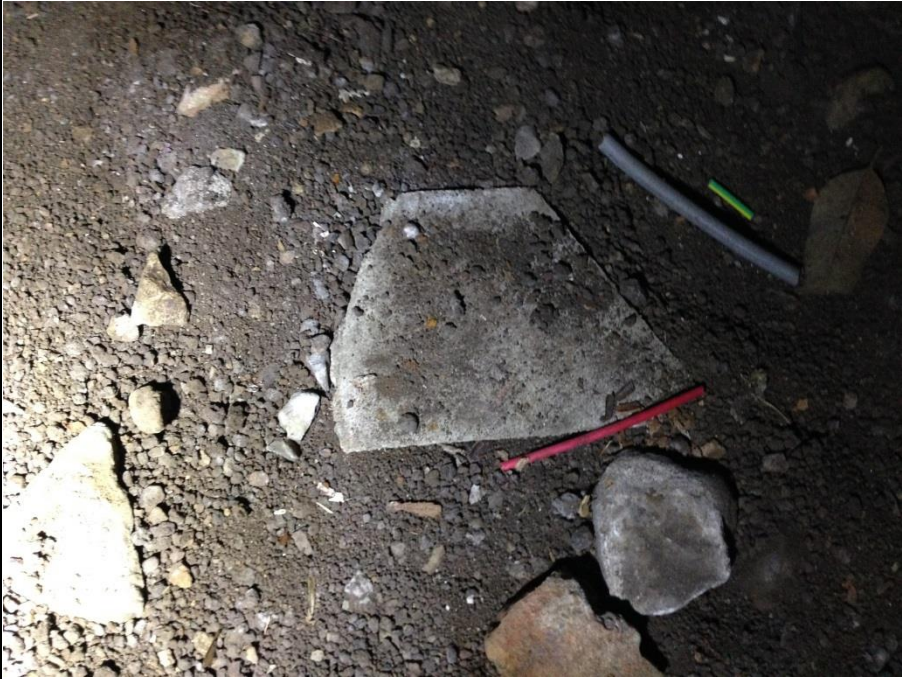
Photo No. 41	Date 19/11/2014

Location Sub floor		
Sample Reference 00006107B-002		
ACM / NAD ACM	Nature of ACM Non-friable	
Comments Debris present scattered within the sub floor space. Confirmed by analysis as being non-friable ACM. In poor condition and unpainted.		
Photo No. 42	Date 19/11/2014

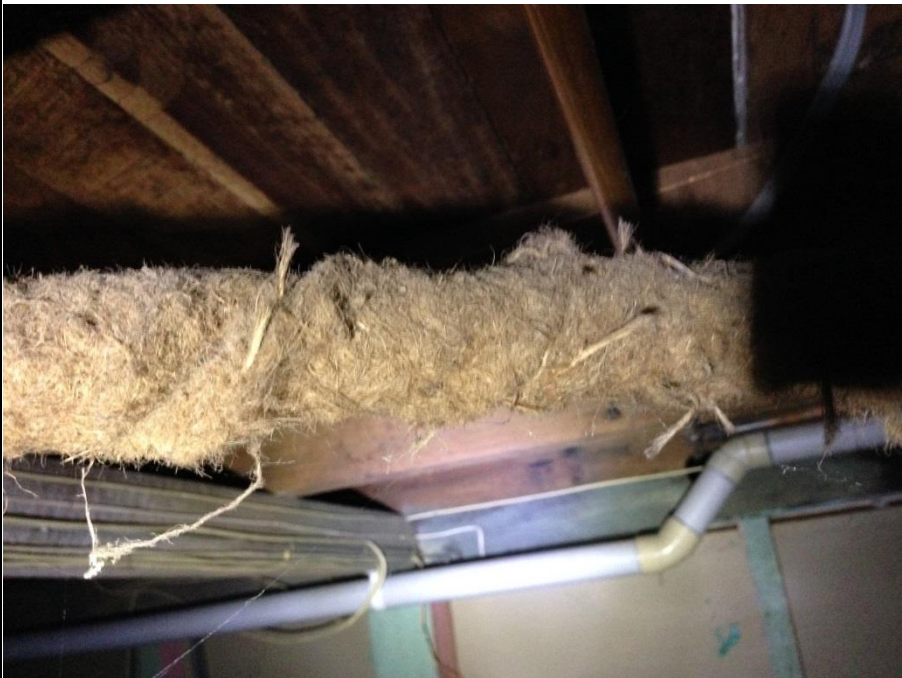
Location Sub floor		
Sample Reference -		
ACM / NAD NAD	Nature of ACM -	
Comments Insulation covering pipe suspended within the sub floor area visually identified on site as synthetic mineral fibre (SMF).

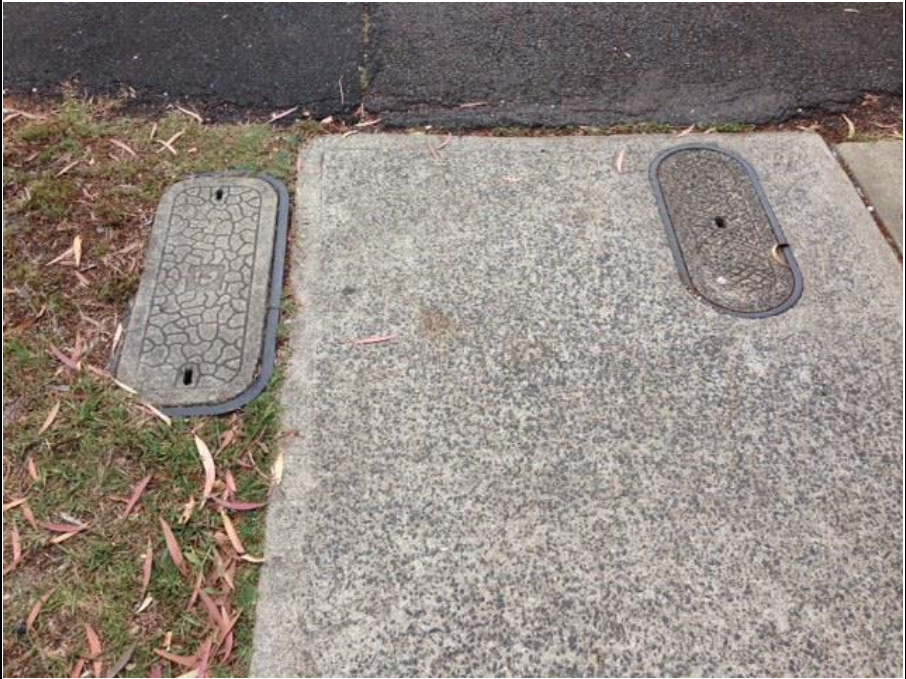
Photo No. 43	Date 19/11/2014

Location External		
Sample Reference -		
ACM / NAD -	Nature of ACM -	
Comments x2 service pits on footpath outside 69 Uralba Street not able to be accessed during the survey.
