# Hazardous Materials Management Survey and Register

## 366 Jamison Rd, Jamisontown NSW 2750

**JOB NUMBER:** JN05770

**ISSUED DATE:** 31 January 2025

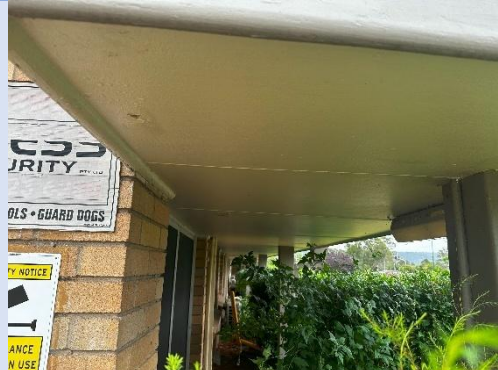
| Material Identification | | | Risk Assessment | | Risk Management & Corrective Actions | | | Photo |
|---|---|---|---|---|---|---|---|---|
| External, northern eave lining | Fibre cement sheeting | ASB01 | NAD* Presumed Asbestos | TH | NF | Low | <p>No asbestos detected by the laboratory. Asbestos has been detected in samples of eaves linings/soffits from other locations around the site.</p> <p>Due to no easily discernible visual difference between the full extents of asbestos and non-asbestos containing eaves linings/soffits ALL eaves linings/soffits at the site are to be managed as asbestos containing.</p> <p>Prior to demolition works, this material must be removed by a Class A or B licensed asbestos removalist with a clearance certificate issued by a competent third party. Air monitoring is also recommended.</p> | |

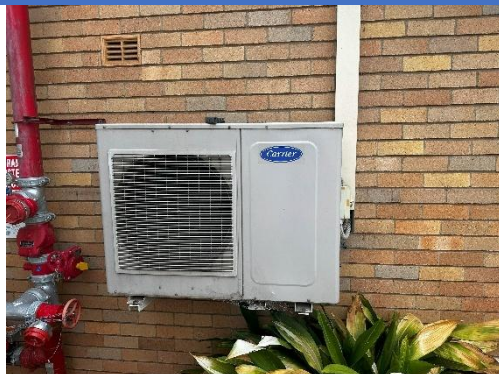
| Material Identification | | Risk Assessment | | | Risk Management & Corrective Actions | | Photo | |
|---|---|---|---|---|---|---|---|---|
| External, Zone 1, eastern Carrier unit | R22 refrigerant, 3.4KG | ODS01 | ODS | 1 unit | NA | Negligible | Ozone depleting gas should be degassed by a licenced refrigerant tradesperson prior to demolition works and disposed of as per EPA requirements. | |

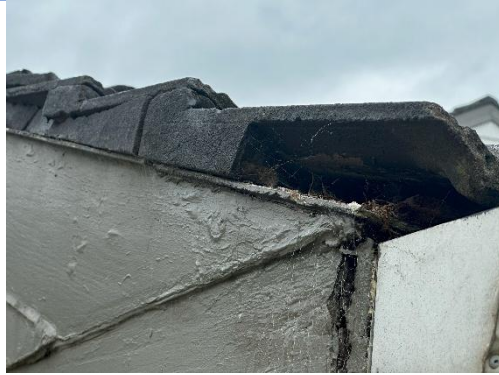
| Material Identification | | Risk Assessment | | | Risk Management & Corrective Actions | | Photo | |
|---|---|---|---|---|---|---|---|---|
| External, Zone 1, gables throughout, under roof tiles, edging strip | Fibre cement sheeting | ASB02 | CH | TH | NF | Low | Prior to demolition works, this material must be removed by a Class A or B licensed asbestos removalist with a clearance certificate issued by a competent third party. Air monitoring is also recommended. | |

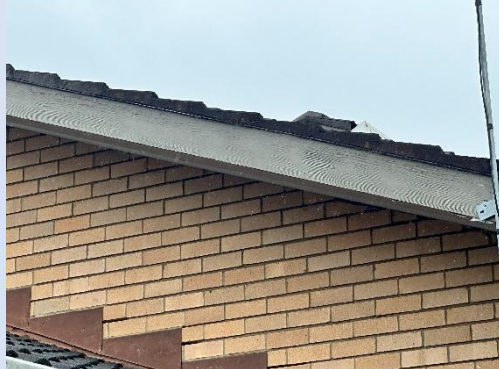
| Material Identification | | Risk Assessment | | | Risk Management & Corrective Actions | | Photo | |
|---|---|---|---|---|---|---|---|---|
| External, Zone 1, gables throughout, edging strip | Fibre cement sheeting | ASB02/R1 | CH | TH | NF | Low | Prior to demolition works, this material must be removed by a Class A or B licensed asbestos removalist with a clearance certificate issued by a competent third party. Air monitoring is also recommended. | |

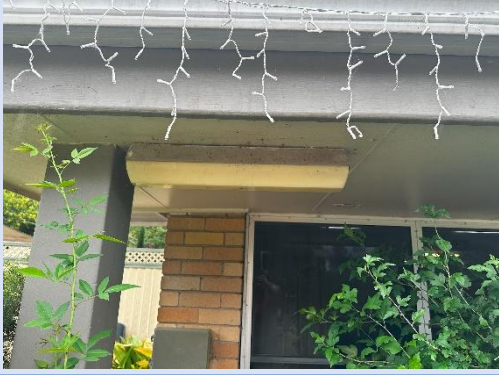
| Material Identification | | Risk Assessment | | | Risk Management & Corrective Actions | | | Photo |
|---|---|---|---|---|---|---|---|---|
| External, Zone 1, northern eave, light fittings throughout | PCB-containing capacitors | PCB01 | <b>Presumed PCB</b> | 3 units | NA | Negligible | Inaccessible during survey due to live electrical hazard. Confirm presence of polychlorinated biphenyls prior to demolition. PCB-containing material should be removed prior to demolition works and disposed of as per EPA requirements. | |

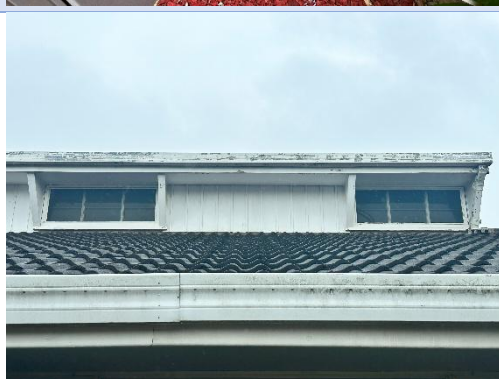
| Material Identification | | Risk Assessment | | | Risk Management & Corrective Actions | | | Photo |
|---|---|---|---|---|---|---|---|---|
| External, Zone 1, raised roof section, corrugated external wall material | Inaccessible | - | Unknown | - | NA | - | No access at the time of inspection. Gain access to confirm presence of hazmat. | |

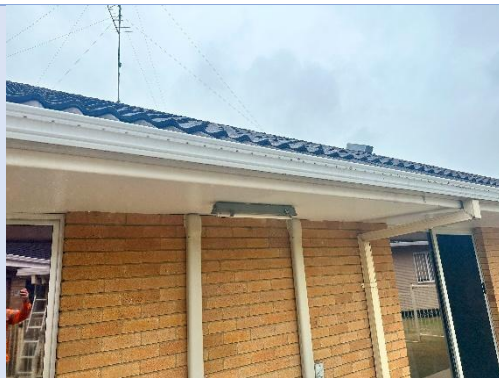
| Material Identification | | Risk Assessment | | | | Risk Management & Corrective Actions | | Photo |
|---|---|---|---|---|---|---|---|---|
| External, Zone 1, western light fittings | PCB-containing capacitors | PCB03 | Presumed PCB | 5 units | NA | Negligible | Inaccessible during survey due to live electrical hazard. Confirm presence of polychlorinated biphenyls prior to demolition. PCB-containing material should be removed prior to demolition works and disposed of as per EPA requirements. | |

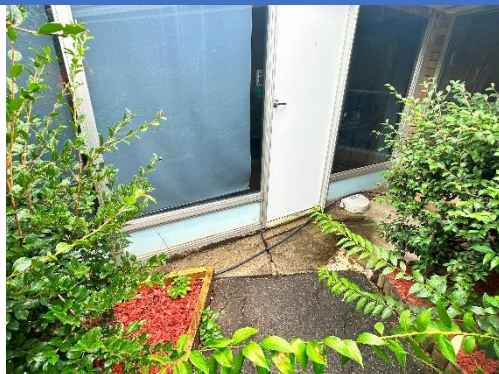
| Material Identification | | Risk Assessment | | | Risk Management & Corrective Actions | | Photo | |
|---|---|---|---|---|---|---|---|---|
| External, Zone 2, eastern diagonal hallway blue infill panels below glass | Fibre cement sheeting | ASB19 | CH | 5 sqm | NF | Low | Prior to demolition works, this material must be removed by a Class A or B licensed asbestos removalist with a clearance certificate issued by a competent third party. Air monitoring is also recommended. | |

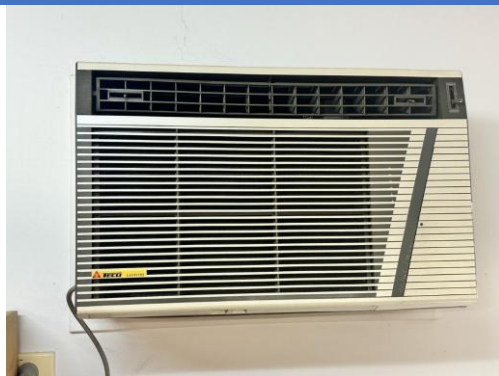
| Material Identification | | | Risk Assessment | | | Risk Management & Corrective Actions | | Photo |
|---|---|---|---|---|---|---|---|---|
| External, Zone 2, Seminar Room, north unit, TECO unit LA1293YHS | Refrigerant gas | ODS09 | Presumed ODS | 1 unit | NA | Negligible | Ozone depleting gas should be degassed by a licenced refrigerant tradesperson prior to demolition works and disposed of as per EPA requirements. | |

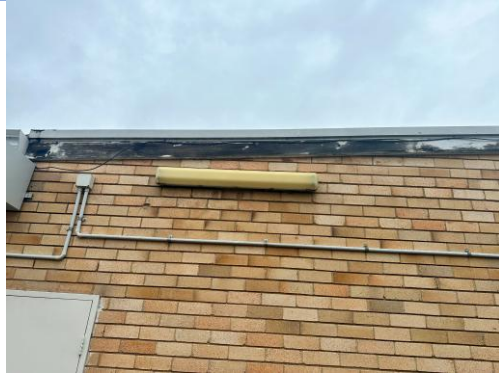
| Material Identification | | | Risk Assessment | | | Risk Management & Corrective Actions | | Photo |
|---|---|---|---|---|---|---|---|---|
| External, Zone 2, southern area, light fittings | PCB-containing capacitors | PCB04 | Presumed PCB | 6 units | NA | Negligible | Inaccessible during survey due to live electrical hazard. Confirm presence of polychlorinated biphenyls prior to demolition. PCB-containing material should be removed prior to demolition works and disposed of as per EPA requirements. | |

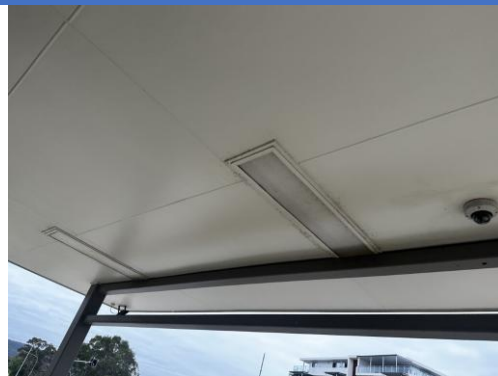
| Material Identification | | Risk Assessment | | | Risk Management & Corrective Actions | | Photo | |
|---|---|---|---|---|---|---|---|---|
| External, Zone 3, entrance portico | Fibre cement sheeting | ASB04 | CH | 36 sqm | NF | Negligible | Prior to demolition works, this material must be removed by a Class A or B licensed asbestos removalist with a clearance certificate issued by a competent third party. Air monitoring is also recommended. | |

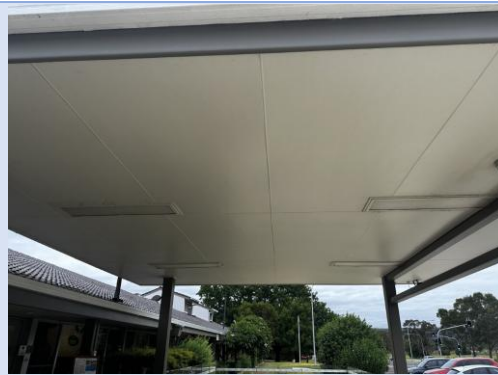
| Material Identification | | Risk Assessment | | | Risk Management & Corrective Actions | | Photo | |
|---|---|---|---|---|---|---|---|---|
| External, Zone 3, entrance portico, light fittings | PCB-containing capacitors | PCB05 | Presumed PCB | 4 units | NF | Low | Inaccessible during survey due to live electrical hazard. Confirm presence of polychlorinated biphenyls prior to demolition. PCB-containing material should be removed prior to demolition works and disposed of as per EPA requirements. | |

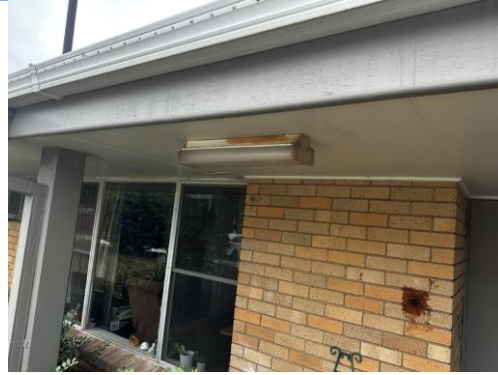
| Material Identification | | Risk Assessment | | | Risk Management & Corrective Actions | | Photo | |
|---|---|---|---|---|---|---|---|---|
| External, Zone 3, northern light fitting | PCB-containing capacitor | PCB06 | Presumed PCB | 1 unit | NF | Negligible | Inaccessible during survey due to live electrical hazard. Confirm presence of polychlorinated biphenyls prior to demolition. PCB-containing material should be removed prior to demolition works and disposed of as per EPA requirements. | |

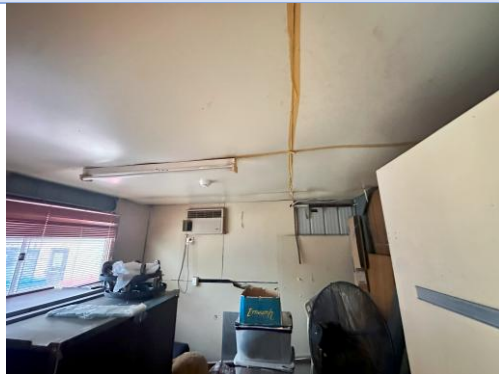
| Material Identification | | Risk Assessment | | | Risk Management & Corrective Actions | | | Photo |
|---|---|---|---|---|---|---|---|---|
| External, Zone 6, Maintenance Shed, light fittings | PCB-containing capacitors | PCB07 | Presumed PCB | 5 units | NA | Negligible | Inaccessible during survey due to live electrical hazard. Confirm presence of polychlorinated biphenyls prior to demolition. PCB-containing material should be removed prior to demolition works and disposed of as per EPA requirements. | |

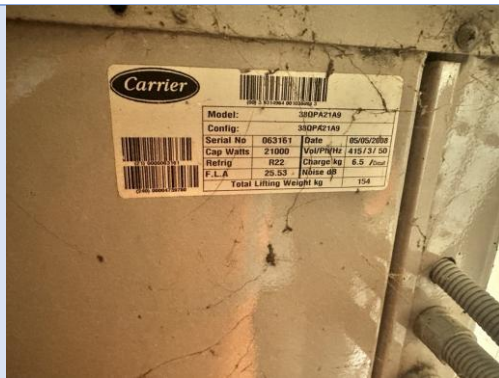
| Material Identification | | Risk Assessment | | | Risk Management & Corrective Actions | | | Photo |
|---|---|---|---|---|---|---|---|---|
| External, Zone 6, Plant Room, Carrier units | R22 Refrigerant gas, 6.3KG | ODS23 | ODS | 2 units | NA | Negligible | Ozone depleting gas should be degassed by a licenced refrigerant tradesperson prior to demolition works and disposed of as per EPA requirements. | |

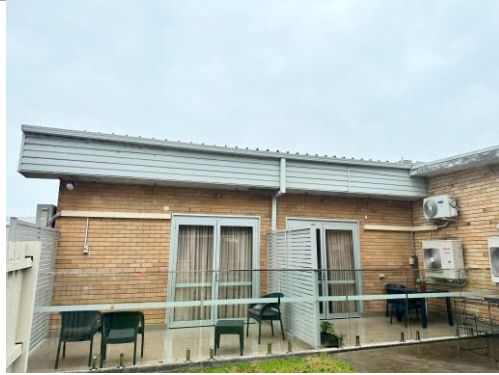
| Material Identification | | Risk Assessment | | | Risk Management & Corrective Actions | | | Photo |
|---|---|---|---|---|---|---|---|---|
| External, Zone 10, southeast courtyard, concealed eaves | Fibre cement sheeting | P2 | Presumed Asbestos | 10 sqm | NF | Low | Eaves concealed by cladding. It is presumed that asbestos cement soffits are under the cladding. Prior to demolition works, this material must be removed by a Class A or B licensed asbestos removalist with a clearance certificate issued by a competent third party. Air monitoring is also recommended. | |

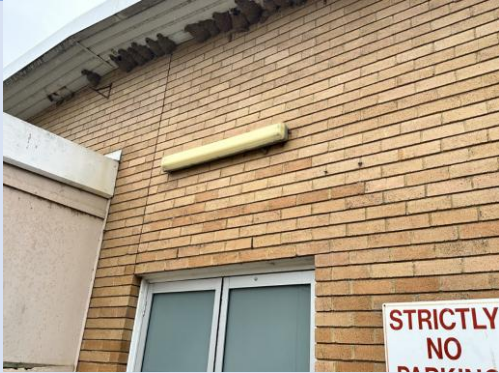
| Material Identification | | | Risk Assessment | | Risk Management & Corrective Actions | | | Photo |
|---|---|---|---|---|---|---|---|---|
| External, Zone 7, south, western MSB light fitting | PCB-containing capacitors | PCB09 | <b>Presumed PCB</b> | 1 unit | NA | Negligible | Inaccessible during survey due to live electrical hazard. Confirm presence of polychlorinated biphenyls prior to demolition. PCB-containing material should be removed prior to demolition works and disposed of as per EPA requirements. | |

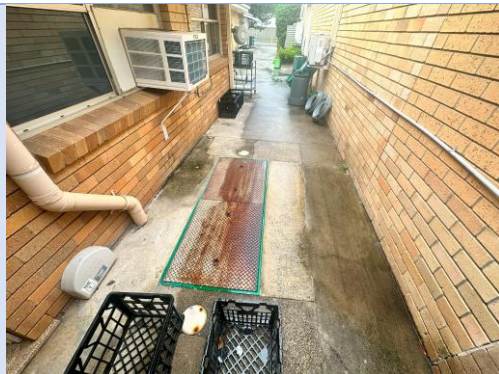
| Location | Reason for inaccessibility |
|---|---|
| External, Zone 10, east ground, inaccessible pits | No access at the time of inspection. Gain access to identify any potential hazardous materials e.g. asbestos pit wall linings. |

| Material Identification | | Risk Assessment | | | Risk Management & Corrective Actions | | | Photo |
|---|---|---|---|---|---|---|---|---|
| External, Zone 10, east ground, inaccessible pits | Inaccessible | - | Unknown | 3 units | NA | - | No access at the time of inspection. Gain access to identify any potential hazardous materials e.g. asbestos pit wall linings. | |

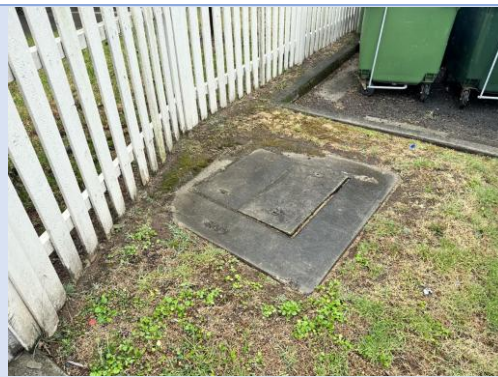
| Location | Reason for inaccessibility |
|---|---|
| External, Zone 10, external south ground pit | No access at the time of inspection. Gain access to identify any potential hazardous materials e.g. asbestos pit wall linings. |

| Material Identification | | Risk Assessment | | | | Risk Management & Corrective Actions | | Photo |
|---|---|---|---|---|---|---|---|---|
| External, Zone 10, external south ground pit | Inaccessible | - | Unknown | NA | NA | - | No access at the time of inspection. Gain access to identify any potential hazardous materials e.g. asbestos pit wall linings. | |

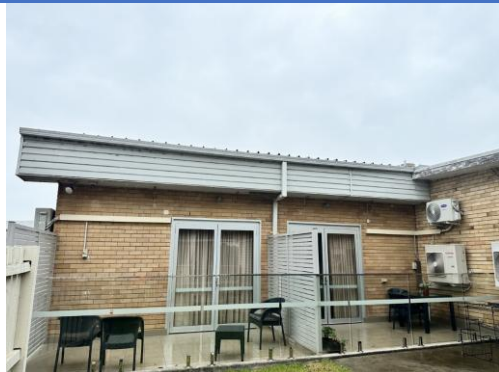
| Material Identification | | Risk Assessment | | | Risk Management & Corrective Actions | | | Photo |
|---|---|---|---|---|---|---|---|---|
| External, Zone 10, south courtyard, light fittings | PCB-containing capacitors | PCB11 | Presumed PCB | 2 units | NA | Negligible | Inaccessible during survey due to live electrical hazard. Confirm presence of polychlorinated biphenyls prior to demolition. PCB-containing material should be removed prior to demolition works and disposed of as per EPA requirements. | |

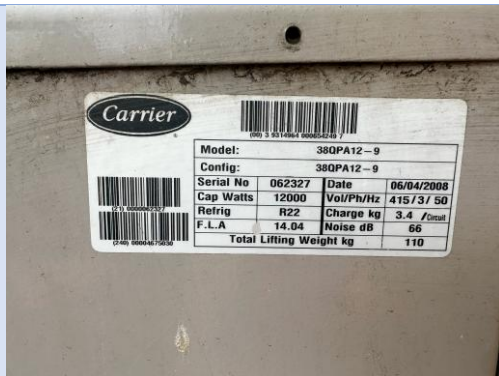
| Material Identification | | Risk Assessment | | | Risk Management & Corrective Actions | | | Photo |
|---|---|---|---|---|---|---|---|---|
| External, Zone 10, south wall unit, Carrier | R22 Refrigerant gas, 3.4KG | ODS30 | ODS | 1 unit | NA | Negligible | Ozone depleting gas should be degassed by a licenced refrigerant tradesperson prior to demolition works and disposed of as per EPA requirements. | |

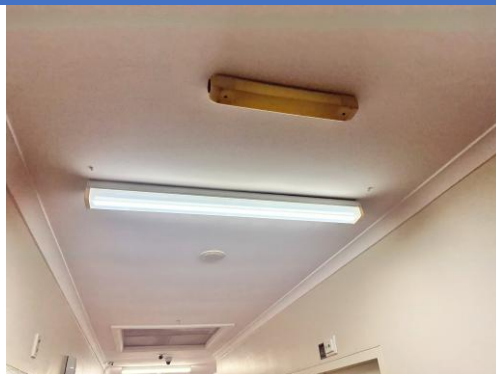
| Material Identification | | | Risk Assessment | | | Risk Management & Corrective Actions | | Photo |
|---|---|---|---|---|---|---|---|---|
| Internal, Zone 1, light fittings throughout | PCB-containing capacitors | PCB13 | Presumed PCB | TH | NA | Negligible | Inaccessible during survey due to live electrical hazard. Confirm presence of polychlorinated biphenyls prior to demolition. PCB-containing material should be removed prior to demolition works and disposed of as per EPA requirements. | |

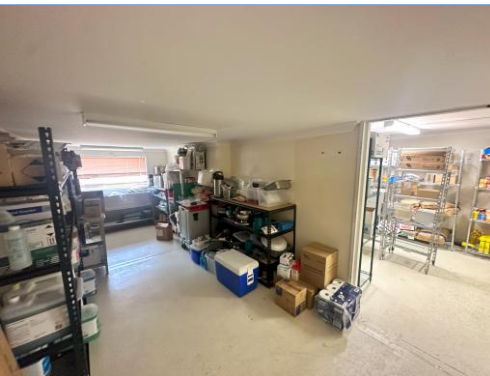
| Material Identification | | Risk Assessment | | | Risk Management & Corrective Actions | | Photo | |
|---|---|---|---|---|---|---|---|---|
| Internal, Zone 2, Food Storage Room, light fittings | PCB-containing capacitors | PCB14 | Presumed PCB | 5 units | NA | Negligible | Inaccessible during survey due to live electrical hazard. Confirm presence of polychlorinated biphenyls prior to demolition. PCB-containing material should be removed prior to demolition works and disposed of as per EPA requirements. | |

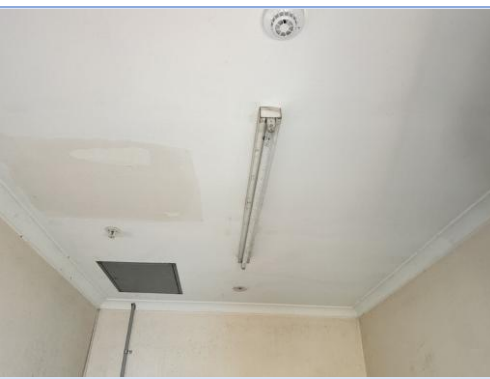
| Material Identification | | Risk Assessment | | | Risk Management & Corrective Actions | | Photo | |
|---|---|---|---|---|---|---|---|---|
| Internal, Zone 2, Hot Water Heater Room, light fitting | PCB-containing capacitor | PCB15 | Presumed PCB | 1 unit | NA | Negligible | Inaccessible during survey due to live electrical hazard. Confirm presence of polychlorinated biphenyls prior to demolition. PCB-containing material should be removed prior to demolition works and disposed of as per EPA requirements. | |

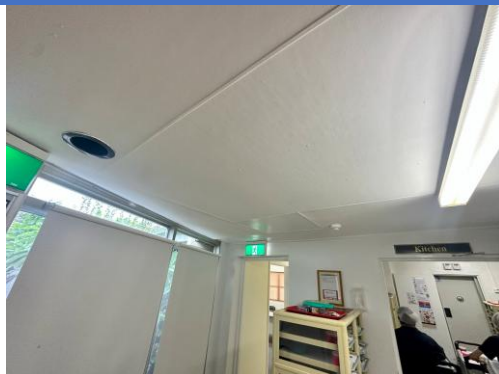
| Material Identification | | Risk Assessment | | | | Risk Management & Corrective Actions | | Photo |
|---|---|---|---|---|---|---|---|---|
| Internal, Zone 2, room northeast of Kitchen, ceiling | Fibre cement sheeting | ASB23 | CH | 8 sqm | NF | Negligible | Prior to demolition works, this material must be removed by a Class A or B licensed asbestos removalist with a clearance certificate issued by a competent third party. Air monitoring is also recommended. | |

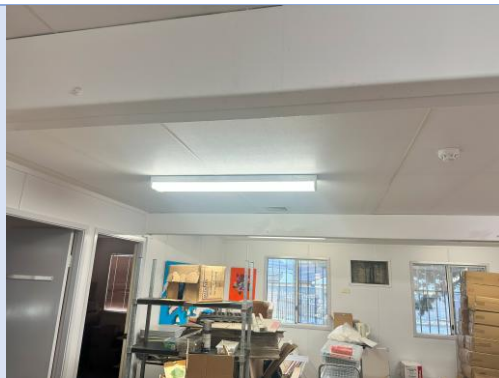
| Material Identification | | Risk Assessment | | | | Risk Management & Corrective Actions | | Photo |
|---|---|---|---|---|---|---|---|---|
| Internal, Zone 2, Seminar Room light fittings | PCB-containing capacitors | PCB20 | Presumed PCB | 11 units | NA | Negligible | Inaccessible during survey due to live electrical hazard. Confirm presence of polychlorinated biphenyls prior to demolition. PCB-containing material should be removed prior to demolition works and disposed of as per EPA requirements. | |

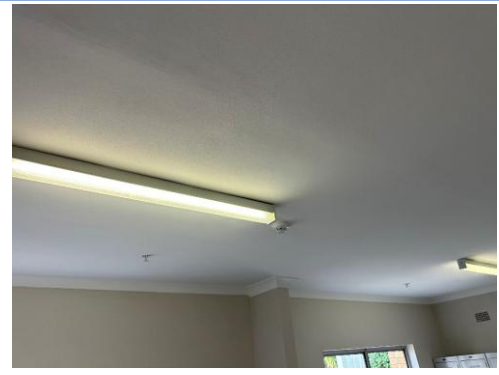
| Material Identification | | Risk Assessment | | | | Risk Management & Corrective Actions | | Photo |
|---|---|---|---|---|---|---|---|---|
| Internal, Zone 2, southern Staff Room, light fittings | PCB-containing capacitors | PCB21 | Presumed PCB | 3 units | NA | Negligible | Inaccessible during survey due to live electrical hazard. Confirm presence of polychlorinated biphenyls prior to demolition. PCB-containing material should be removed prior to demolition works and disposed of as per EPA requirements. | |

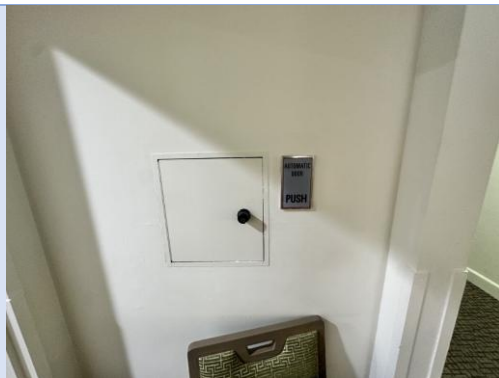
| Material Identification | | Risk Assessment | | | Risk Management & Corrective Actions | | | Photo |
|---|---|---|---|---|---|---|---|---|
| Internal, Zone 3, Dining Room hallway, western hatch | Inaccessible | - | Unknown | - | NA | - | No access at the time of inspection. Gain access to confirm presence of hazmat. | |

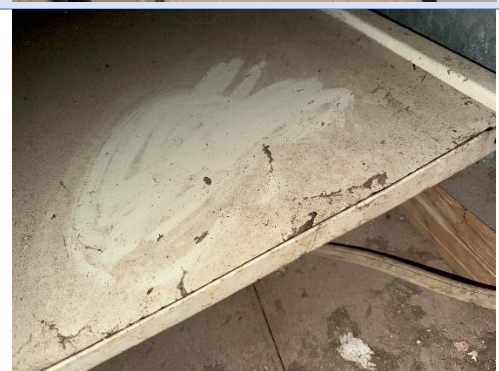
| Lead dust | Ceiling spaces to Zones 2 and 6 | Low | The lead dust should be removed under controlled conditions by competent person(s) prior to demolition works. Appropriate PPE and RPE is required. Air monitoring and validation dust samples after completion of remediation is recommended. |

| Material Identification | | Risk Assessment | | | Risk Management & Corrective Actions | | | Photo |
|---|---|---|---|---|---|---|---|---|
| Internal, Zone 6, Plant Room, ceiling cavity | Lead dust | LD01 | 38 mg/m² | 12 sqm | NA | Low | The lead dust should be removed under controlled conditions by competent person(s) prior to demolition works. Appropriate PPE and RPE is required. Air monitoring and validation dust samples after completion of remediation is recommended. | |

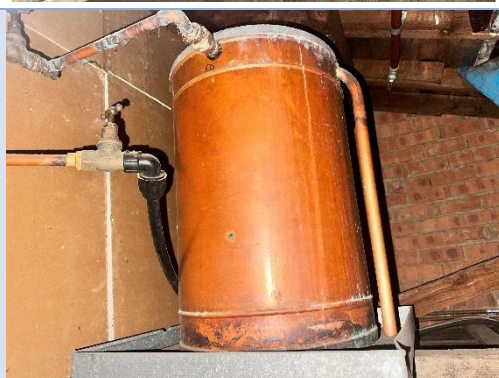
| Location | Reason for inaccessibility |
|---|---|
| Internal, Zone 6, Plant Room, ceiling cavity, hot water tank | No access at the time of inspection. Gain access to confirm presence of hazardous materials in the water tank e.g. insulation, electrical wiring etc. |

| Material Identification | | Risk Assessment | | | Risk Management & Corrective Actions | | | Photo |
|---|---|---|---|---|---|---|---|---|
| Internal, Zone 6, Plant Room, ceiling cavity, hot water tank | Inaccessible insulation | - | Unknown | - | NA | - | No access at the time of inspection. Gain access to confirm presence of hazardous materials in the water tank e.g. insulation, electrical wiring etc. | |

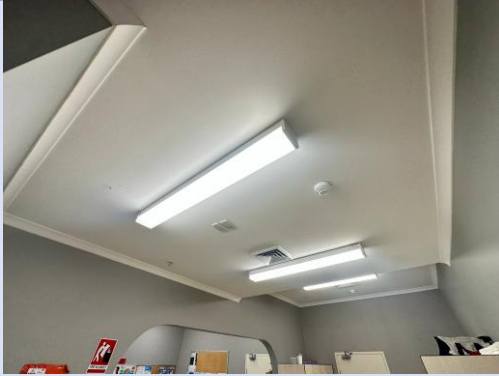
| Material Identification | | Risk Assessment | | | Risk Management & Corrective Actions | | | Photo |
|---|---|---|---|---|---|---|---|---|
| Internal, Zone 7, Staff Room amenities, light fittings | PCB-containing capacitors | PCB27 | <b>Presumed PCB</b> | 5 units | NA | Negligible | Inaccessible during survey due to live electrical hazard. Confirm presence of polychlorinated biphenyls prior to demolition. PCB-containing material should be removed prior to demolition works and disposed of as per EPA requirements. | |

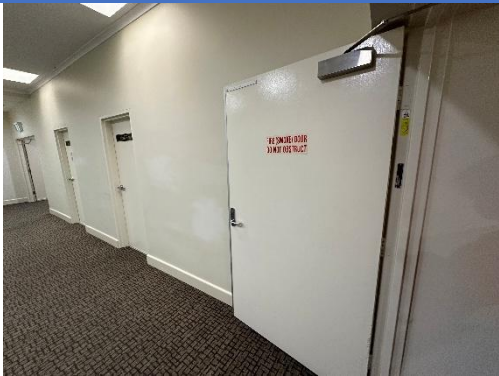
| Material Identification | | Risk Assessment | | | Risk Management & Corrective Actions | | | Photo |
|---|---|---|---|---|---|---|---|---|
| Internal, Zone 7, western double fire doors, core material | Millboard | SP7 | <b>Strongly Presumed Asbestos</b> | 2 units | F | Negligible | 1989 tag. Remove item intact under controlled conditions prior to demolition works by a Class A asbestos removal contractor, with mandatory asbestos air monitoring and clearance certificate issued by a Licensed Asbestos Assessor (LAA). | |

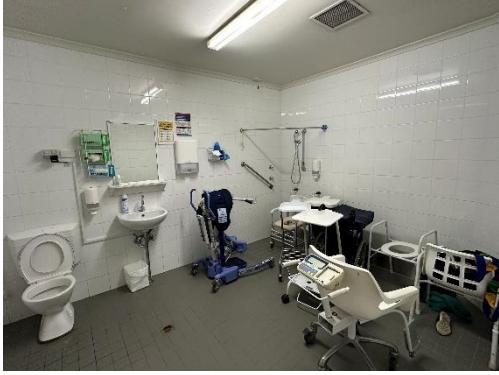
| Material Identification | | Risk Assessment | | | Risk Management & Corrective Actions | | | Photo |
|---|---|---|---|---|---|---|---|---|
| Internal, Zone 8, Aged Care Rooms, bathroom wall lining behind tiles | Fibre cement sheeting | P17 | <b>Presumed Asbestos</b> | 20 sqm | NF | Negligible | Prior to demolition works, this material must be removed by a Class A or B licensed asbestos removalist with a clearance certificate issued by a competent third party. Air monitoring is also recommended. | |

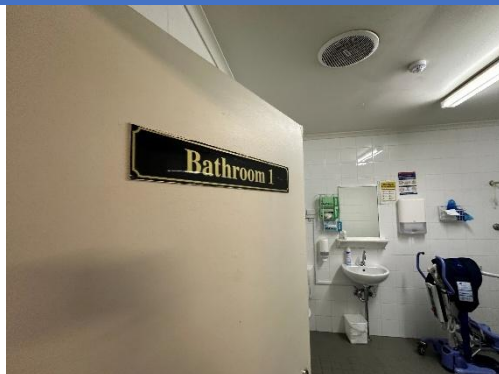
| Material Identification | | Risk Assessment | | | Risk Management & Corrective Actions | | Photo | |
|---|---|---|---|---|---|---|---|---|
| Internal, Zone 8, Bathroom 1, behind tiles walls | Fibre cement sheeting | P18 | Presumed Asbestos | 36 sqm | NF | Negligible | Prior to demolition works, this material must be removed by a Class A or B licensed asbestos removalist with a clearance certificate issued by a competent third party. Air monitoring is also recommended. | |

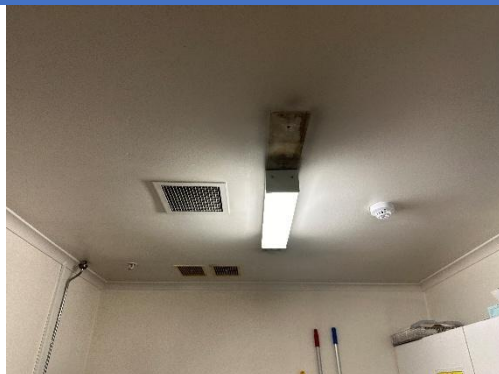
| Material Identification | | | Risk Assessment | | | Risk Management & Corrective Actions | | Photo |
|---|---|---|---|---|---|---|---|---|
| Internal, Zone 8, light fittings throughout | PCB-containing capacitors | PCB29 | Presumed PCB | TH | NA | Negligible | Inaccessible during survey due to live electrical hazard. Confirm presence of polychlorinated biphenyls prior to demolition. PCB-containing material should be removed prior to demolition works and disposed of as per EPA requirements. | |

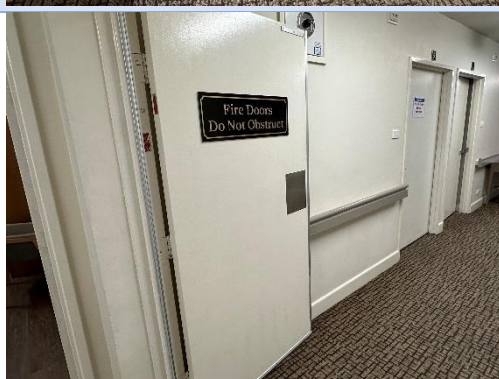
| Material Identification | | | Risk Assessment | | | Risk Management & Corrective Actions | | Photo |
|---|---|---|---|---|---|---|---|---|
| Internal, Zone 8, southern double fire doors | Fire door core insulation | P19 | Presumed Asbestos | 2 units | F | Negligible | 1990 tag. Remove item intact under controlled conditions prior to demolition works by a Class A asbestos removal contractor, with mandatory asbestos air monitoring and clearance certificate issued by a Licensed Asbestos Assessor (LAA). | |

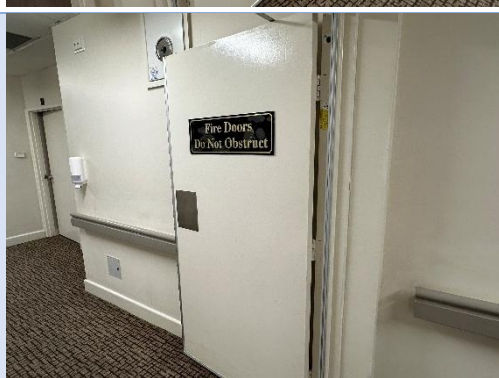
| Material Identification | | | Risk Assessment | | | Risk Management & Corrective Actions | | Photo |
|---|---|---|---|---|---|---|---|---|
| Internal, Zone 8, southern double fire doors, core material | Fire door core insulation | P20 | Presumed Asbestos | 2 units | F | Negligible | 1990 tag. Remove item intact under controlled conditions prior to demolition works by a Class A asbestos removal contractor, with mandatory asbestos air monitoring and clearance certificate issued by a Licensed Asbestos Assessor (LAA). | |

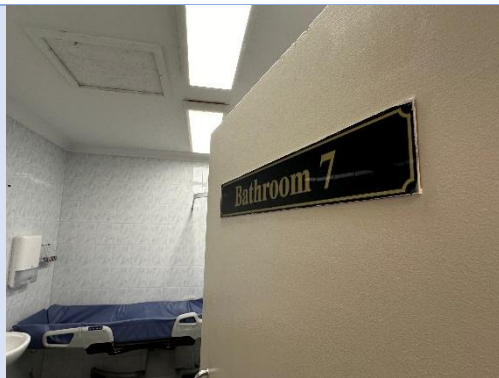
| Material Identification | | Risk Assessment | | | Risk Management & Corrective Actions | | | Photo |
|---|---|---|---|---|---|---|---|---|
| Internal, Zone 9, Bathroom 7, floor to ceiling walls behind tiles | Fibre cement sheeting | P21 | Presumed Asbestos | 30 sqm | NF | Negligible | Prior to demolition works, this material must be removed by a Class A or B licensed asbestos removalist with a clearance certificate issued by a competent third party. Air monitoring is also recommended. | |

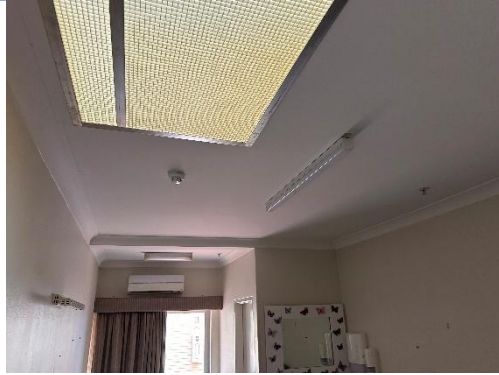
| Material Identification | | Risk Assessment | | | Risk Management & Corrective Actions | | | Photo |
|---|---|---|---|---|---|---|---|---|
| Internal, Zone 9, light fittings throughout | PCB-containing capacitors | PCB30 | Presumed PCB | 4 units | NA | Negligible | Inaccessible during survey due to live electrical hazard. Confirm presence of polychlorinated biphenyls prior to demolition. PCB-containing material should be removed prior to demolition works and disposed of as per EPA requirements. | |

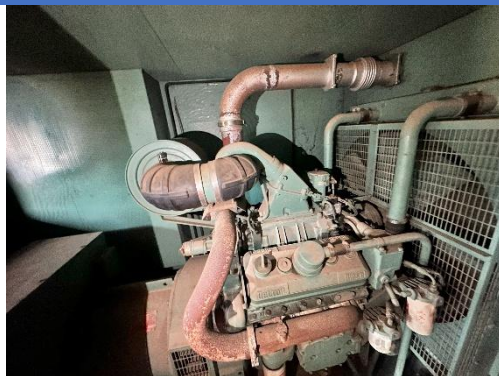
| Material Identification | | Risk Assessment | | | Risk Management & Corrective Actions | | Photo | |
|---|---|---|---|---|---|---|---|---|
| Internal, Zone 11, emergency back-up generator | Inaccessible, likely to contain gaskets | P24 | Presumed Asbestos | 6 units | NF | Negligible | <p>Generators of this type and age are known to contain asbestos gaskets within the engine components (eg head gasket). No access was possible to any gaskets of the generator at the time of inspection.</p> <p>Prior to demolition works, this material must be removed by a Class A or B licensed asbestos removalist with a clearance certificate issued by a competent third party. Air monitoring is also recommended.</p> | |

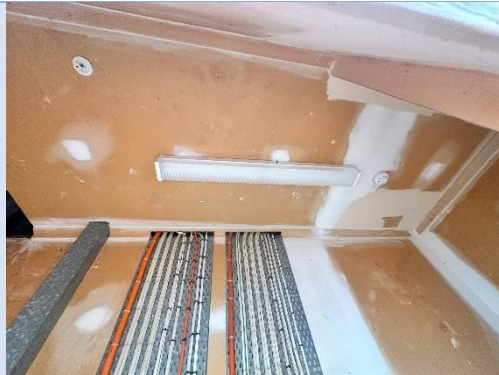
| Material Identification | | Risk Assessment | | | Risk Management & Corrective Actions | | Photo | |
|---|---|---|---|---|---|---|---|---|
| Internal, Zone 11, Main Power Board Room, light fittings | PCB-containing capacitors | PCB32 | Presumed PCB | 2 units | NA | Negligible | <p>Inaccessible during survey due to live electrical hazard. Confirm presence of polychlorinated biphenyls prior to demolition. PCB-containing material should be removed prior to demolition works and disposed of as per EPA requirements.</p> | |

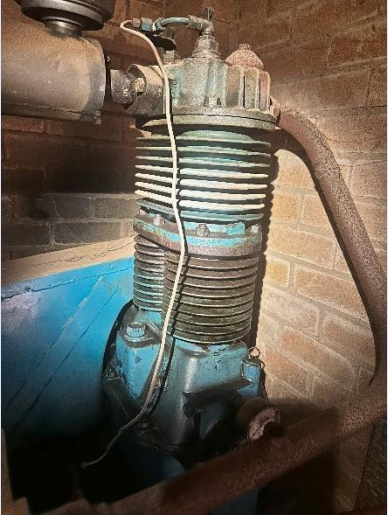
| Gasket | Plant/motor rooms throughout | Low | Prior to demolition works, this material must be removed by a Class A or B licensed asbestos removalist with a clearance certificate issued by a competent third party. Air monitoring is also recommended. |

| Material Identification | | | Risk Assessment | | Risk Management & Corrective Actions | | Photo |
|---|---|---|---|---|---|---|---|
| Internal, Zone 11, Motor Room, machinery gaskets | Gasket | ASB09 | CH | 4 units | NF | Low | <p>Prior to demolition works, this material must be removed by a Class A or B licensed asbestos removalist with a clearance certificate issued by a competent third party. Air monitoring is also recommended.</p> |
