# Hazardous Materials Register

## Education Centre

| Site Details | | Building Details | | | | | | Audit Details | |
|---|---|---|---|--|--|---|---|---|---|
| Full Address: | Holden Street Gosford NSW 2250 | Building Name: | Education Centre | | | Number of Levels: | 3 | Survey Date: | 04-11-2014 |
| Client Name: | Gosford Hospital | Roof Type: | Metal | | | Construction Type: | Brick | Company: | GreencapNAA |

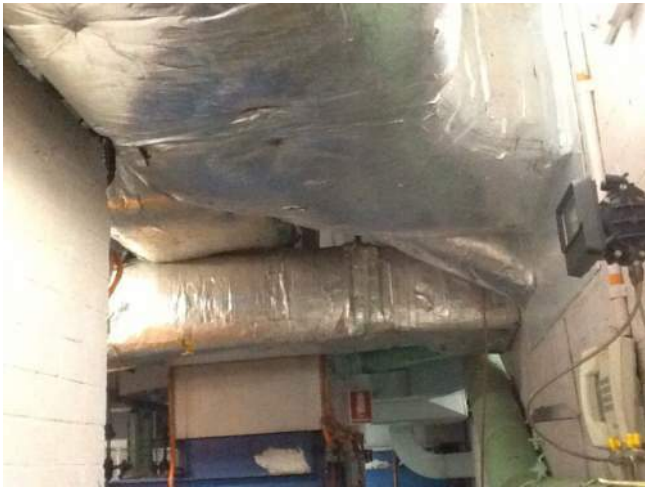
Photo No: J128740-001-MAND-Photo002  
Result: SMF - Positive  
Building/Level: Main Building-All Levels  
Room/Location: All areas-Throughout  
Feature/Material: Ductwork Insulation-Insulation Material

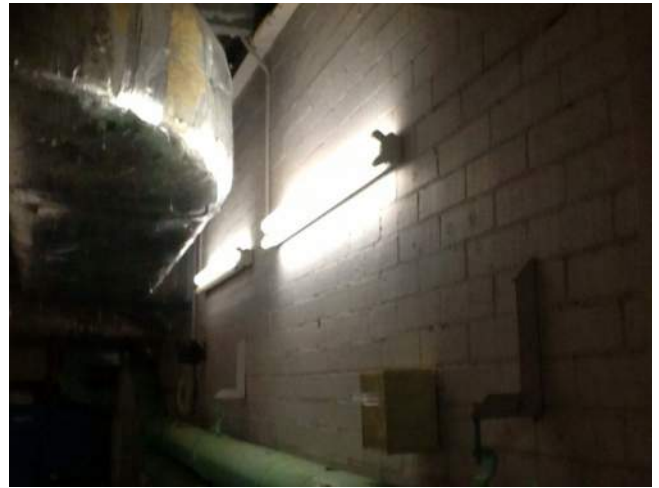
Photo No: J128740-001-MAND-Photo010  
Result: PCB - Presumed Positive  
Building/Level: Main Building-All Levels  
Room/Location: All areas-Throughout  
Feature/Material: Fluorescent Light Fitting-Capacitor

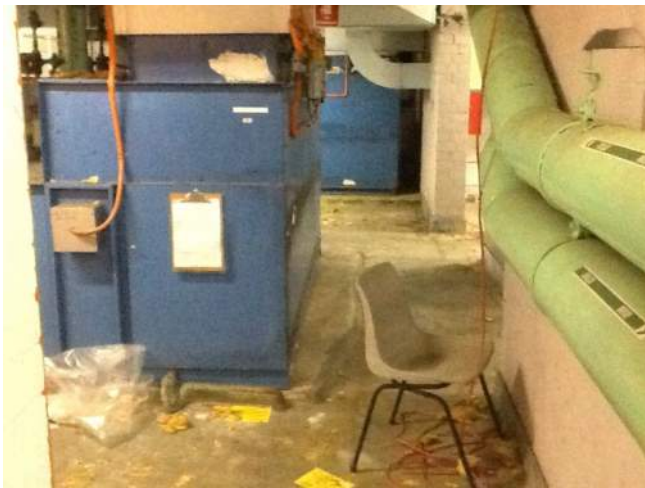
Photo No: J128740-001-MAND-Photo004  
Result: SMF - Positive  
Building/Level: Main Building-All Levels  
Room/Location: All areas-Throughout  
Feature/Material: On Ground-Insulation Material

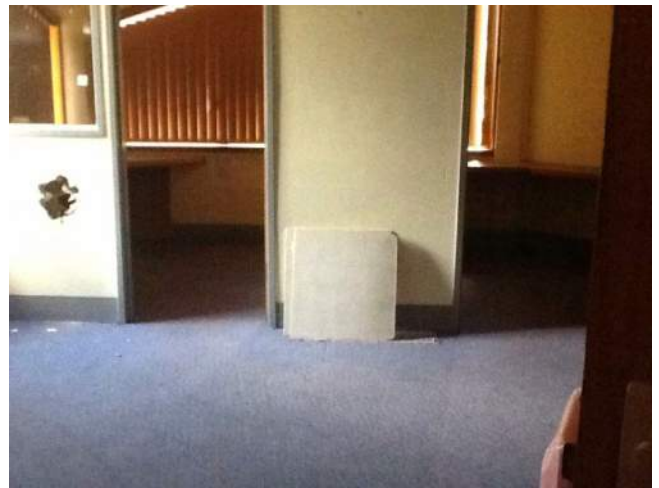
Photo No: J128740-001-MAND-Photo015  
Result: Asbestos - Positive  
Building/Level: Main Building-Level One  
Room/Location: All areas-  
Feature/Material: Access Hatch-Fibre Cement Sheetting

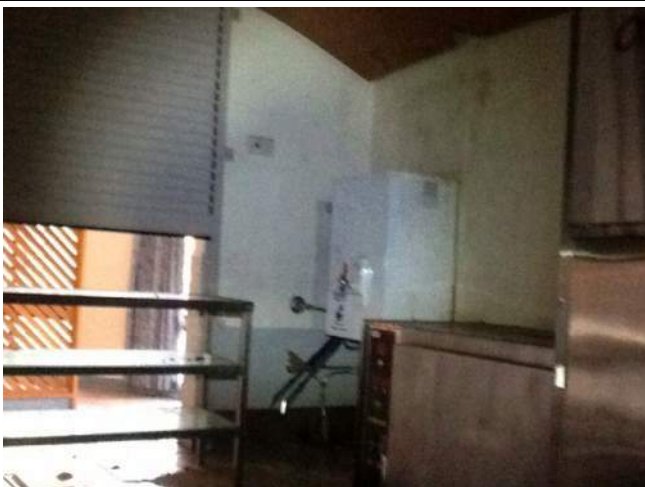
Photo No: J128740-001-MAND-Photo037  
Result: SMF - Presumed Positive  
Building/Level: Main Building-Level One  
Room/Location: Dining Kitchen-Northeast  
Feature/Material: Boiler Insulation-Insulation Material

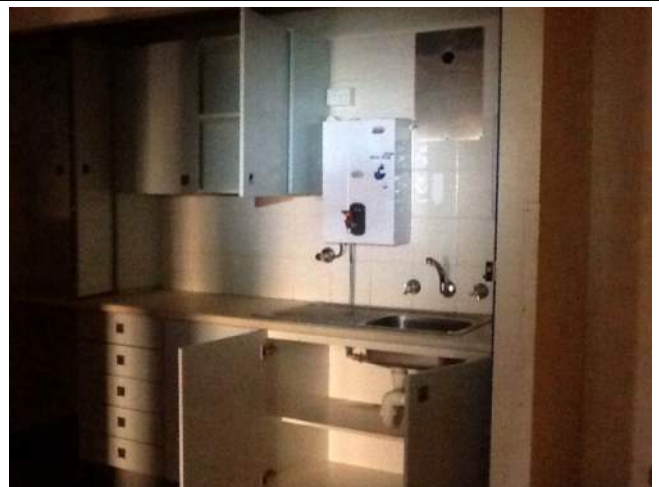
Photo No: J128740-001-MAND-Photo039  
Result: SMF - Presumed Positive  
Building/Level: Main Building-Level One  
Room/Location: Kitchenette West of Southern Reception Area-West  
Feature/Material: Boiler Insulation-Insulation Material

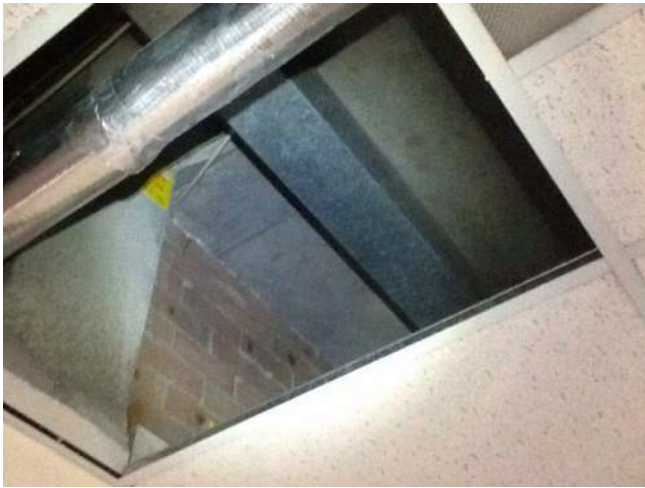
Photo No: J128740-001-MAND-Photo038  
Result: SMF - Positive  
Building/Level: Main Building-Level One  
Room/Location: Room 5 (adjacent Kitchen)-Northeast  
Feature/Material: Ceiling-Kao-Wool

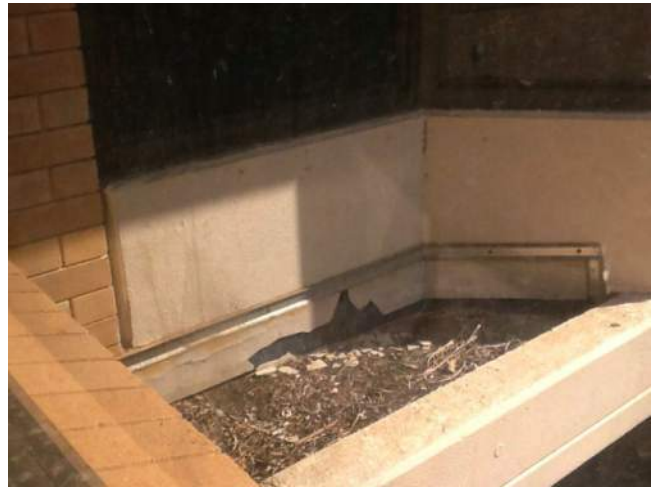
Photo No: J128740-001-MAND-Photo023  
Result: Asbestos - Presumed Positive  
Building/Level: Main Building-Level Two  
Room/Location: Main Entrance-Adjacent Door  
Feature/Material: Debris-Fibre Cement Sheetting

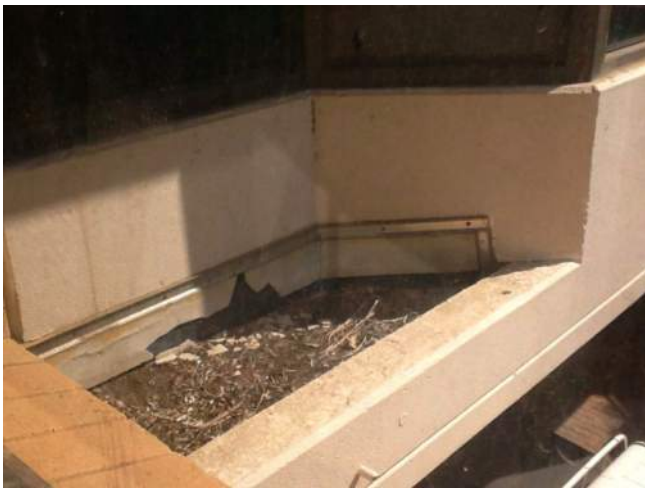
Photo No: J128740-001-MAND-Photo024  
Result: Asbestos - Presumed Positive  
Building/Level: Main Building-Level Two  
Room/Location: Main Entrance-Adjacent Door  
Feature/Material: Wall Cladding-Fibre Cement Sheetting

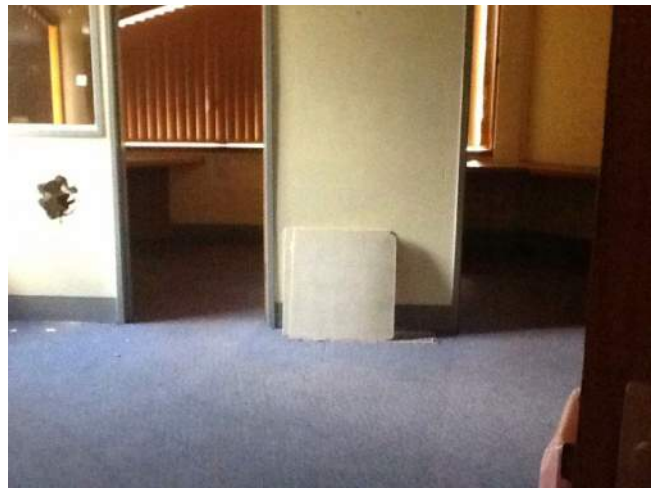
Photo No: J128740-001-MAND-Photo015  
Result: Asbestos - Presumed Positive  
Building/Level: Main Building-Level Two  
Room/Location: All areas-  
Feature/Material: Access Hatch-Fibre Cement Sheetting

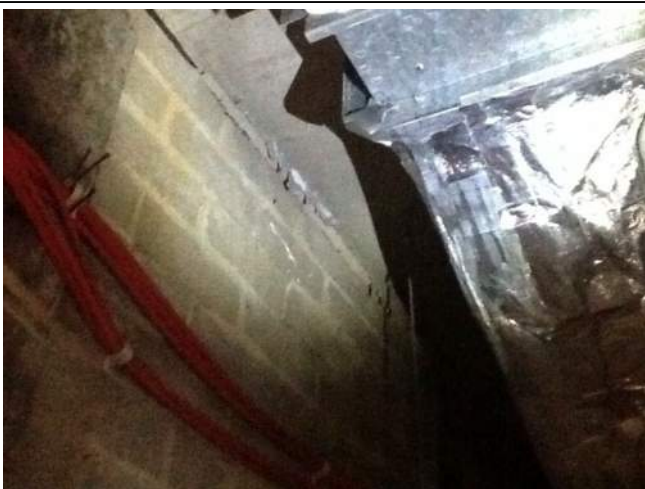
Photo No: J128740-001-MAND-Photo025  
Result: Asbestos - Presumed Positive  
Building/Level: Main Building-Level Two  
Room/Location: Main Entrance-Adjacent Door  
Feature/Material: Ceiling Space-Packing

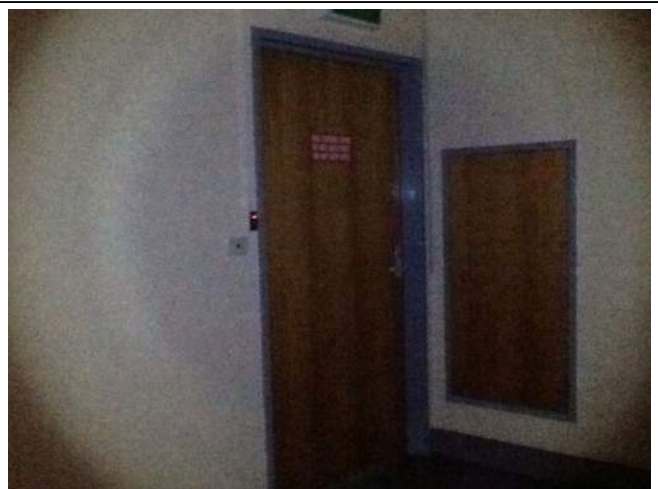
Photo No: J128740-001-MAND-Photo019  
Result: Asbestos - Presumed Positive  
Building/Level: Main Building-Level Two  
Room/Location: Northern Fire Stairwell-Entrance  
Feature/Material: Fire Door-Fire Door Core

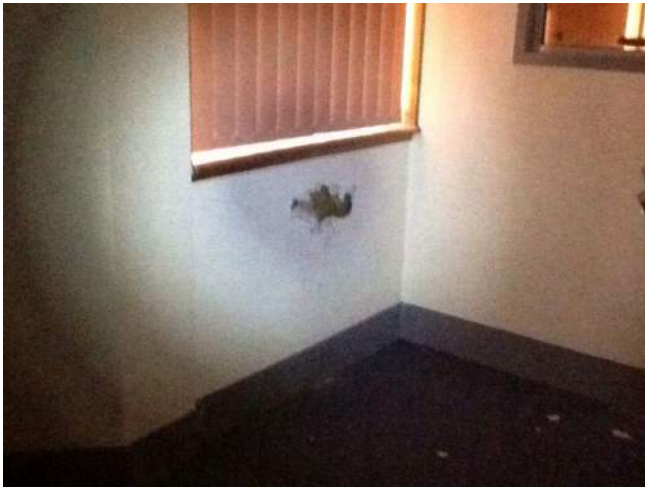
Photo No: J128740-001-MAND-Photo017  
Result: SMF - Positive  
Building/Level: Main Building-Level Two  
Room/Location: Office Area opposite Tea Room-Wall below Windows  
Feature/Material: Insulation-Insulation Material

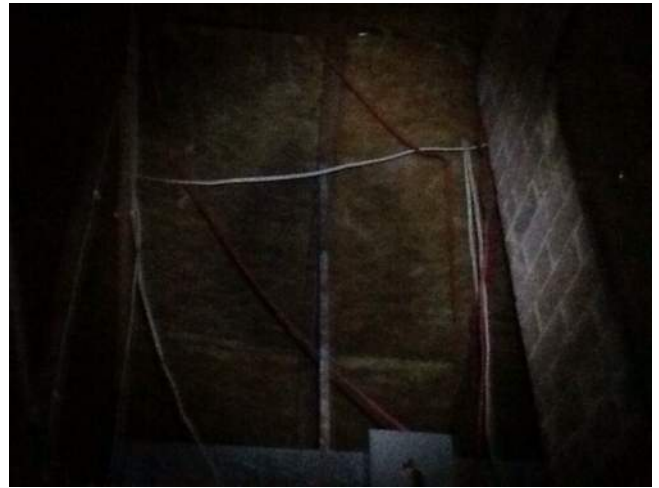
Photo No: J128740-001-MAND-Photo021  
Result: SMF - Positive  
Building/Level: Main Building-Level Two  
Room/Location: Roof Space-Throughout  
Feature/Material: Roof Lining-Insulation Material

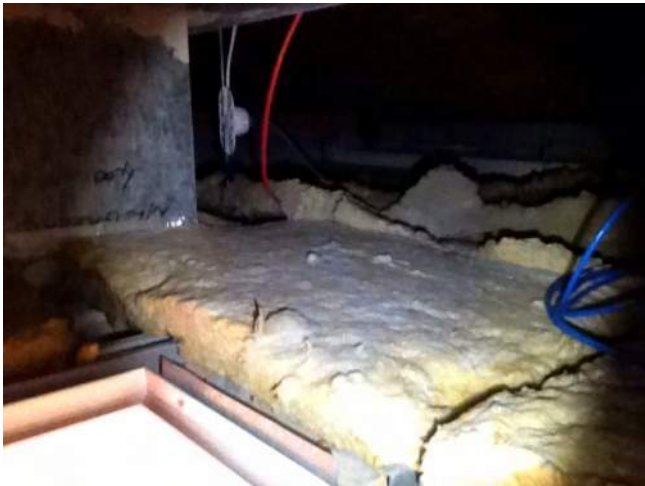
Photo No: J128740-001-MAND-Photo034  
Result: SMF - Positive  
Building/Level: Main Building-Levels One & Two  
Room/Location: Ceiling Space-Variou Throughout  
Feature/Material: Insulation-Insulation Batts

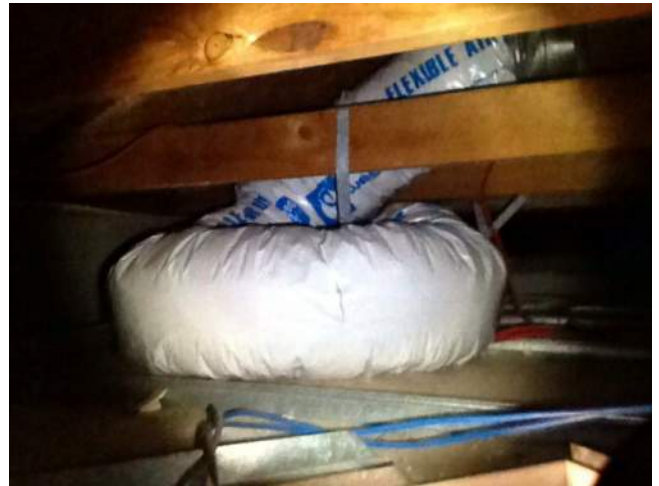
Photo No: J128740-001-MAND-Photo029  
Result: SMF - Positive  
Building/Level: Main Building-Levels One & Two  
Room/Location: Various Rooms-Ceiling Space  
Feature/Material: Flexible Ductwork Insulation-Insulation Material

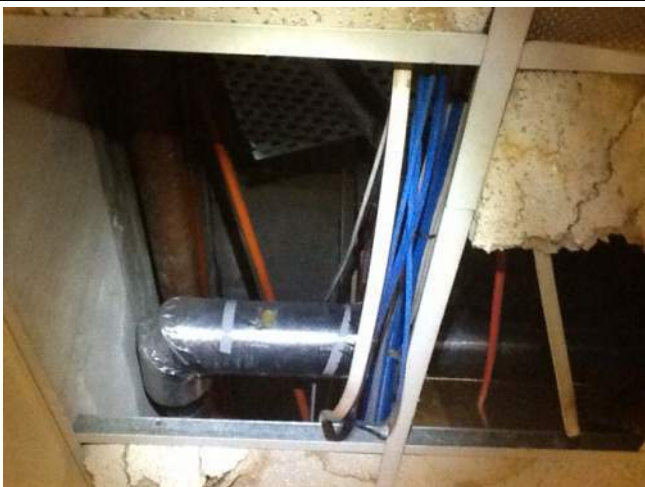
Photo No: J128740-001-MAND-Photo033  
Result: SMF - Positive  
Building/Level: Main Building-Levels One & Two  
Room/Location: Various Rooms-Ceiling Space  
Feature/Material: Pipework Insulation-Insulation Material

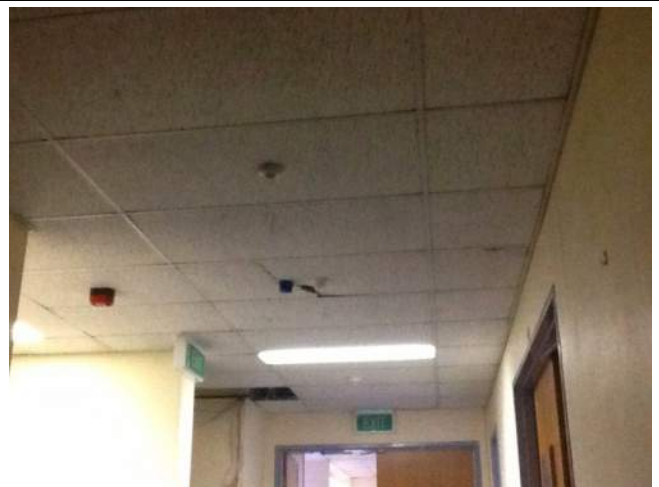
Photo No: J128740-001-MAND-Photo011  
Result: SMF - Positive  
Building/Level: Main Building-Levels One & Two  
Room/Location: Various Rooms-Throughout  
Feature/Material: Ceiling Tiles-Compressed Ceiling Tiles

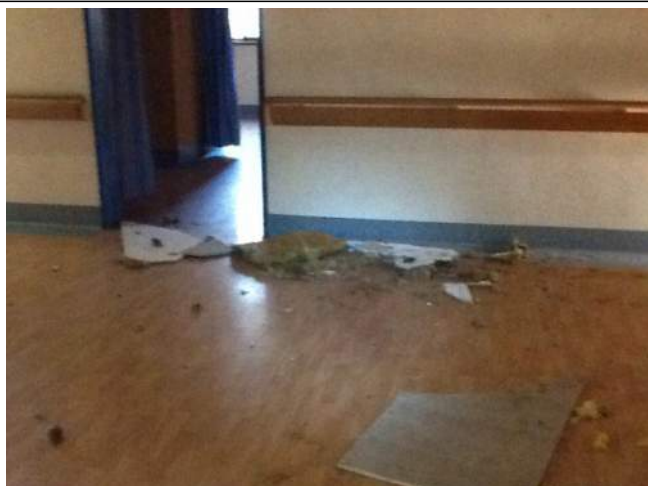
Photo No: J128740-001-MAND-Photo035  
Result: SMF - Positive  
Building/Level: Main Building-Levels One & Two  
Room/Location: Various Rooms-Throughout  
Feature/Material: On Ground-Insulation Batt's

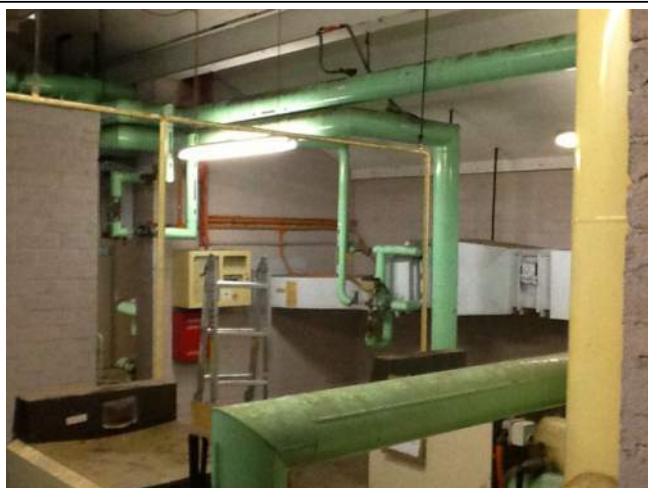
Photo No: J128740-001-MAND-Photo003  
Result: SMF - Presumed Positive  
Building/Level: Main Building-Level Three  
Room/Location: All areas-Throughout  
Feature/Material: Pipework Insulation-Insulation Material

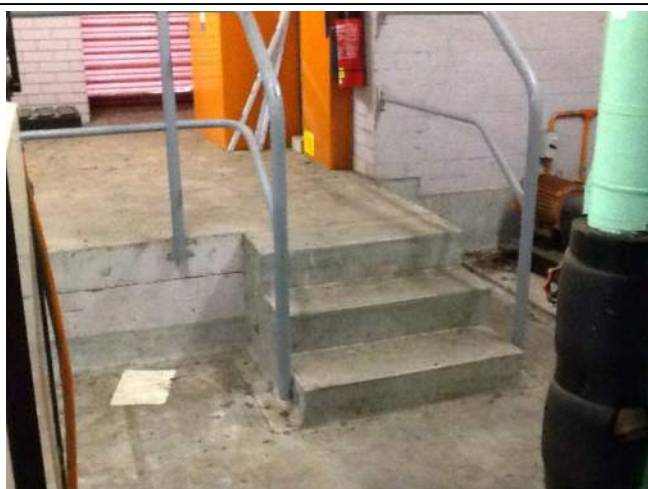
Photo No: J128740-001-MAND-Photo007  
Result: Lead (Dust) - Positive  
Building/Level: Main Building-Level Three  
Room/Location: All areas-Various Throughout  
Feature/Material: All surfaces-Accumulated Dust

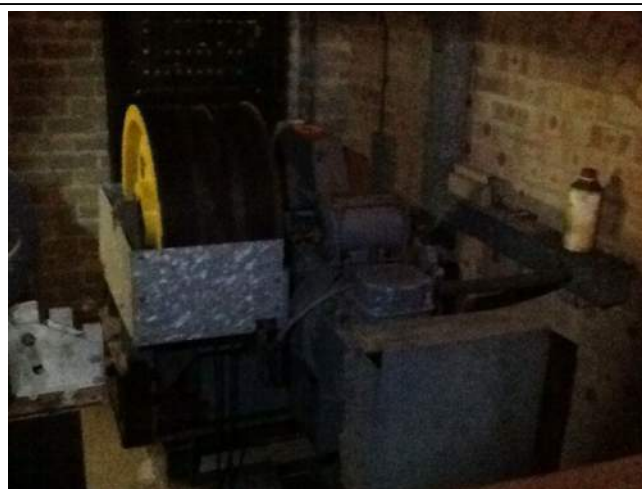
Photo No: J128740-001-MAND-Photo001  
Result: Asbestos - Presumed Positive  
Building/Level: Main Building-Level Three  
Room/Location: Lift Motor Room-  
Feature/Material: Lift Motor-Brake Pads

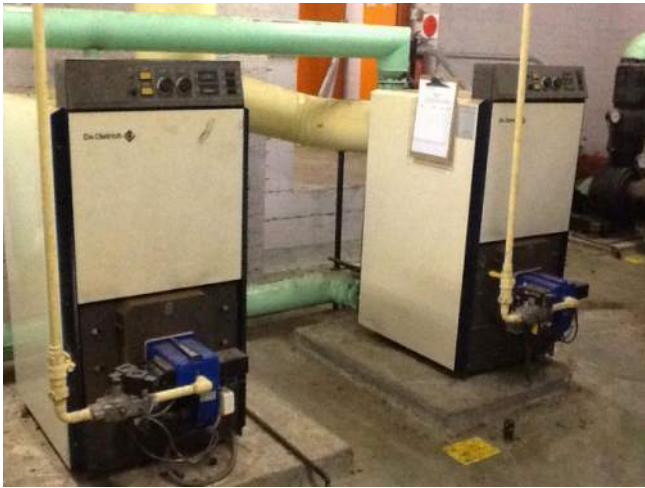
Photo No: J128740-001-MAND-Photo009  
Result: SMF - Presumed Positive  
Building/Level: Main Building-Level Three  
Room/Location: Plant Room-  
Feature/Material: Boiler Insulation-Insulation Material

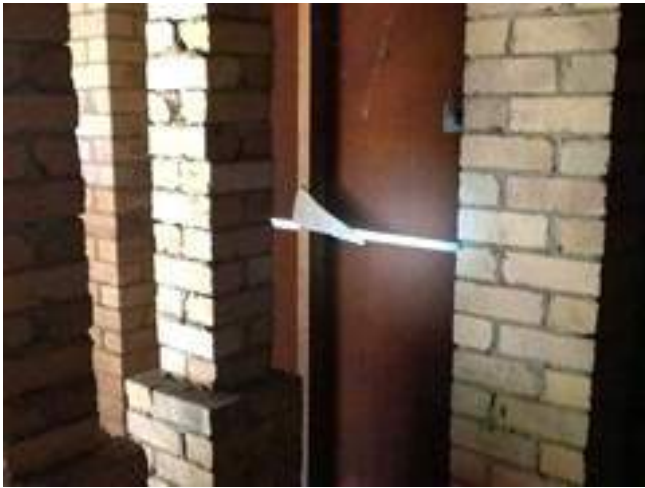
Photo No: J128740-002-ABOR-Photo102  
Result: Asbestos - Presumed Positive  
Building/Level: Main Building-Sub-Floor  
Room/Location: North of Toilets-Behind Masonite Walls (accessible through Northern side)  
Feature/Material: Wall Cladding-Fibre Cement Sheetting

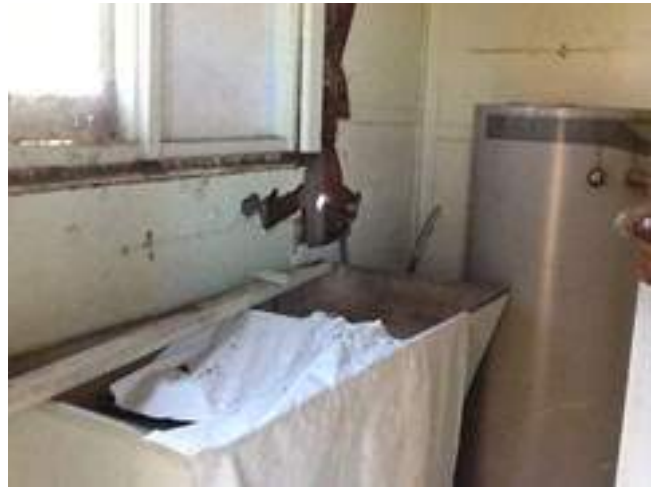
Photo No: J128740-002-ABOR-Photo103  
Result: Asbestos - Positive  
Building/Level: Main Building-Basement  
Room/Location: All rooms-Throughout  
Feature/Material: Wall-Fibre Cement Sheetting

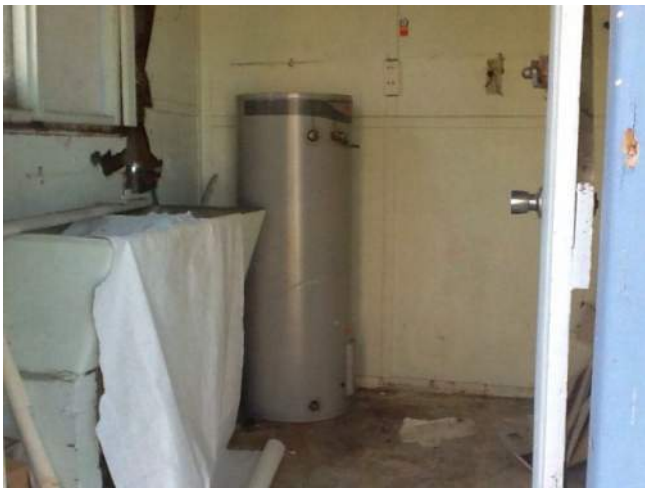
Photo No: J128740-002-ABOR-Photo018  
Result: SMF - Presumed Positive  
Building/Level: Main Building-Basement  
Room/Location: Laundry (adjacent Toilets)-  
Feature/Material: Hot Water Heater-Insulation Material

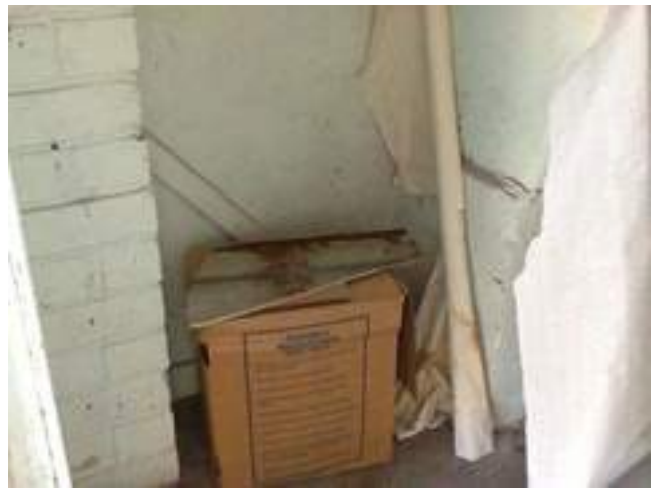
Photo No: J128740-002-ABOR-Photo100  
Result: Asbestos - Presumed Positive  
Building/Level: Main Building-Basement  
Room/Location: Laundry (adjacent Toilets)-Along Southern Wall  
Feature/Material: On Ground-Fibre Cement Debris

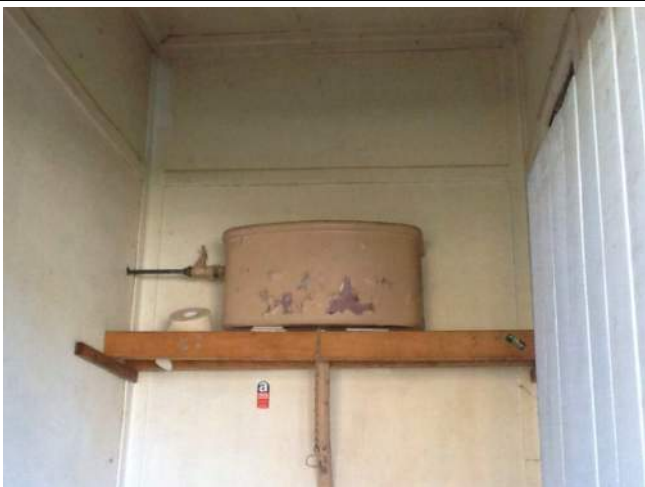
Photo No: J128740-002-ABOR-Photo020  
Result: Lead (Paint) - Positive  
Building/Level: Main Building-Basement  
Room/Location: Toilet-  
Feature/Material: Plant & Equipment-Paint System/s

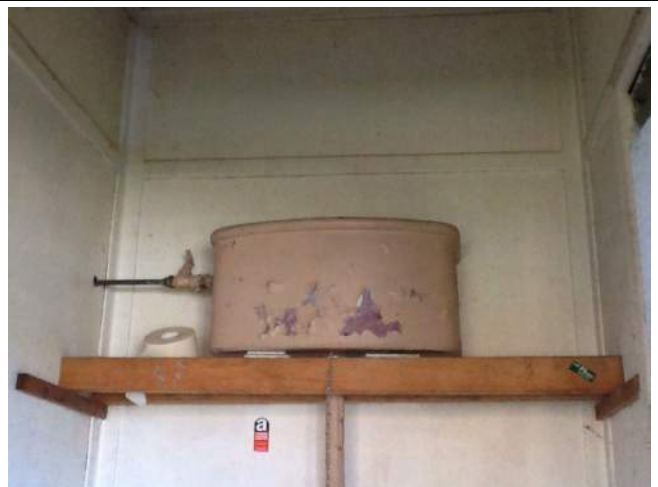
Photo No: J128740-002-ABOR-Photo017  
Result: Asbestos - Positive  
Building/Level: Main Building-Basement  
Room/Location: Toilets-  
Feature/Material: Toilet Cistern-Packing

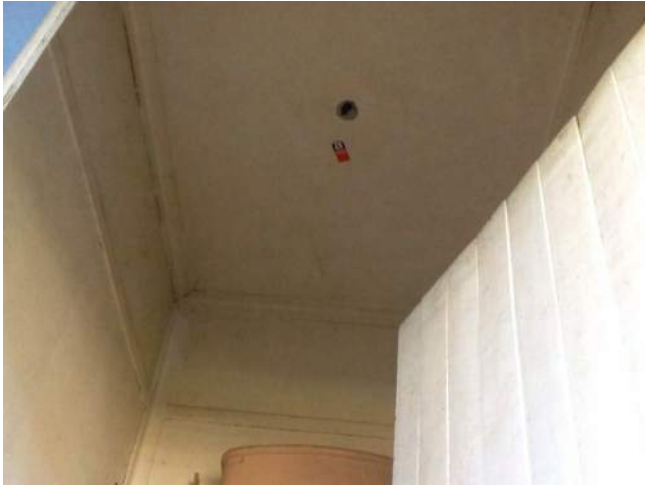
Photo No: J128740-002-ABOR-Photo019  
Result: Asbestos - Presumed Positive  
Building/Level: Main Building-Basement  
Room/Location: Toilets & Laundry-Throughout  
Feature/Material: Ceiling-Fibre Cement Sheetting

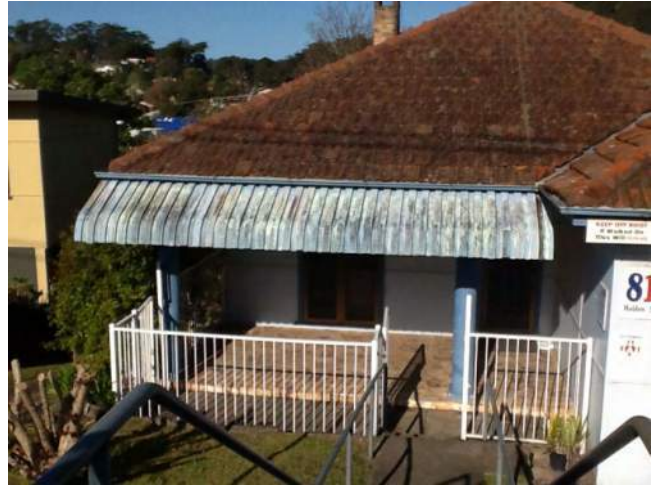
Photo No: J128740-002-ABOR-Photo022  
Result: Lead (Paint) - Presumed Positive  
Building/Level: Main Building-Ground Level  
Room/Location: Front Porch-  
Feature/Material: Awning-Paint System/s

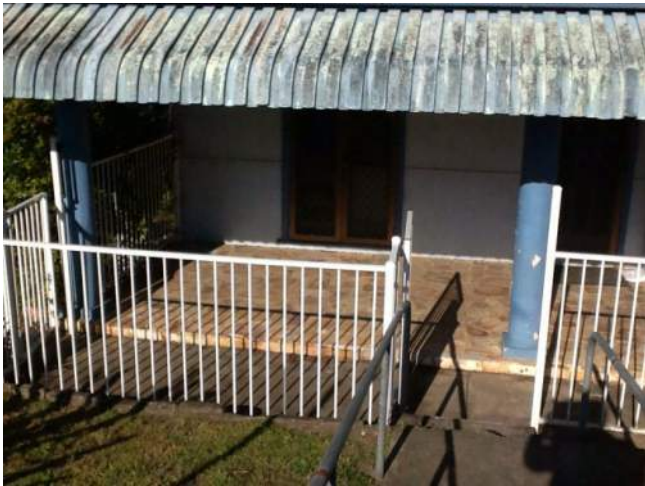
Photo No: J128740-002-ABOR-Photo021  
Result: Lead (Paint) - Presumed Positive  
Building/Level: Main Building-Ground Level  
Room/Location: Front Porch-  
Feature/Material: Beam-Paint System/s

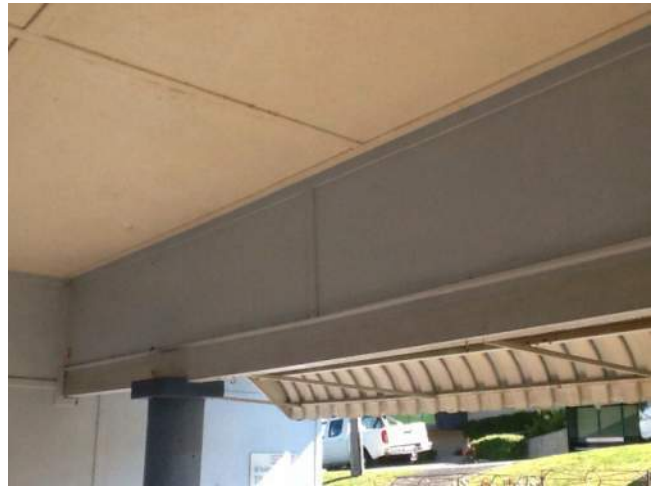
Photo No: J128740-002-ABOR-Photo012  
Result: Asbestos - Presumed Positive  
Building/Level: Main Building-Ground Level  
Room/Location: Front Porch-  
Feature/Material: Infill Panels - High Level-Fibre Cement Sheetting

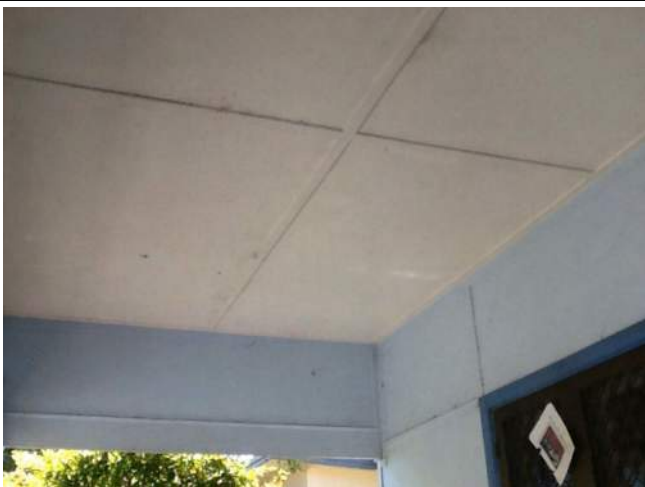
Photo No: J128740-002-ABOR-Photo013  
Result: Asbestos - Presumed Positive  
Building/Level: Main Building-Ground Level  
Room/Location: Front Porch-Throughout  
Feature/Material: Ceiling-Fibre Cement Sheetting

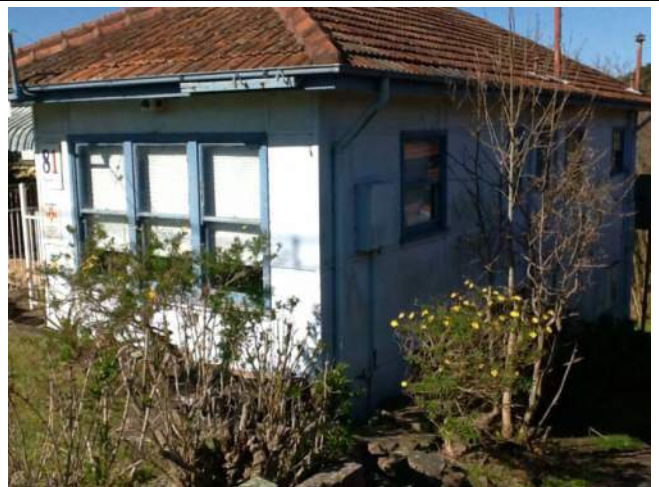
Photo No: J128740-002-ABOR-Photo014  
Result: Lead (Paint) - Presumed Positive  
Building/Level: Main Building-Ground Level  
Room/Location: Surroundings-  
Feature/Material: Wall-Paint System/s

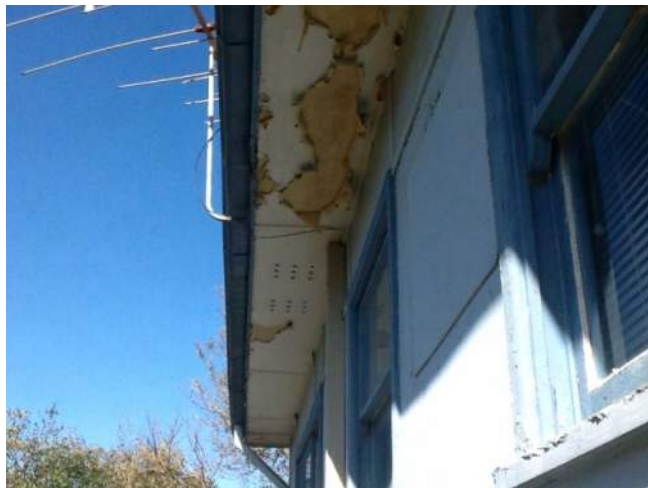
Photo No: J128740-002-ABOR-Photo015  
Result: Asbestos - Presumed Positive  
Building/Level: Main Building-Ground Level  
Room/Location: Surroundings-Throughout  
Feature/Material: Eaves-Fibre Cement Sheetting

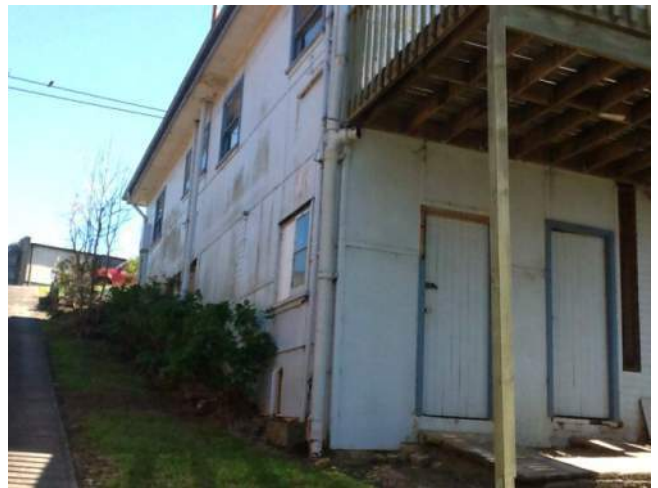
Photo No: J128740-002-ABOR-Photo001  
Result: Asbestos - Positive  
Building/Level: Main Building-Ground Level  
Room/Location: Surroundings-Throughout  
Feature/Material: Wall-Fibre Cement Sheetting

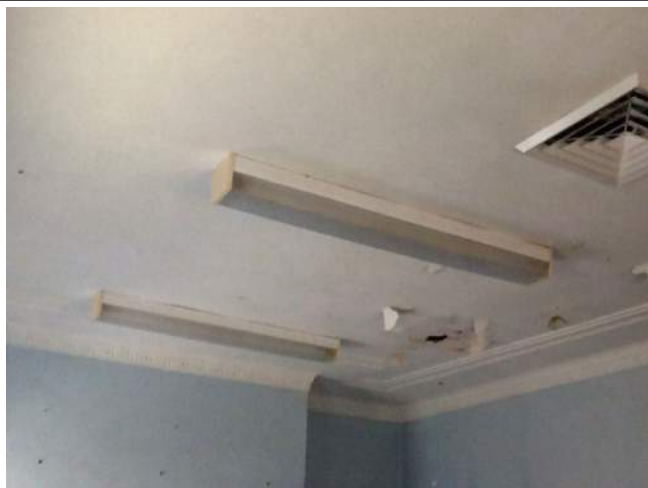
Photo No: J128740-002-ABOR-Photo011  
Result: PCB - Presumed Positive  
Building/Level: Main Building-Ground Level  
Room/Location: All rooms-  
Feature/Material: Fluorescent Light Fitting - Double Tube-Capacitor

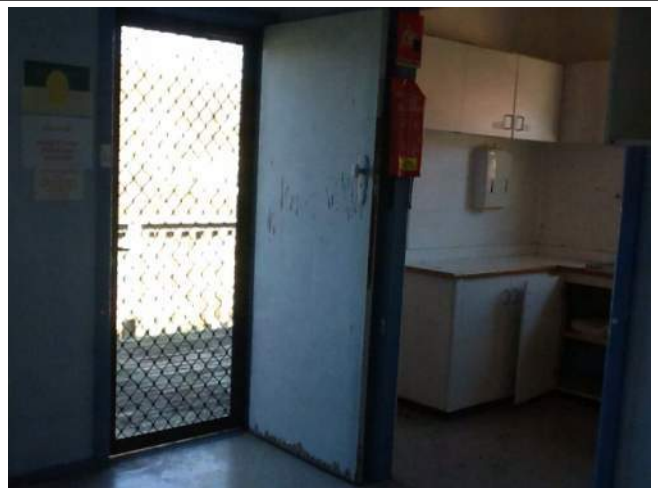
Photo No: J128740-002-ABOR-Photo010  
Result: Lead (Paint) - Positive  
Building/Level: Main Building-Ground Level  
Room/Location: Back Entrance-  
Feature/Material: Door-Paint System/s

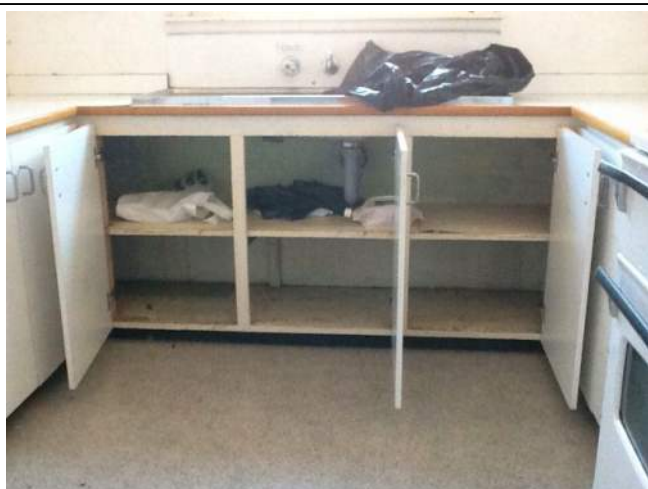
Photo No: J128740-002-ABOR-Photo004  
Result: Asbestos - Presumed Positive  
Building/Level: Main Building-Ground Level  
Room/Location: Kitchen-Throughout  
Feature/Material: Infill Panels - Low Level-Fibre Cement Sheetting

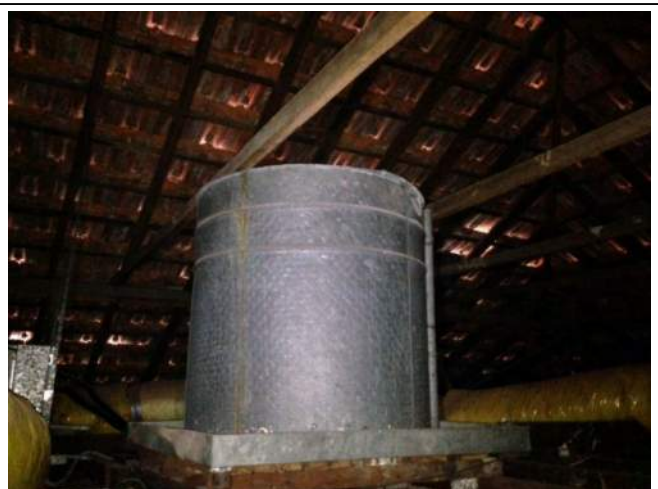
Photo No: J128740-002-ABOR-Photo007  
Result: Asbestos - Presumed Positive  
Building/Level: Main Building-Ground Level  
Room/Location: Roof Space-Central  
Feature/Material: Storage Tank-Insulation

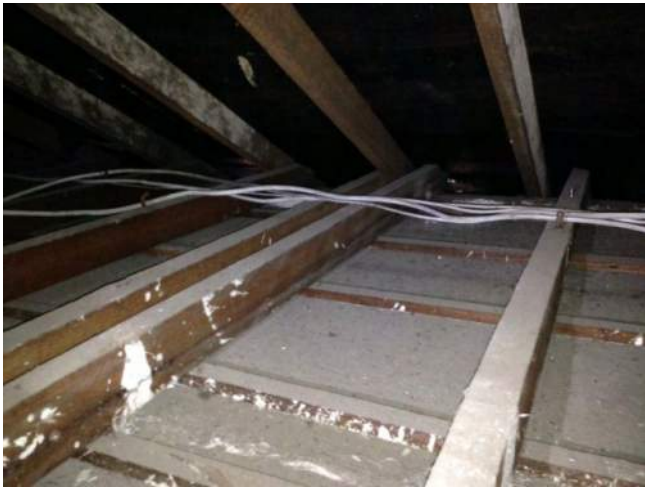
Photo No: J128740-002-ABOR-Photo006  
Result: Lead (Dust) - Positive  
Building/Level: Main Building-Ground Level  
Room/Location: Roof Space-Throughout  
Feature/Material: All surfaces-Accumulated Dust

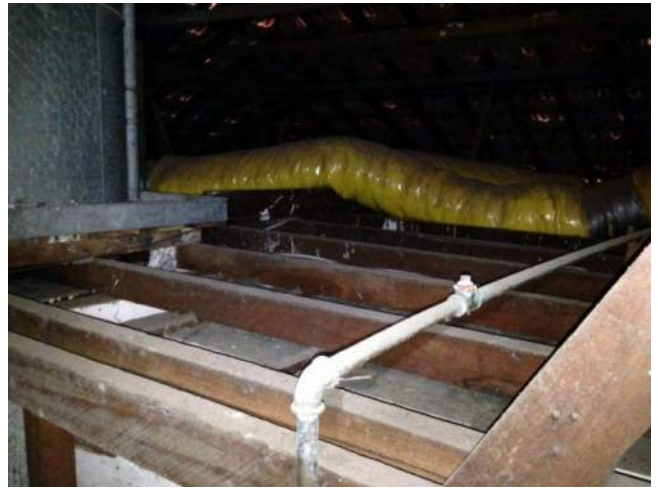
Photo No: J128740-002-ABOR-Photo008  
Result: SMF - Positive  
Building/Level: Main Building-Ground Level  
Room/Location: Roof Space-Throughout  
Feature/Material: Flexible Ductwork Insulation-Insulation Material

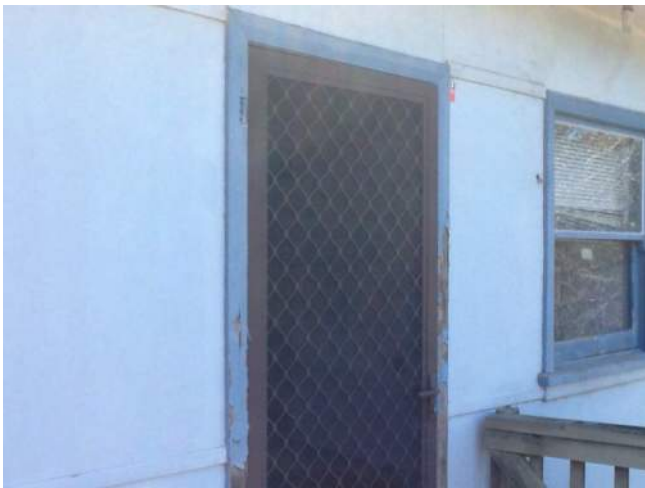
Photo No: J128740-002-ABOR-Photo009  
Result: Lead (Paint) - Positive  
Building/Level: Main Building-Ground Level  
Room/Location: All rooms-Throughout  
Feature/Material: Windows & Door Frames-Paint System/s

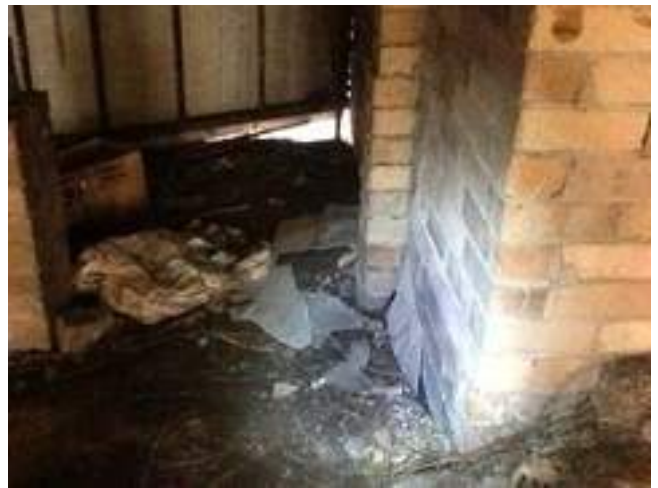
Photo No: J128740-002-ABOR-Photo101  
Result: Asbestos - Presumed Positive  
Building/Level: Main Building-All Levels  
Room/Location: Various Throughout-Throughout  
Feature/Material: Debris-Fibre Cement Sheetting

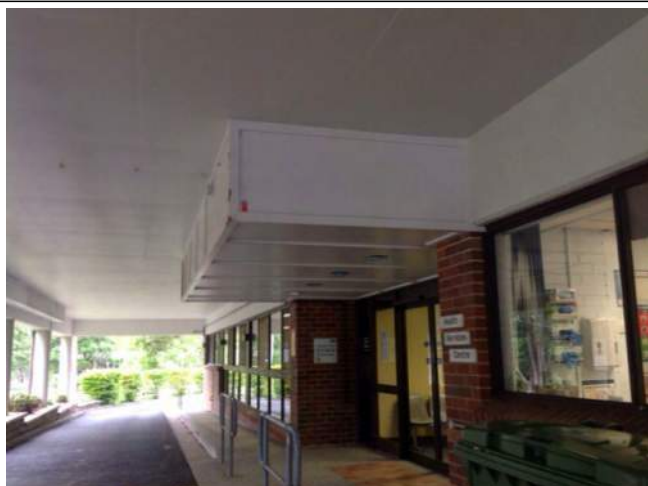
Photo No: J128740-003-HEAL-Photo028  
Result: Asbestos - Previously Sampled Positive  
Building/Level: Health Services Building-Level One  
Room/Location: South-West Entrance-Ceiling  
Feature/Material: Awning-Fibre Cement Sheetting

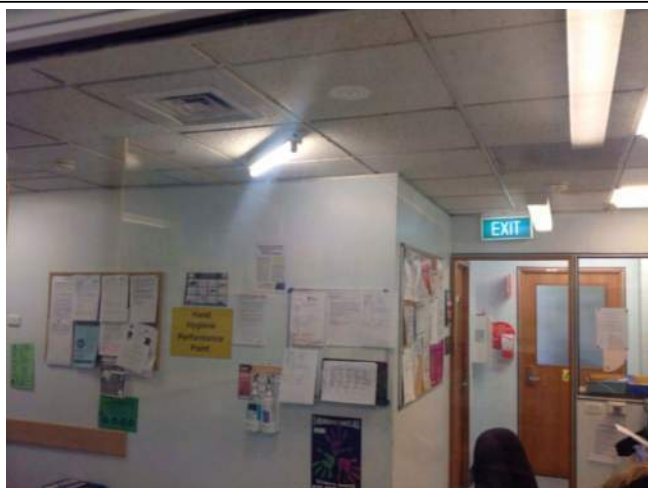
Photo No: J128740-003-HEAL-Photo001  
Result: SMF - Presumed Positive  
Building/Level: Health Services Building-Level One  
Room/Location: Dental Surgery 1, 2, 3, 4 & 5, Laboratory, Stores and Reception Area-  
Feature/Material: Ceiling Tiles-Compressed Ceiling Tiles

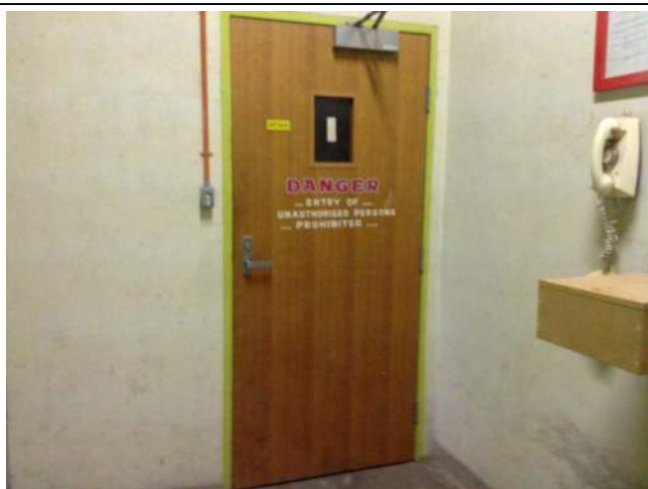
Photo No: J128740-003-HEAL-Photo007  
Result: Asbestos - Positive  
Building/Level: Health Services Building-Level One  
Room/Location: Lift Motor Room-At Entrance  
Feature/Material: Fire Door-Fire Door Core

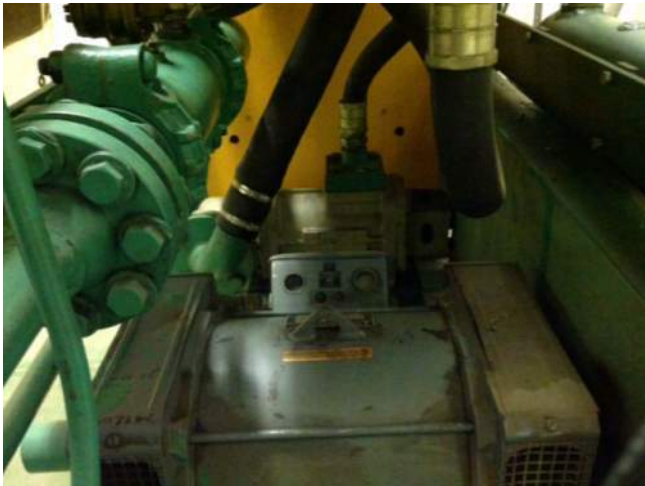
Photo No: J128740-003-HEAL-Photo006  
Result: Asbestos - Presumed Positive  
Building/Level: Health Services Building-Level One  
Room/Location: Lift Motor Room-Hydraulic Lift Motor  
Feature/Material: Pipework Flange Joint-Gasket Material

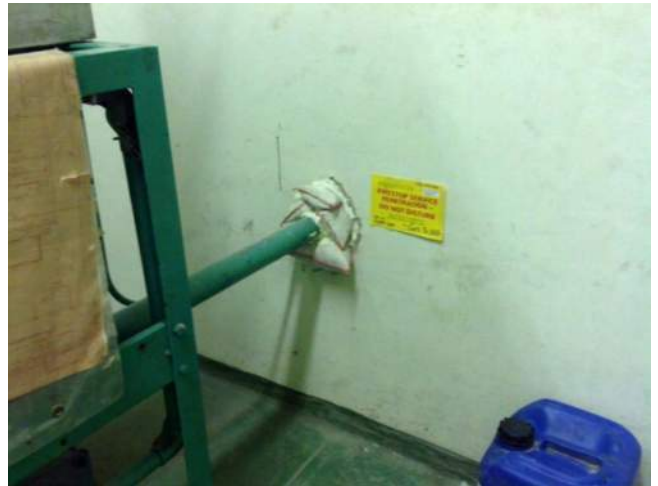
Photo No: J128740-003-HEAL-Photo004  
Result: SMF - Presumed Positive  
Building/Level: Health Services Building-Level One  
Room/Location: Lift Motor Room-Northern Side  
Feature/Material: Penetrations-Pillow Insulation

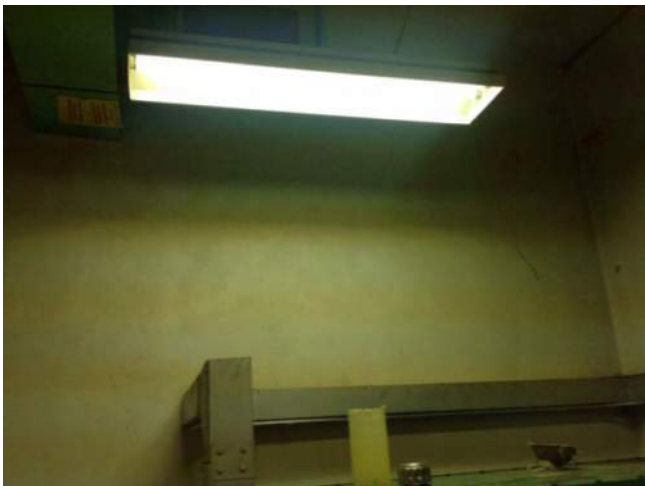
Photo No: J128740-003-HEAL-Photo005  
Result: PCB - Presumed Positive  
Building/Level: Health Services Building-Level One  
Room/Location: Lift Motor Room-To Ceiling  
Feature/Material: Fluorescent Light Fitting-Capacitor

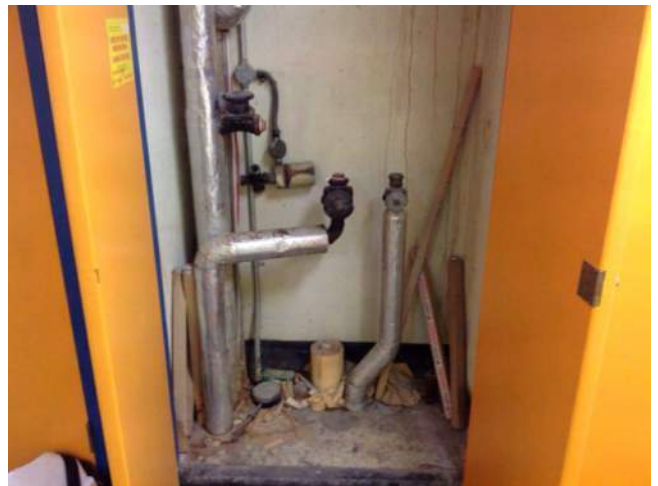
Photo No: J128740-003-HEAL-Photo035  
Result: SMF - Presumed Positive  
Building/Level: Health Services Building-Level One  
Room/Location: Main Corridor-Header Cupboard  
Feature/Material: Pipework Insulation-Insulation Material

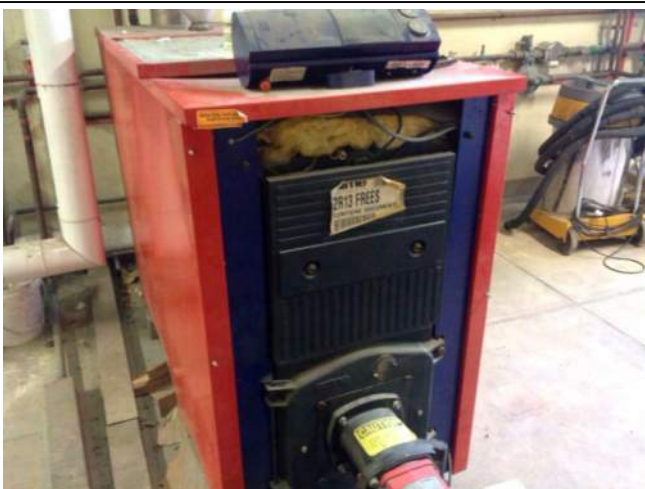
Photo No: J128740-003-HEAL-Photo008  
Result: SMF - Presumed Positive  
Building/Level: Health Services Building-Level One  
Room/Location: Plant Room-  
Feature/Material: Boiler Insulation-Insulation Material

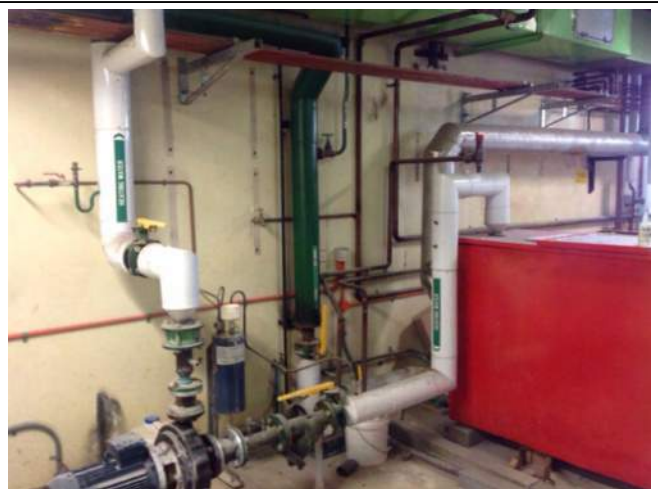
Photo No: J128740-003-HEAL-Photo009  
Result: SMF - Presumed Positive  
Building/Level: Health Services Building-Level One  
Room/Location: Plant Room-From Boiler  
Feature/Material: Pipework Insulation-Insulation Material

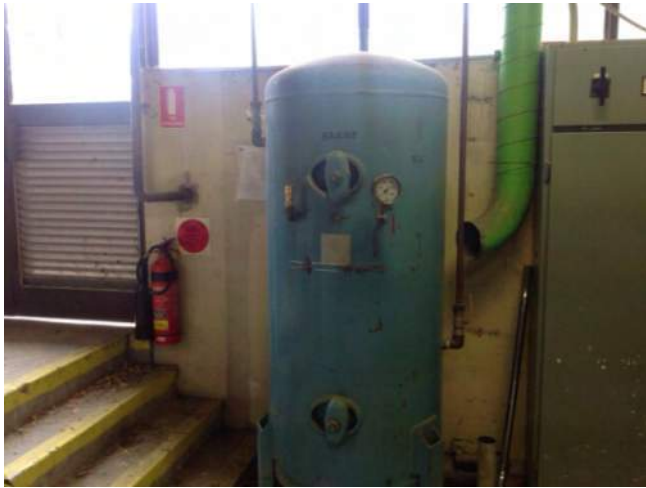
Photo No: J128740-003-HEAL-Photo012  
Result: Asbestos - Presumed Positive  
Building/Level: Health Services Building-Level One  
Room/Location: Plant Room-South  
Feature/Material: Boiler-Insulation

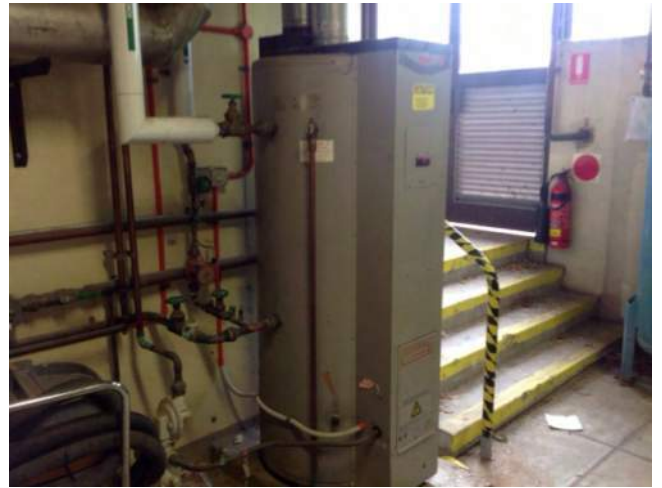
Photo No: J128740-003-HEAL-Photo010  
Result: SMF - Presumed Positive  
Building/Level: Health Services Building-Level One  
Room/Location: Plant Room-Southeast  
Feature/Material: Hot Water Heater-Insulation Material
