# Hazardous Materials Survey Report - Administration Building

132 McCredie Road, Smithfield NSW 2161

11-Feb-2025

Doc No. 60635909\_Hazmat\_Rpt\_132 McCredie Rd\_20250211\_0

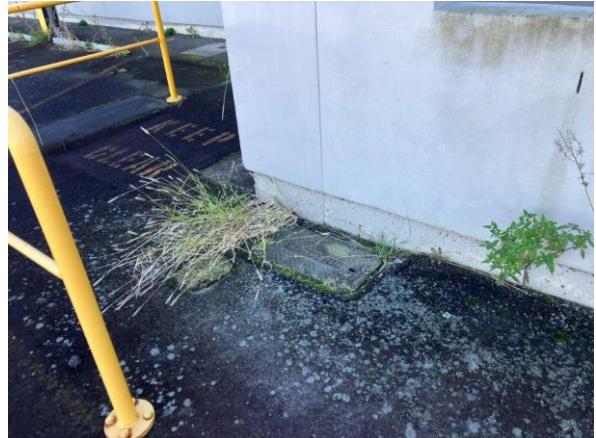
Photo 13

| No. | Location | | | Material Description | | | | | | | | Risk Assessment | | | | | | Recommendation |
|---|---|---|---|---|---|---|---|---|---|---|---|---|---|---|---|---|---|---|
| 12 | External | South | Bollards and rails | Yellow paint | 13 | 5 | m <sup>2</sup> | Lead paint | P5 | Lead detected above 0.1% w/w | 2.5 %w/w | - | Fair | - | - | - | Medium | Lead paint in fair condition should be stabilised and/or encapsulated with reference AS4361.2-2017. |

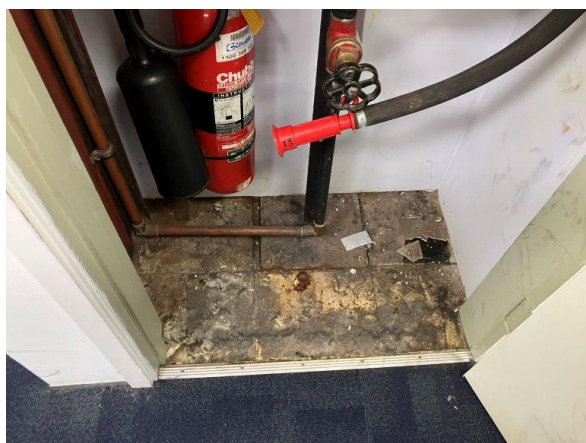
Photo 48

Non-friable ACM was confirmed in samples taken from the Site. The majority of ACM was found to be in good condition and posed a low risk. However, one ACM sample (ID P17), cream items located in the west wing fire hose room, was in poor condition and posed a medium risk.

| No. | Location | | | Material Description | | | | | | | | Risk Assessment | | | | | | Recommendation |
|---|---|---|---|---|---|---|---|---|---|---|---|---|---|---|---|---|---|---|
| 79 | West wing | Fire hose room | Floor | Cream tiles | 48 | 1 | m <sup>2</sup> | ACM | P17 | Asbestos detected | Chrysotile | Non-friable | Poor | Moderate | Low | Moderate | Medium | Access to exposed/damaged materials should be restricted. Consider removal as soon as practicable by a Class A or Class B licensed asbestos removal contractor. |
