# **Pre-Dilapidation Report**

**19 GEORGE STREET**

**REAR BUILDING (UNITS 20-29)**

Project Reference: 20250047.19G.3

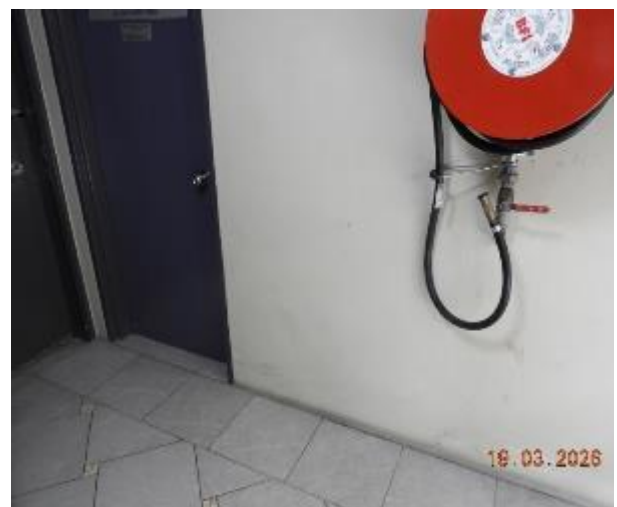
Figure 18 - General condition of level 1 common area internal wall

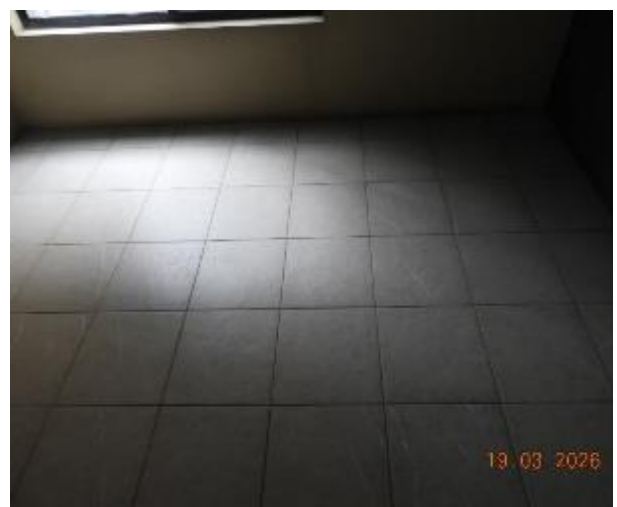
Figure 30 - General condition of level 2 common area floor tiles

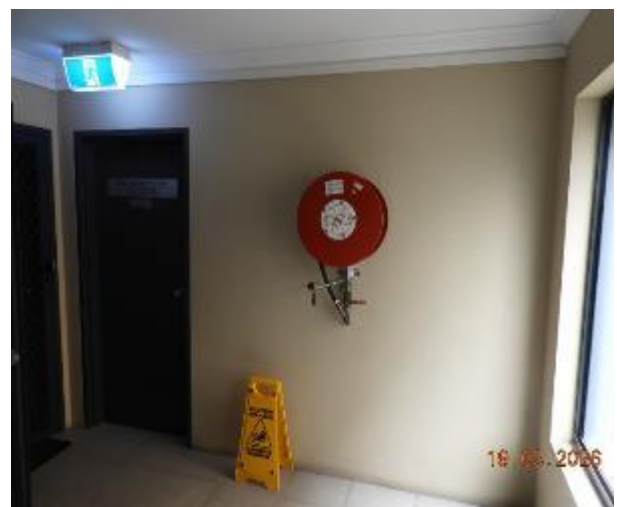
Figure 42 - General condition of level 2 common area internal wall

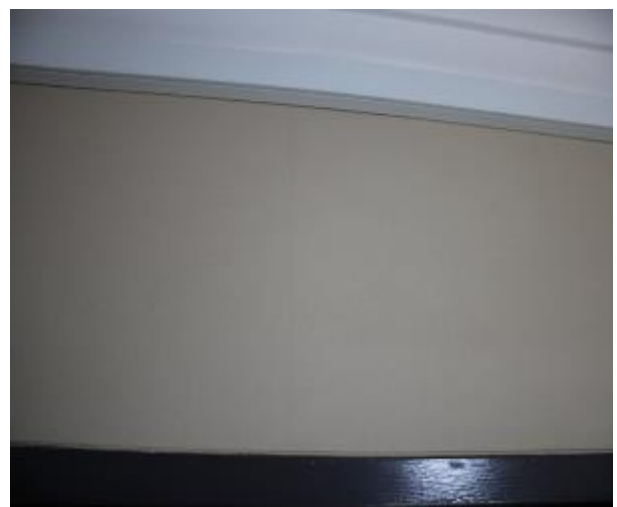
Figure 90 - Crack propagation through level 4 common area internal wall

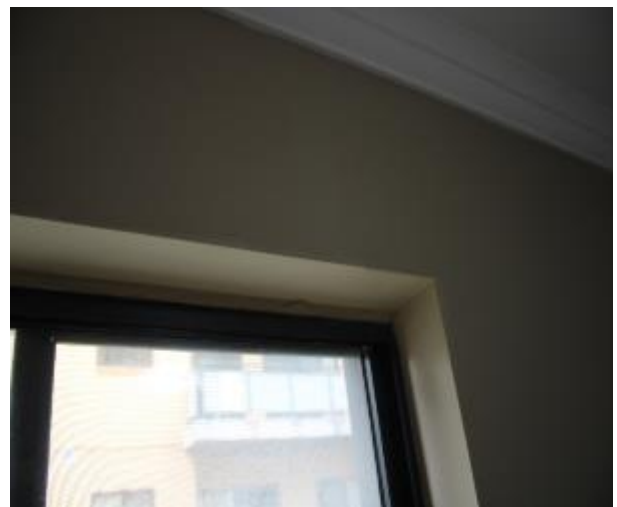
Figure 96 - Crack propagation through level 4 common area internal wall

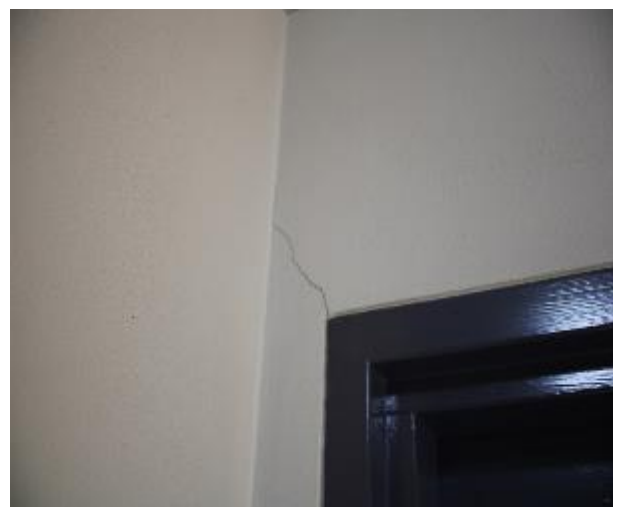
Figure 102 - Crack propagation through level 4 common area internal wall

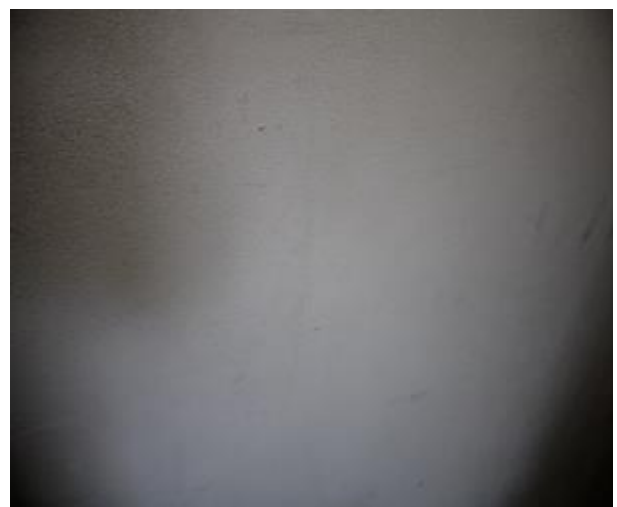
Figure 144 - Crack propagation through level 5 common area internal wall

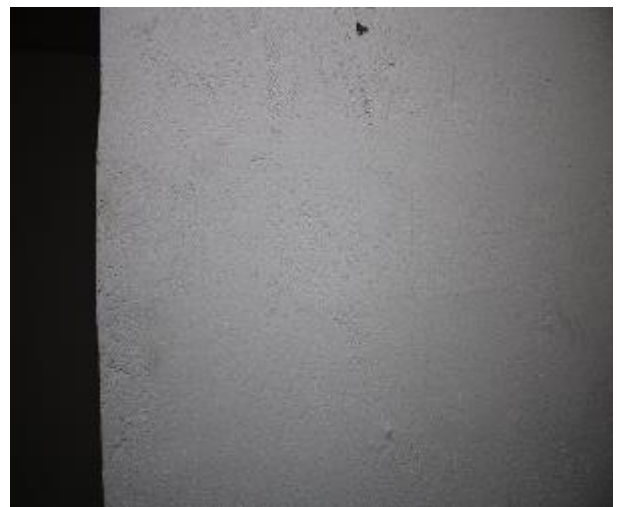
Figure 230 - Crack propagation through level 5 to basement B2 fire stairs internal wall

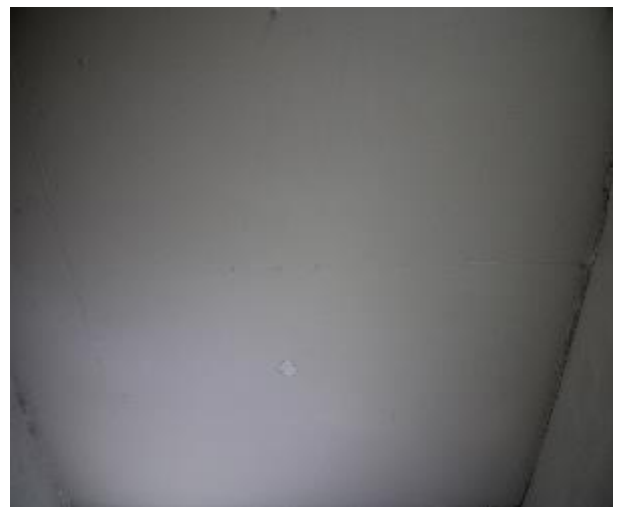
Figure 248 - Crack propagation through level 5 to basement B2 fire stairs underside slab

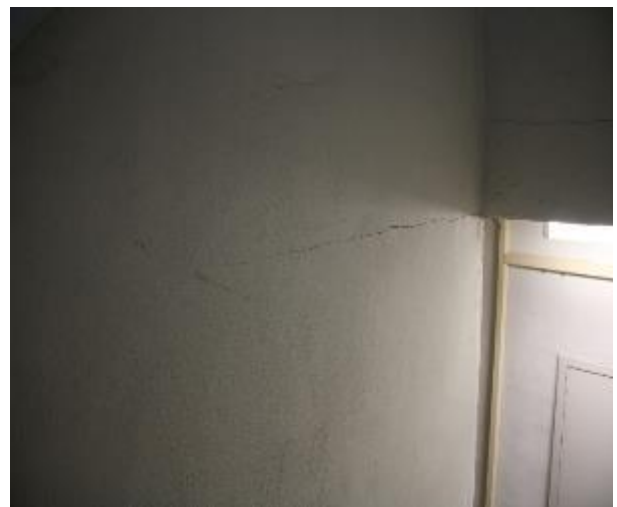
Figure 272 - Crack propagation through level 5 to basement B2 fire stairs internal wall

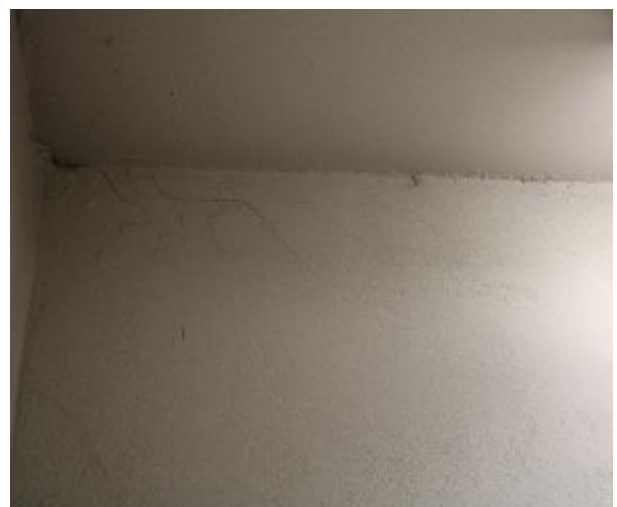
Figure 314 - Crack propagation through level 5 to basement B2 fire stairs internal wall

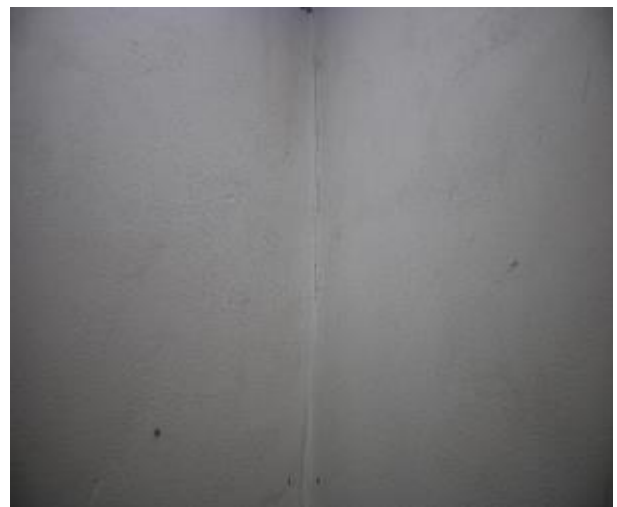
Figure 338 - Crack propagation through level 5 to basement B2 fire stairs internal wall

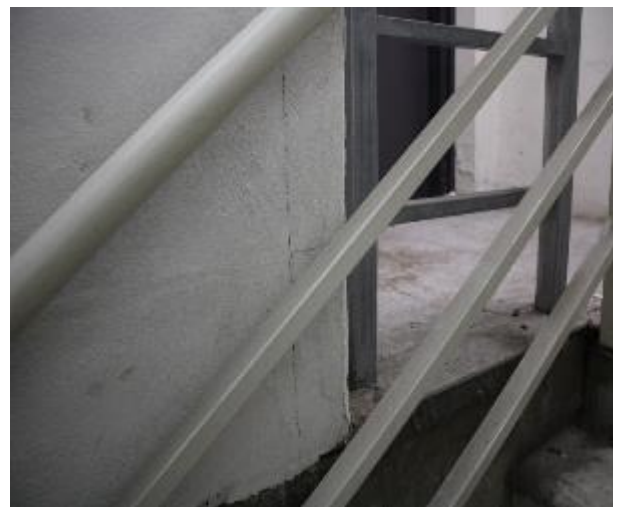
Figure 422 - Crack propagation through level 5 to basement B2 fire stairs internal wall

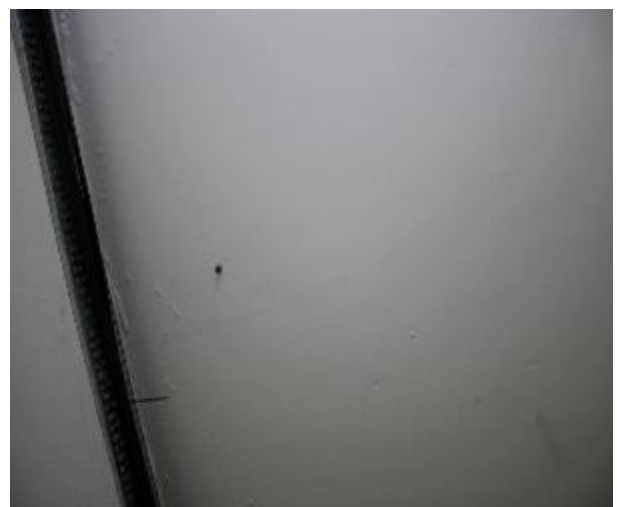
Figure 428 - Crack propagation through level 5 to basement B2 fire stairs underside stairs

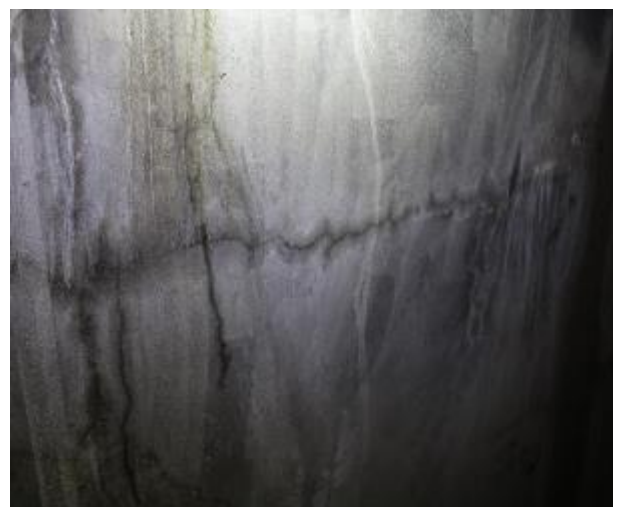
Figure 470 - Crack propagation through basement B2 fire stairs internal wall

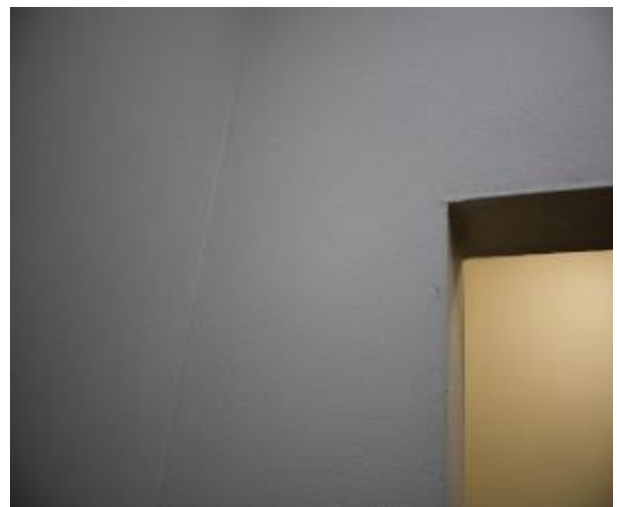
Figure 507 - Crack propagation through open kitchen/ lounge room internal wall
