# **Pre-Dilapidation Report**

**19 GEORGE STREET**

**FRONT BUILDING (UNITS 1-19)**

Project Reference: 20250047.19G.2

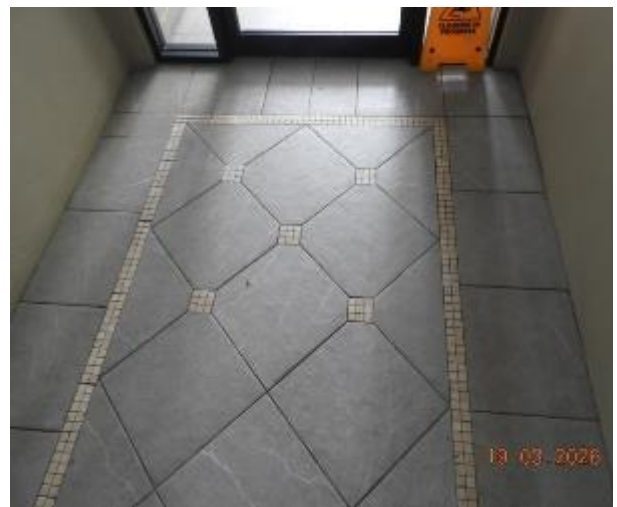
Figure 6 - General condition of level 1 common area floor tiles

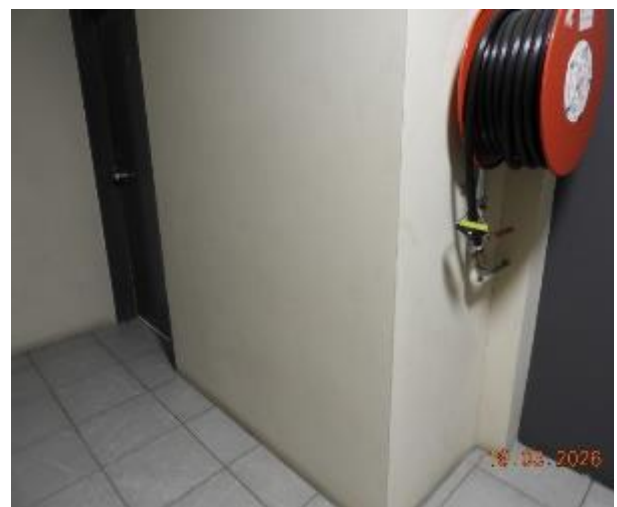
Figure 48 - General condition of level 2 common area internal wall

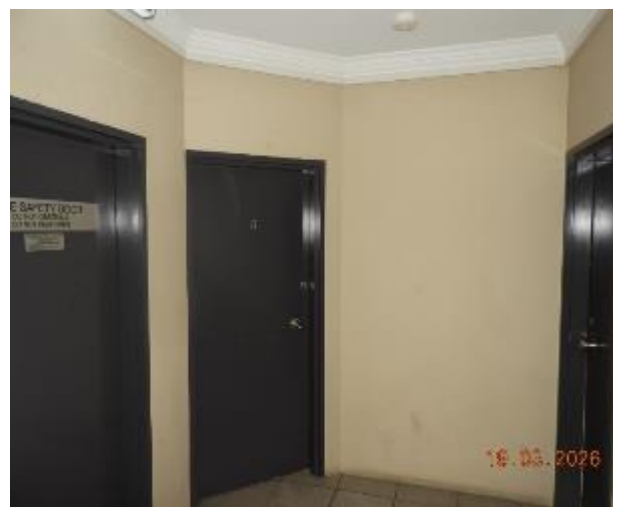
Figure 54 - General condition of level 2 common area internal wall

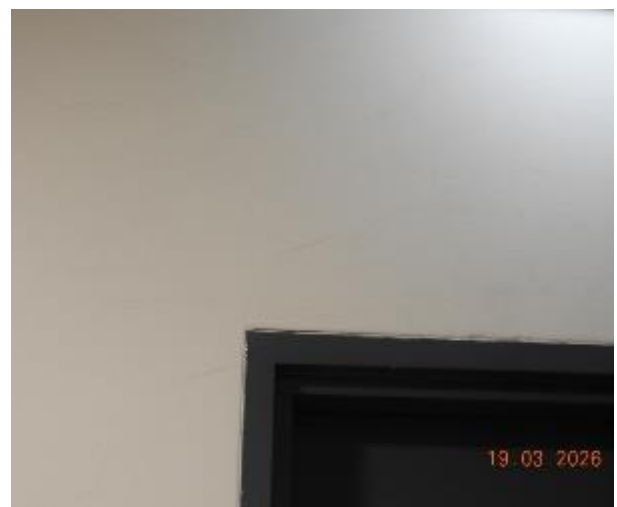
Figure 60 - Crack propagation through level 2 common area internal wall

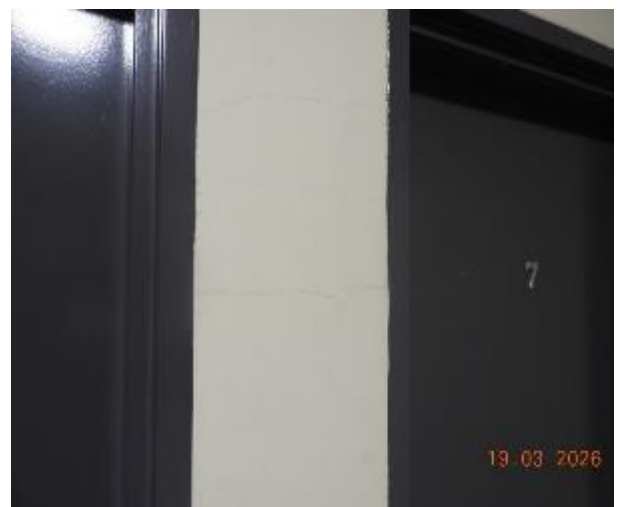
Figure 66 - Crack propagation through level 2 common area internal wall

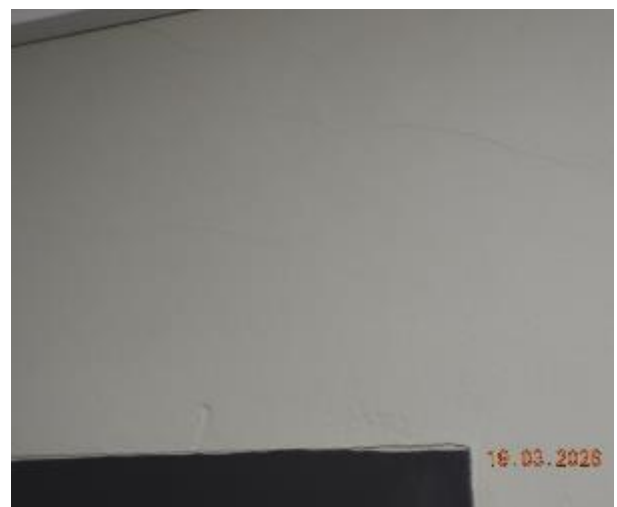
Figure 84 - Crack propagation through level 3 common area internal wall

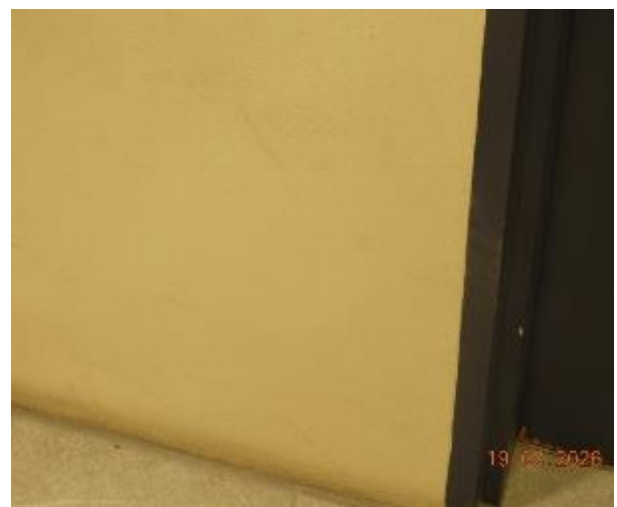
Figure 96 - Crack propagation through level 3 common area internal wall

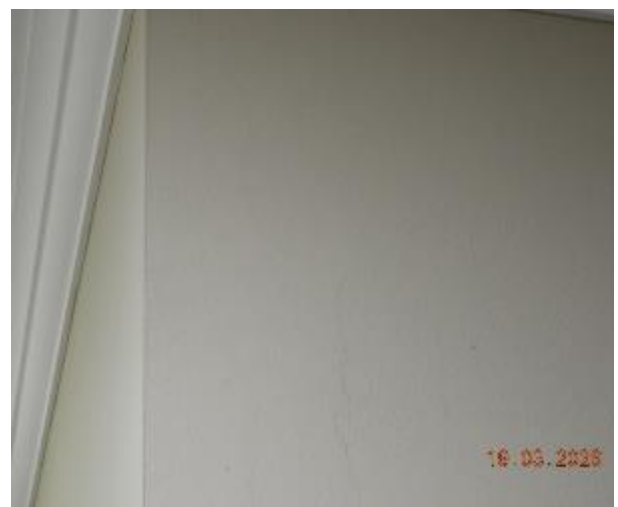
Figure 108 - Crack propagation through level 3 common area internal wall

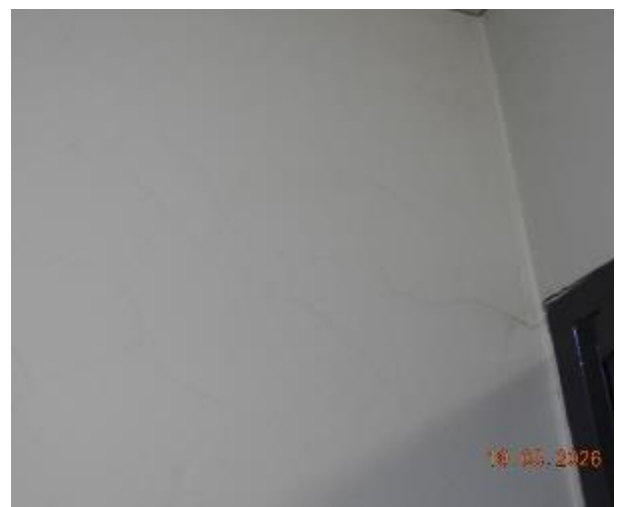
Figure 126 - Crack propagation through level 4 common area internal wall

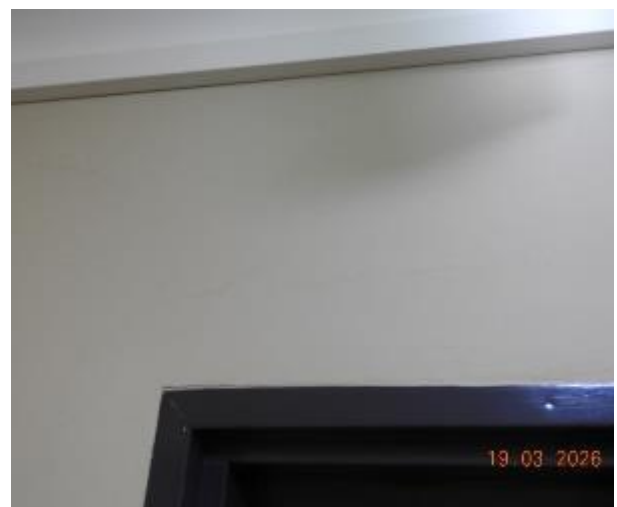
Figure 132 - Crack propagation through level 4 common area internal wall

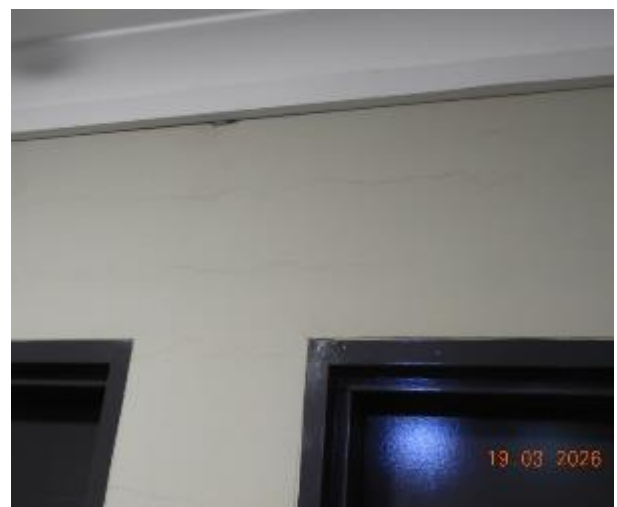
Figure 138 - Crack propagation through level 4 common area internal wall

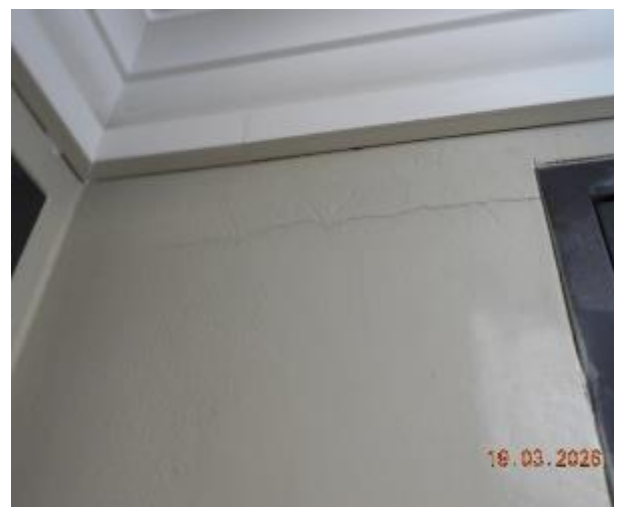
Figure 162 - Crack propagation through level 5 common area internal wall

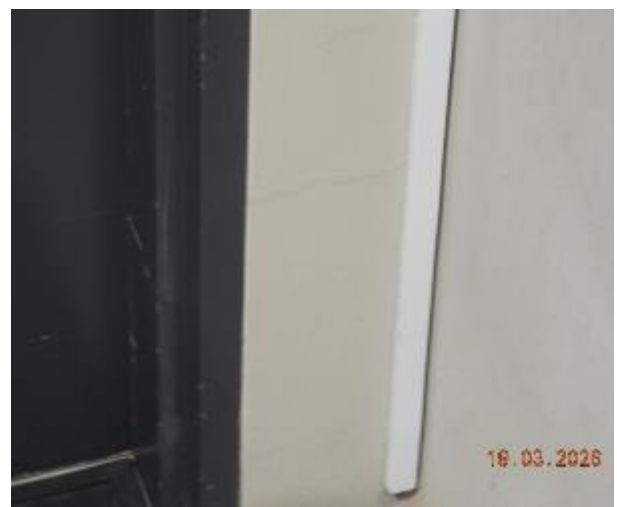
Figure 174 - Crack propagation through level 5 common area internal wall

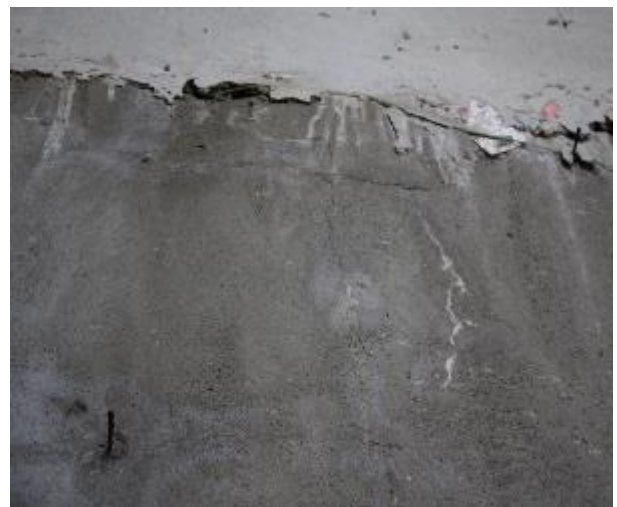
Figure 226 - Crack propagation through B1 fire stairs internal wall

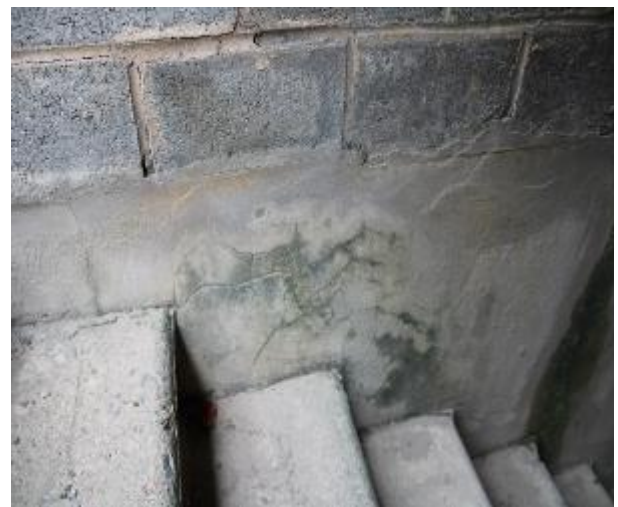
Figure 262 - Crack propagation through level 1 fire stairs internal wall

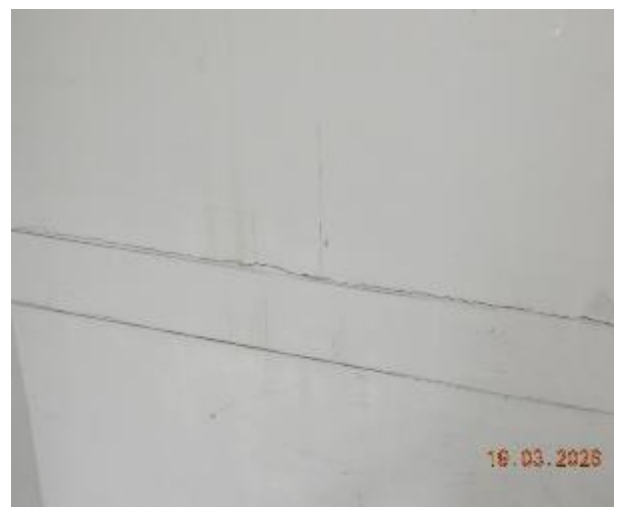
Figure 299 - Crack propagation through level 5 fire stairs internal wall

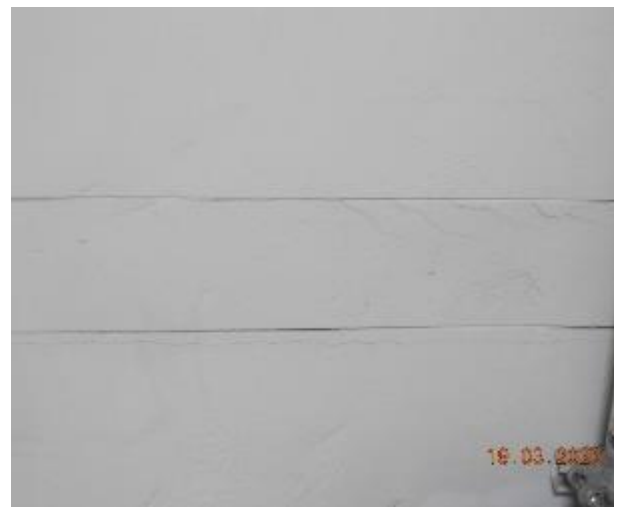
Figure 335 - Crack propagation through level 3 fire stairs internal wall

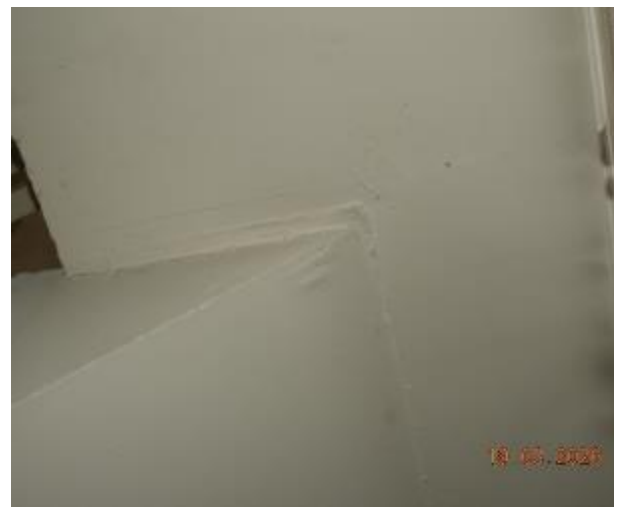
Figure 341 - Crack propagation through level 3 fire stairs underside stairs
