# **PRE-DILAPIDATION REPORT**

**COUNCIL ASSETS**

**21 GEORGE STREET,  
BURWOOD, NSW 2134**

PROJECT REFERENCE: 20250047.CA.1  
17/04/2026

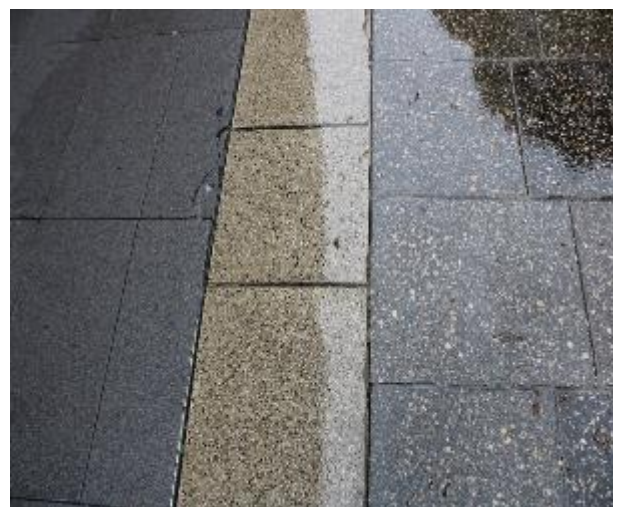
Figure 5 - General condition of footpath pavers heading East

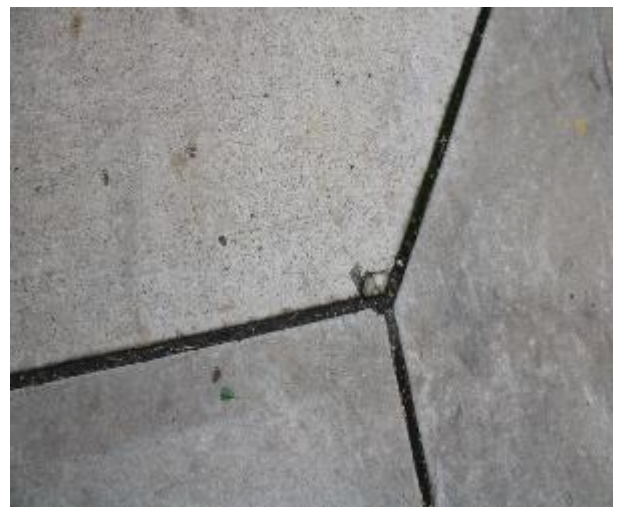
Figure 47 - General condition of footpath pavement heading East

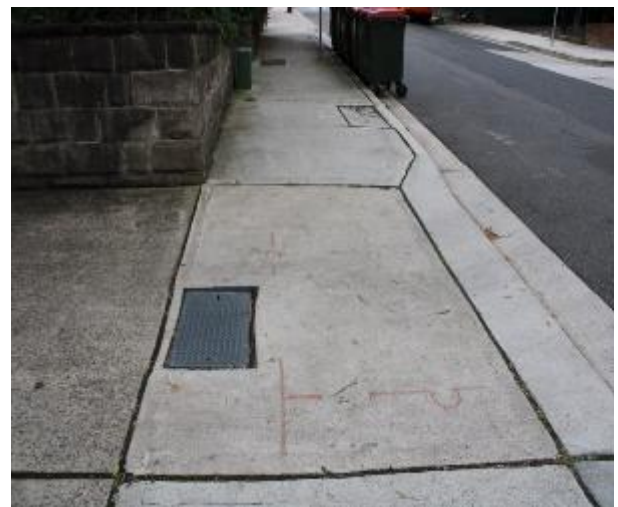
Figure 53 - General condition of stormwater inlet pit

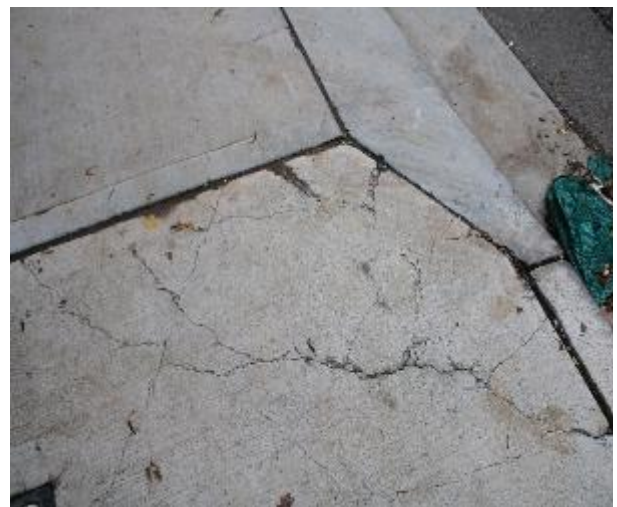
Figure 71 - Crack propagation through footpath pavement heading East

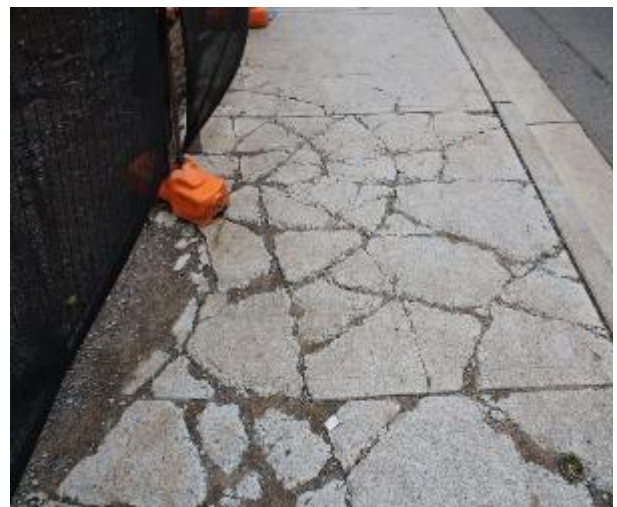
Figure 77 - Crack propagation and loss of materials through footpath pavement heading East

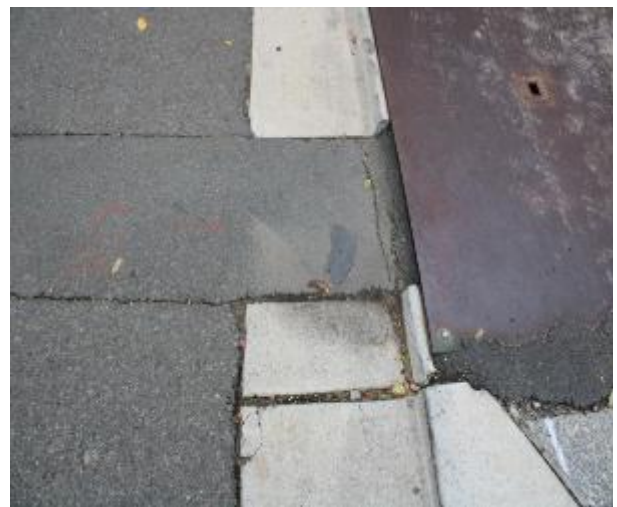
Figure 89 - General condition of kerb and gutter heading West

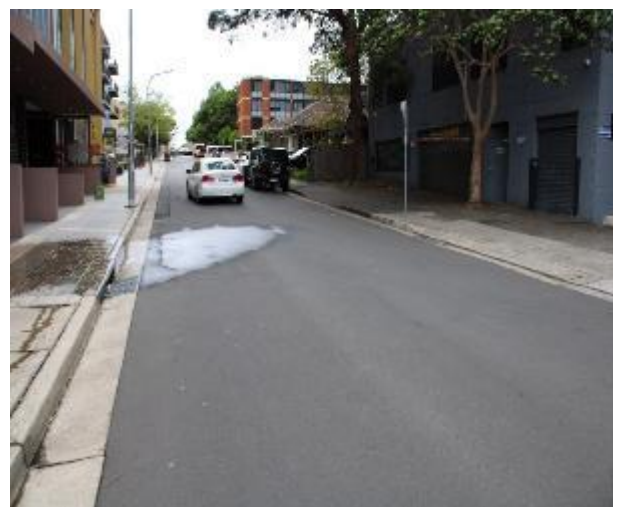
Figure 149 - General condition of road surface heading East

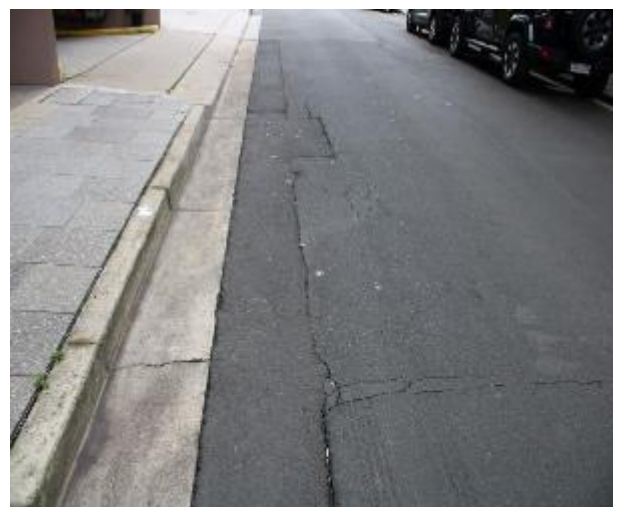
Figure 161 - Patchwork evident through road surface heading East

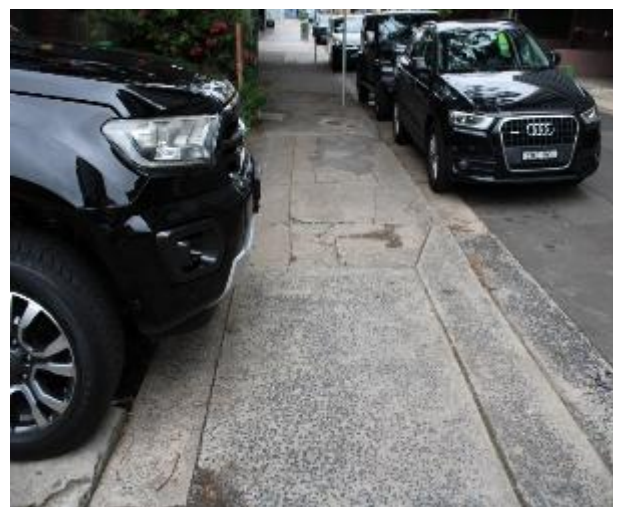
Figure 257 - Crack propagation and loss of materials through footpath pavement heading West

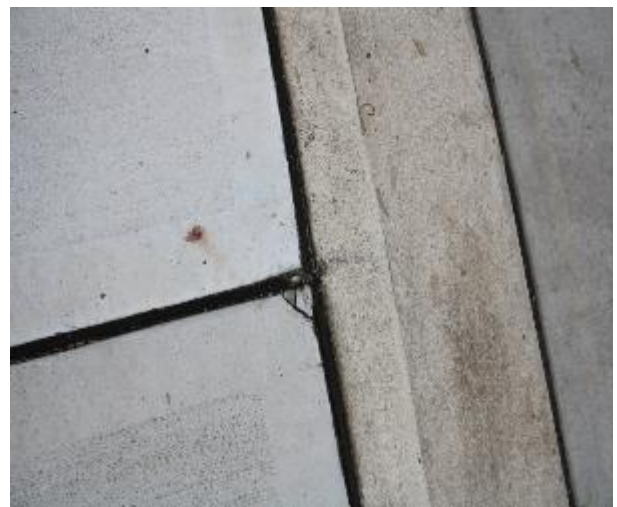
Figure 401 - General condition of footpath pavement heading South

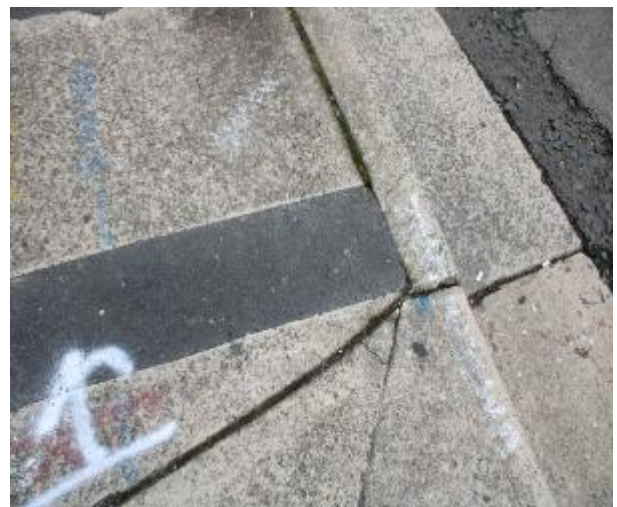
Figure 432 - Crack propagation and patchwork evident through footpath pavement heading South

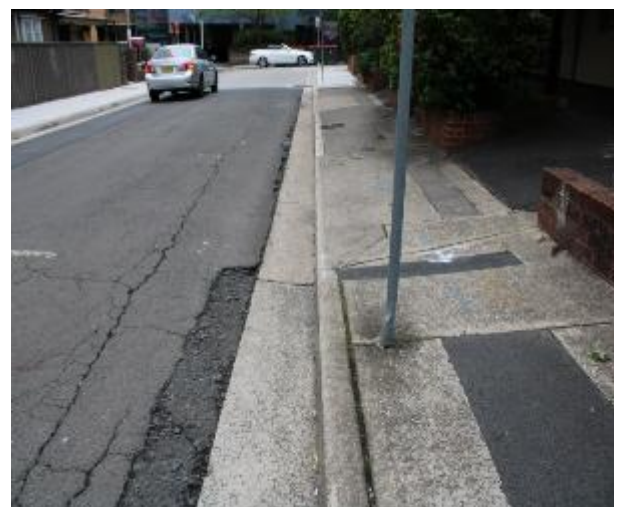
Figure 485 - Crack propagation through kerb and gutter heading North

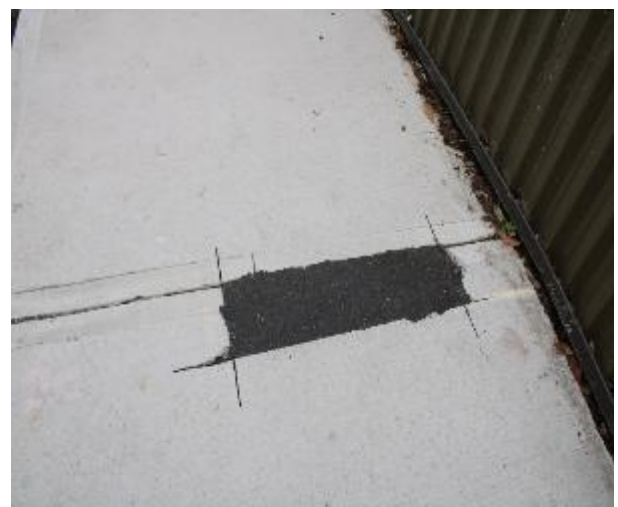
Figure 516 - Patchwork evident through footpath pavement heading South
