**Hazardous Building Materials (HAZMAT)  
Report  
SSD-70283710: 1 Crescent Street Holrou**

**Proposed Crescent Parklands**

**1 Crescent Street, Holroyd**

**14 November 2024**

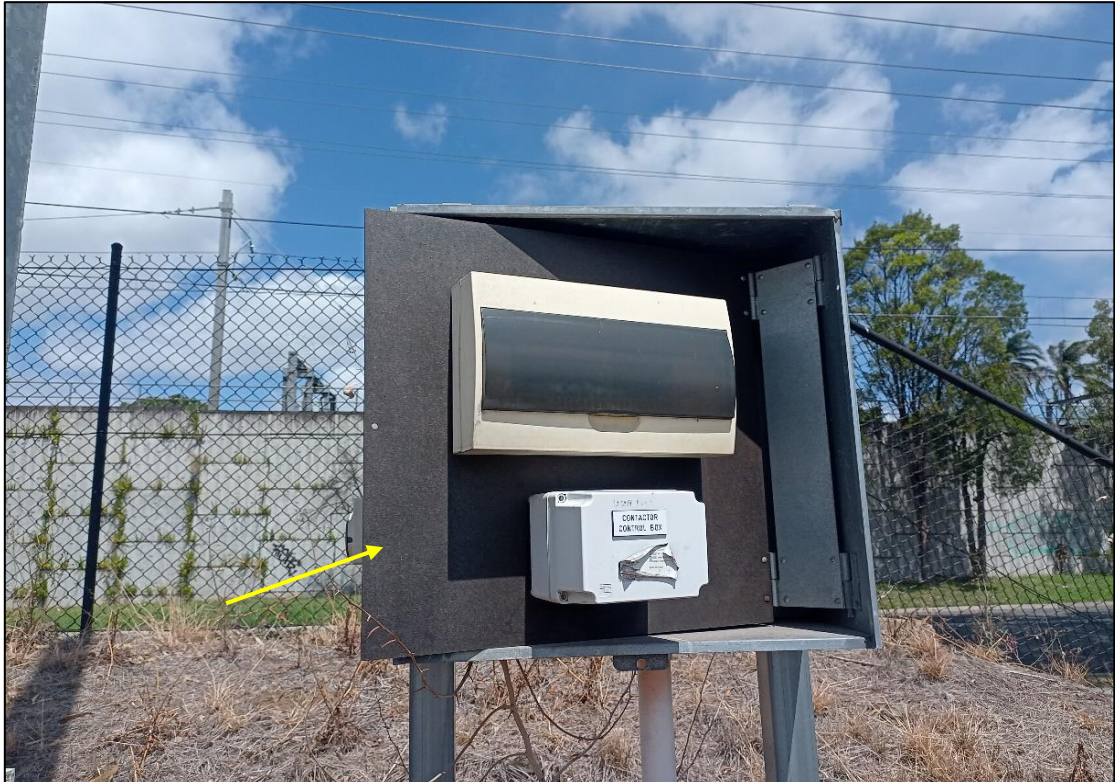
Photo 1: Electrical panel electrical backing board, fibrous cement, asbestos detected by analysis.

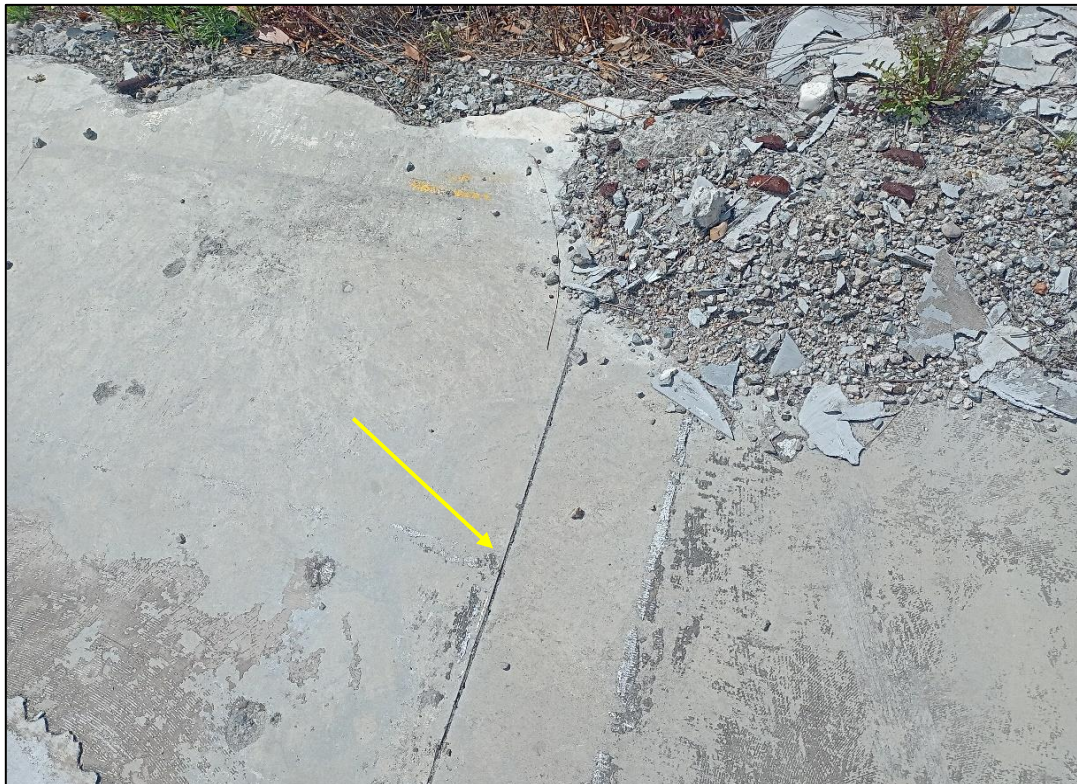
Photo 2: Concrete joints, northern area, jointing, black mastic, asbestos detected by analysis.

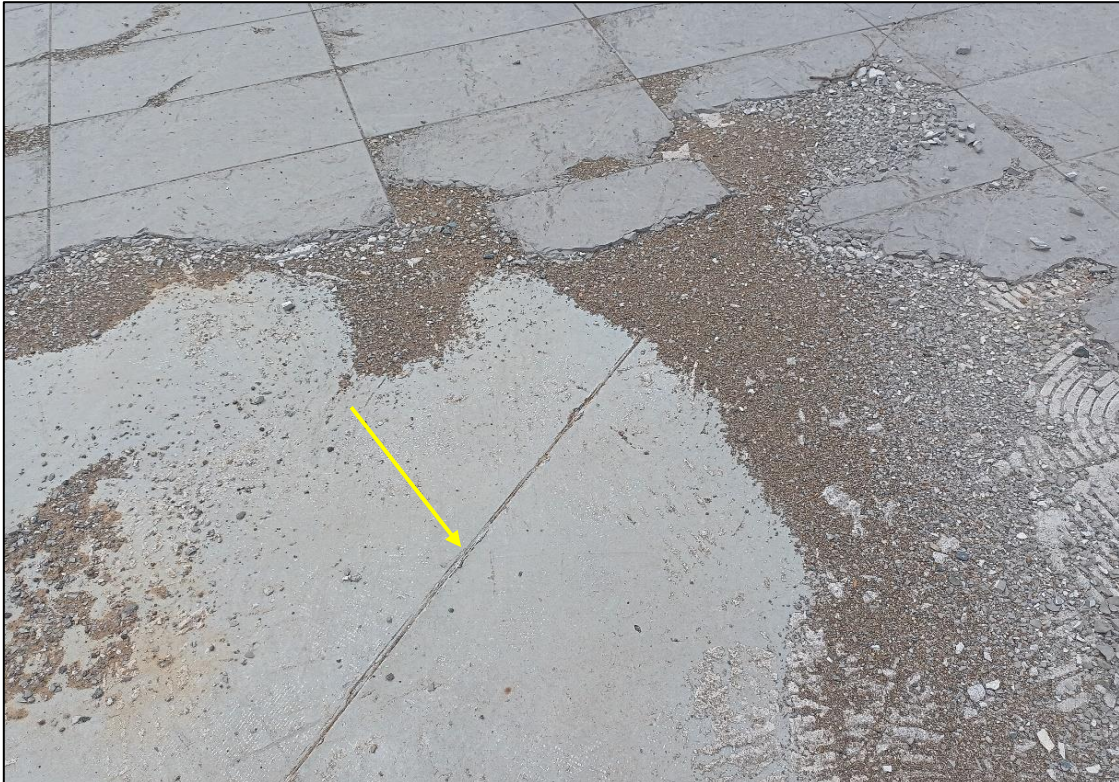
Photo 3: Concrete joints, north-eastern area, jointing, grey mastic, asbestos detected by analysis.

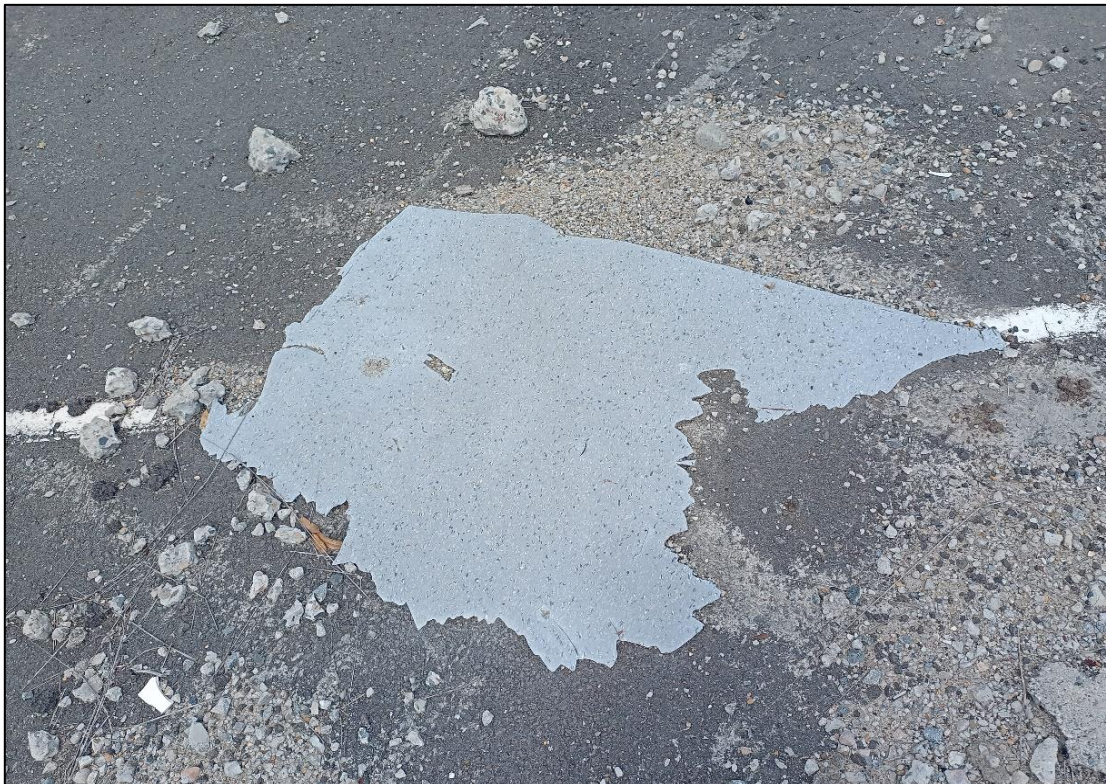
Photo 4: Floor Linoleum, building footprint / north-eastern area, surface, linoleum 1, no asbestos detected by analysis.

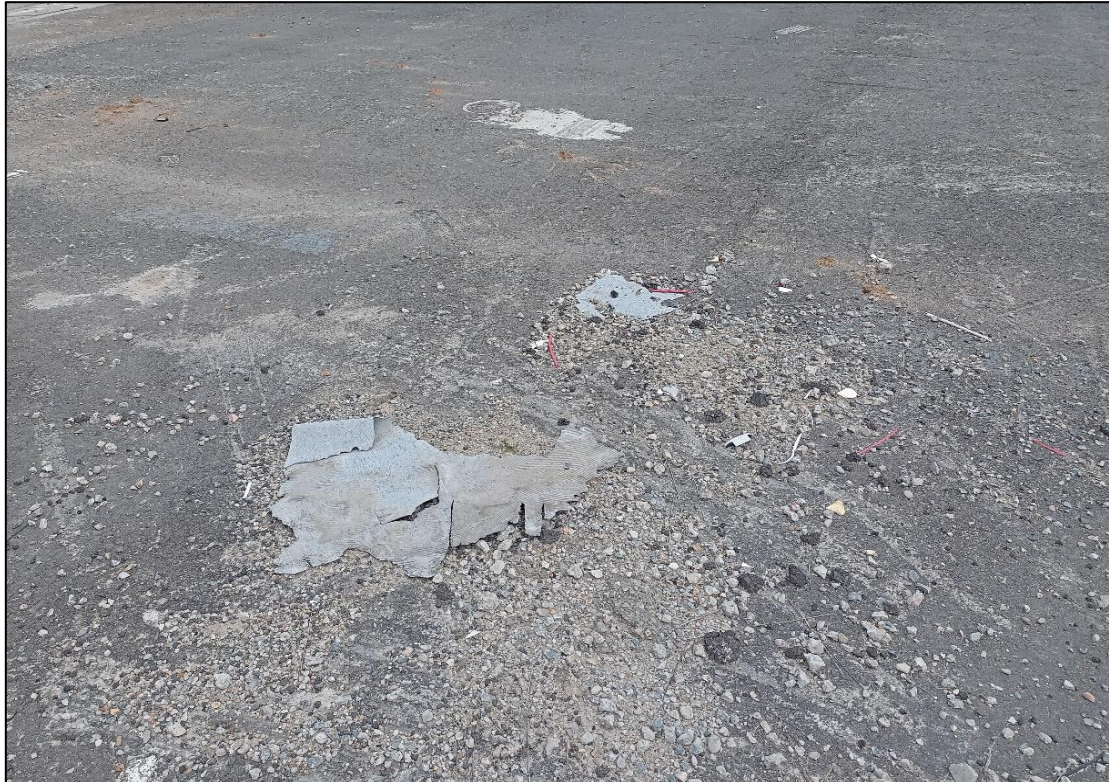
Photo 5: Floor Linoleum, building footprint / north-eastern area, surface, linoleum 2, no asbestos detected by analysis.

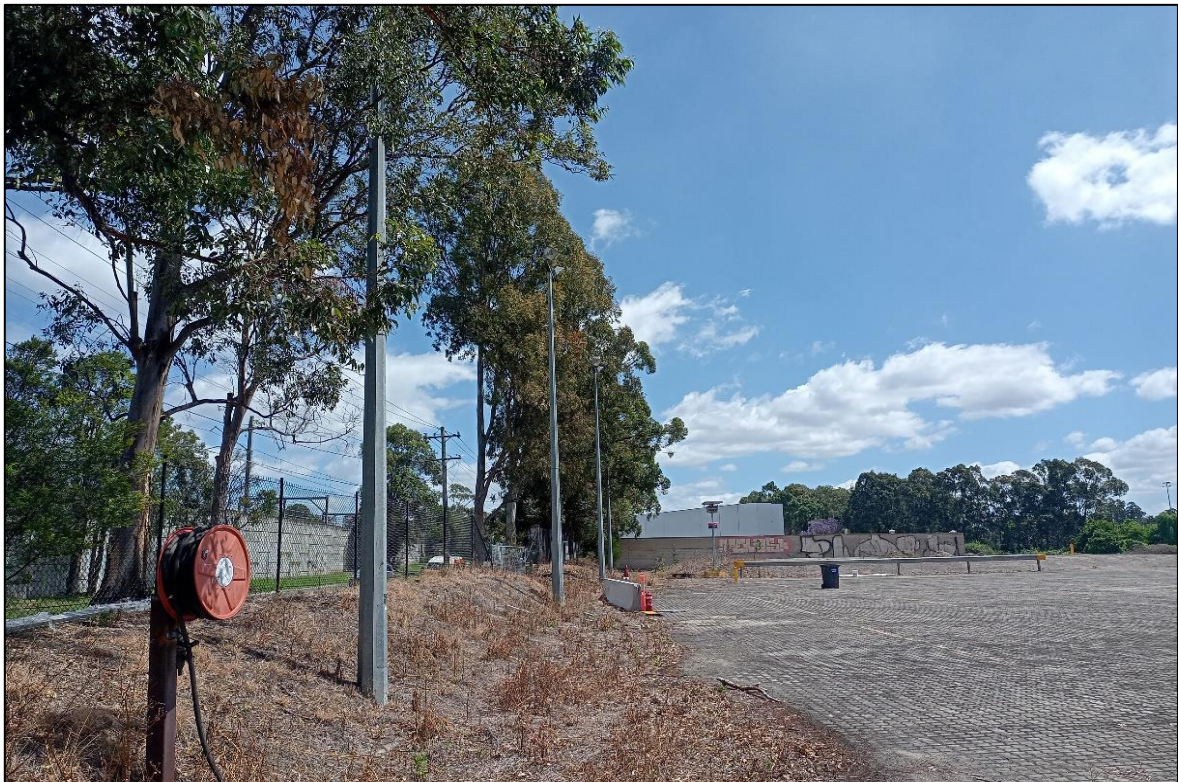
Photo 6: Southern street lights, along northern boundary fence, internal components (e.g. capacitors, ballasts) PCB (suspected).

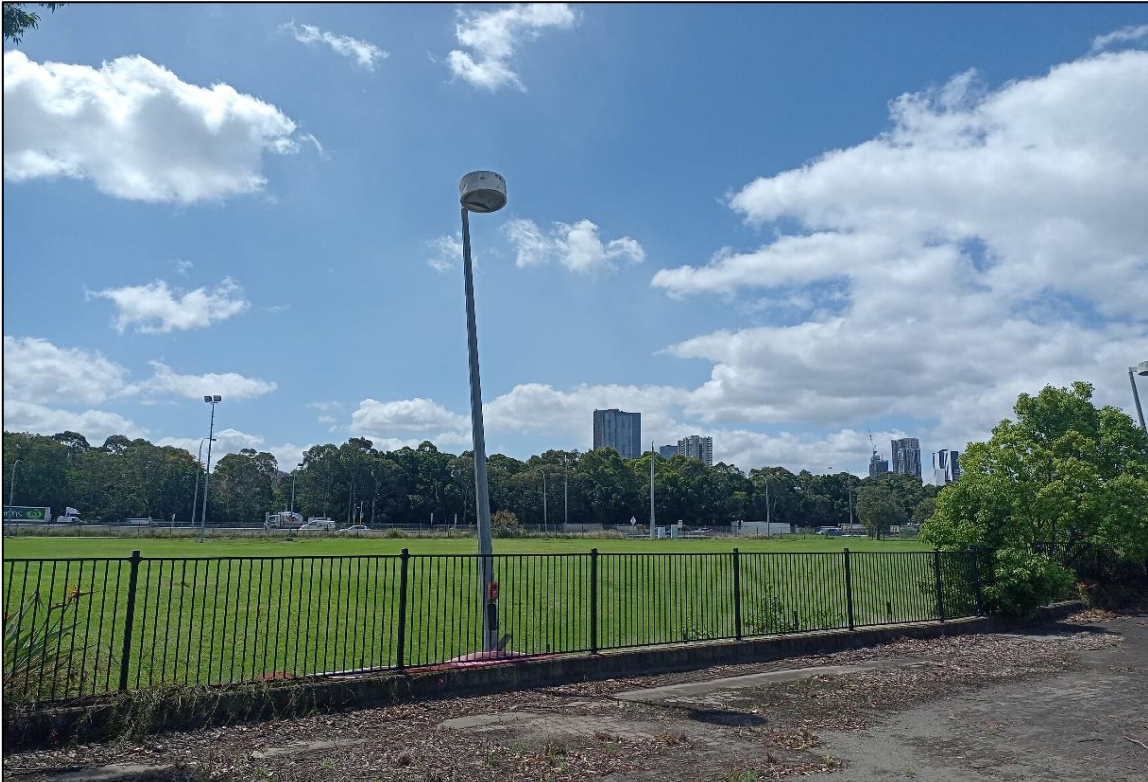
**Photo 7: Northern street lights, along northern boundary fence, internal components (e.g. capacitors, ballasts), PCB (suspected).**
