# Hazardous Material Report

**Burrah Park, 1953-2109 Elizabeth Drive,  
Badgerys Creek**

26 September 2024

**Our Ref:** 30206389-R02-Burrah Park-HazMat

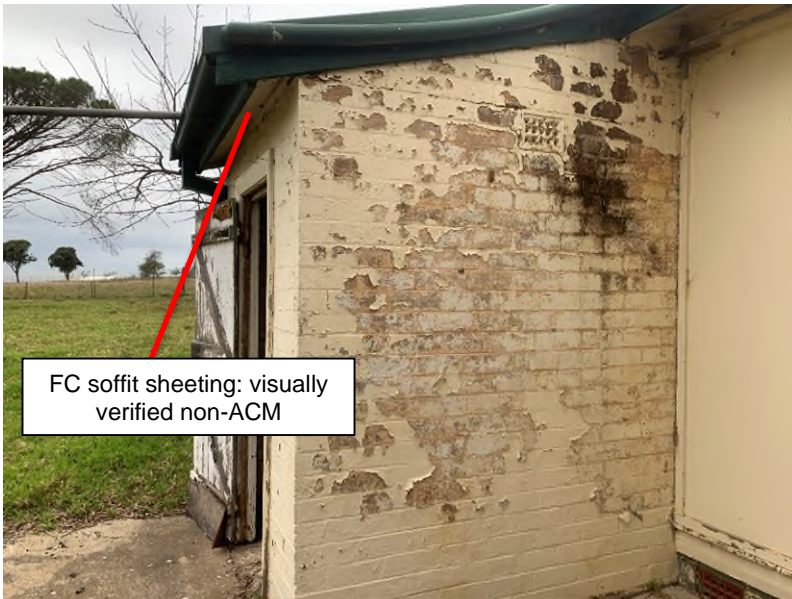
FC soffit sheeting: visually verified non-ACM

**Print 4**  
*Unoccupied house*  
View of the semi-detached outhouse showing FC soffit sheeting (visually verified non-ACM).

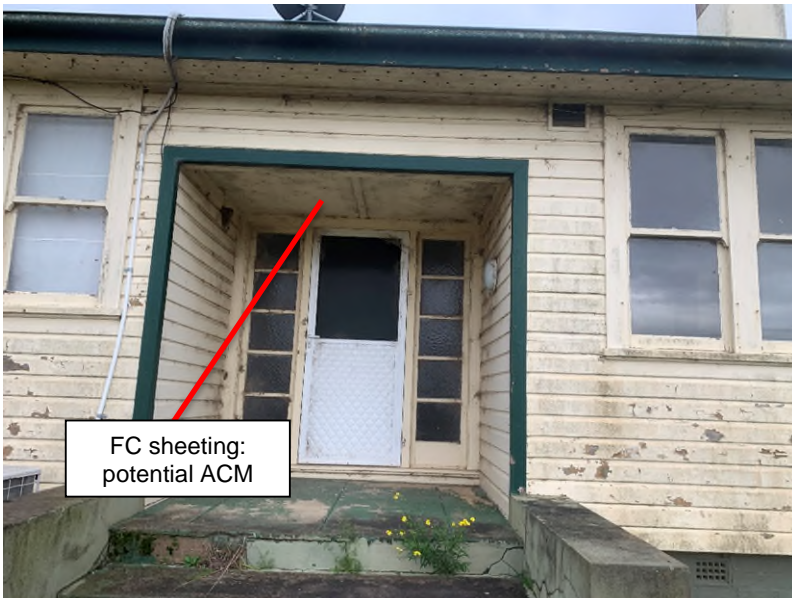
FC sheeting: potential ACM

**Print 5**  
*Unoccupied house*  
View of the southwest entrance to the house.

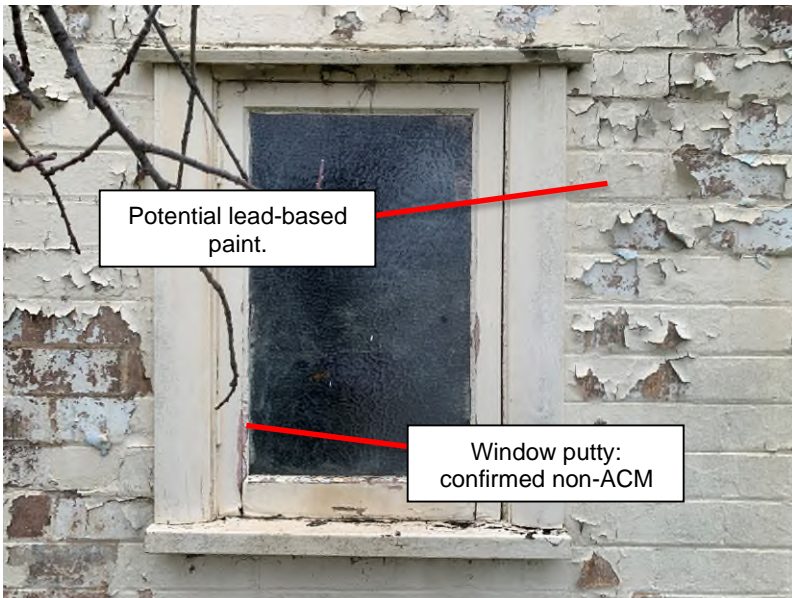
Potential lead-based paint.

Window putty: confirmed non-ACM

**Print 6**  
*Unoccupied house*  
Southeast window of the former outhouse. Sample of window putty (HS-WINDOW-PUTTY) collected for analysis and confirmed as non-ACM.

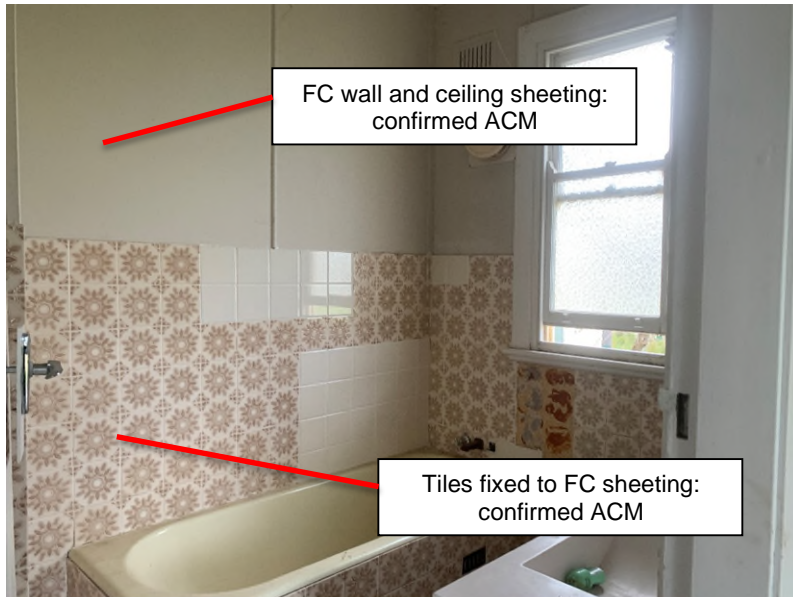
**Print 10***Unoccupied house*

Bathroom tiles fixed to FC sheeting in bathroom (consistent with adjoining shower and water closet). Sample of wall sheeting collected (HS-BATHROOM WALL) and confirmed as ACM.

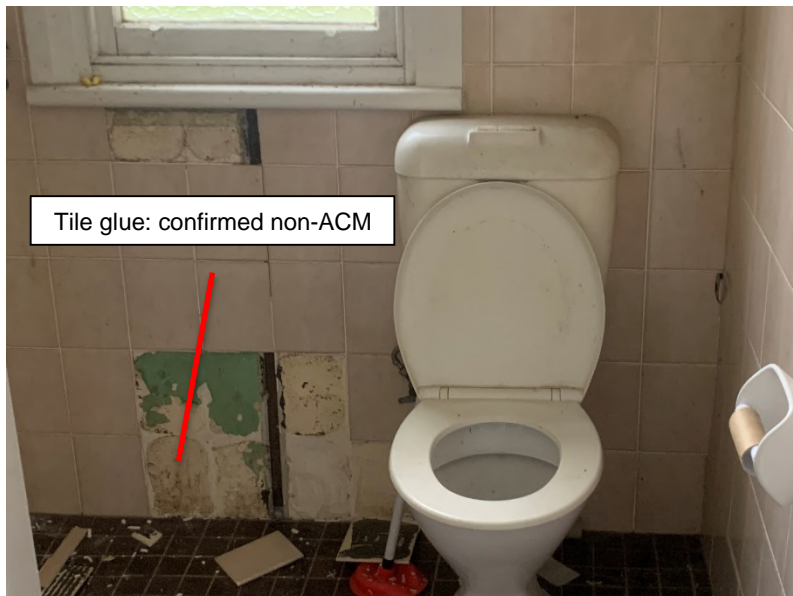
**Print 11***Unoccupied house*

Tiles fixed to FC sheeting in toilet. Sample of tile glue (HS-TILEGLUE) collected and confirmed as non-ACM.

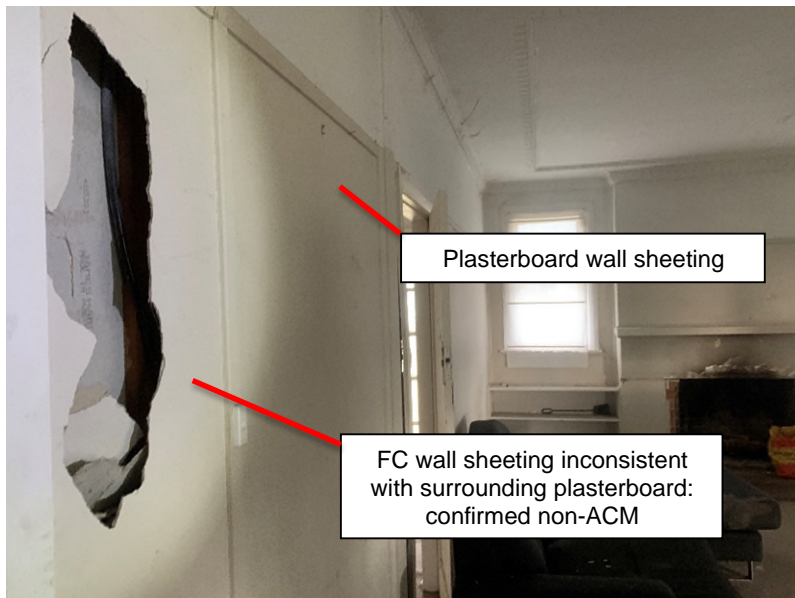
**Print 14**  
*Unoccupied house*  
Lined internal walls in lounge room showing broken panel inconsistent with surrounding wall sheeting. Sample of panel collected (HS-LOUNGE PANEL) and confirmed as non-ACM.

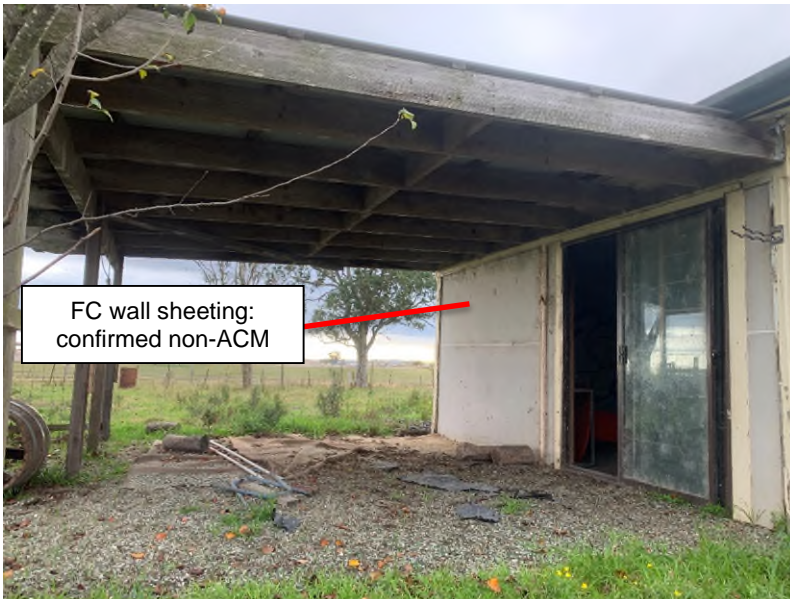
**Print 22**

View of the adjoining covered area at the northwest of the auxiliary building. Wall sheeting consistent with internal sheeting identified as non-ACM.

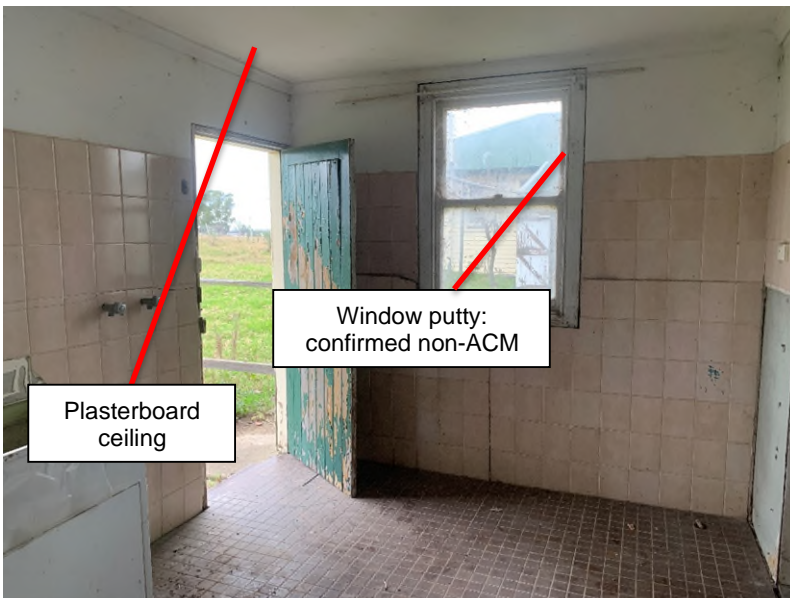
**Print 23a**

Laundry area at the southeast of the building. Sample of window putty (GS-WINDOW-PUTTY) collected and confirmed non-ACM.

Wall sheeting behind wall tiles is likely ACM along northern wall (back of wall visible in Print 23b)

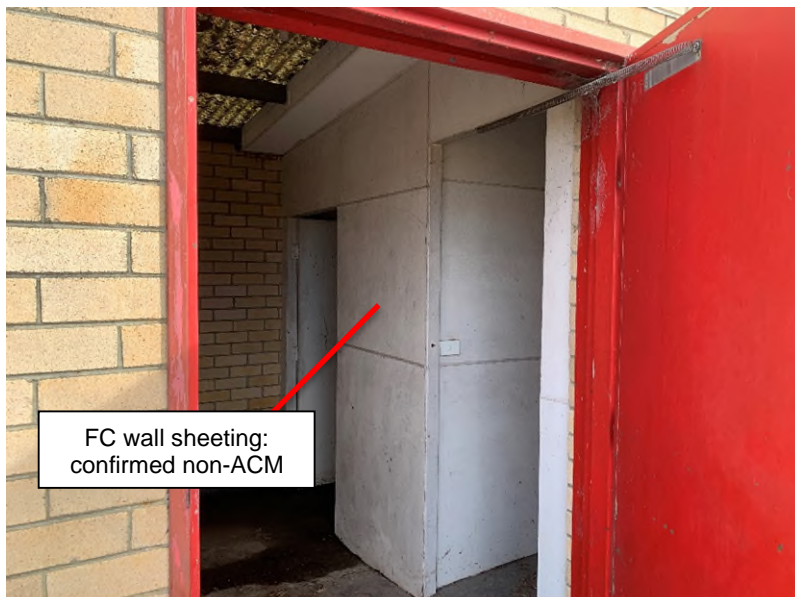
**Print 29**  
*Toilet block*  
Internal view of the toilet block. Sample of wall sheeting (SY-TOILETBLOCK) collected and confirmed non-ACM.

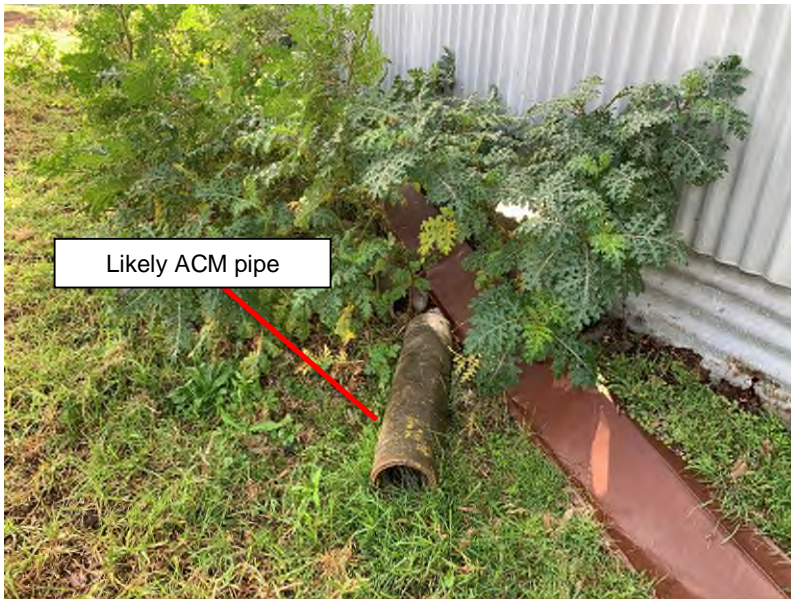
**Print 33***Shed 1 ACM Pipe*

ACM pipe against the southwestern wall of stockyard shed 1.

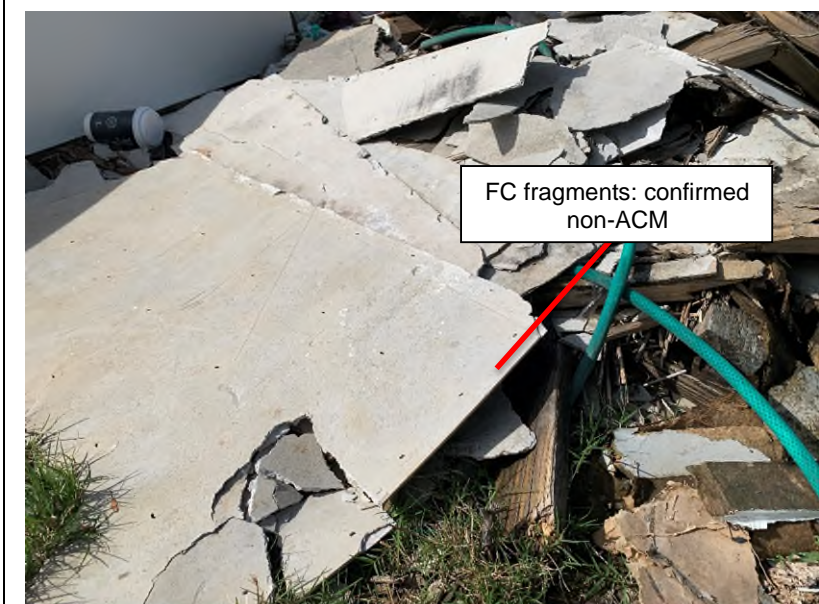
**Print 38**

Stockpile of mixed building material and rubble northwest of shed 2. One sample of FC sheeting (SY-SP1) collected from northwest side of stockpile and confirmed non-ACM.

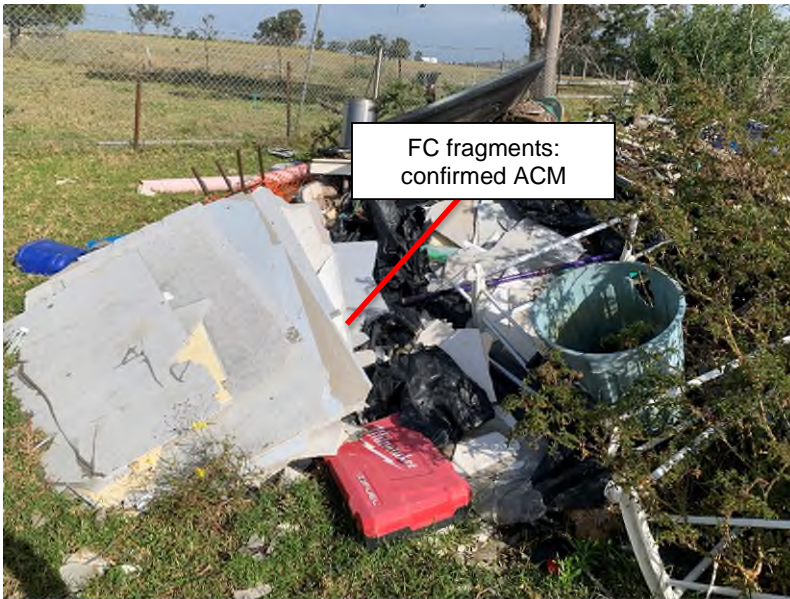
**Print 39***Shed 2 Stockpile 1*

One sample of FC sheeting (SY-SP2) collected from southeast side of stockpile and confirmed ACM.

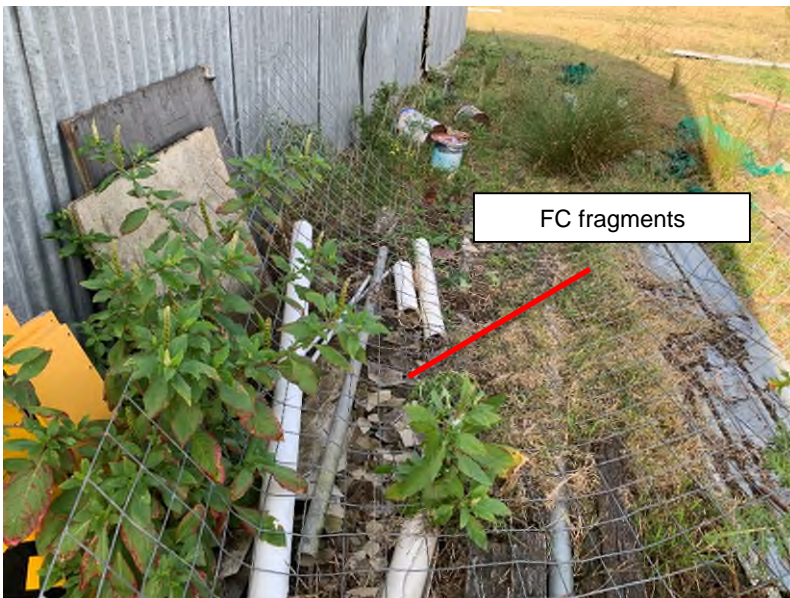
**Print 40***Shed 2 Stockpile 2*

Mixed building material and rubble along the southwest wall of shed 2. Not likely ACM.

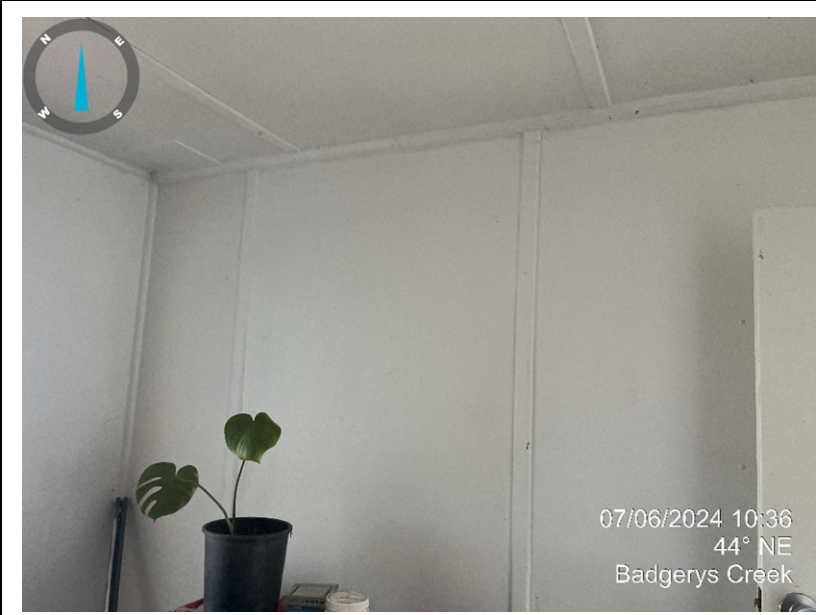
**Print 60**  
*Tenanted house*  
Storage room wall. ACM Sheeting present.

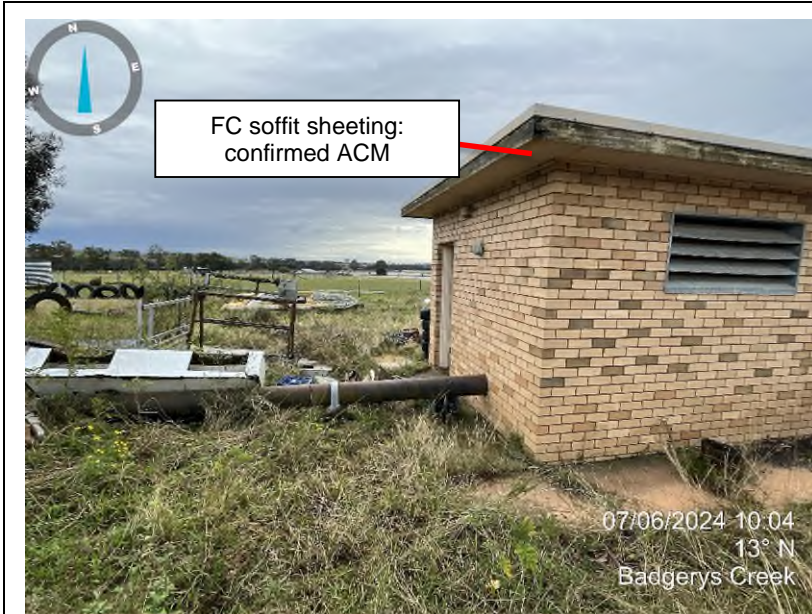
**Print 66**

FC soffit sheeting:  
confirmed ACM

View of the pump house looking north showing the pipe between the pump house and former storage tank to the west. Sample of the FC sheet from below the eave collected (Pump house Eave) and confirmed ACM.

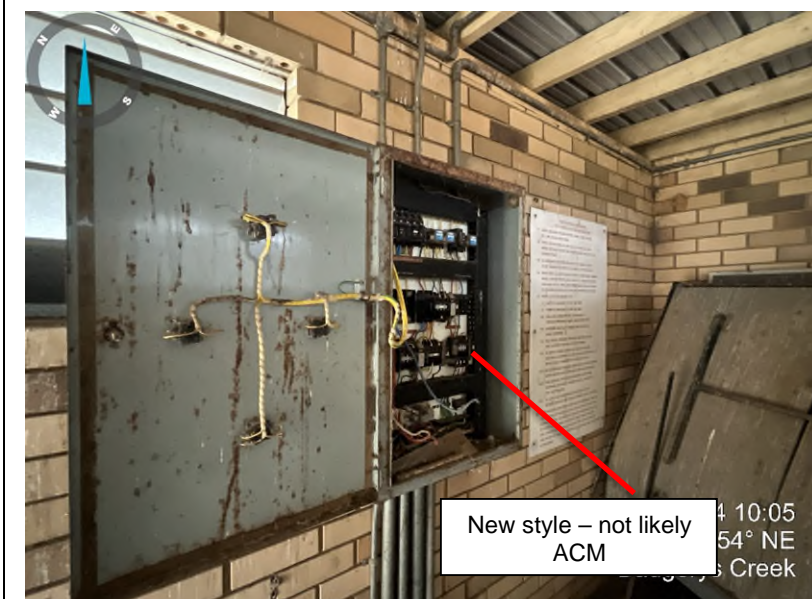
New style – not likely  
ACM
