Mirvac Developments Pty Ltd  
Hazardous Materials Survey

SOPA Site 53  
2 Figtree Drive, Sydney Olympic Park, NSW

17 September 2014  
43567/58847 (Rev A)  
JBS&G

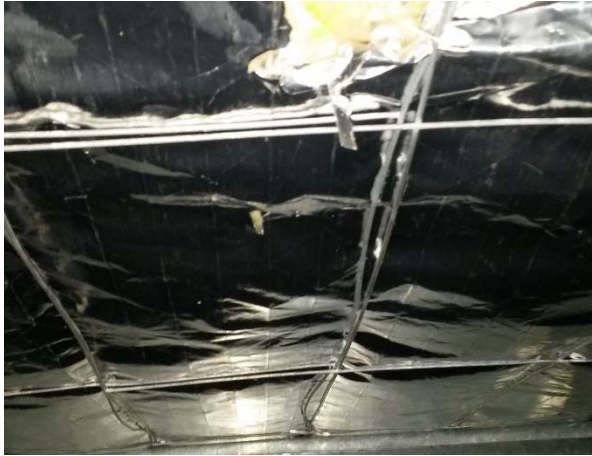
One sample, identified as M2 (**Appendix B**), indicated the presence of SMF. This sample was taken from Building 2 in the power room from the insulation between the sarking and the wall cavity. Sarking was also observed in the ceiling cavities of Building 1 and Building 2, but was not accessible due to height restrictions. Further investigation of this material in other locations was not undertaken due to its inaccessibility.

SMF containing materials were observed and sampled in the area between the sarking and wall cavity of building 2 in the power room. Sarking was also observed in the ceiling cavities of Building 1 and Building 2. Due to the inaccessibility of these areas, no further sampling of the material underneath the sarking could be taken. SMF containing material is therefore assumed to be in these areas and should be treated with the following management practice.

Photograph 1: Synthetic Mineral Fibre Insulation Located between sarking and wall cavity (Building 2)

- SMF materials can be removed with the building waste with care taken not to generate fibres. Appropriate PPE is recommended including the use of P2 respirator as minimum and appropriate removal methodology as outlined in *the National Standard for Synthetic Mineral Fibres* [NOHSC: 1004(1990)] and *National Code of Practice for the Safe Use of Synthetic Mineral Fibres* [NOHSC: 2006(1990)].

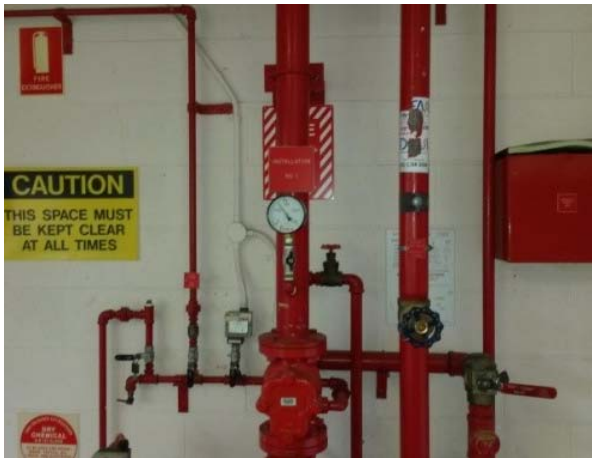
Photograph 4: Pipework without insulation lagging or identifiable fibrous gaskets. (Building 2 – Plant Room)
