Preliminary Geotechnical Assessment

Huntlee New Town Stage 2 DA

304001022-003

5 December 2023

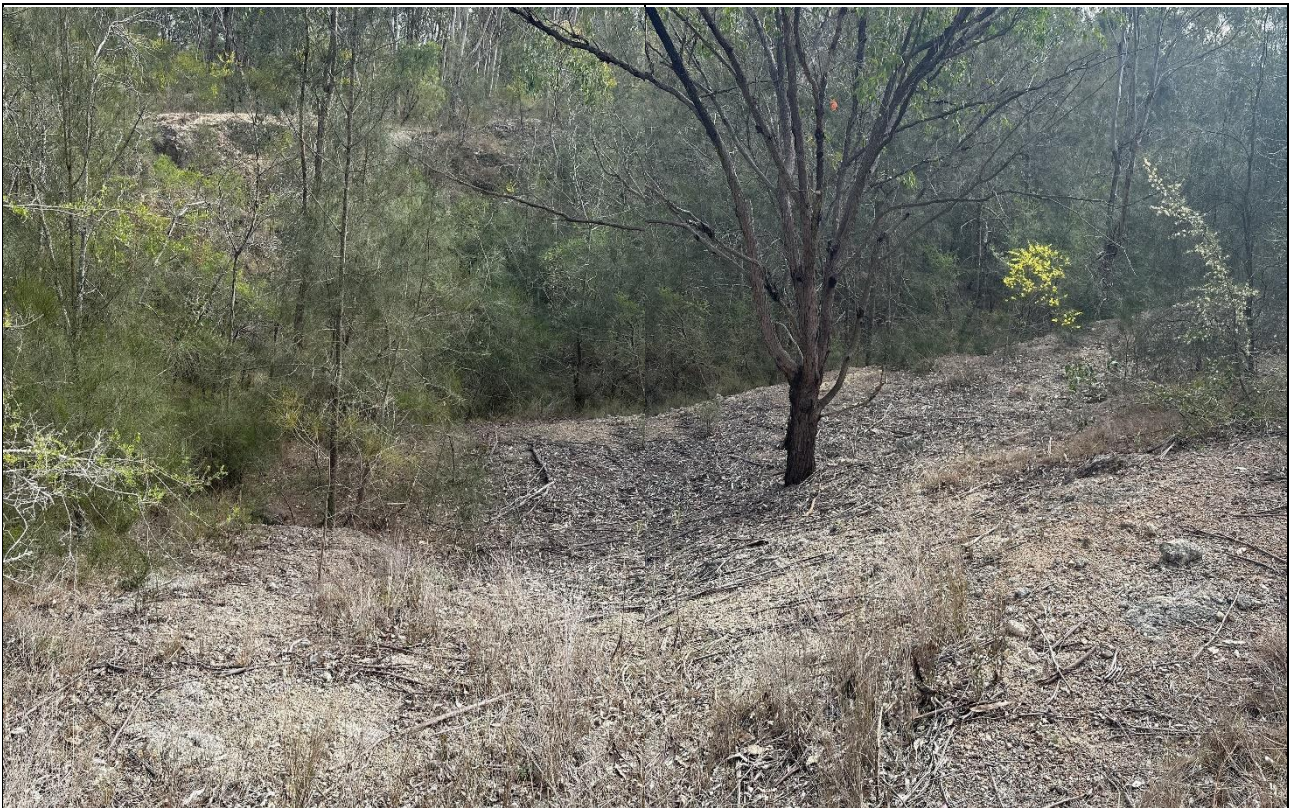
S01: Southern Site Area (SSA) quarry – general view from eastern crest

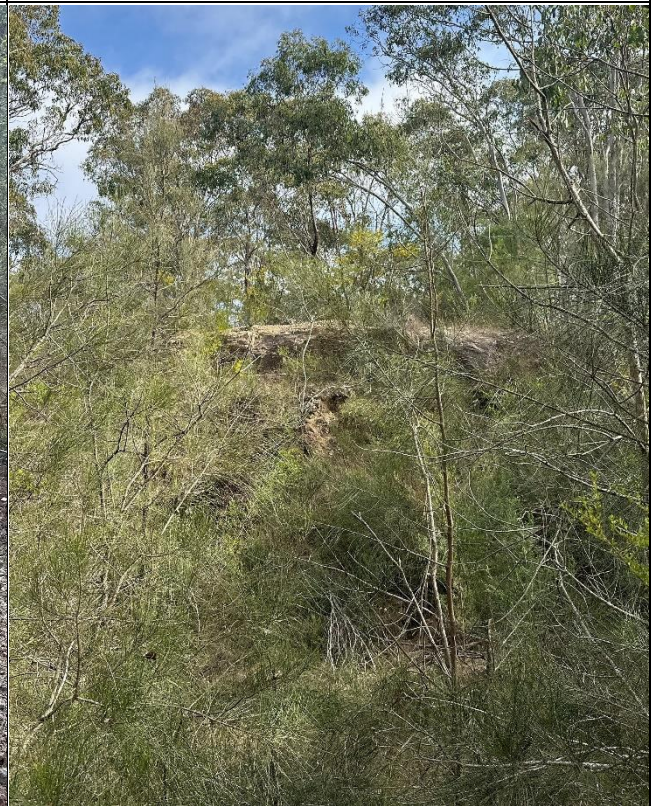
S04: SSA quarry - near vertical rock face

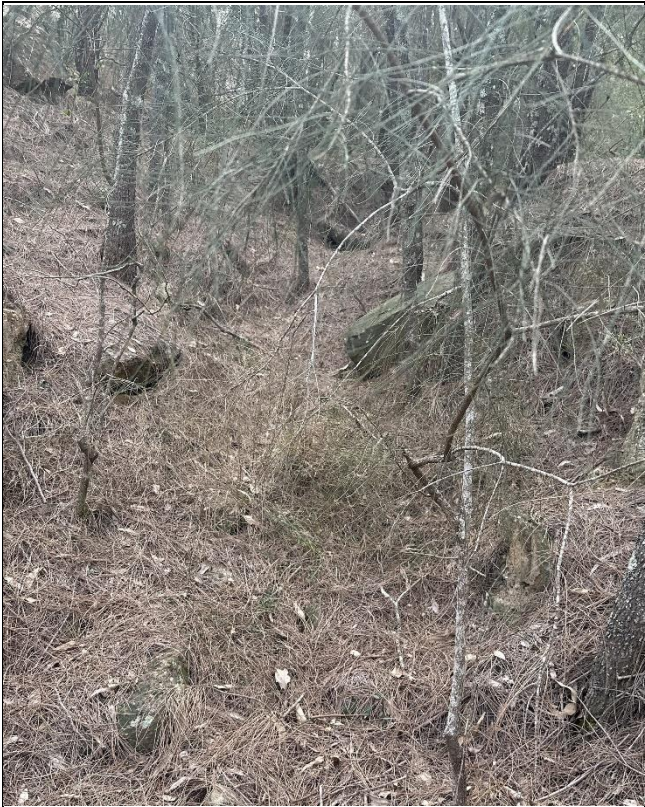
S05: SSA quarry - fallen boulders withing quarry floor

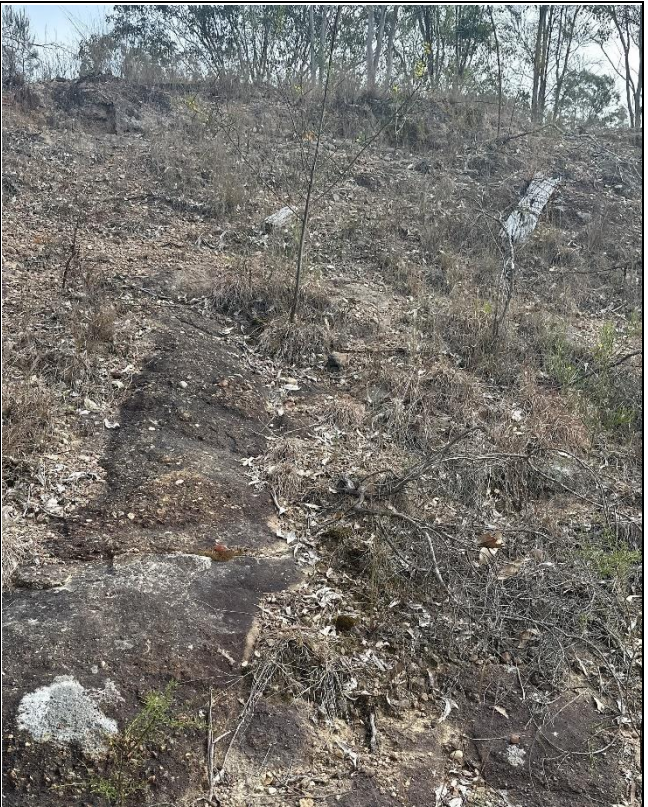
S06: SSA quarry – exposed quarry face

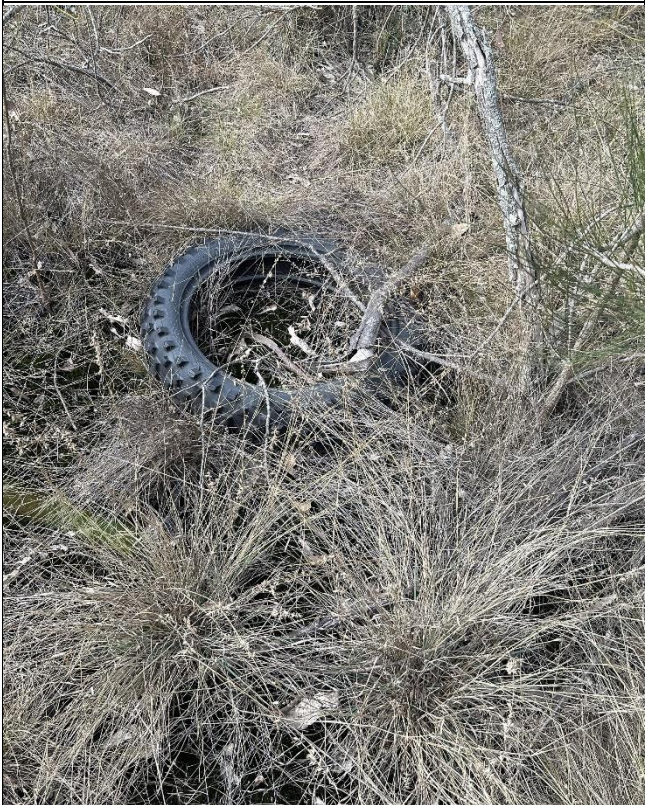
S07: SSA general refuse

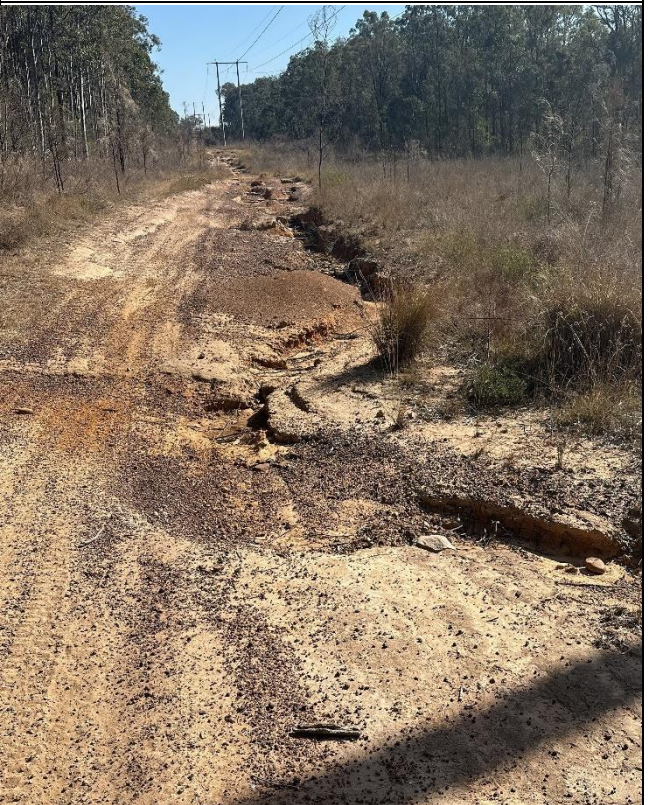
S08: SSA northern site boundary - significant rutting within easement access track (looking west)

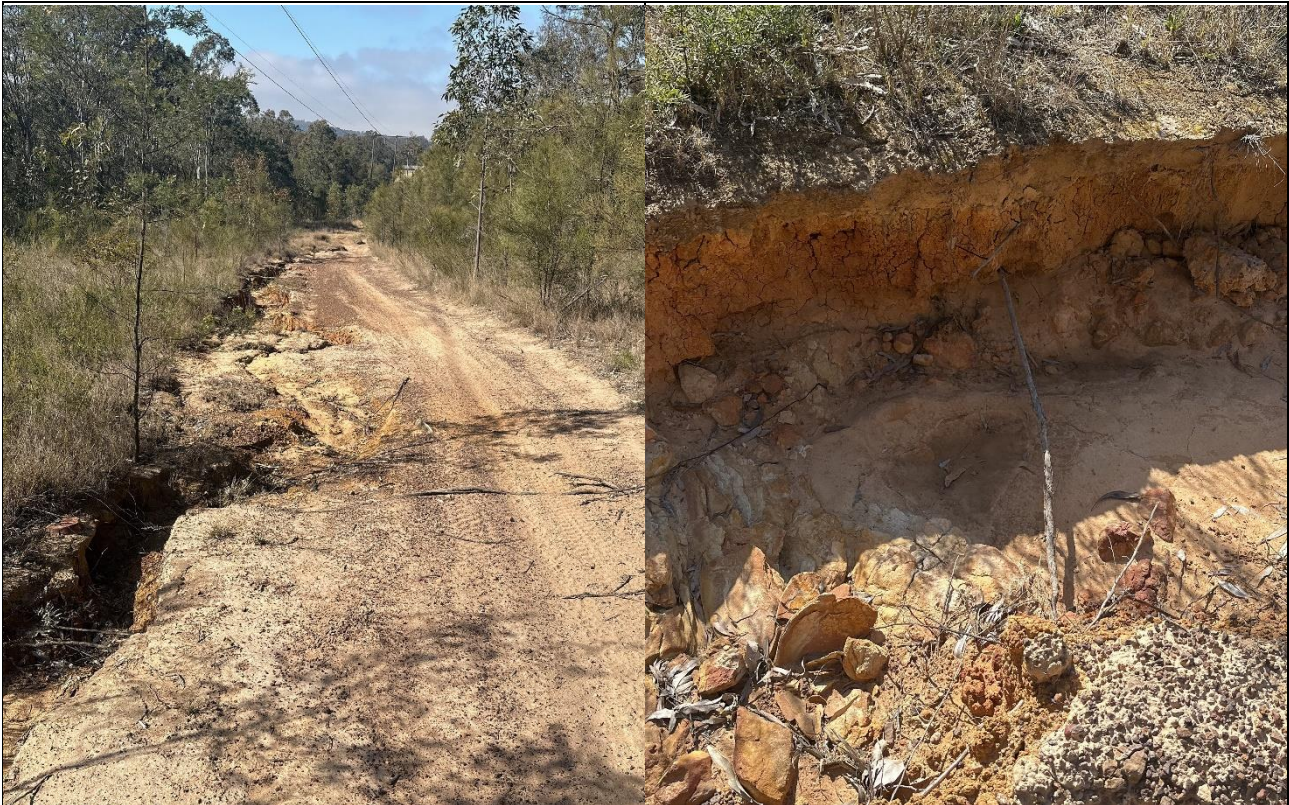
S09: SSA northern site boundary - significant rutting within easement access track (looking east)

S10: SSA northern site boundary – erosion of exposed sodic residual clays

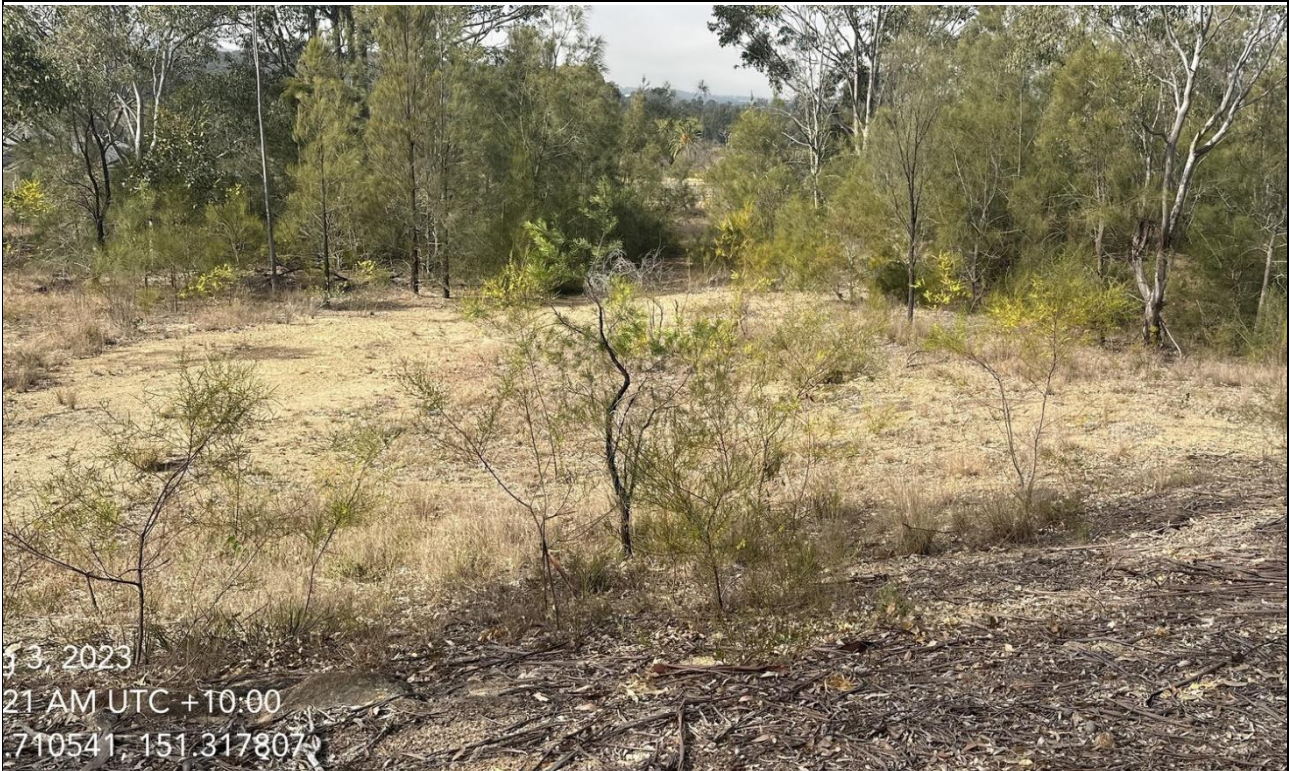
S11: SSA disturbance / clearing to the northern portion quarry (looking east)

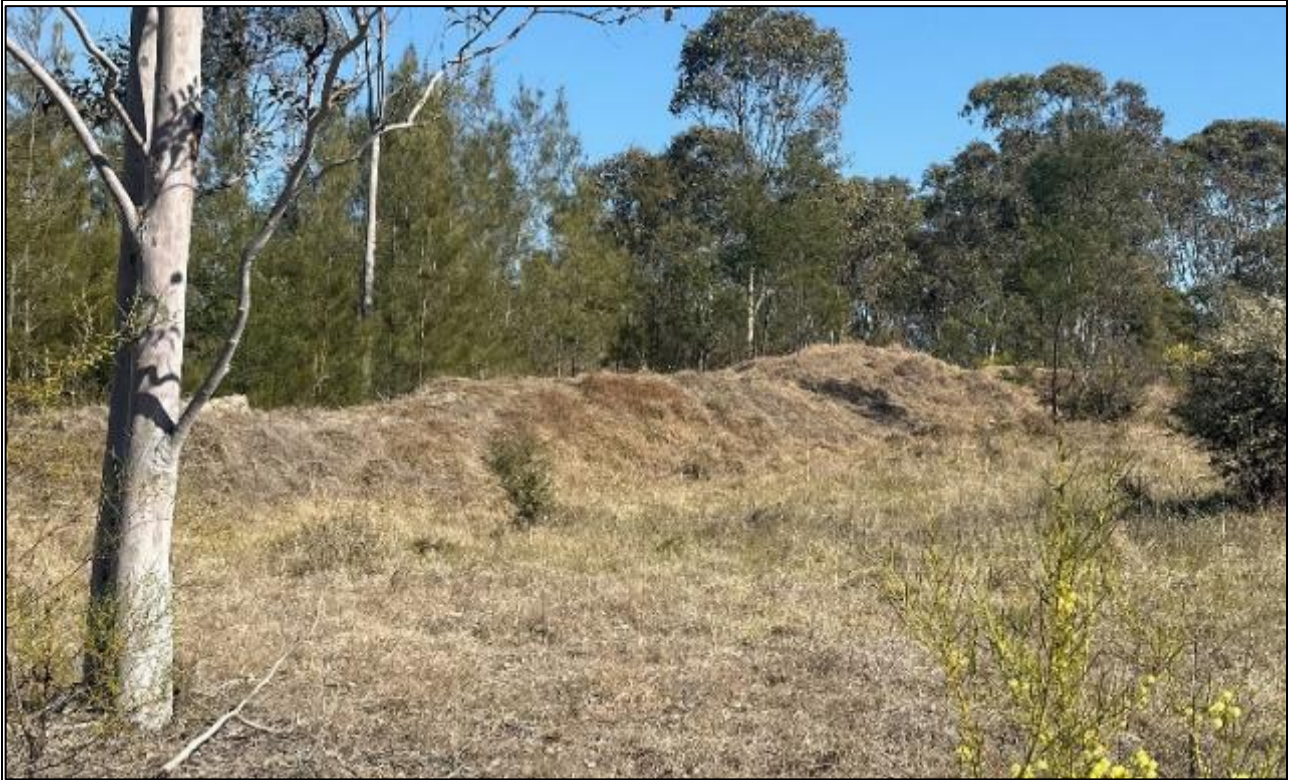
S12: SSA overgrown filled berm / stockpile to the north of the former quarry (looking southwest)

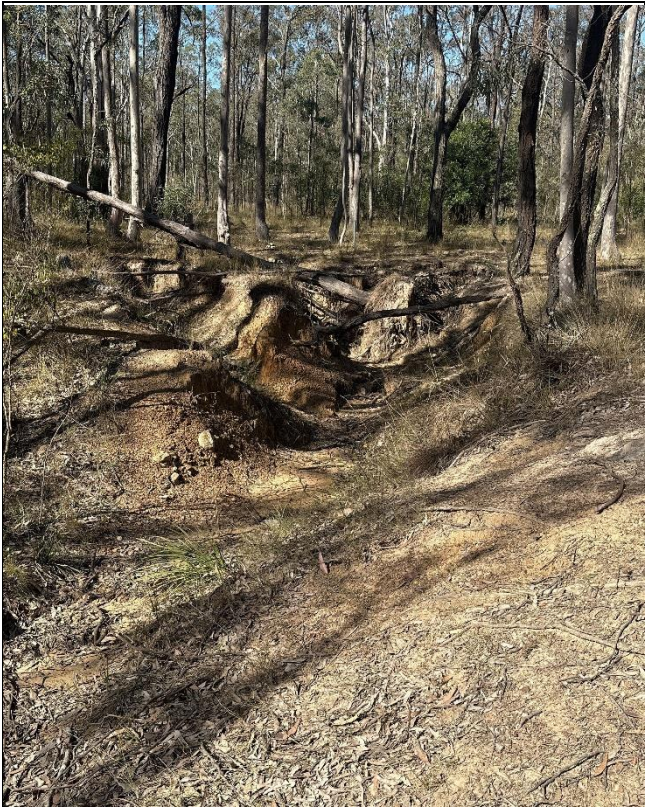
N03: NSA – area of significant scour / rutting and fallen tree southwest of smaller land parcel (looking east)

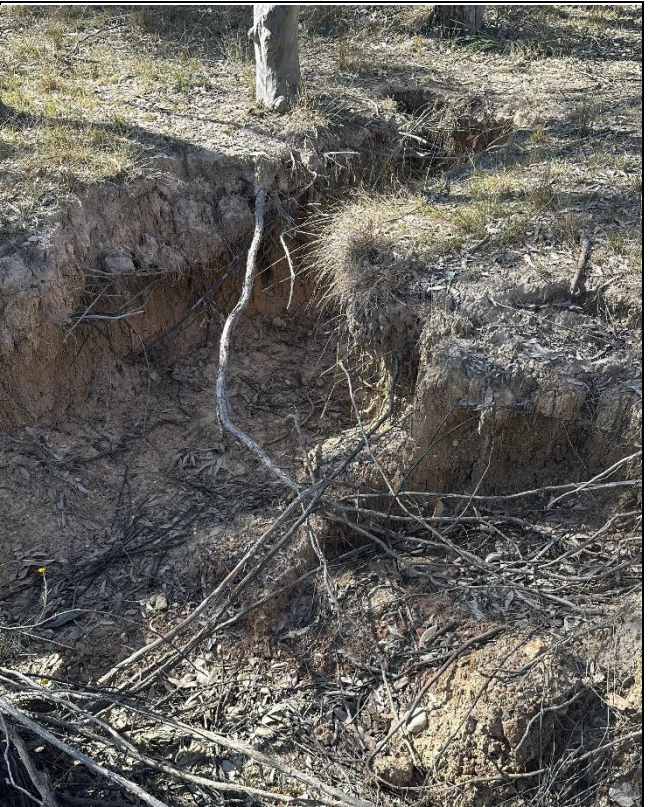
N04: NSA – area of significant scour / rutting and fallen tree southwest of smaller land parcel (close view)

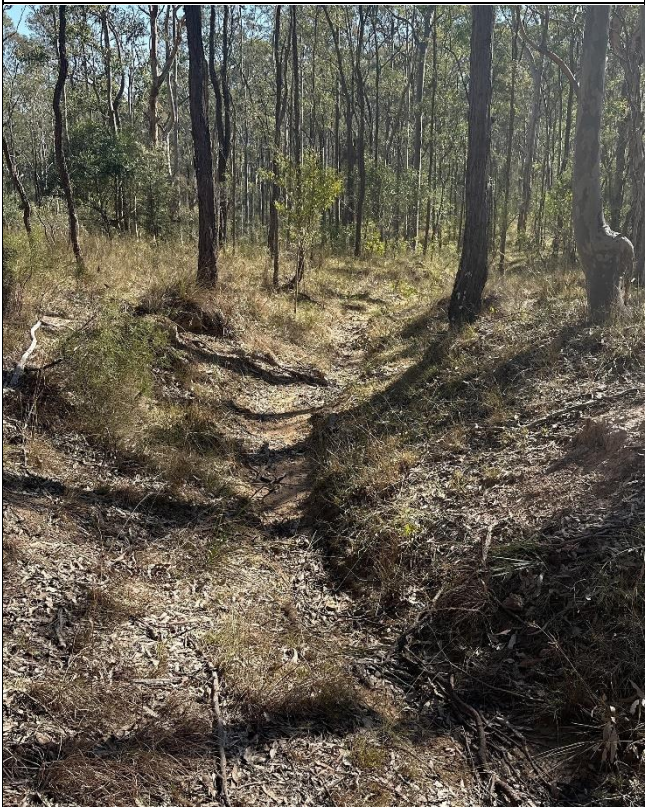
N05: NSA – down slope of area of significant scour / rutting southwest of smaller land parcel (looking west)

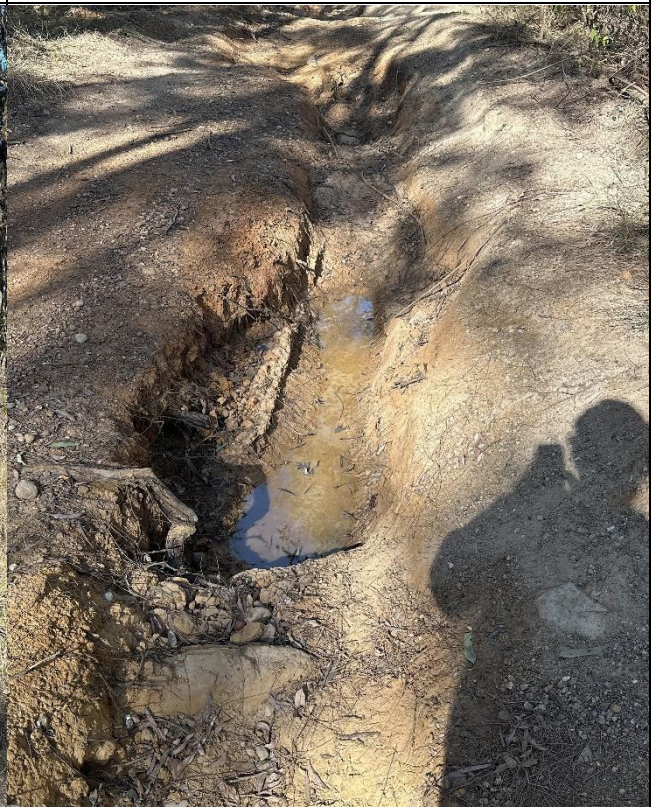
N10: NSA – significant rutting within access track adjacent rail line (looking southeast)

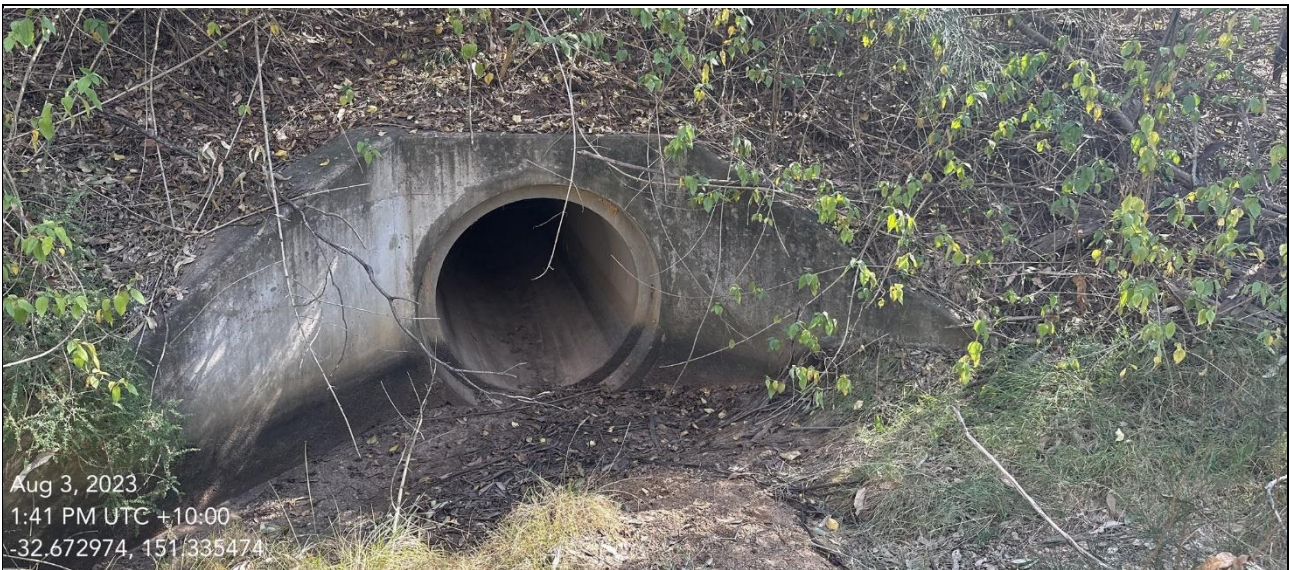
N11: NSA – existing concrete culvert inlet below approx. 5m high rail embankment (looking west)

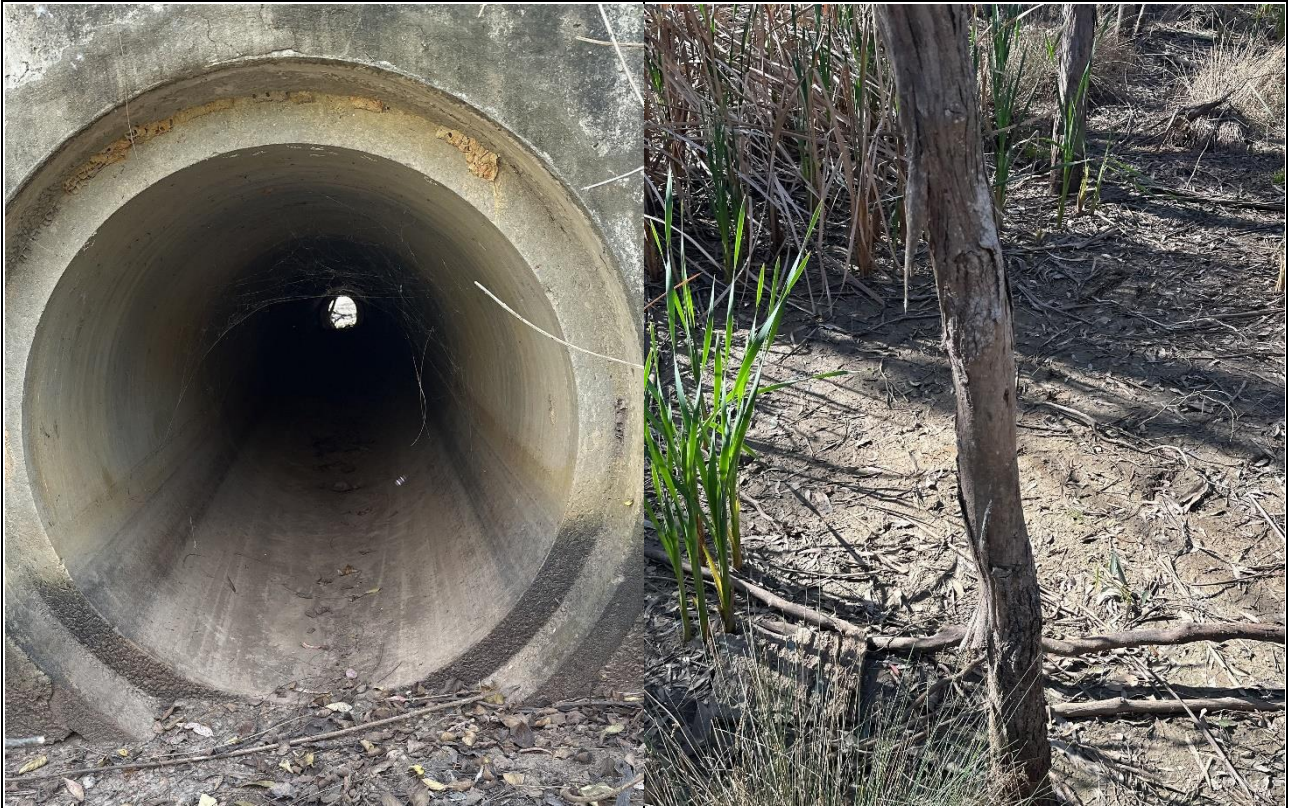
N12: NSA – existing concrete culvert (inlet side), no signs of significant blockage evident.

N13: NSA – Soft / moist surface soils immediately upstream of culvert (N11/N12).

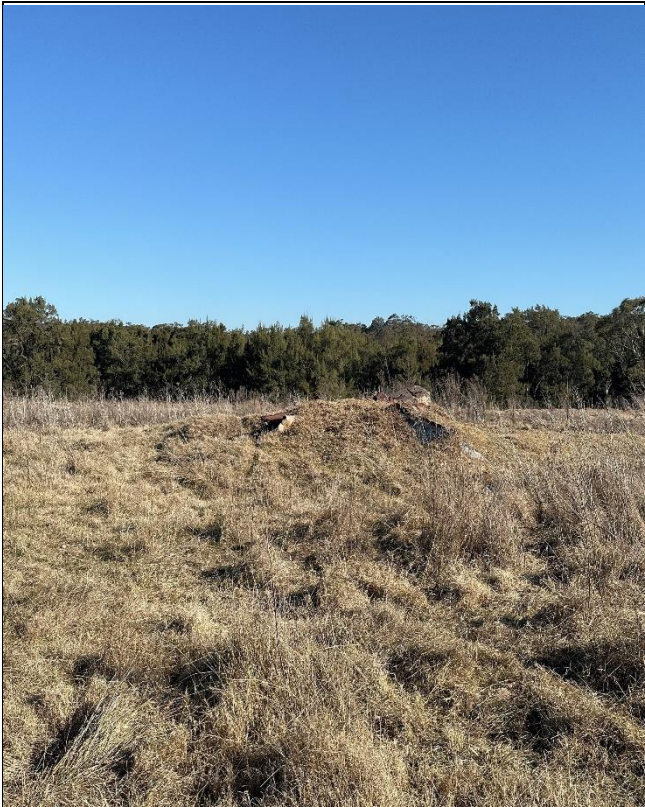
N20: NSA – small building rubble stockpile, southwest of site

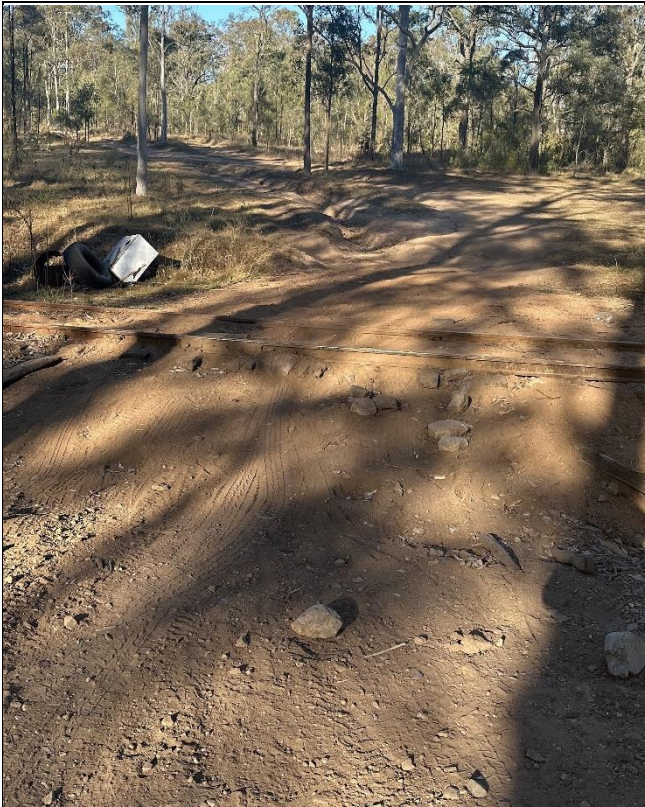
N27: NSA – northern level crossing (looking east), approx transitional zone between cut and fill track construction, general refuse also noted in area

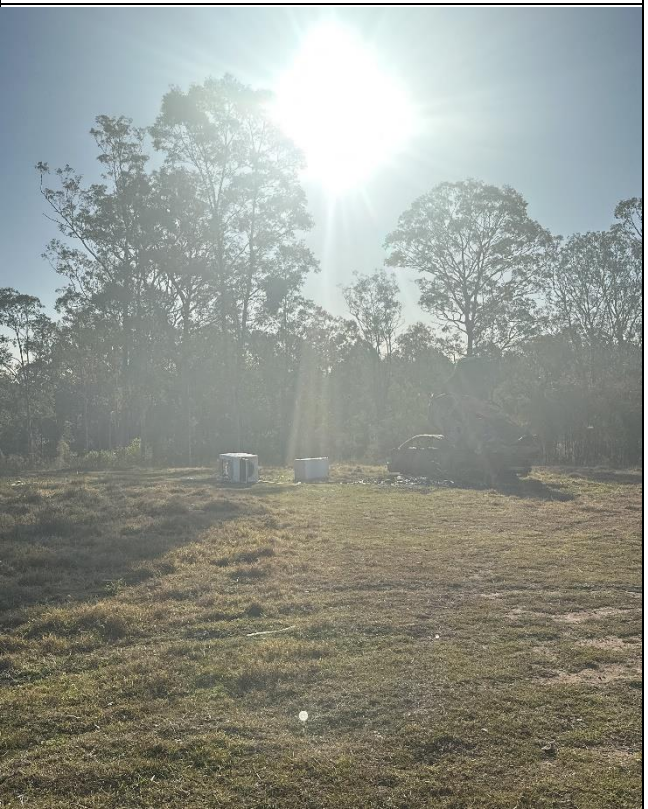
N30: NSA – cleared area, including abandoned motor vehicle wreck and general refuse

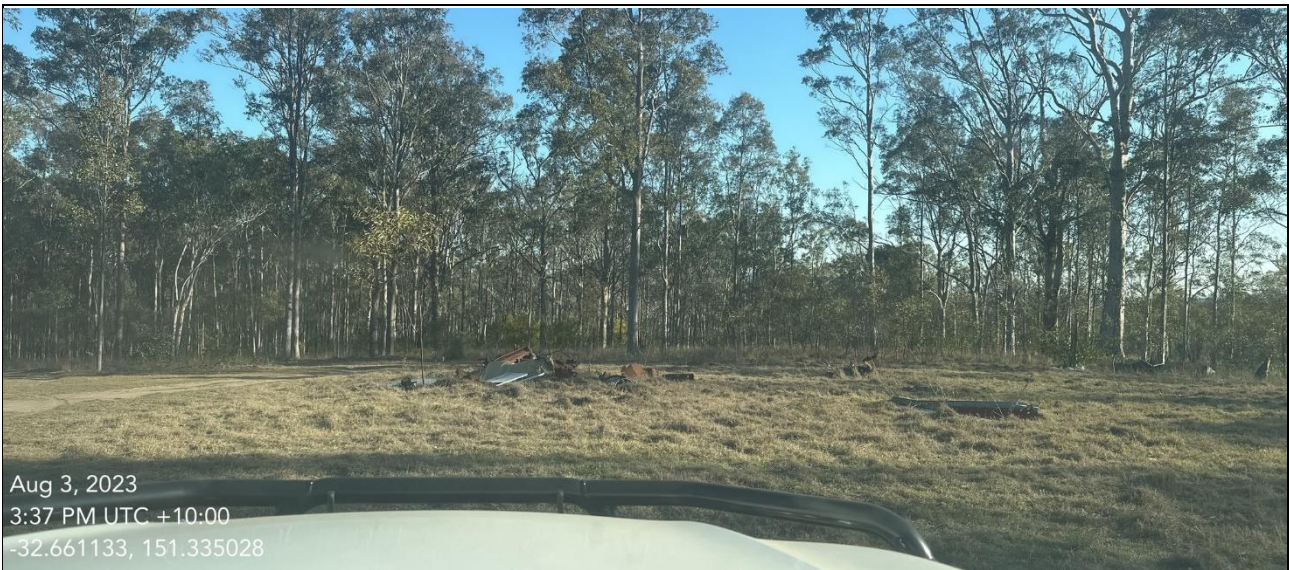
N31: NSA – cleared area, including pile of appeared building waste

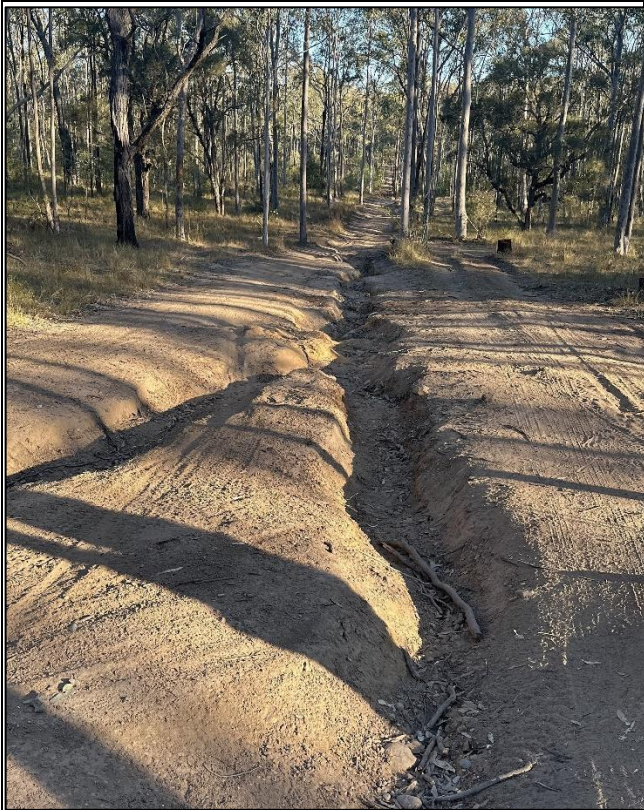
N32: NSA – existing rutting within bare access track

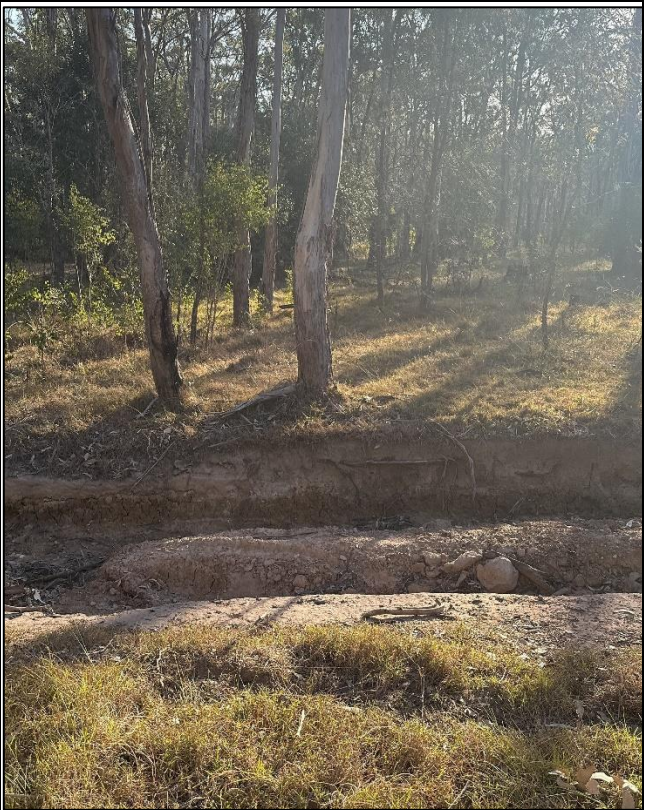
N33: NSA – exposed surficial soils and residual clays in area of rutting

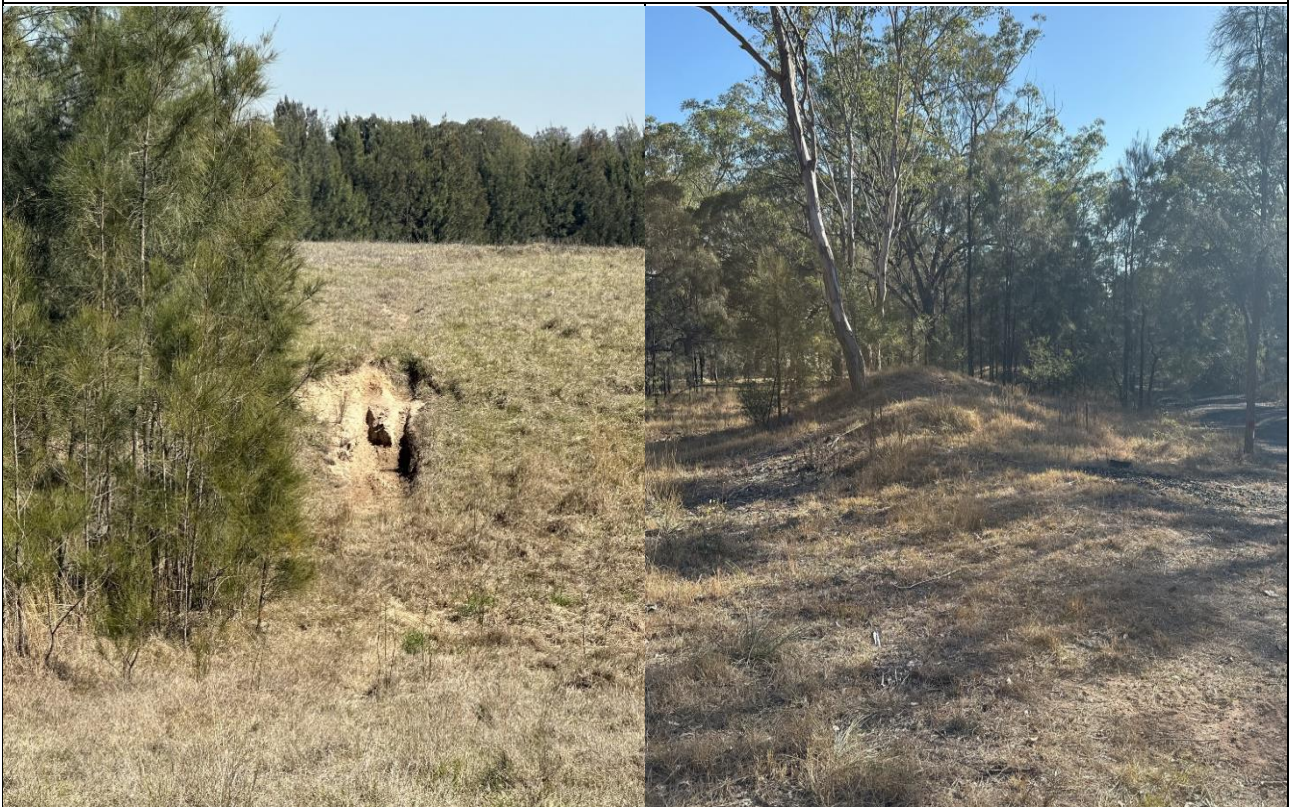
N35: NSA – scoured slope face to the west

N36: NSA – overgrown filled berm

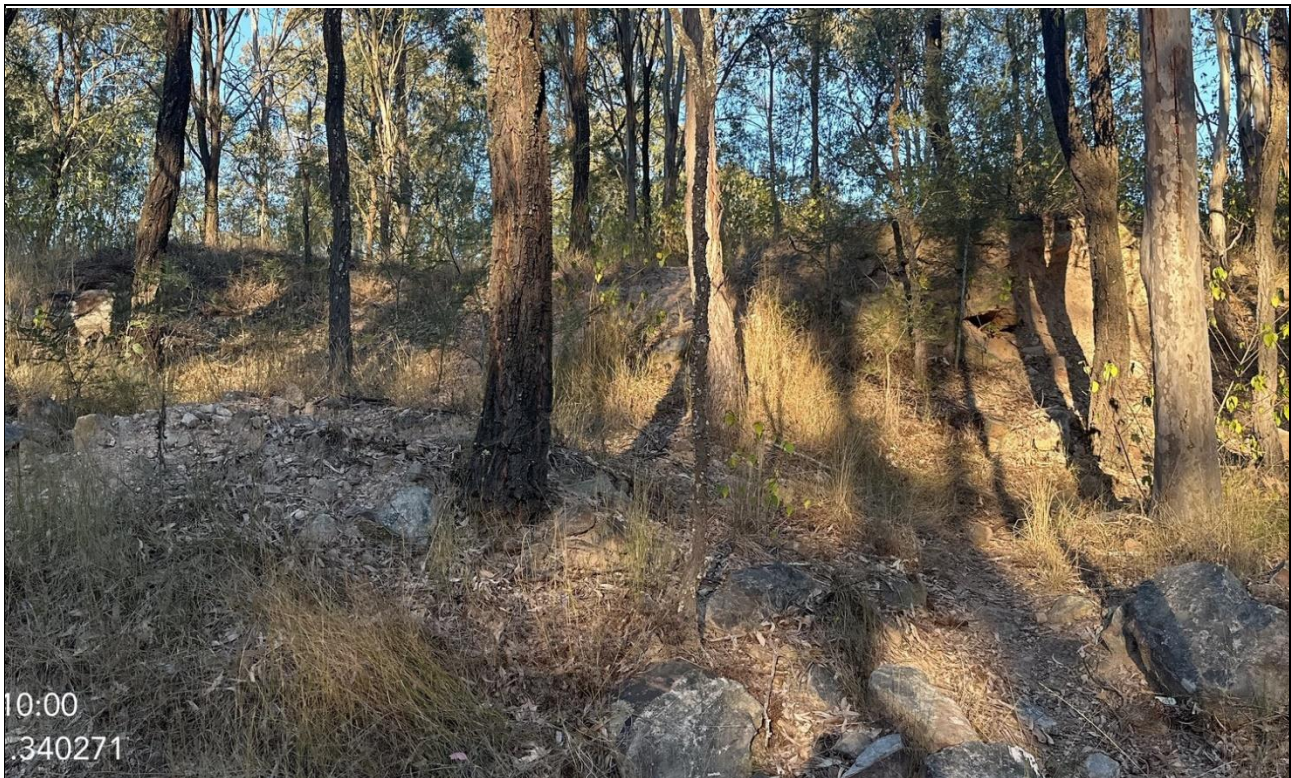
N37: NSA –built up access track, appeared to comprise overburden / waste rock material near colliery area

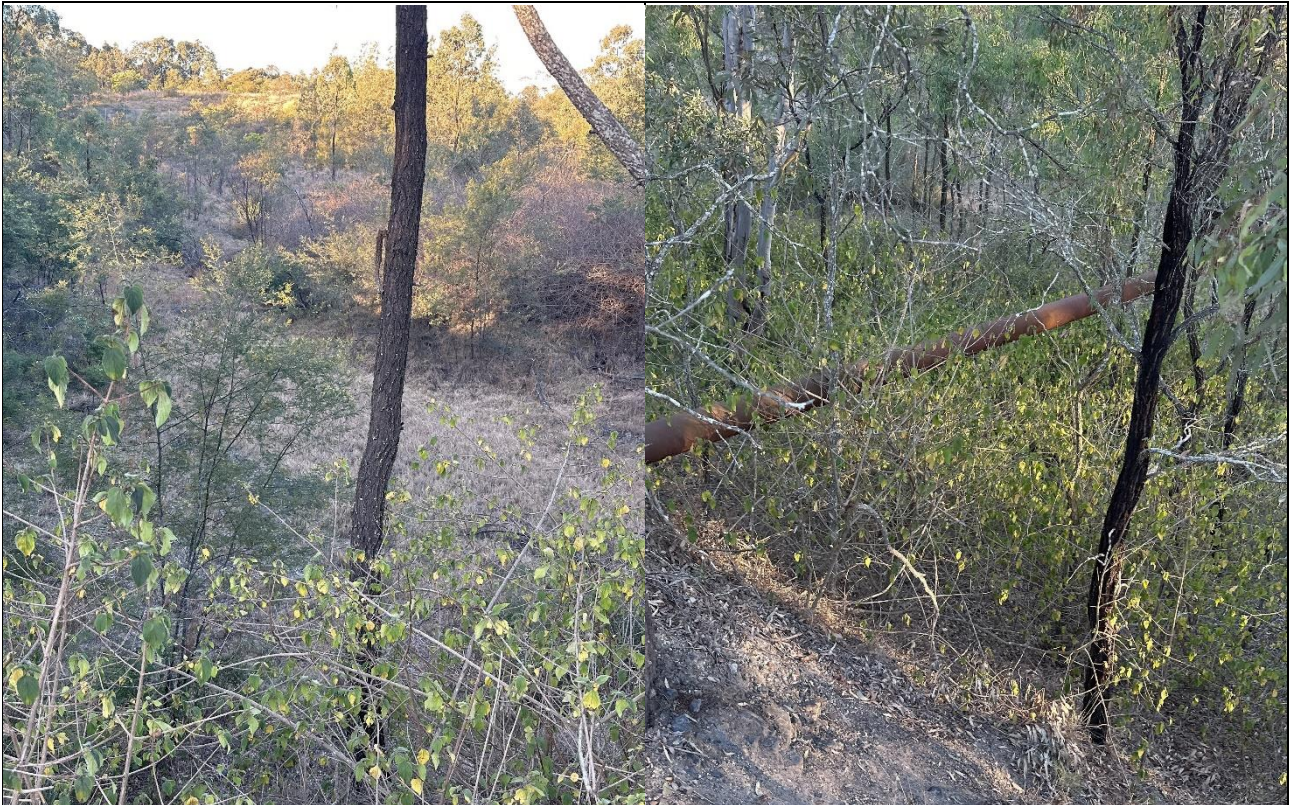
N39: NSA – overlooking possible colliery landfill cell from crest of wall

N40: NSA – appeared overflow pipe, installed approx. 1-1.5m below crest level.
