# Fabric Survey

R.D Watt Building, Science Road, University of  
Sydney

June 2016

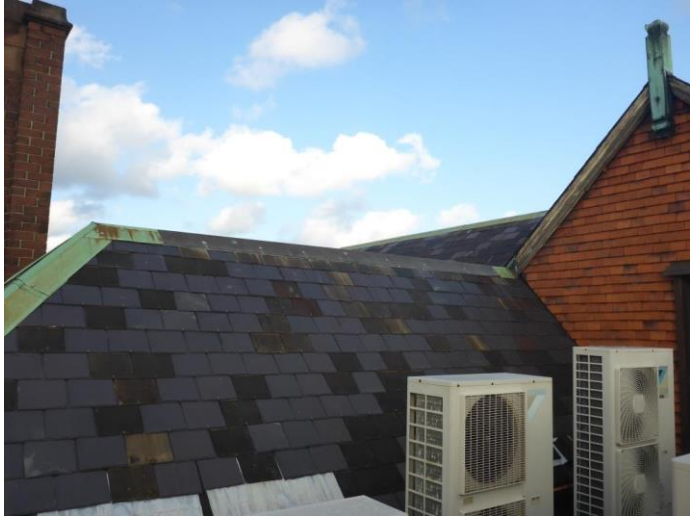
<p>Photo 1: View of the northern hipped roof showing patched slates, copper ridge capping and terracotta shingled gable end</p>

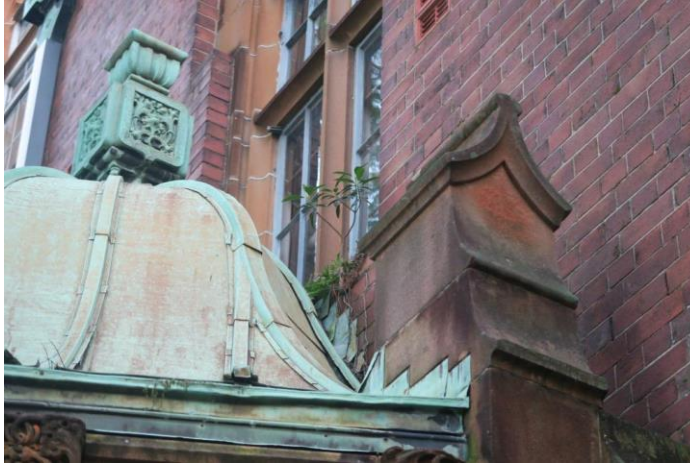
<p>Photo 2: Detail of the copper porch roof – check over flashings.</p>

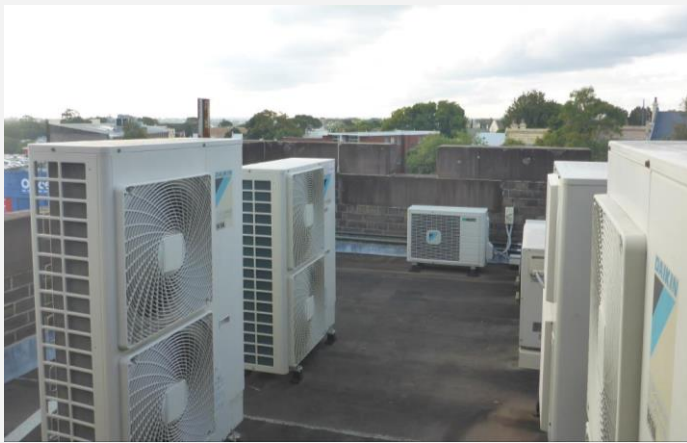
ITEM #	ELEMENT	SIGNIFICANCE	CONDITION	DESCRIPTION OF ELEMENT AND RECOMMENDATION	PRIORITY	IMAGE/ ADDITIONAL COMMENTS
1.2	Roof Terrace	Safety handrails to roof of west wing – Little (3)	Good.	<p>Flat bitumen roof. Generally appears in good condition.</p> <p>Recommendation:</p> <ul style="list-style-type: none"> <li>Remove plant and connect building A/C to FASS building.</li> <li>Make good after removal of condensers</li> <li>Remove redundant services</li> </ul>	Current

<p>Photo 3: View of the roof terrace</p>

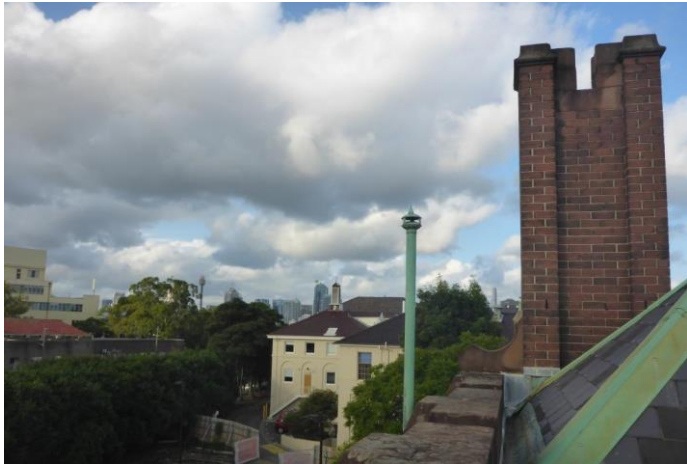
1.3	Chimneys	High (1)	Fair	<p>Face brick with stone cappings. Some stone capping shows deterioration.</p> <p>Recommendation:</p> <ul style="list-style-type: none"> <li>Allow to inspect at roof level. Allow to repair/ replace stone capping (where required). New lead capping for chimney top</li> <li>Allow to repoint open brick joints</li> </ul>	<p>Current (capping)</p> <p>Low (repointing)</p>

<p>Photo 4: View of the rear chimney.</p>

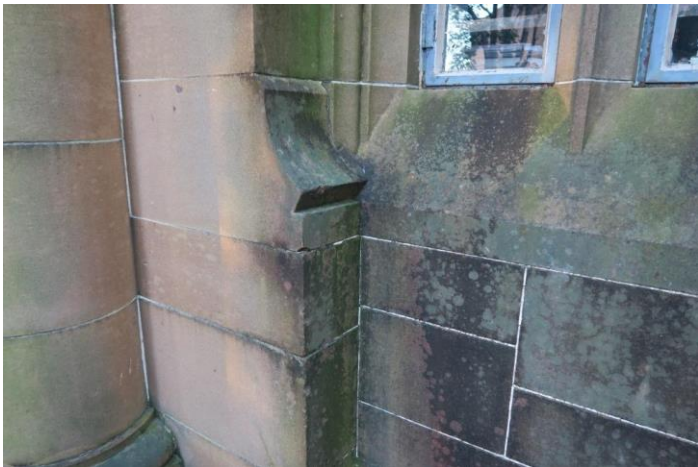
2.0 South Elevation						
2.1	Stonework	<p>Stone and copper portico – High (1)</p> <p>Carved stone crests and gargoyles (1)</p> <p>Brick and stone facades - Moderate (2)</p> <p>Decorative stone tracery and Coat of Arms – Moderate (2)</p> <p>String courses, window mullions and transoms – Moderate (2)</p>	<p>Good</p> <p>Good</p> <p>Fair/ Poor</p> <p>Good/ fair</p>	<p>Random pattern sandstone ashlar coursing at the low level. Generally good condition, evidence of damp and algal growth,</p> <p>Recommendation:</p> <ul style="list-style-type: none"> <li>Investigate damp and determine remediation required. This may include provision of additional drainage and landscaping works</li> </ul> <p>Dressed and rubbed sandstone window frames including transoms and mullions. Generally in good condition, some evidence of damp and algal growth to sills.</p> <p>Recommendation:</p> <ul style="list-style-type: none"> <li>Investigate damp</li> <li>Allow to repoint open joints</li> </ul> <p>Dressed and rubbed sandstone cornice below crenelated parapet with ornate sandstone carvings. Cornice shows considerable damp/ salt activity and deterioration.</p> <p>Recommendation:</p> <ul style="list-style-type: none"> <li>Allow for close inspection of carvings to determine degree of deterioration and remedial work required. This may include patching cornice with synthetic stone.</li> </ul> <p>Crenelated dressed sandstone parapet wall.</p> <p>Recommendation:</p> <ul style="list-style-type: none"> <li>Allow to repoint open joints</li> </ul>	<p>Current</p> <p>Current (investigation)</p> <p>High (repoint)</p> <p>Current</p> <p>Current</p>

<p>Photo 5: Evidence of damp and moss growth to lower stonework</p>

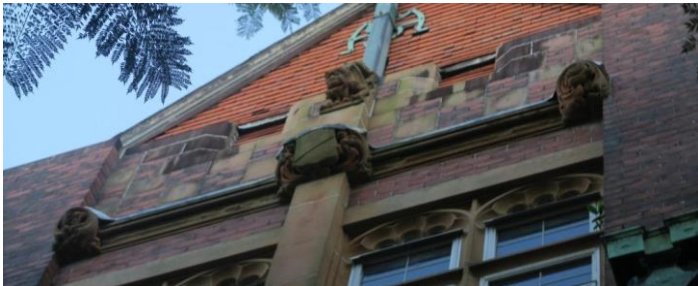
<p>Photo 6: Detail of the cornice</p>

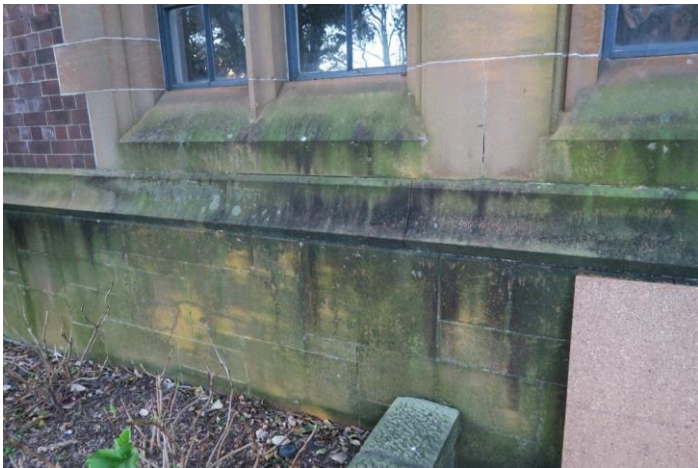
<p>Photo 7: Detail of dressed stone windows and lower level ashlar</p>

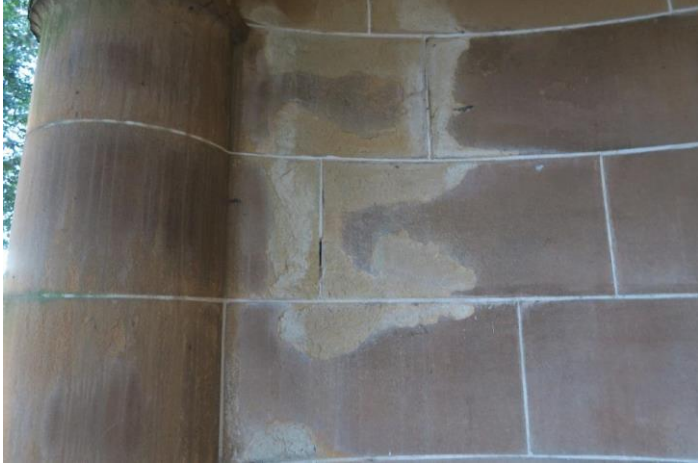
ITEM #	ELEMENT	SIGNIFICANCE	CONDITION	DESCRIPTION OF ELEMENT AND RECOMMENDATION	PRIORITY	IMAGE/ ADDITIONAL COMMENTS
			Fair	<p>Dressed and rubbed sandstone columns to entry porch in good condition, arches and walling to entry porch. The interior stonework of the porch shows extensive deterioration, with salt activity, spalling and fretting of stone caused by water leakage from porch roof above. External stonework and buttresses show evidence of damp.</p> <p>Recommendation:</p> <ul style="list-style-type: none"> <li>• Investigate to determine cause of damp under muntz metal roof</li> <li>• Investigate interior stone to determine extent of decay. Allow to rub back or patch spalled stone (subject to specialist advice)</li> <li>• Allow to desalinate as required</li> <li>• Allow to repoint open joints</li> </ul>	Current

<p>Photo 8: Detail of spalling to stonework within the entrance porch</p>

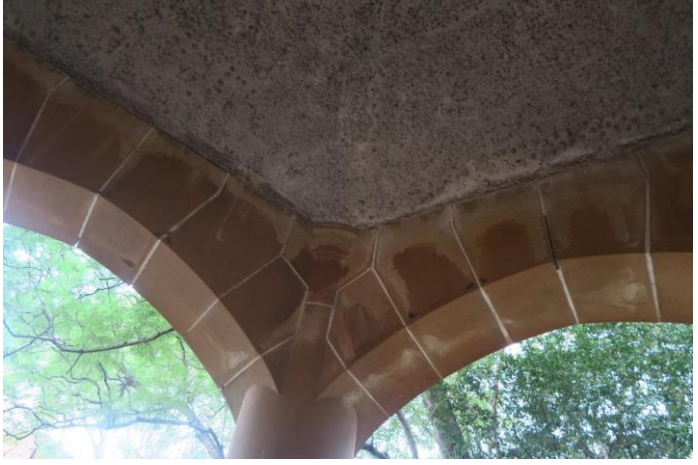
<p>Photo 9: Detail of spalling to stonework within the entrance porch</p>

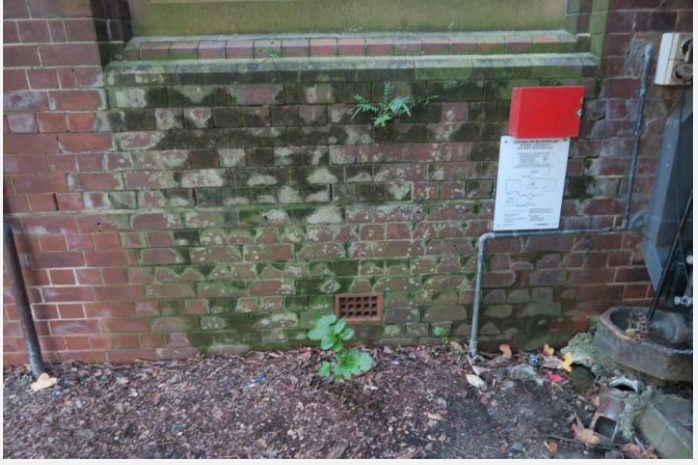
2.2	Brickwork	Brick and stone facades - Moderate (2)	Good	<p>Face brick English bond with corner buttresses and terracotta ventilators, Brick work shows evidence of salt deposits in some areas, extensive areas of damp at the ground level. Plant growth. Evidence of previous fixings and damage to bricks.</p> <p>Recommendation:</p> <ul style="list-style-type: none"> <li>• Allow to poison and remove plant growth</li> <li>• Investigate damp and determine remediation required, This may include provision of additional drainage. Check DPC.</li> <li>• Allow to repoint missing joints TME</li> <li>• Allow for removal of redundant fixings, localised repair and patching to damaged bricks</li> </ul>	Current

<p>Photo 10: Detail of brickwork showing evidence of salt, damp and extensive build-up of moss/ algal growth as well as plant growth.</p>

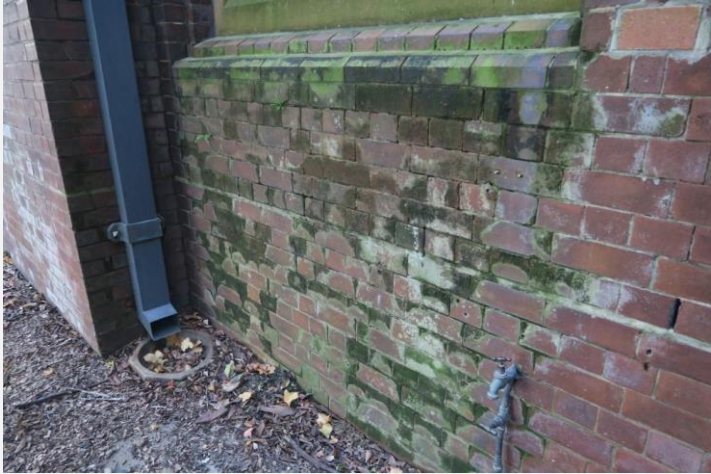
<p data-bbox="2131 688 2795 743">Photo 11: Detail of brickwork showing evidence of salt, damp and extensive build-up of moss/ algal growth as well as plant growth.</p>

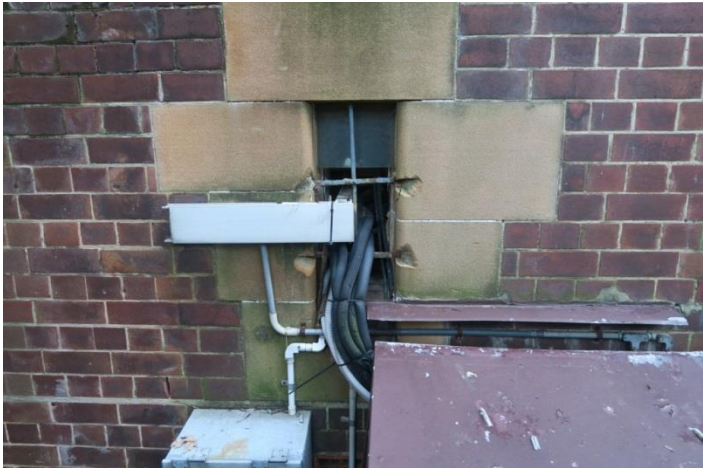
2.3	Windows	<p data-bbox="572 785 783 953">Original and reproduction steel framed and leadlight window assemblies – Moderate (2)</p> <p data-bbox="572 991 783 1159">Alterations to steel framed windows (including removal of glazing bars) – Intrusive (4)</p> <p data-bbox="572 1197 783 1289">Replacement aluminium windows – Little (3)</p>	Good/ Fair	<p data-bbox="1032 785 1911 882">Original steel framed windows with new aluminium replacement windows on the upper levels. Aluminium frames generally in good condition. Some rust evident to the original steel.</p> <p data-bbox="1032 919 1222 945">Recommendation:</p> <ul data-bbox="1080 982 1863 1079" style="list-style-type: none"> <li data-bbox="1080 982 1383 1008">• Allow to de-rust and paint</li> <li data-bbox="1080 1016 1863 1079">• Repair missing glazing TME on ground floor window east utility window, in conjunction with rationalisation of services</li> </ul>	Current

<p data-bbox="2131 1243 2623 1268">Photo 12: Detail of window glazing to be repaired</p>

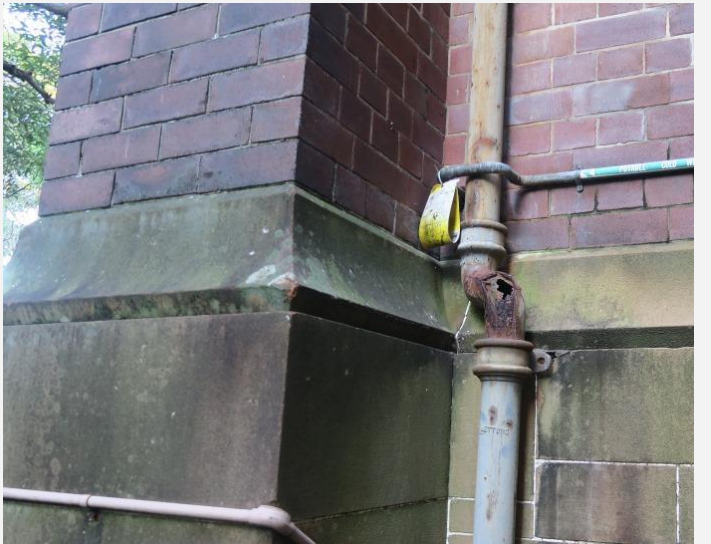
2.4	Rainwater goods	Original copper rainwater heads – High (1)	Fair	<p data-bbox="1032 1335 1786 1360">Cast iron down pipes in fair condition. Cooper rainwater heads and elbows.</p> <p data-bbox="1032 1398 1222 1423">Recommendation:</p> <ul data-bbox="1080 1461 1905 1667" style="list-style-type: none"> <li data-bbox="1080 1461 1905 1558">• Undertake a full survey of the roof drainage system to ascertain that all outlets flow properly into the rainwater system. Some gargoyles are noted as missing outlets.</li> <li data-bbox="1080 1566 1863 1629">• Allow to inspect rainwater goods at close range including repair of cracked downpipes etc.</li> <li data-bbox="1080 1638 1709 1663">• Allow to inspect rainwater heads to determine deterioration</li> </ul>	Current

<p data-bbox="2131 1864 2499 1890">Photo 13: Detail of eroded downpipe</p>

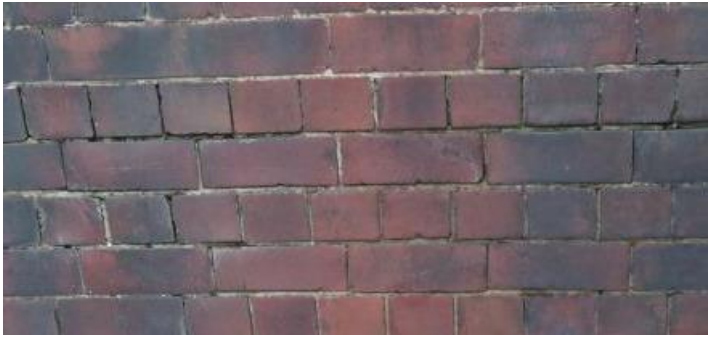
ITEM #	ELEMENT	SIGNIFICANCE	CONDITION	DESCRIPTION OF ELEMENT AND RECOMMENDATION	PRIORITY	IMAGE/ ADDITIONAL COMMENTS
3.2	Brickwork	Brick and stone facades - Moderate (2)  Remains of service enclosures at base of east elevation – Intrusive (4)	Good	Face brick English bond and stretcher bond mix, with corner buttresses and terracotta ventilators, Brick work shows evidence of salt deposits in some areas, areas of damp at the ground level. Plant growth. Evidence of previous fixings and damage to bricks.  Recommendation: <ul style="list-style-type: none"> <li>• Allow to poison and remove plant growth</li> <li>• Investigate damp and determine remediation required, This may include provision of additional drainage</li> <li>• Allow to repoint missing joints TME</li> <li>• Allow for removal of redundant fixings, localised repair and patching to damaged bricks</li> <li>• Allow to replace damaged squints to lower window sill, repoint brickwork</li> </ul>	Current (investigate)  Current (repointing)  Low (localised repairs)  Medium (squints)

<p>Photo 16: Detail of low level masonry - allow for investigation of damp and repointing of missing mortar joints</p>

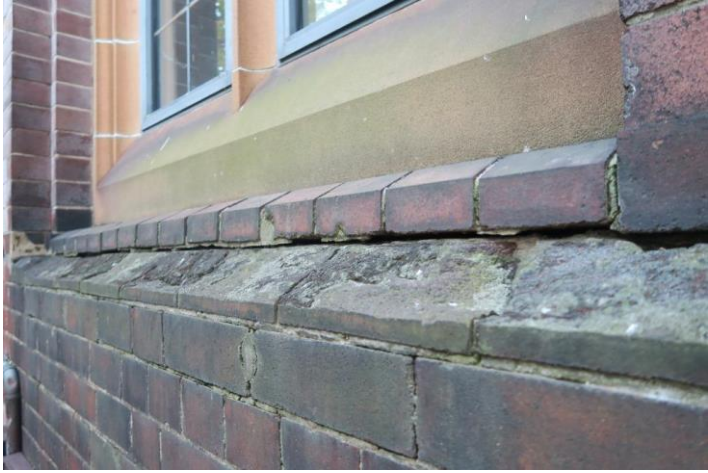
<p>Photo 17: Detail of <b>squints to be replaced</b></p>

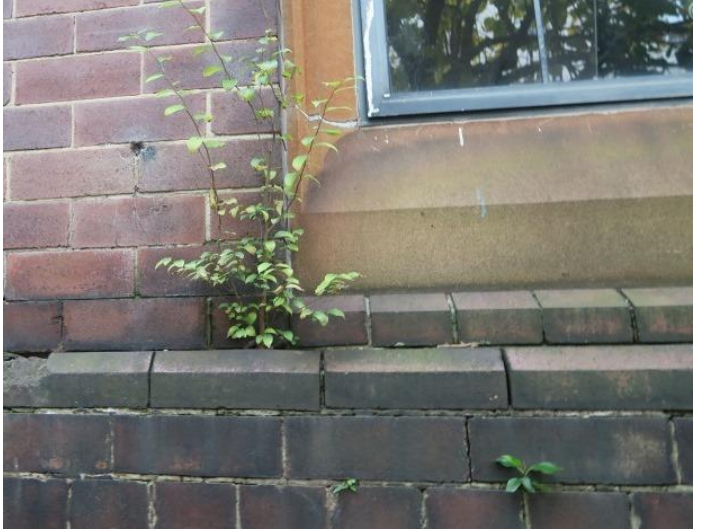
<p>Photo 18: Detail of ground level east elevation showing plant growth</p>

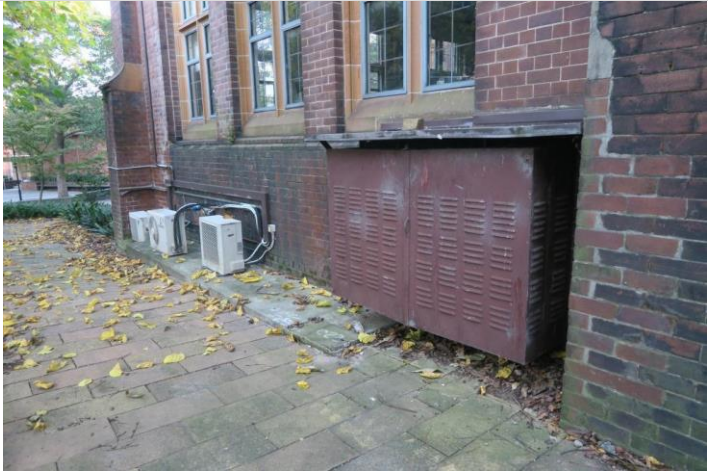
ITEM #	ELEMENT	SIGNIFICANCE	CONDITION	DESCRIPTION OF ELEMENT AND RECOMMENDATION	PRIORITY	IMAGE/ ADDITIONAL COMMENTS
				<p>As part of the proposed works:</p> <ul style="list-style-type: none"> <li>Allow for removal of redundant services cabinet and patch repairs</li> </ul>	Current

<p>Photo 19: Remove redundant services and patch repair</p>

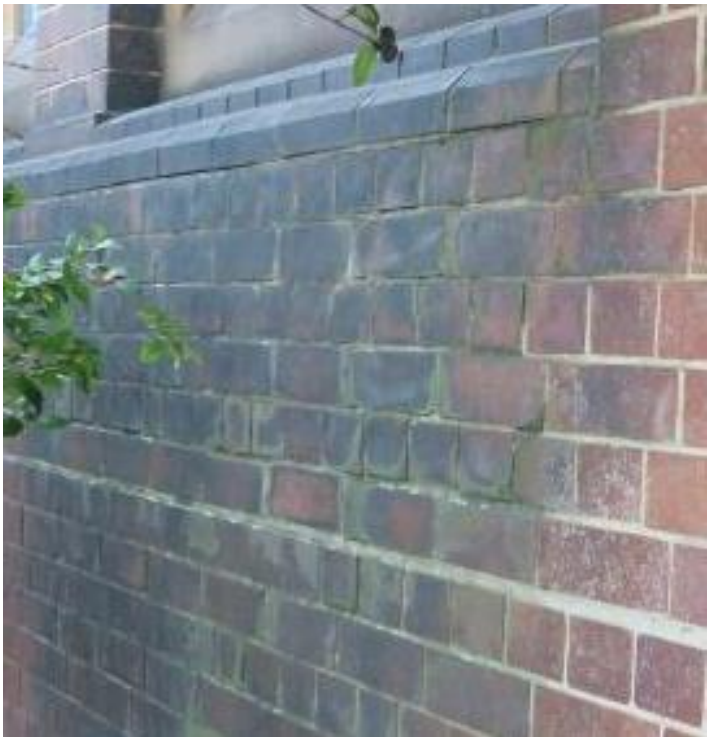
ITEM #	ELEMENT	SIGNIFICANCE	CONDITION	DESCRIPTION OF ELEMENT AND RECOMMENDATION	PRIORITY	IMAGE/ ADDITIONAL COMMENTS
4.2	Brickwork		Good	<p>Face brick English bond and stretcher bond mix, with corner buttresses and terracotta ventilators, Brick work shows evidence of salt deposits in some areas, areas of damp at the ground level.</p> <p>Recommendation:</p> <ul style="list-style-type: none"> <li>Investigate damp and determine remediation required, This may include provision of additional drainage</li> <li>Allow to repoint missing joints TME</li> </ul>	Current

<p>Photo 20: Detail of west elevation lower level brickwork showing evidence of damp and open joints</p>

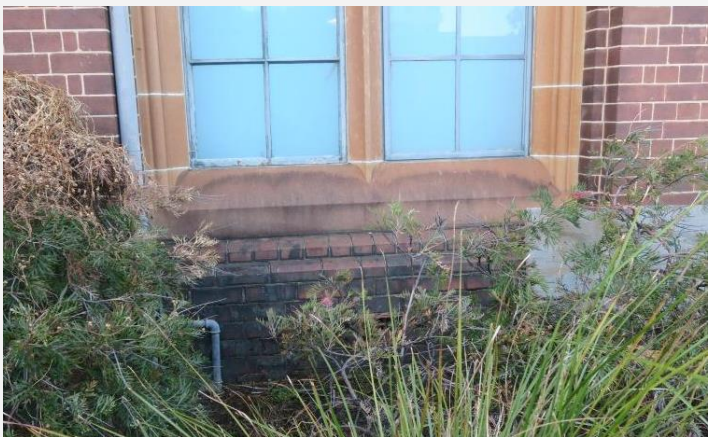
5.0 North Elevation						
5.1	Stonework	<p>Carved stone crests and gargoyles (1)</p> <p>Brick and stone facades - Moderate (2)</p> <p>Decorative stone tracery and Coat of Arms – Moderate (2)</p> <p>String courses, window mullions and transoms – Moderate</p>	Good	<p>Dressed and rubbed sandstone window frames including transoms and mullions. Generally in good condition, some evidence of damp to sills.</p> <p>Recommendation:</p> <ul style="list-style-type: none"> <li>Investigate damp</li> <li>Allow to repoint open joints TME</li> </ul>	Current

<p>Photo 21: One of the ground floor window sills showing evidence of damp.</p>

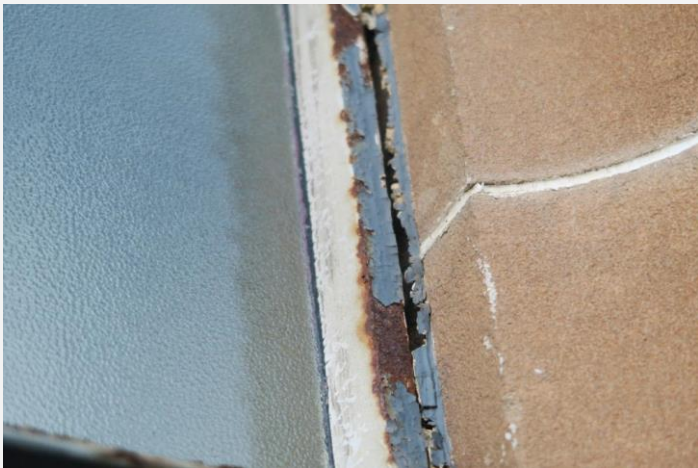
ITEM #	ELEMENT	SIGNIFICANCE	CONDITION	DESCRIPTION OF ELEMENT AND RECOMMENDATION	PRIORITY	IMAGE/ ADDITIONAL COMMENTS
5.3	Windows	<p>Glass ventilation panels to men's lavatory windows – High (1)</p> <p>Original and reproduction steel framed and leadlight window assemblies – Moderate (2)</p> <p>Replacement aluminium windows – Little (3)</p> <p>Package air-conditioning units through original windows – Intrusive (4)</p> <p>Alterations to windows of women's lavatory – Intrusive (4)</p> <p>Replacement window assemblies, where imitation leadlight stripping has fallen off - - Intrusive (4)</p>		<p>Mix of original steel (with some modified) and new aluminium windows. Steel windows show evidence of rust, but aluminium windows generally in good condition.</p> <p>Recommendation:</p> <ul style="list-style-type: none"> <li>• Allow to de-rust and paint steel windows where required</li> <li>• No works to aluminium windows.</li> </ul> <ul style="list-style-type: none"> <li>• Allow to reinstate missing piece of ventilation glass to mens WC window TME in conjunction with removal of services.</li> </ul>	<p>Current</p> <p>Current</p>

<p>Photo 28: Detail of a rusted sill.</p>

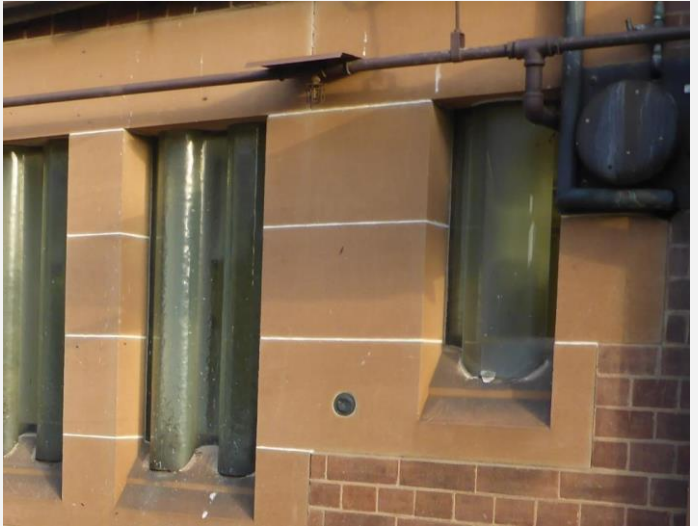
<p>Photo 29: Detail of the mens WC windows. The western-most window (right) is missing a section of glass.</p>

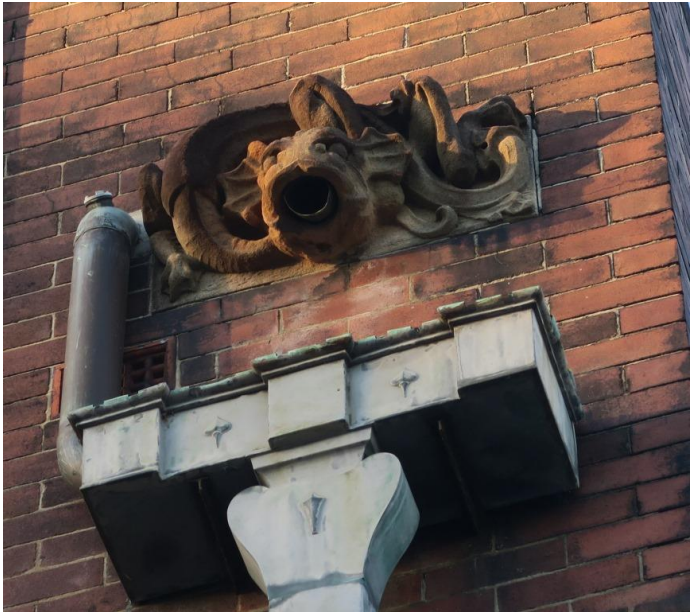
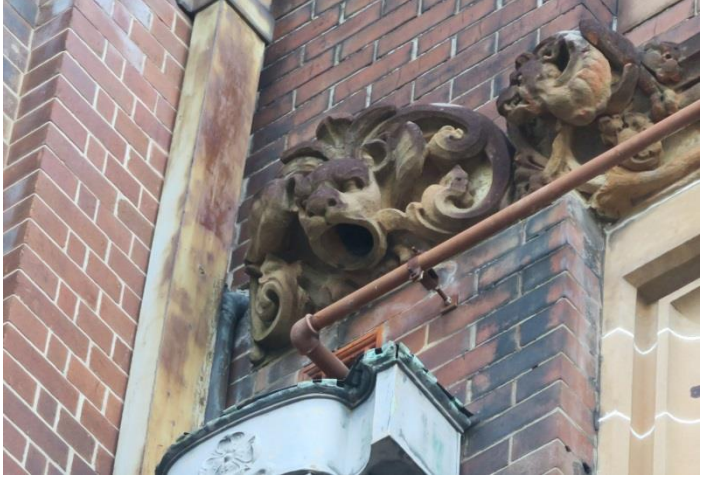
5.4	Rainwater Goods	<p>Original copper rainwater heads – High (1)</p> <p>Exposed plumbing on north elevation – Little (3)</p>	Fair	<p>Cast iron and other downpipes. Some cooper rainwater heads and elbows.</p> <p>Recommendation:</p> <ul style="list-style-type: none"> <li>• Undertake a full survey of the roof drainage system to ascertain that all outlets flow properly into the rainwater system. Some gargoyles are noted as missing outlets.</li> <li>• Allow to inspect rainwater goods at close range including repair of cracked or corroded downpipes etc.</li> <li>• Allow to inspect rainwater heads to determine deterioration</li> </ul>	Current

<p data-bbox="2131 688 2700 716">Photo 30a) and 30b) Details of gargoyles missing outlets</p>

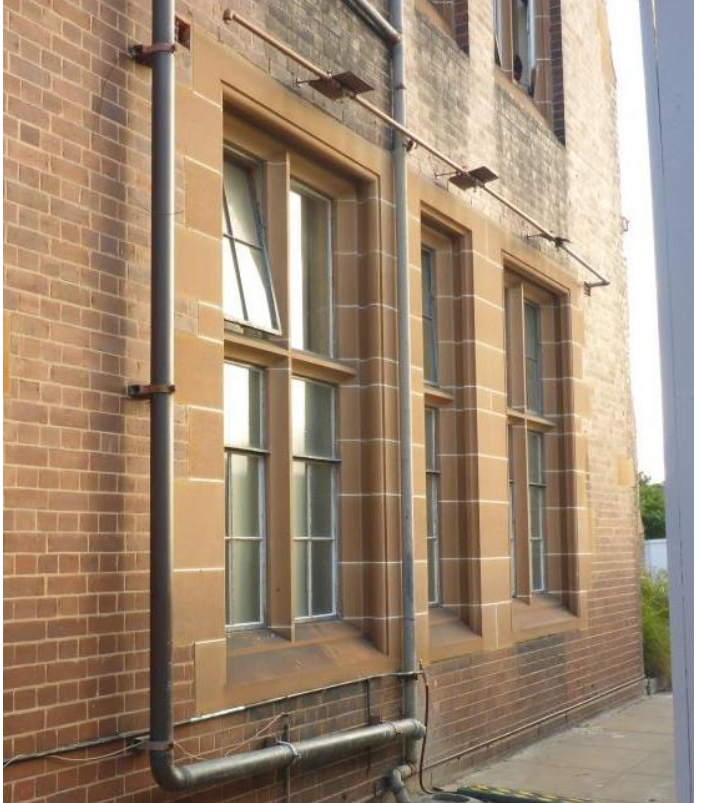
5.6	General	Brick and stone facades - Moderate (2)  String courses, window mullions and transoms – Moderate (2)		<p data-bbox="1032 1108 1917 1171">The subject proposal includes conversion of one (1) ground floor window to a door and provision of a new opening on the eastern end of the (north) façade</p> <ul data-bbox="1080 1207 1917 1308" style="list-style-type: none"> <li>• Allow for salvage of the stone window sill and mullion, steel window frames and brick below the sill (subject to approval of the works)</li> <li>• Allow for salvage of bricks in conjunction with new openings.</li> </ul>	Current

<p data-bbox="2131 1885 2748 1934">Photo 31: View of the ground floor northern elevation showing window to be modified (left)</p>

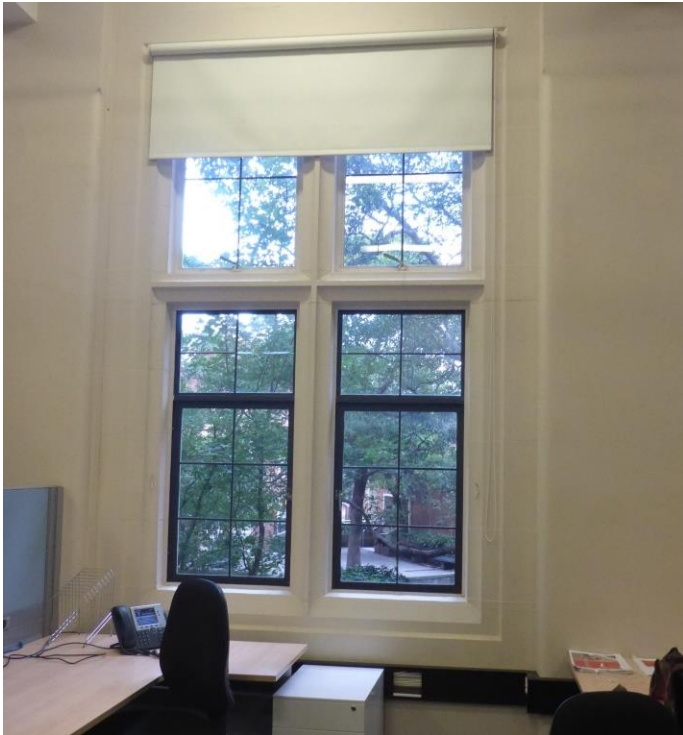
ITEM #	ELEMENT	SIGNIFICANCE	CONDITION	DESCRIPTION OF ELEMENT AND RECOMMENDATION	PRIORITY	IMAGE/ ADDITIONAL COMMENTS
Interior 6.0						
6.1	Stonework	String courses, window mullions and transoms – Moderate (2)	Good	<p>Dressed and rubbed sandstone window frames including transoms and mullions.</p> <p>Recommendation:</p> <ul style="list-style-type: none"> <li>• Allow to strip paintwork to all painted stone window reveals throughout the building including levels 1-3.</li> <li>• Strip paint from all stonework with Peelaway or similar as approved by the Heritage Consultant or University Heritage Architect. Thoroughly clean facade immediately after stripping paint ensuring the removal of all paint and chemicals</li> </ul>	Current

<p>Photo 32: Detail of one of the painted stone windows (room 202 south)</p>
