Project 86548.20
13 March 2025
R.009.Rev0
GAR

Contamination Summary Letter Proposed Commercial/Industrial Development DHL Stage 2, Part of 1953 - 2109 Elizabeth Drive, Badgerys Creek NSW

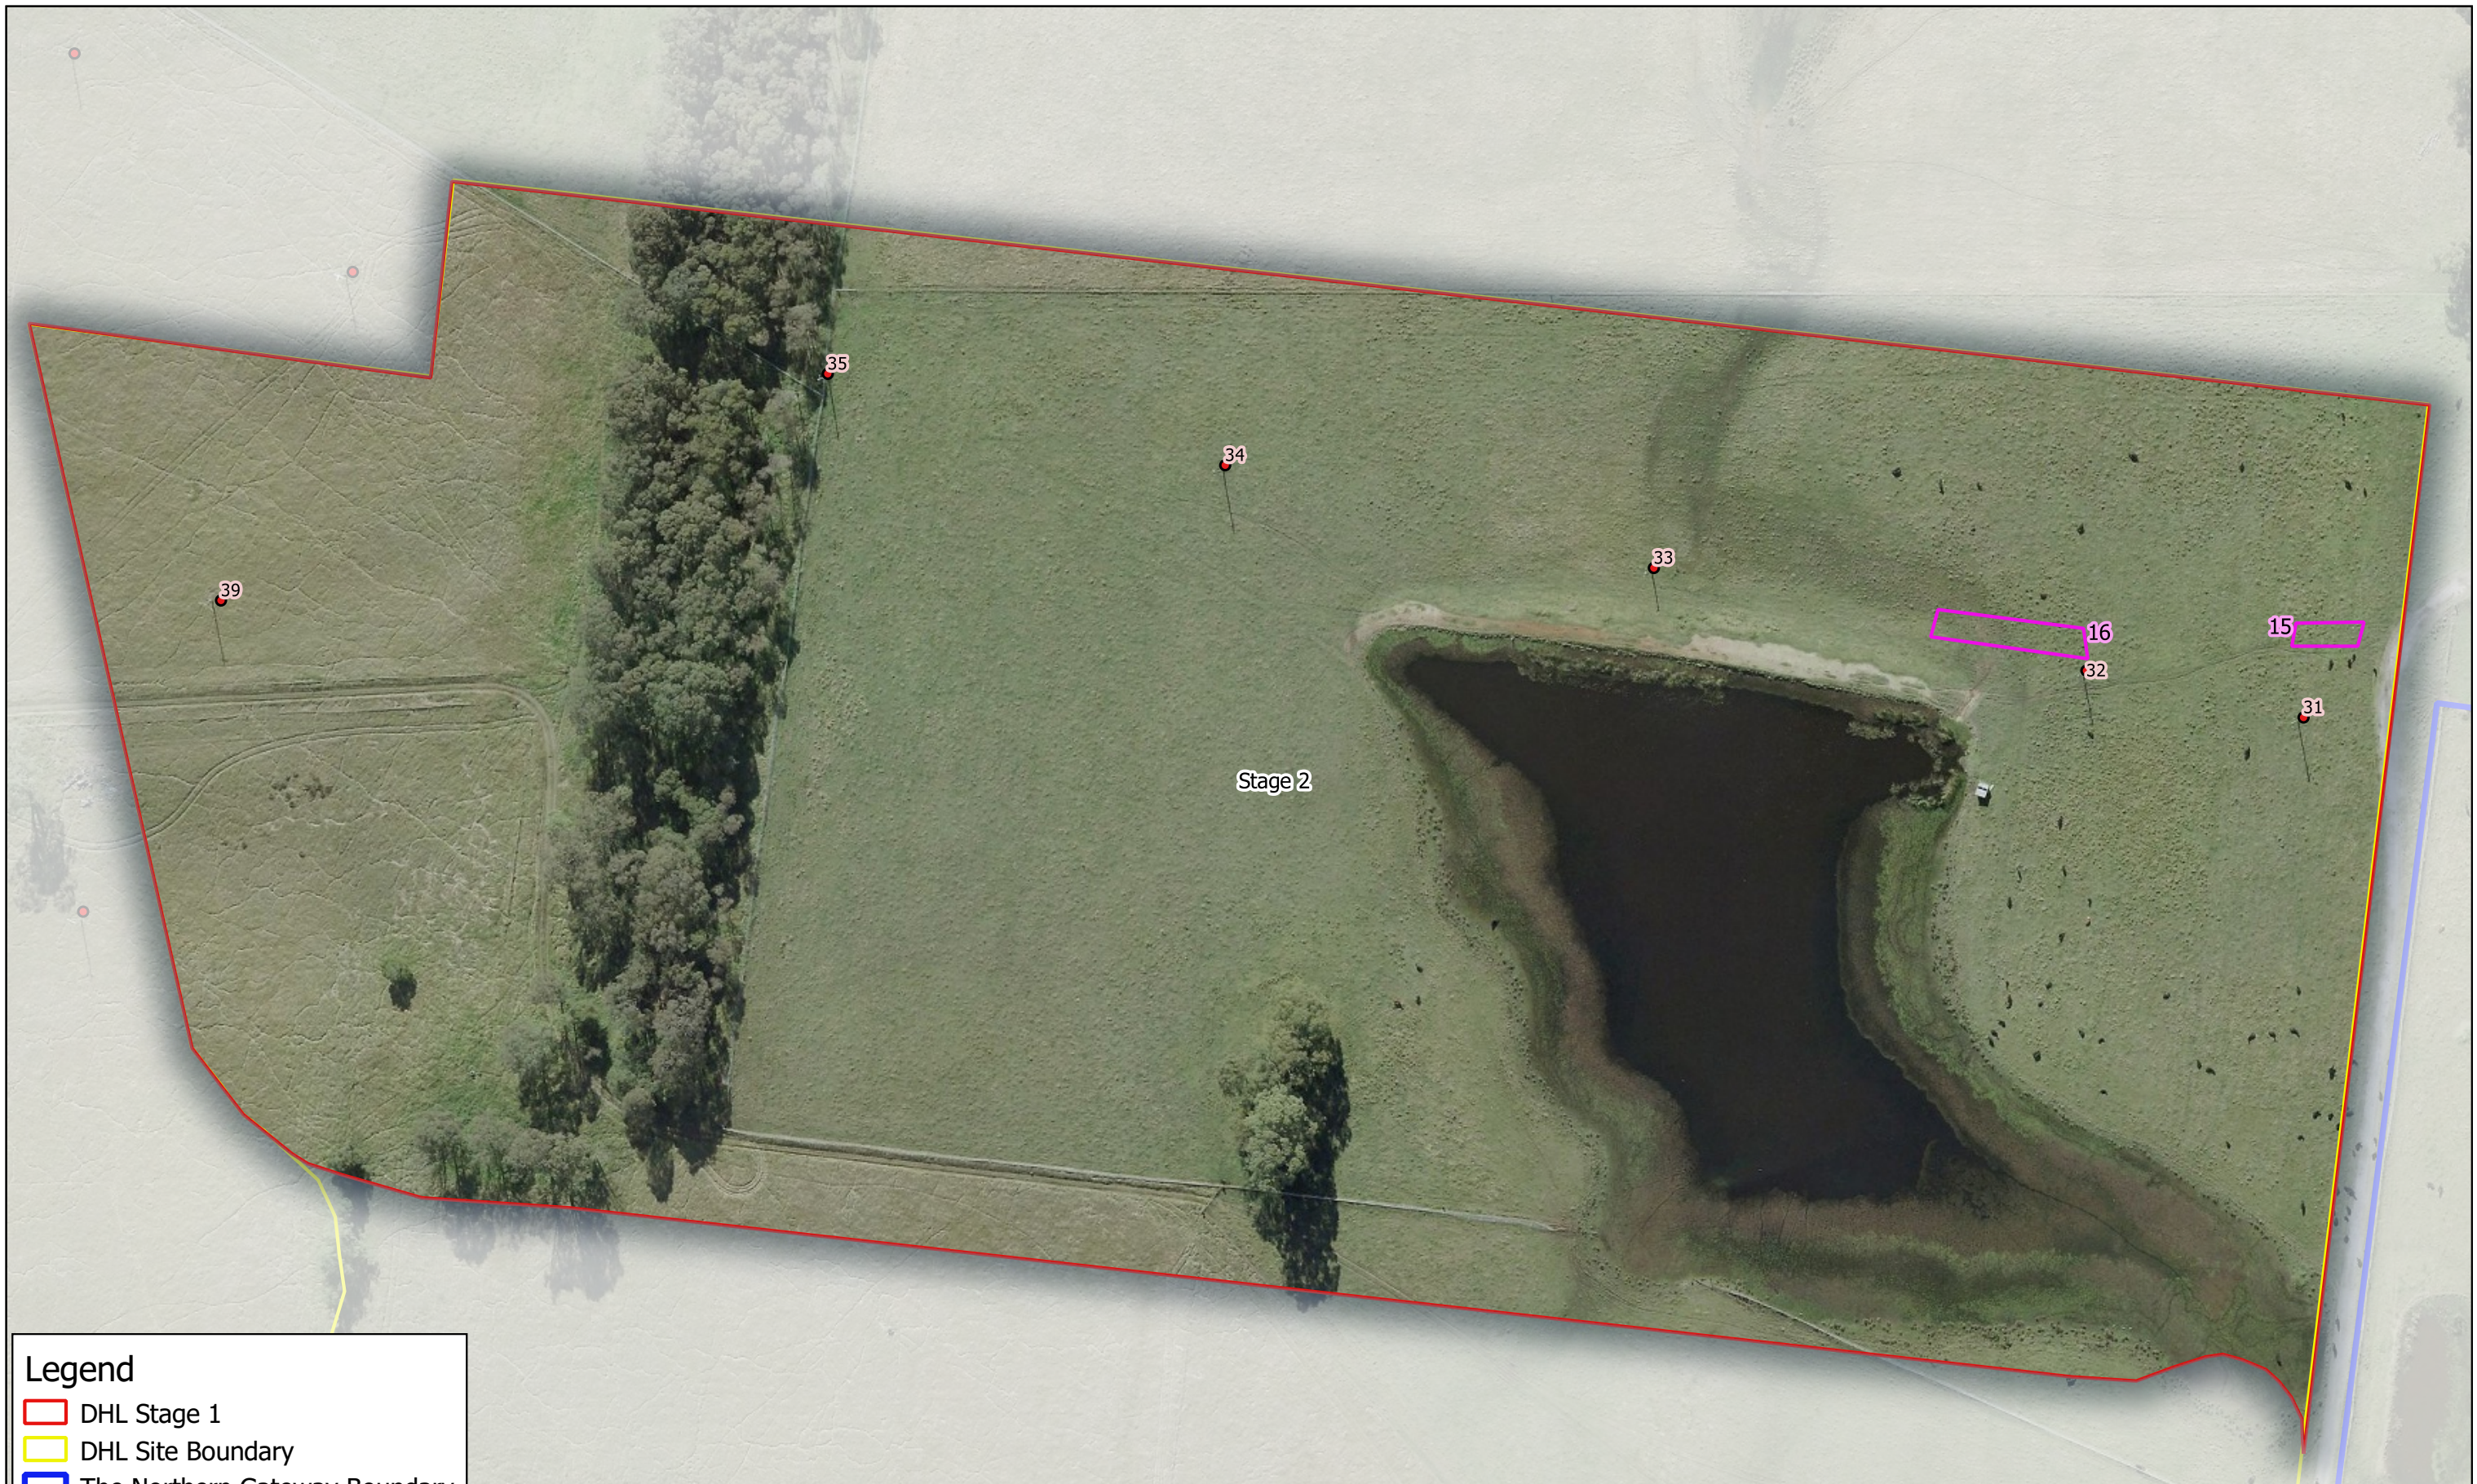
TITLE: **Drawing 2 - AEC15, AEC17 and Timber Power Poles (AEC36)**
Contamination Summary Letter - DHL Stage 2
Part of 1953 - 2109 Elizabeth Drive, Badgerys Creek, NSW

Soil analytical results were assessed against SAC and reviewed alongside observations made in the detailed site walk over. The findings of the DSI established that there was no evidence of widespread or significant contamination across the site. Localised contamination in some AECs was observed as requiring further investigation, delineation and/or remediation. The identified AEC are shown on Drawing 2, attached.

- AEC 36 – Exceedances of Metals (As), TRH, benzo(a)pyrene, and total PAH were recorded for surface soils around the two power poles assessed at the site. It was noted that exceedances of metals, TRH, benzo(a)pyrene, total PAHs and total PCBs have been observed next to power poles from elsewhere across the wider TNG site. Additional investigations would be required around all power poles at the site to establish and further define which are suitable to be retained on site and which will require remediation; and
- ACM Pipe network – an ACM pipe network has been sighted in several AECs (AEC 15 and 16). ACM pipe network should be removed, followed to their full extent and validated. Where observed, ACM fragments on the surface should be removed by hand.

- AEC 36: The results of power pole delineation sampling at power poles (PP32 and PP35), generally identified the lateral extents of surface topsoil impacted by power pole related COCP, as requiring remediation, to be limited to within 1 m (north, south, east and west) of each of the power poles across an approximate area of 4 m². The vertical extent of impact to topsoil was delineated in the vicinity of power pole (PP35) to depths of approximately 0.3 m bgl with the exception of power pole PP32. The vertical extent of impact to topsoils at power pole PP32 should be confirmed with validation sampling at the time of remediation.

- AEC15 and 16: ACM pipe network to be removed, the full extent of the network investigated and validated. Where observed, ACM fragments on the surface should be removed by hand. A RAP would be required to document the process for the remediation and validation works. There is the potential that an ACM pipe network not observed in the SCI is present at the site.

Based on the results of sampling of the remaining power poles on-site, and those samples with power pole related COPC exceeding the commercial/industrial land use criteria, remediation will be required of soil in the vicinity of power pole PP33. Based on the results of the delineation sampling the extent of impact to soil from related COPC in the vicinity of remaining power poles requiring remediation is expected to be limited to approximately 1 m from each power pole. The lateral and vertical extents of impact from power pole related COPC should be confirmed with validation sampling at the time of remediation.

Source/COPC	Transport Pathway	Receptor	Remediation action/further investigation requirements
AEC 15 and 16			
ACM pipe network – asbestos	Inhalation of dust	Future site users Adjacent land users	<p>ACM pipe network to be removed, including investigation and removal of the full extent and validated. Where observed, ACM fragments on the surface should be removed by hand. There is the potential that an ACM pipe network not observed in this investigation is present at the site.</p> <p>It is noted that DRM (2024) also identified fragments of ACM at AEC15 and AEC16. DRM (2024) also recommended that any topsoils from asbestos impacted AECs will require appropriate testing prior to beneficial re-use.</p> <p>Validation sampling requirements for ACM impacted areas have been documented in the Douglas (2024b) RAP.</p>
