DHL Supply Chain (Australia) Pty Limited  
Level 4, Building C  
1 Homebush Bay Drive  
Rhodes NSW 2138

Project 86548.20  
12 March 2025  
R.008.Rev0  
GAR

## **Contamination Summary Letter Proposed Commercial/Industrial Development DHL Stage 1, Part of 1953 - 2109 Elizabeth Drive, Badgerys Creek NSW**

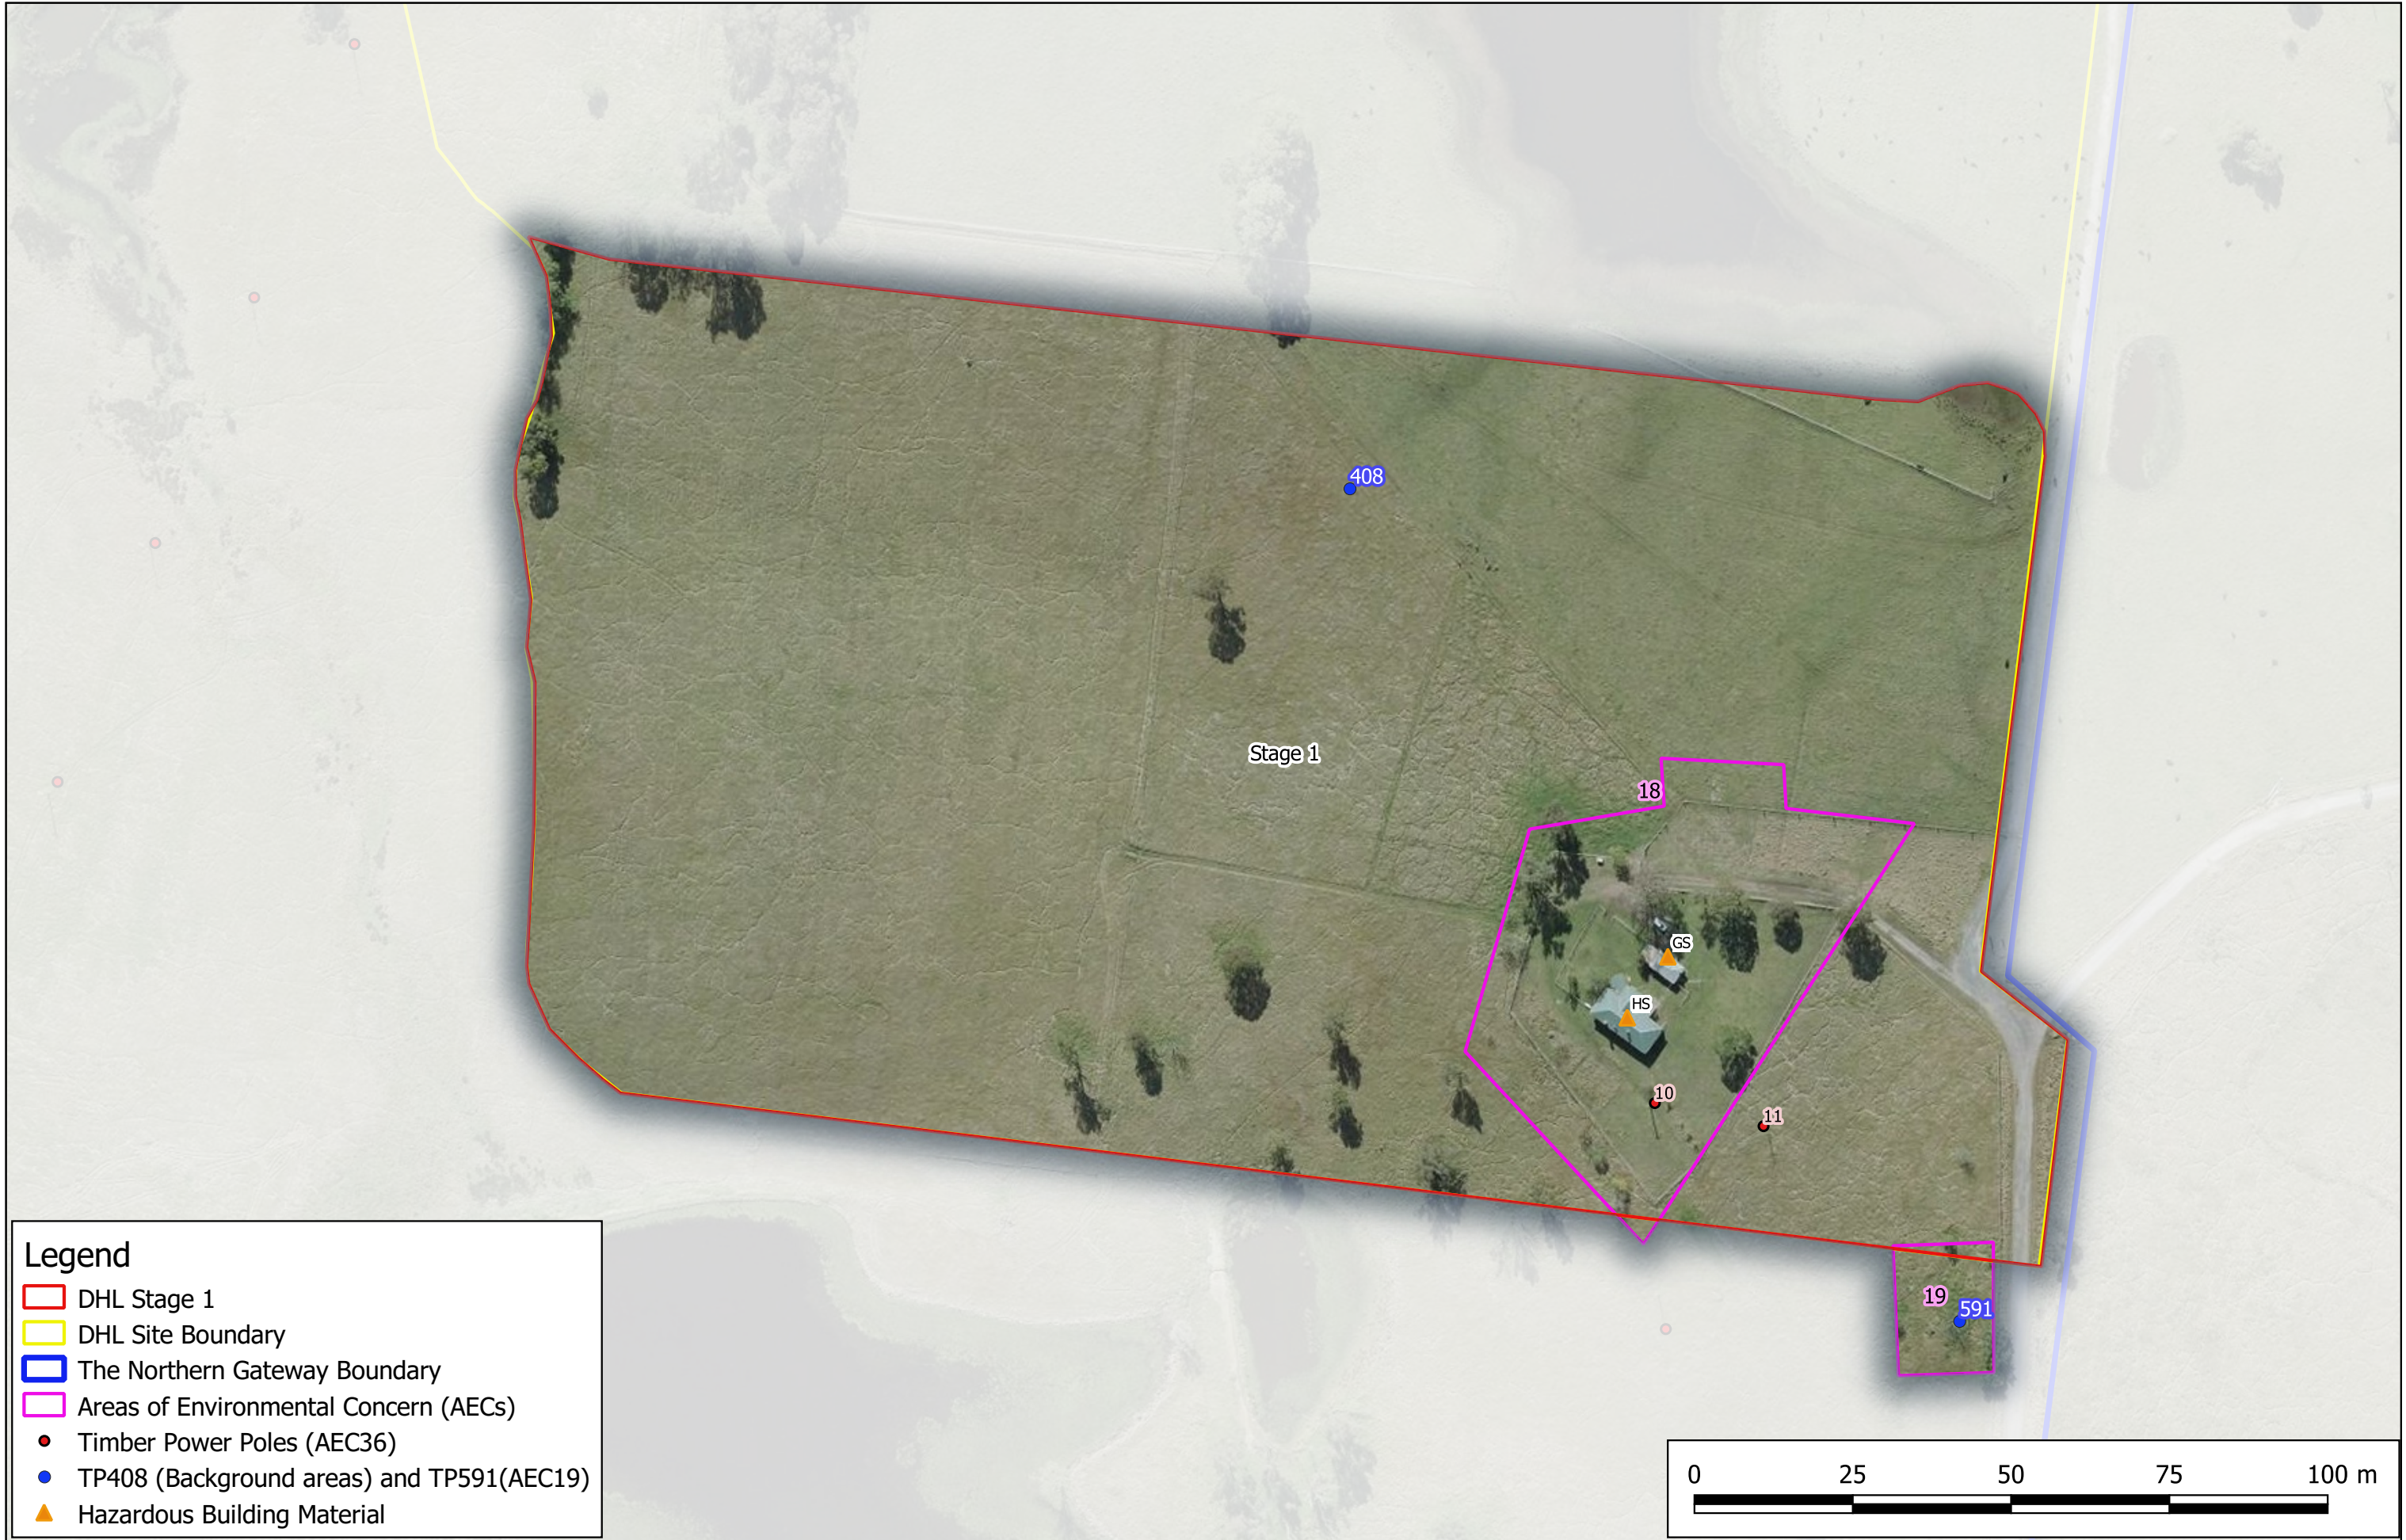
Soil analytical results were assessed against SAC and reviewed alongside observations made in the detailed site walk over. The findings of the DSI established that there was no evidence of widespread or significant contamination across the site. Localised contamination in some AECs was observed as requiring further investigation, delineation and/or remediation. Sampling locations and identified AEC are shown on Drawing 2, attached.

- AEC 36 – An exceedance of Metals (As) was recorded for surface soils around one of the two power poles assessed at the site. It was noted that exceedances of metals, TRH, benzo(a)pyrene, total PAHs and total PCBs have been observed next to power poles from elsewhere across the wider TNG site. It was noted that the number of exceedances observed in the DSI for the wider TNG site indicate additional targeted investigations of all power poles would be required to establish and further define which are suitable to be retained on site and which will require remediation;

- AEC 19 (Located immediately adjacent to the site) – ACM impact on the ground surface, a targeted investigation (double density, with reference to NSW EPA 1995 guidelines) should be undertaken to ascertain the extent of asbestos impact here. Where observed, ACM fragments on the surface should be removed by hand and the process documented in a RAP; and

- Background Areas - The DSI identified concentrations of nickel in shallow soil at levels exceeding the ecological SAC investigation levels (45 mg/kg) at Pit 408 (94 mg/kg). Further investigation would be required to assess whether the nickel exceedance was either an anomalous isolated occurrence or indicative of more extensive nickel impact to site soil that may require remediation.

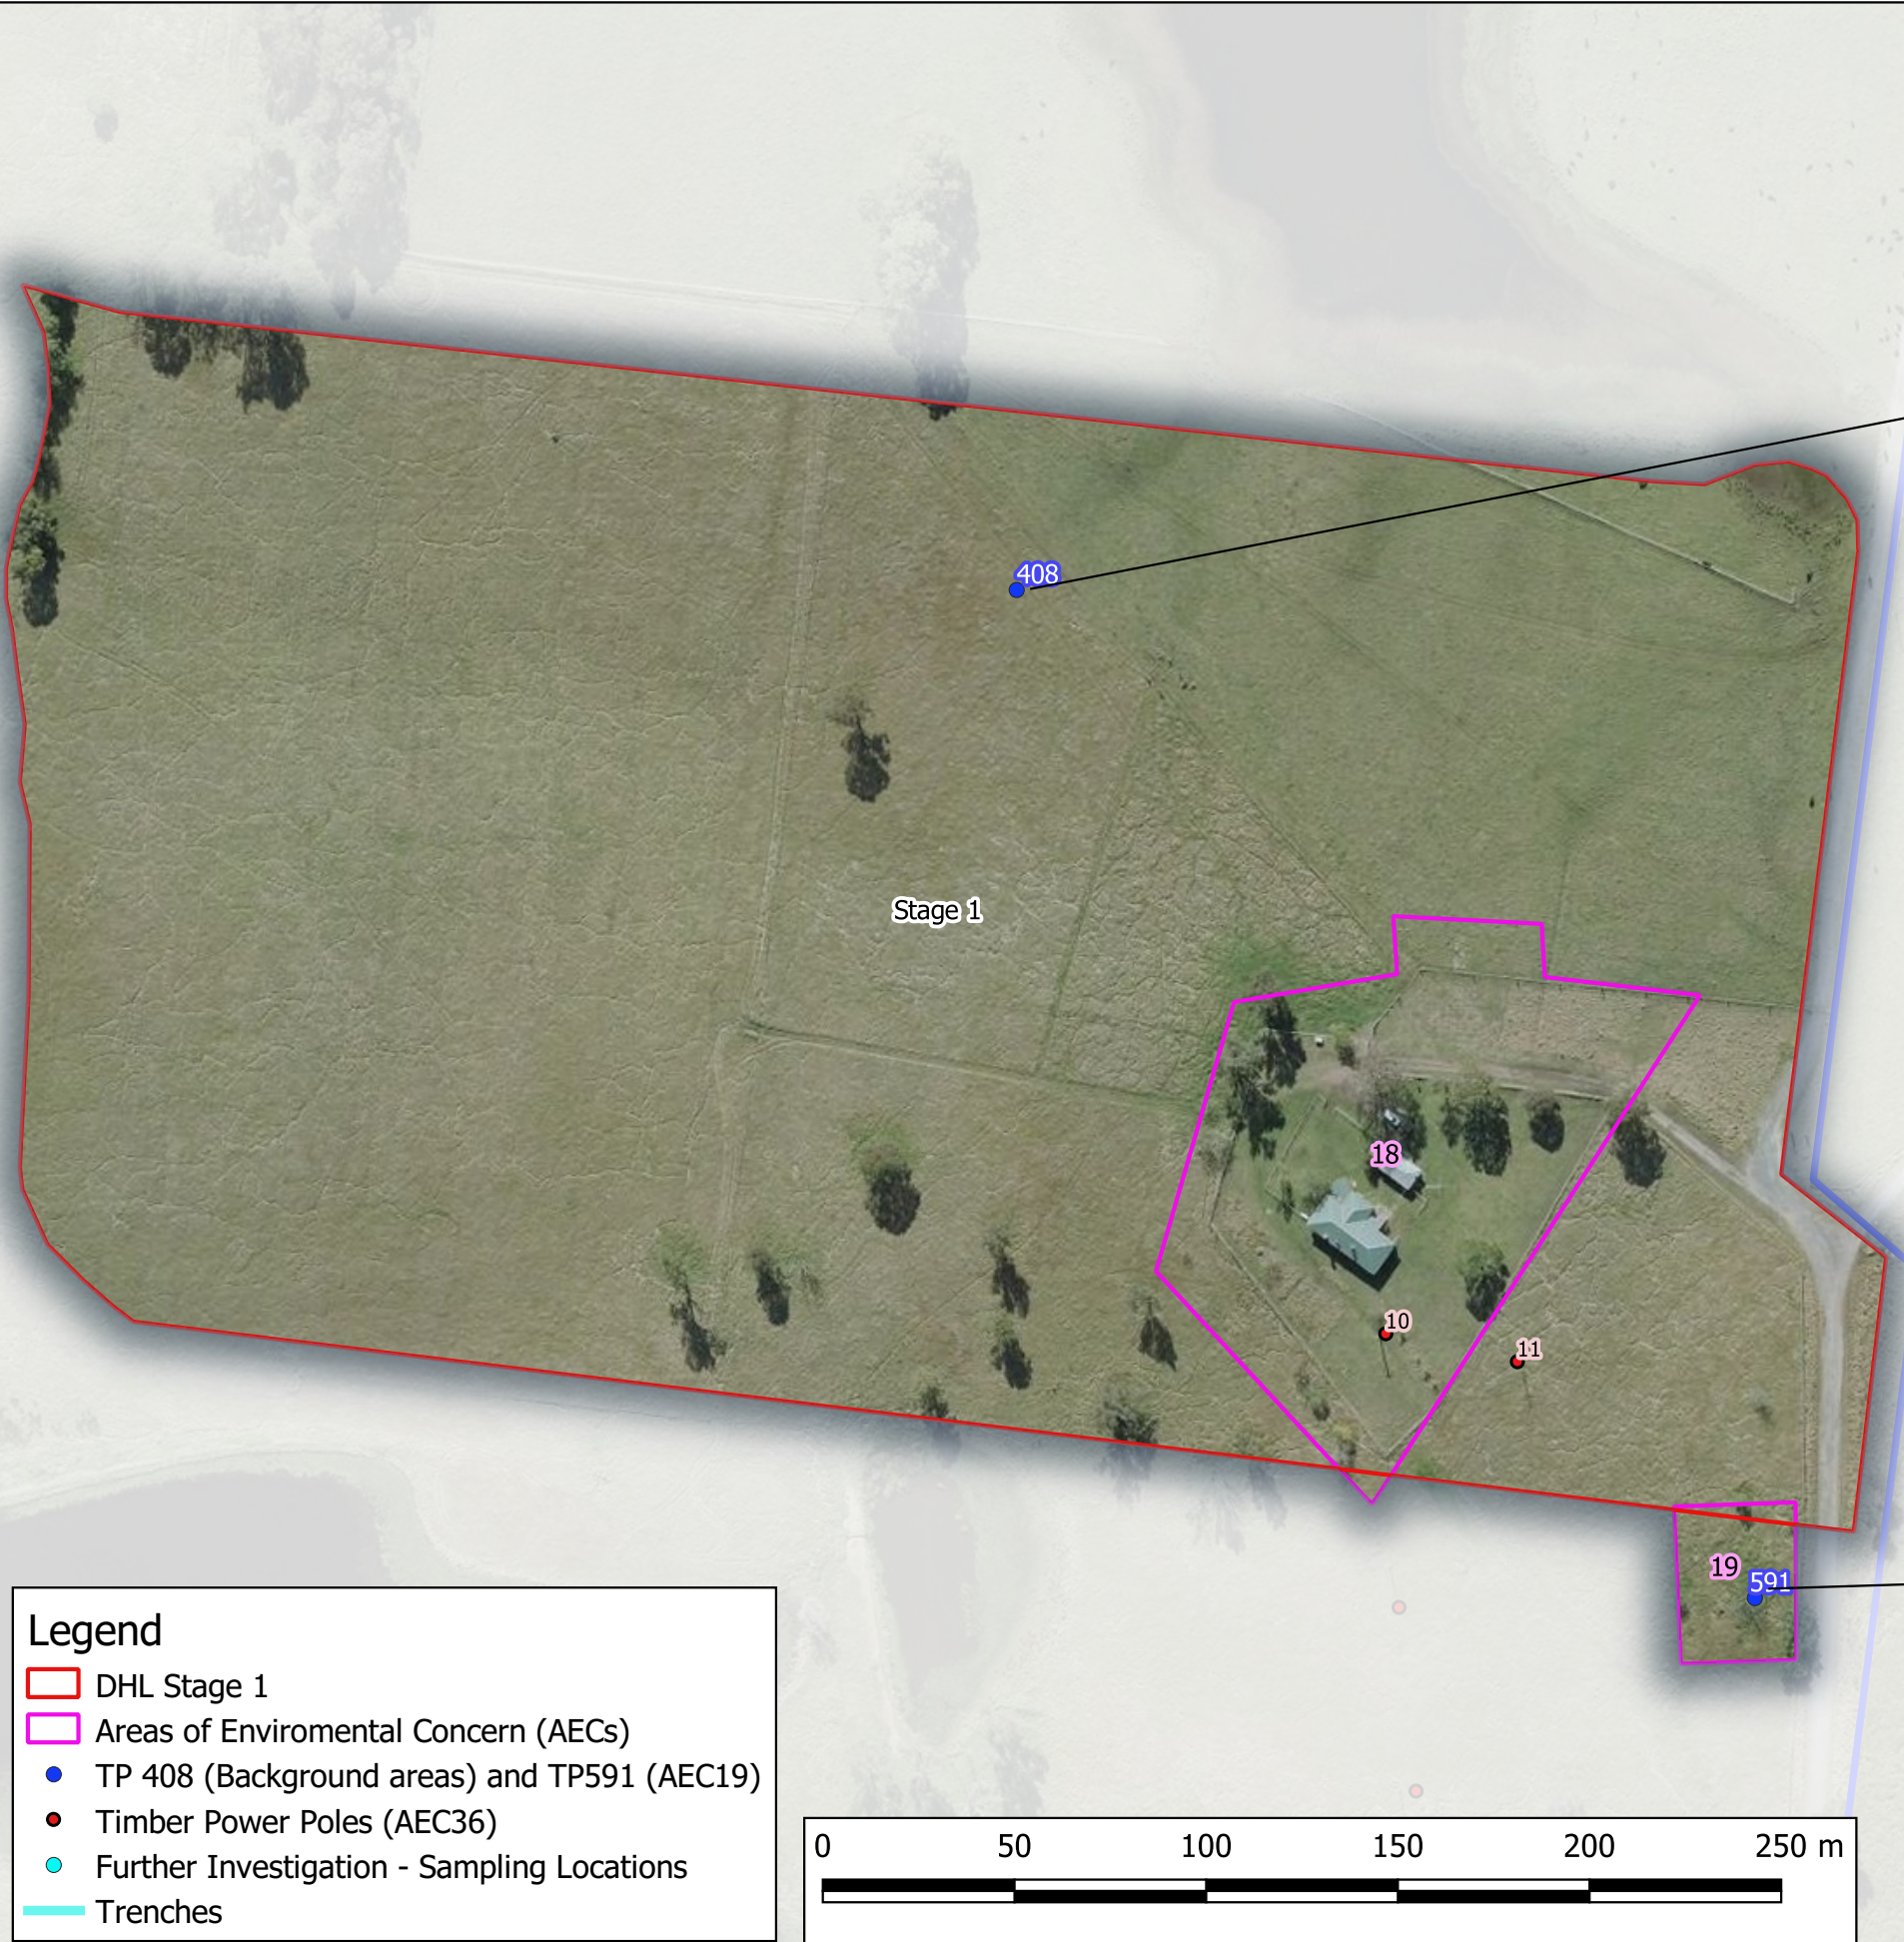
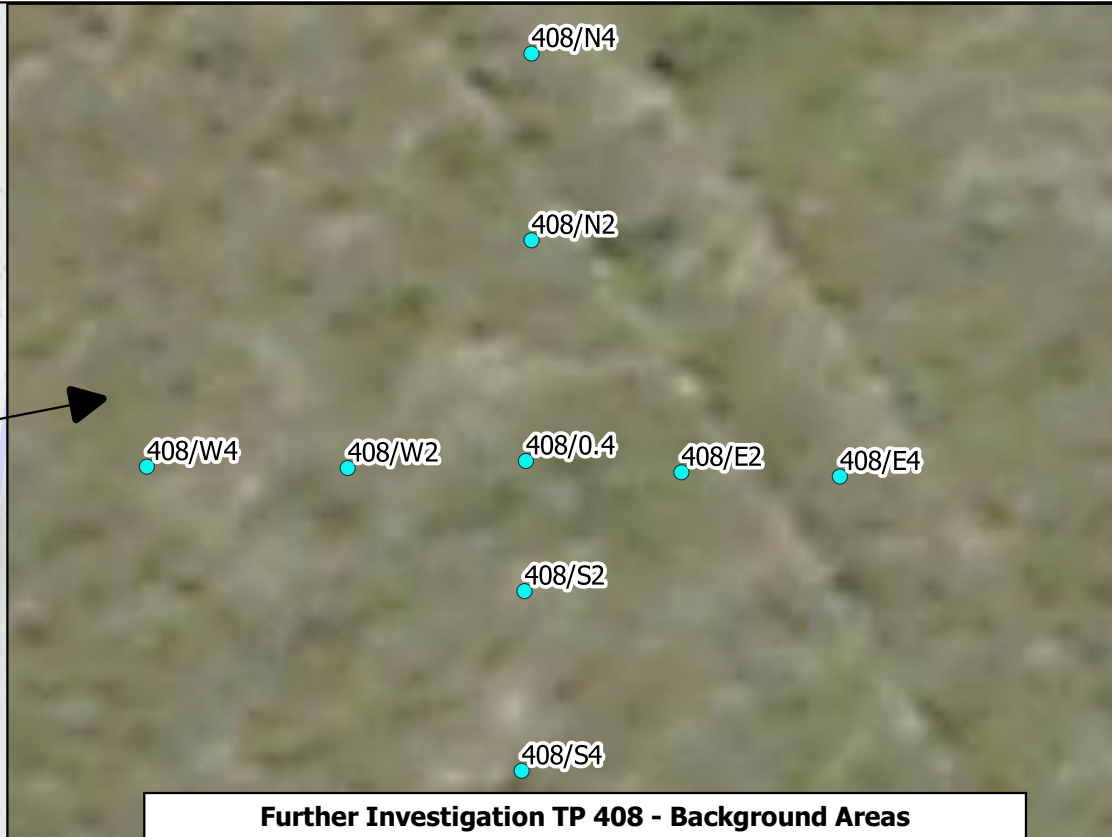
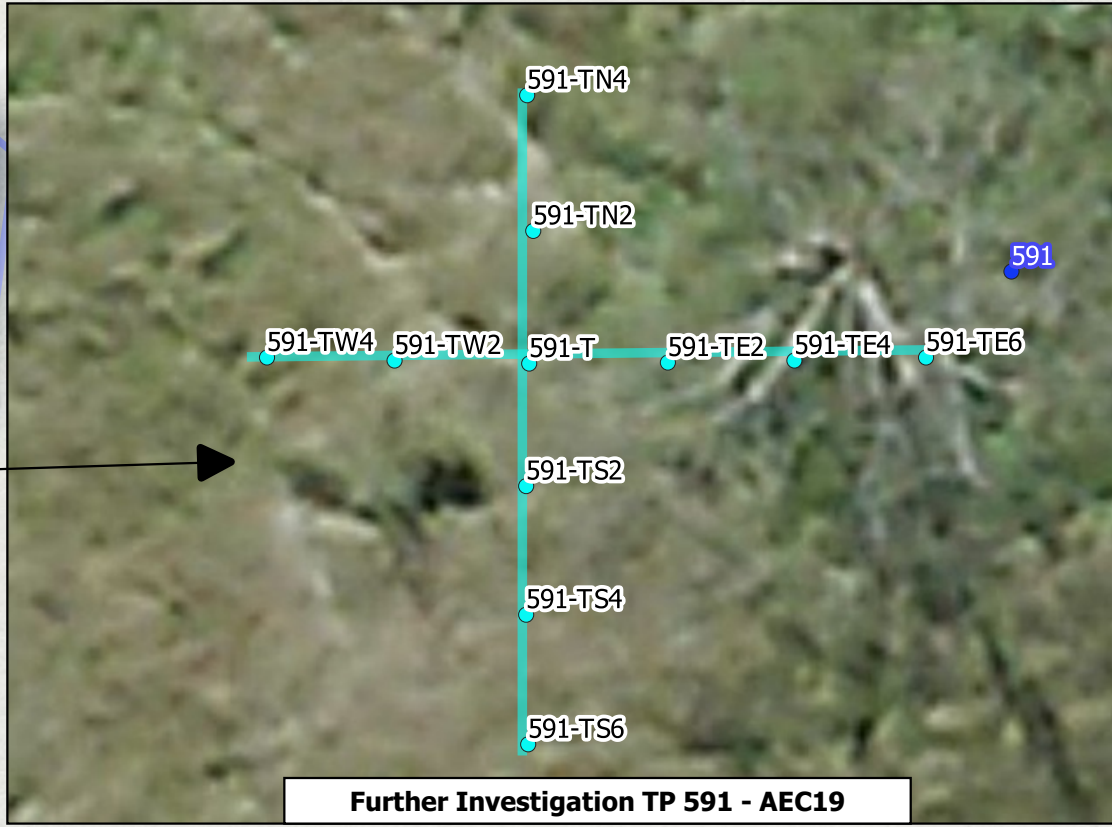
SCI fieldwork was completed at the site on 14 to 20 December 2022 and 7 to 9 February 2023. SCI sample locations are shown on Drawing 3, attached. To assess the AEC identified as requiring further investigation, the following scope of work was completed:

- AEC 36: The results of power pole delineation sampling at power pole (PP10), identified the lateral extents of surface topsoil, as requiring remediation across an approximate area of 4 m<sup>2</sup> to a vertical depth of approximately 0.3 m bgl. Exceedances for ESLs and or public open space criteria only (without exceeding commercial/industrial criteria) were not considered to warrant remediation of soil in the vicinity of the power pole (PP11) given the primary commercial/industrial land use of the site and the limited potential for public or ecological access to soil;

- AEC 19 (Located immediately adjacent to the site): Whilst the fill in the vicinity of pit 591 is considered suitable from a contamination perspective to remain on-site, given the presence of ACM identified on the surface, minor remediation will be required to ensure that no visible asbestos remains in surface soils in the vicinity of pit 591. It is noted that the area identified within AEC 19 as requiring remediation is not within the Stage 1 boundary.

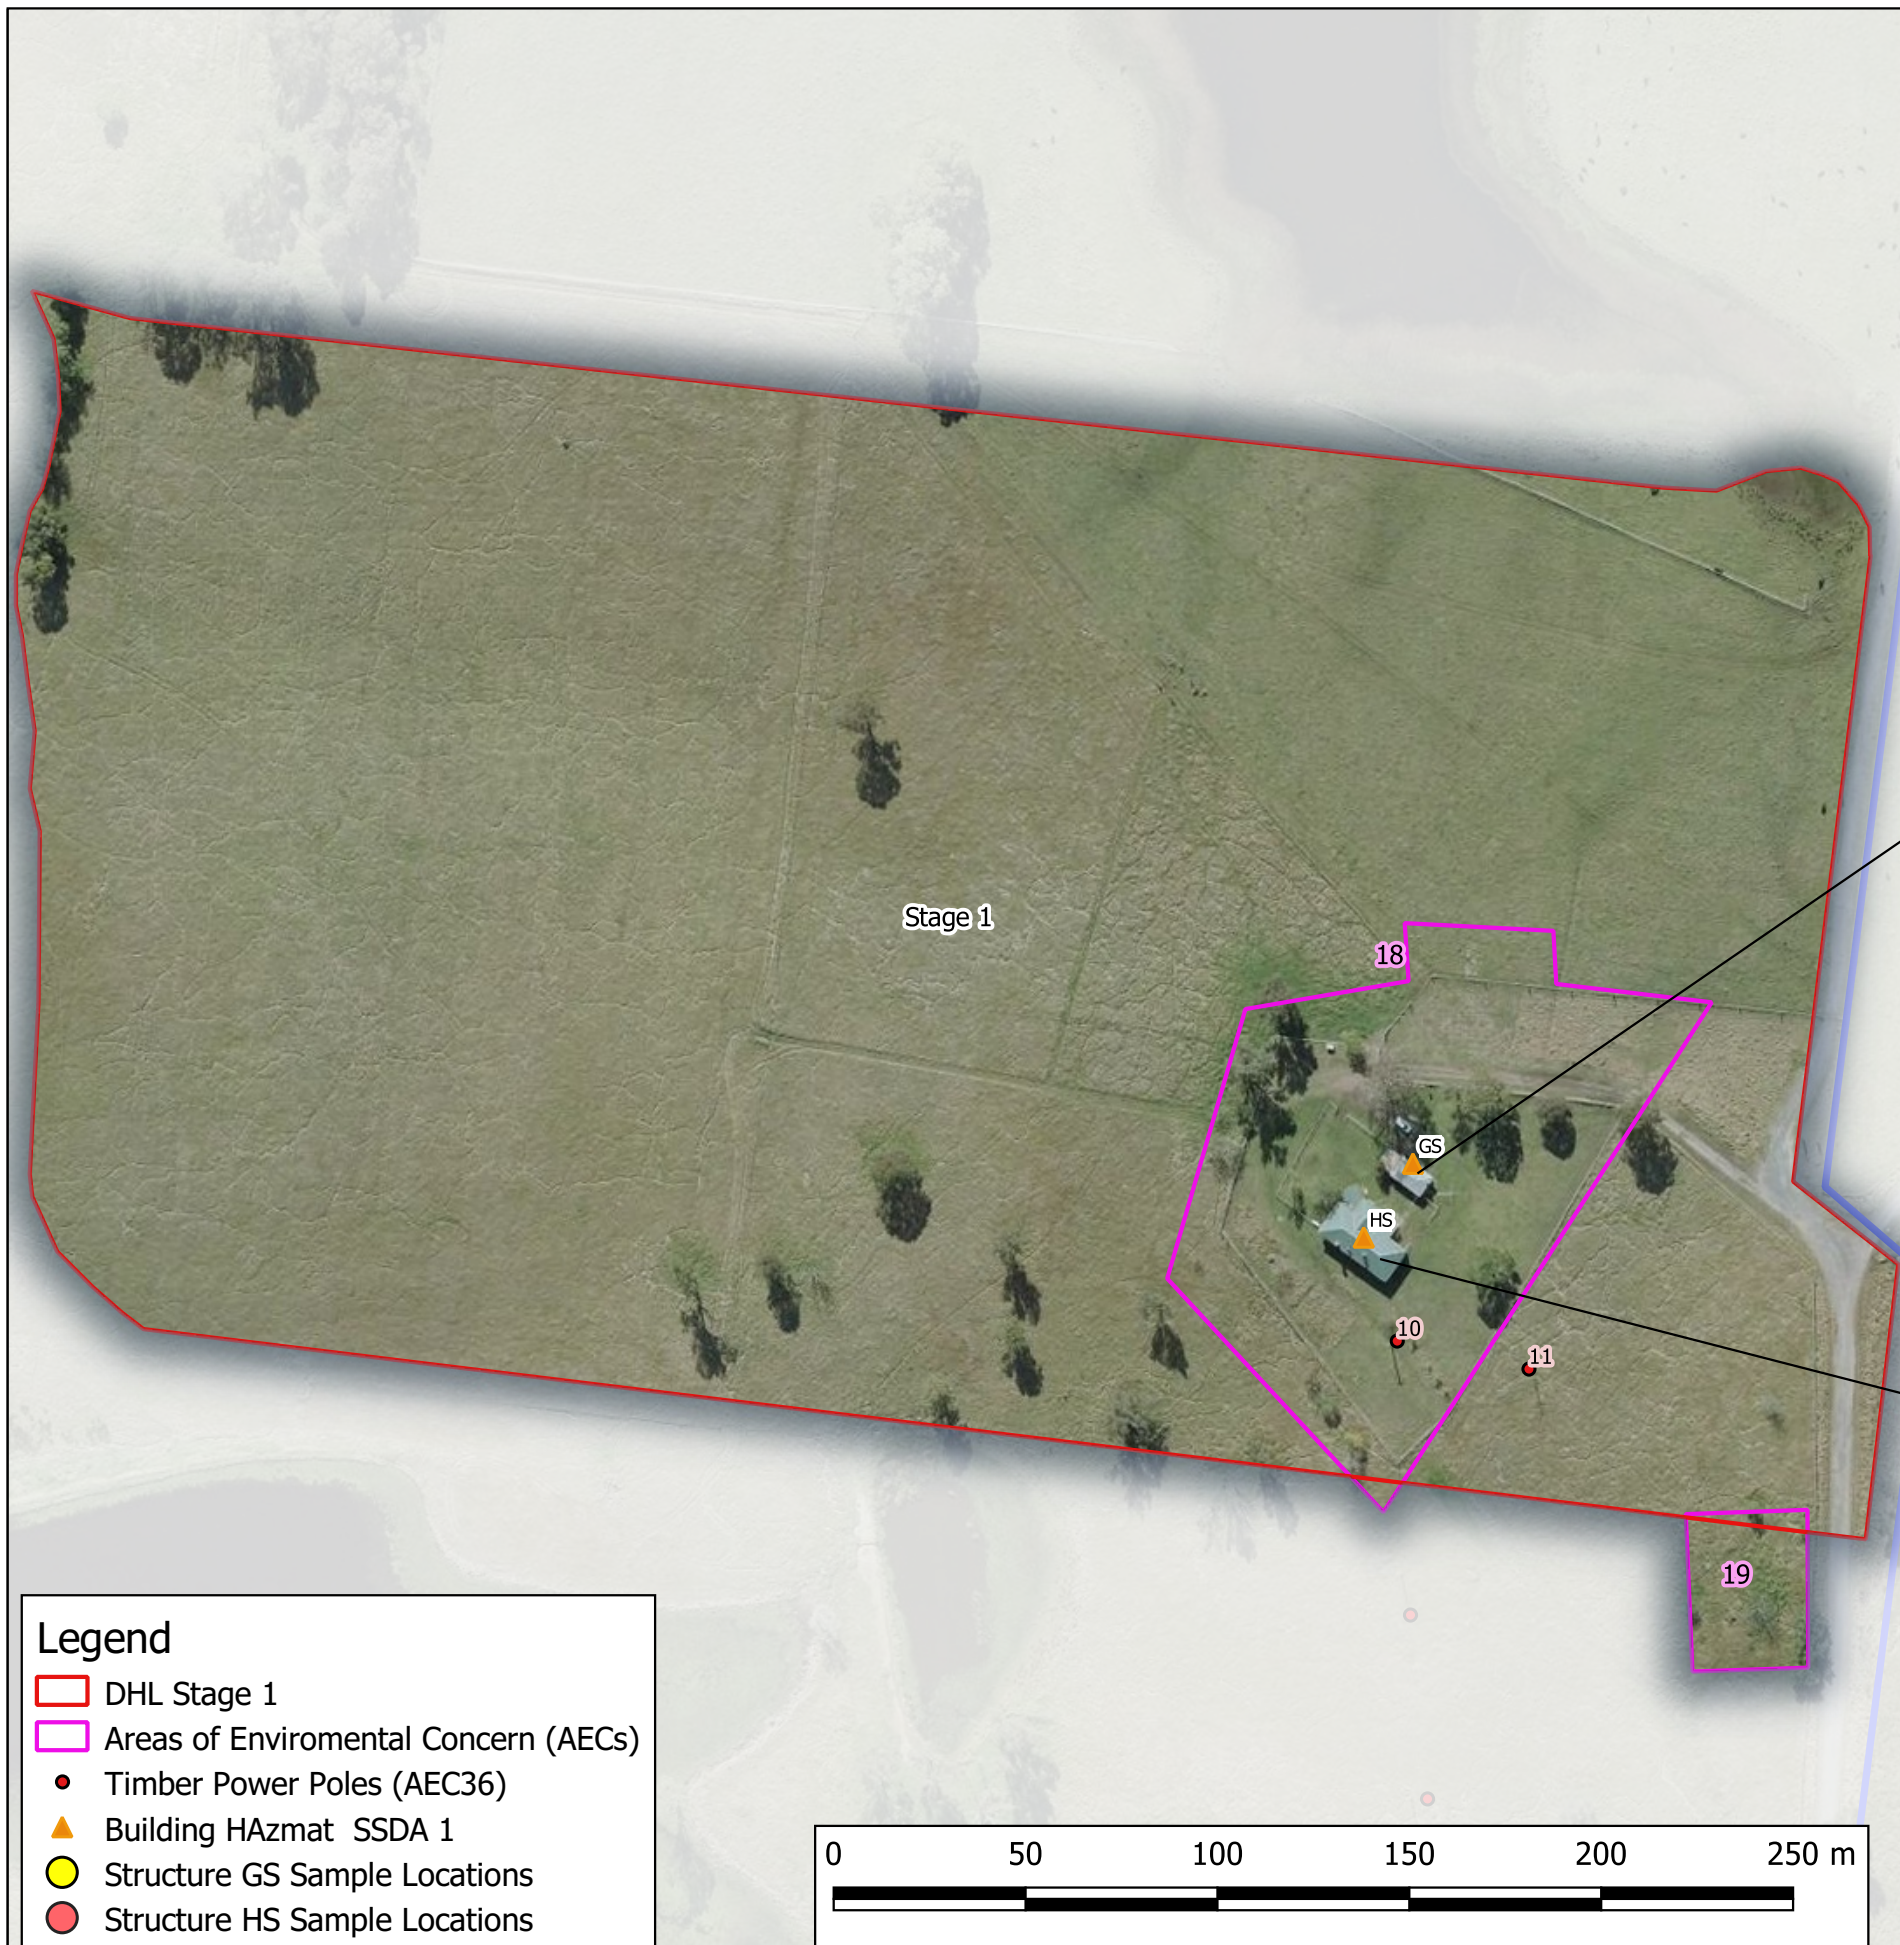
Hazardous building material sample locations are shown on Drawing 4, attached.

- Building HS (house structure) - contained non-friable asbestos within interior ceiling and walls sheeting. Lead was also detected in exterior and interior paint from the building, and it presented elevated lead dust concentration ( $\geq 0.5 \text{ mg/m}^2$ ); and
- Building GS (garage structure) - contained lead in interior and exterior paint(s), elevated lead dust concentration ( $\geq 0.5 \text{ mg/m}^2$ ) and SMF was detected through the ceiling cavity.
