Report on  
Hazardous Building Materials (HBM) Survey

DHL Stage 1  
Part of 1953 - 2109 Elizabeth Drive  
Badgerys Creek

Prepared for  
DHL Supply Chain (Australia) Pty Limited

Project 86548.20  
September 2024

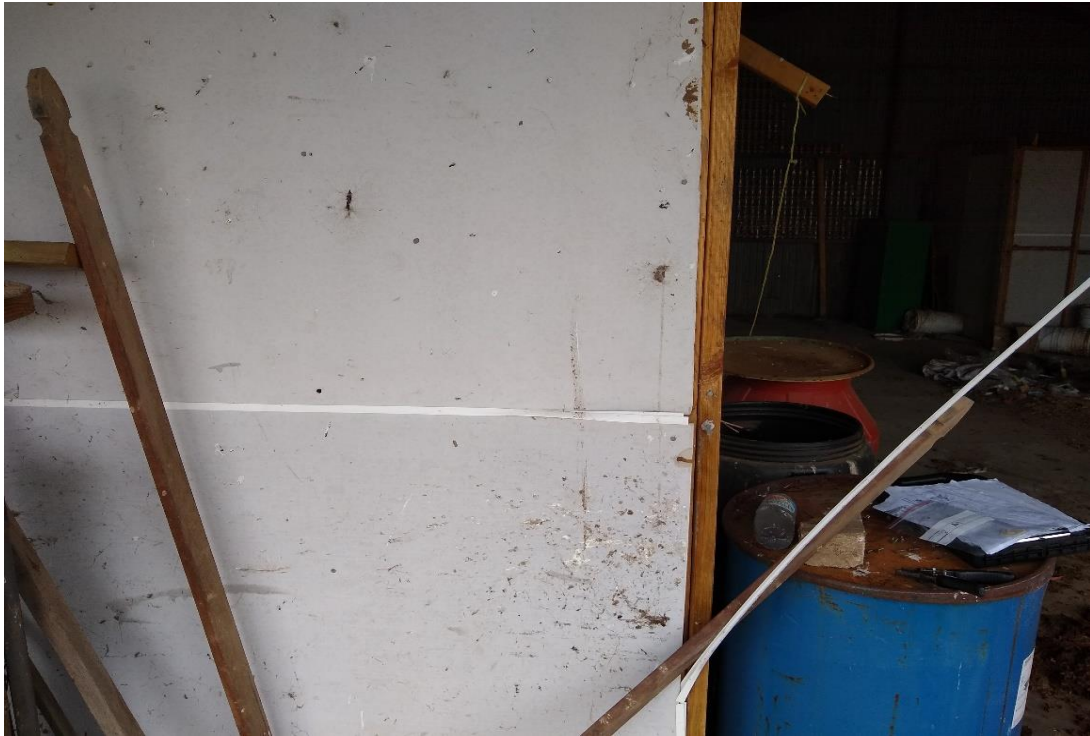
Photo 1: Building 2, interior, wall sheeting, fibre cement sheeting, sample 2A1, no asbestos detected by analysis.

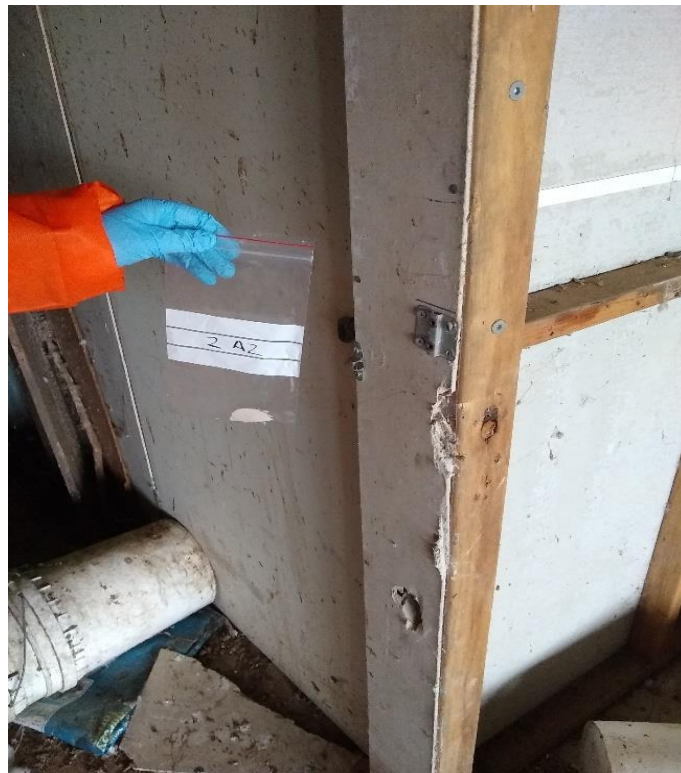
Photo 2: Building 2, interior, wall sheeting, fibre cement sheeting, sample 2A2, no asbestos detected by analysis.

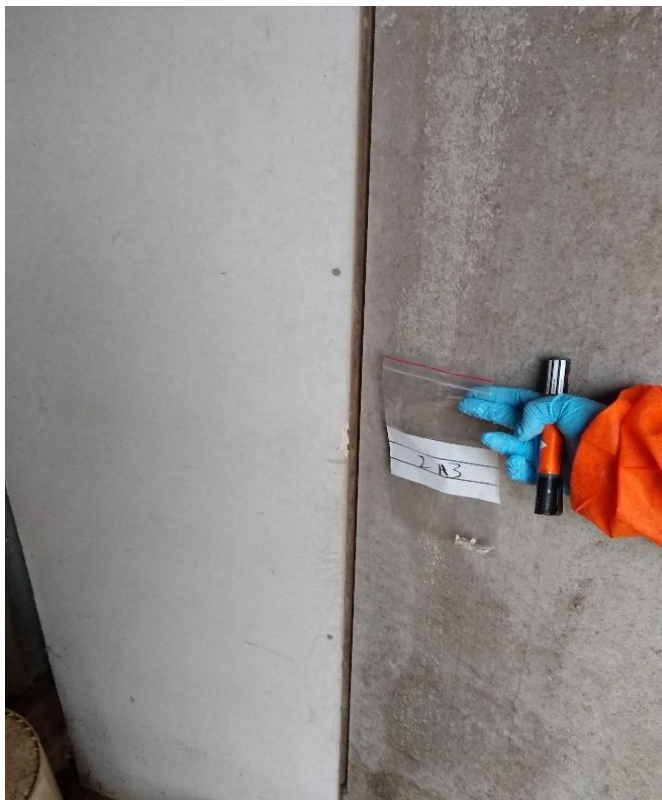
Photo 3: Building 2, interior, wall sheeting, fibre cement sheeting, sample 2A3, no asbestos detected by analysis.

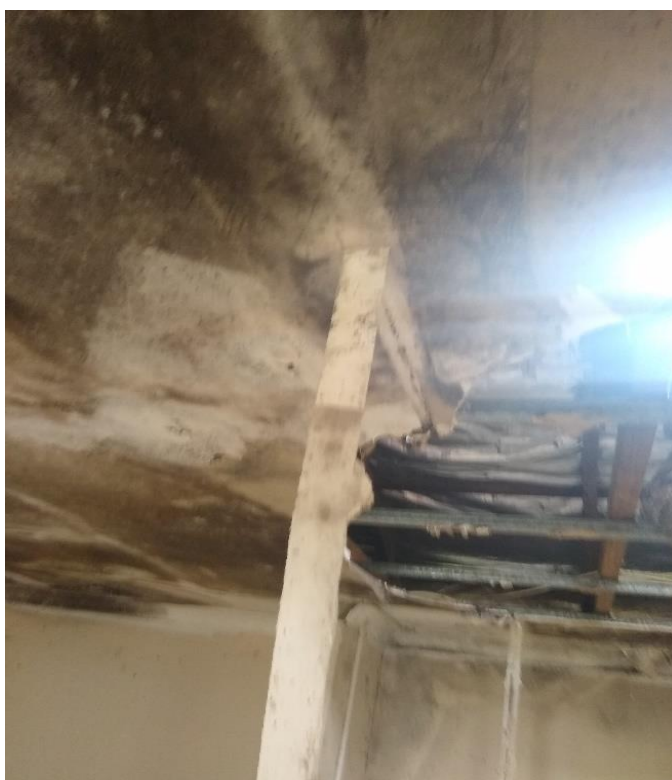
Photo 4: Building 4, interior, ceiling sheeting, plaster sheeting, sample 4A1, no asbestos detected by analysis (SMF detected).

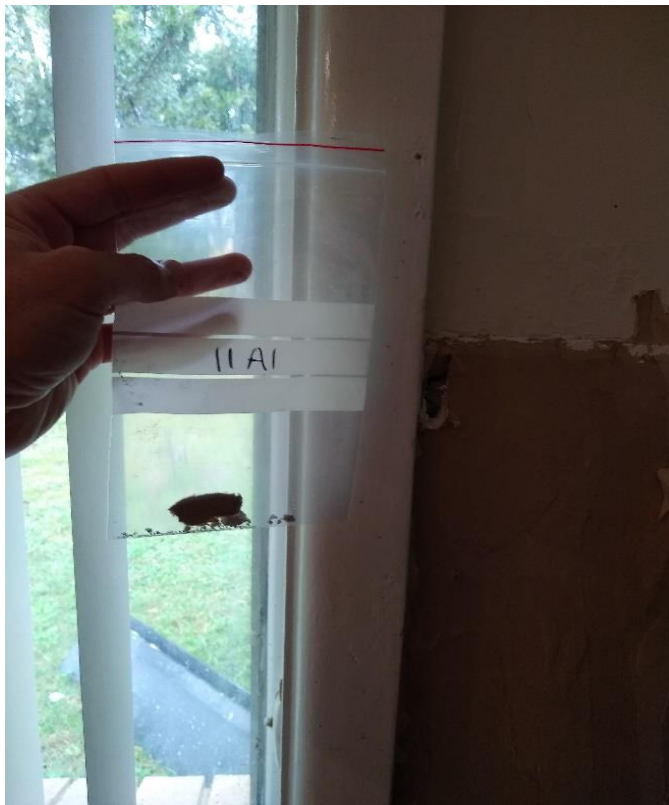
Photo 5: Building 11, interior, wall sheeting in eastern bedroom in house, plaster sheeting, sample 11A1, no asbestos detected by analysis.

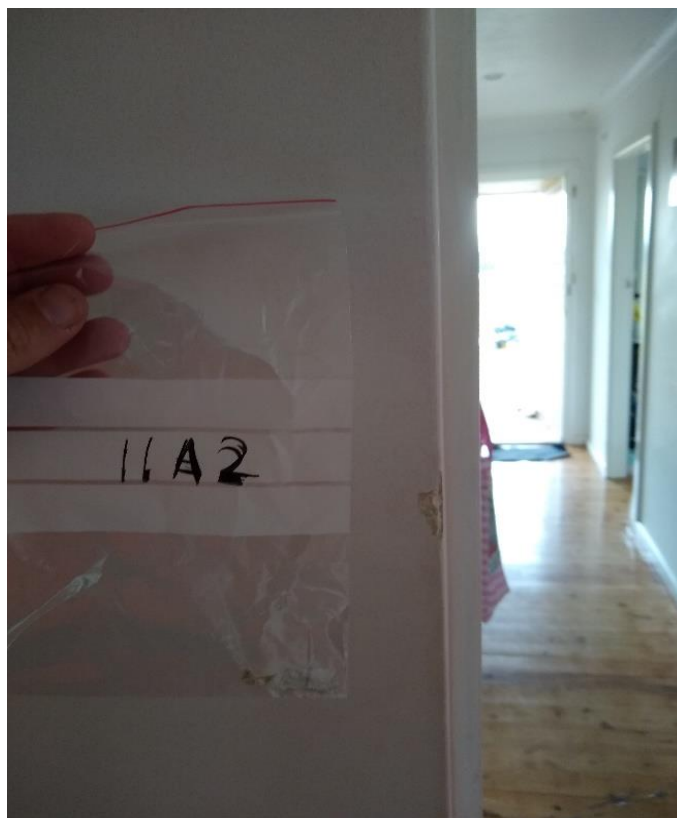
Photo 6: Building 11, interior, wall sheeting within eastern corridor of house, fibre cement sheeting, sample 11A2, asbestos detected by analysis.

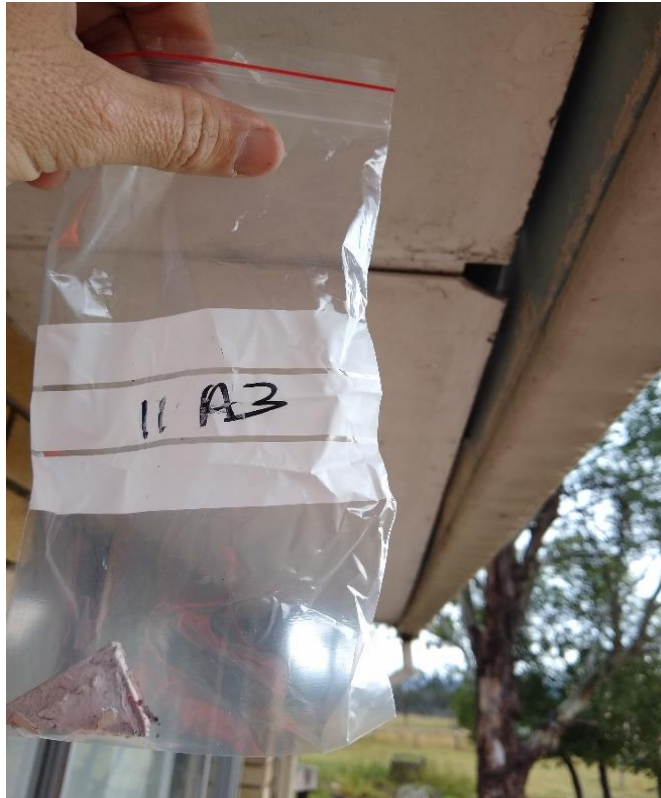
Photo 7: Building 11, exterior, sheeting from eaves, fibre cement sheeting, sample 11A3, asbestos detected by analysis.

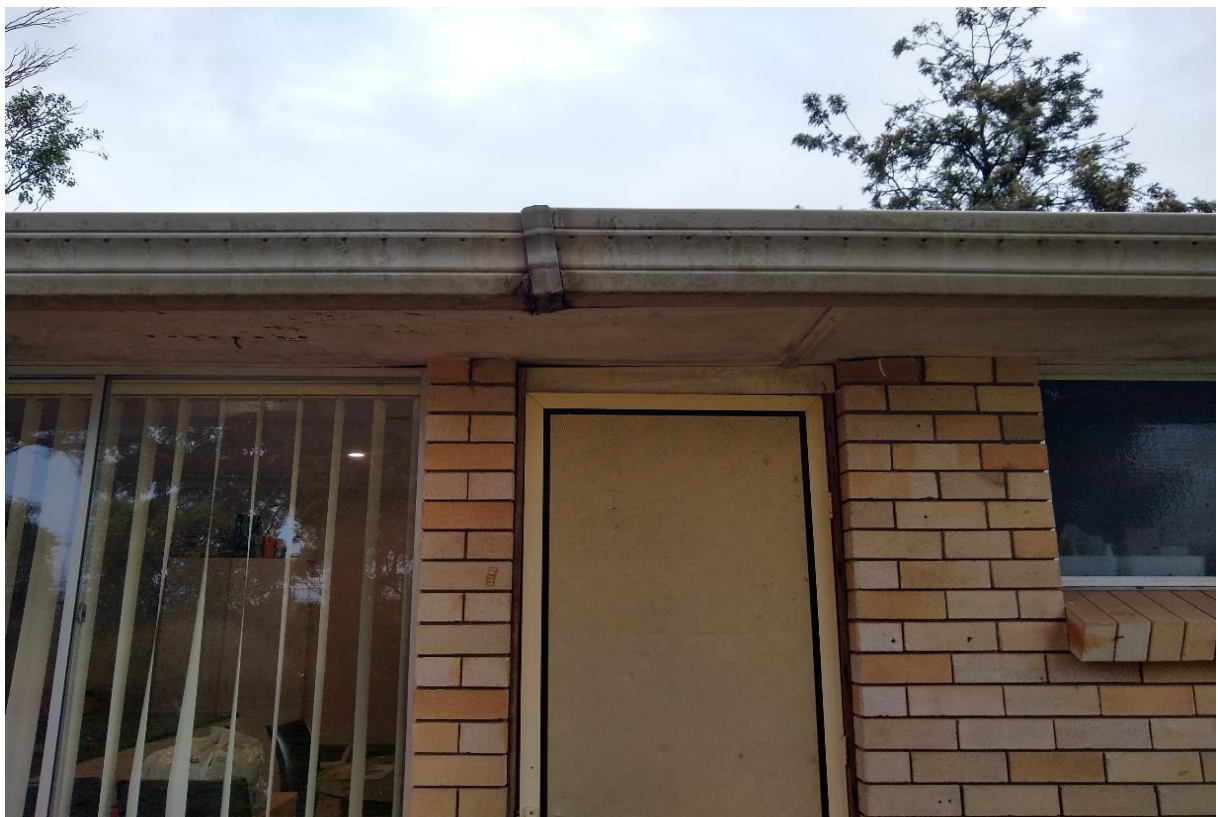
Photo 8: Building 11, exterior, sheeting from eaves, fibre cement sheeting, sample 11A4, asbestos detected by analysis.

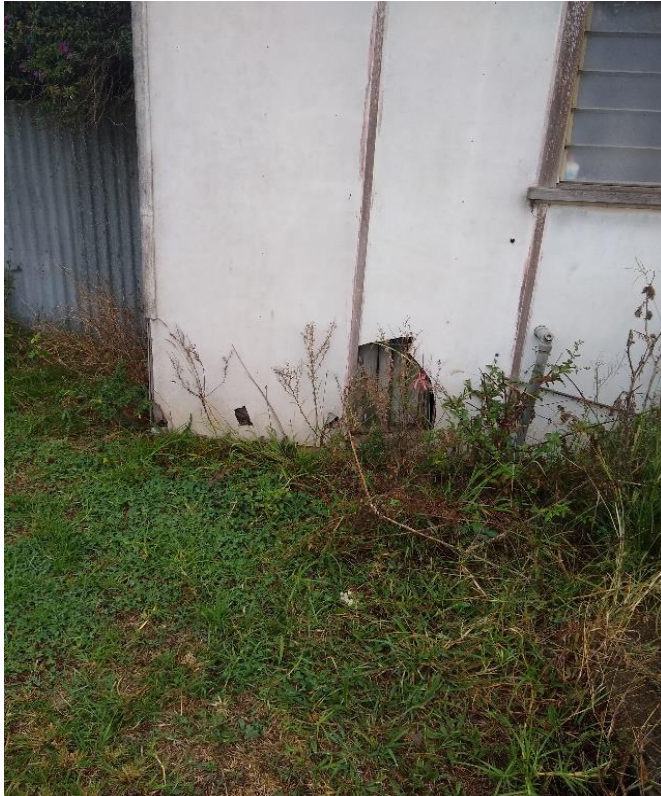
Photo 9: Building 21, exterior, wall sheeting on side shed, fibre cement sheeting, sample 21A1, asbestos detected by analysis.

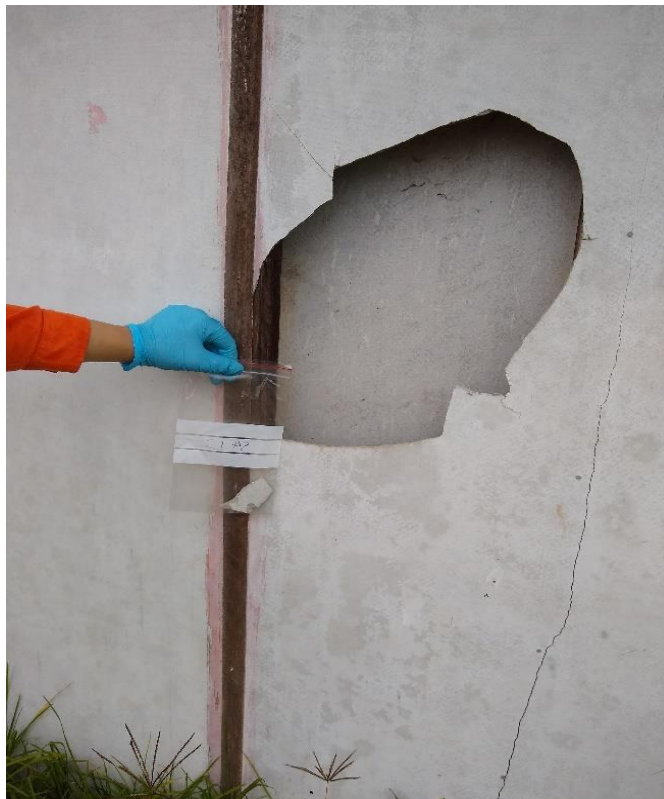
Photo 10: Building 21, exterior, wall sheeting on side shed, fibre cement sheeting, sample 21A2, asbestos detected by analysis.

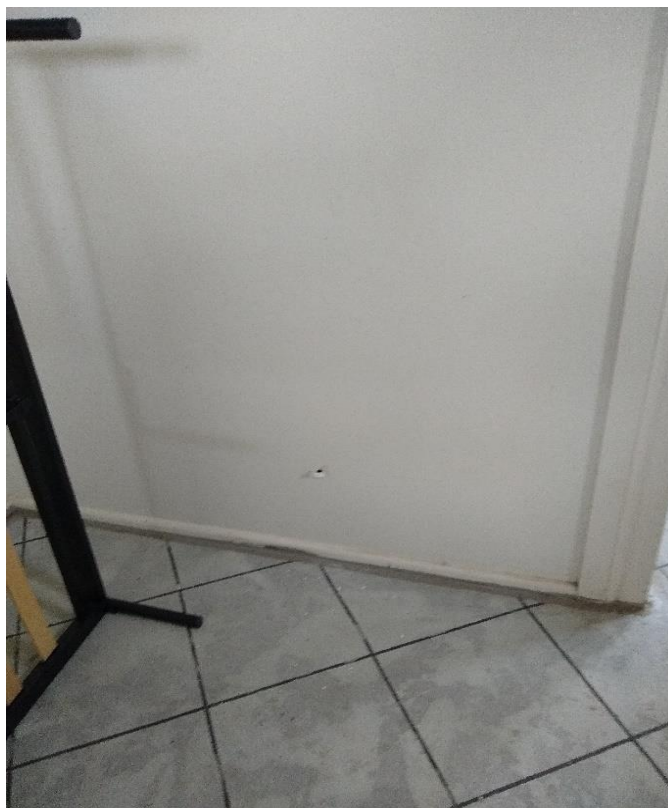
Photo 14: Building 25, interior, wall sheeting in northern bedroom, plaster sheeting, sample 25A1, no asbestos detected by analysis.

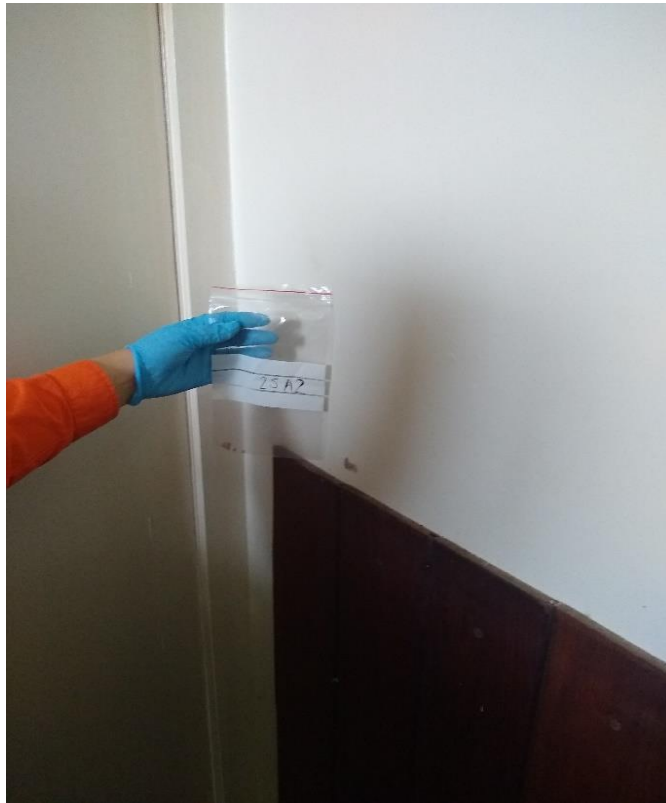
Photo 15: Building 25, interior, wall sheeting in southern portion of house, fibre cement sheeting, sample 25A2, asbestos detected by analysis.

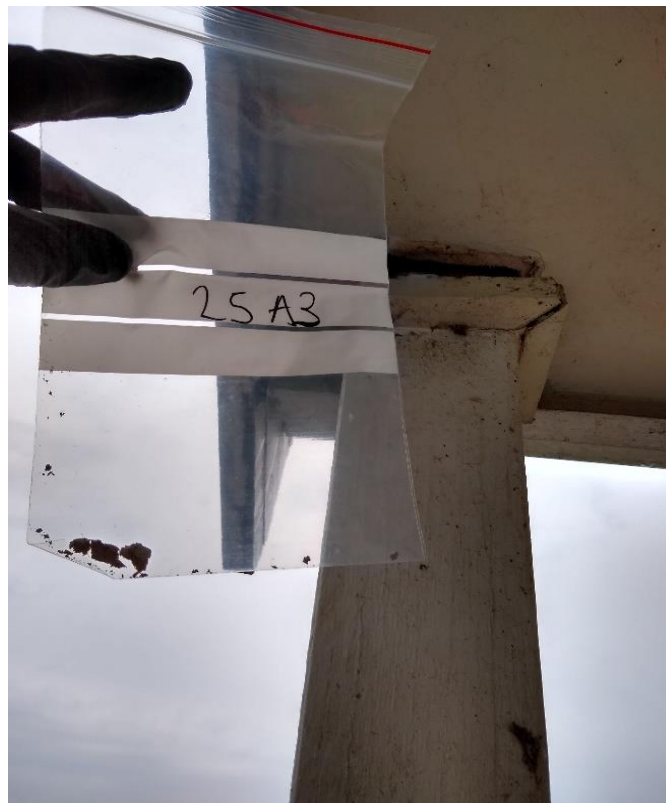
Photo: 16 Building 25, exterior, sheeting from eaves, fibre cement sheeting, sample 25A3, asbestos detected by analysis.

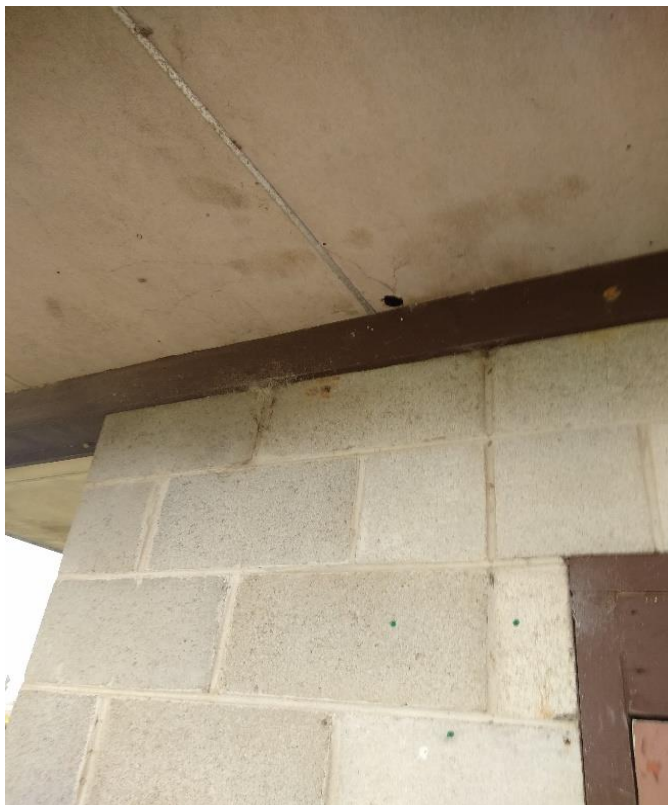
Photo 17: Building 34, exterior, sheeting from eaves, fibre cement sheeting, sample 34A1, asbestos detected by analysis.

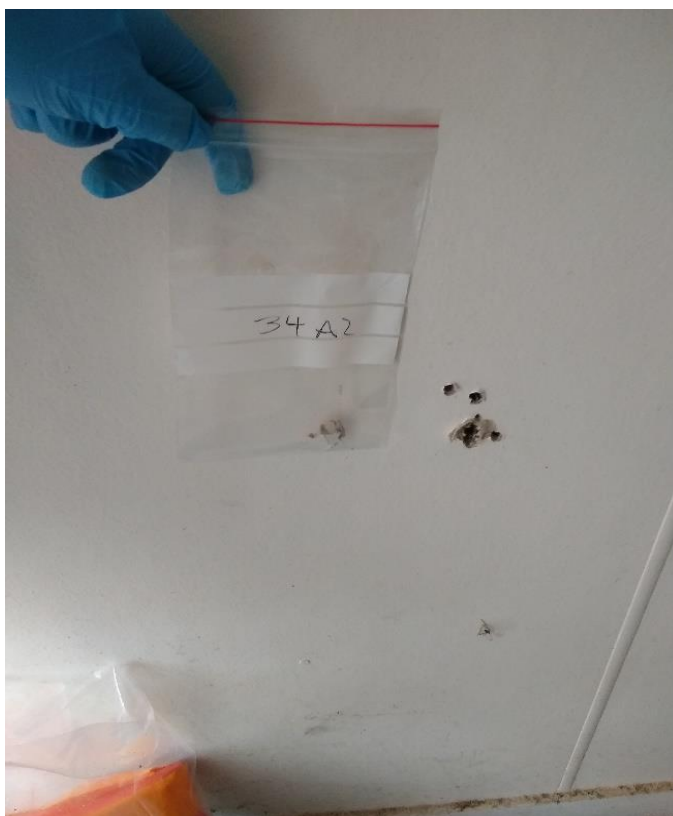
Photo 18: Building 34, interior, sheeting from wall, fibre cement sheeting, sample 34A2, no asbestos detected by analysis.

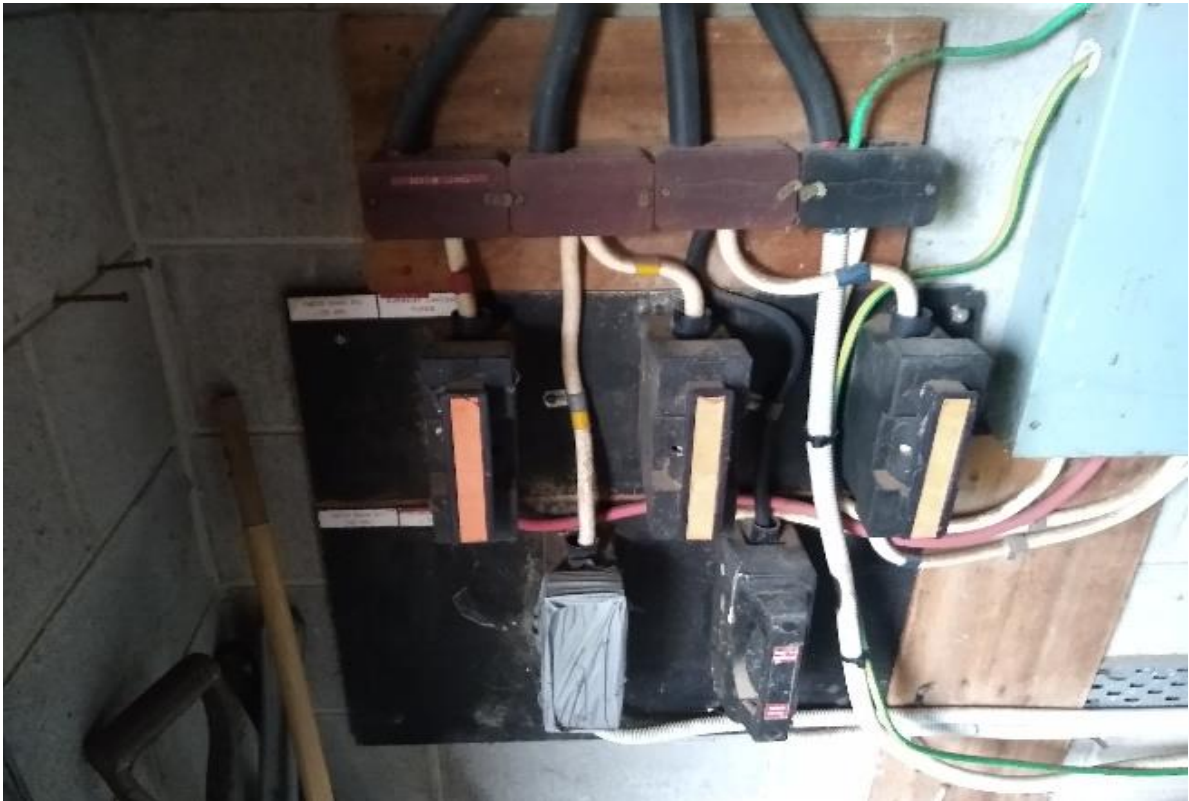
Photo 19: Building 34, interior, backing board from electrical box, black bituminous material, sample 34A3, asbestos detected by analysis.

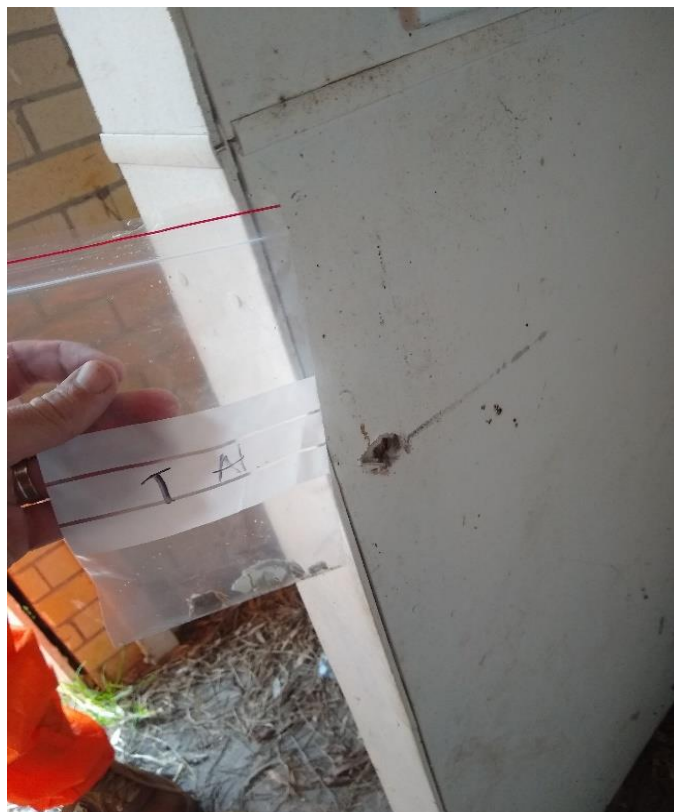
Photo 20: Toilet (T), interior, sheeting from wall, fibre cement sheeting, sample TA1, no asbestos detected by analysis.

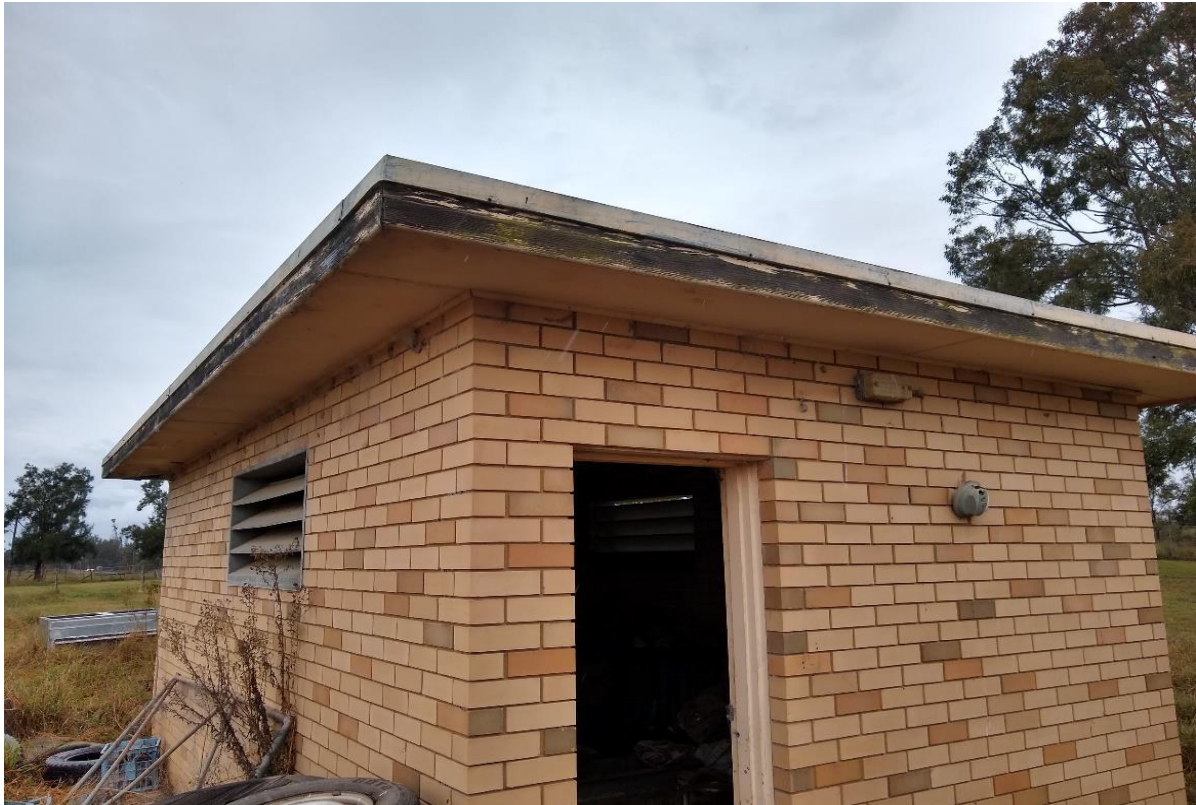
Photo 21: Building 23a, exterior, sheeting from eaves, fibre cement sheeting, N/A, suspected asbestos.

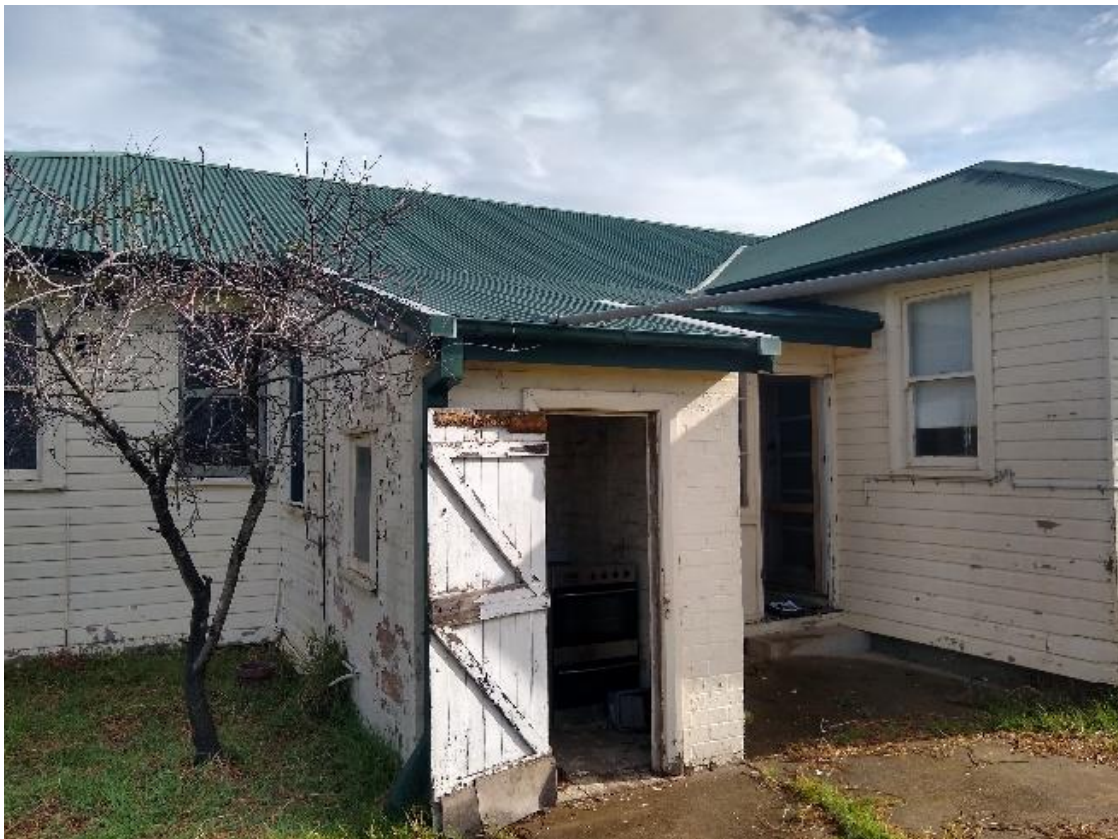
Photo 22: Building HS, exterior, sheeting from eaves, fibre cement sheeting, sample HSA1, no asbestos detected by analysis.

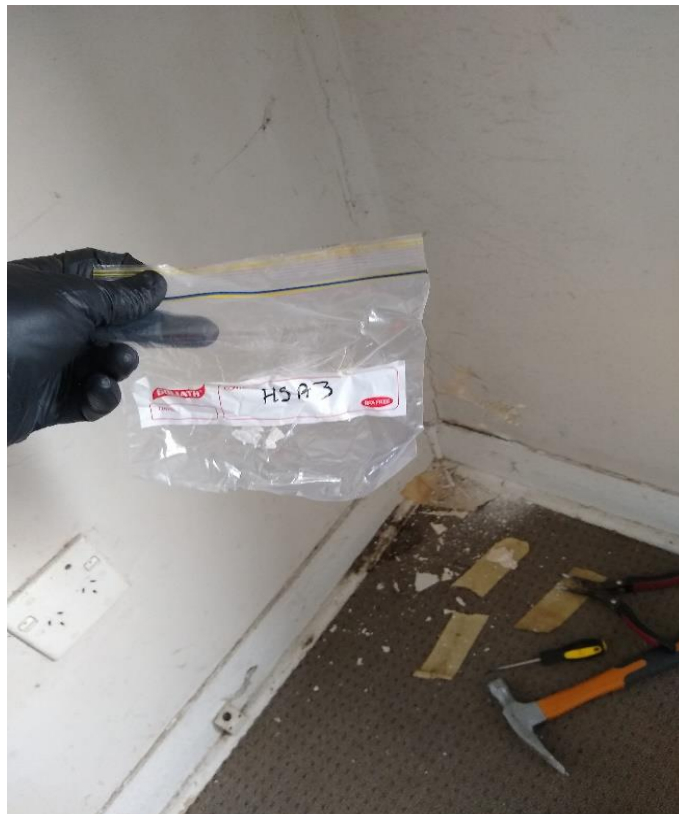
Photo 24: Building HS, interior, sheeting from walls in south western portion of house, plaster sheeting, sample HSA3, no asbestos detected by analysis.

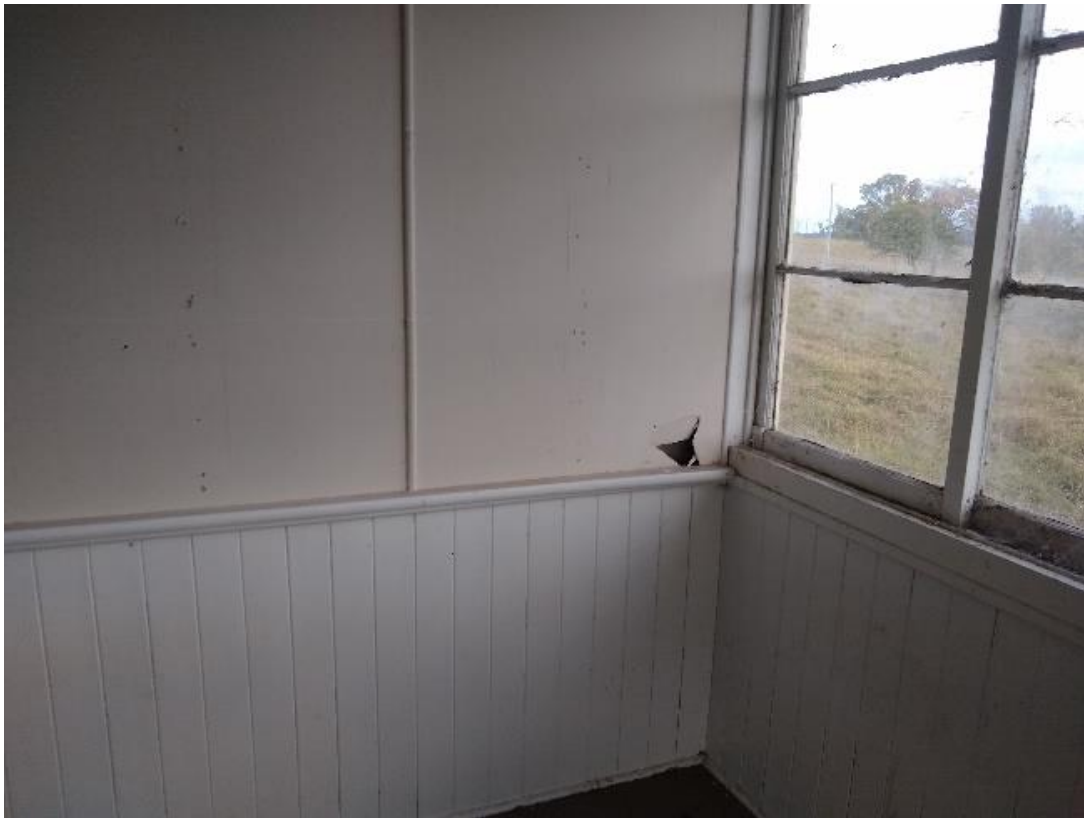
Photo 25: Building HS, interior, sheeting from partition in western portion of house, fibre cement sheeting, sample HSA4, asbestos detected by analysis.

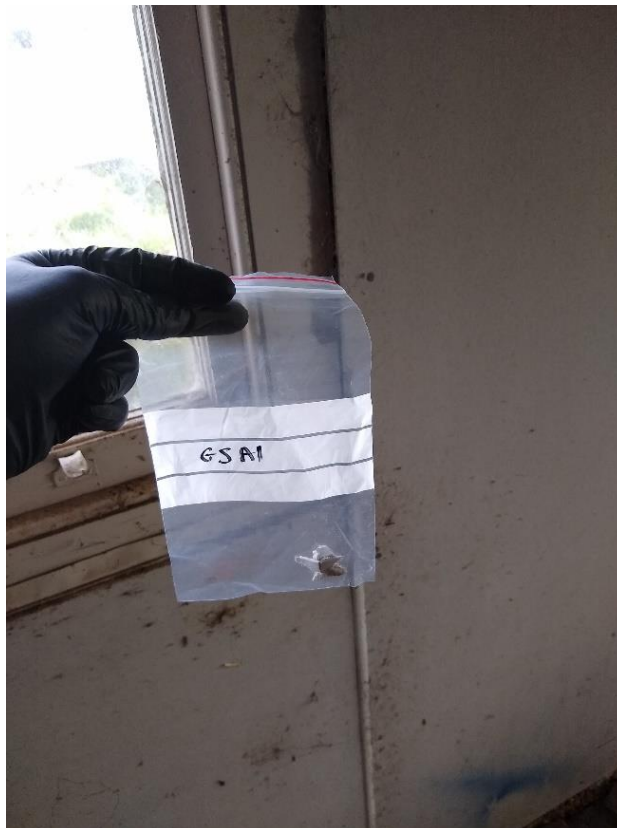
Photo 26: Building GS, interior, sheeting from walls in south western portion of garage structure, fibre cement sheeting, sample GSA1, no asbestos detected by analysis.

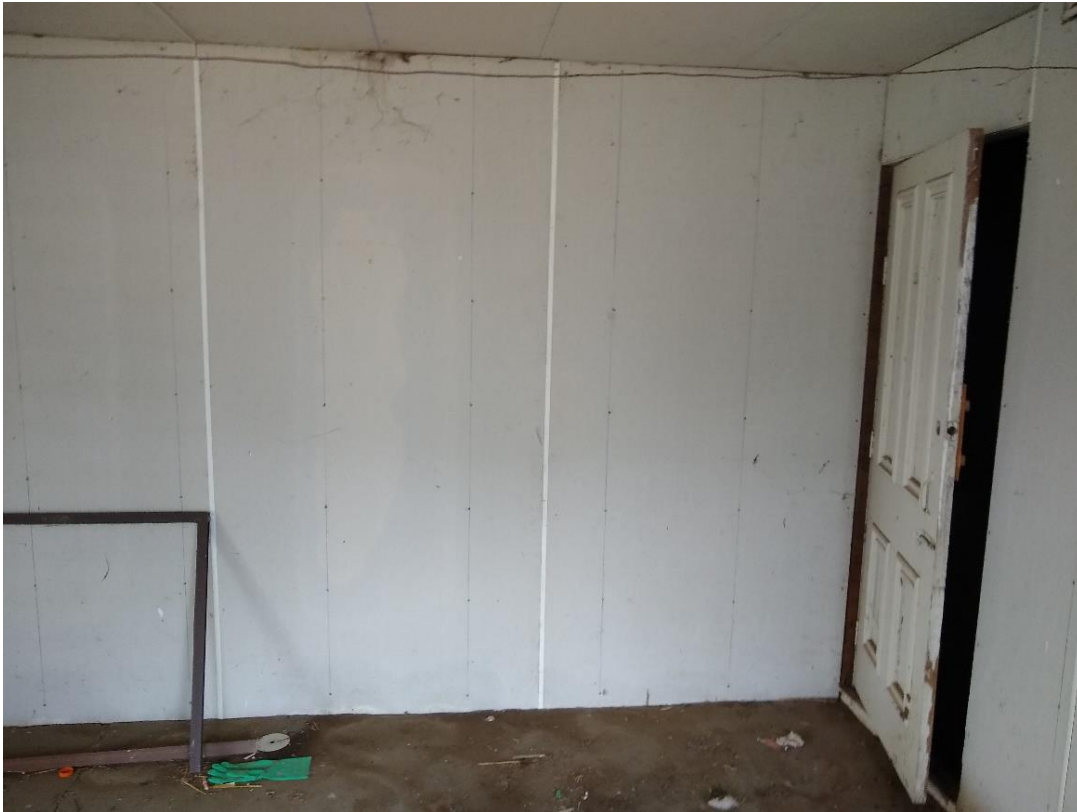
Photo 27: Building GS, interior, sheeting from walls in north eastern portion of garage structure, fibre cement sheeting, sample GSA2, no asbestos detected by analysis.

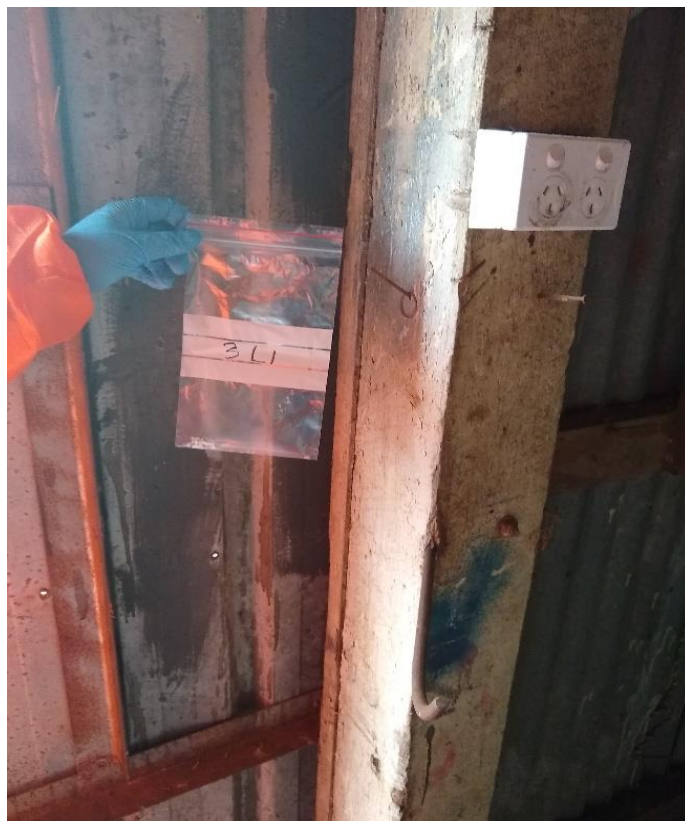
Photo 28: Building 3, interior, paint off timber post in western portion of shed structure, light red paint, sample 3L1, lead paint(s) identified

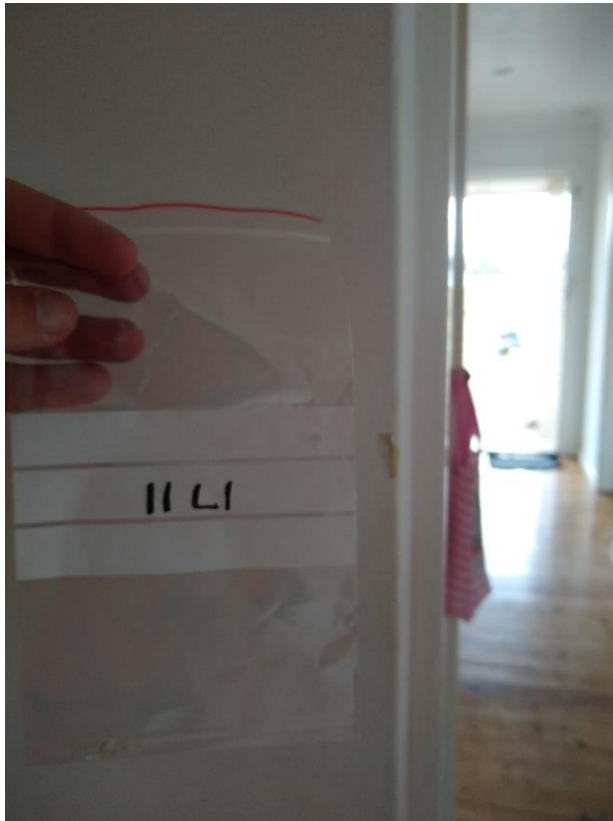
Photo 29: Building 11, interior, paint off timber frame within corridor, white paint, sample 11L1, no lead paint(s) identified

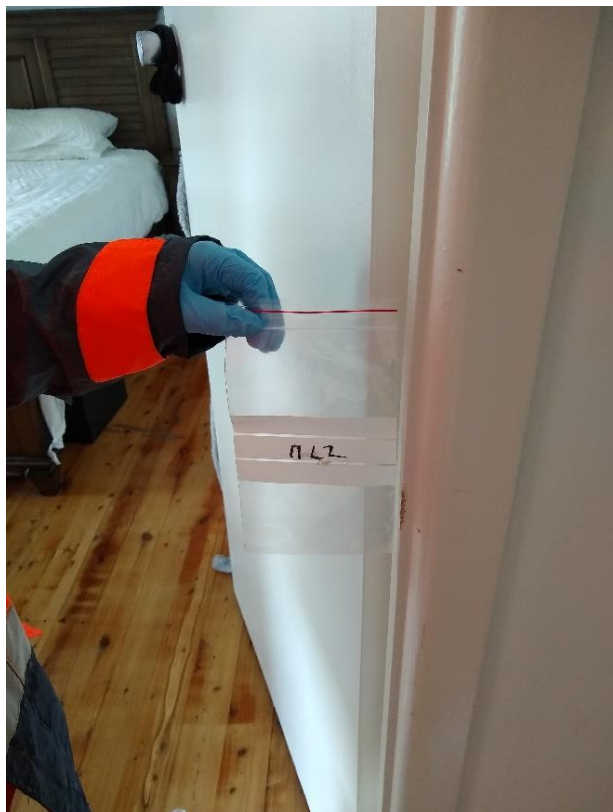
Photo 30: Building 11, interior, paint off timber door frame to bedroom in north eastern portion of house, white paint, sample 11L2, no lead paint(s) identified

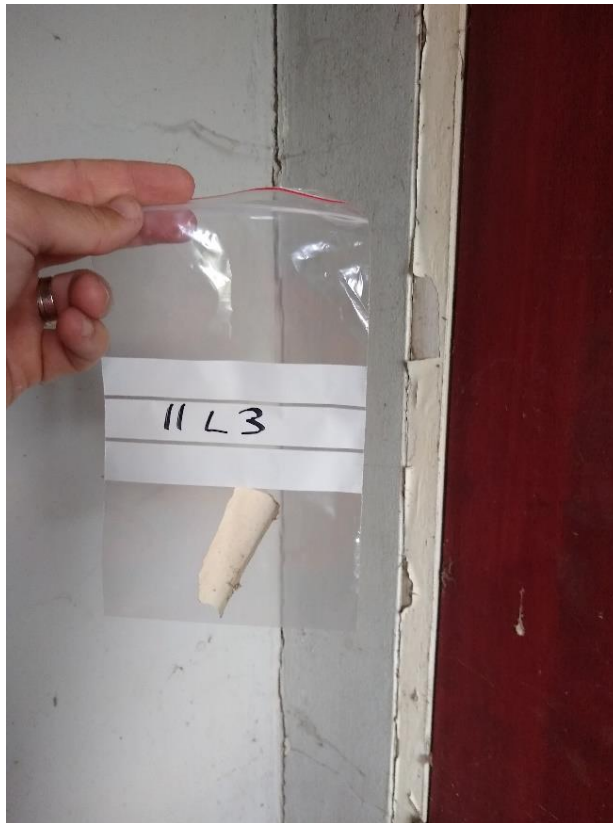
Photo 31: Building 11, interior, paint off timber door frame in south western portion of house, white paint, sample 11L3, lead paint(s) identified

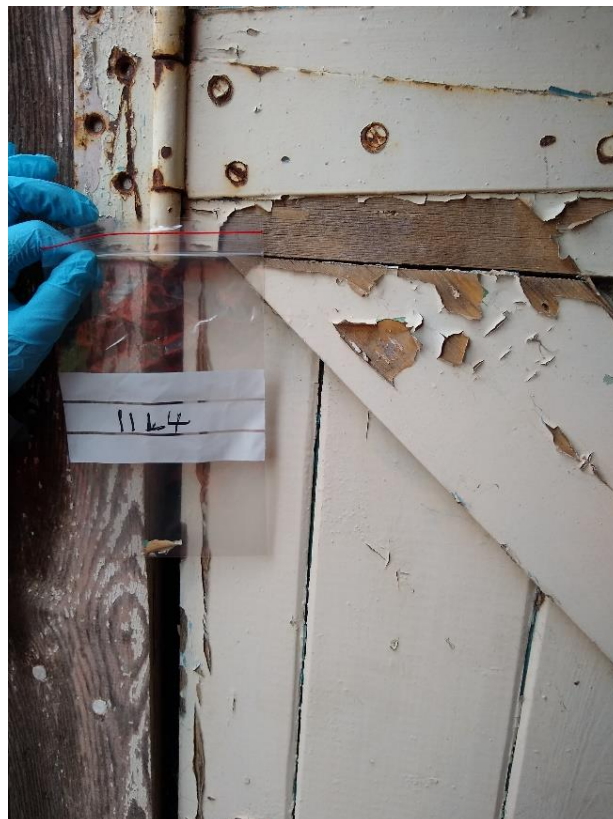
Photo 32: Building 11, exterior, paint off timber exterior door on southern side of dwelling, white paint, sample 11L4, lead paint(s) identified

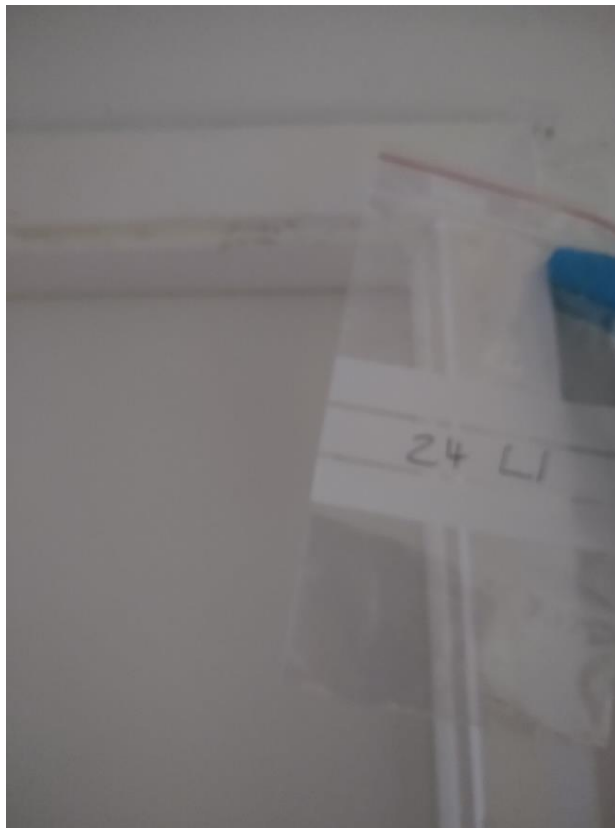
Photo 33: Building 24, interior, paint off timber door frame within corridor of dwelling, white paint, sample 24L1, no lead paint(s) identified

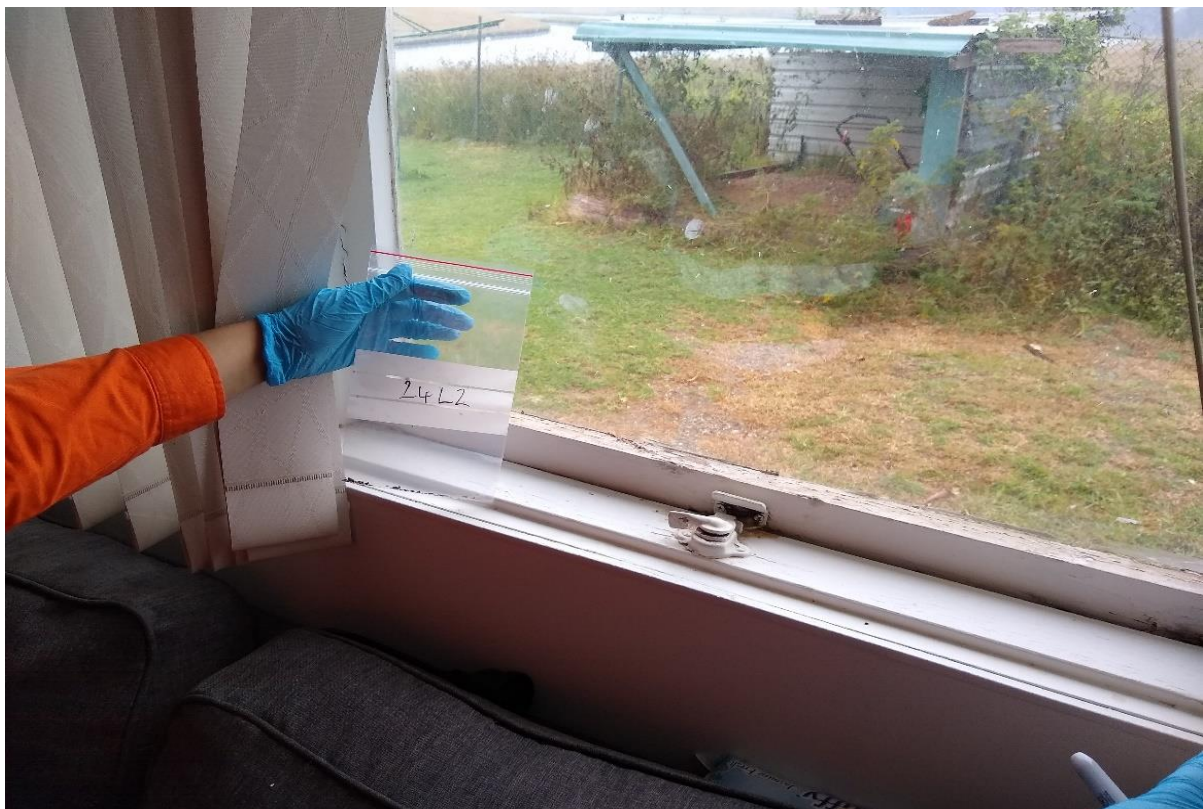
Photo 34: Building 24, interior, paint off timber window frame in southern bedroom in house, white paint, sample 24L2, no lead paint(s) identified

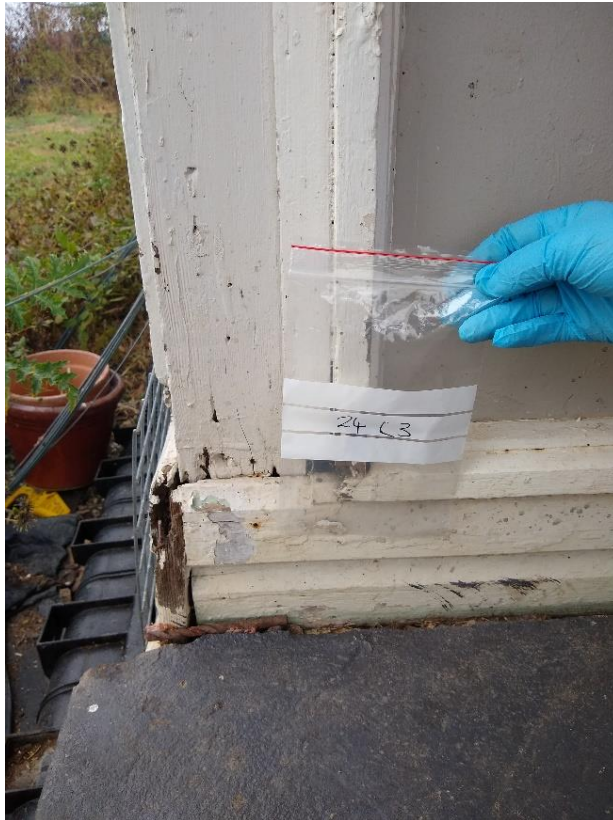
Photo 35: Building 24, exterior, paint off timber frame of north eastern portion of house, white paint, sample 24L3, no lead paint(s) identified

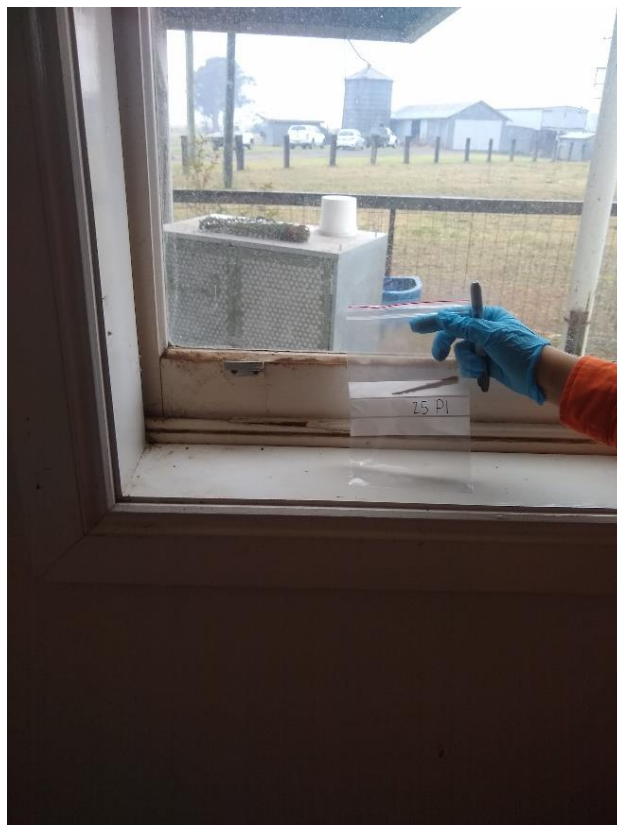
Photo 36: Building 25, interior, paint off timber window frame in northern bedroom in house, white paint, sample 25L1, no lead paint(s) identified

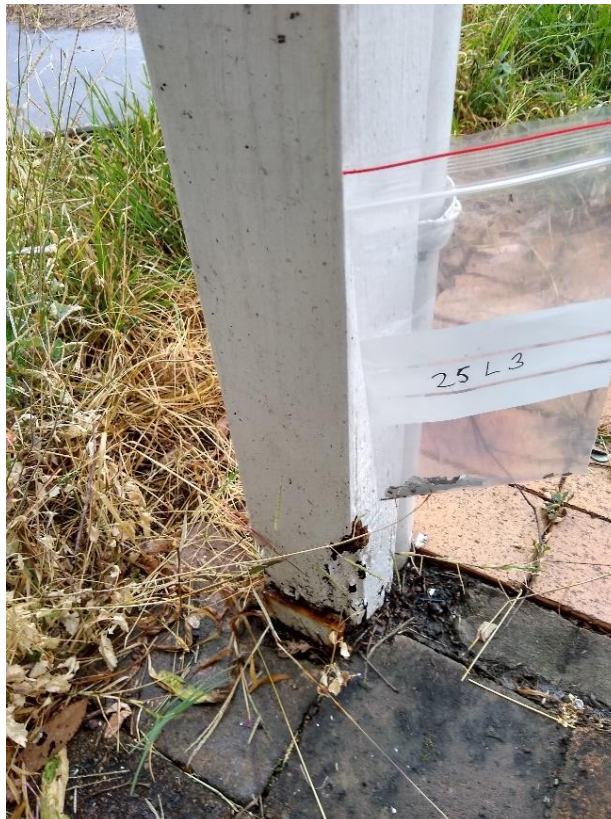
Photo 38: Building 25, exterior, paint off timber post on eastern side of house, white paint, sample 25L3, no lead paint(s) identified

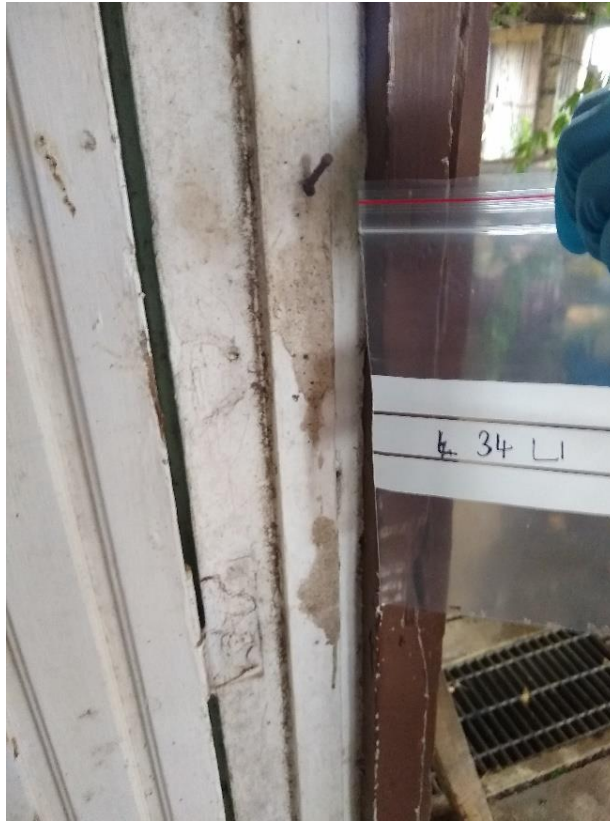
Photo 39: Building 34, interior, paint off timber door frame on eastern side of structure, brown paint, sample 34L1, lead paint(s) identified

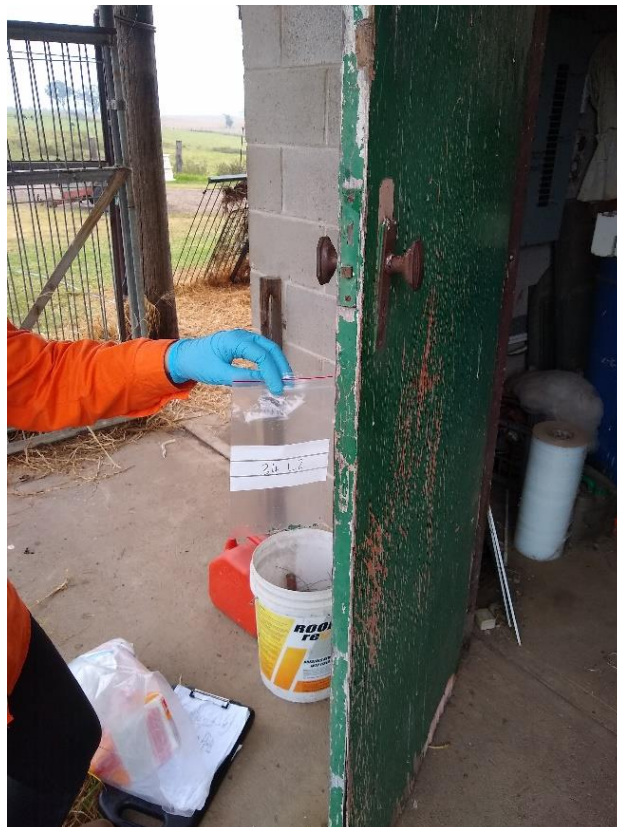
Photo 40: Building 34, exterior, paint off timber door, green paint, 34L2, lead paint(s) identified
