Report on  
Hazardous Building Materials (HBM) Survey

DHL Stage 1  
Part of 1953 - 2109 Elizabeth Drive  
Badgerys Creek

Prepared for  
DHL Supply Chain (Australia) Pty Limited

Project 86548.20  
September 2024

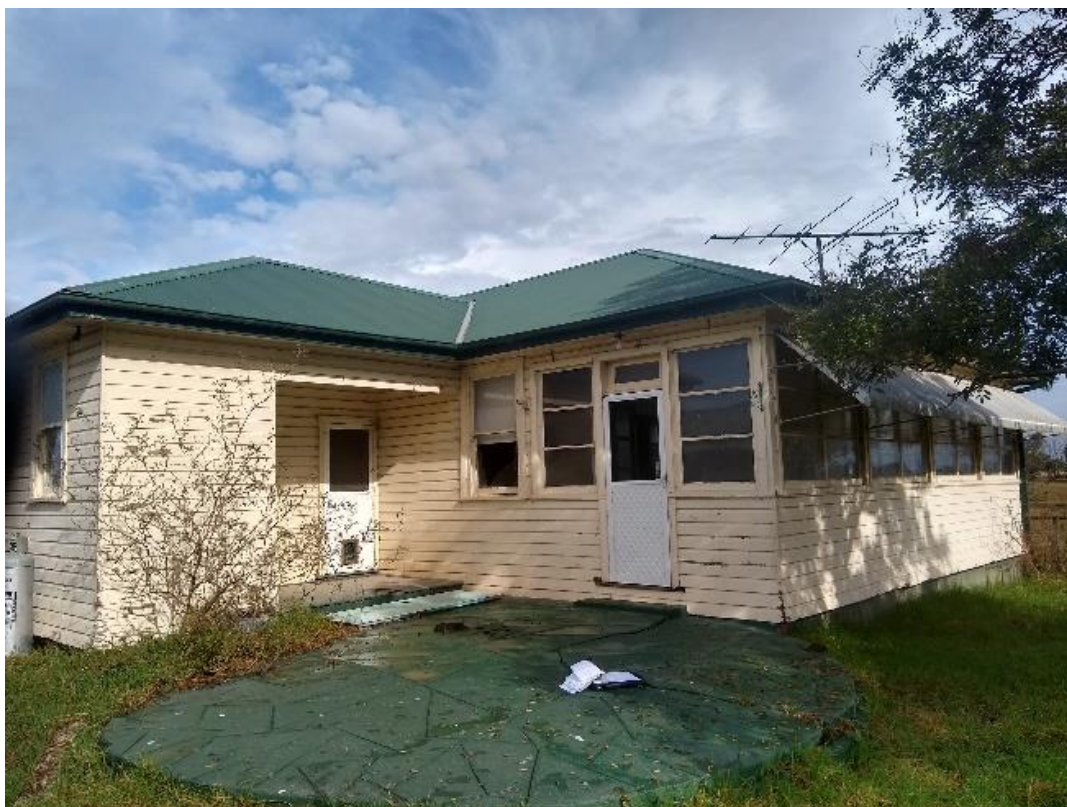
Photo 41: Building HS, exterior, paint off timber on northern side of house, beige paint, sample HSL1, lead paint(s) identified

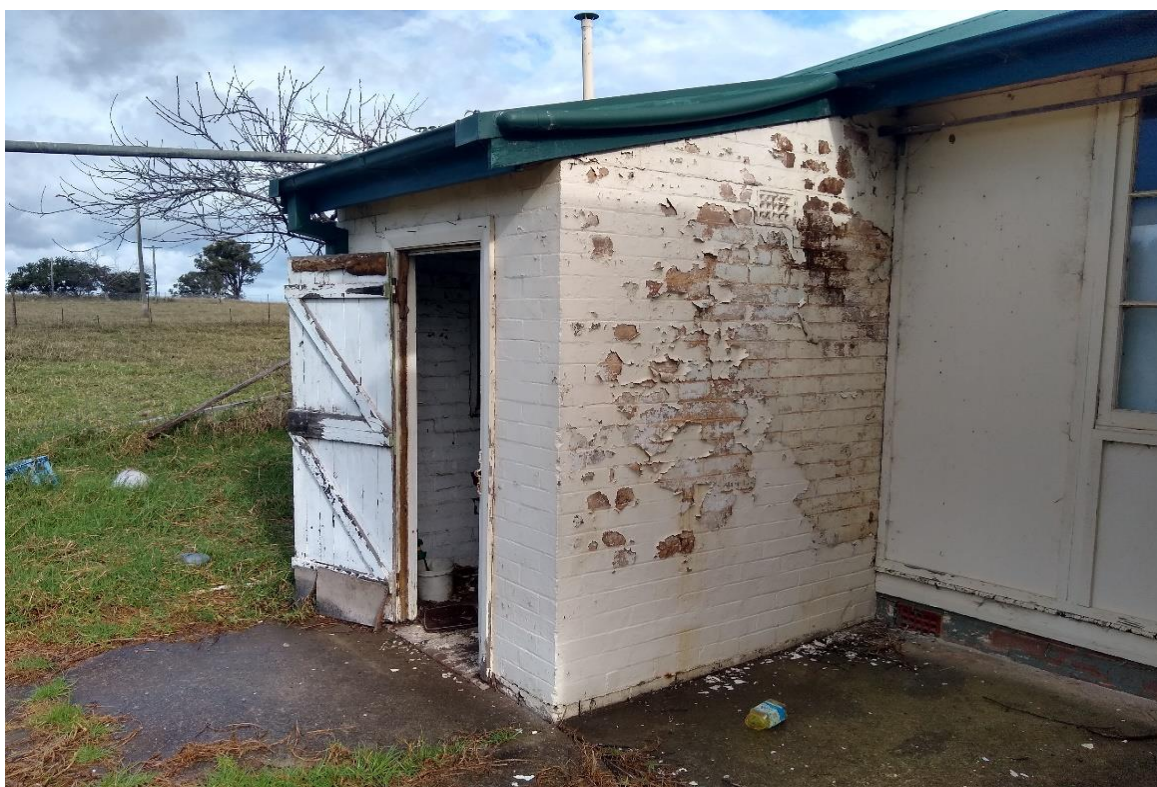
Photo 42: Building HS, exterior, paint off brickwork on exterior toilet, beige paint, sample HSL2, lead paint(s) identified

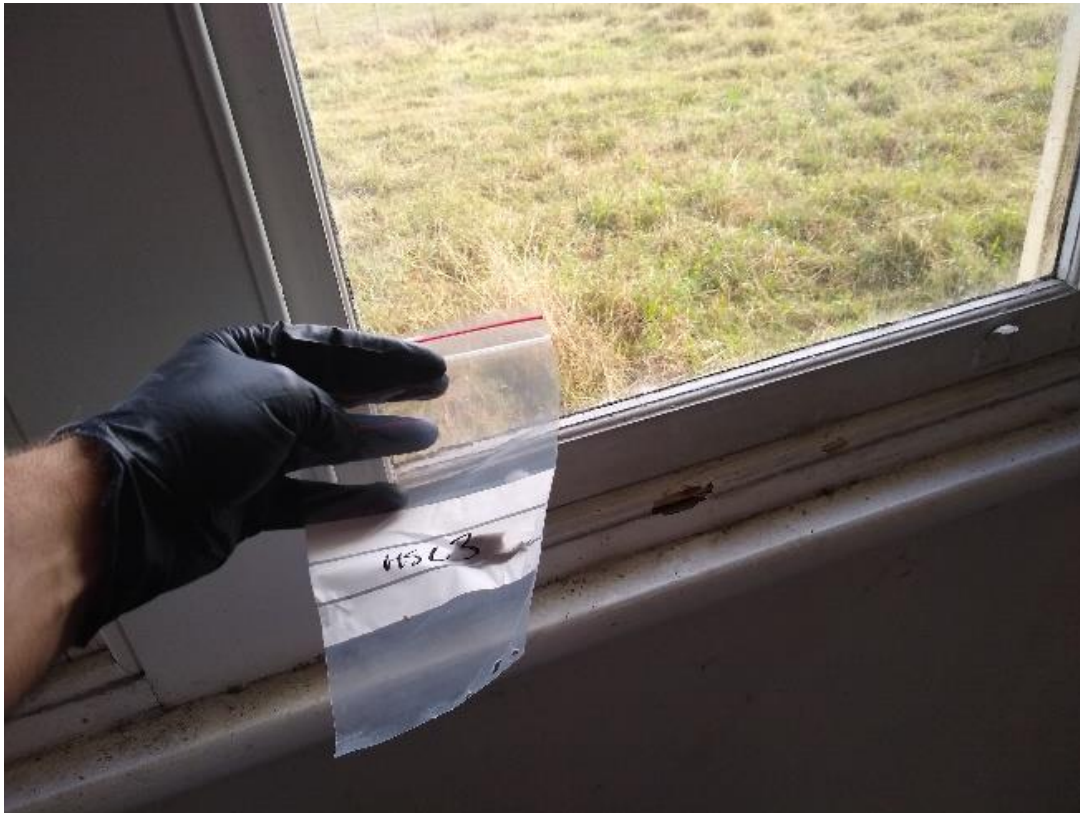
Photo 43: Building HS, interior, paint off timber window frame on southern side of house, white paint, sample HSL3, lead paint(s) identified

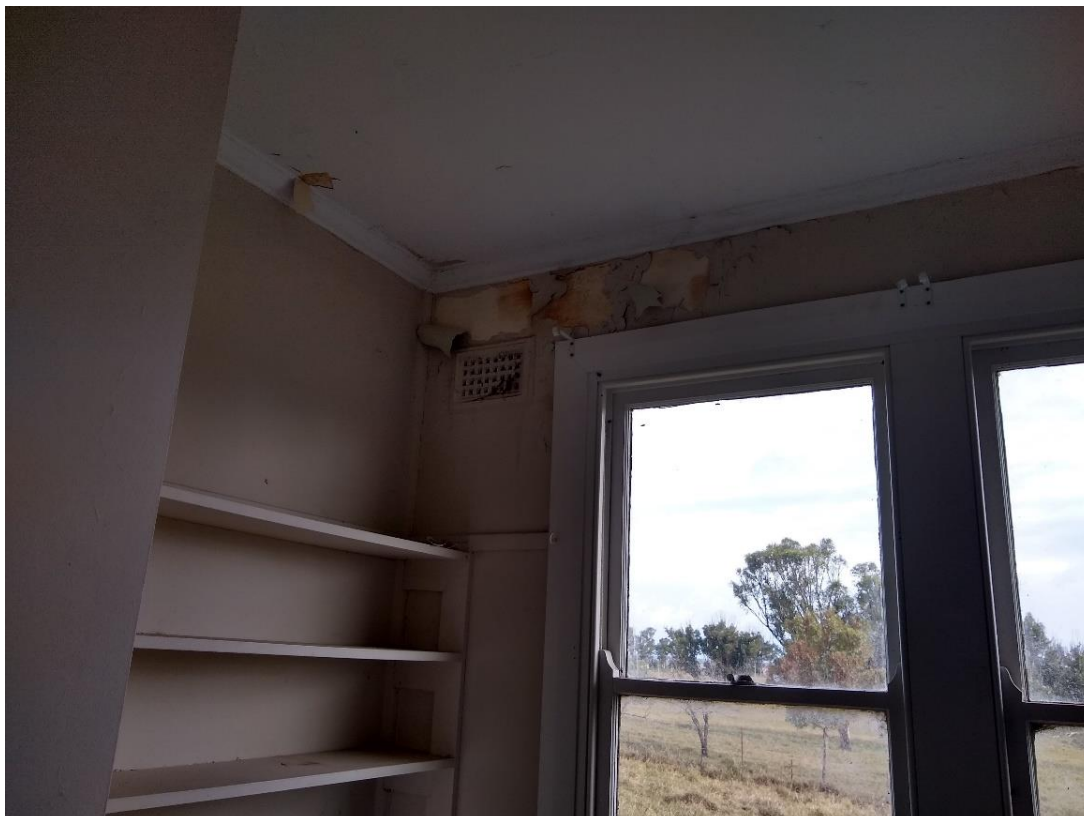
Photo 44: Building HS, interior, paint off wall on southern side of house, white paint, sample HSL4, lead paint(s) identified

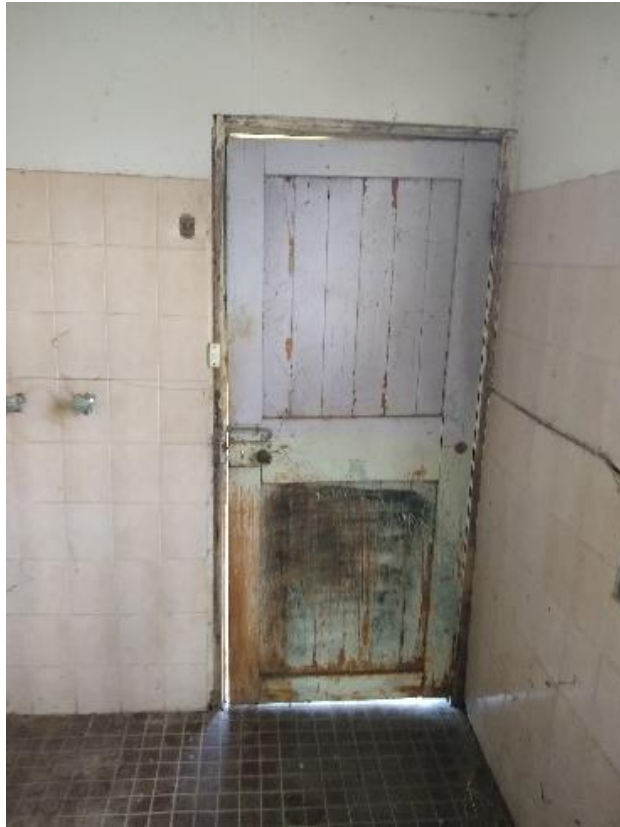
Photo 45: Building GS, interior, paint off timber door on eastern side of garage structure, white paint, sample GSL1, lead paint(s) identified

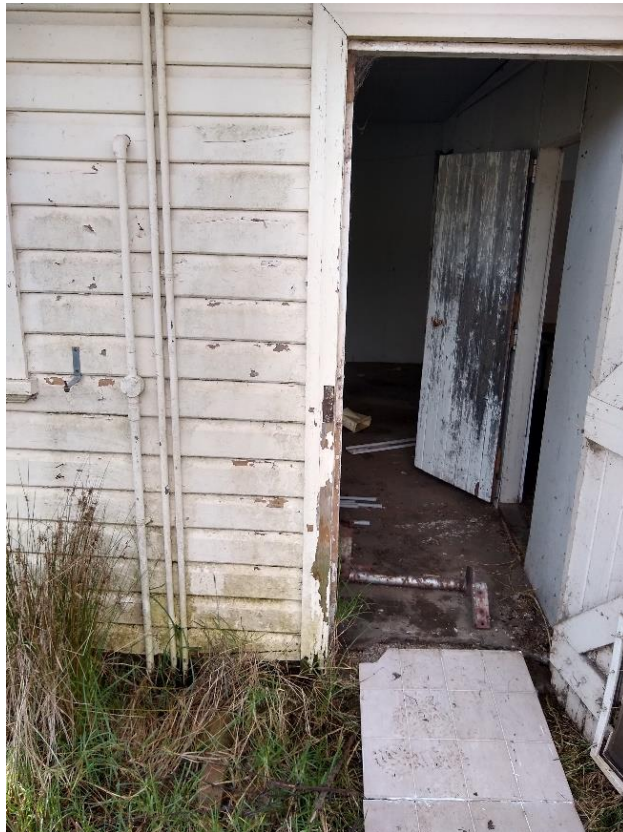
Photo 46: Building GS, exterior, paint off timber door on southern side of garage structure, white paint, sample GSL2, lead paint(s) identified

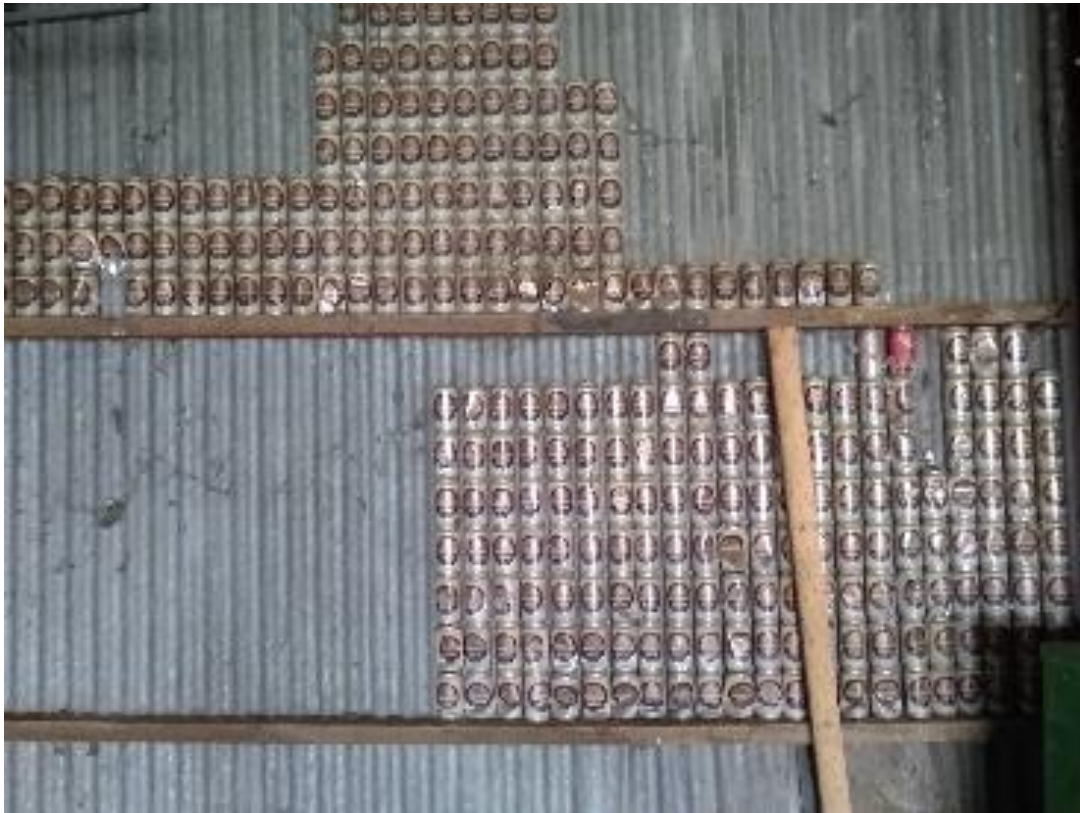
Photo 47: Building 2, timber frame on eastern side of shed, throughout, settled dust, sample 2D1, elevated lead concentration ( $\geq 0.5$  mg/m<sup>2</sup>)

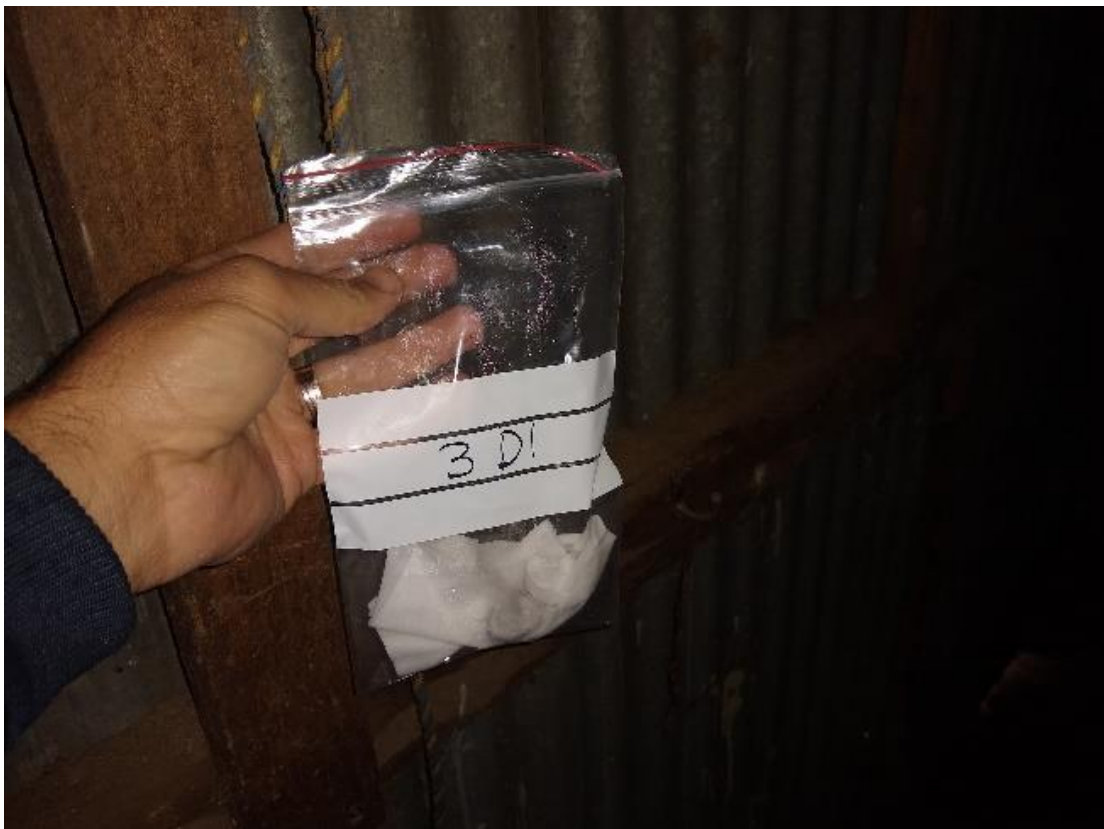
Photo 48: Building 3, timber frame on western side of shed, throughout, settled dust, sample 3D1, elevated lead concentration ( $\geq 0.5$  mg/m<sup>2</sup>)

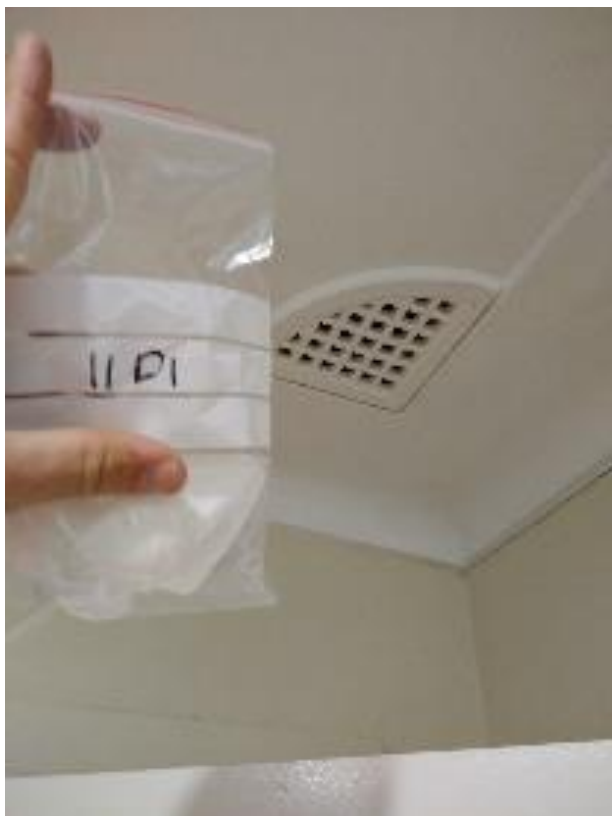
Photo 49: Building 11, ventilation grate in front bedroom, throughout, settled dust, sample 11D1, lead concentration <0.5 mg/m2

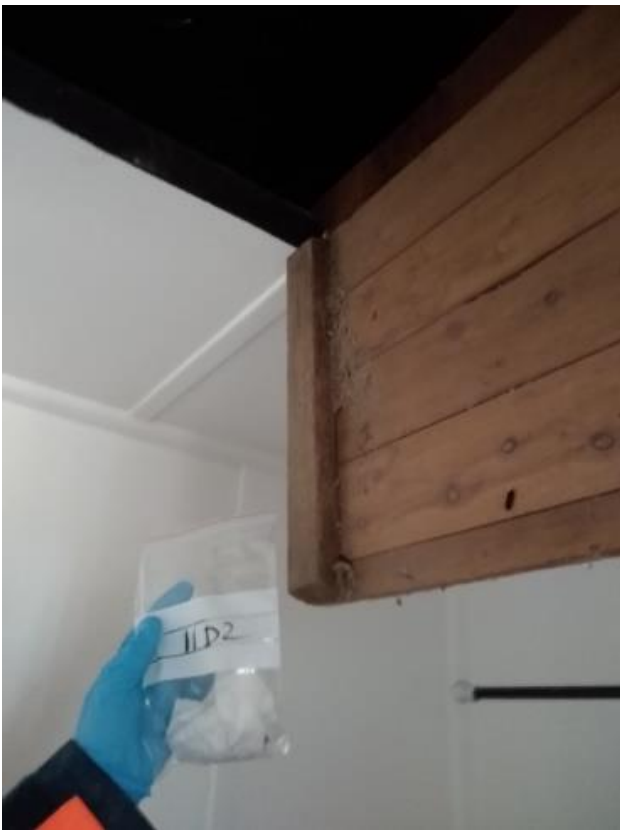
Photo 50: Building 11, manhole in western portion of house, throughout, settled dust, sample 11D2, lead concentration <0.5 mg/m2

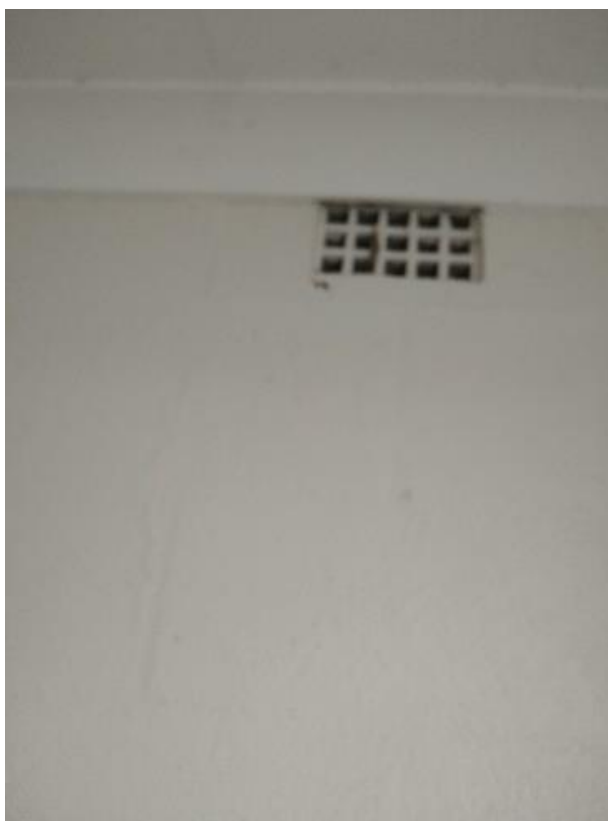
Photo 52: Building 25, ventilation grate in front bedroom, throughout, settled dust, sample 25D1, lead concentration <0.5 mg/m2

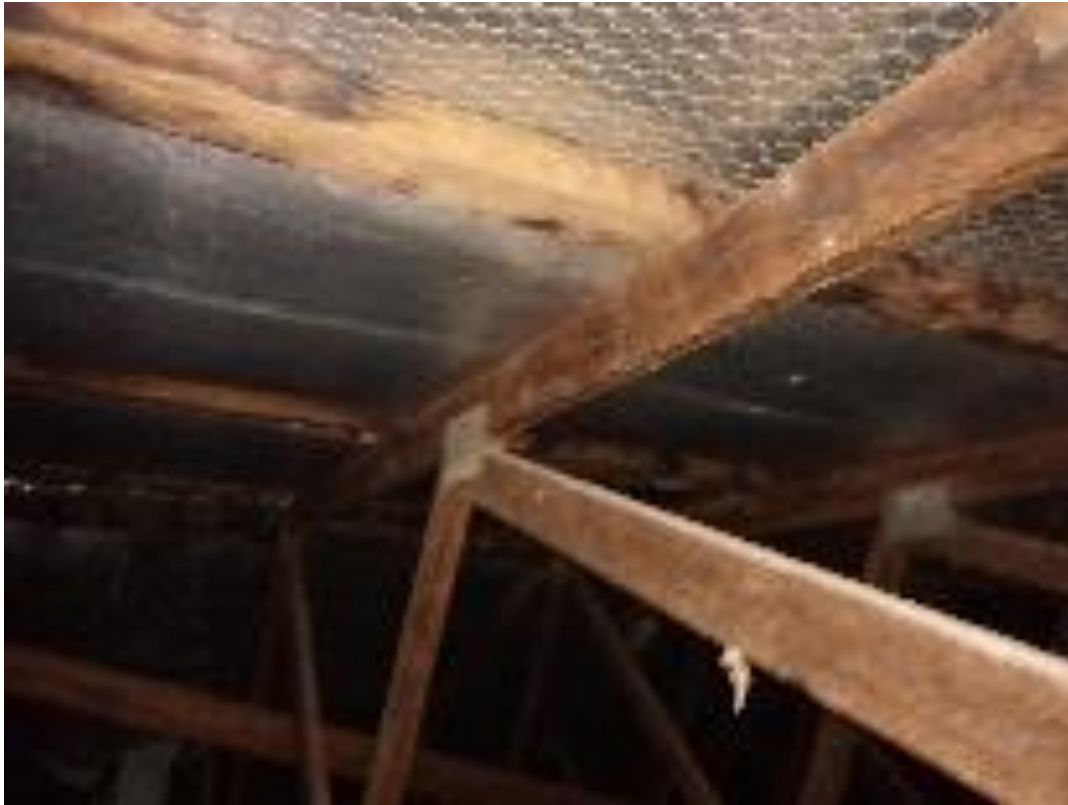
Photo 53: Building 25, manhole in central western portion of house, throughout, settled dust, sample 25D2, lead concentration <0.5 mg/m2

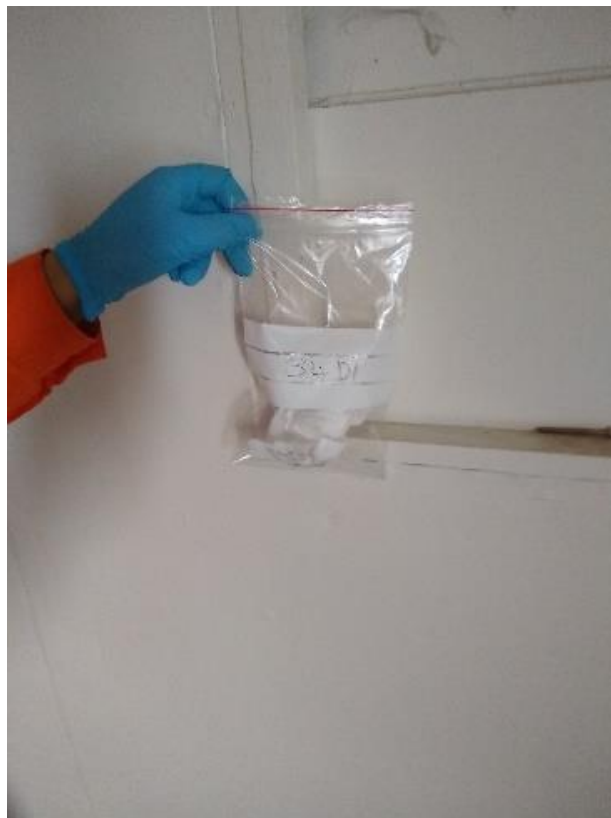
Photo 54: Building 34, timber window sill in central portion of structure, throughout, settled dust, sample 34D1, lead concentration <0.5 mg/m2

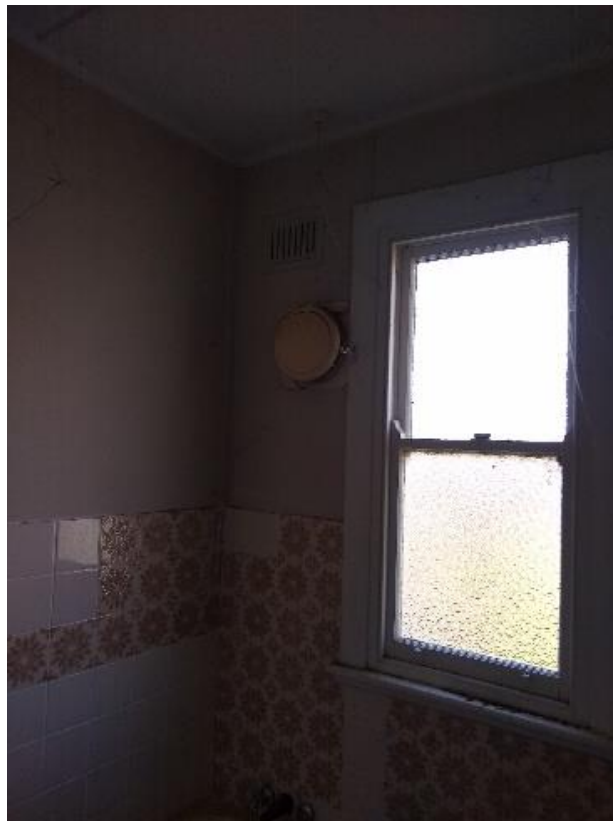
Photo 56: Building HS, ventilation grate in bathroom, throughout, settled dust, sample HSD2, elevated lead concentration ( $\geq 0.5$  mg/m<sup>2</sup>)

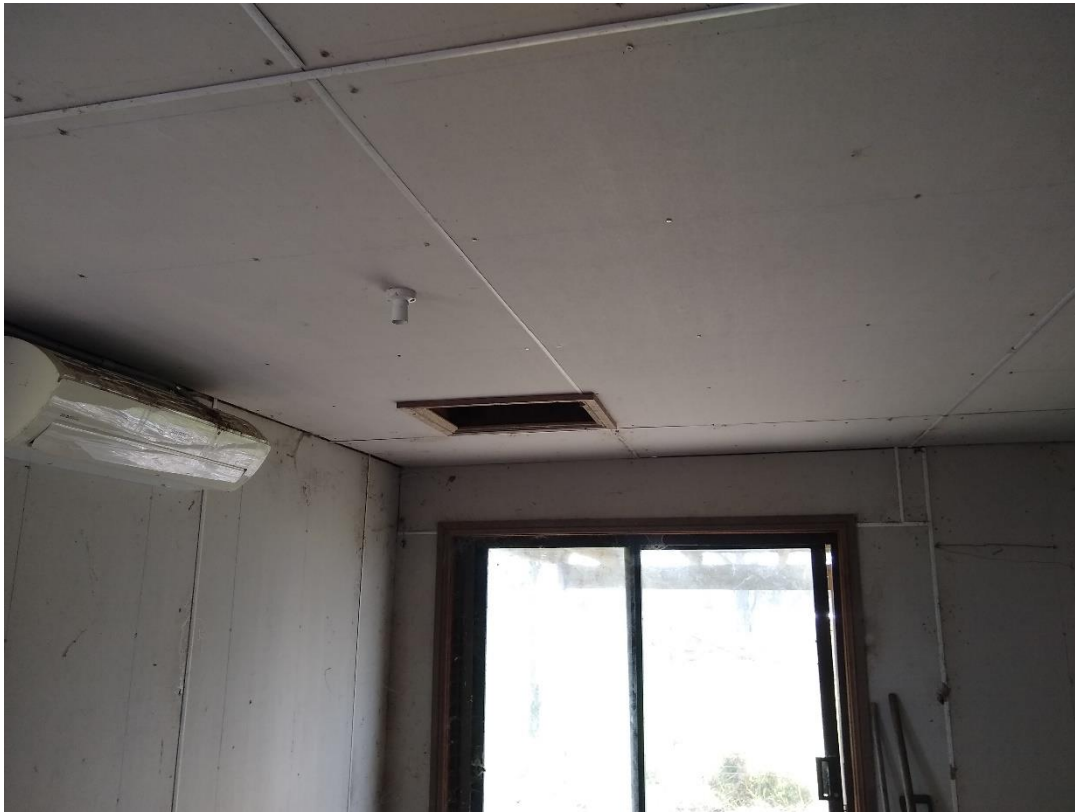
Photo 57: Building GS, manhole on garage ceiling, throughout, settled dust, sample GSD1, elevated lead concentration ( $\geq 0.5$  mg/m<sup>2</sup>)

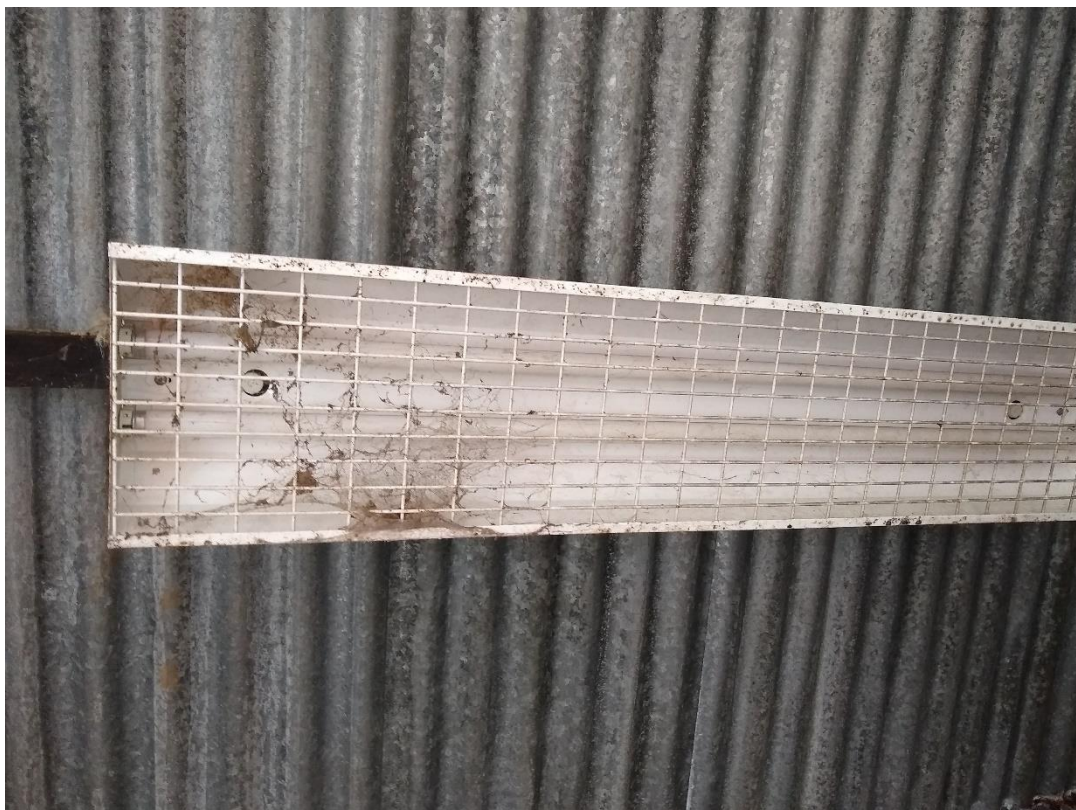
Photo 58: Building 2, interior , eastern portion of shed structure, fluorescent light fittings, internal components, nil PCB (suspected)

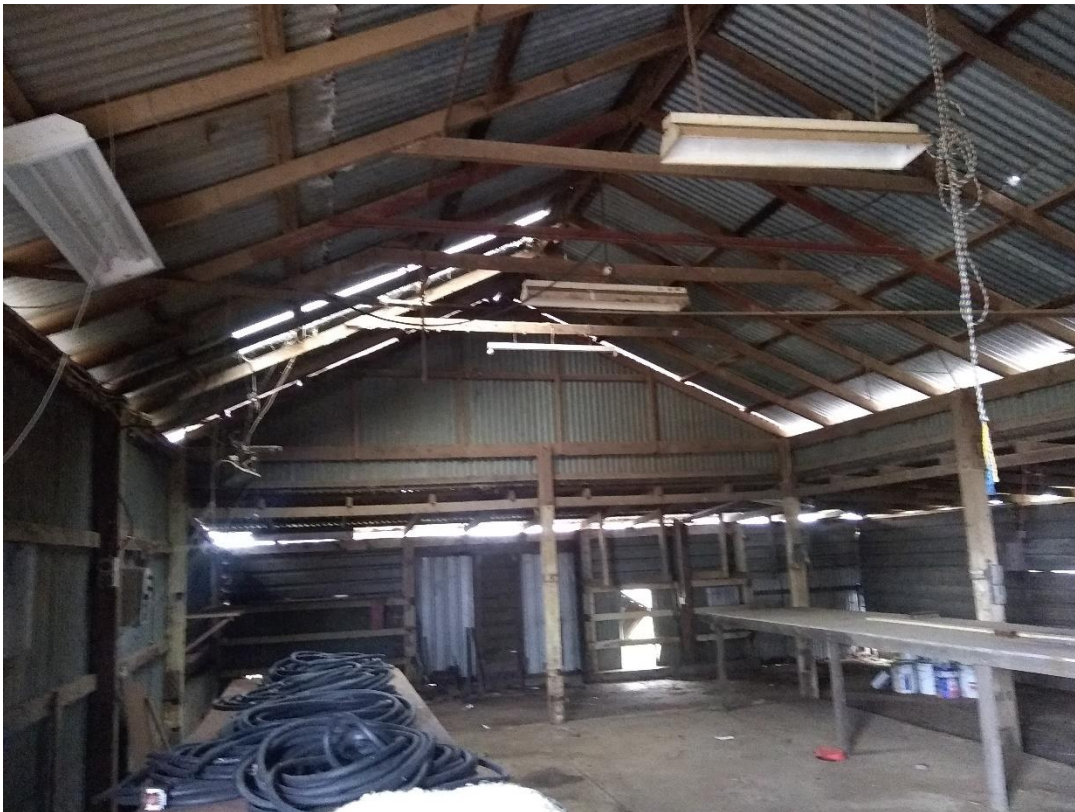
Photo 59: Building 3, interior , throughout, fluorescent light fittings, internal components, inaccessible

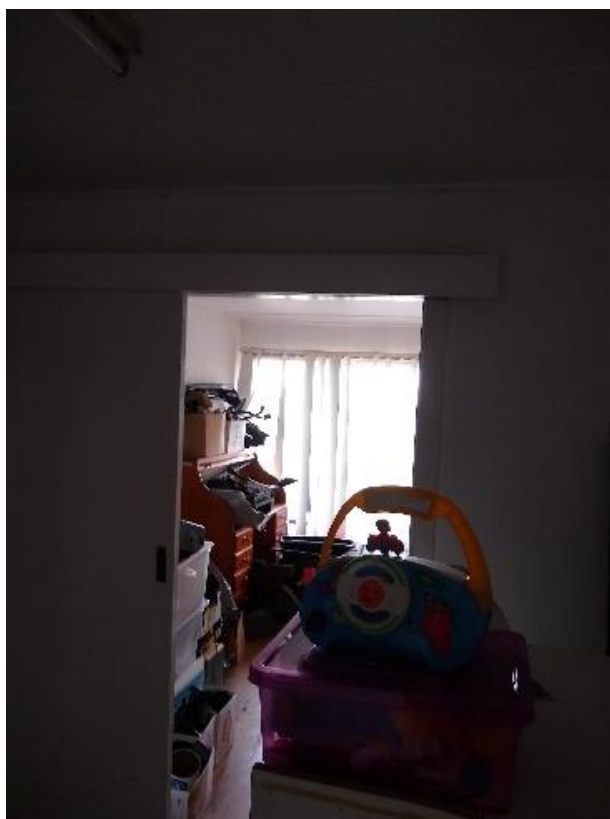
Photo 60: Building 11, interior , central western portion of house, fluorescent light fittings, internal components, nil PCB (suspected)

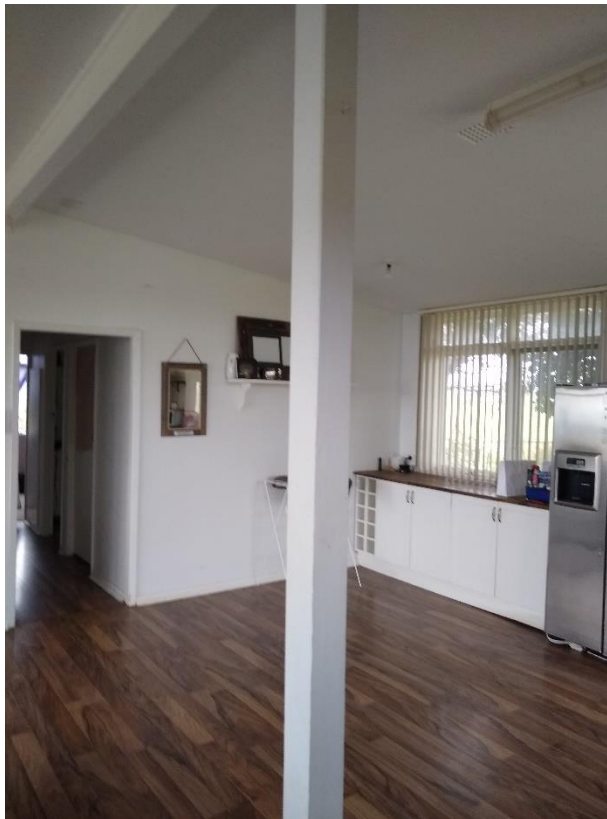
Photo 61: Building 24, interior , central portion of house, fluorescent light fittings, internal components, nil PCB (suspected)

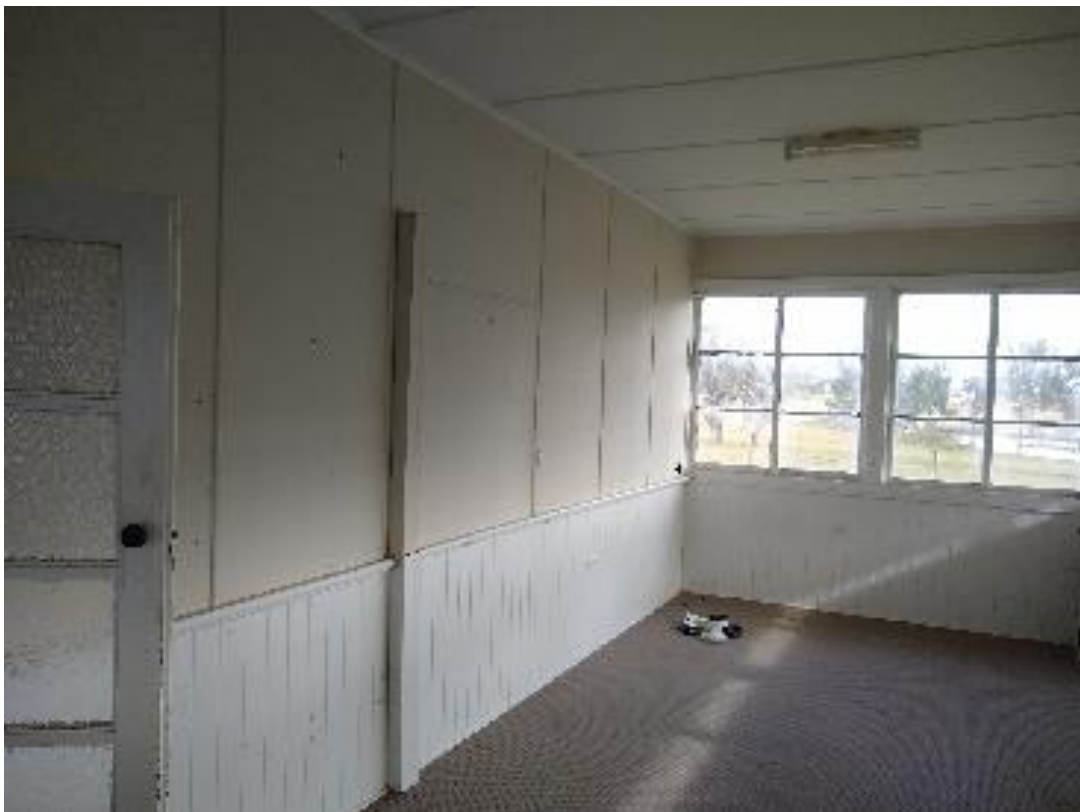
Photo 62: Building HS, interior , western portion of house, fluorescent light fittings, internal components, nil PCB (suspected)

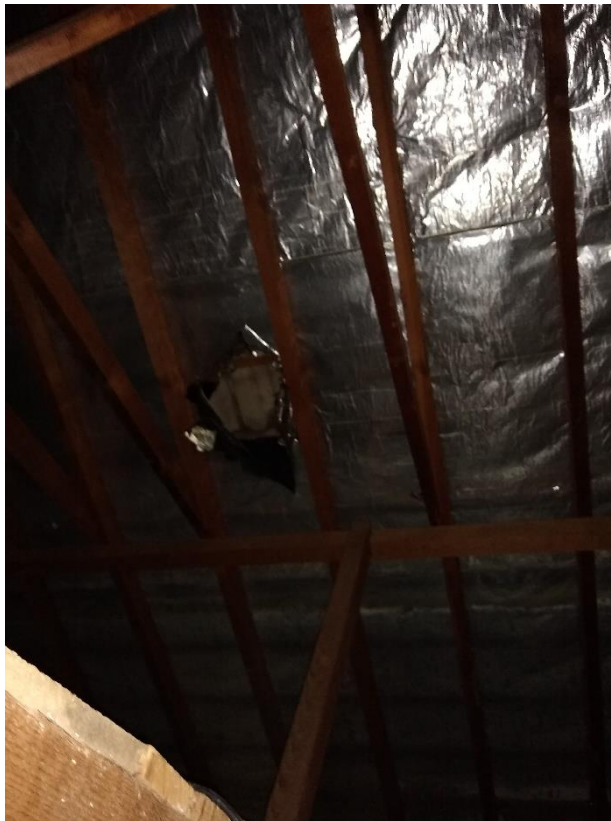
Photo 63: Building 11, ceiling cavity, throughout ceiling cavity, insulation generally, SMF (suspected)

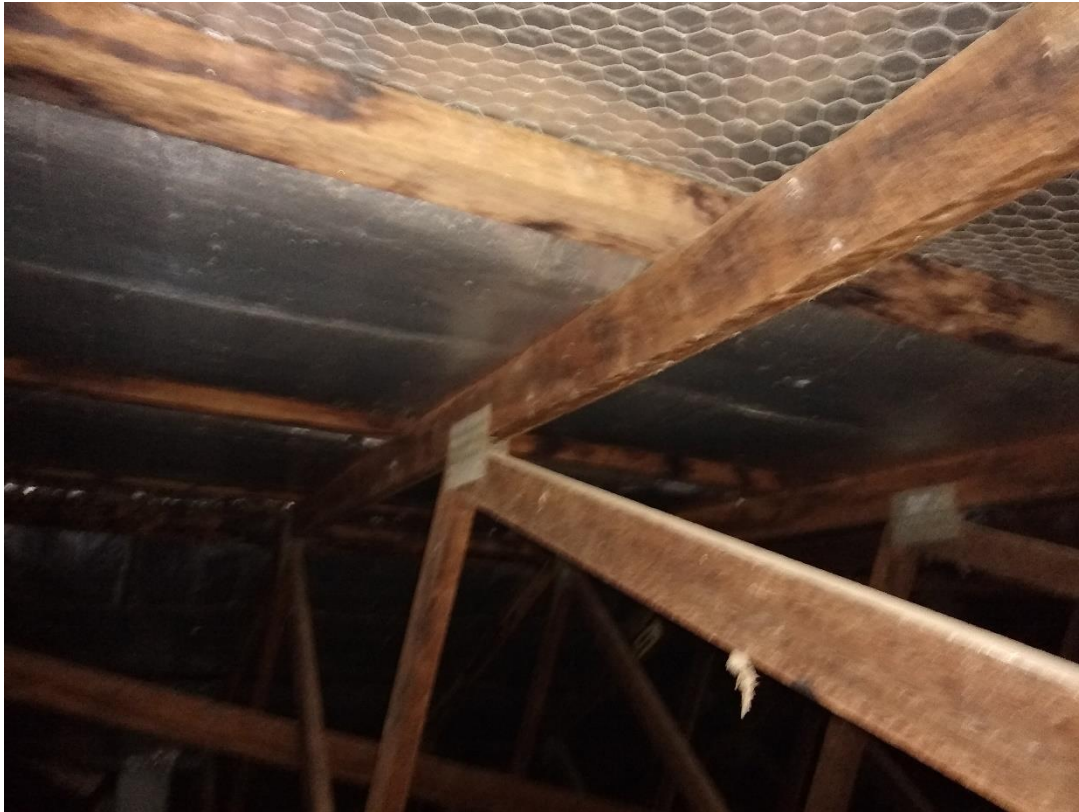
Photo 65: Building 25, ceiling cavity, throughout ceiling cavity, insulation generally, SMF (suspected)

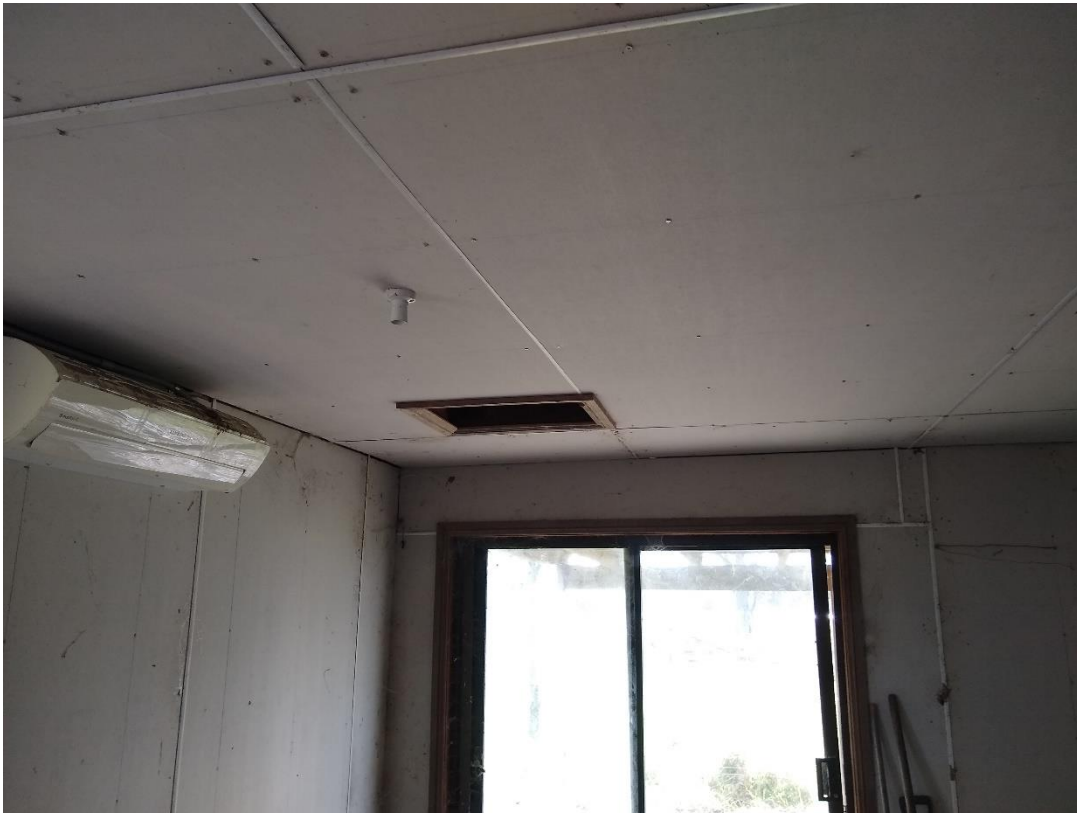
Photo 67: Building GS, ceiling cavity, throughout ceiling cavity, insulation generally, SMF (suspected)

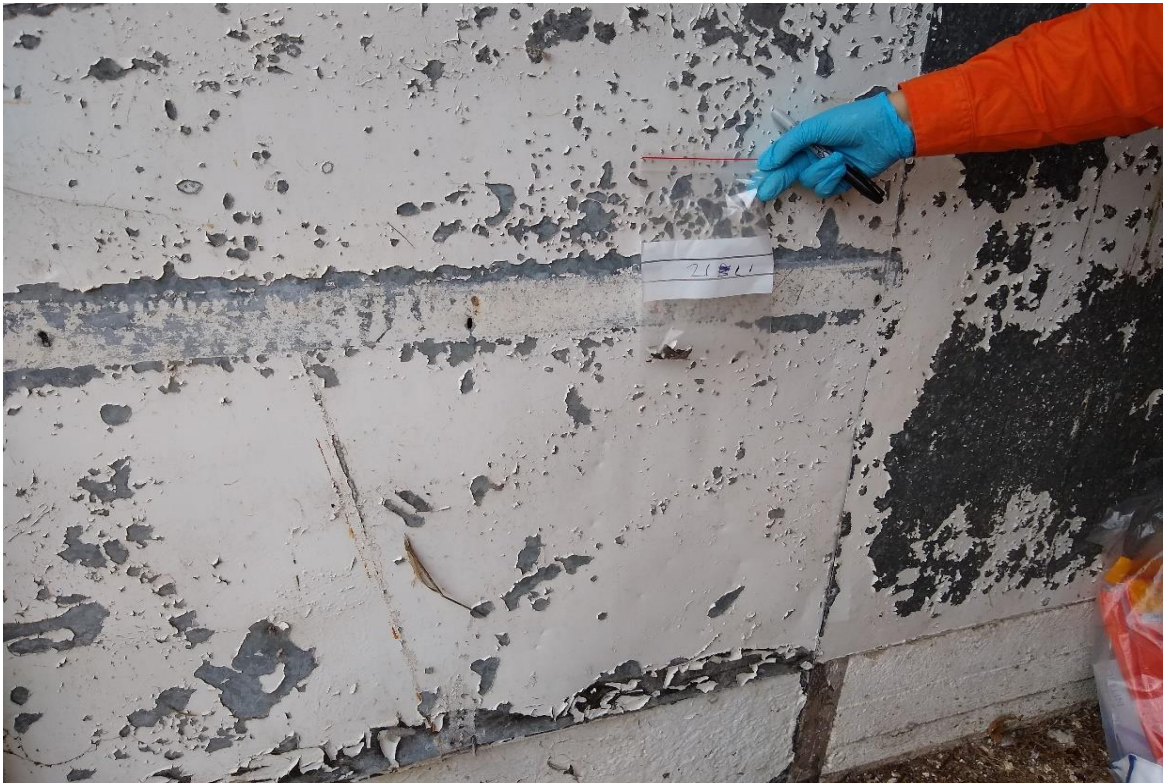
Photo 68: Building 21, interior, paint off wall within southern portion of shed, white paint, sample 21L1, lead paint(s) identified

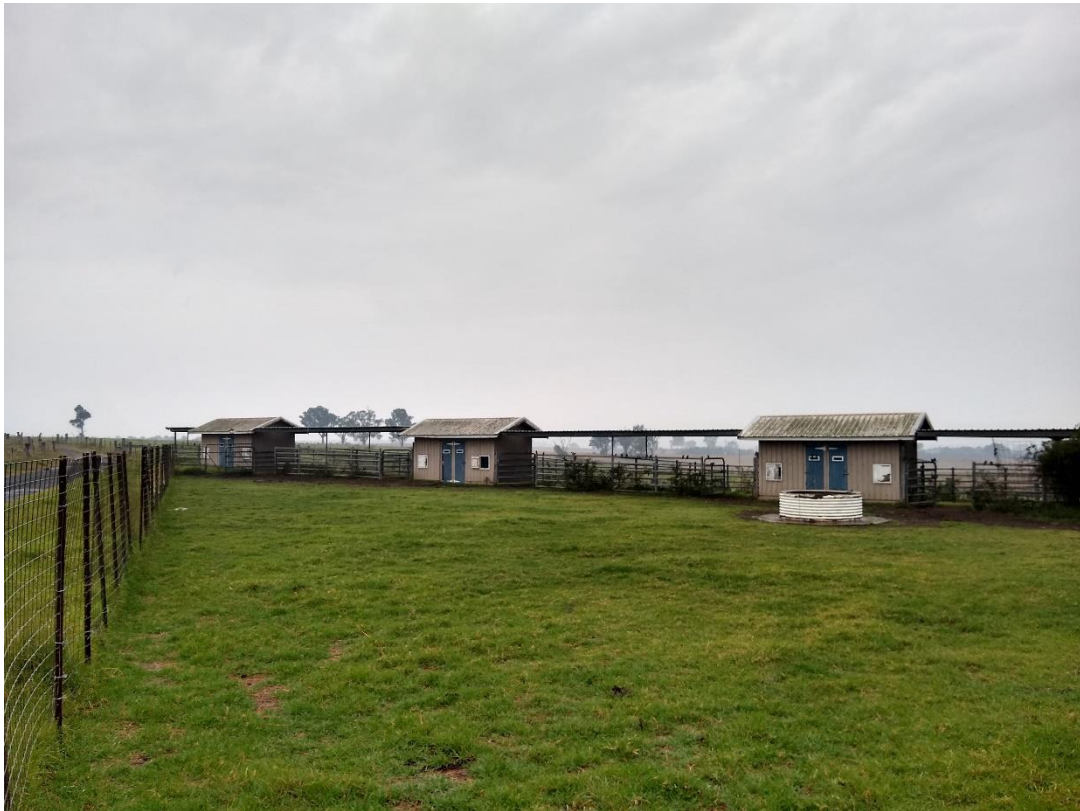
Photo 69: Structure 36, No hazardous building materials identified

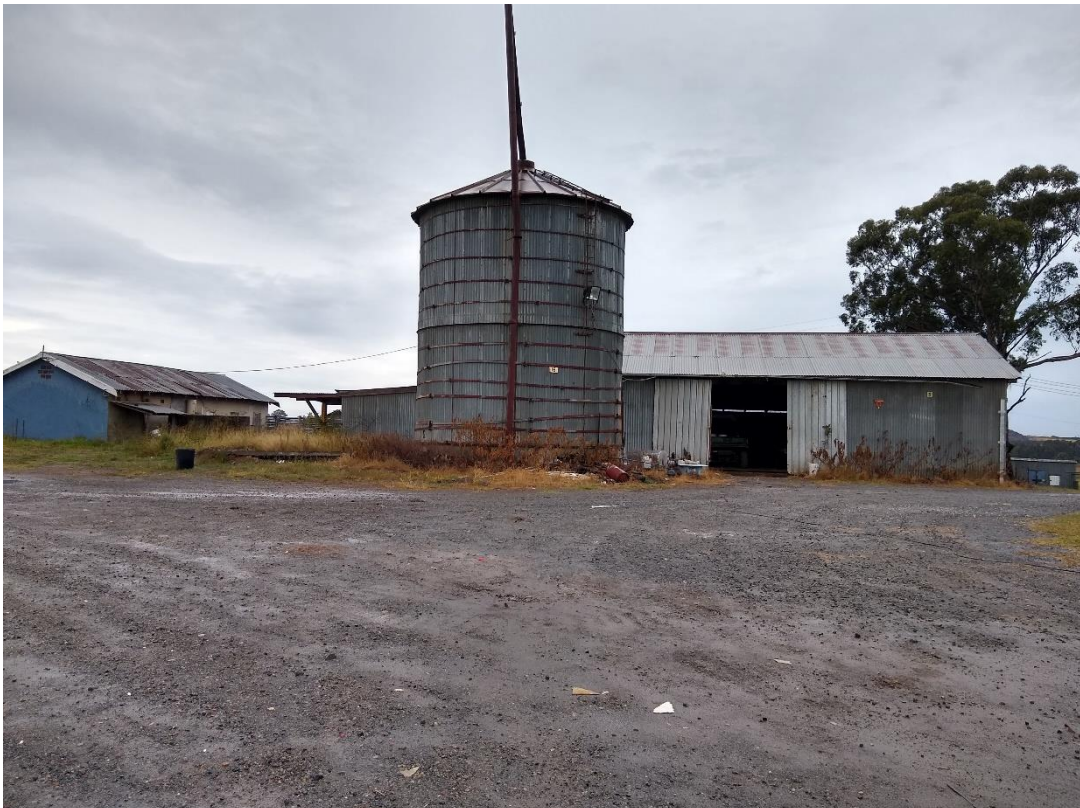
Photo 70: Structure 16 (Silo), no hazardous building materials identified

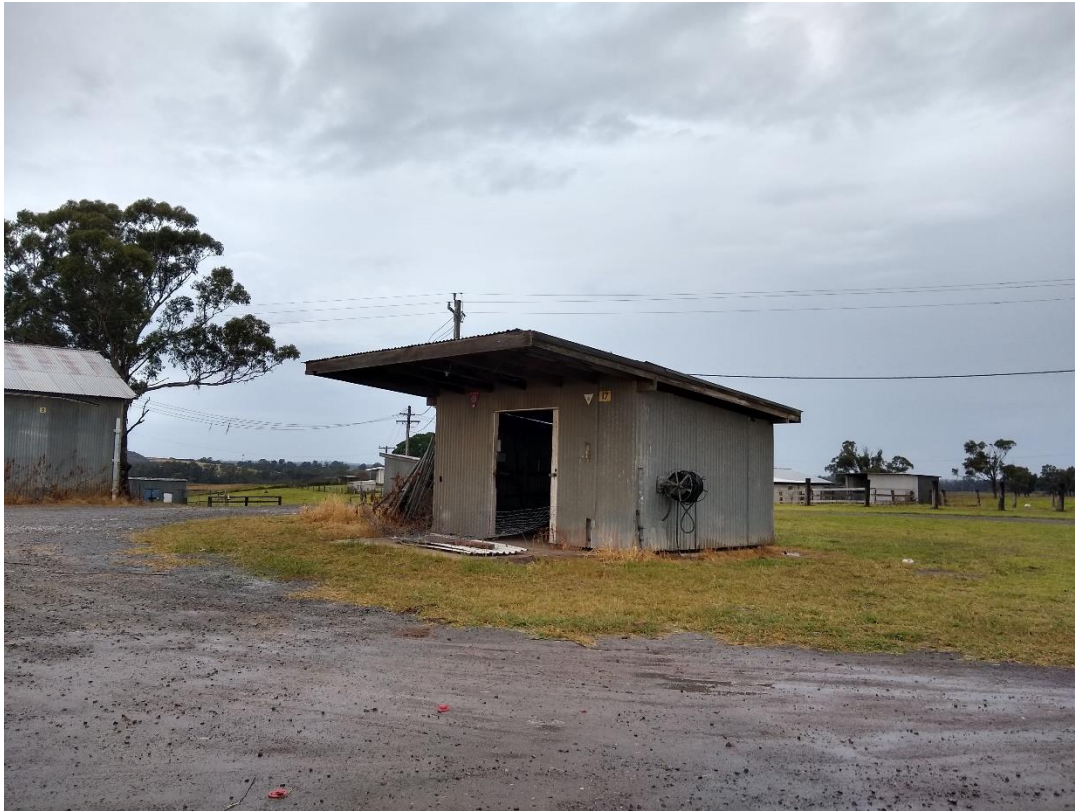
Photo 71: Structure 17, no hazardous building materials identified

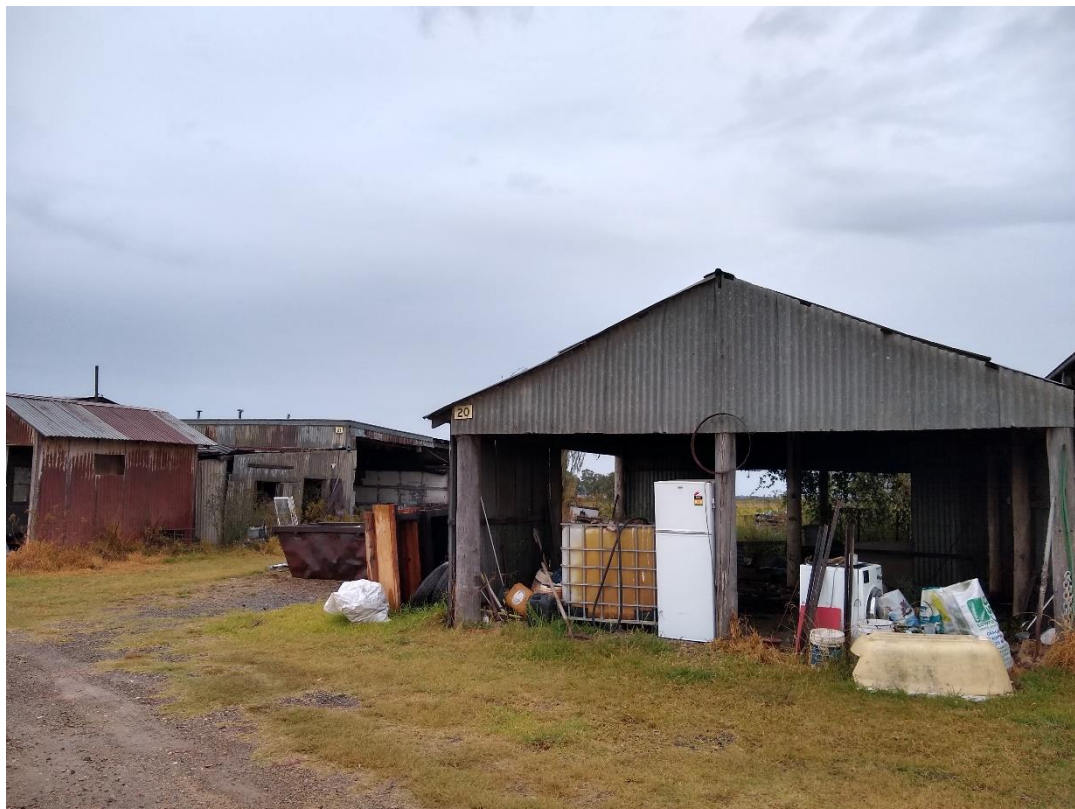
Photo 72: Structure 20, no hazardous building materials identified
