**Australia Sydney 1 Project**

Historical Asbestos Data Review

5 June 2015

Prepared for  
Wanda One Sydney Pty Ltd

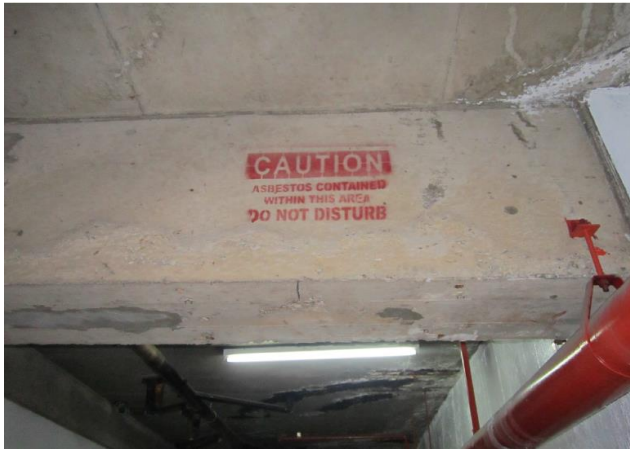
- A large number of structures (i.e. concrete structural beams and columns, metal clad pipework, fire doors, electrical backing boards, various plant, waterproofing membranes and spandrel panels throughout) have not been accessed and in accordance with regulation and industry practice, these areas must be presumed to be asbestos-containing until such time that a pre-demolition/ intrusive inspection can verify or refute this presumption (see **photographs 1, 2 and 3**).

**Photograph 1:** Goldfield's House, concrete beams and columns throughout with suspected asbestos-containing insulation on the enclosed steelwork.

- A destructive hazardous building material survey must be carried out prior to any demolition or refurbishment works. Any hazardous building materials identified within this survey should be removed prior to the commencement of any works that may cause disturbance - as per NSW Code of Practice: *Demolition Work 2014*.

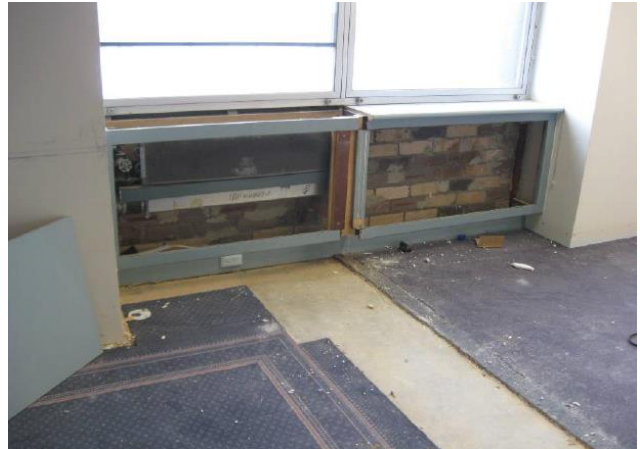
**Photograph 2:** Goldfield's House, spandrel panel voids throughout with suspected asbestos-containing insulation in inaccessible areas.

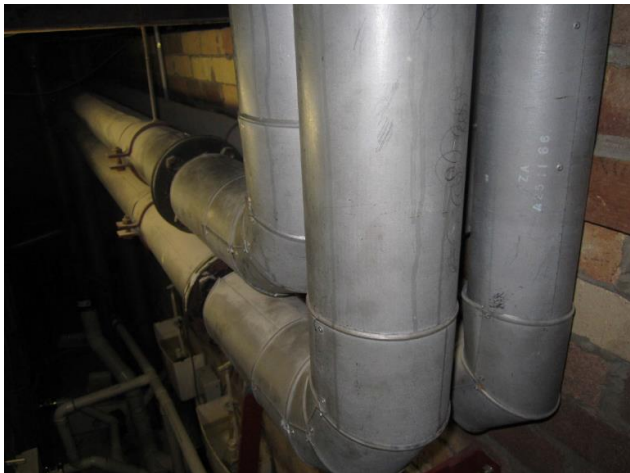
**Photograph 3:** Goldfield's House, metal clad pipework throughout (predominantly SMF) with suspected asbestos-containing insulation in unidentified areas.

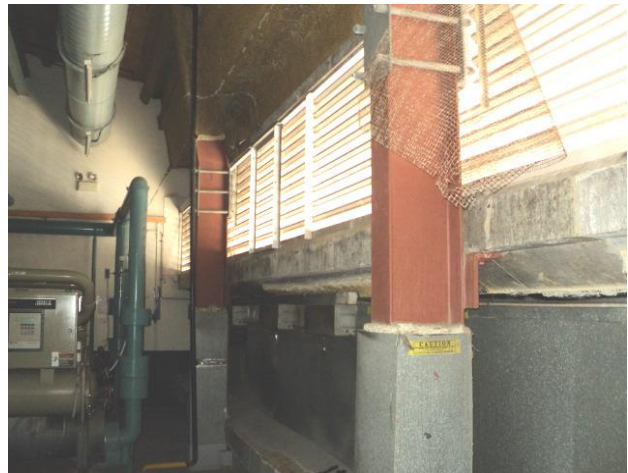
- A large number of structures (i.e. lift motor brake shoes, plant room – behind metal sheeting, fire door cores, electrical backing boards, various plant) have not been accessed due to access

constraint or health and safety reasons and in accordance with regulation and industry practice, these areas must be presumed to be asbestos-containing until such time that a pre-demolition/ intrusive inspection can verify or refute this presumption (see **photographs 4, 5, 6 and 7**);

**Photograph 4:** Fairfax House, Level 15 plant room, metal sheeting affixed to walls and columns protecting suspected underlying friable asbestos.

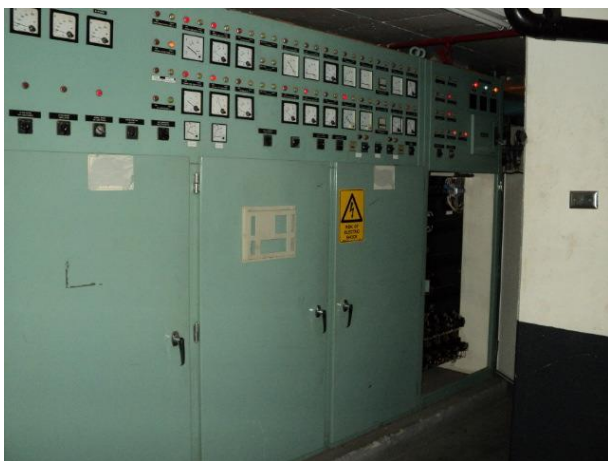
**Photograph 5:** Fairfax House, Level 15 plant room, suspected ACM electrical backing boards.

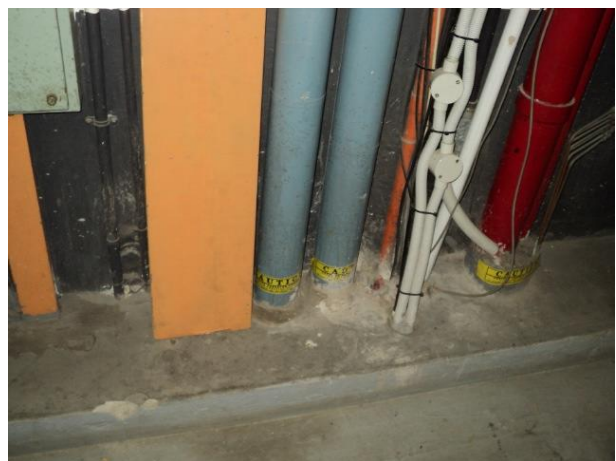
**Photograph 6:** Fairfax House, Level 15 plant room, suspected ACM cable and pipe penetration packing.

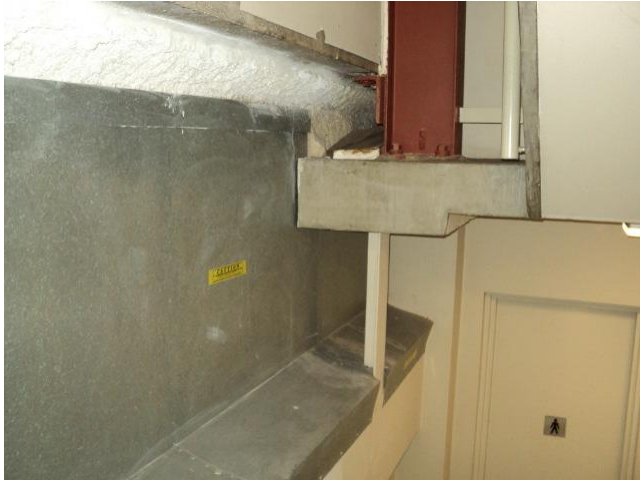
**Photograph 7:** Fairfax House, Level 14-15 south west fire stairs, exposed (sealed) friable ACM to the ceiling and partially covered friable ACM with sheet metal.

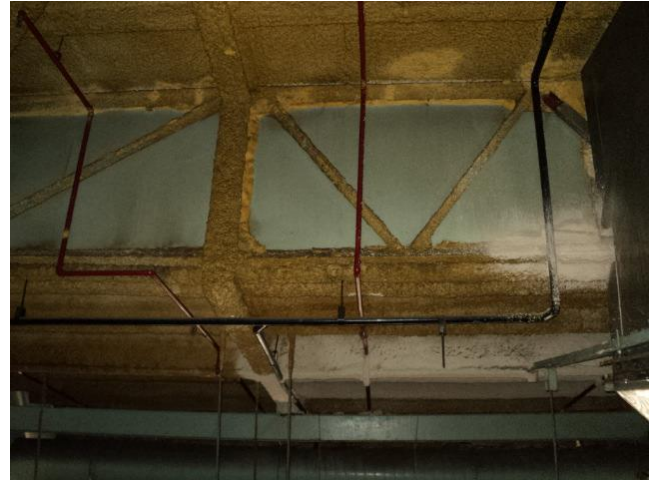
**Photograph 8:** Fairfax House, Level 15 plant room, exposed (sealed) friable asbestos to underside of the roof and on structural steel.

- Coffey recommends that an asbestos re-inspection is undertaken within the building particularly given the friable nature and exposed location of many of the asbestos-containing materials (see **photograph 8**). Although the regulatory driven re-inspection time frames were extended to at least 5 year intervals in the Code of Practice *'How to Manage and Control Asbestos in the Workplace' (2011)*, Coffey recommends that given the nature and location of the friable asbestos

within the building, that a more conservative time frame between re-inspections is instigated, i.e. annually;
