Hazardous Building Materials Survey

**4/56 Yorktown Parade,
Maroubra, NSW, 2035**

New South Wales Land Housing Corporation

17716-ER-4-1 Rev 2

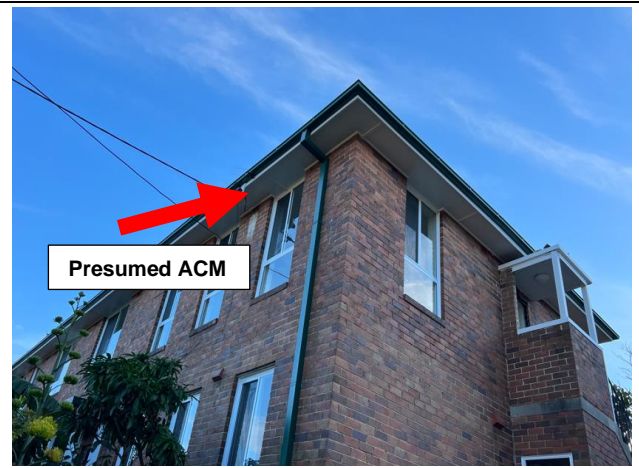
Photograph 2 (20.06.24): Representative photos of White coloured fibre cement sheeting board, External, Roof- Eaves; Sample ID: Visual Only (Presumed ACM)

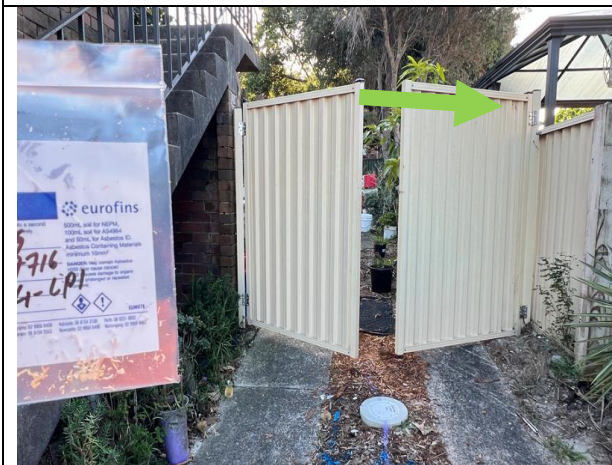
Photograph 3 (20.06.24): Representative photo of yellow paint system, external, northern side gate, Sample ID: 4-LP1 (< 0.01 % w/w)

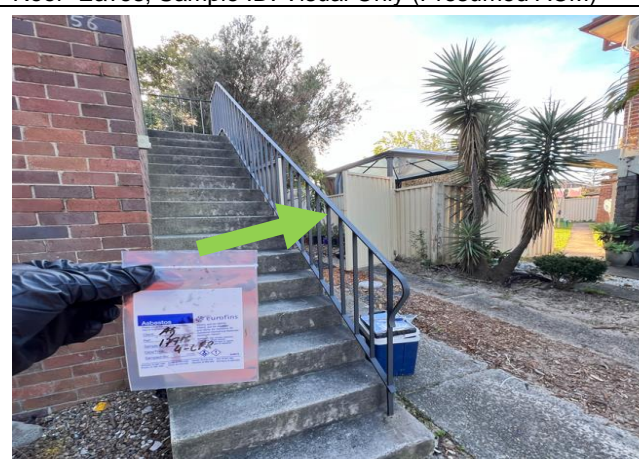
Photograph 4 (20.06.24): Representative photo of dark grey paint system, external, northern side staircase handrail, Sample ID: 4-L2 (0.07 % w/w)

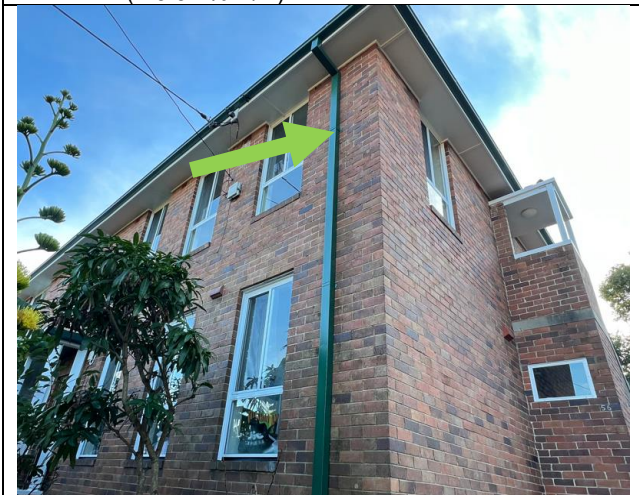
Photograph 5 (20.06.24): Representative photo of green paint system, external roof gutter system and downpipe, Sample ID: 4-LP3 (< 0.01 % w/w)

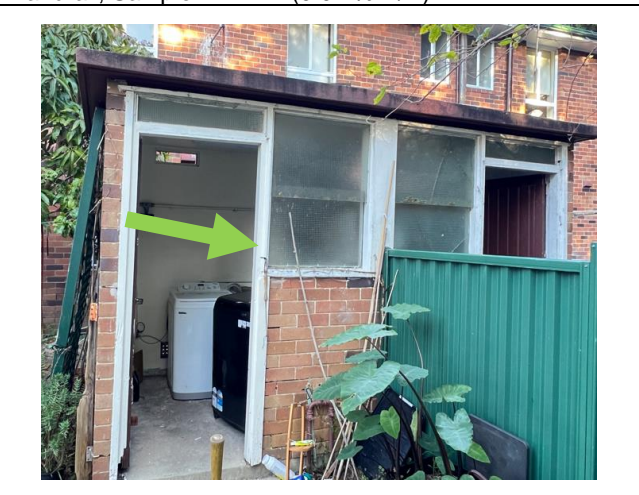
Photograph 6 (20.06.24): Representative photo of white paint system, external backyard laundry shed door frame, Sample ID: 4-LP4 (0.09 % w/w)

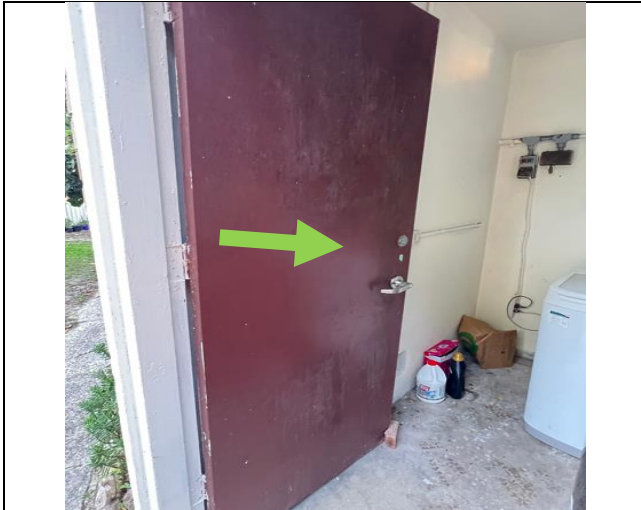
Photograph 7 (20.06.24): Representative photo of brown paint system, external backyard laundry shed door, Sample ID: 4-LP5 (< 0.01 % w/w)

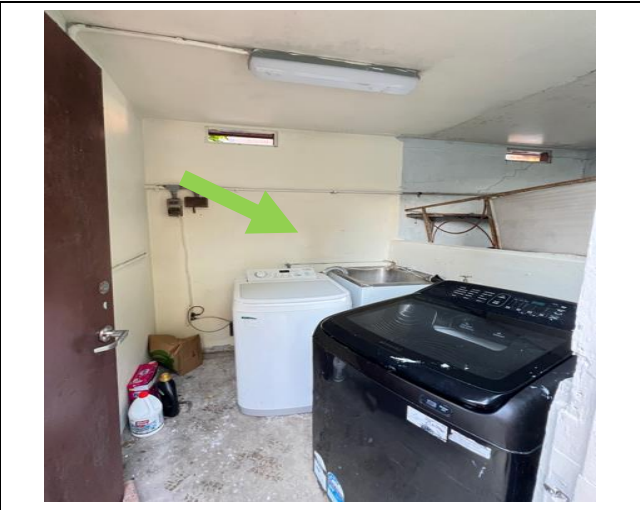
Photograph 8 (20.06.24): Representative yellow paint system, external backyard laundry shed walls, Sample ID: Same as 4-LP8 (0.03 % w/w)

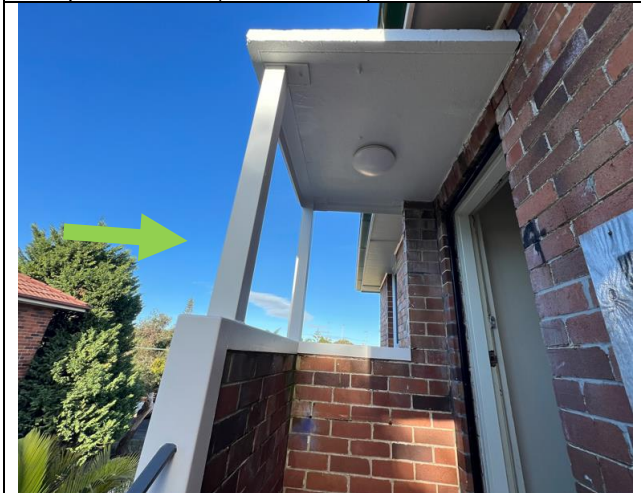
Photograph 9 (20.06.24): Representative photo of white paint system, external porch area, Sample ID: 4-LP6 (<0.01 % w/w)

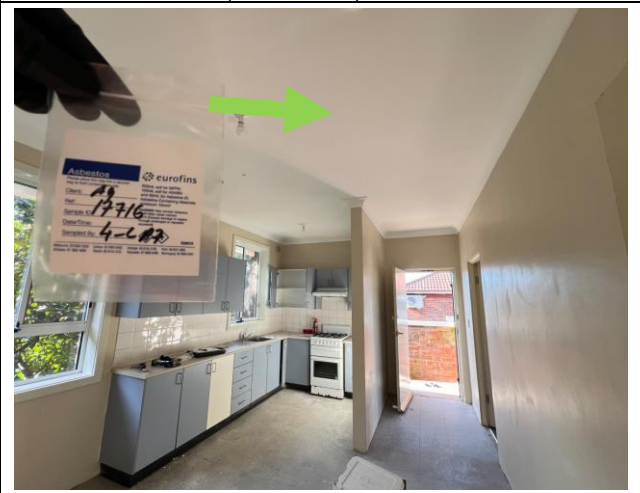
Photograph 10 (20.06.24): Representative photo of white paint system, internal kitchen and hallway ceiling, Sample ID: 4-LP7 (< 0.01 % w/w)

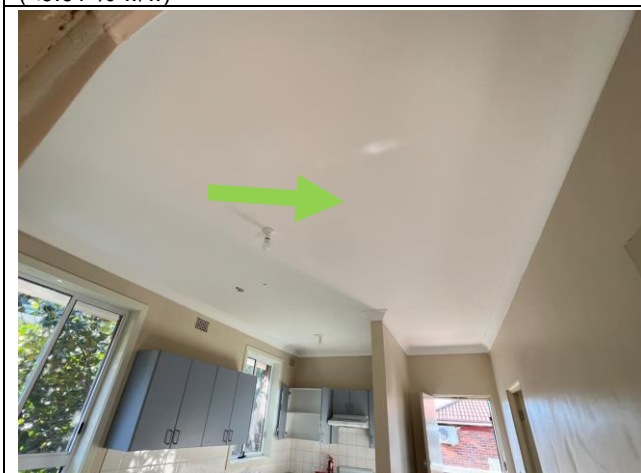
Photograph 11 (20.06.24): Representative photo of white-coloured plasterboard, internal kitchen and hallway ceiling, Sample ID: 4-A1 (NAD)

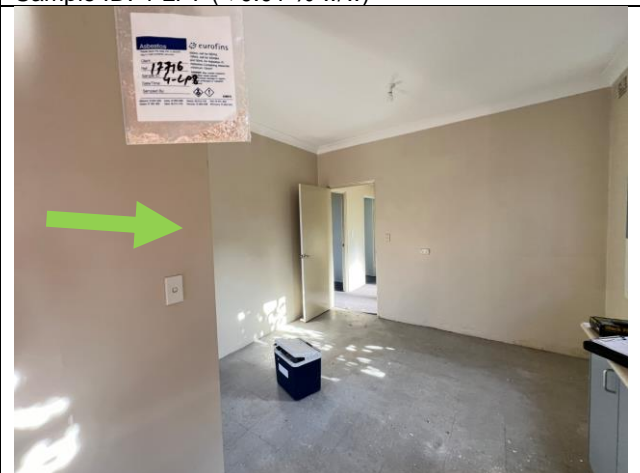
Photograph 12 (20.06.24): Representative photo of yellow paint system, internal kitchen walls on all four walls, Sample ID: 4-LP 8 (< 0.01 % w/w).

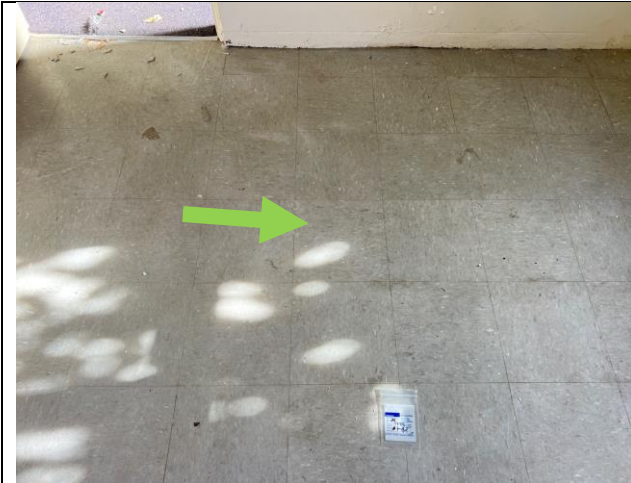
Photograph 13 (20.06.24): Representative photo of vinyl tiles on the internal kitchen floor, Sample ID: 4-A2 (NAD).

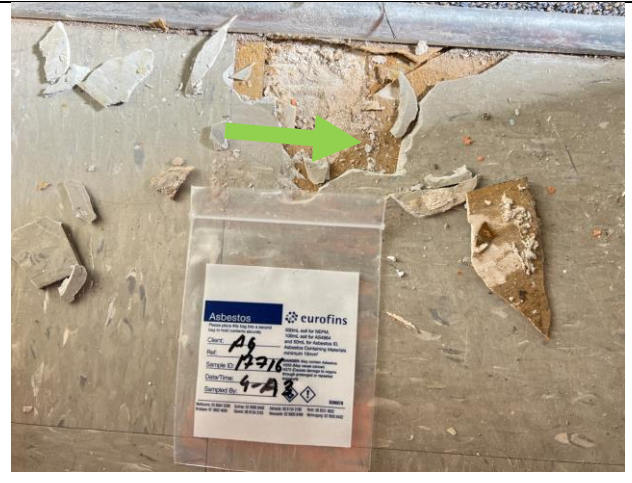
Photograph 14 (20.06.024): Representative photo of the brown-coloured base to vinyl tiles on the internal kitchen floor, Sample ID: 4-A3 (NAD).

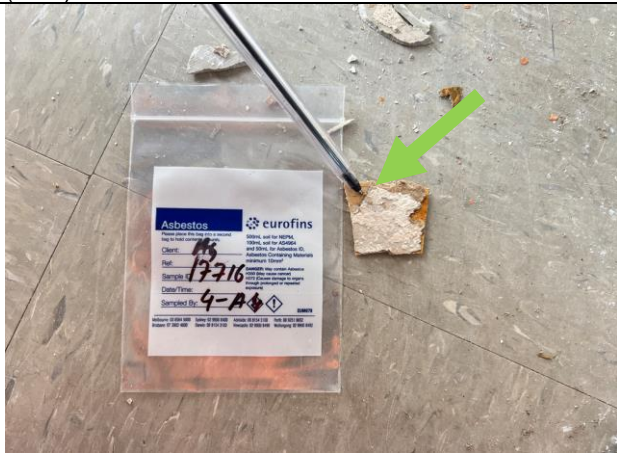
Photograph 15 (20.06.24): Representative photo of adhesive glue at the base to vinyl tiles on the internal kitchen floor, Sample ID: 4-A4 (NAD).

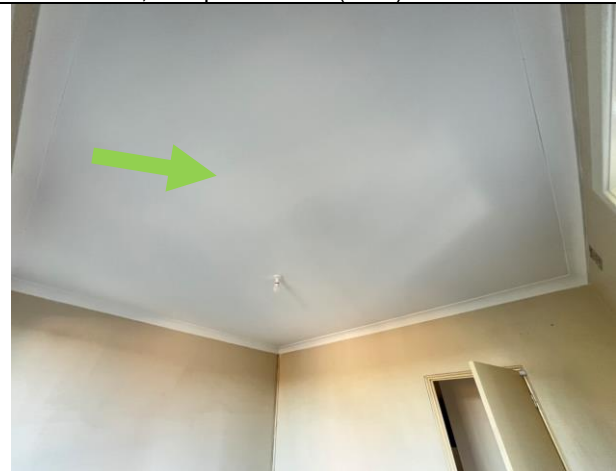
Photograph 16 (20.06.24): Representative photo of white paint system and plasterboard, internal Room 1 ceiling, Sample ID: Lead - Same as 4- LP7 (< 0.01 % w/w) and Asbestos – Same as A1.

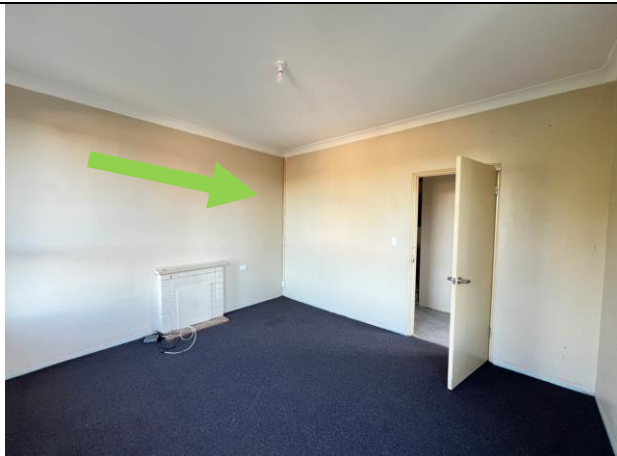
Photograph 17 (20.06.24): Representative photo of yellow paint system, internal room 1 walls on all 4 walls, Sample ID: same as 4- LP 8 (< 0.01 % w/w).

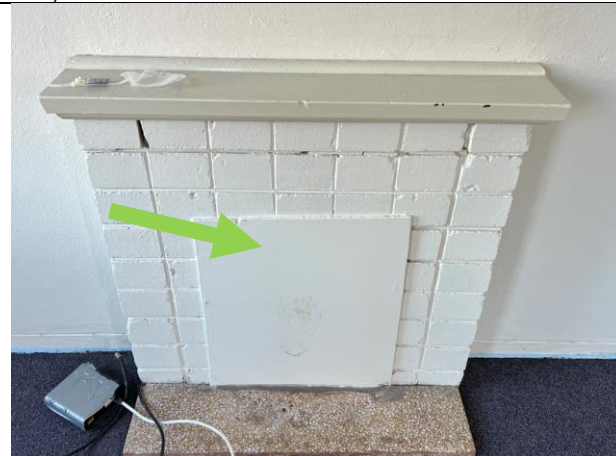
Photograph 18 (20.06.24): Representative photo of yellow coloured plasterboard, internal Room 1 on the fireplace cover, Sample ID: A5 (NAD).

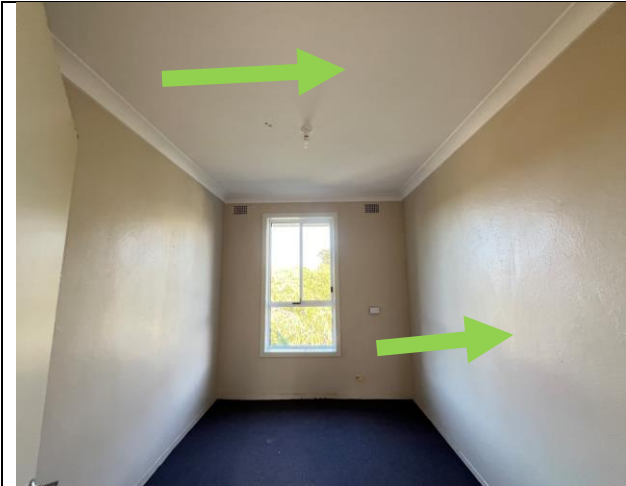
Photograph 19 (20.06.24): Representative photo of yellow paint system (walls) and white paint system (ceiling) and white coloured plasterboard (ceiling), internal Room 2 Sample ID: Lead - Same as 4- LP 8 (< 0.01 % w/w) and Asbestos – Same as A1 (NAD).

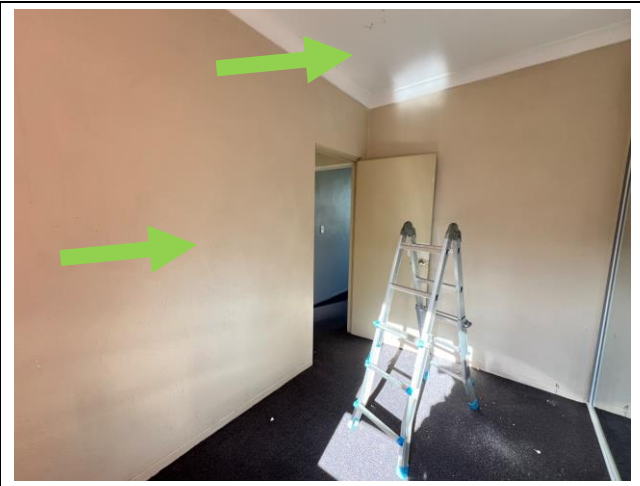
Photograph 20 (20.06.24): Representative photo of yellow paint system (walls), white paint system (ceiling) and white coloured plasterboard (ceiling), internal Room 3, Sample ID: Lead - Same as 4- LP 8 (< 0.01 % w/w) and Asbestos – Same as A1 (NAD).

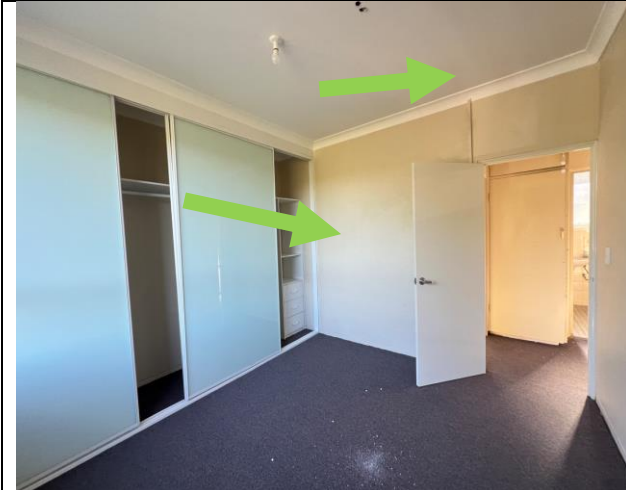
Photograph 21 (20.06.24): Representative photo of yellow paint system (walls), white paint system (ceiling) and white coloured plasterboard (ceiling), internal Room 4, Sample ID: Lead - Same as 4- LP 8 (< 0.01 % w/w) and Asbestos – Same as A1 (NAD).

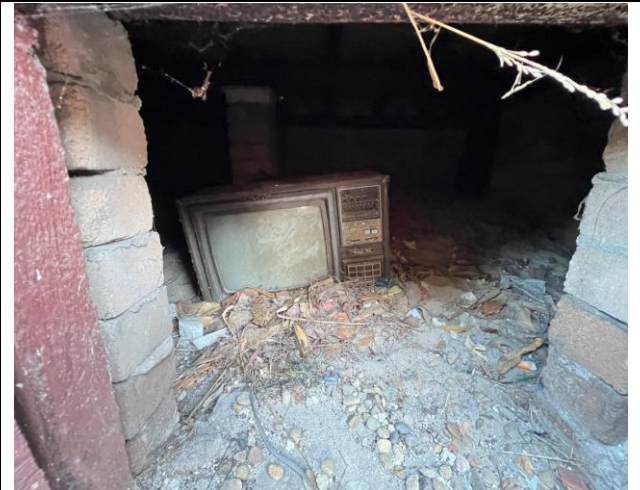
Photograph 22 (20.06.24): Representative photos of basement of building structure located at 56 Yorktown Parade, Maroubra (inaccessible).
