GTE549-Stage 1 Contamination  
7 May 2015

**RE: STAGE 1 CONTAMINATION ASSESSMENT at 34 Yarrunga Street, Prestons.**

This letter presents a Stage 1 Contamination report on the inspection and testing services associated with the contamination assessment undertaken at the above project.

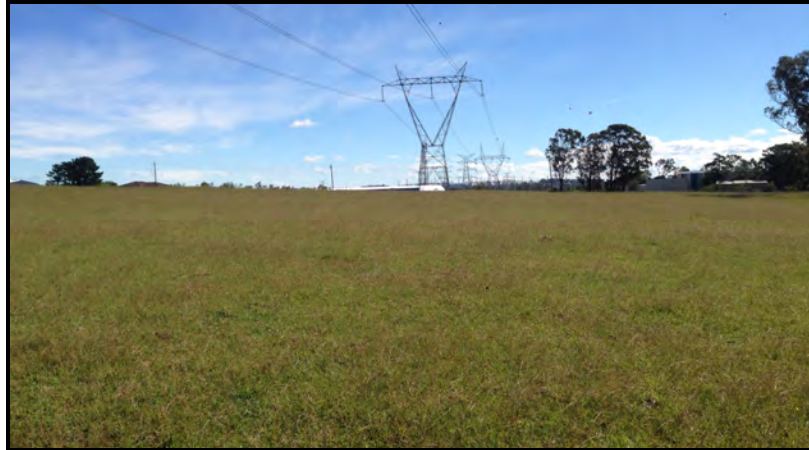
**Photograph 1 – Lot 33**

Lot 33 and 35 are grass covered and vacant. High voltage power lines traverse through the site in a north / south alignment.

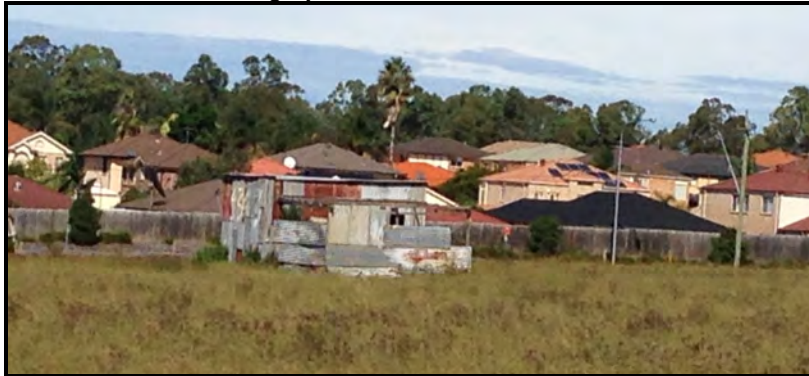
**Photograph 5 – Metal Shed on Lot 43**

Lot 43 contains a metal shed located centrally within the lot

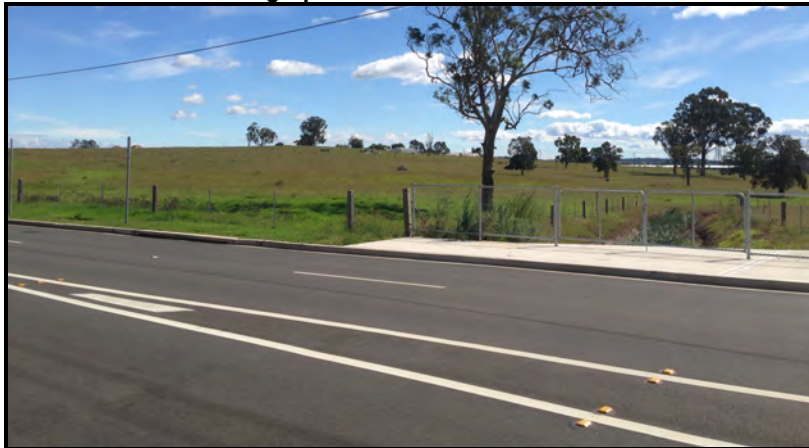
**Photograph 6 – Fill area within Lot 20**

Lot 20 of DP1173483 is predominately vacant. An old drainage line has been re-aligned within this site with a new culvert placed under Kurrajong Road.

Filling was observed within the south-eastern corner of the site for the re-alignment of a drainage channel (see figure 10). Correspondence from council indicates that no fill was imported and the material was sourced from within the subject site (See Appendix F).

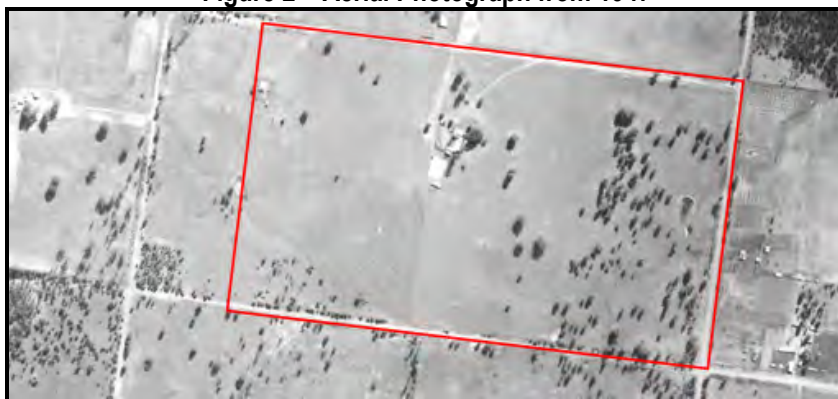
**Figure 2 – Aerial Photograph from 1947**

1947 – In 1947 the site is predominately vacant and covered in a light scattering of trees. A residential homestead has been constructed within the centre portion of the site. Adjoining sites are predominately vacant whilst the region appears to be rural / farming properties. No industrial or manufacturing plants could be identified within the aerial photograph. The subject site is highlighted in figure 2.

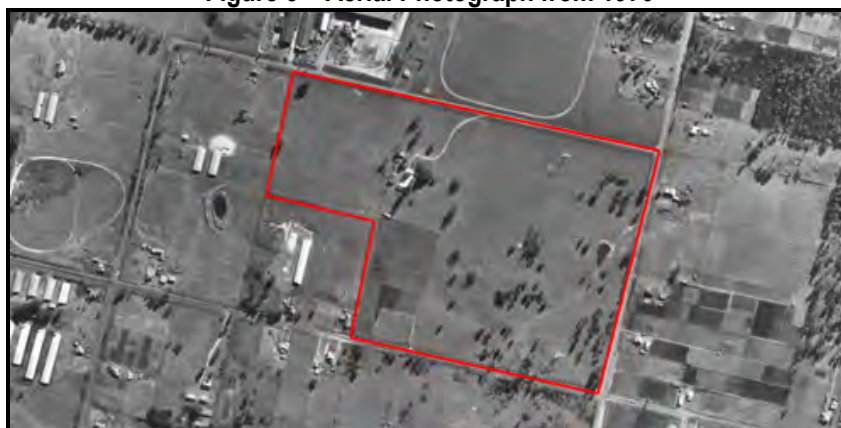
**Figure 3 – Aerial Photograph from 1970**

1970 – In 1970 the site is predominately vacant and covered in a light scattering of trees. The residential house within the centre of the site is still standing. Market Gardening appears to have been undertaken within the south-western portion of the site. No industrial or manufacturing plants could be identified within the aerial photograph. The subject site is highlighted in figure 3.

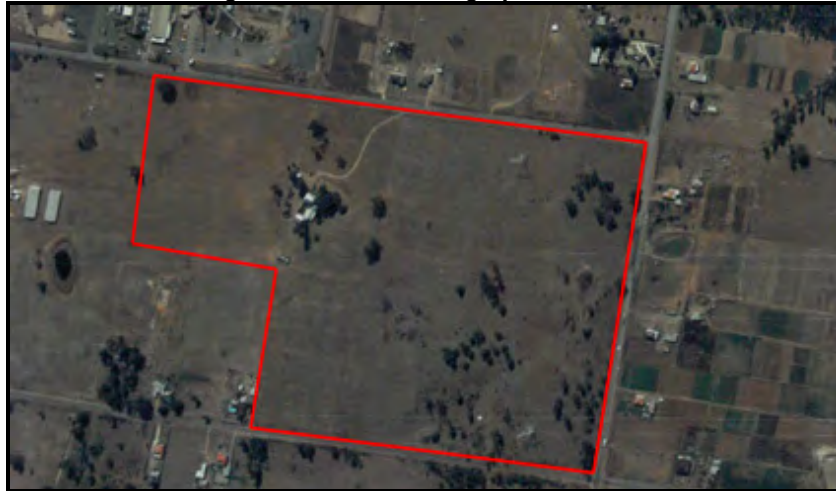
**Figure 4 – Aerial Photograph from 1982**

1982 – In 1982 the site is predominately vacant and covered in trees. The residential house within the centre of the site is still standing. Market Gardening appears to have been undertaken within the south-western portion of the site. No industrial or manufacturing plants could be identified within the aerial photograph. The subject site is highlighted in figure 4.

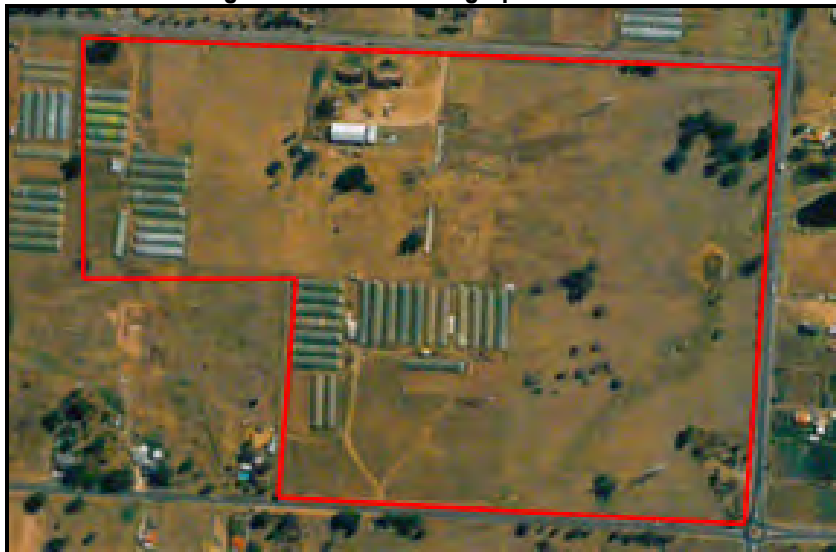
**Figure 5 – Aerial Photograph from 1994**

1994 – In 1994 the the original homestead, which was destroyed by fire, has been replaced by a new residential house and shed which have been constructed along the Yarunga Street frontage. The market gardening appears to have ceased and has been replaced by the green houses. No industrial or manufacturing plants could be identified within the aerial photograph. The subject site is highlighted in figure 5.

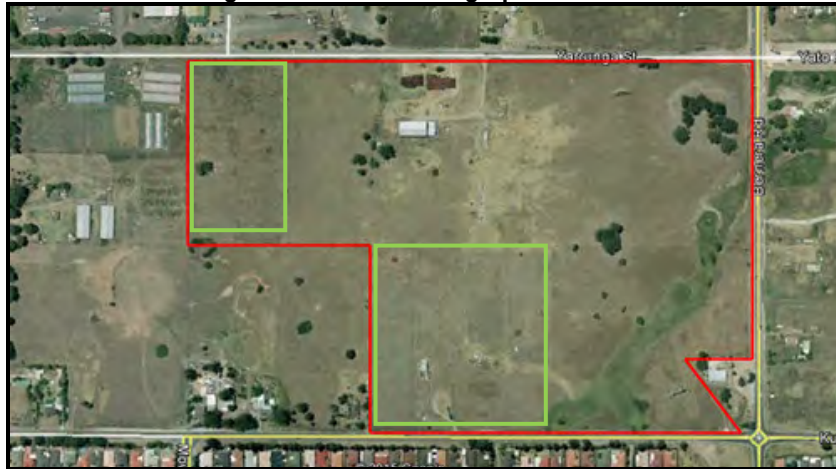
**Figure 5 – Aerial Photograph from 2006**

2006 – In 2006 the residential house and shed along the Yarunga Street frontage is still standing. The green houses have been removed. The remnants of market gardening can be observed within the western and south-western corners of the site. Industrial or manufacturing plants have started to be constructed within the region and new residential subdivisions have been constructed to the south of the site. The subject site is highlighted in figure 6.

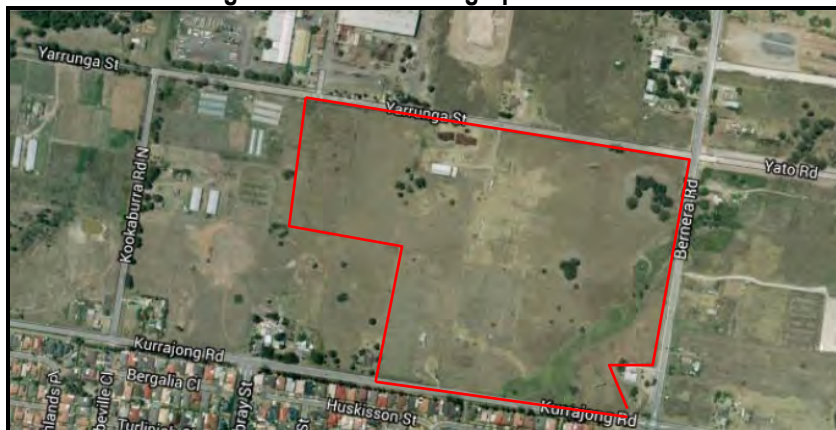
**Figure 7 – Aerial Photograph from 2012**

2012 – In 2012 no significant changes to the land usage were observed from 2006, The subject site is highlighted in figure 7.

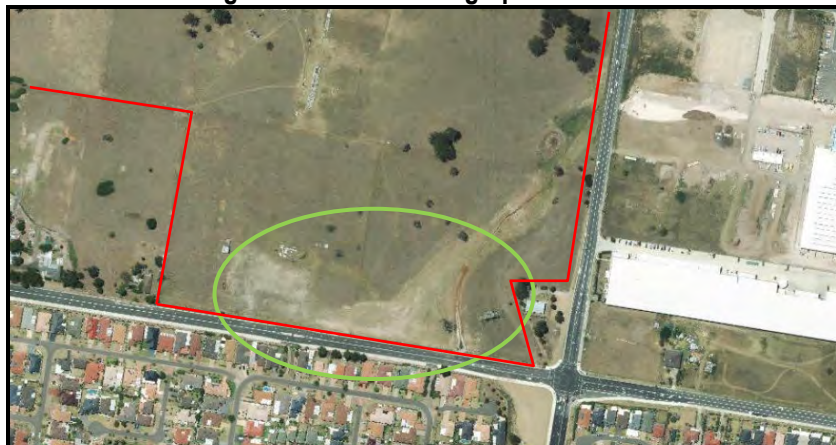
**Figure 8 – Aerial Photograph from 2015**

2015 – In 2015 no significant changes to the land usage were observed from 2006, however, the natural water course within the south-eastern corner of the site has been re-aligned and the previous channel has been backfilled. The location channel re-alignment is highlighted in figure 8.

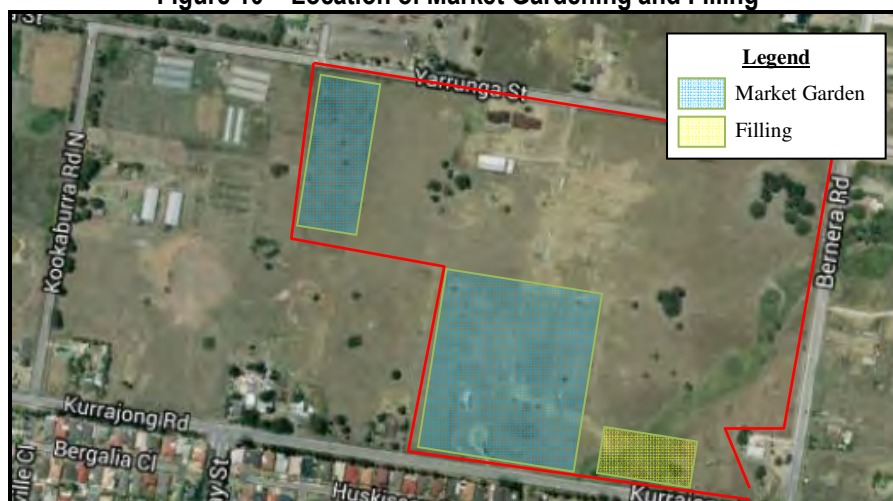
**Figure 10 – Location of Market Gardening and Filling**

The subject site appears to have been used for significant market gardening. A review of aerial photography supports this assumption. With reference to "Contaminated Sites – Guidelines for Assessing Former Orchards and Market Gardens. Department of Environment and Conservation (NSW) 2005", the contaminants of concern within site used for market gardening are Metals (Arsenic, Copper, Lead) and Organochlorine Pesticides (OCP).

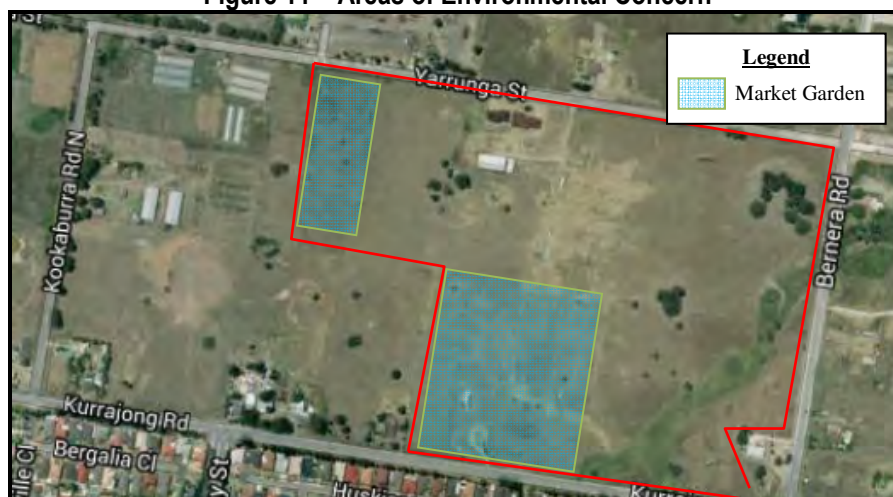
**Figure 11 – Areas of Environmental Concern**

This report is a Stage 1 Contamination Assessment with limited chemical testing undertaken. Market gardening was observed within the desktop study, and filling of an unknown origin was identified. Preliminary testing indicates that the risk of contamination is low, however in accordance "Guidelines for Assessing Former Orchards and Market Gardens" Department of Environment and Conservation (NSW), it is recommended that these areas of environmental concern be further investigated for the development application process and any contaminants found be appropriately treated under a site management plan during construction.
