Project 85374.01  
21 March 2016  
85374.01.R.001.Rev1  
TW:jlb

**Review of Reports – Site Contamination**  
**Arthur Phillip High School and Parramatta Public School**  
**Macquarie Street, Parramatta**

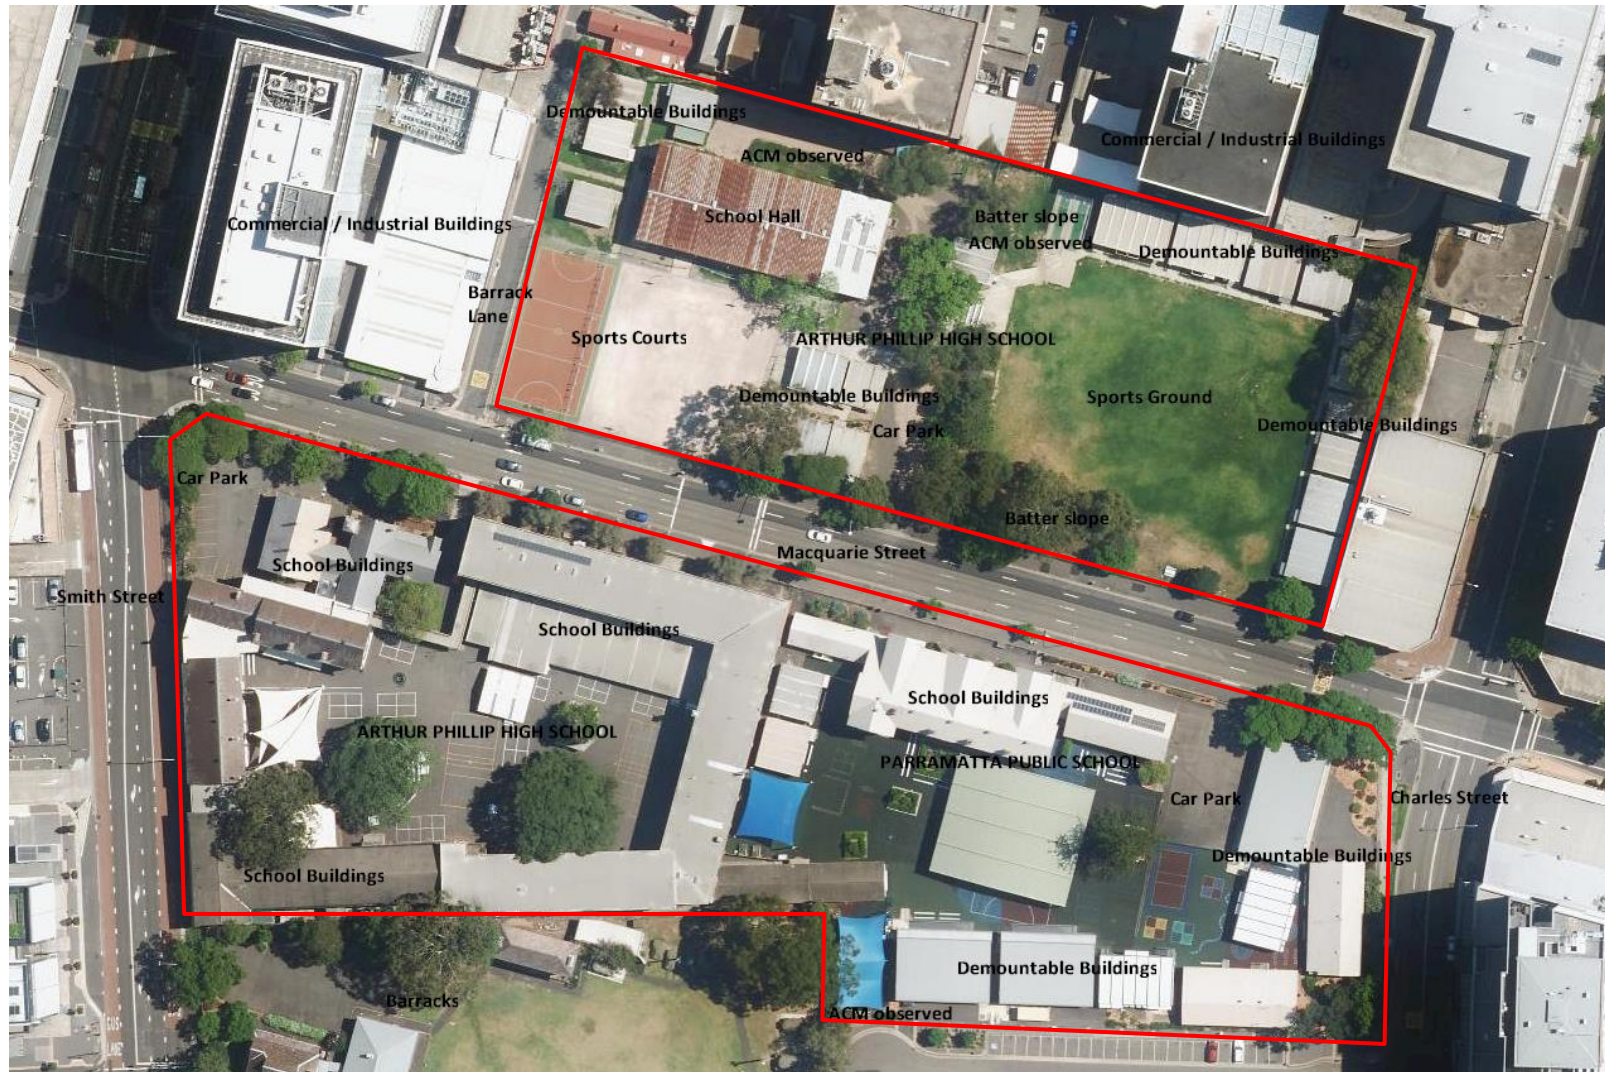
Alliance Geotechnical Drawing Number: 1915-ER-1-B

The findings of a site walkover conducted by AG on 9, 10 and 13 July 2015 are summarised as follows (refer to AG Drawing Number: 1915-ER-1-B attached):

- PPS comprised a large brick building and ten demountable classrooms, a bitumen car park, a large metal awning and a number of bitumen and soft bitumen playgrounds. Suspected ACM fragments were observed on the ground surface in the south west of the PPS site;
- The site was bound by a 2.5 m high fence with secure gates;
- No underground or above ground storage tanks were observed; and
- No bulk storage of dangerous chemicals or other hazardous goods were observed.

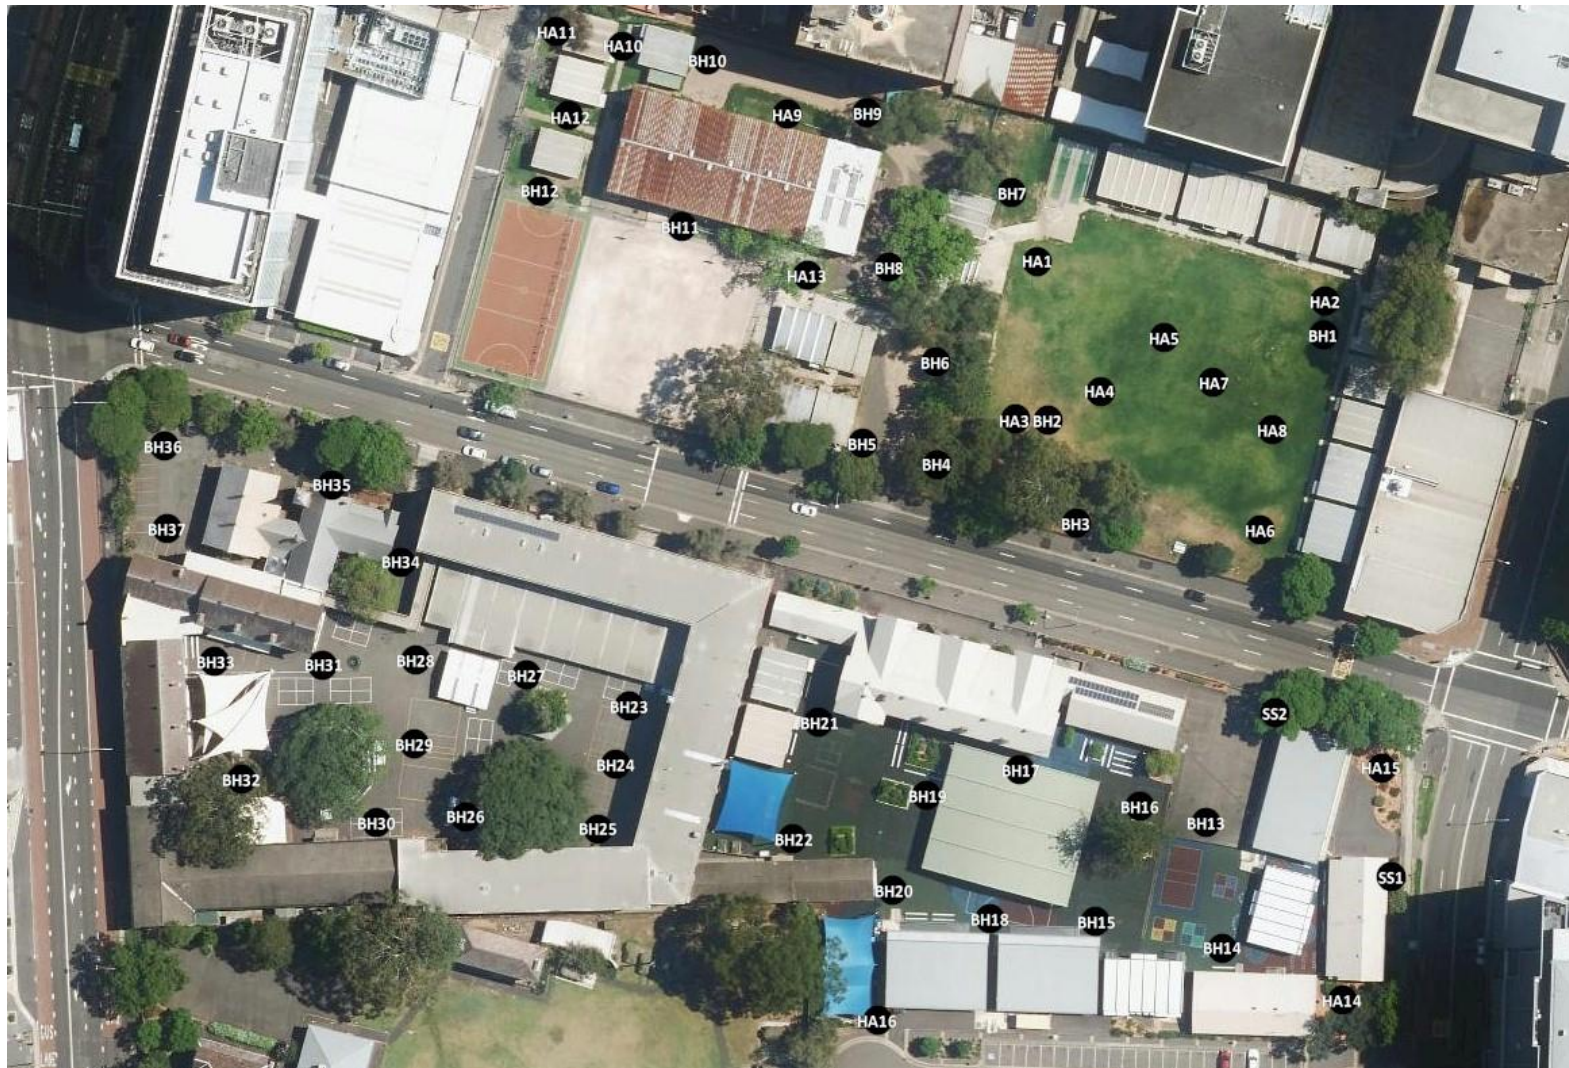
Alliance Geotechnical Drawing Number: 1915-ER-1-C

The filling in the south site was encountered to depths of between 0.4 m and 0.7 m bgl and comprised brown to grey gravelly clay/silty clay with foreign materials such as igneous gravel and bitumen. Fragments of ACM were observed on the ground surface in the south west of the PPS site (HA16) (refer to AG Drawing Number: 1915-ER-1-C attached), however, the condition of the fragments is not given.

Thirty one samples were analysed for asbestos, however, ten of the samples analysed were natural soils and would not be expected to contain asbestos. Of the remaining 21 samples (17 from the north site and four from the south site – Tables 1 and 2 above) AG (2015a) states that three samples exceeded the SAC, however, it is not stated how the concentrations of asbestos %w/w were calculated. Asbestos was reported in the laboratory certificate to be present in the following four samples (refer to AG Drawing Number: 1915-ER-1-C attached):

- HA9-0.0-0.2 – chrysotile, amosite and crocidolite in fibre cement fragments, and chrysotile and amosite in loose fibre bundles (north site – filling);
- HA16-0.0-0.2 – chrysotile, amosite and crocidolite in fibre cement fragments and in loose fibre bundles (south site – filling);
- BH4-0.0-0.1 – chrysotile and amosite in fibre cement fragments (north site – filling); and
- BH12-0.0-0.1 – chrysotile in loose fibre bundles (north site – filling).

AG (2015b) states that soils impacted by friable asbestos (AF/FA – asbestos fines / fibrous asbestos) were present in three locations; HA9, HA16 and BH4. However, the asbestos identified in the sample from BH4 was not in a friable form; and friable asbestos was also recorded in a sample from BH12. To summarise the results as reported by AG (2015a), as corrected by the contents of the laboratory certificate of analysis, asbestos / asbestos impacted soil was recorded in the following locations (refer to AG Drawing Number: 1915-ER-1-C attached):

- HA9 – non-friable on the surface and, friable and non-friable at 0.0-0.2 m depth – north site; HA16 - non-friable on the surface and, friable and non-friable at 0.0-0.2 m depth – south site;
- BH4 – non-friable at 0.0-0.1 m depth – north site;
- BH7 – non-friable on the slope surface – north site; and
- BH12 - friable at 0.0-0.1 m depth – north site.

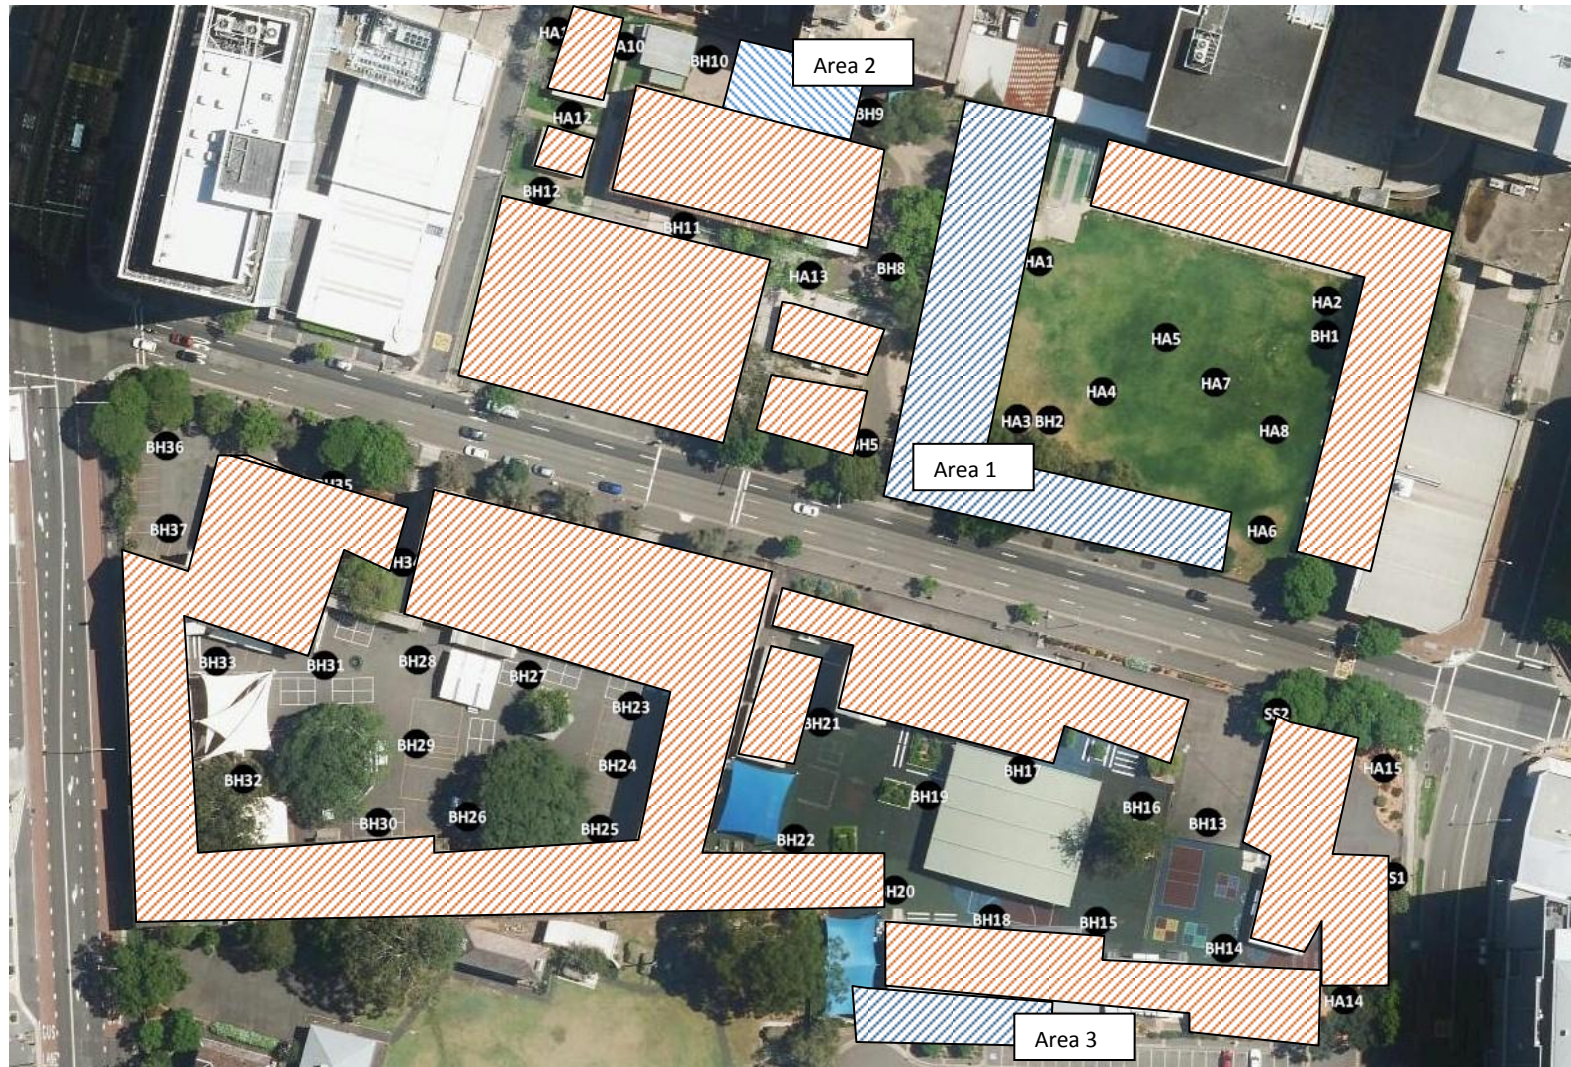
Alliance Geotechnical Drawing Number: 1915-ER-1-D

In areas which are currently inaccessible (the sports courts, building footprints and areas covered with hard or soft bitumen, refer to AG Drawing Number: 1915-ER-1-D attached) AG (2015b) recommends the following post removal of the buildings / surfaces:

- An inspection for visible signs of contamination such as ACM, hydrocarbons staining or odours, underground storage tanks or other sources of contamination; and
- Collection of soil samples in areas of identified contamination, which may include test pits for ACM assessment.

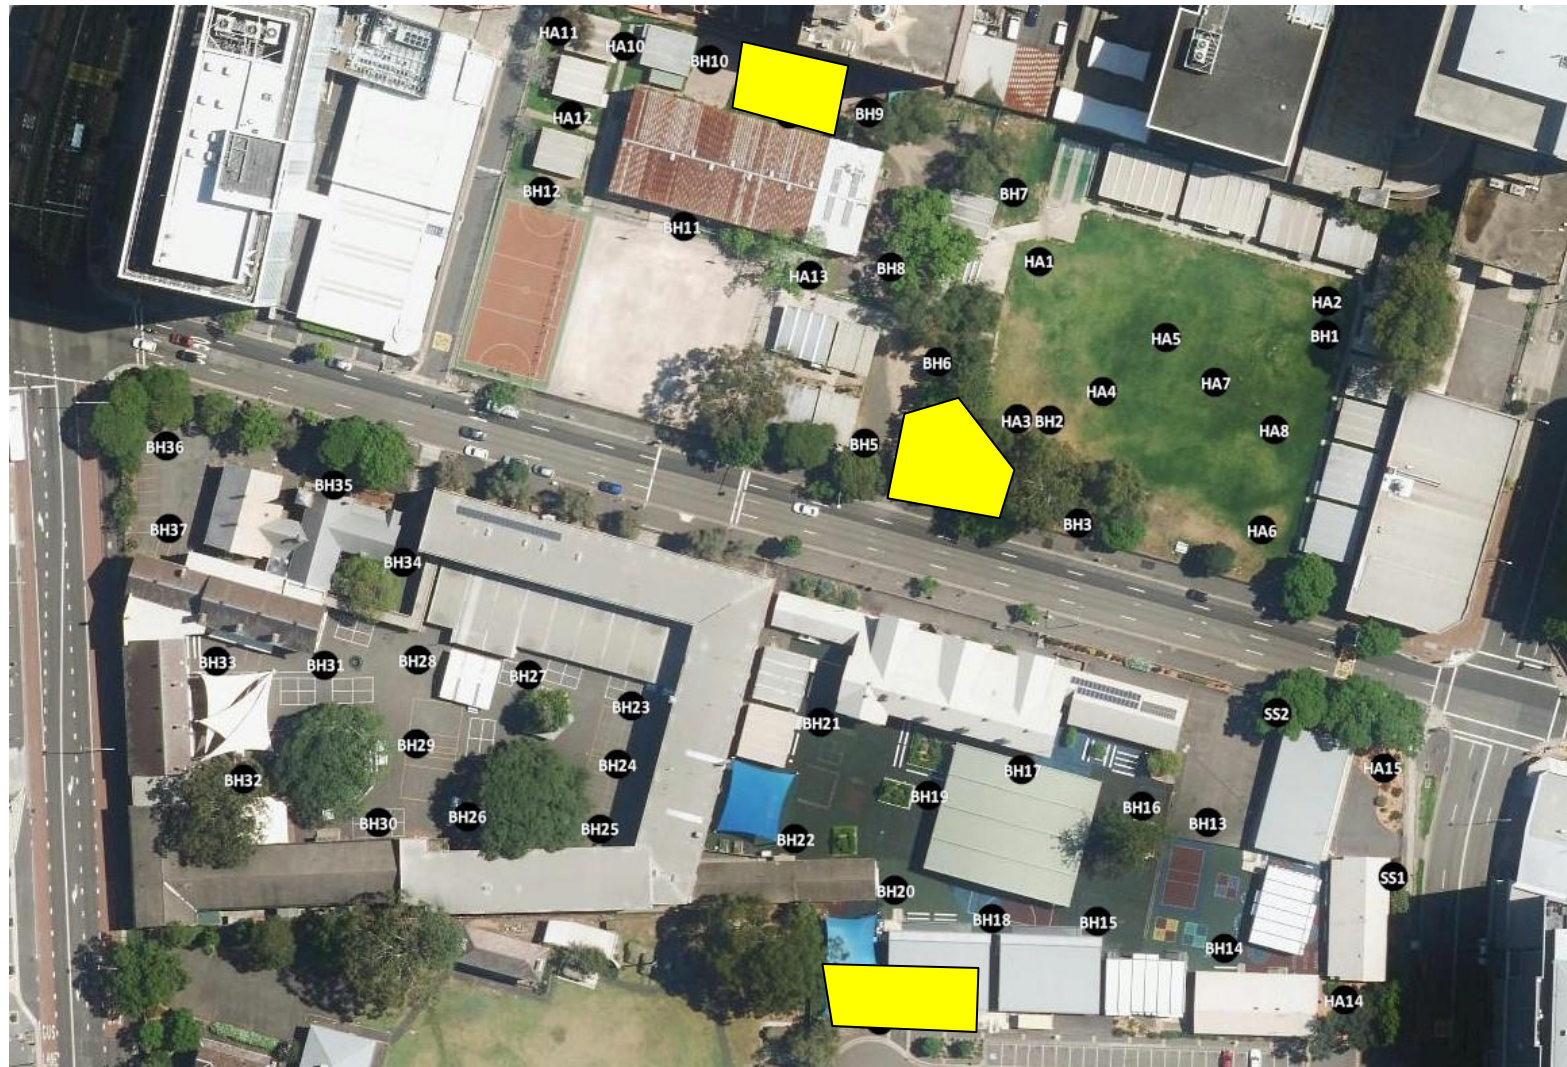
Alliance Geotechnical Drawing Number: 1915-ER-1-E

AG (2015b) notes that the extent of remediation required is currently unknown but based on a conservative approach approximate areas of remediation are provided. The areas of remediation (refer to AG Drawing Number: 1915-ER-1-E attached) are much smaller than the three areas previously identified as requiring additional asbestos quantification works (refer to AG Drawing Number: 1915-ER-1-D attached). However, there is no rationale provided for these reduced areas and the areas do not include BH12.
