## Site Photos

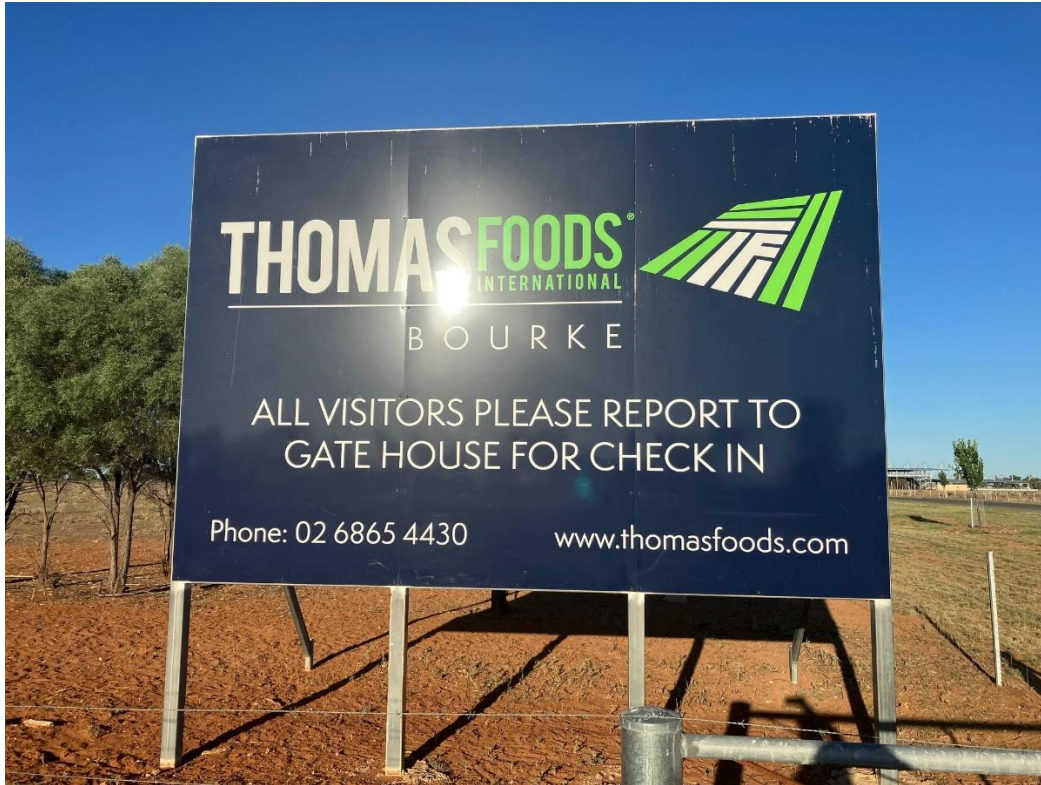
*Figure 1: TFI Bourke Entrance Display Board*

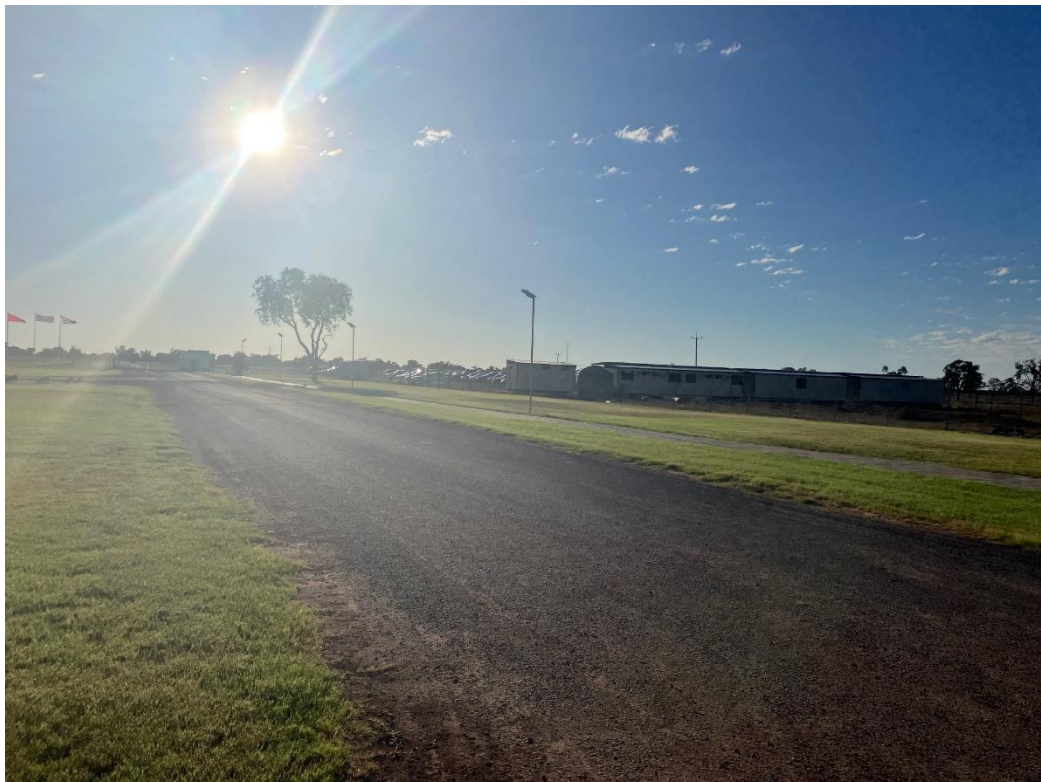
*Figure 2: Front lawns and internal road*

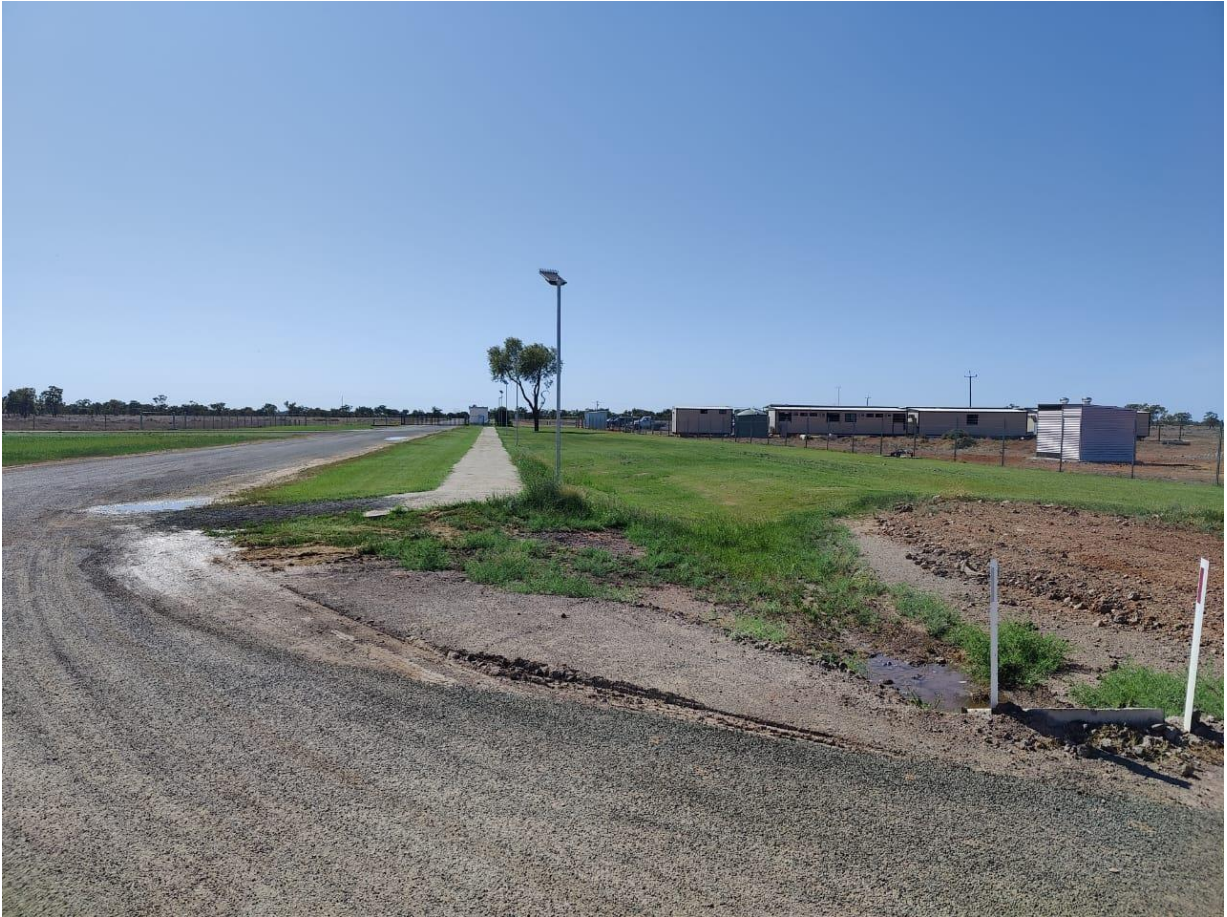
*Figure 3: Pedestrian walkway*

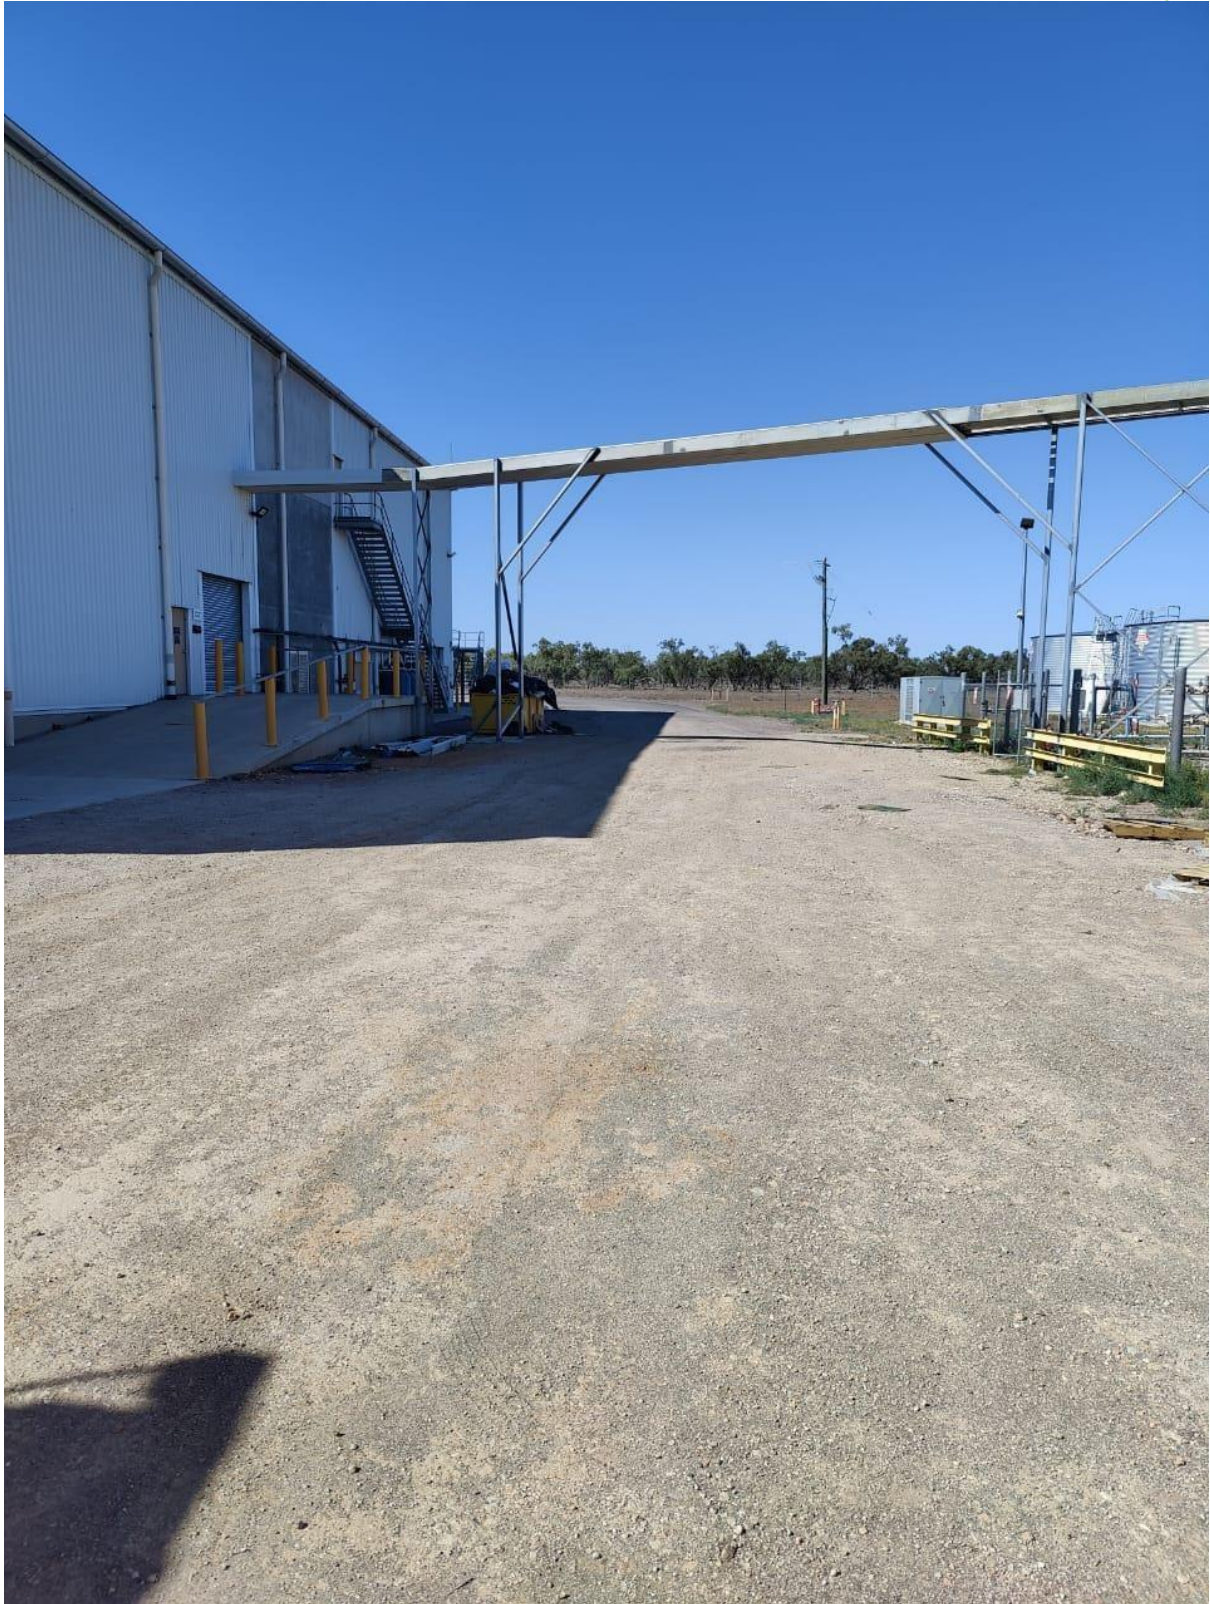
*Figure 4: Backside road of the building*

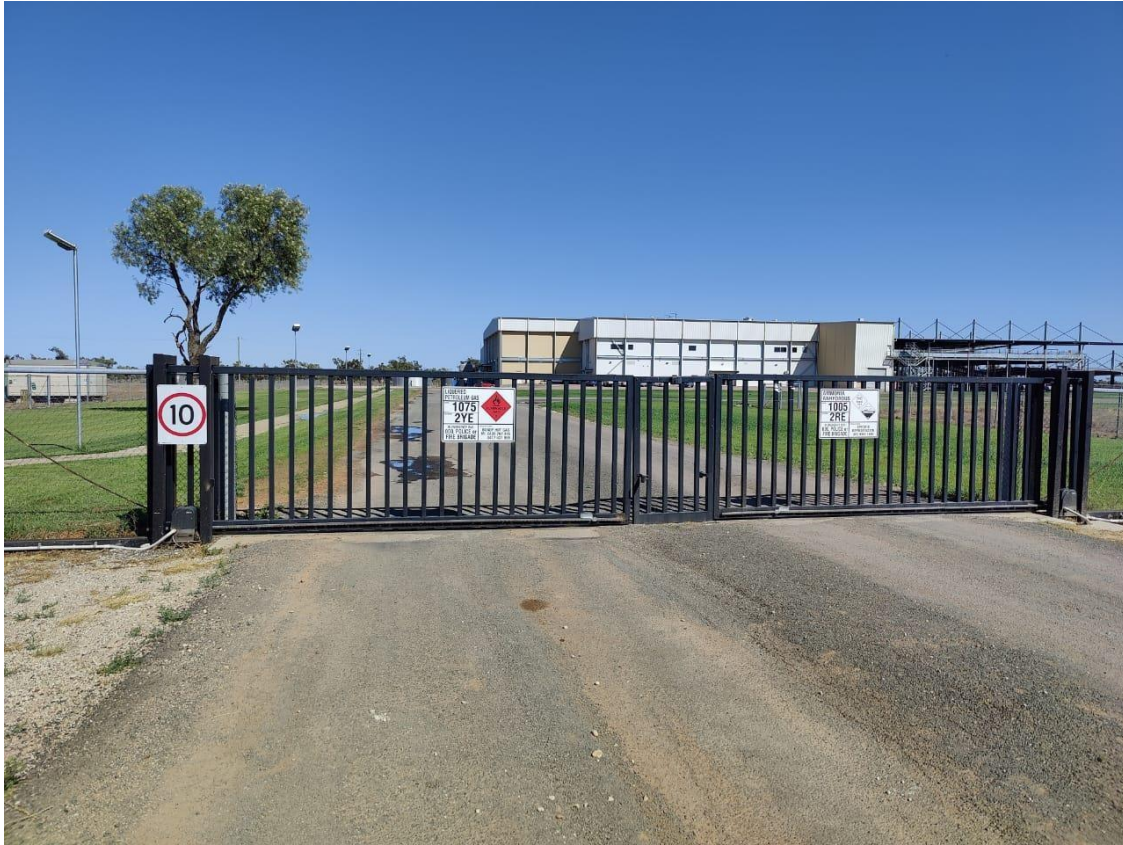
Figure 5: Front gate entry and associated signage

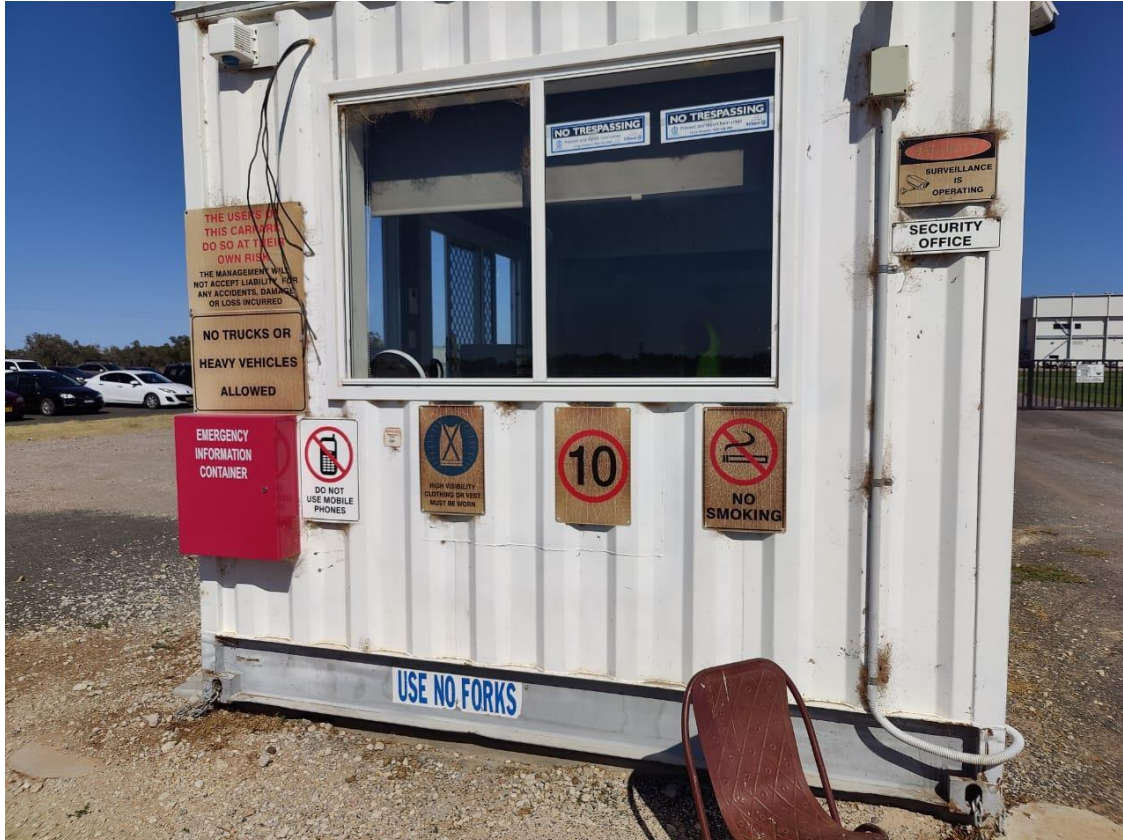
Figure 6: Security office at front entrance

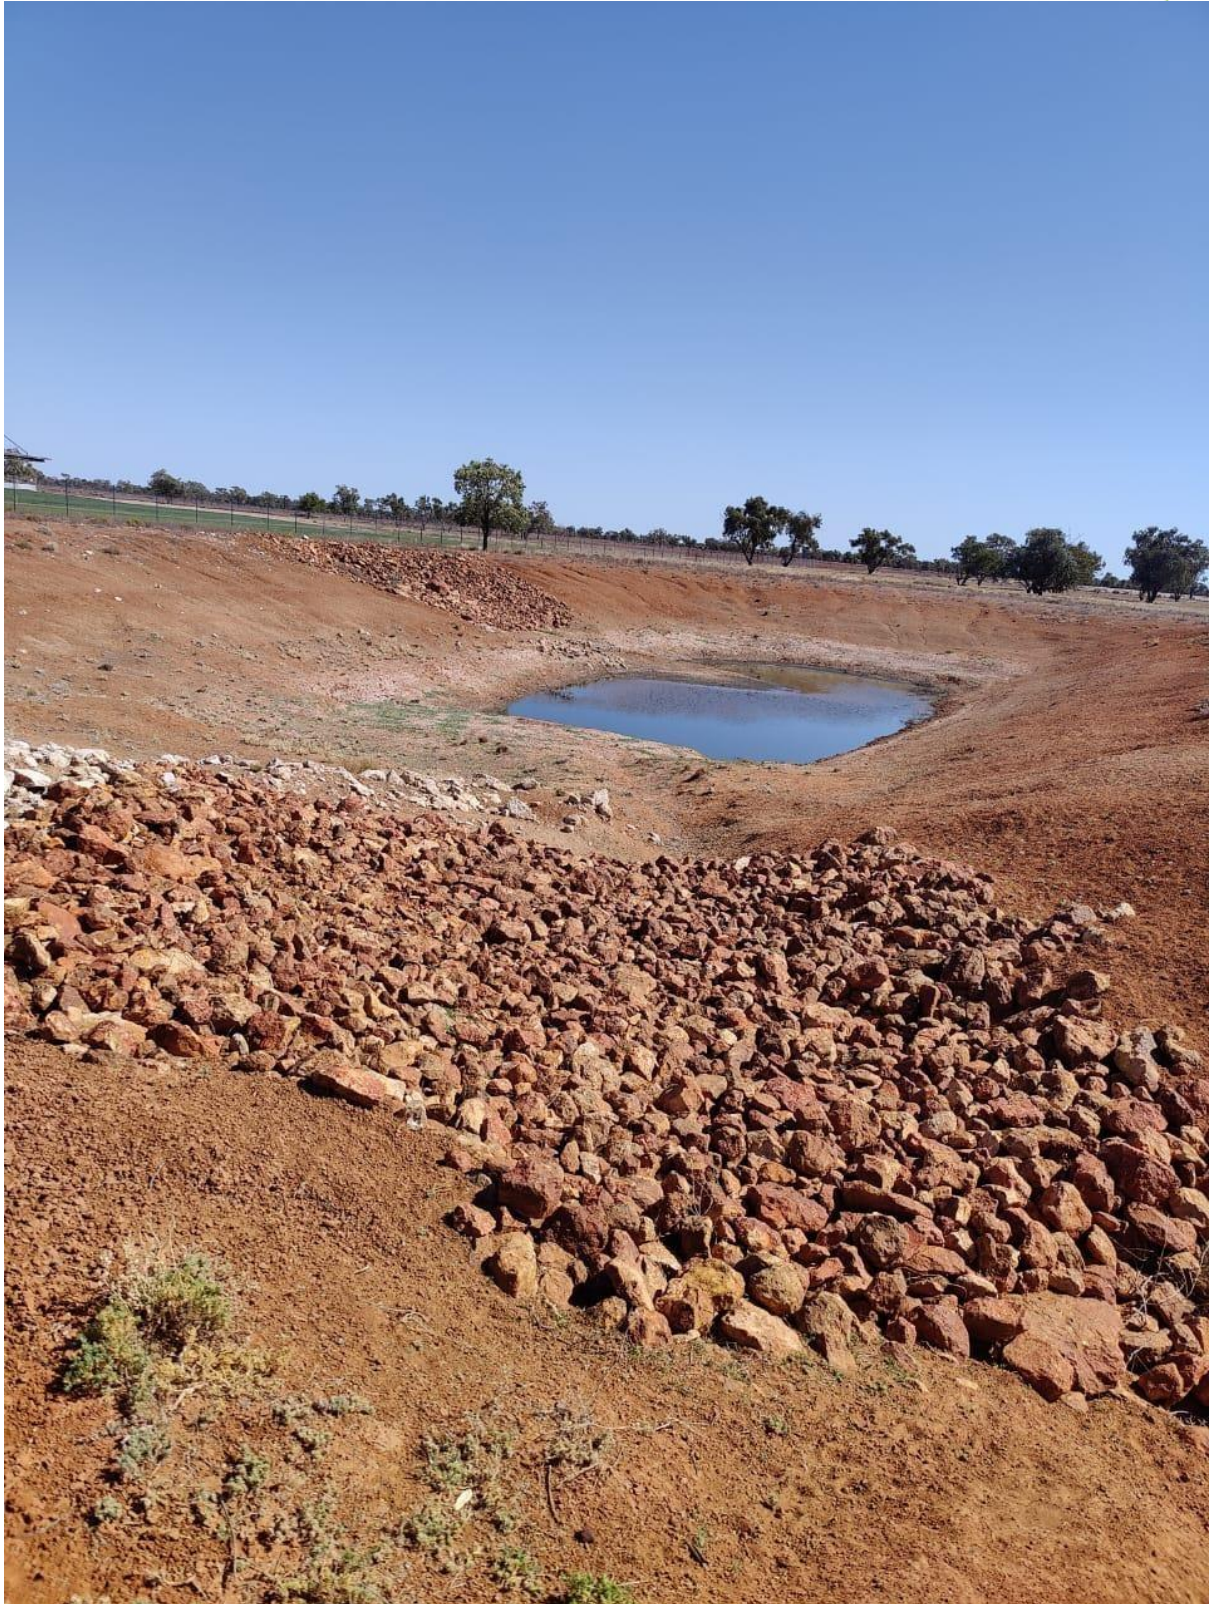
*Figure 7: Sediment Dam*

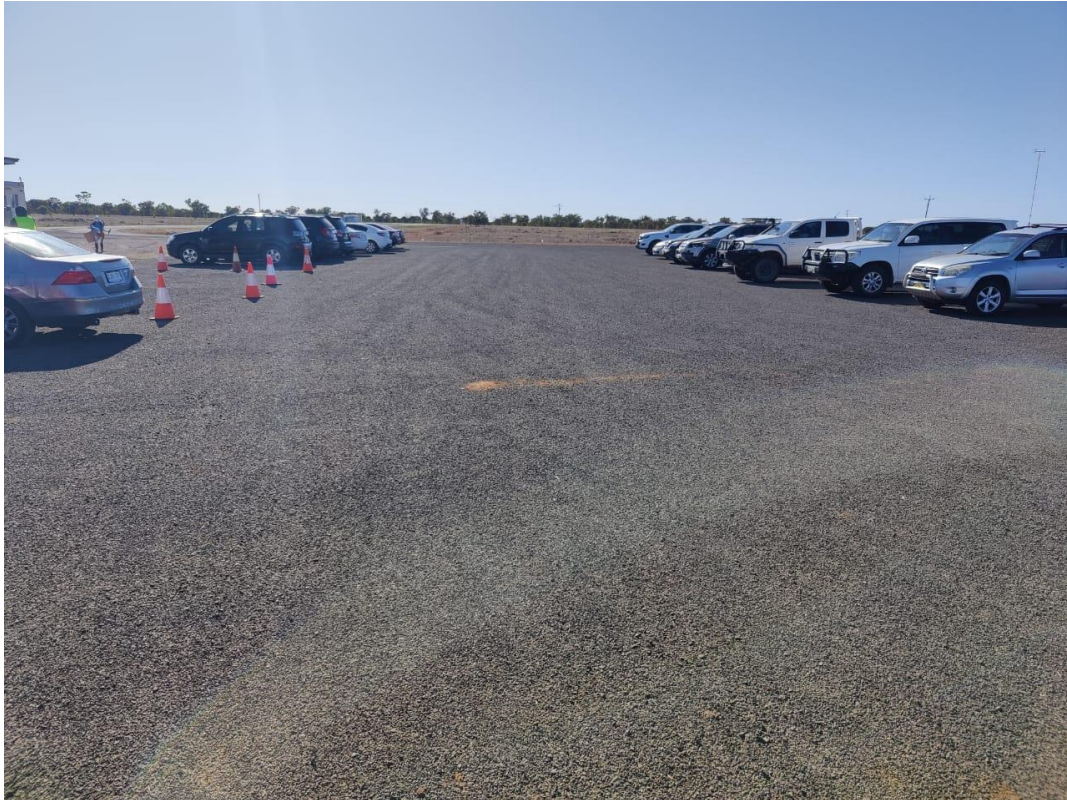
Figure 8: Car park

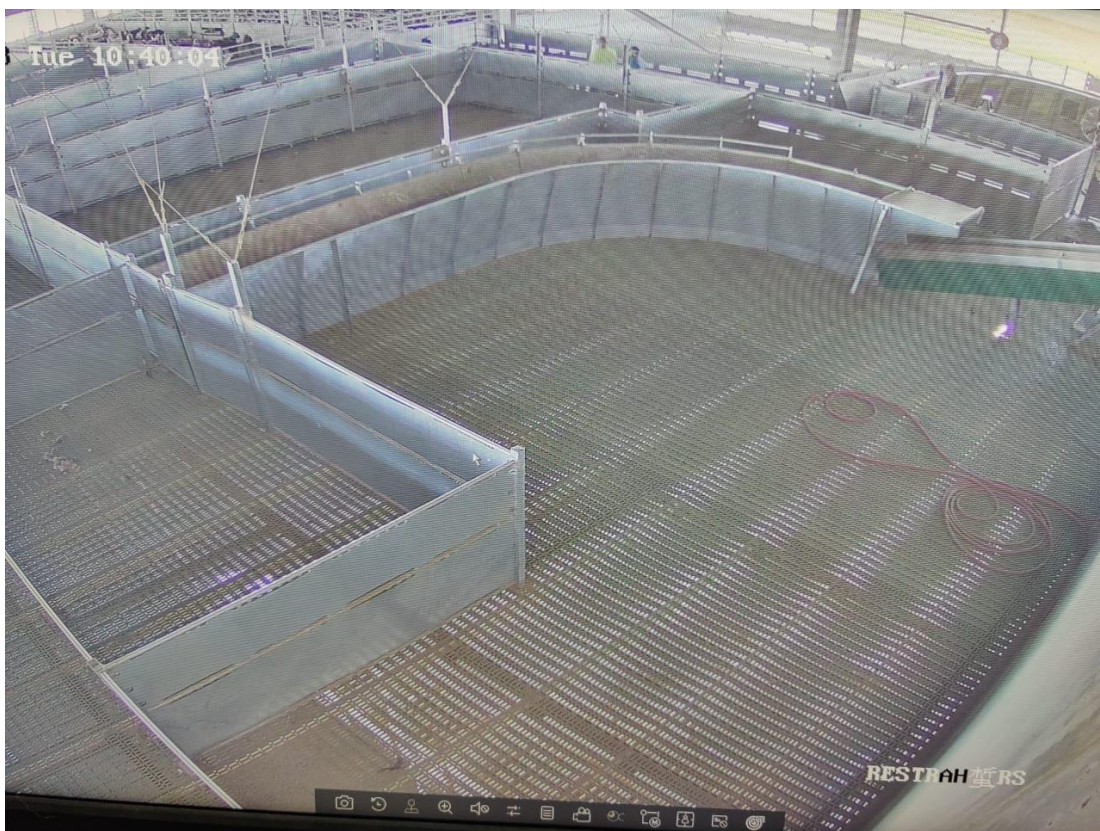
Figure 9: Ramp

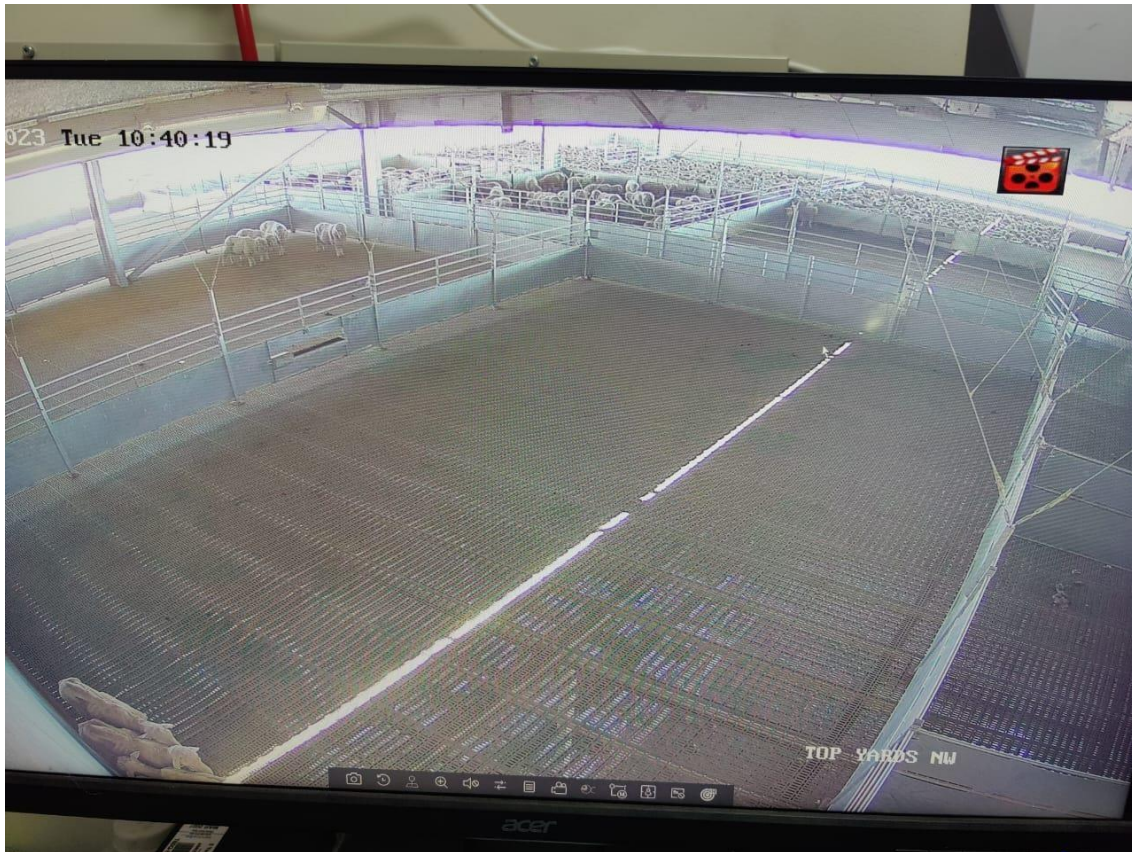
Figure 10: Livestock chilling area

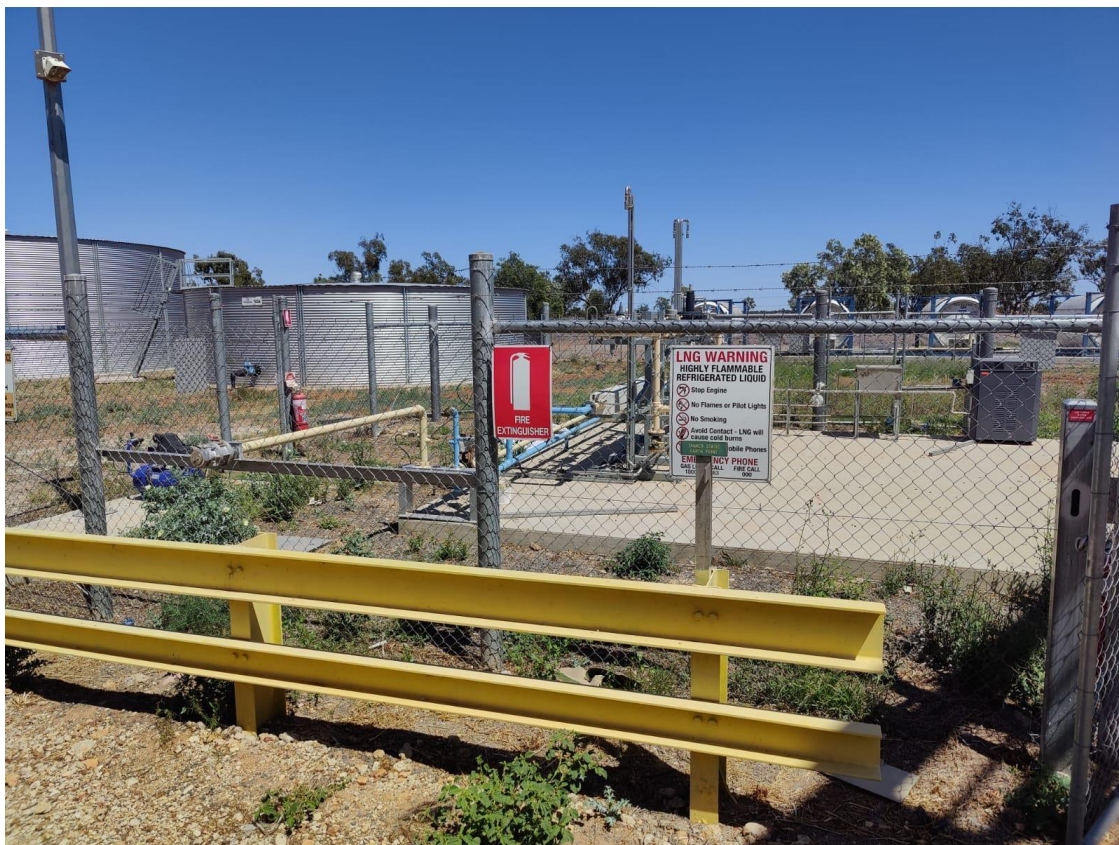
Figure 11: Safety Signs for LPG filling area

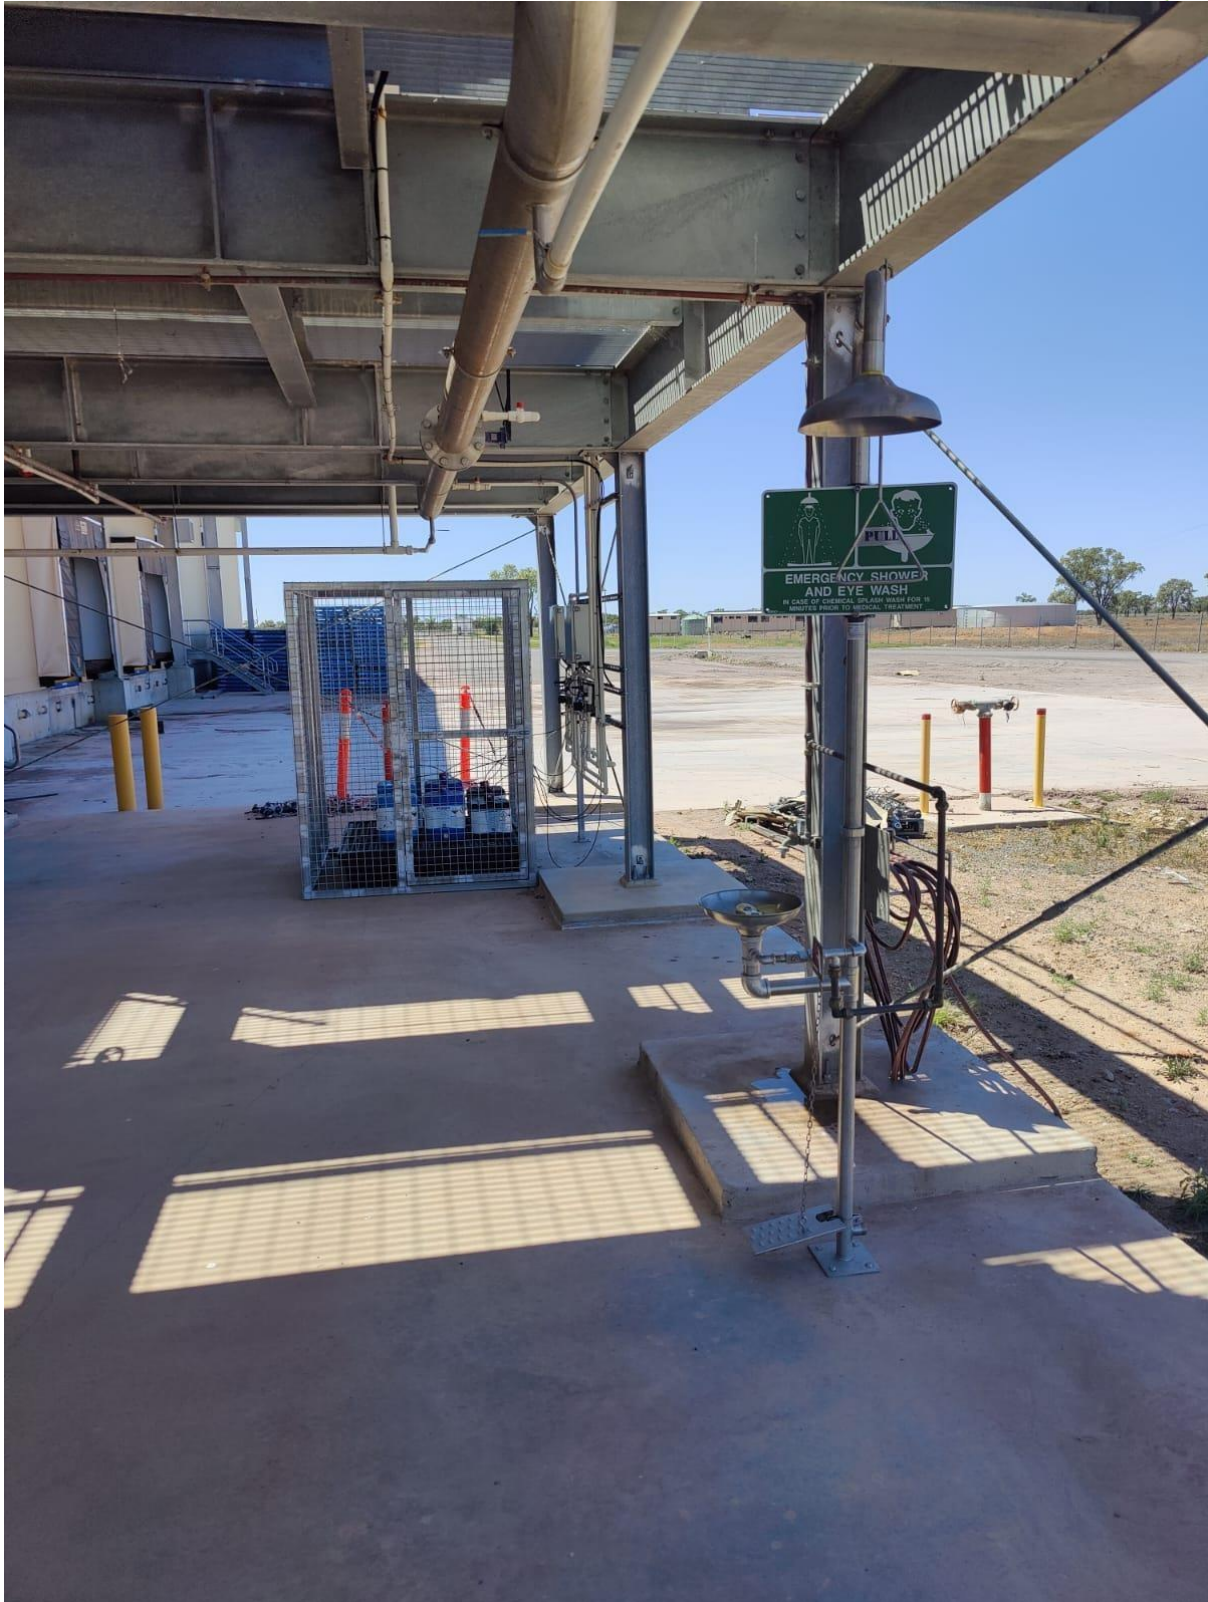
Figure 12: Water dosing chemical stored on a bunding

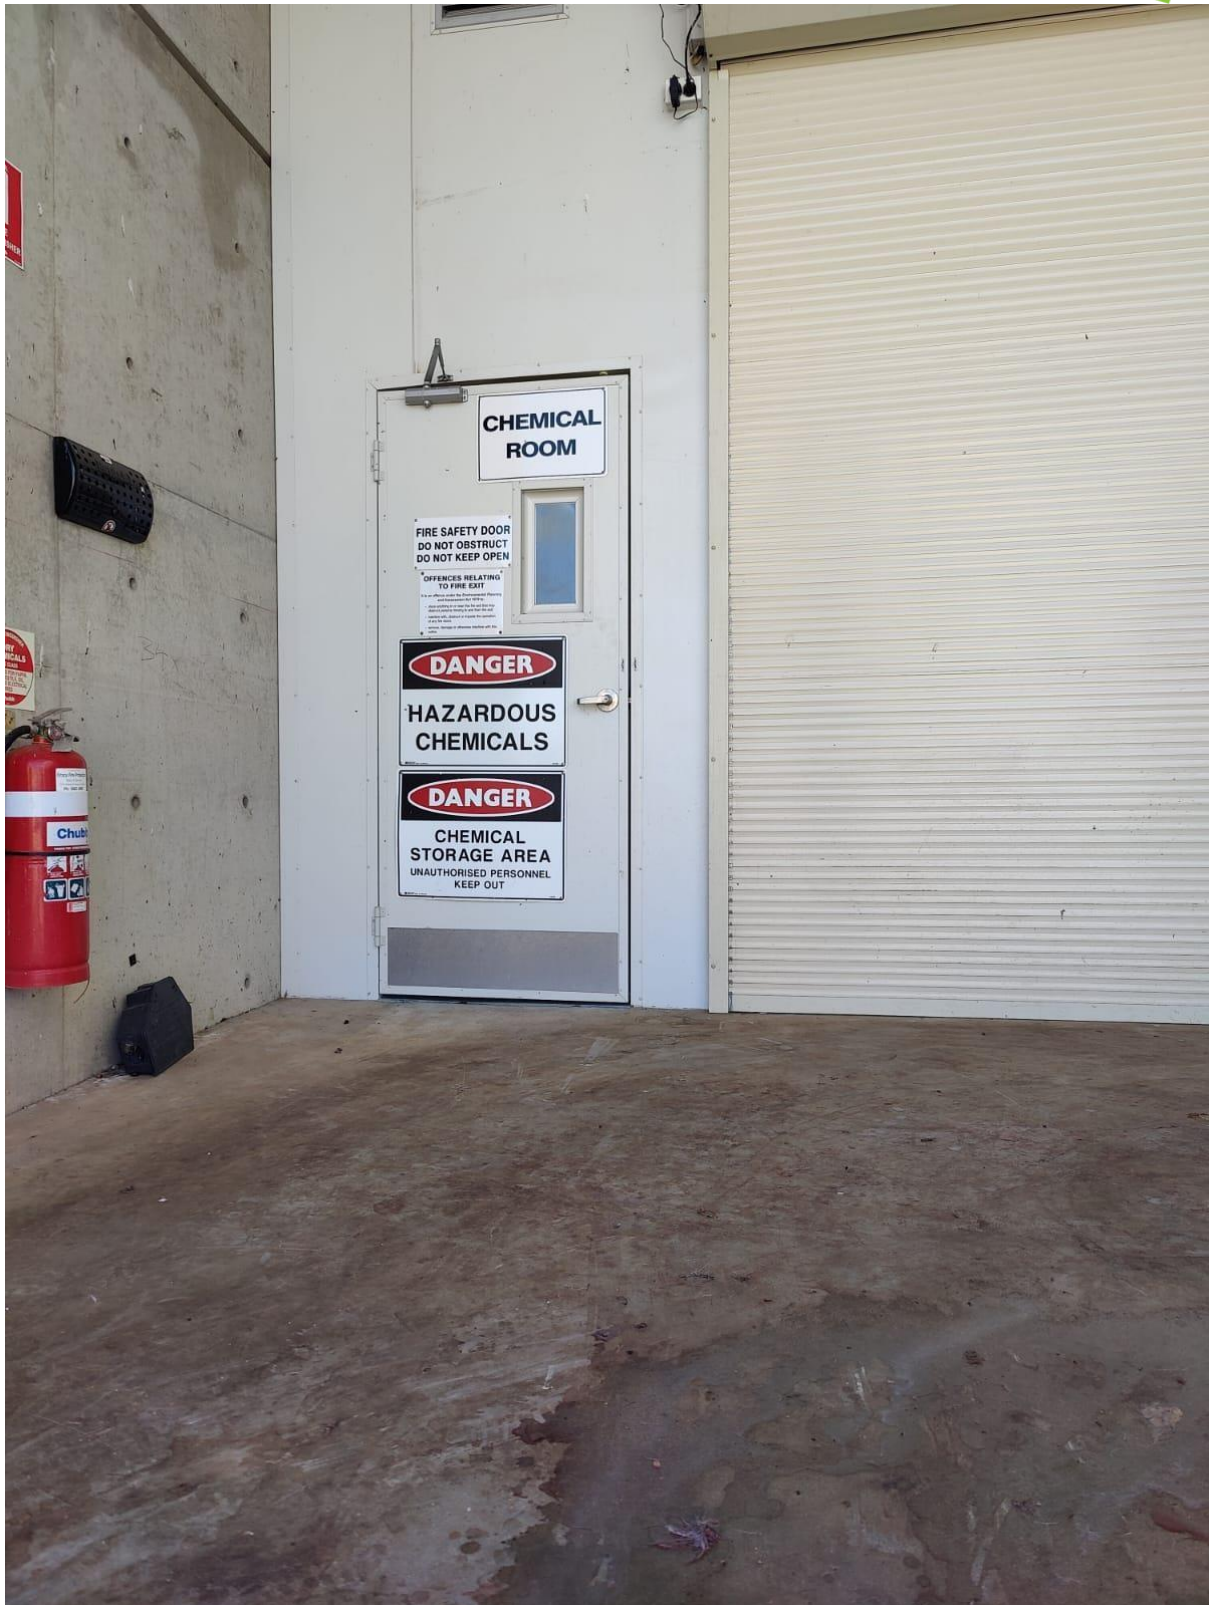
Figure 13: Chemical Room Signage (a)

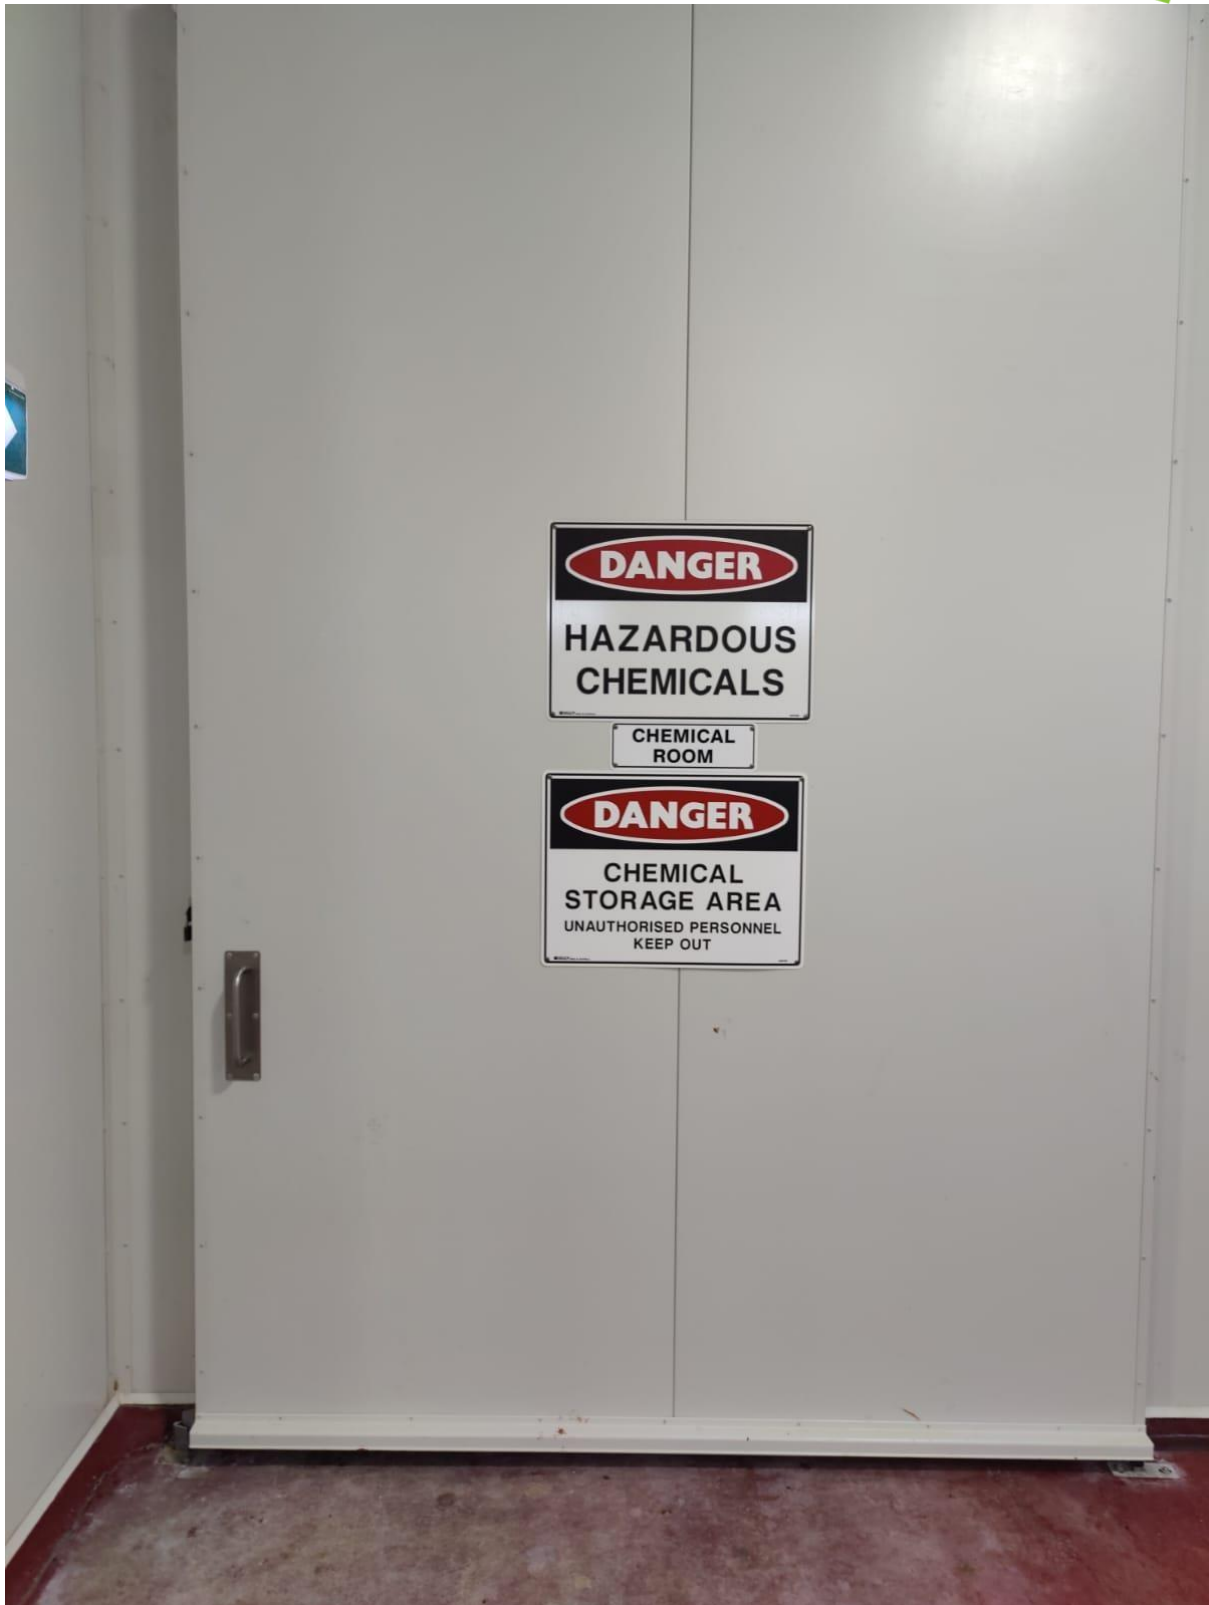
Figure 14: Chemical Room Signage (b)

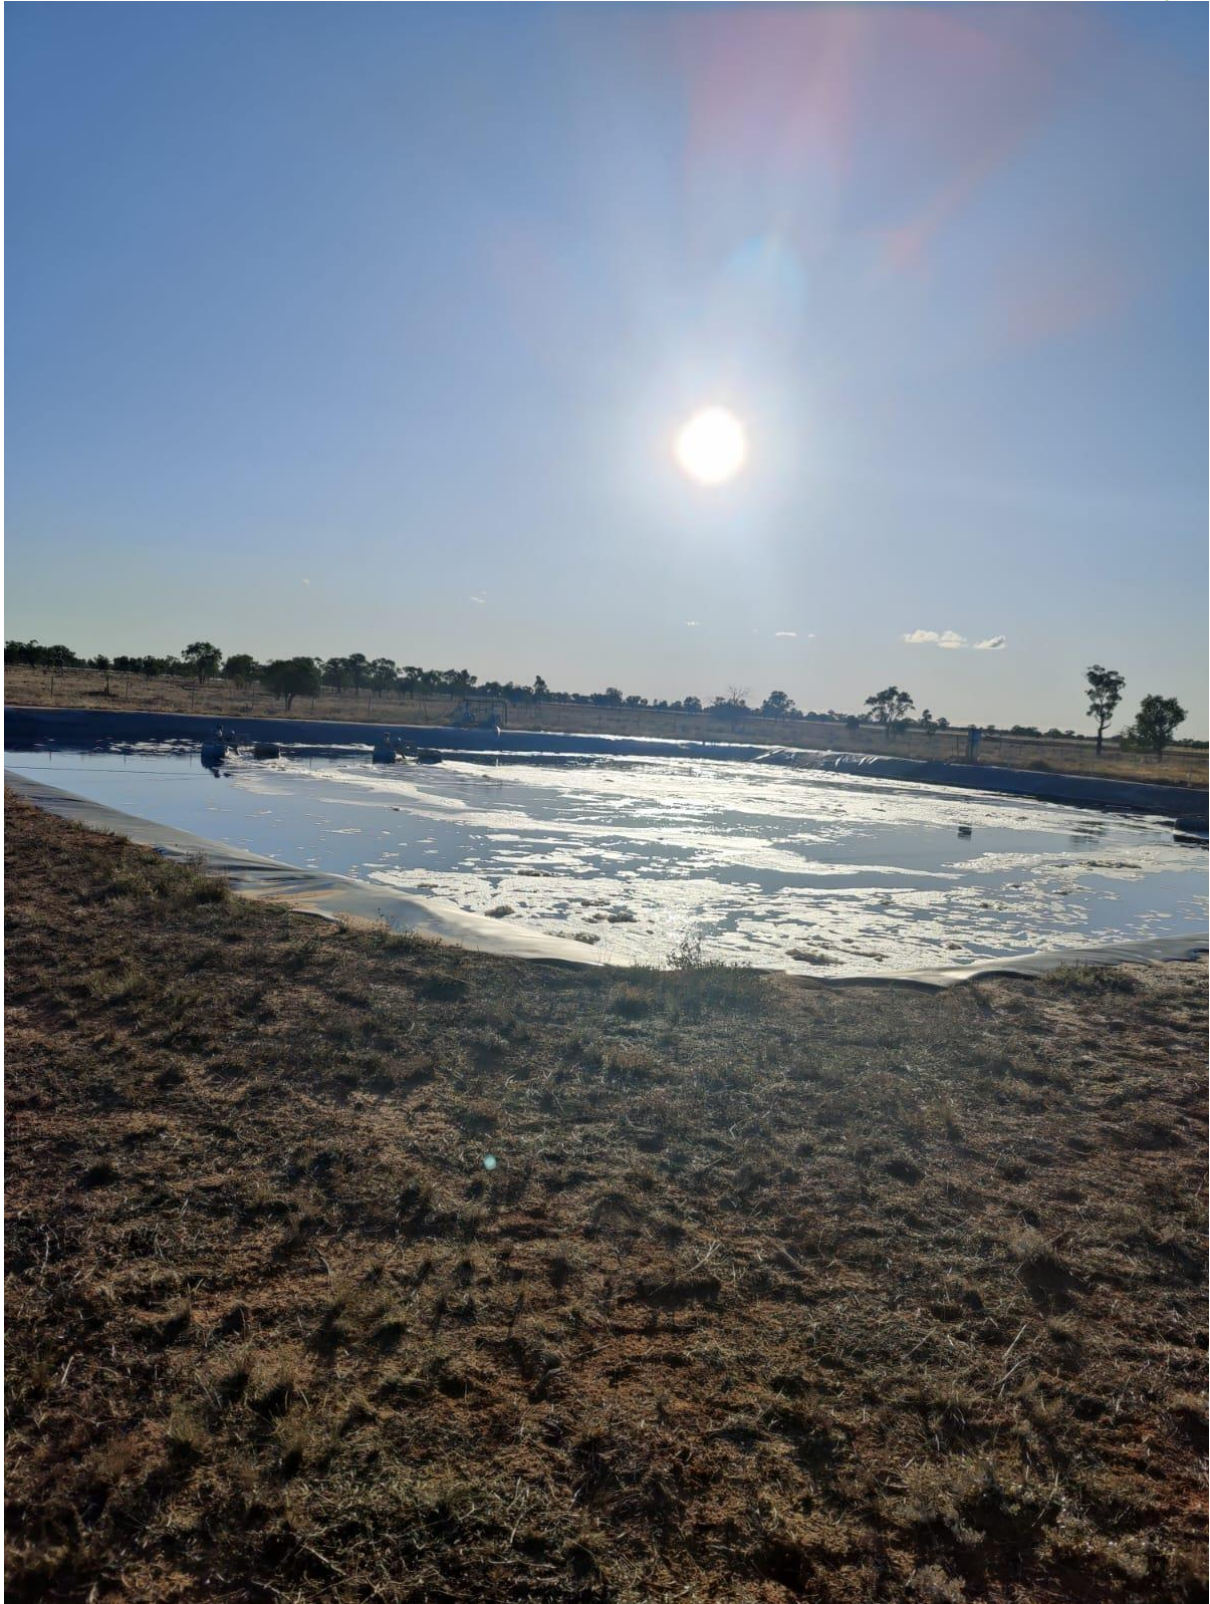
*Figure 15: SBR Pond*

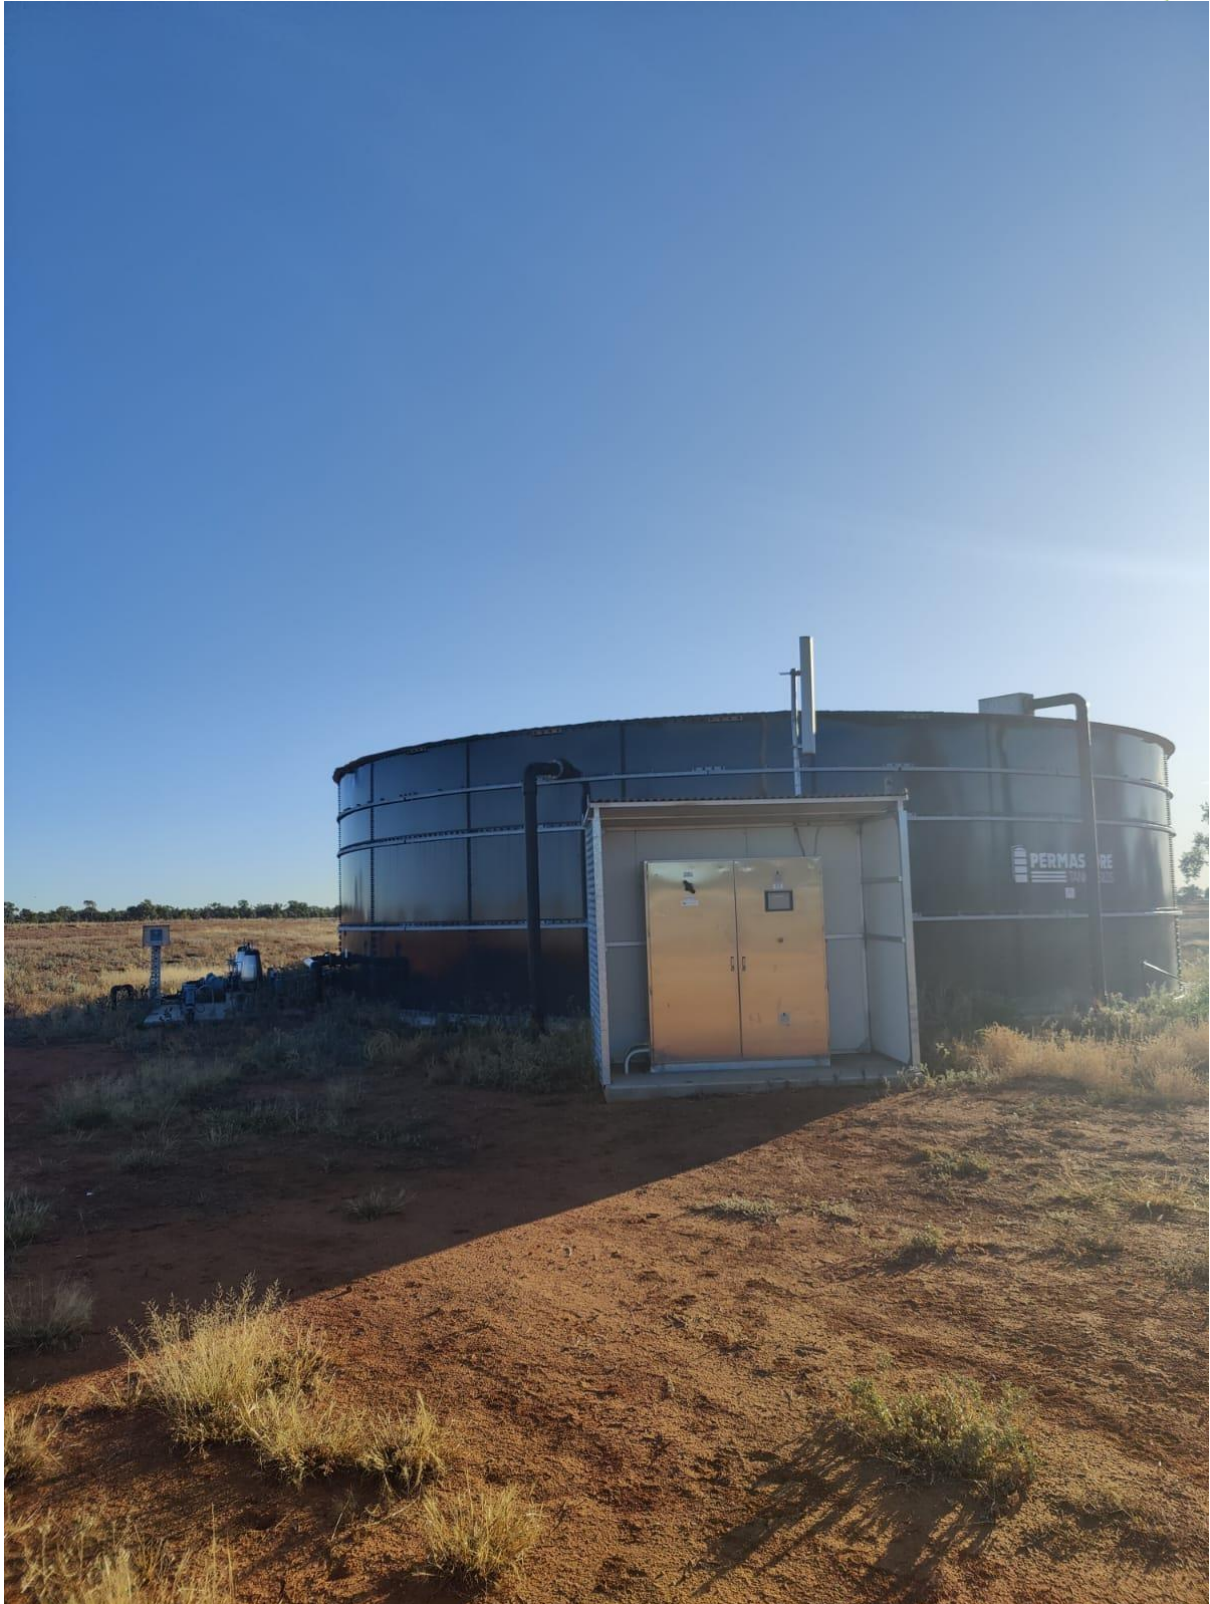
*Figure 16: Balance Tank in WWTP Area*
